**RE: PHASE 1 ARCHAEOLOGICAL IMPACT ASSESSMENT OF THE PROPOSED
BLOUBERGSTRAND EAST-WEST ACTIVITY/MOBILITY LINK FOR BIG BAY
DEVELOPMENT**

**DEVELOPMENT OF BIG BAY :
ALIGNMENT OF EAST-WEST ROUTES**

Hawkins Hawkins & Osborn South (Pty) Ltd
Consulting Engineers
Cape Town

5853
November 2002

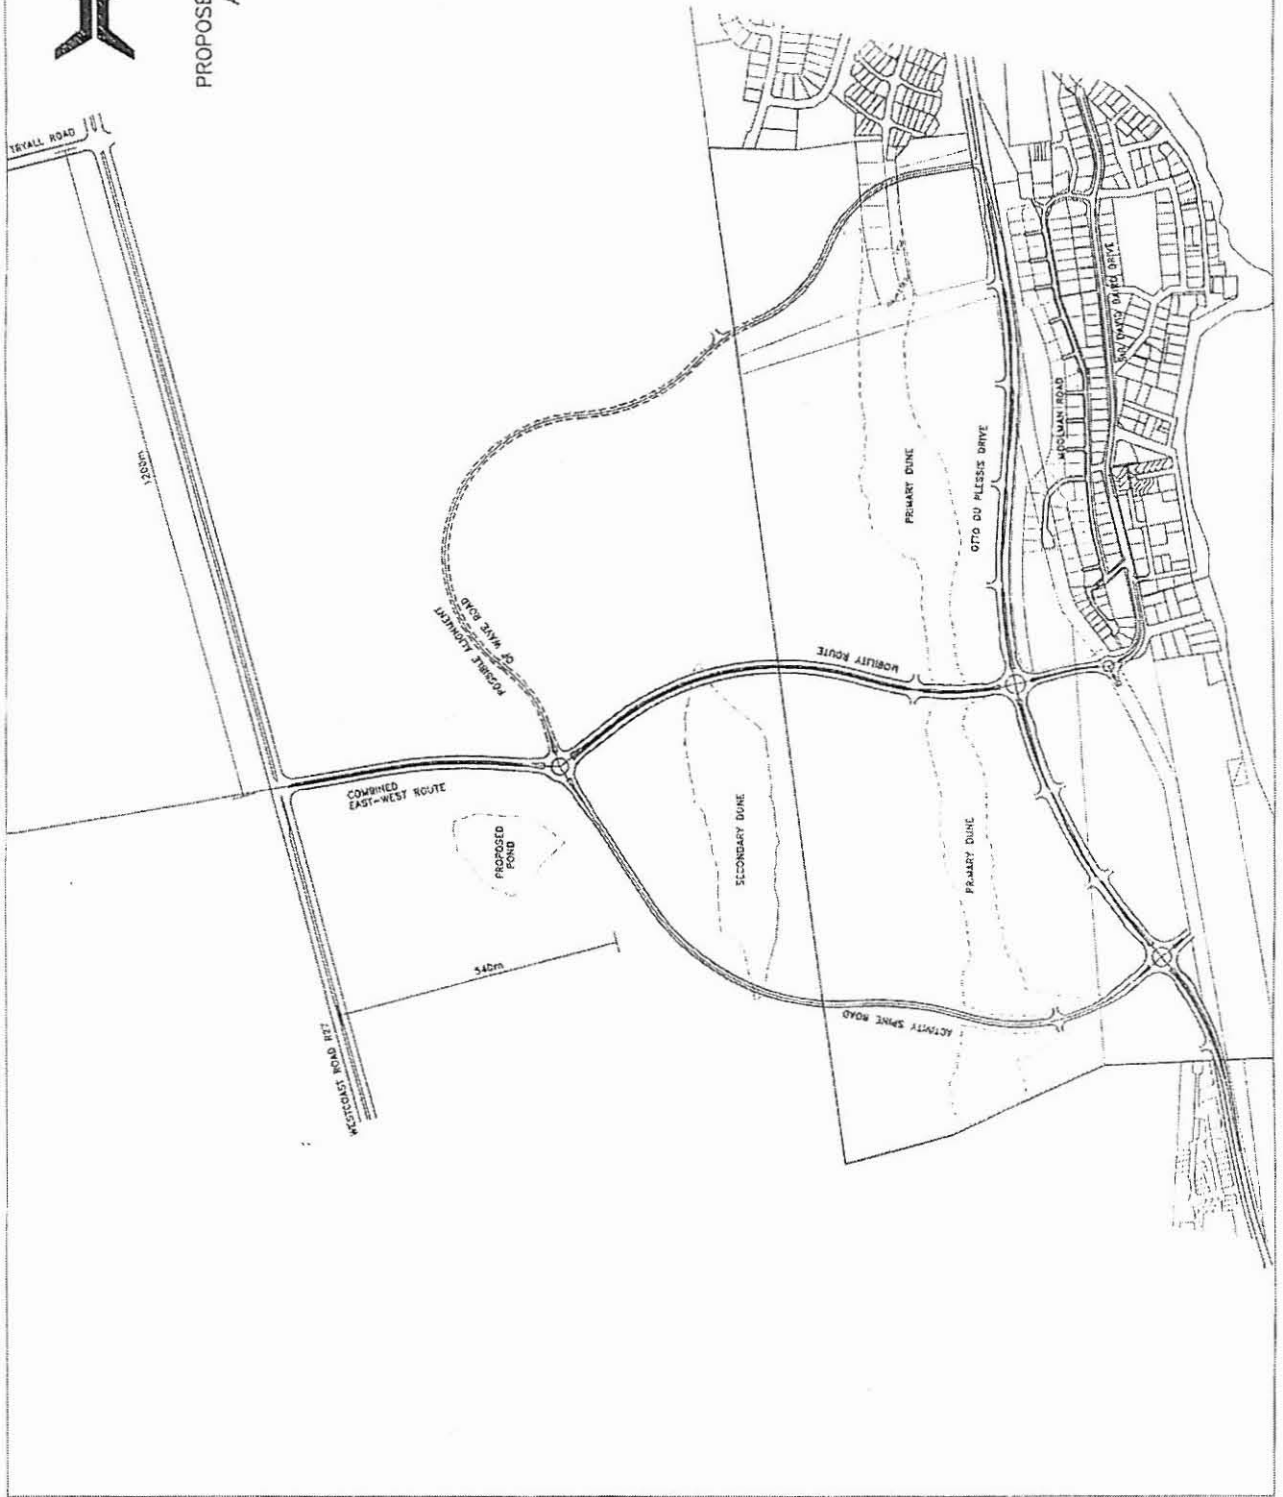
FIGURE 1

PROPOSED EAST-WEST ROUTE
ALTERNATIVE A
(NOT TO SCALE)

Alignment A shown in Figure 1 is the alignment proposed in the East-West Activity Route Strategic Assessment (Ref 2). The proposed route comprises essentially 3 components - the Activity Spine (to the north), the Mobility Route, and the combined route. An alignment has been indicated for the proposed Wave Road (to the south) which shows it forming the fourth leg of the roundabout. We would like to emphasise that this is essentially a notional alignment included to demonstrate that a link between Wave Road and the East-West Route is easily achievable. The

As such the proposed alignment satisfies the geometric and other criteria stated in the previous section. Furthermore, no significant archeological sites or remains were located in the Phase 1 AIA. In terms of the botanical assessment, the three components of the proposed routes pass through an area highly disturbed by the infestation of Port Jackson willow and rooikrans with little evidence of species or habitats worth preserving. Comment was made on the low point immediately north of the proposed traffic roundabout where wetland species were encountered. Both alignments pass well clear of this localised low point which is also under consideration as a likely site for a future detention pond for the drainage of the land belonging to the Department of Public Works once it has been developed.

Topographically the principal feature of the area is a dune orientated north-south immediately west of the Big Bay boundary. The Activity Spine and Mobility Route branches of Alignment A impinge slightly on the northern and southern toe of the dune respectively. An alternative Alignment B shown in Figure 2 was investigated. Given the geometric constraints it is not feasible to offset the Activity and Mobility branches simultaneously. Since the southern toe of the dune would be affected more than the northern toe, in this alternative alignment the proposed traffic roundabout would be located approximately 80m to the south of the original position which in turn would shift the Mobility branch approximately 30m to the south close to toe of the dune. The route geometry would be adjusted accordingly.

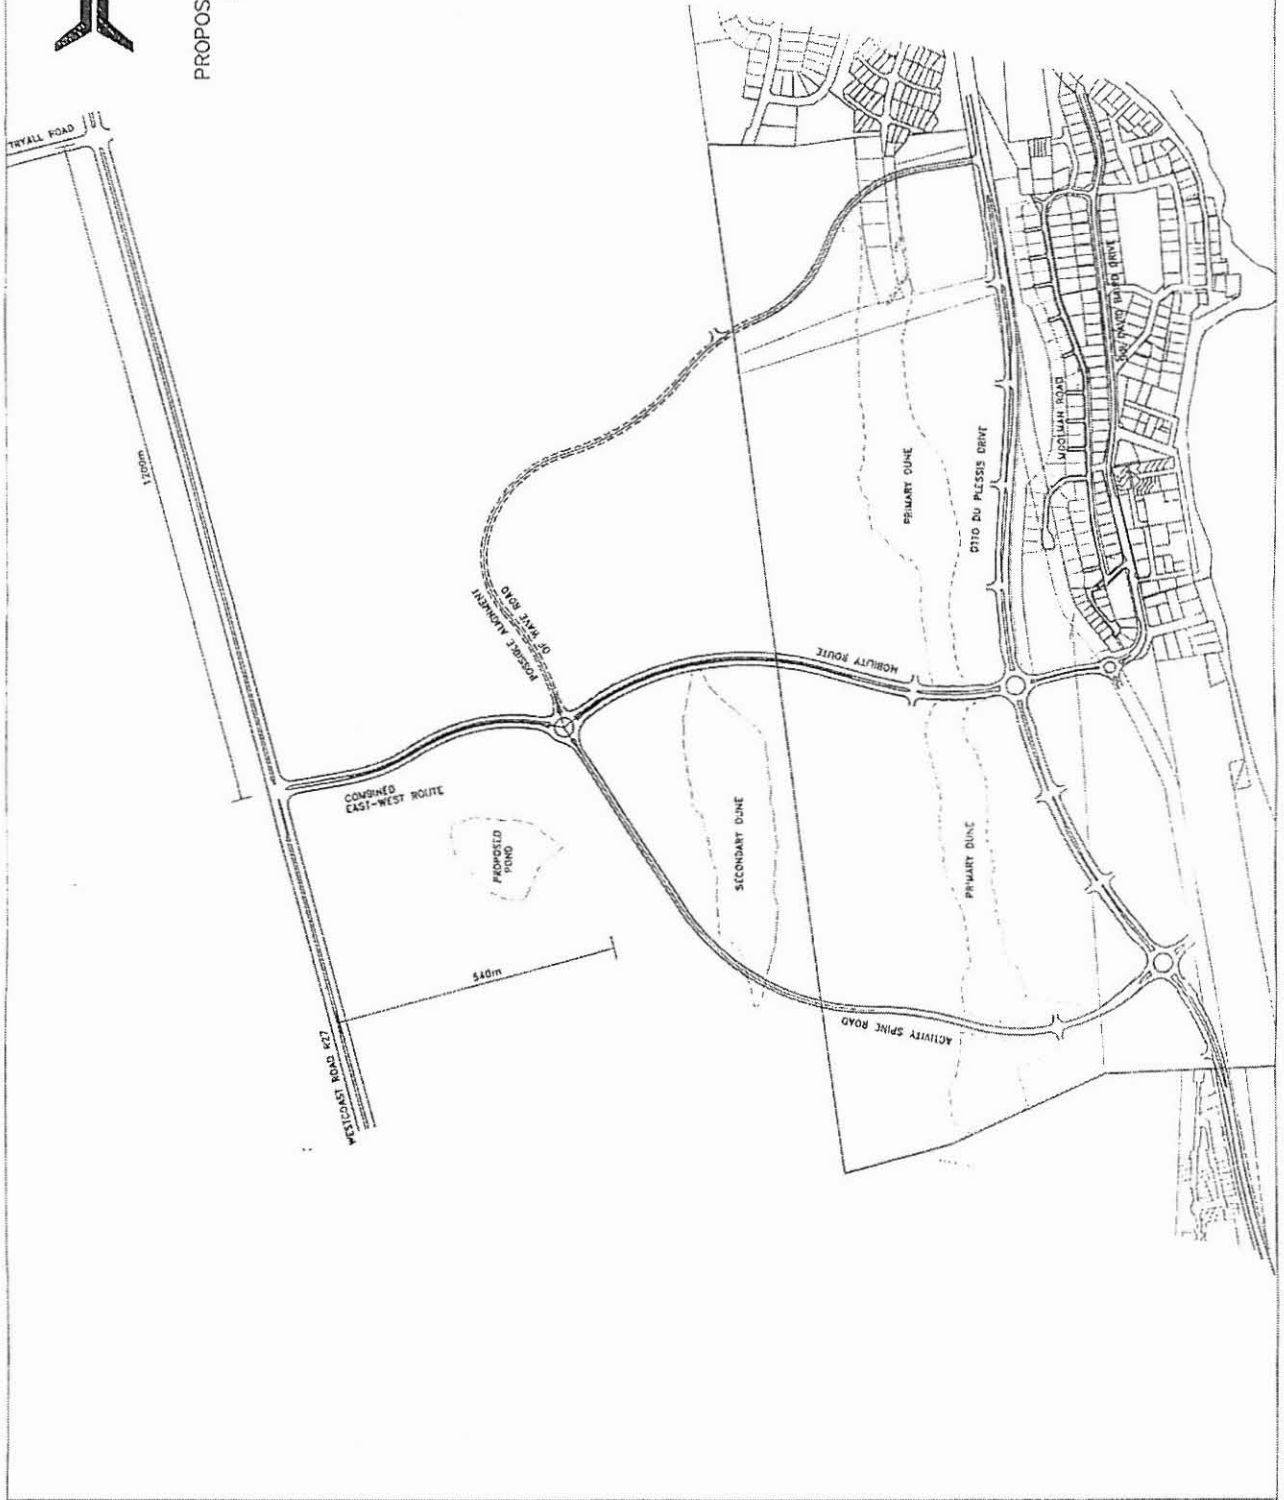
FIGURE 2

PROPOSED EAST-WEST ROUTE
ALTERNATIVE B
(NOT TO SCALE)

While Alternative B would to some degree reduce the effect on the north-south dune, it would be achieved at the expense of introducing a degree of undesirable (but not unachievable) curvilinearity in the alignment of the combined route on the approach to the future major interchange.
