**ARCHAEOLOGICAL IMPACT ASSESSMENT
THE PROPOSED SANDRIFT OXIDATION PONDS
AND SEWER PIPELINE
NORTHERN CAPE**

**AUGUST
2011**

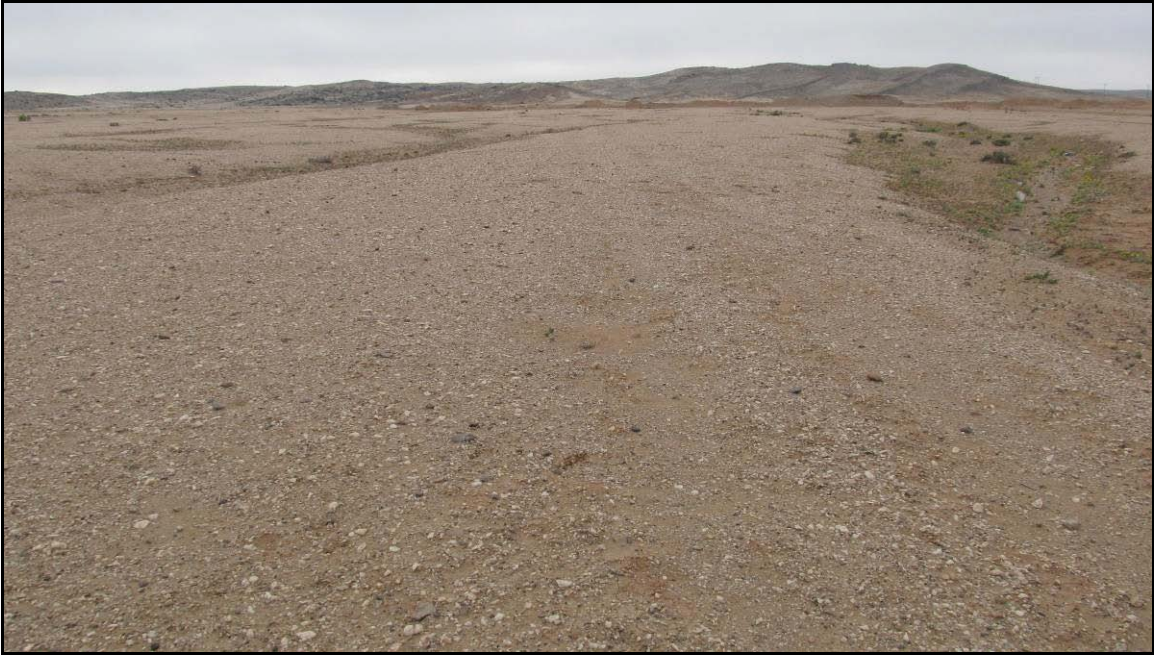
Figure 4. View of the site facing south east. Note the drainage channels

The proposed site for the oxidation ponds is situated on the right hand side of the road and about 1.5 kms before the entrance to the small township (Figures 4 & 5). The site is fairly level and covered in wind blown sand, small stone and some larger rocks. There are several gravel tracks that intersect the site. A recently graded road has also been made. Drainage channels are also visible on the landscape and in the surrounding area. There are, no significant landscape on the proposed site, which is featureless and slopes slightly from south to north. The proposed site is quite degraded. Surrounding land use is vacant land (mainly used for small stock grazing) and extensive diamond mining. Much of the surrounding lands to the west of the `main' road is owned by the Trans Hex Diamond Mining Company.

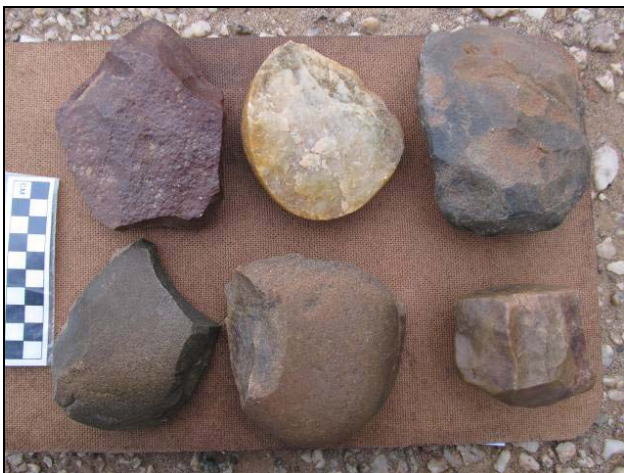
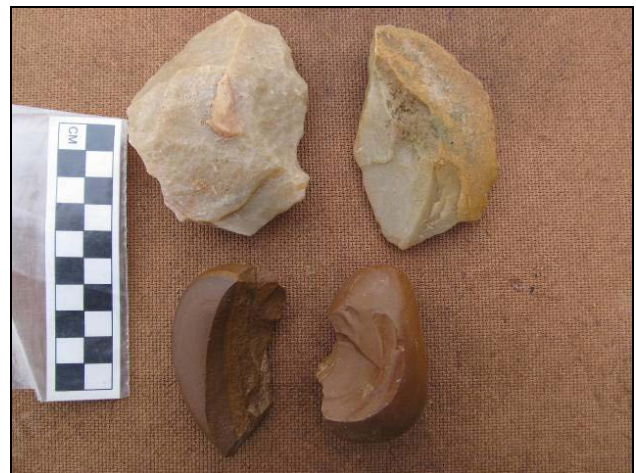
Eleven stone implements (116-126) were documented in the footprint area for the proposed oxidation ponds. There is no spatial distribution or integrity to the finds and they all occur randomly and unevenly over the surrounding landscape. No organic remains such as pottery, ostrich eggshell or bone were found. The tools are in highly patinated quartzite and chalcedony. Quartzite is locally available, but fine grained chalcedony would have washed down the river from higher upstream and were prized by the early inhabitants of the area for the production of stone artefacts. Most of the tools are utilized, modified and retouched flakes, chunks and smashed cobbles. Only one round core (120) was found among the small collection. One ESA flake (116) was also counted, while the remainder of the tools is assigned to the MSA and LSA.

Figure 9. Artefacts from the proposed oxidation ponds. Scale is in cm

Figure 10. Artefacts from the proposed oxidation ponds. Scale is in cm

The small numbers and the isolated and disturbed context in which they were found mean that the remains have been rated as having low archaeological significance.

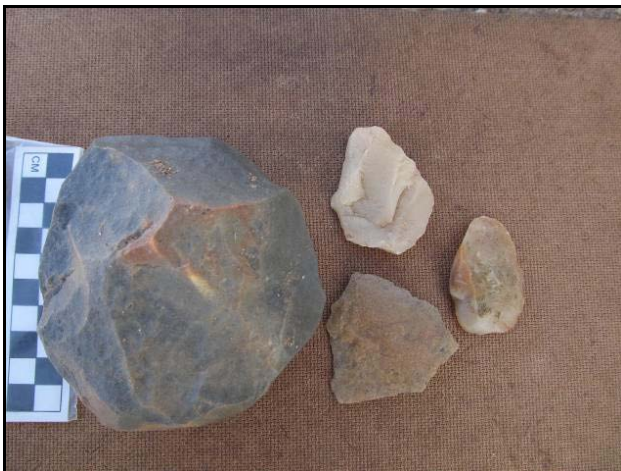
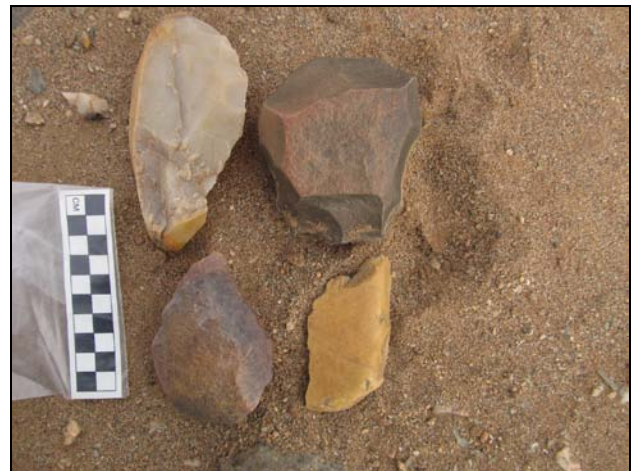
Sixteen archaeological occurrences (212-231) numbering 19 stone tools were documented within the area identified as the proposed sewer pipeline.

The tools are not unlike those found in the footprint area of the proposed oxidation ponds and comprise two cores (214 & 231), one small bifacial flake (213), a retouched pointed flake (214), flakes, chunks and smashed and broken cobbles. The material used is quartzite and chalcedony and all the tools are highly patinated. The remains are spread very thinly and unevenly over the surrounding landscape. No activity areas or evidence of any human settlement were recognized. No organic remains such as pottery, bone or ostrich eggshell was found.

Figure 11. Collection of tools from the proposed sewer pipeline. Scale is in cm

Figure 12. Collection of tools from the proposed sewer pipeline. Scale is in cm.

The small numbers isolated and disturbed context in which they were found means that the remains have been rated as having low archaeological significance.

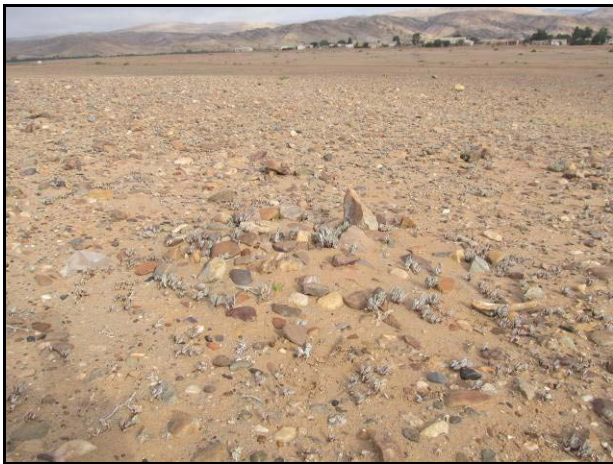
Figure 13. Grave 1

Five graves were documented in, or close to the alignment of the proposed sewer pipeline (Figures 13-16 and refer to Figures 17 & 18 in the Appendix). None of the graves show Christian influences (such as rectangular mounds of stone, headstones or footstones), and are more traditional in form with circular stone cairns covering them. These types of graves are common in the Richtersveld landscape (Halkett 1999), and are often encountered alongside the roads.

Grave 1 (S28 24.789 E16 46.849) and Grave 5 (S28 24.741 E16 46.944) may be in the actual alignment of the pipeline servitude. The graves are very visible in an otherwise featureless landscape. Grave 1 is less visible, as the cairn appears to have collapsed. While no grave goods (such as glass bottles, jars, or even marine shellfish) were found, a plastic jar was found alongside Grave 5.

The route for the proposed sewerage pipeline might need to be adjusted to take cognizance of Grave 1 and Grave 5 which are in, or very close to the proposed servitude.

1. The project is deemed to be viable.
2. No archaeological mitigation is required.
3. All graves must be avoided with particular attention to Grave 1 and Grave 5 which are located in or very close to the pipeline servitude. This might require a slight adjustment being made to the route.
4. Should any unmarked human remains, or features such as buried ostrich eggshell caches be exposed or uncovered during excavations and bulk earthworks these must immediately be reported to the South African Heritage Resources Agency (Ms Mariagrazia Galimberti 021 4624502). Burials must not be removed until inspected by the archaeologist and will have to be removed by an archaeologist under a permit issued by SAHRA.

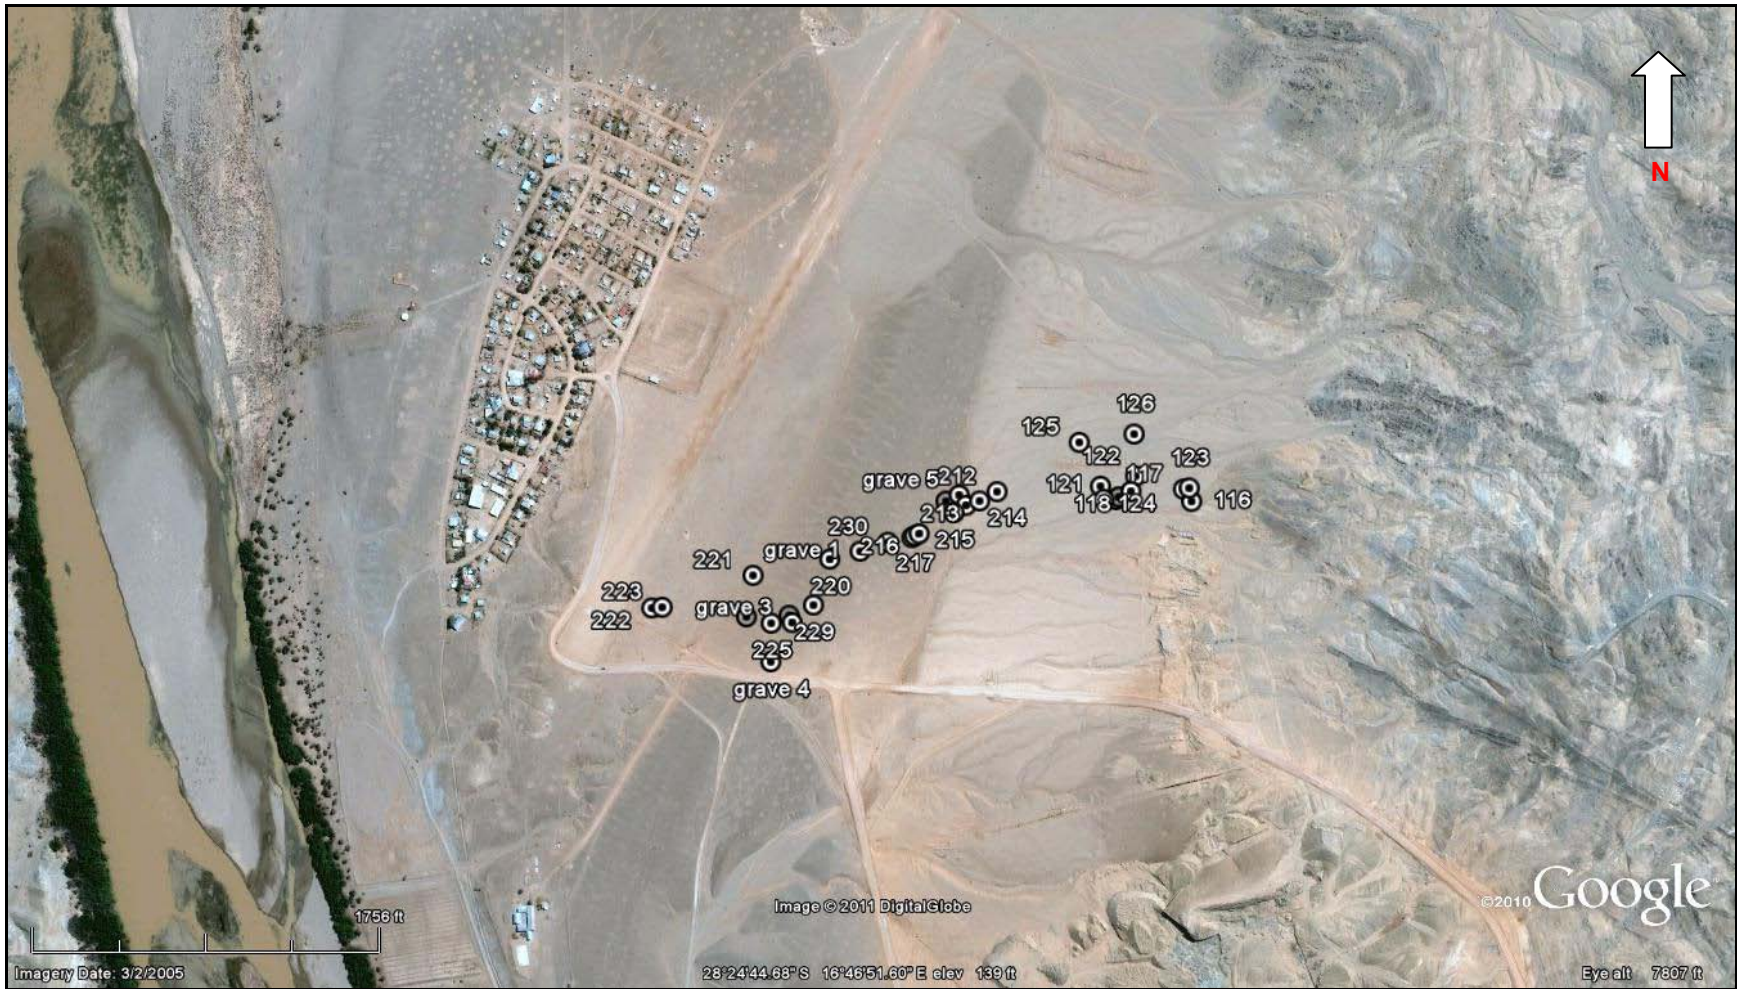
A Google aerial photograph indicating the waypoints of archaeological occurrences documented during the study is illustrated in Figures 17 and 18 in the Appendix.

Figure 17. Waypoints of archaeological finds
