A HERITAGE IMPACT ASSESSMENT  
OF THE AREA AFFECTED BY THE  
RAISING OF THE SCHRODA DAM WALL  
VHEMBE DISTRICT, LIMPOPO PROVINCE

DE BEERS CONSOLIDATED  
(The Venetia Diamond Mine)

E.O.M. HANISCH

May 2005

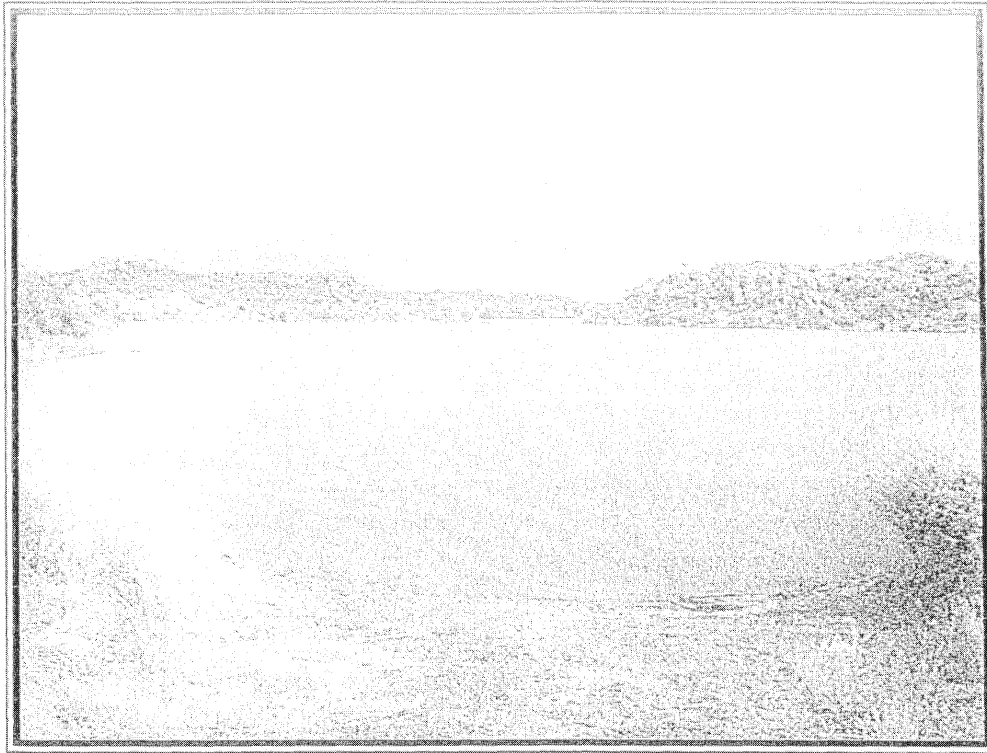
**Figure 1** A view of the Schroda dam looking northwards towards the dam wall. On the horizon on the left hand side of the photo, is the elongated hill, behind which the Schroda Early Iron Age site lies.

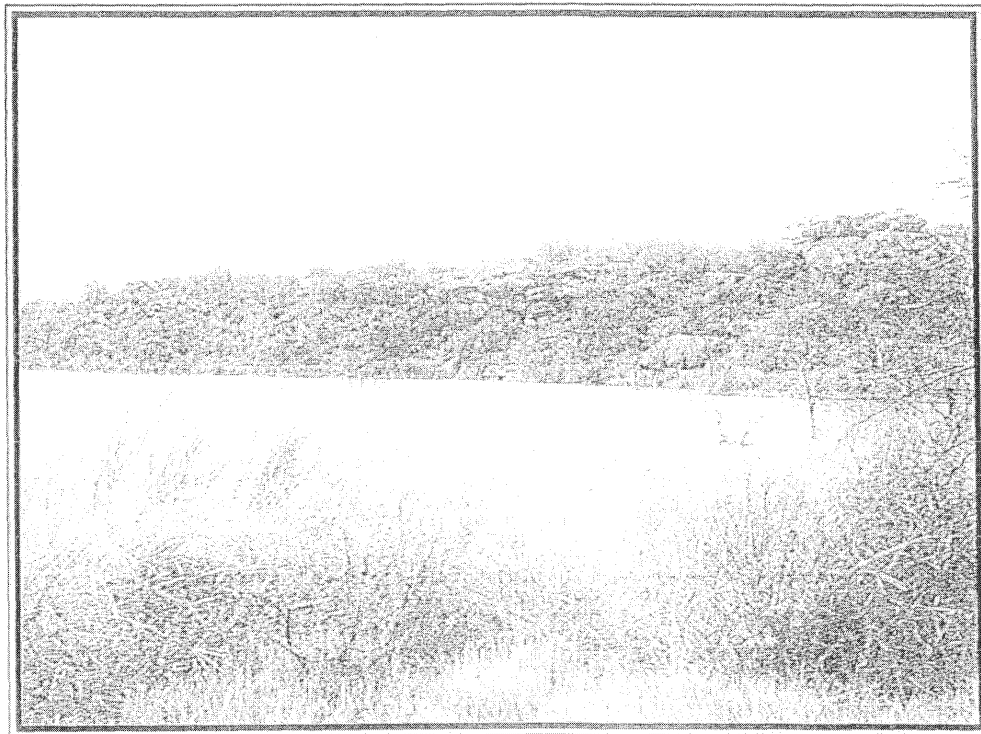
**Figure 2** This photo has been taken from the same position as figure 1 above, but is now looking south eastwards.

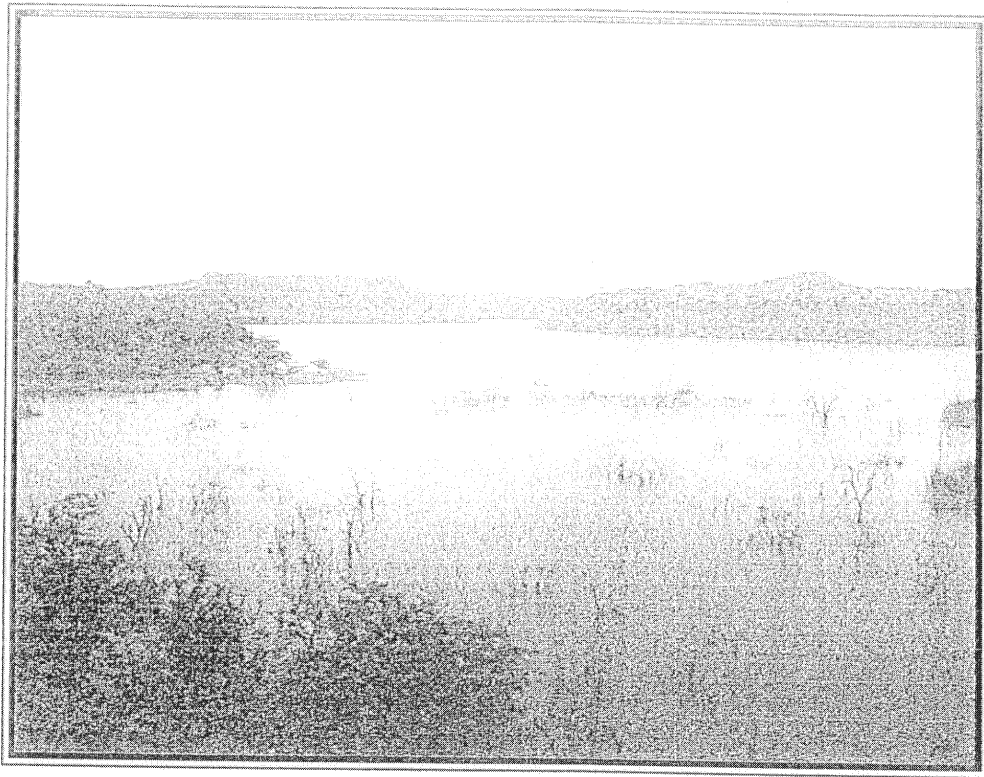
**Figure 3** This photo has been taken from the hills shown in figure 2 and looks towards the dam wall in a north westerly direction

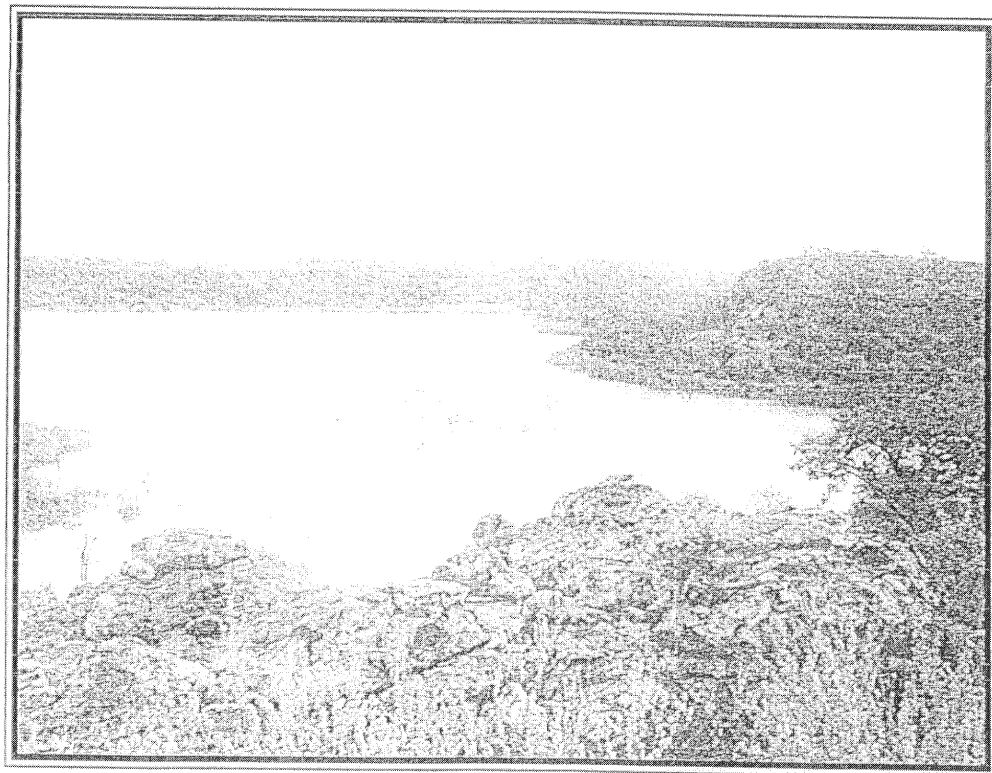
**Figure 4** View looking north eastwards. The area where the fossil deposits are, lies behind the hill on the middle right of the photo.

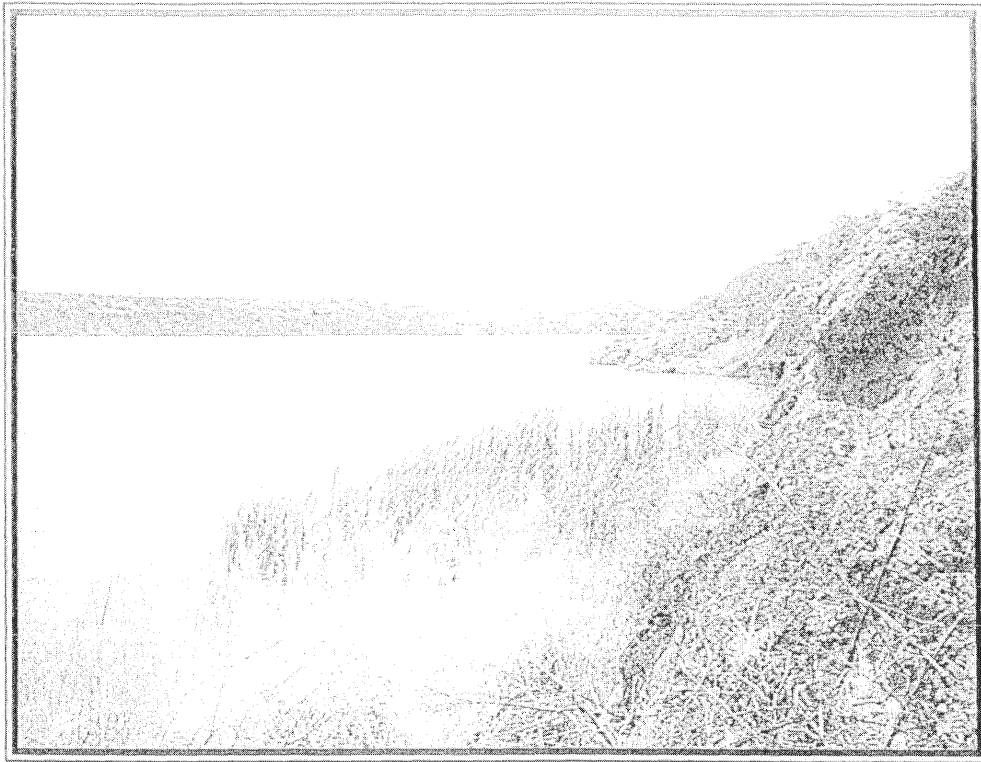
**Figure 5** Here the northern side of the dam can be seen. The photo was taken in a westerly direction.

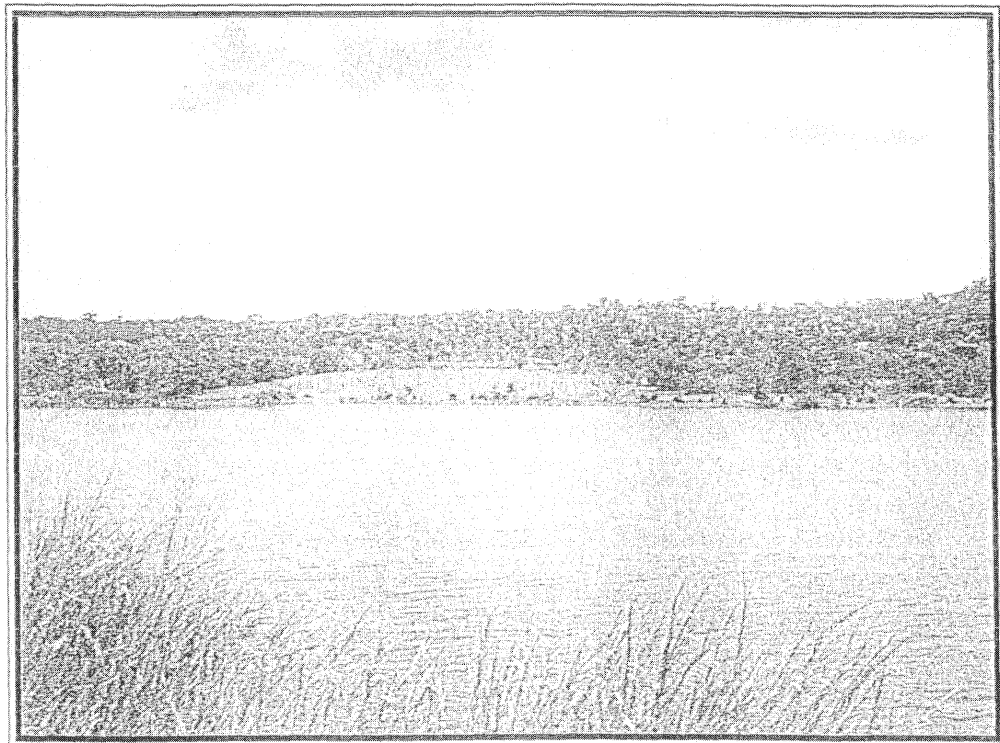
**Figure 6** A photo taken from the northern side of the dam, looking south eastwards. The clearing seen in the centre of the picture is the beginning of the area where the fossils are eroding.

These fossils should be professionally removed by a palaeontologist, and be placed in the Mapungubwe interpretive centre for storage and where possible, exhibited in the new displays that are being planned.

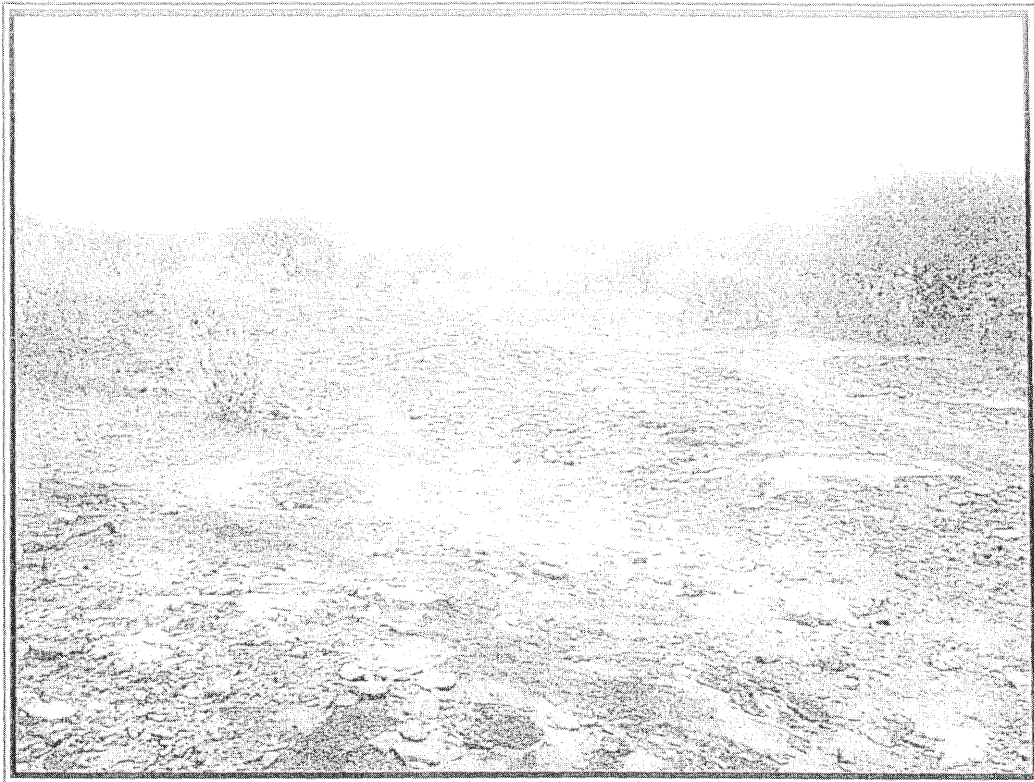
At the time of the survey, three elephants came down to the water, and it was obvious how their weight damages the soft sandstone rock. It is very likely that, given the present numbers of elephants in that section of the park, considerable damage may be done in the future.

**Figure 7** One of the sandstone outcrops where the fossils occur. A game track is clearly visible on the centre right of the photo.

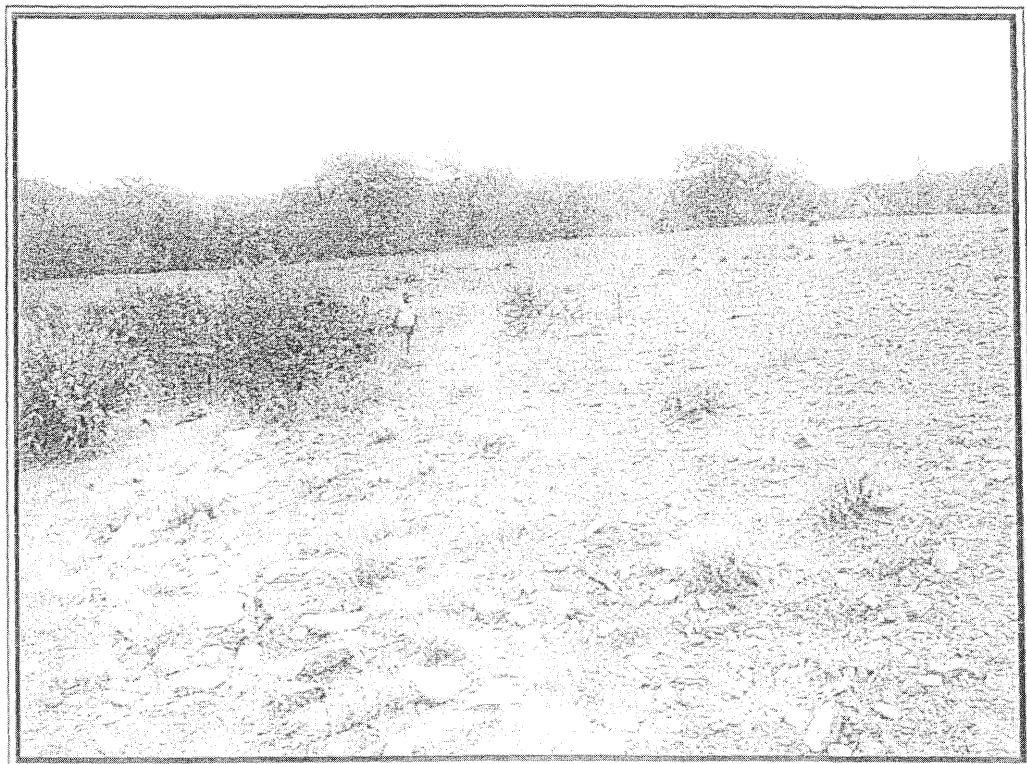
**Figure 8** An area where fossils occur that was damaged by earthworks during the building of the dam.

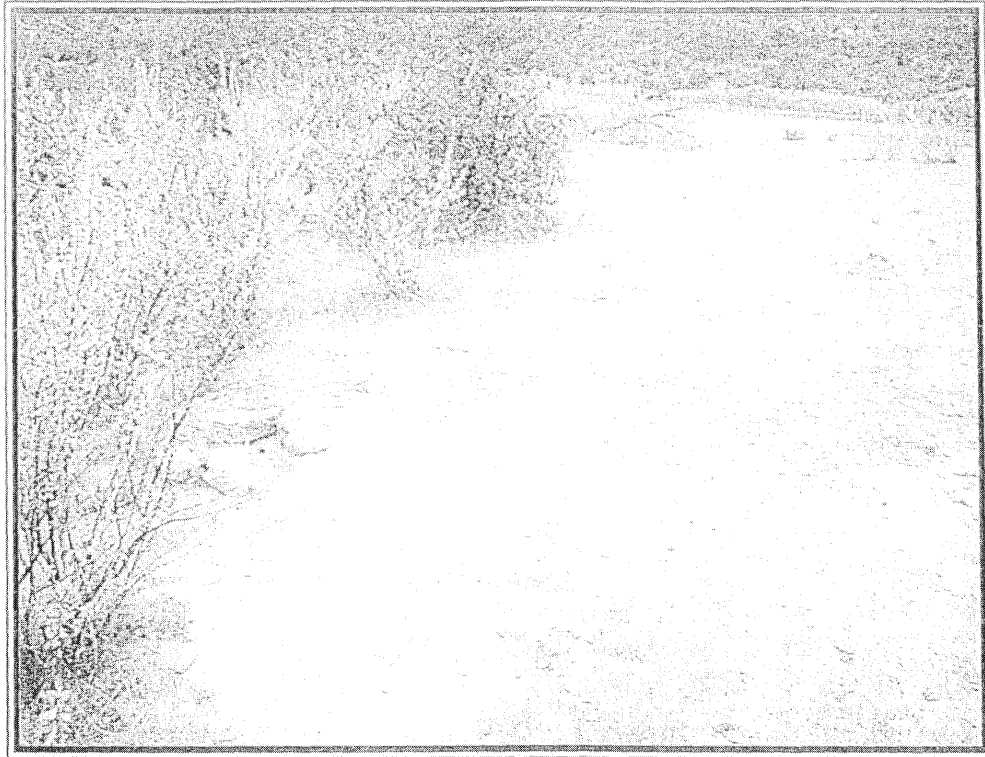
During the current survey, again nothing of archaeological significance was found. However the planned raising of the dam wall will bring the full supply level very close to areas where fossils are eroding out.

**Figure 9** When looking back to the present water level, the edge of the water appears to be far away. However, at this point the slope to the water is very shallow, and when the new full supply line is reached, then the water's edge will be very close to where the photographer is standing.

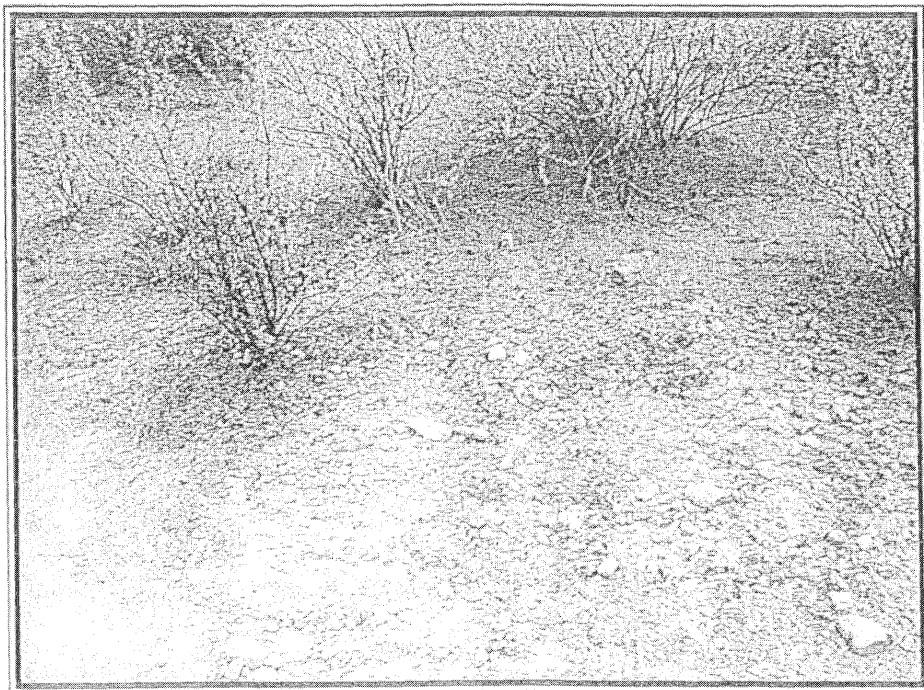
**Figure 10** An area where a lot of fossil bone is eroding out. More appears to be visible that at the time of the original survey.

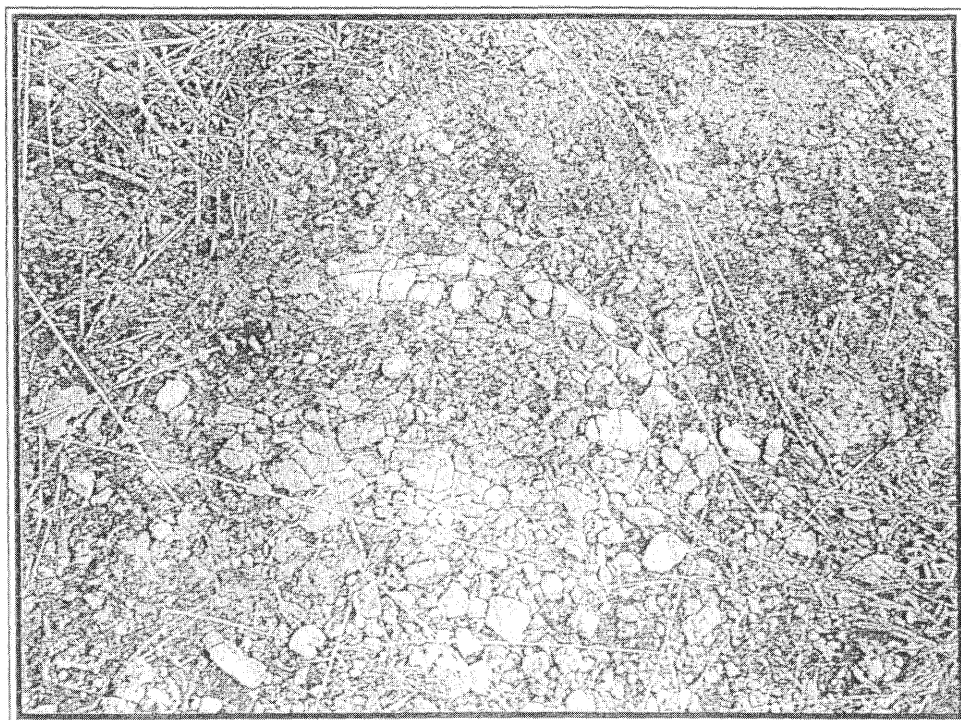
Figure 12 A piece of fossil rib can be seen in the centre of the photo.

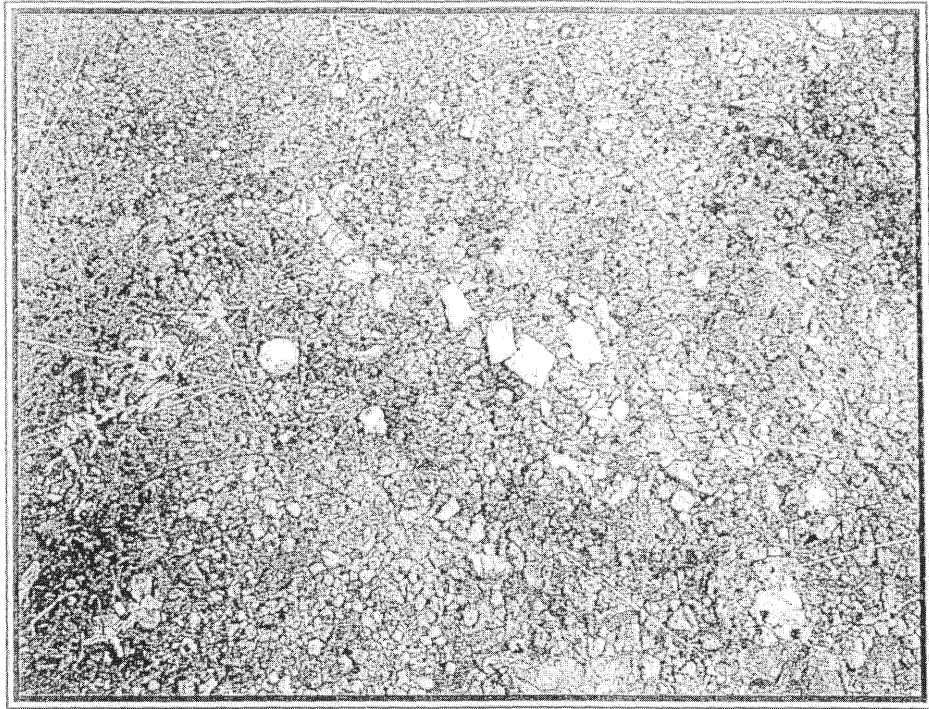
**Figure 13** Fragments of at least two legs bone are extruding from the sandstone.

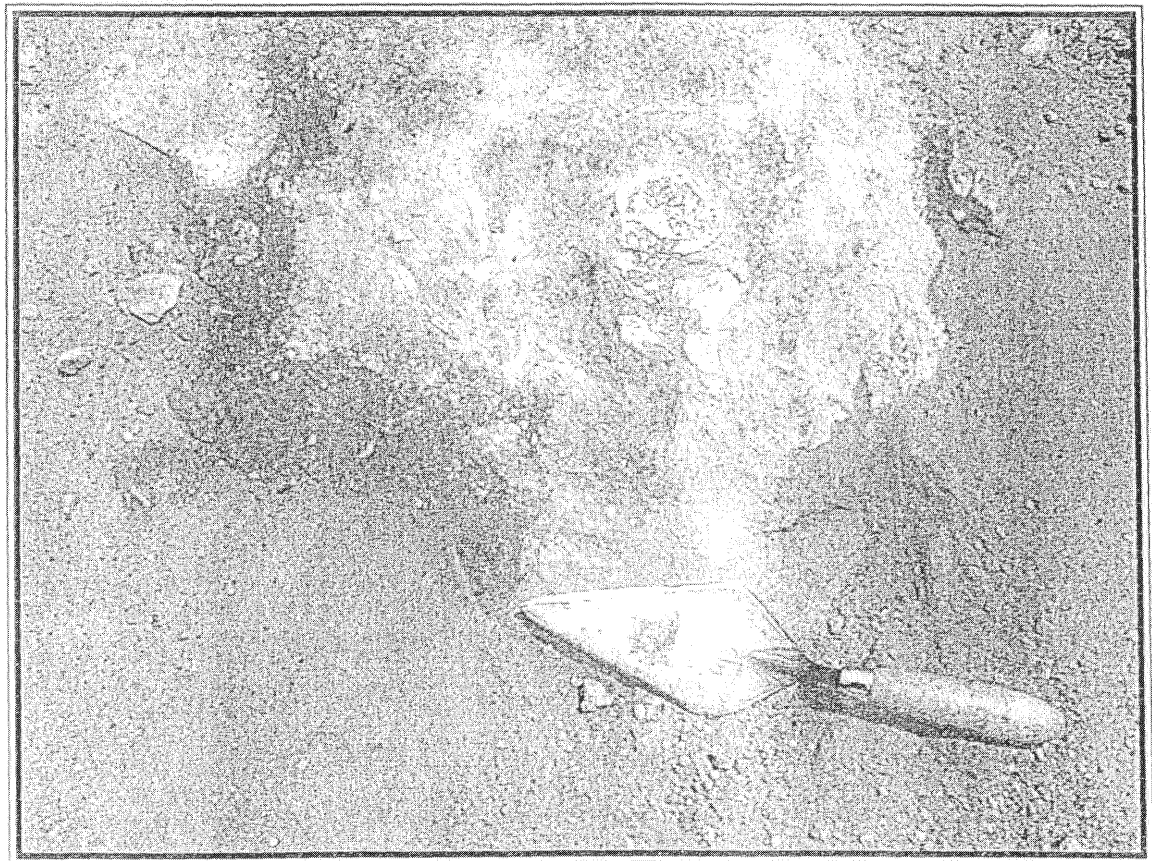
**Figure 14** Parts of a *Massospondylis* skeleton are still visible in the rock. There is still at least one other similar skeleton eroding out from the rock least
