**HERITAGE SURVEY OF THE PROPOSED ESKOM
SIYALU-KIEPERSOL & KIEPERSOL-GROOTHOUT
TRANSMISSION LINES**

EIA REFERENCE: 12/12/20/1586

FOR WANDIMA

DATE: 11 DECEMBER 2009

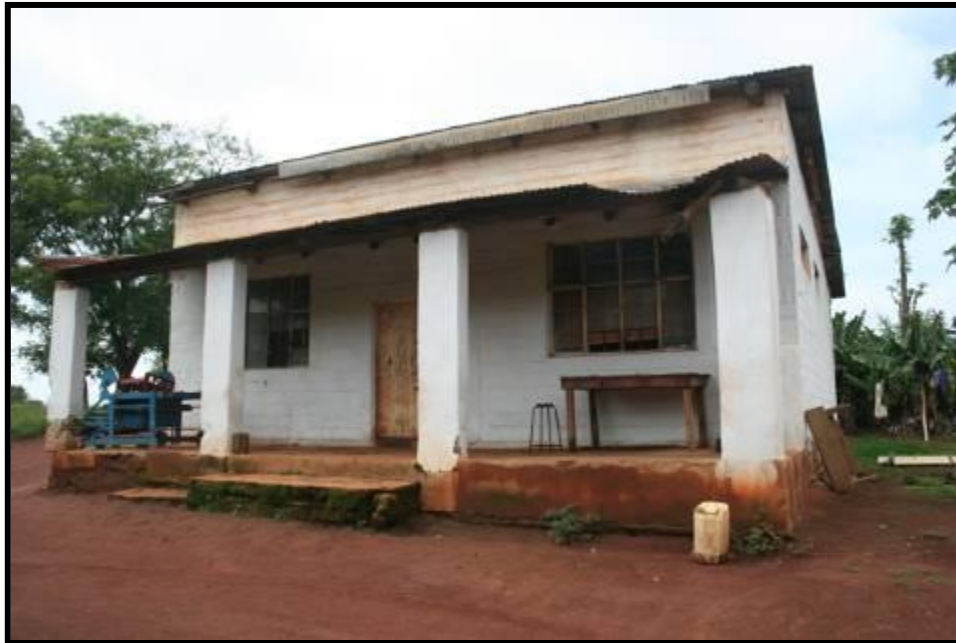
FIG. 4: ALBANY LAODING DEPOT

SK08 is referred to as the Albany Loading Depot (fig. 4). The current building does not appear to be older than 60 years in age; however, the plantation has been in use since the 1930s. The fruit and Jacaranda trees are also large, and indicate that the area has been in use for some time. According to the signage, the “Old Harbour Road” (the Delagoa Bay Road) passes through this area. If there was an older building at the depot, then the historical rubbish

dumps may be affected by the pylons. I am currently requesting information regarding this building from colleagues.

Significance: The area is of medium significance in terms of trade routes.

Mitigation: The area should be monitored during construction activity to salvage possible finds.
