**PHASE 1 ARCHAEOLOGICAL IMPACT ASSESSMENT
PROPOSED SEWERAGE SCHEME FOR STRUISBAAI &
CAPE AGULHAS**

Client: **Cape Agulhas Municipality**

**JUNE
2008**

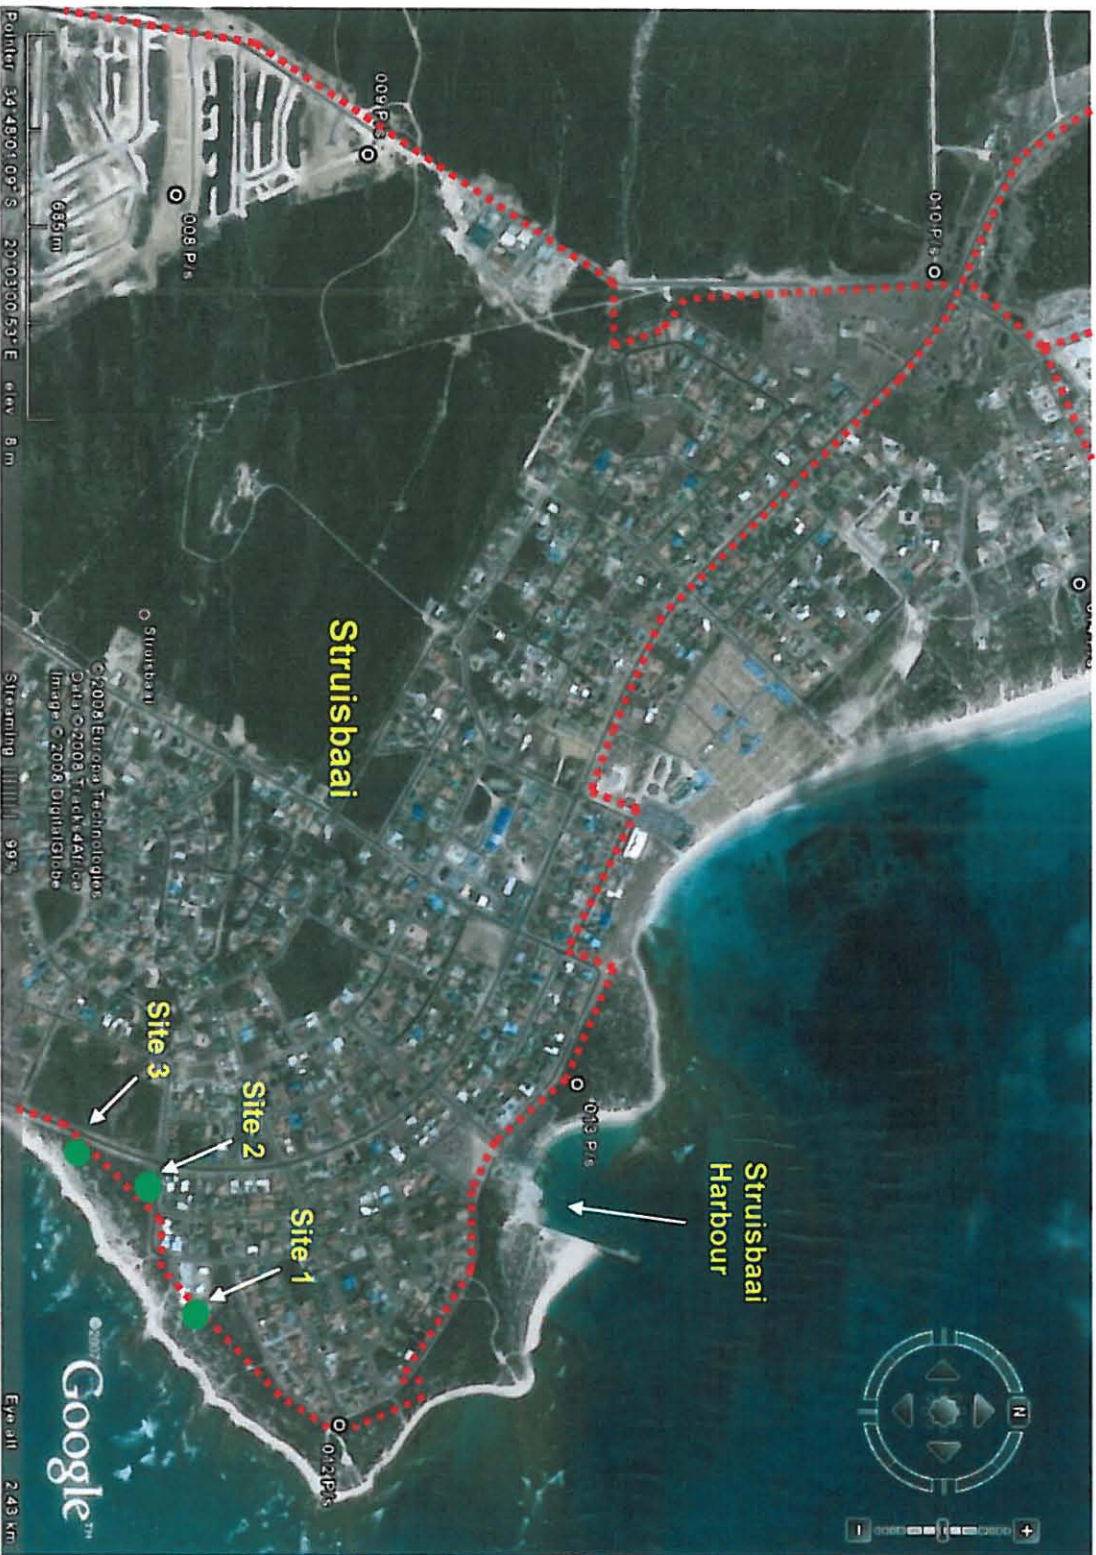
Figure 4. Overview of the Struisbaai – Cape Agulhas pipeline showing pump station positions

The proposed bulk pipeline may impact negatively on potentially important archaeological remains, alongside the beach front between Struisbaai and Cape Agulhas. These include the sites known as Site 1, Site 2, Site 3 and Site 4 (refer to Figures 4 and 5).

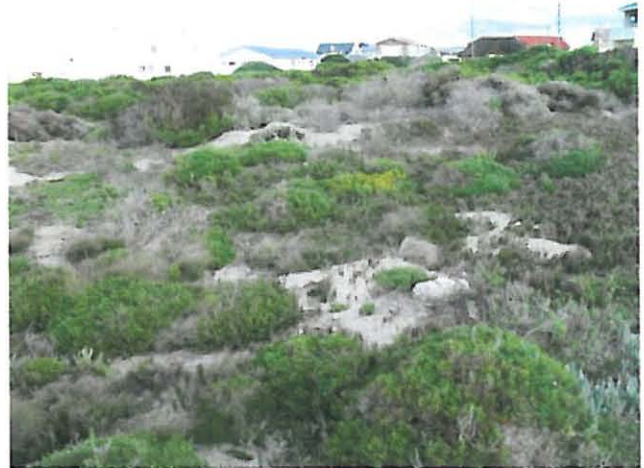
Figure 9. Site 1 view facing west

Site 1 comprises a thin scatter of shellfish in an open patch of sand behind the coastal dunes and alongside the beach road in Struisbaai (Figure 9 and refer to Figure 4). The shellfish comprises mainly fragments of Turbo sarmaticus, several, Operculum and some limpets. One quartz flake and one quartzite flake was counted.

The archaeological remains have been rated as having low local significance.

- Vegetation clearing operations and excavations for the bulk pipeline (along the beach front/Marine Drive) must be monitored by a professional archaeologist during the Construction Phase of the project. If any important shell midden deposits are exposed or uncovered, some sampling and dating of deposits may be required.

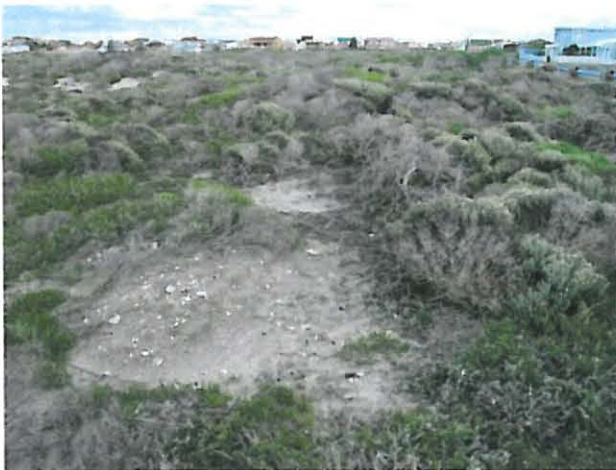
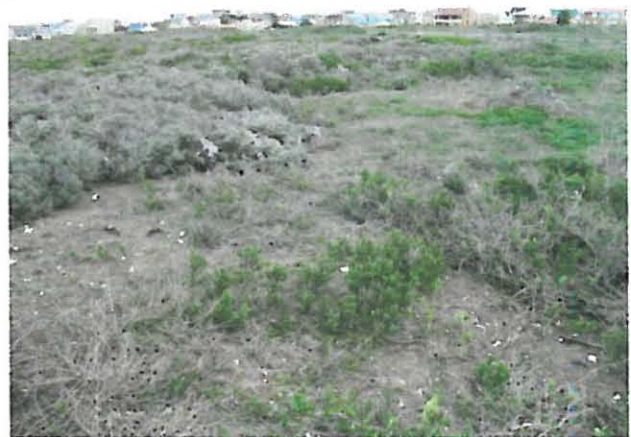
Figure 10. Site 2 view facing west

Several, small scatters of shellfish were documented in open patches of sand, surrounded by thick coastal vegetation alongside the beach road in Struisbaai (Figures 10 and 11& refer to Figure 4). The shellfish is dominated by fragments of Turbo sarmaticus, some Operculum, periwinkle and a few fragments of limpets. Several quartz flakes, chips, one chunk, a small round silcrete core and relatively large numbers of small round quartzite pebbles were counted. There are areas where the vegetation has been cut back, but it has slowly recovered.

The archaeological remains have been rated as having low local significance

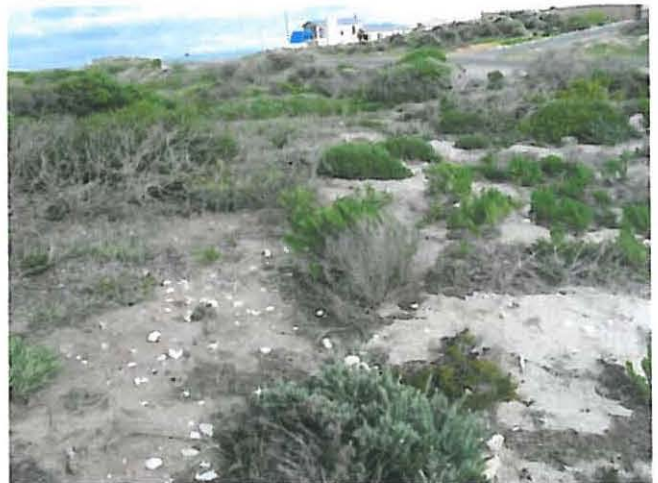
Figure 12. Site 3 view facing west.

A dispersed scatter of shellfish was documented in an open patch of wind blown sand alongside Marine Drive in Struisbaai (Figure 12 and refer to Figure 4). The shellfish comprises mainly Turbo sarmaticus including some large, whole shell, a few Operculum and a few fragments of limpets (Scutellastra argenvillei), Perlemoen (Haliotis), periwinkle and barnacle. Several quartzite cobbles, one quartzite flake and one quartz chunk were also counted.

The archaeological remains have been rated as having low local significance

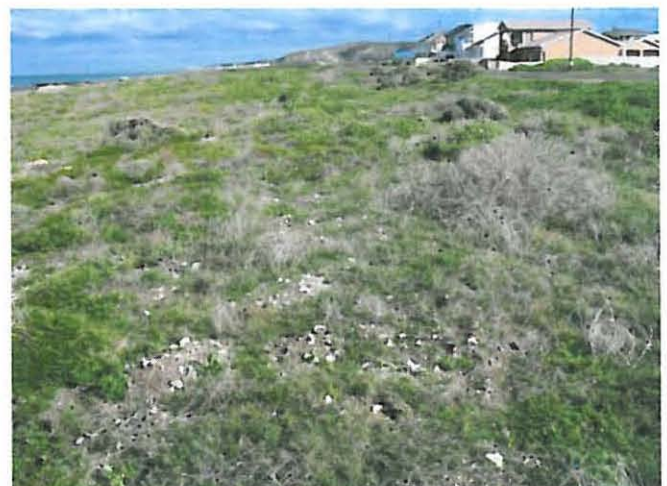
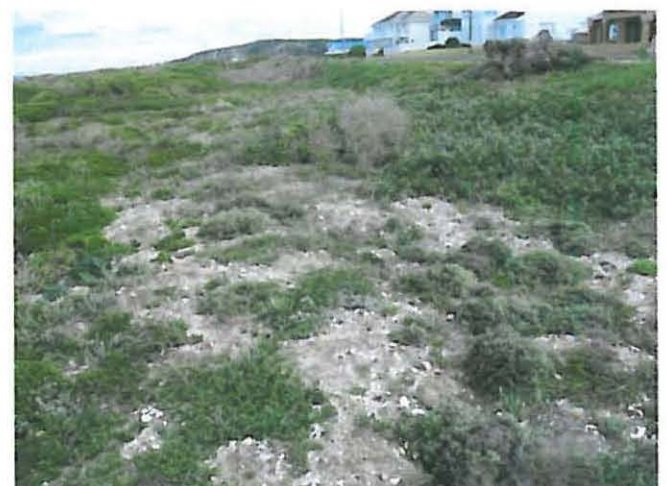
Figure 13. Site 4 view facing west

Shellfish remains and large numbers of rounded quartzite pebbles occur on a slightly elevated, well vegetated dune ridge alongside Marine Drive, between Myburgh Street and Stanley Street in Struisbaai (Figures 13 and 14 and refer to Figure 5). The shellfish is dominated by large numbers of limpets (S. argenvillei), including large whole shell, whelk and periwinkle. Fewer Turbo sarmaticus are visible. It is unclear whether this is an archaeological deposit, or the remains of a raised beach. No cultural remains were found.

The archaeological remains have been rated as having low local significance

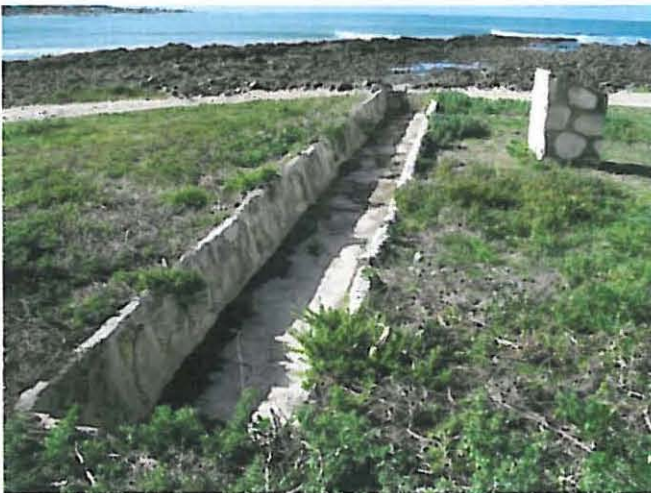
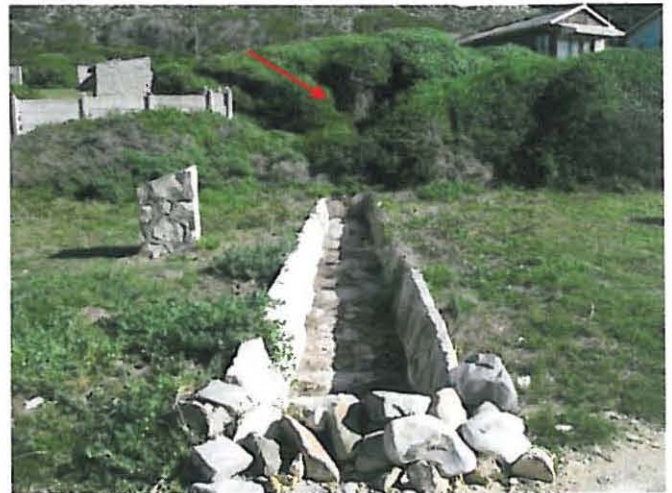
Figure 15. Site 5. Hangnes Outspan

Site 5 comprises a well preserved limestone and lime washed water drinking trough situated a few metres from the rocky shoreline in Cape Agulhas, very close to proposed Pump Station 3 (Figures 15 and 16 and refer to Figures 6 and 7). A plaque on a concrete column stands alongside the water feature alerting passers by to its historical significance. The historic feature is situated on what was then known as the Farm Zoetendals Valleij, which formerly stretched all the way down to the coast. Flocks of sheep wandered around the area and the water trough was used to water the sheep. A natural spring, now overgrown with Rooikranz, was used to feed the trough. Later, transport riders and holiday makers stopped to water their livestock, at the stopover known as Hangnes Outspan.

The historical archaeological remains have been rated as having high local significance.

The proposed route may impact negatively on the historic water drinking trough (Hangnes Outspan) near Pump Station 3 (Site 5 and refer to Figures 6/7).

- The historic drinking trough at Hangnes Outspan (Pump Station 3) on the coast in Cape Agulhas must not be disturbed or damaged in any way. The proposed pump station must be placed well away from this historic feature.

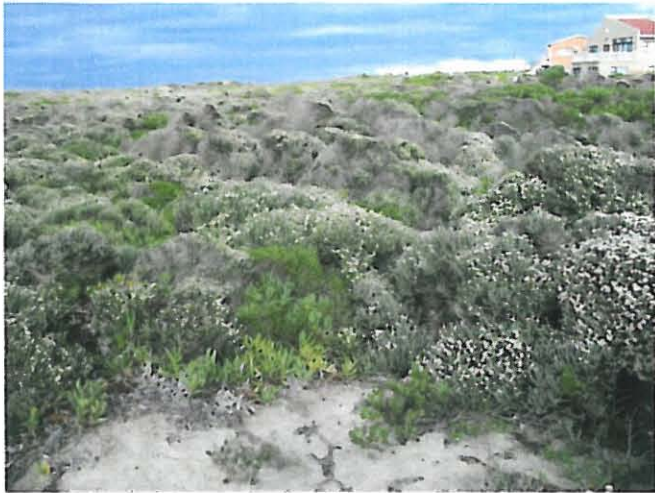
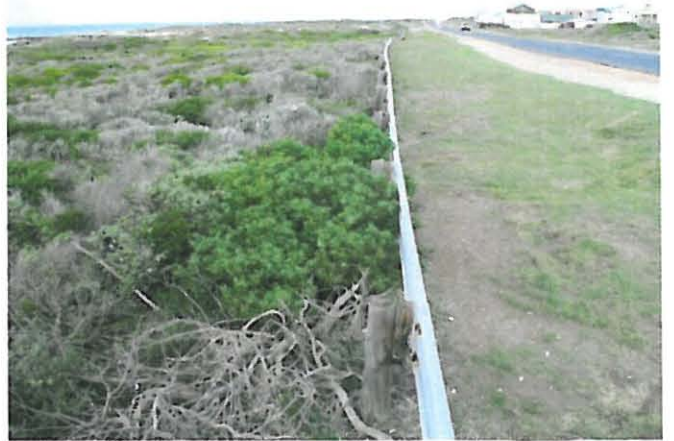
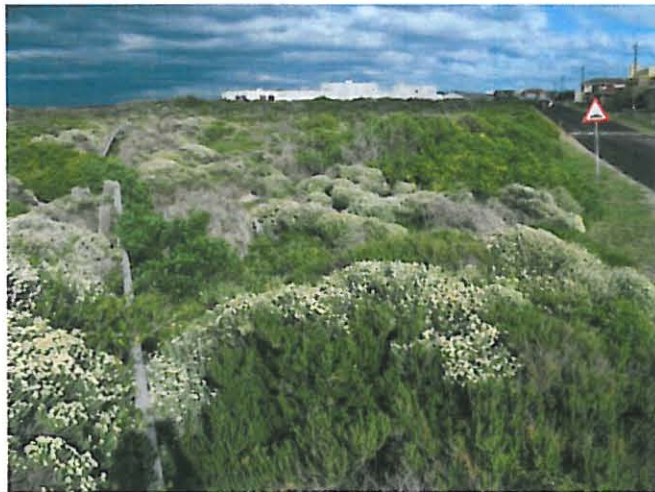
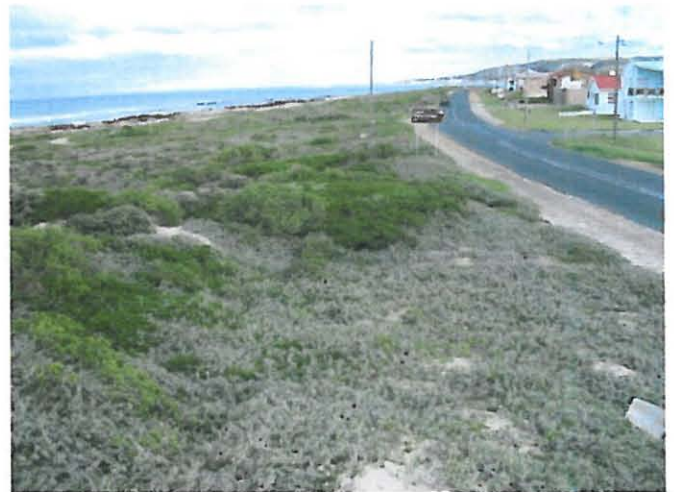
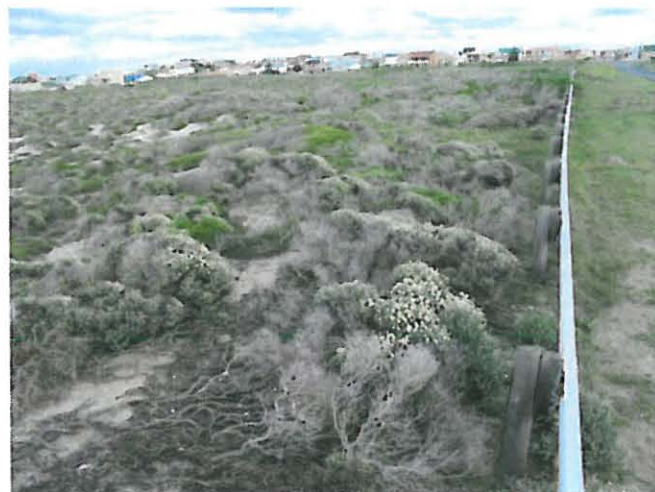
Sections of the pipeline route alongside the beach front between Struisbaai and Cape Agulhas (between Pump Station 12 and Pump Station 11 – refer to Figures 4 & 5) do, however pass through extremely thick coastal vegetation, where, archaeological visibility is poor (refer to Figures 17-21). Vegetation clearing operations along the beach front may well expose additional shell middens, especially since the proposed route is aligned alongside a wave cut and rocky shoreline that are known to support archaeological sites (Kaplan 1993).

- Ideally, the proposed bulk pipeline should be located within the road reserve (along the beach front) between Struisbaai and Cape Agulhas so as not to impact negatively on any potentially important shell midden deposits.
