**HERITAGE SURVEY OF THE PROPOSED  
TSOLWANA ROAD UPGRADE, EASTERN CAPE

FOR COASTAL ENVIRONMENTAL SERVICES**

**DATE: 1 MARCH 2012**

**Umlando: Archaeological Tourism and Resource  
Management**

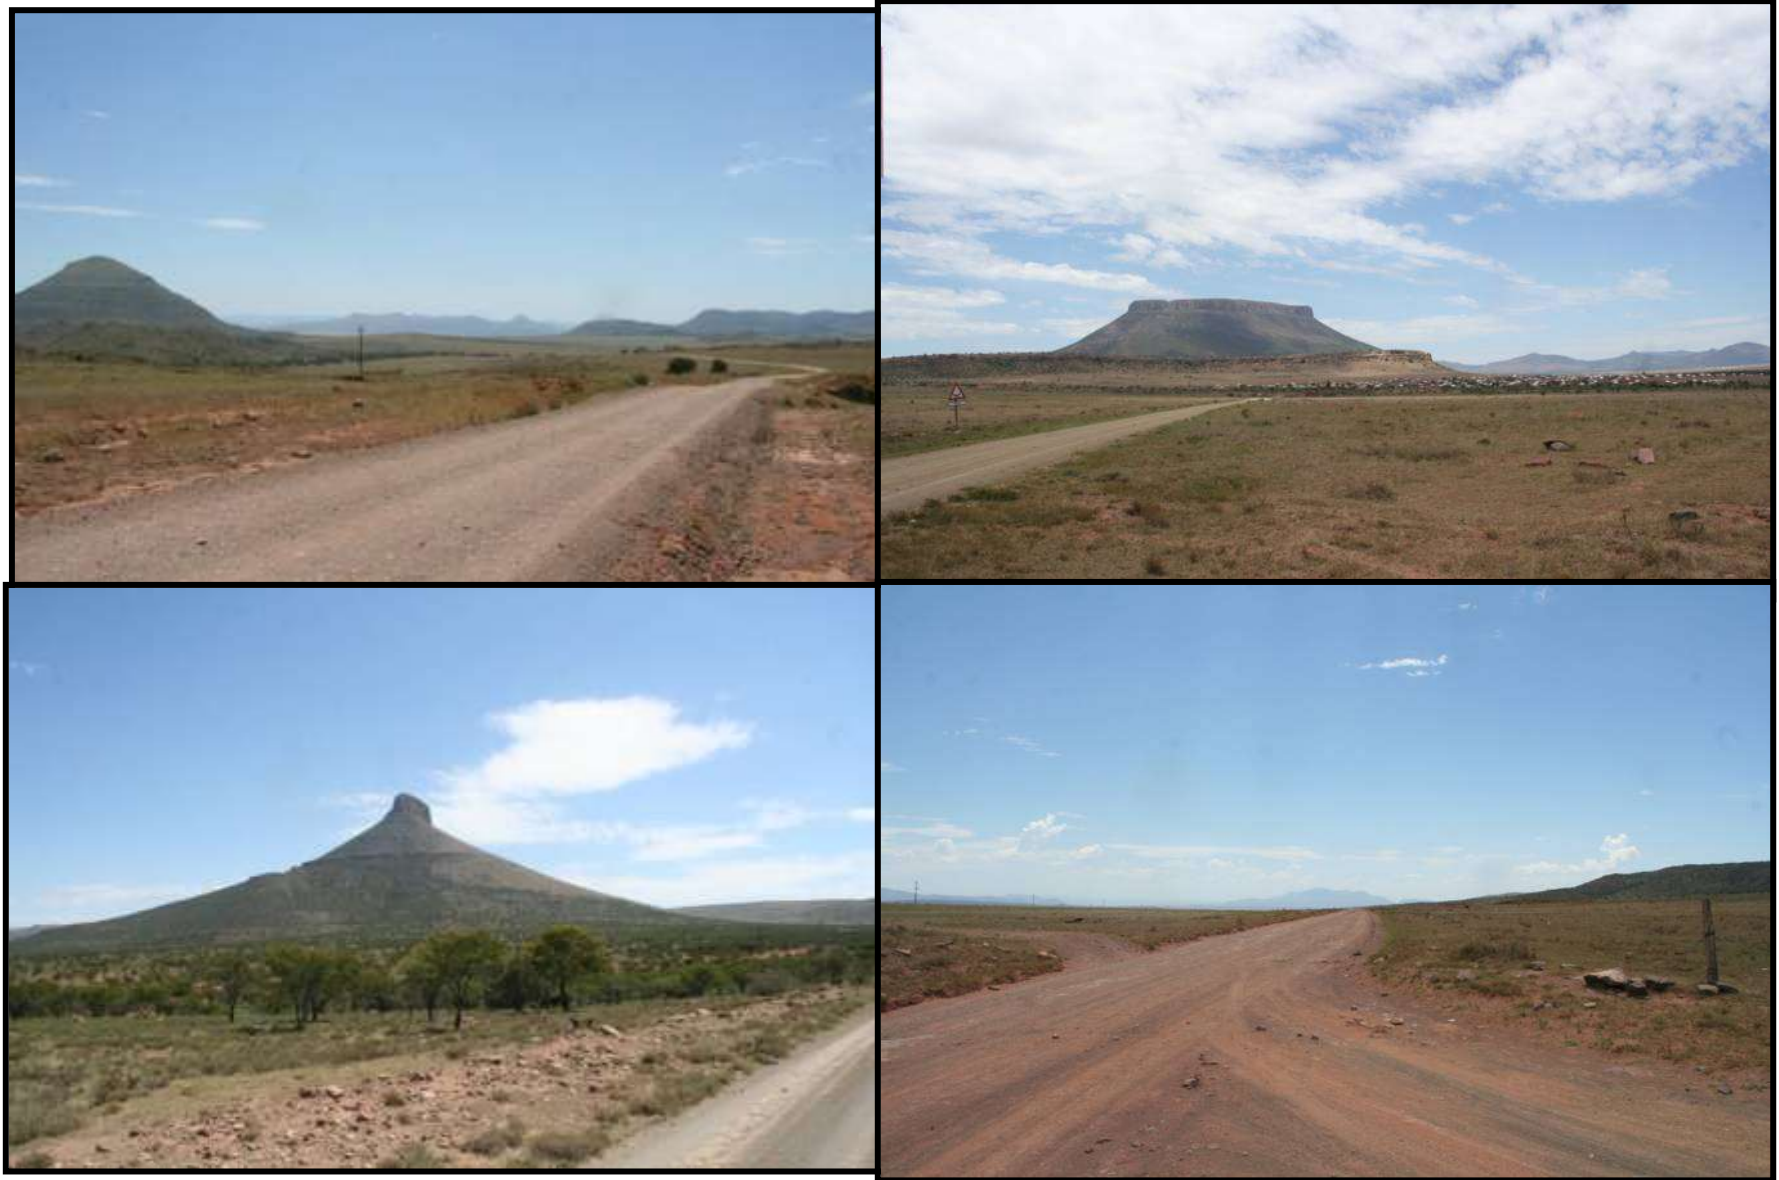
FIG. 5: LOCALITY PHOTOS OF THE ROAD UPGRADE ENVIRONMENT

The environment was arid with scrub and bushes. Dense vegetation only occurred alongside river beds. Most of the area is flat, with Karoo outcrops of various geological formations (fig. 5). This made for very good archaeological visibility. A total of ten sites were observed during the survey, as well as isolated occurrences of Late Stone Age (LSA) and Middle Stone Age (MSA) stone tools (fig. 6 and Table 3).. Isolated tools occur throughout the buffer zone. I undertook several test surveys, initially at 100m distances apart to test this hypothesis. The hypothesis held.

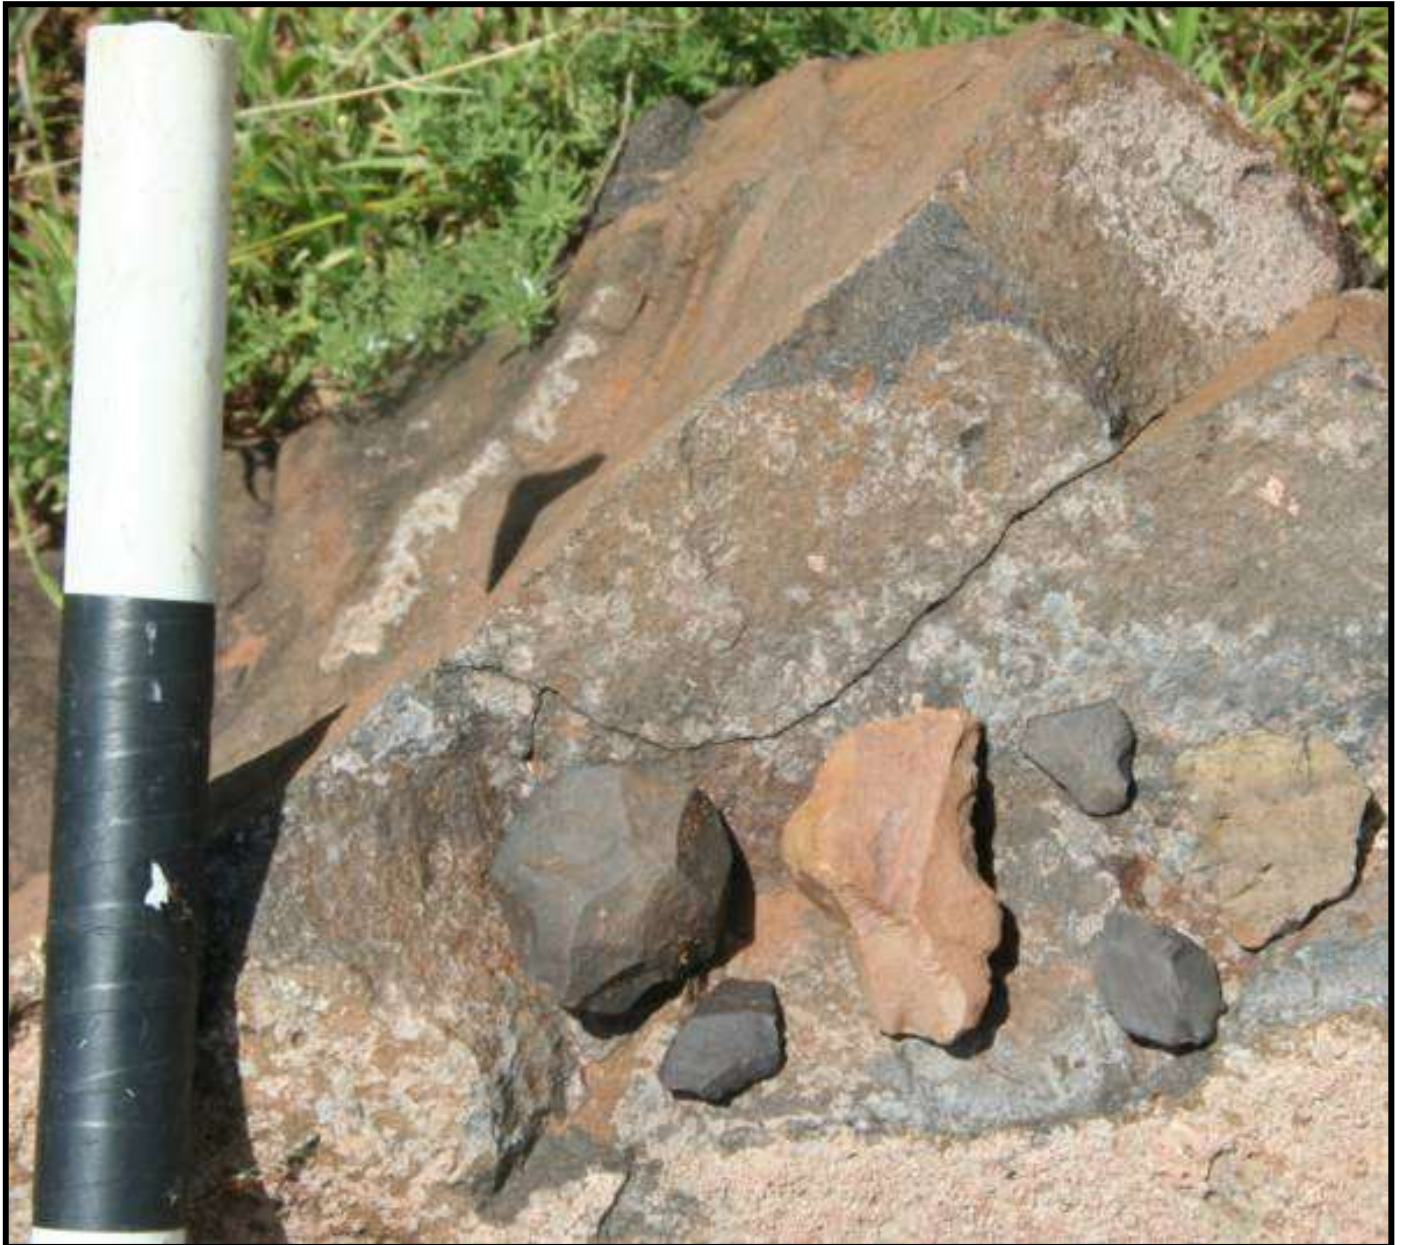
**FIG. 6 SELECTED STONE TOOLS AT TSO01**

TSO01 is located on a downslope in a small erosion gully. The site consists of a small scatter of LSA and MSA tools that are in a secondary context. That is, they have washed down the hill and accumulated in an erosion gully (fig. 6). The stone tools were located over a 10m area, suggesting that the stone tools along the road are very sparse, and only occasionally group together by accident.

The tools included:

- LSA Adze on a MSA flake
- MSA flakes and cores
- LSA flakes and cores

**Significance:** The site is of low significance as the tools are very few in number and a secondary context.

**Mitigation:** No further mitigation is required, as the stone tools will not be affected.

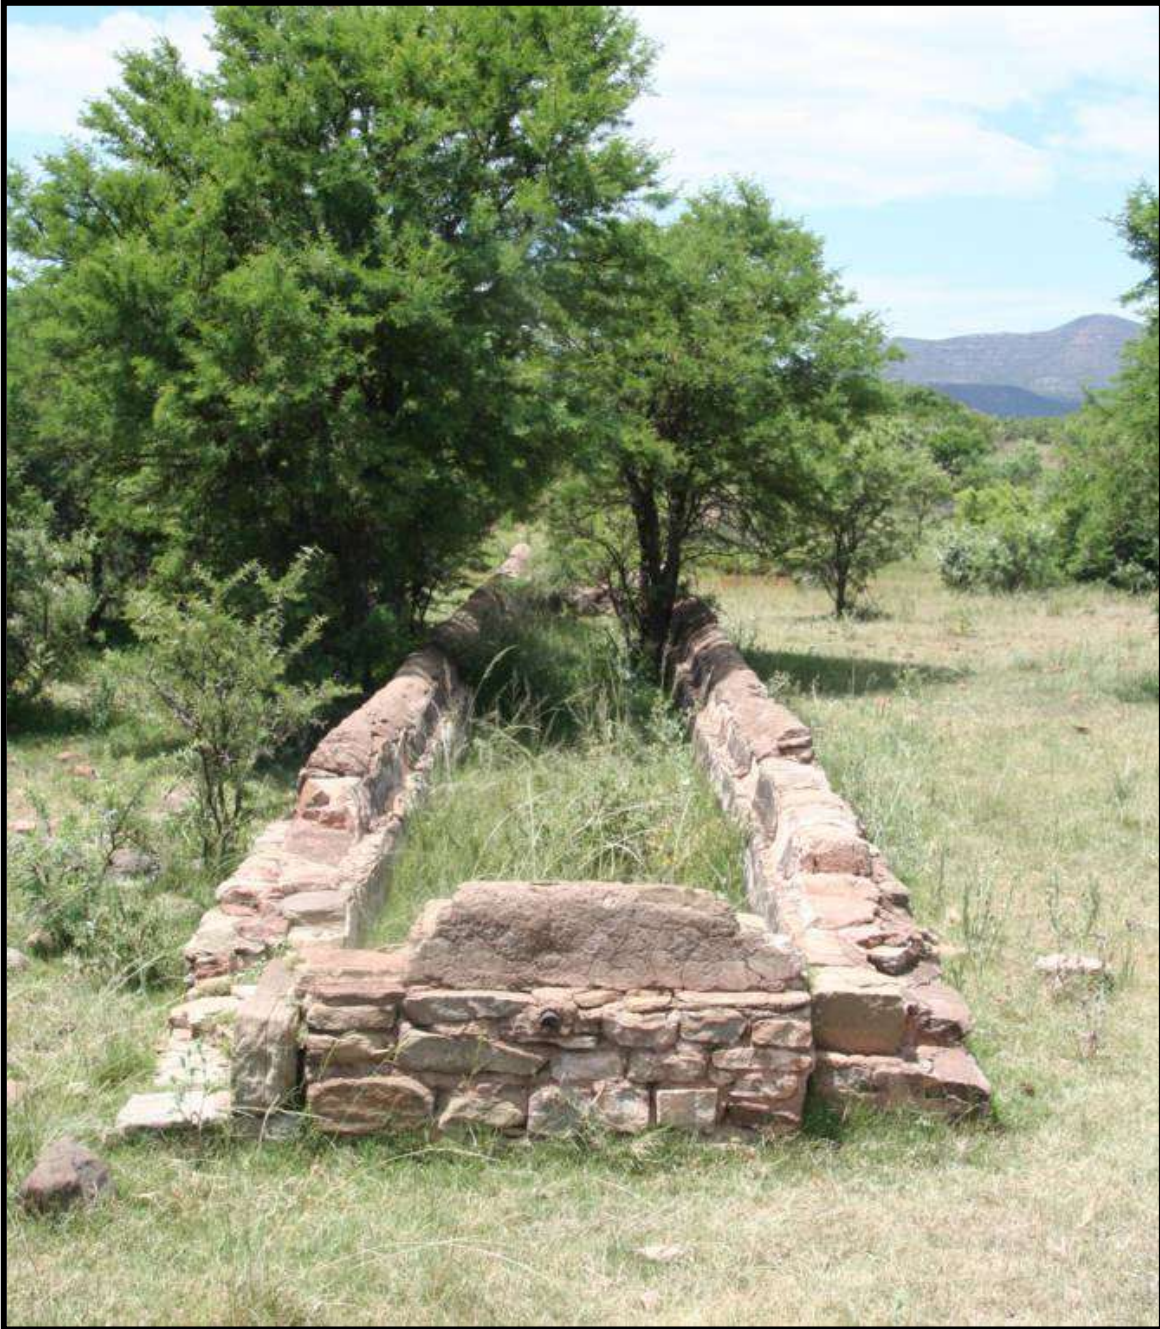
**FIG. 7: WATER TROUGH AT TSO02**

TSO02 is located near the edge of the river bank and consists of several water troughs. One of these appears to be much older than the other troughs and was subsequently recorded (fig. 7).

**Significance:** The site is of low significance as it only has a functional value.

**Mitigation:** No further mitigation is required, as the road upgrade will not affect the site. The area cannot be affected by road infrastructures.

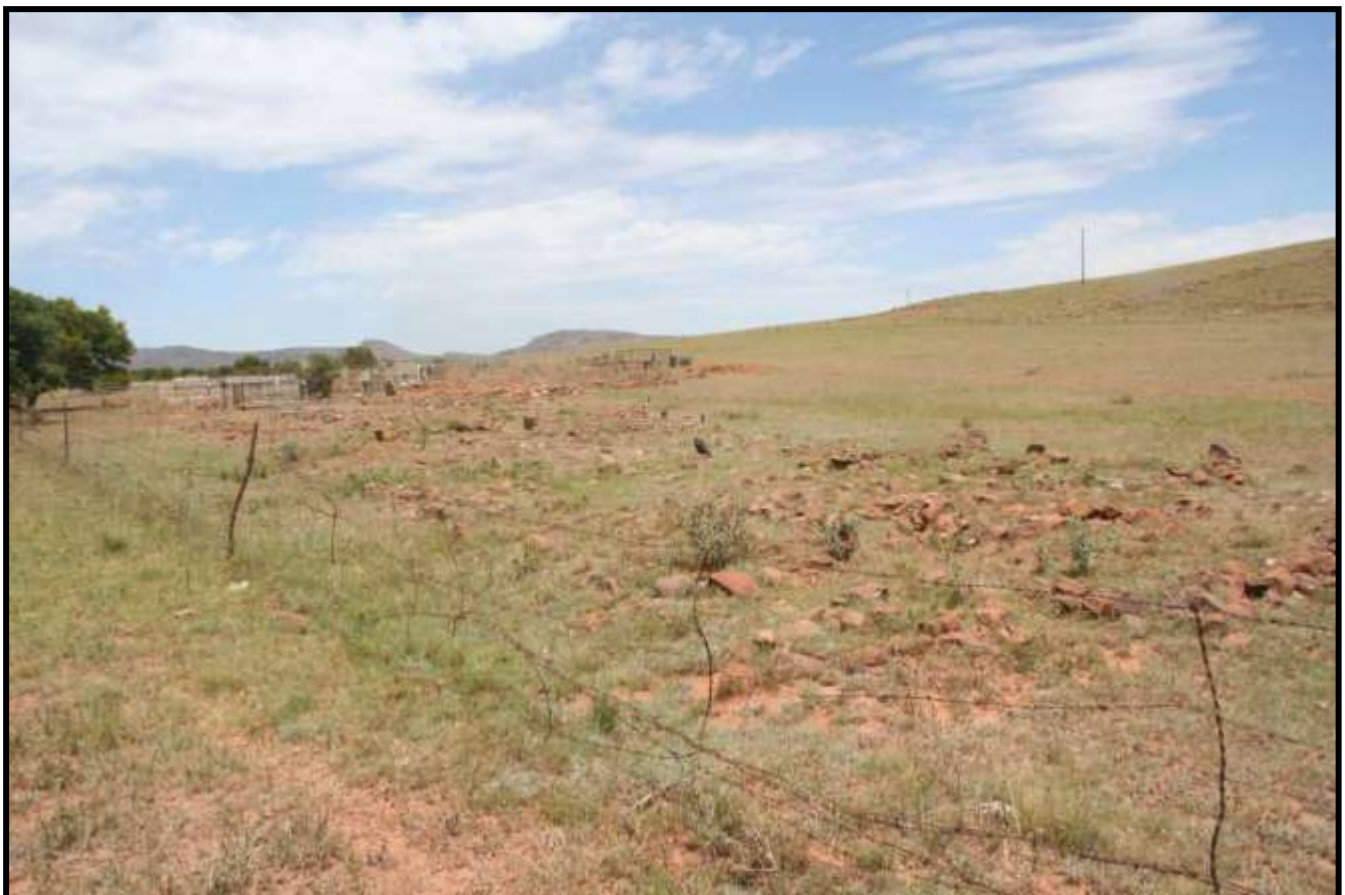
**FIG. 8: CEMETERY AT TSO03**

TSO03 is located near the edge of the road. The site consist of a fenced off and dedicated cemetery (fig. 8). The cemetery appears to have been used for some time.

**Significance:** The site is of high significance as the tools are few in number and a secondary context.

**Mitigation:** No further mitigation is required as the cemetery will not be affected and it is already fenced off.

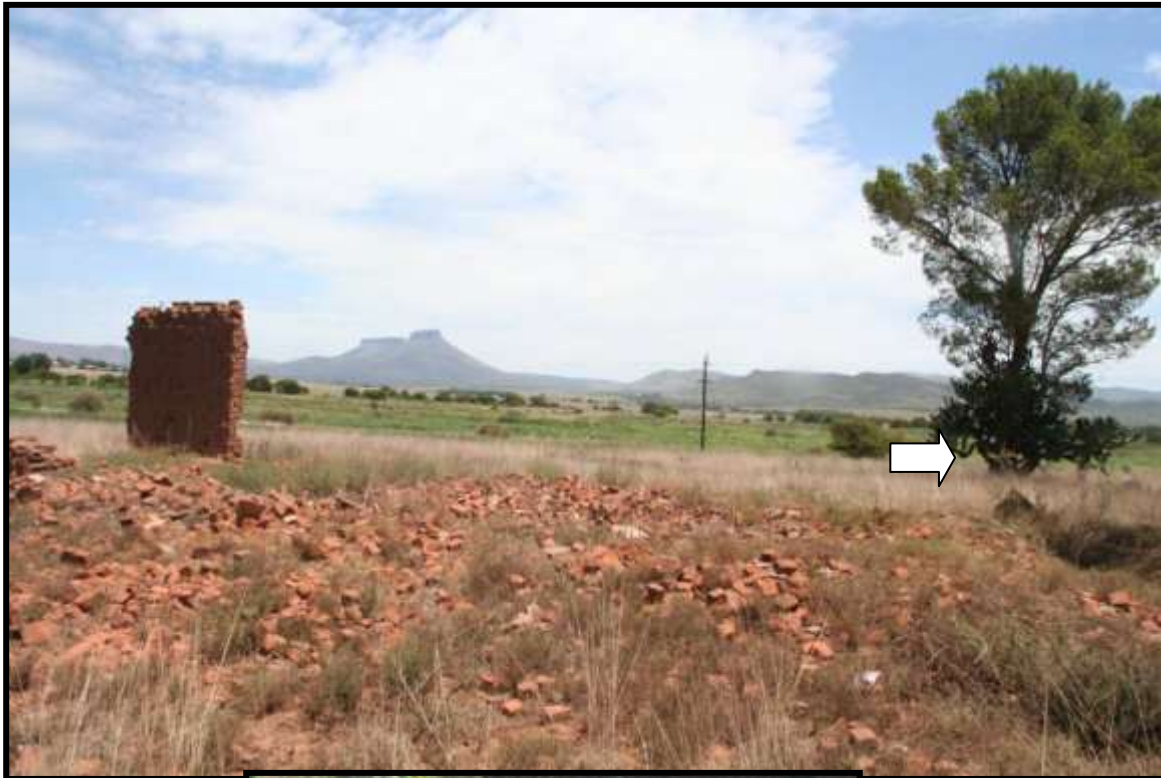
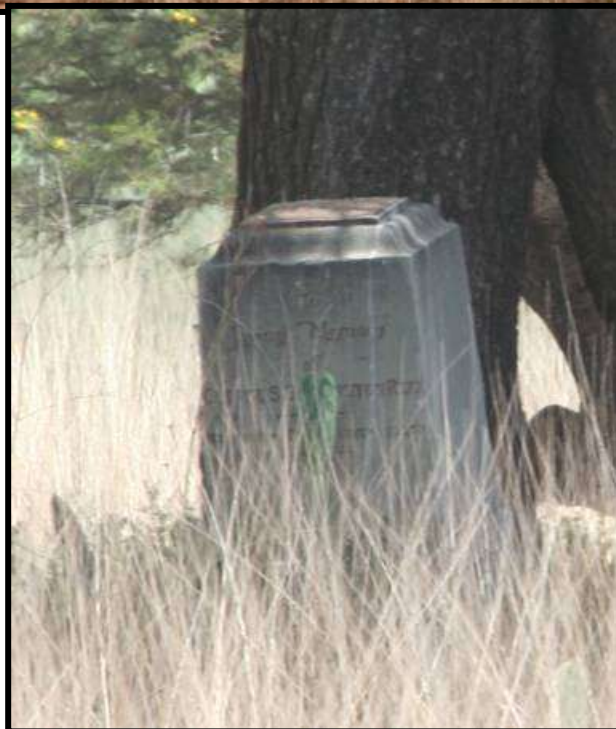
FIG. 8: TENTERGATE CHURCH AND GRAVE)<sup>1</sup>

TSO04, or TS-C1/CA, is located near the edge of the road. The site appears to be part of the original Tentergate church and cemetery. (fig. 9). The building is now a ruin, and only one grave was visible from the road. The area was fenced off (with recent fencing and barbed wire) and I could not access the site. An internet search did not locate any information regarding the buildings. A general internet search noted that George Southey, an 1820's settler, owned a farm called Tentergate in this area.

**Significance:** The buildings are of low significance as they are in ruins with little chance of it being renovated. The cemetery is, however, of high significance

<sup>1</sup> Arrow indicates grave(s)

**Mitigation:** No further mitigation is required as the site is already fenced off and will not be affected. If any earthmoving or trenching activity is to occur in this general area then it should be monitored for historical middens.

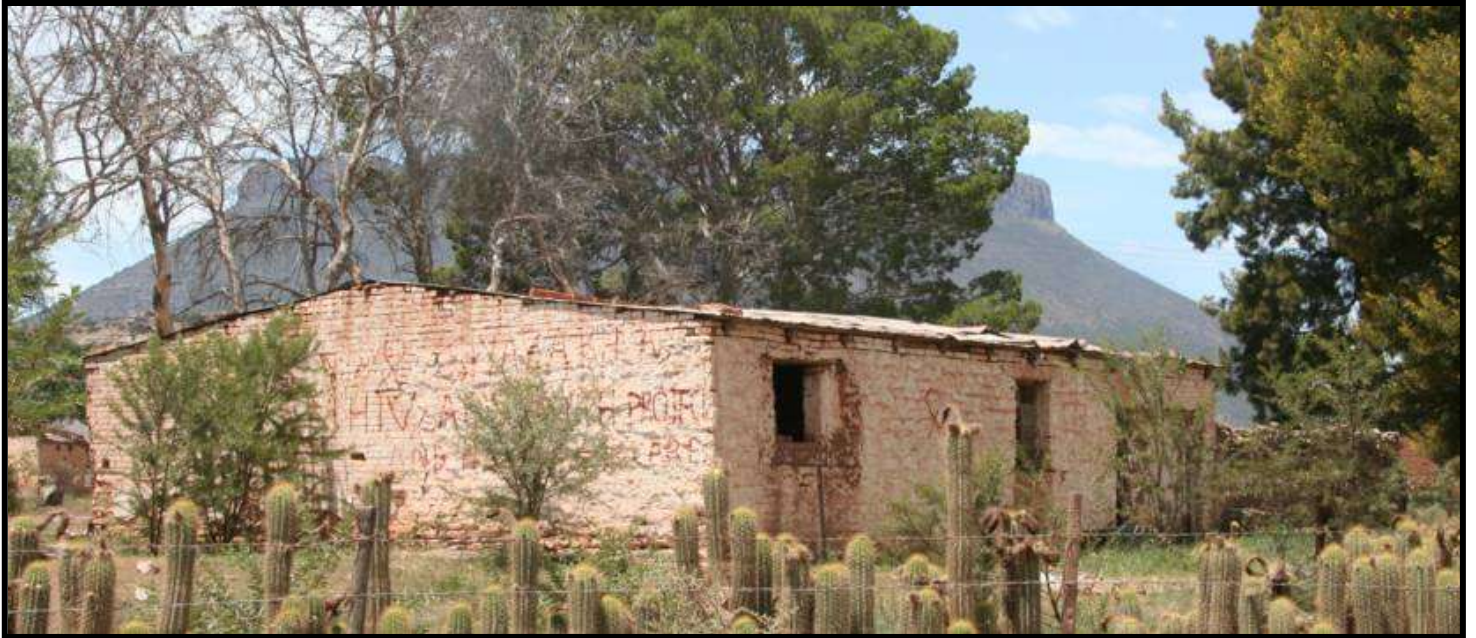
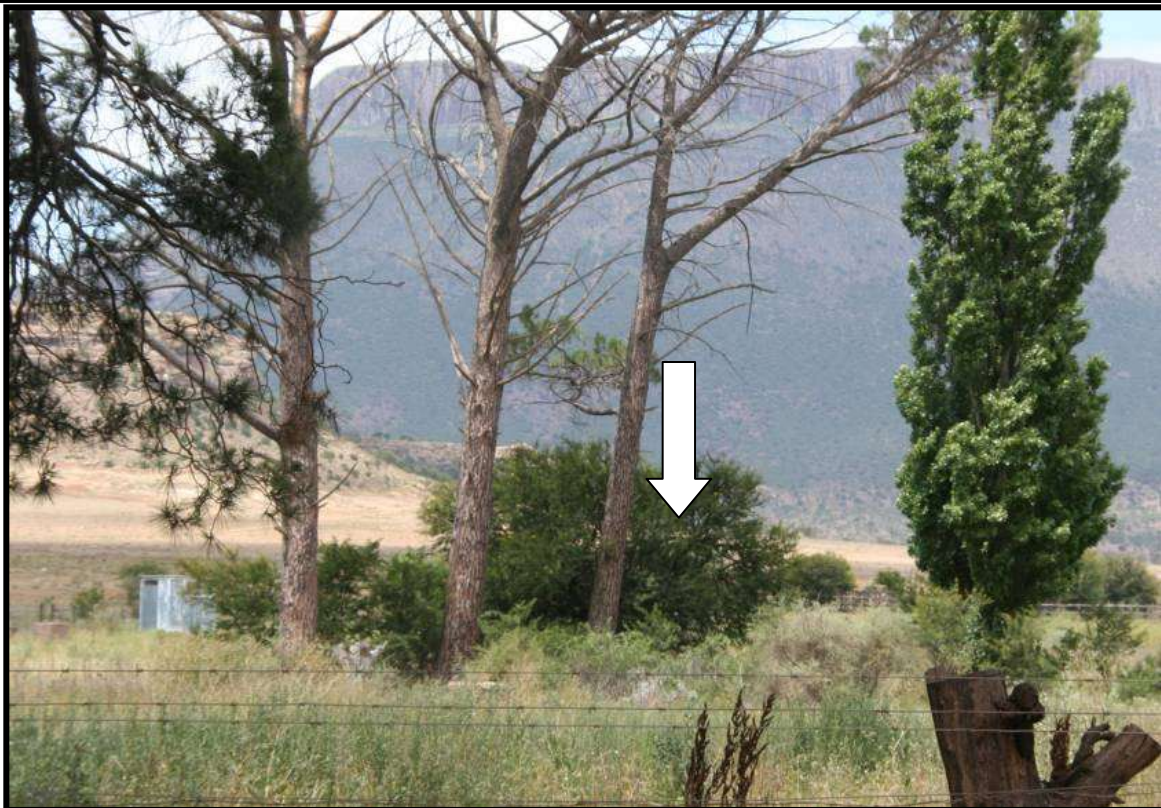
FIG. 9: BUILDINGS AT TS-C1<sup>2</sup>

TS-C1 and CA are the buildings and property probably related to the church, and farm Tentergate. The buildings appear to predate 19<sup>th</sup> century. They are in disrepair, however they are still occupied. The outer walls have been used for an HIV/AIDS awareness campaign (fig. 9). There may be an additional cemetery amongst the older trees in the farm complex.

<sup>2</sup> Arrow indicates possible grave(s)

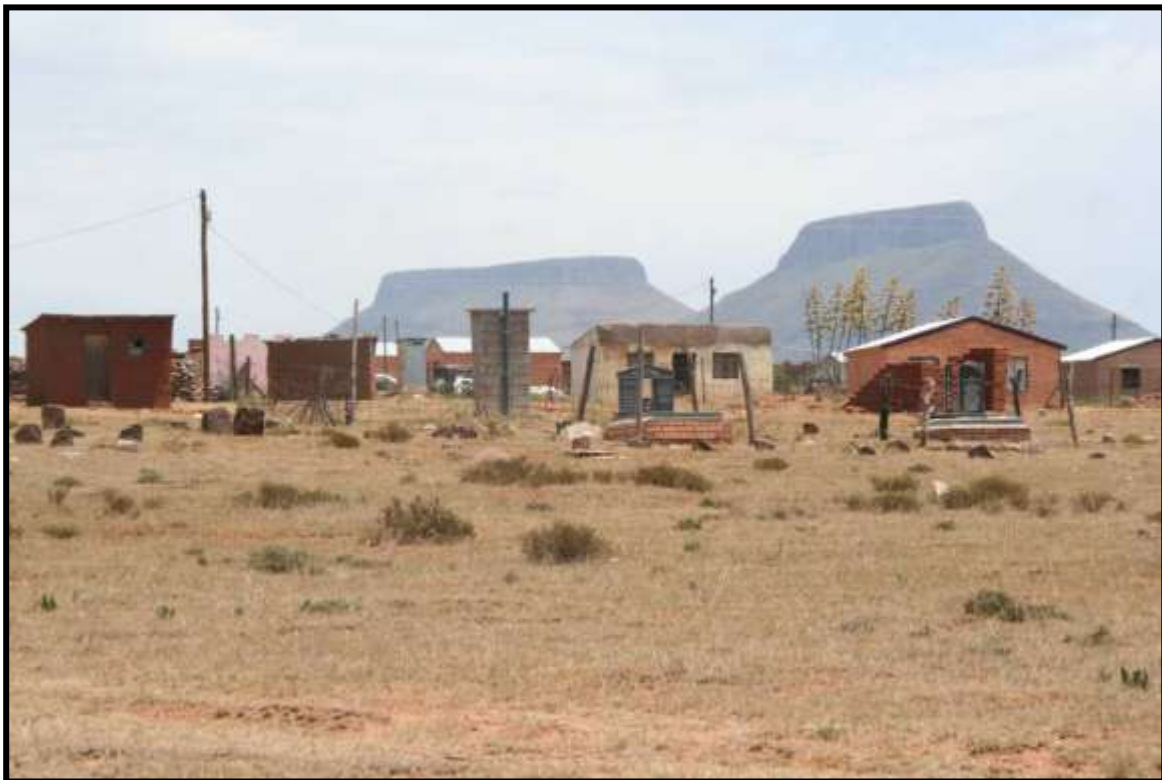
**FIG. 10: CEMETERY AT TSO05**

TSO05 is located near the edge of the road. The site is a cemetery with several graves. Some of the graves have individual fencing. (fig. 10).

**Significance:** The site is of high significance.

**Mitigation:** The cemetery should be fenced off and clearly demarcated before construction phase.

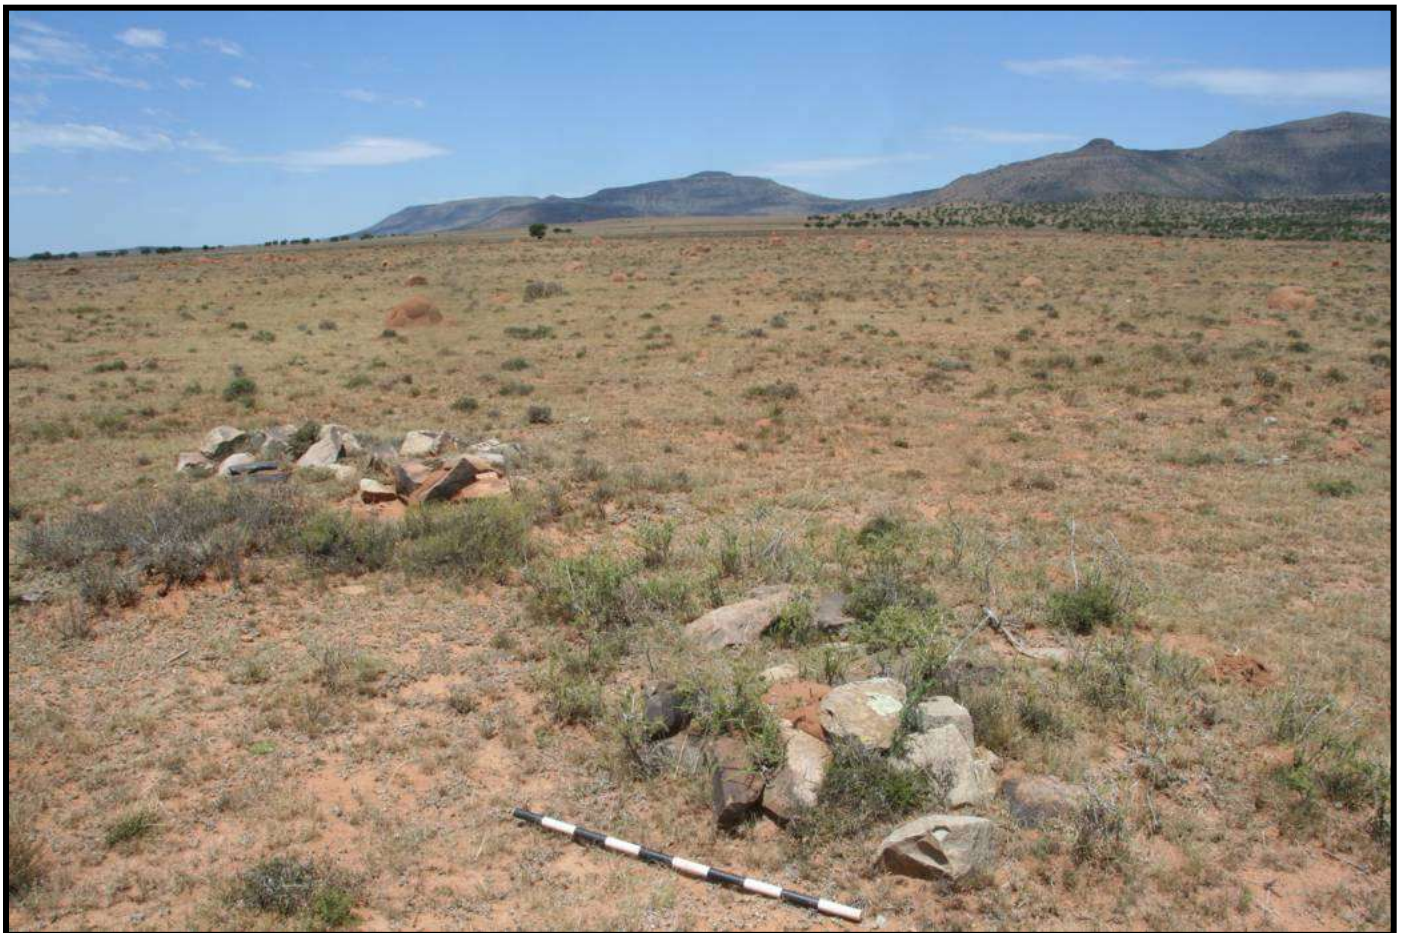
**FIG. 11: GRAVES AT TSO06**

TSO06 is located ~20m west from the road. The site consists of two cairns that appear to be the remnants of old graves (fig. 11). The graves predate 1968 and are ~20m from the road.

**Significance:** The site is of high significance.

**Mitigation:** The graves will need to be fenced off before construction phase and clearly demarcated. This will need to be supervised by a heritage practitioner.

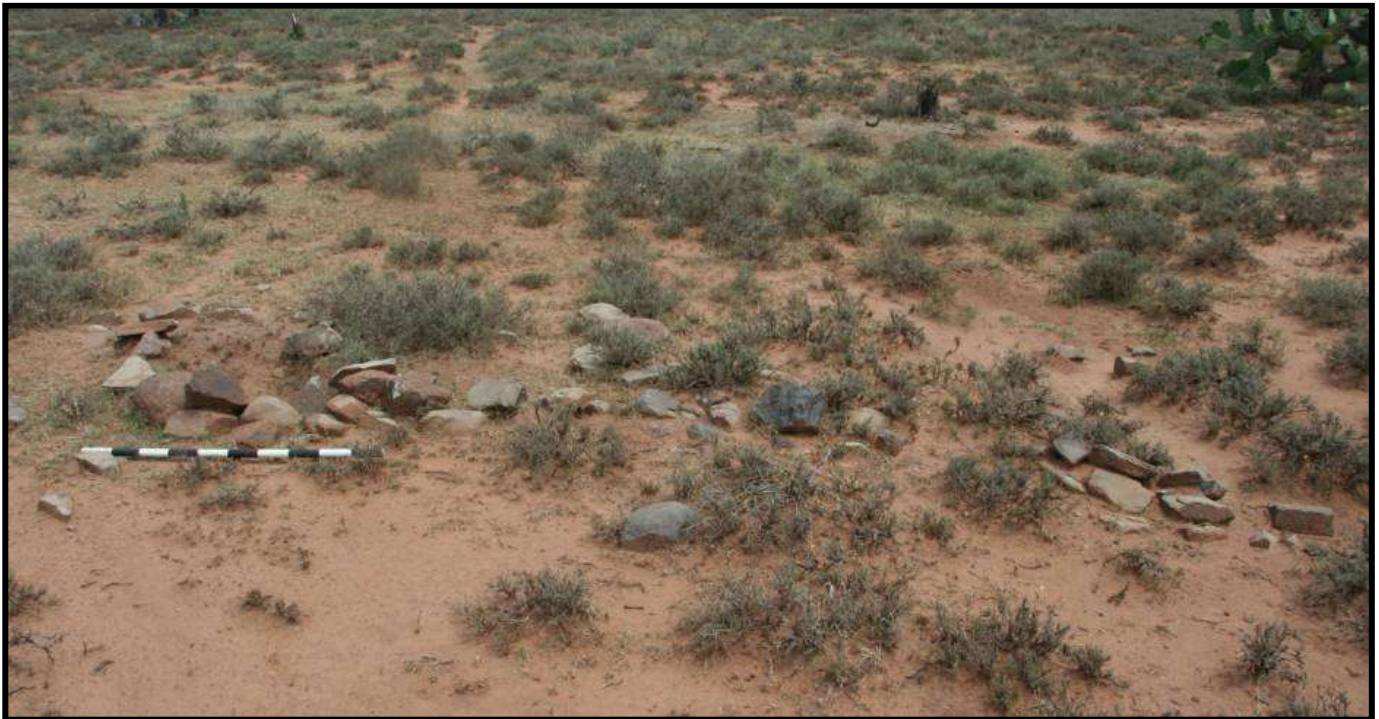
FIG. 12: POSSIBLE GRAVES AT TSO07

TSO01 is located ~20m west of the road. The site consists of two cairns that may be human graves. These cairns are similar to those from TSO06, however, they are more sunken into the soil, and are thus older (fig. 12). Both of the cairns have fewer rocks in the centre than other graves; however, this could be regional variation. Even if these are not human graves, they need to be treated as such until proven otherwise.

**Significance:** the site is of low significance as the tools are few in number and a secondary context.

**Mitigation:** The graves will need to be fenced off before construction phase and clearly demarcated. This will need to be supervised by a heritage practitioner.

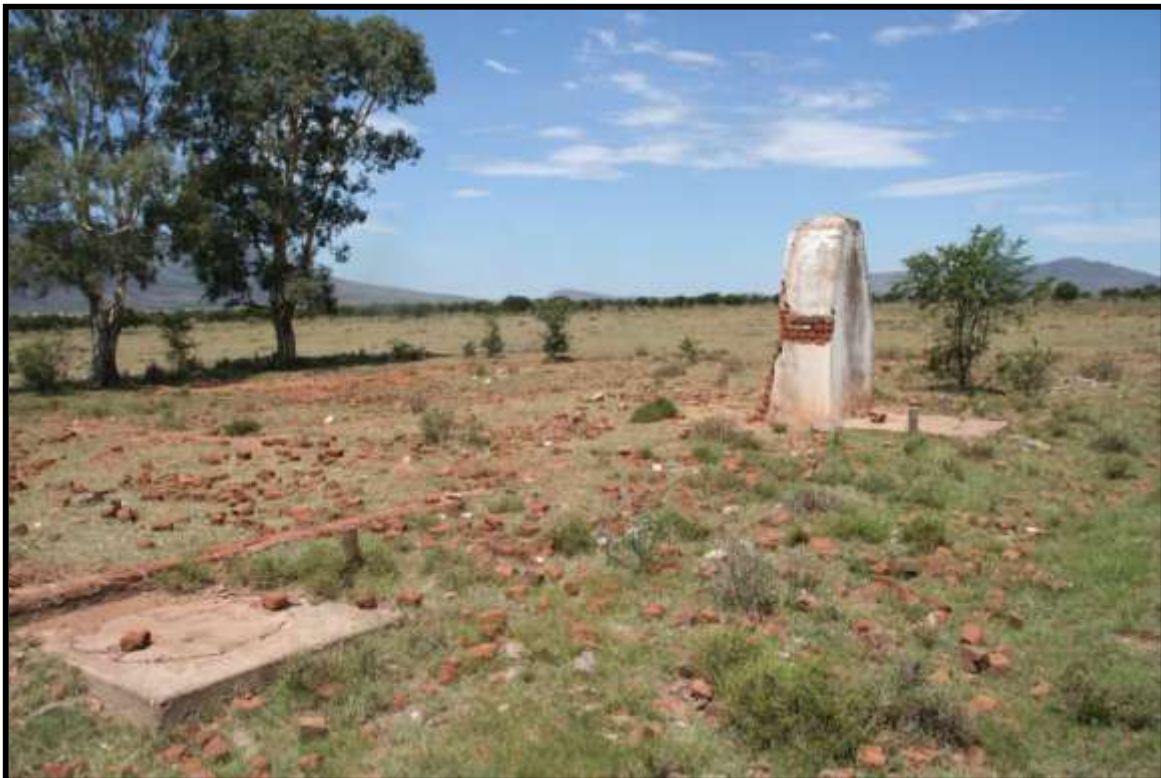
**FIG. 12: HOUSE REMAINS AT TSO08**

TSO08 is located ~100m from the road and is a group of farm buildings. The buildings are in ruins with only the foundations remaining, and do not occur on the 1965 topographical maps. They thus predate 1965 (fig. 12). There is a line of trees that demarcate the “driveway” to the property, and these are stylised with rectangular flowerbeds made from local rocks.

**Significance:** The site is of low significance

**Mitigation:** No further mitigation is required since the road upgrade will not affect the site. However, if any camps and stores are to be placed near the site (within 100m) then the area needs to be assessed, especially if any earthmoving activity occurs, as these may disturb historical middens.

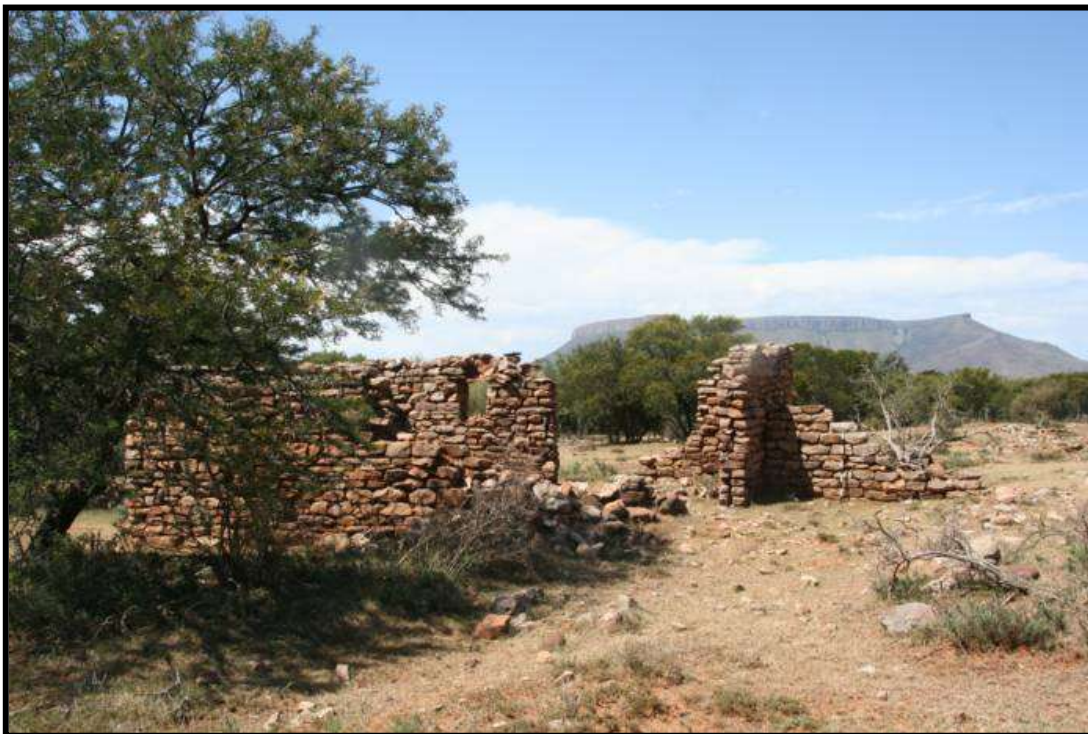
**FIG. 13: HOUSE REMAINS AT TS-H1**

TS-H1, TS-H2 and TS-H3 were identified from the 1965 topographical maps, as being several settlements near each other. The sites are located ~40m from the road. The site consists of 15 – 20 settlements with rectangular mud-brick houses. Some houses have the wattle-and-daub extensions (fig. 13). Most of the houses are in ruin with only the foundations remaining, however they do appear to have been recently abandoned due to the more modern artefacts observable on the ground. I did not see any evidence for human graves in the area.

**Significance:** The site is of low significance

**Mitigation:** No further mitigation is required, however the area should not be used as a camping or storage area in case human graves occur below the surface.

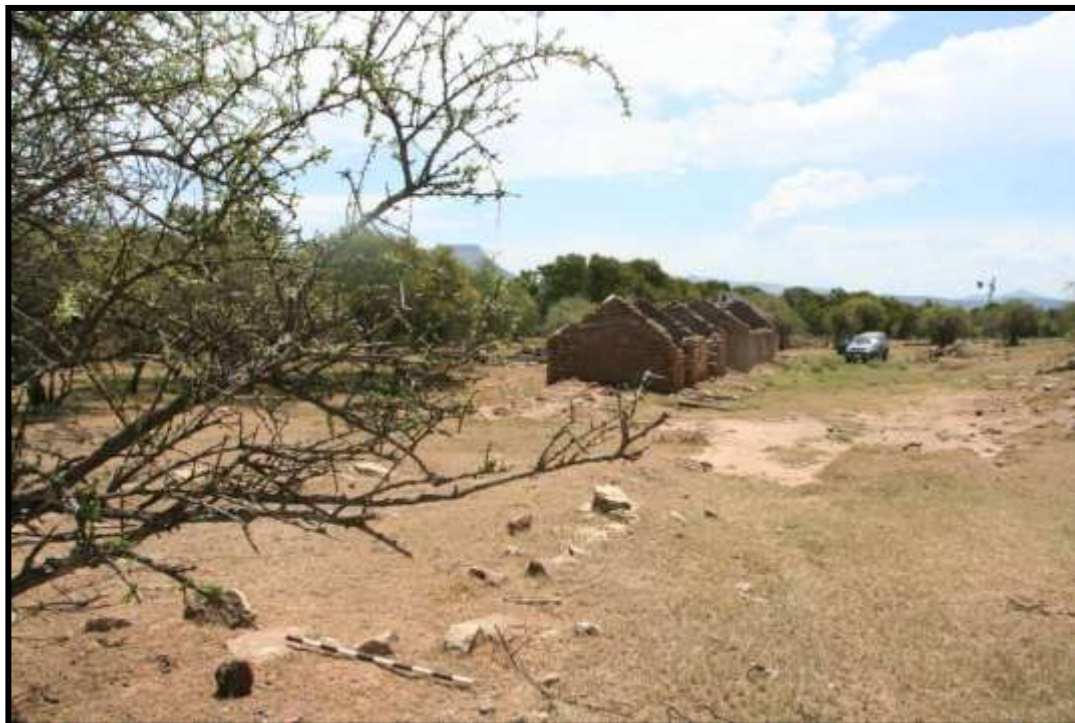
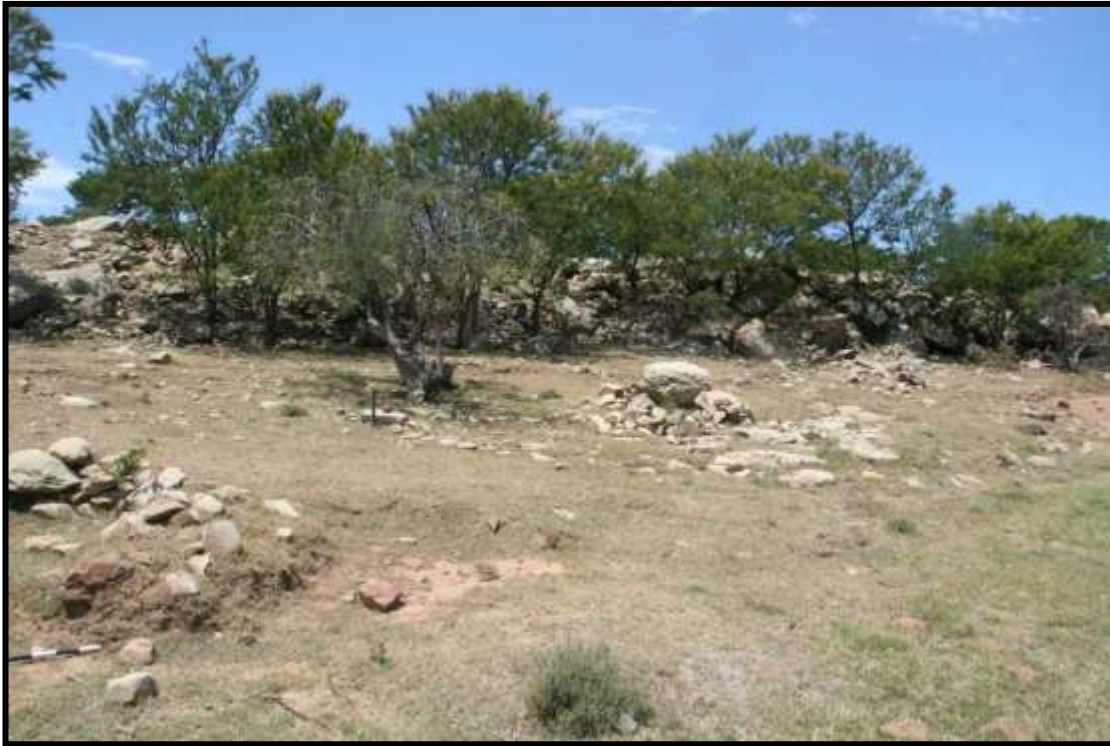
TS-H4 was identified from the 1965 topographical maps, as being a settlement of several houses. The settlement is located ~30m-130m from the road. The site consists of four rectangular mud-brick buildings, chicken coops and several stone kraals.(fig. 14 - 15). Some off the kraals are placed against the rocky outcrop. The houses appear to have been recently abandoned due to the more modern artefacts observable on the ground. There are two stone cairns near the entrance of the site, and these may be graves (fig. 16)

**Significance:** Most the site is of low significance. The area of possible graves is of high significance.

**FIG. 14: HOUSES AT TS-H4**

**FIG. 15: KRAALS AT TS-H4**

**Mitigation:** No further mitigation is required, however the area should not be used as a camping or storage area in case human graves occur below the surface.

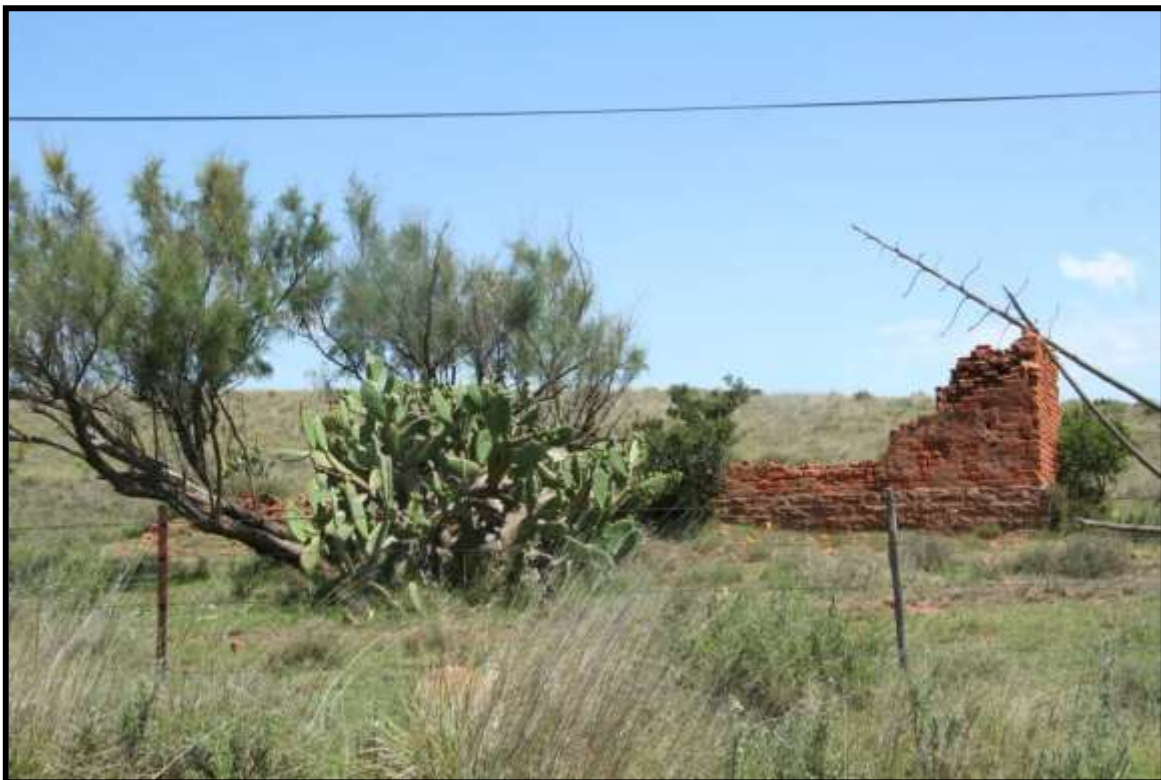
**FIG. 17: FARM HOUSE AT TSO09**

TSO09 is located near the end of the road upgrade. The site consists of a ruined farm house (fig. 17). The building occurs on the 1965 topographical map as a ruin. The house is some distance from the road and will not be affected by the upgrade.

**Significance:** The site is of low significance.

**Mitigation:** No further mitigation is required, however the area should not be used as a camping or storage area.
