**HERITAGE SURVEY OF THE PROPOSED UGIE
ROAD UPGRAID AND BOOROW PIT, EASTERN CAPE**

FOR COASTAL ENVIRONMENTAL SERVICES

DATE: 13 MARCH 2012

**Umlando: Archaeological Tourism and Resource
Management**

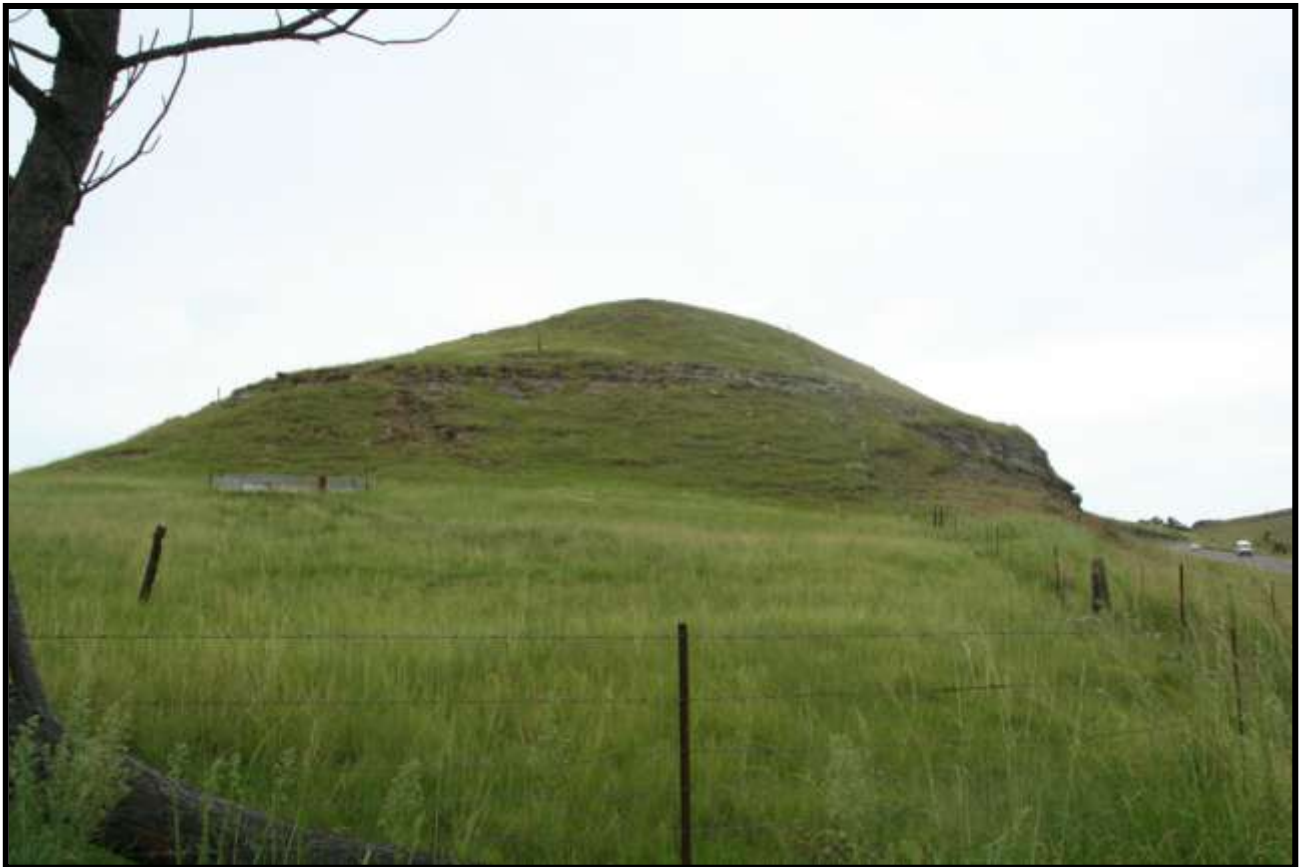
FIG. 10: NORTHERN VIEW OF THE PROPOSED BORROW PIT

Figure 10 shows the northern view of the proposed borrow pit from the side of the farm Sassure.

No artefacts or old structures were observed on the top of the hill, or the sides. The one side of the hill has been used as a borrow pit already, presumably for the existing road.

The road cutting exposes a very thick shale formation that will probably be palaeontologically sensitive.

A palaeontological survey will be required due to the high potential for fossil material.
