# **Proposed Upgrading of Road Sections and Relocation of an Intersection in the Uniondale Area: Archaeological Heritage Impact Assessment**

20 July 2006

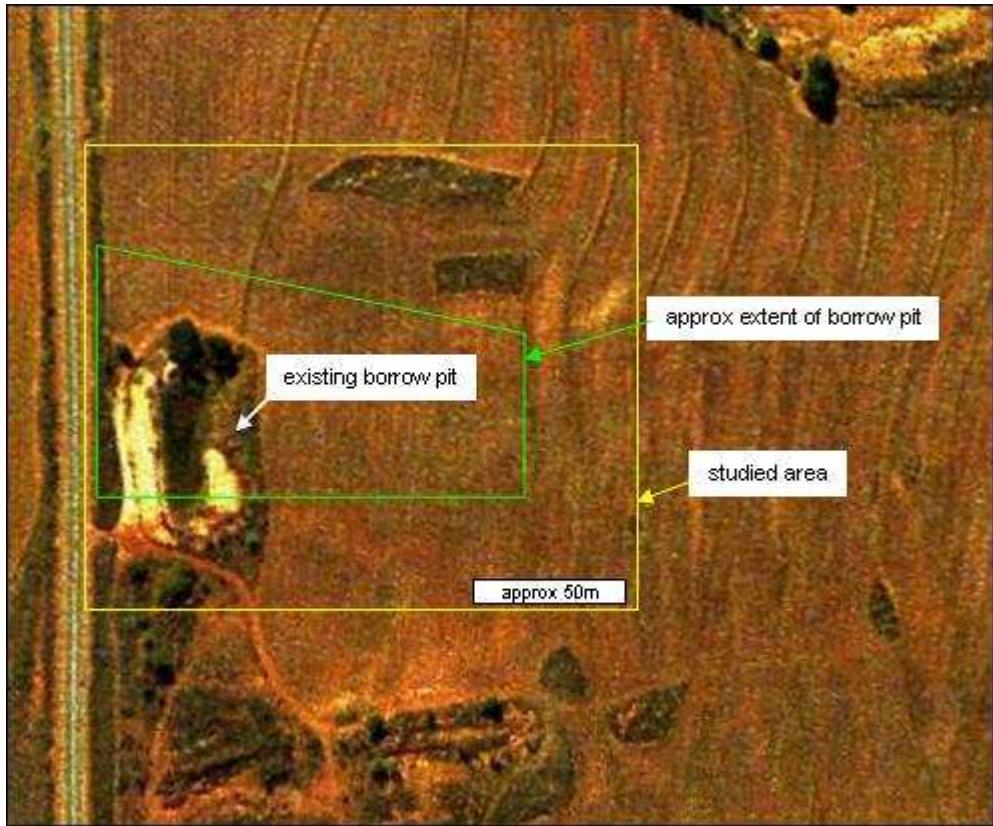
Plate 1. Enlarged area as indicated in Figure 2 showing location and nature of study area and proposed site for borrow pit adjacent (north) of the R339. Note cultivated and formerly disturbed areas.

The site of the proposed extension of an existing borrow pit is situated immediately east of the R339, some 1.6km north of the intersection between the R339 and R62 (Figures 1 and 2). The proposed borrow pit is about 1.2 hectares in extent. The existing borrow pit currently doubles as a dam and the immediate surroundings show clear evidence of former cultivation. The latter included activities associated with clearing fields of stone and plowing. The south western corner of the study area was cleared and plowed while the remainder is very stony and lacking vegetation (Plates 2 and 3 respectively). The topography constitutes gentle sloping hills descending from north to south.

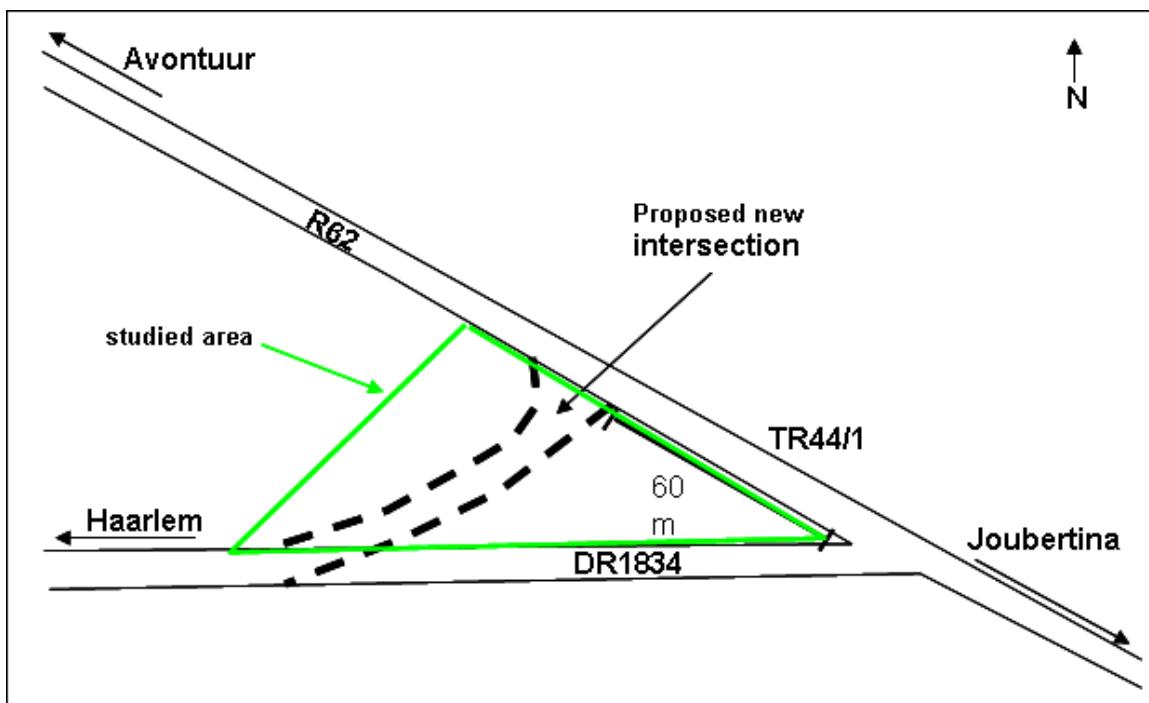
Figure 4. Enlarged area as indicated in Figure 3 (redrawn from Figure 2, CCA Environmental (Pty) Ltd 2006).

The proposed site for the relocation of the eastern intersection of the R62 and Haarlem road (DR1834) is some 60m west of the current intersection (Figures 1, 2, 3 and 4 and Plate 4). The study area is approximately 1.5 hectares in extent (Figure 4). Archaeological visibility is very low as some 95% of the ground surface is covered by grass, bush and shrub (Plate 4). The area includes a small stream channel running in a roughly west to east trajectory (Plate 4). Gentle sloping hills culminate in the small stream channel

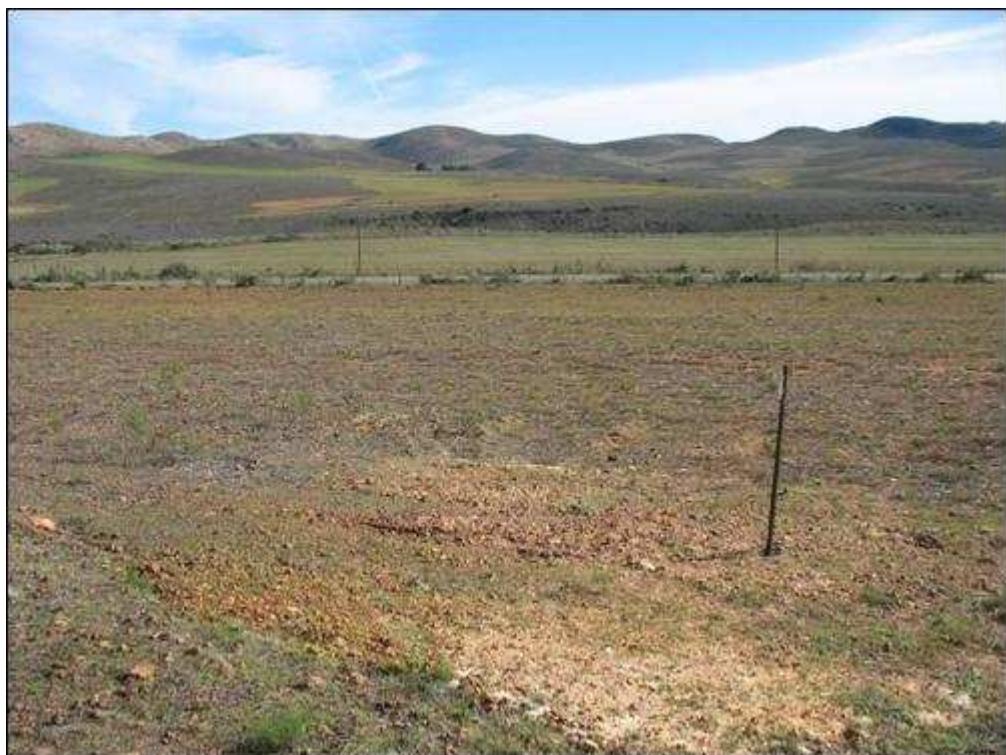
Plate 2. Formerly cleared and plowed portion in the south west corner of the study area at the site of the proposed borrow pit (south to south east view).

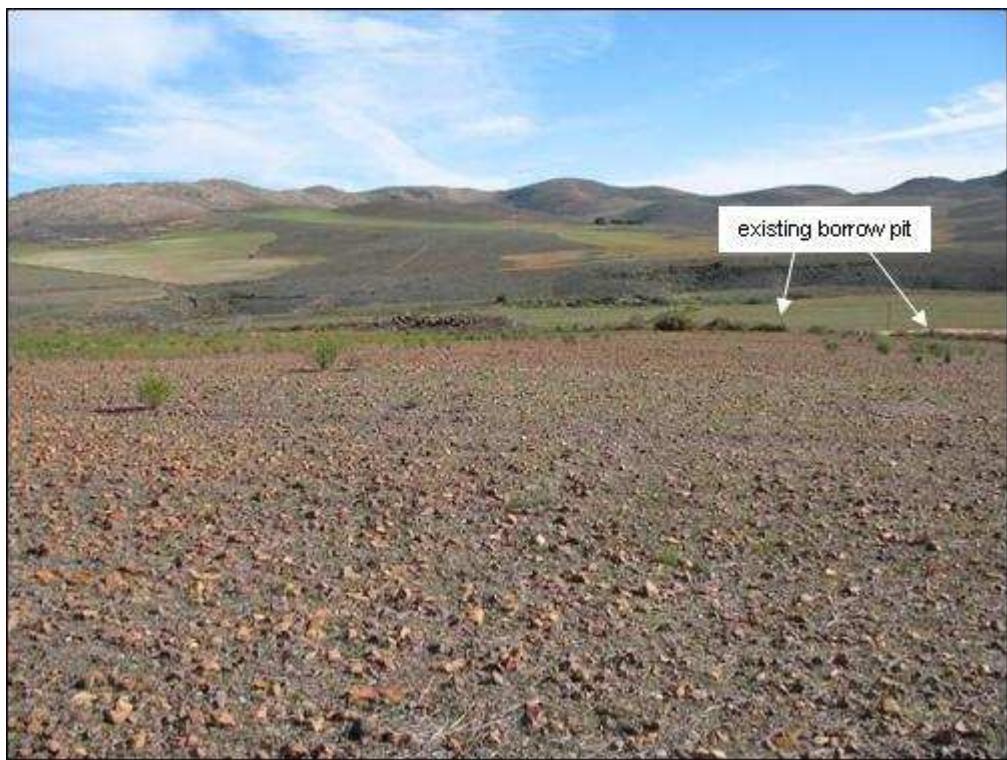
Plate 3. The bulk of the study area is very stony, as is clear in the foreground (picture taken from the north).

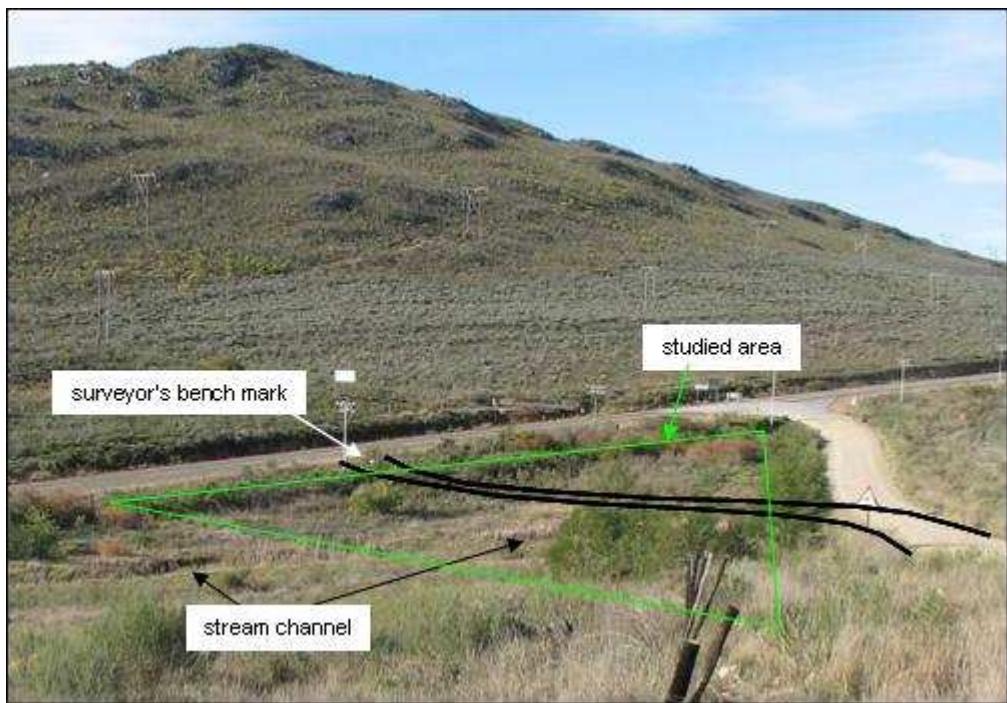
Plate 4. Study area for the proposed new intersection with the R62 in middle of picture and DR1834 at the right. The black lines indicate the approximate position and alignment of the proposed road (see Figure 4). Picture taken from the south, south west.

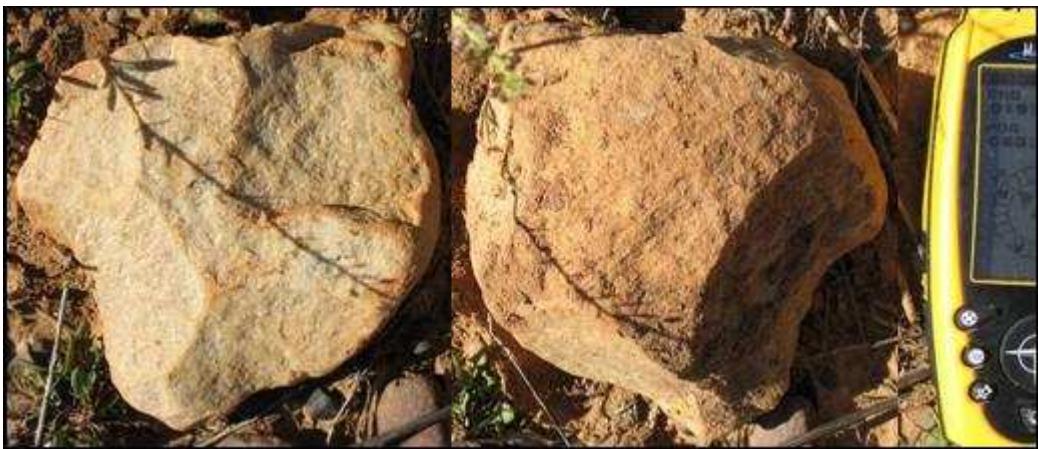
1. Isolated Early Stone Age (ESA) or Middle Stone Age (MSA) core (Plate 5).

Hand held GPS fix:  $33^{\circ} 71147$  S,  $23^{\circ} 16618$  E

Plate 5. Stone artifact (core) of Early or Middle Stone age origin showing ventral and dorsal surfaces (left and right respectively). Hand held GPS (Magellan SporTrak) for scale.

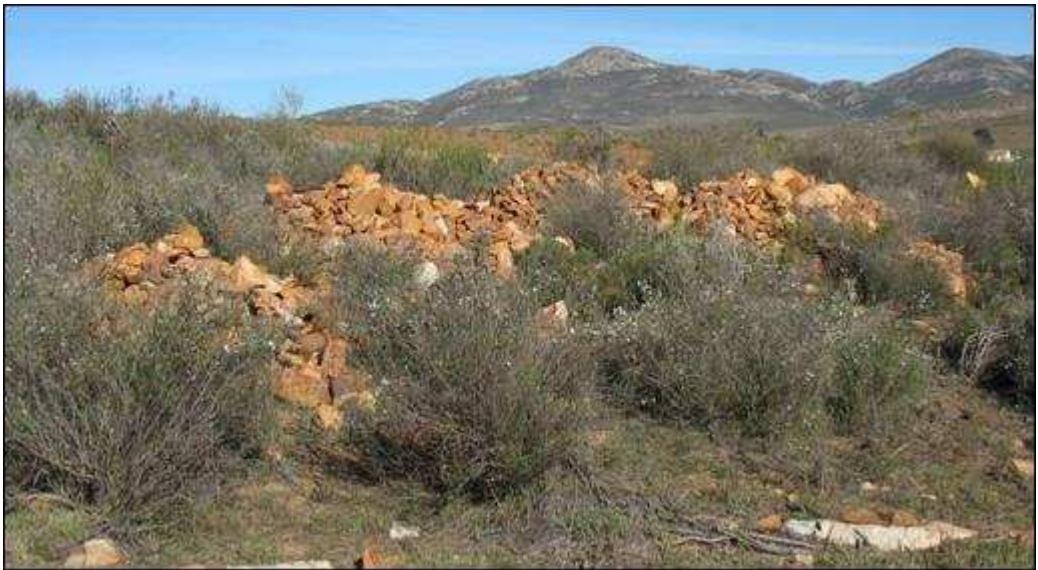
2. Pile of stones from clearing area for plowing. No artifacts were recorded in the mound of stones (Plate 6).

Plate 6. Pile of stone from former activity associated with clearing fields for plowing and cultivation. No artifacts were seen among these stones.

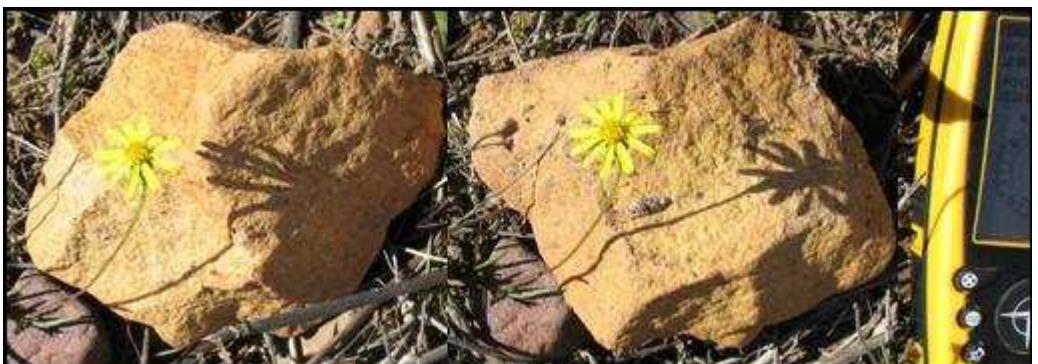
3. Isolated ESA core (Plate 7).

Plate 7. Stone artifact (core) of Early Stone age origin showing dorsal and ventral surfaces (left and right respectively). Hand held GPS (Magellan SporTrak) for scale.

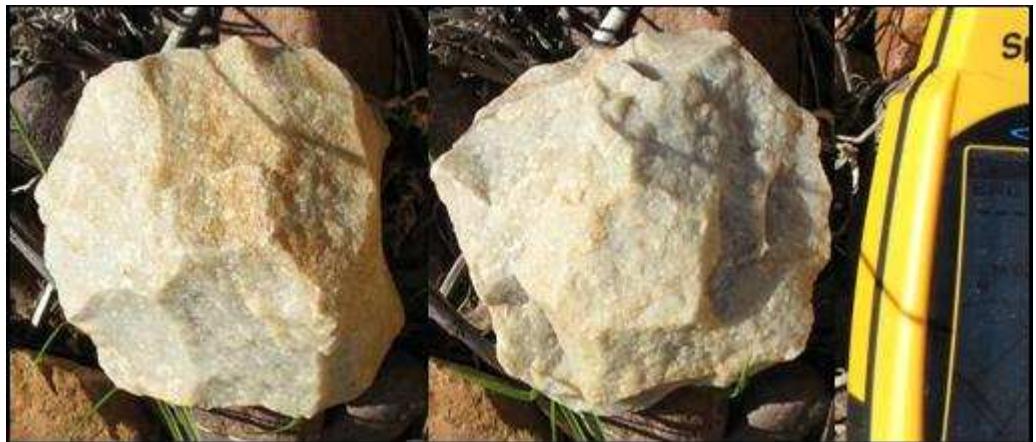
4. Isolated MSA or Later Stone Age (LSA) radial core (Plate 8). A few meters south of this artefact a large retouched quartzite flake was seen.

Plate 8. Stone artifact (radial core) of Middle or Later Stone age origin showing dorsal and ventral surfaces. Hand held GPS (Magellan SporTrak) for scale.
