HERITAGE OPTIONS ANALYSIS

PROPOSED LOW COST HOUSING DEVELOPMENT IN THE VICINITY OF VAAL MARINA, GAUTENG PROVINCE.

Professional Grave Solutions Heritage Unit
Professional Grave Solutions (Pty) Ltd

Compiled by: P.D. Birkholtz
Date: 12 February 2009

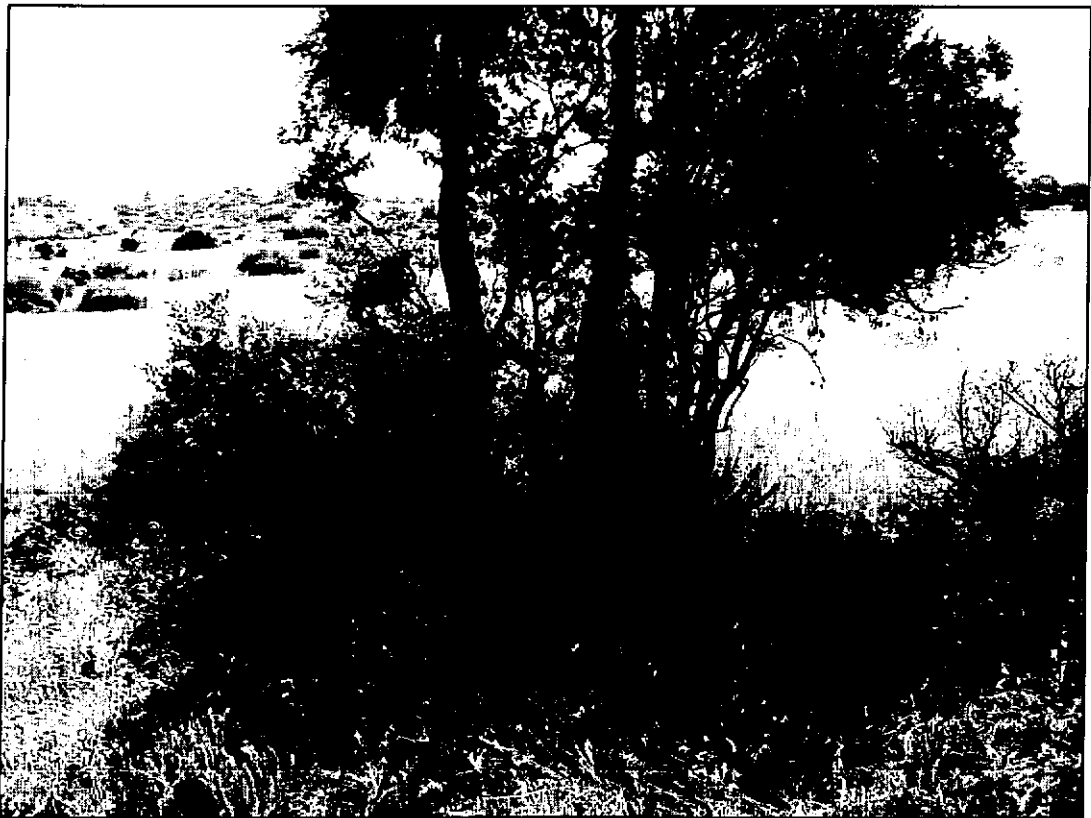
Plate 10 General view of Site 1. As the site is overgrown the possible grave can not be seen.

The stone concentration must be investigated by way of reconnaissance excavation. The excavations will result in one of two outcomes, namely that evidence (i.e. skeletal material, coffin remains etc.) for the existence of a grave is found, or alternatively that no such evidence is found. If no evidence for a grave is found, the site can be destroyed. However, should it be found, the excavation pit must be backfilled upon which a standard grave relocation process must take place. Such a relocation process must always be inclusive of a detailed social consultation process, must be respectful to the deceased and must be undertaken in cognisance of all the relevant legislation.

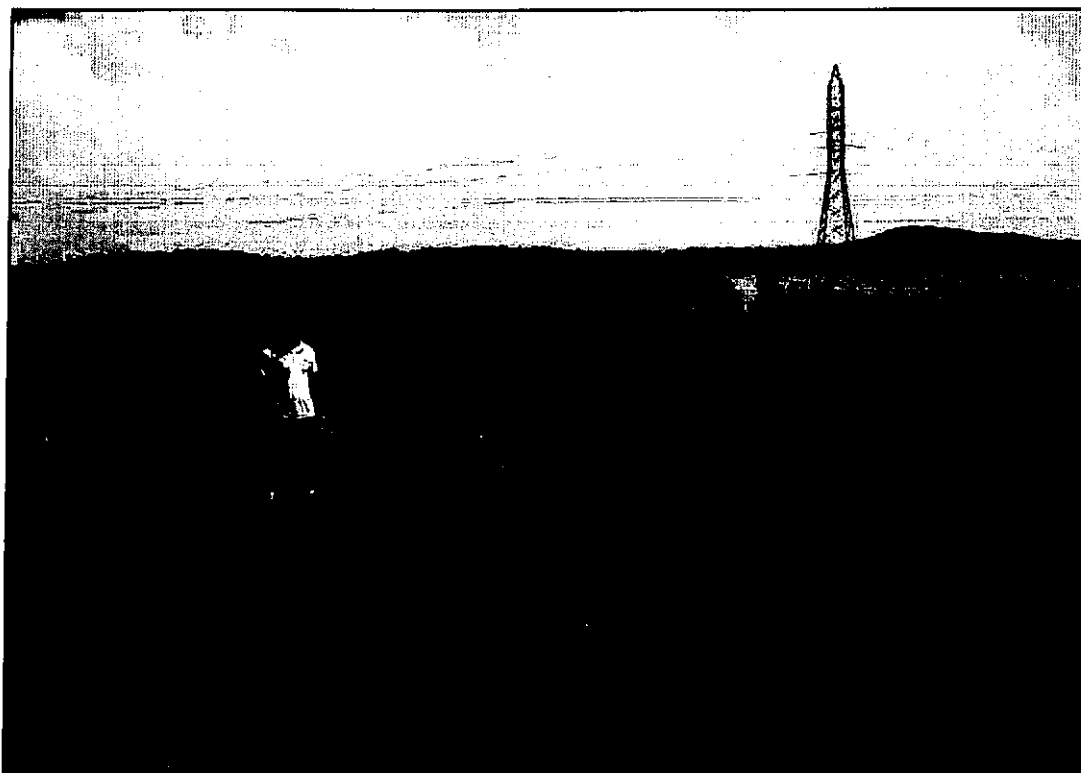
The site consists of a poorly preserved rectangular stone structure measuring 3m x 3m. A small number of glass fragments were observed on the surface of the site.

Although no definite information with regards to the age of the structure could be found, it is believed to be between 60 and 100 years old.

Plate 11 General view of Site 2. The structure is located between the person on the left and the bush on the right.

No mitigation measures are required.

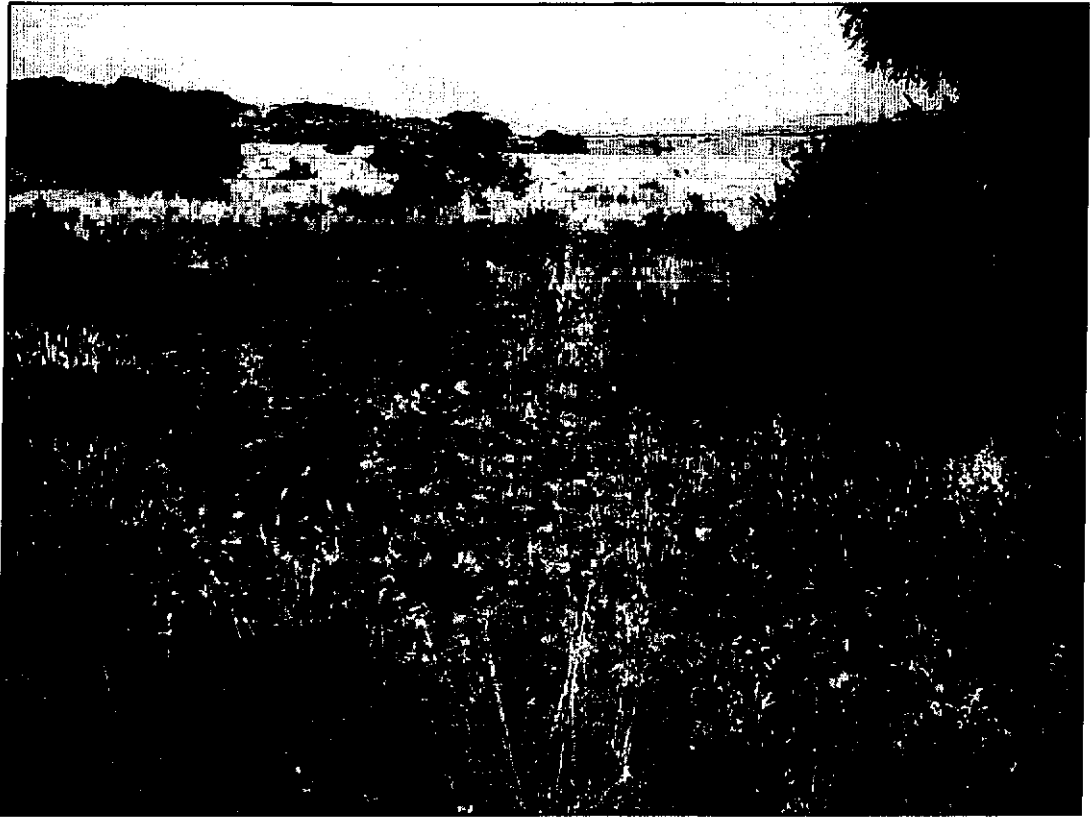
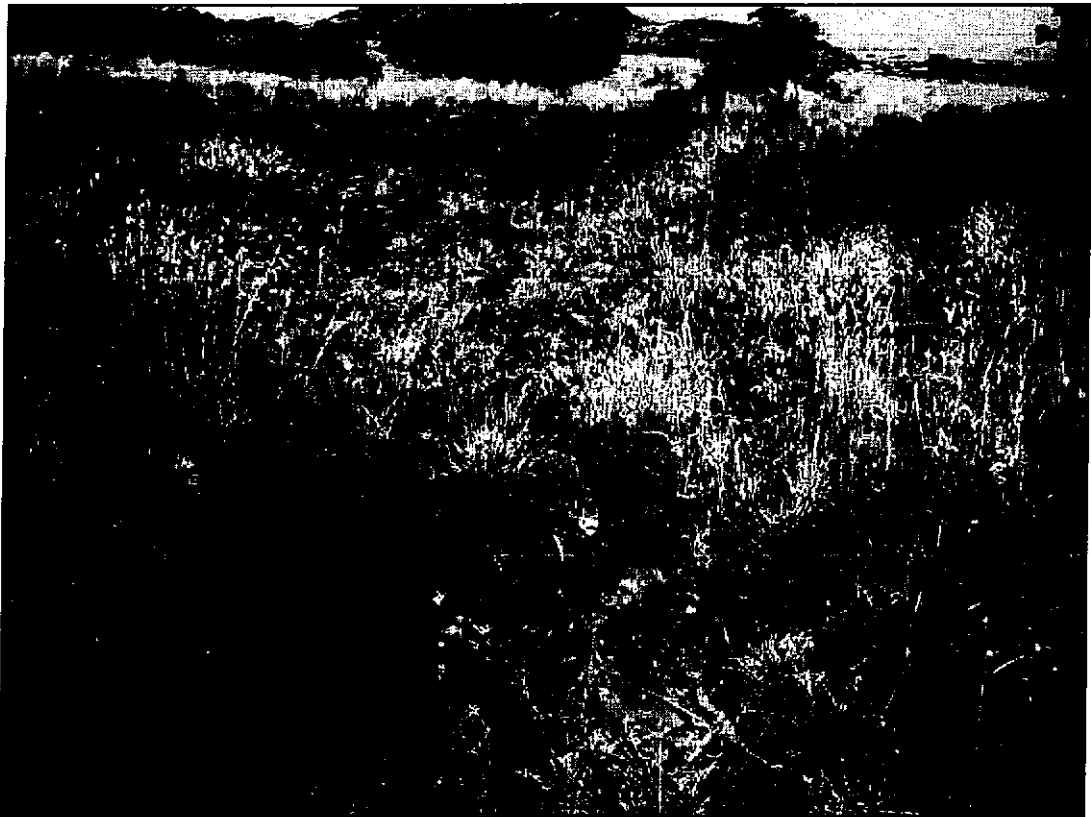
The site consists of a poorly preserved rectangular stone structure. The structure is 4m x 9m in extent. No artefacts could be observed on the surface of the site.

Although no definite information with regards to the age of the structure could be found, it is believed to be between 60 and 100 years old.

Plate 16 General view of Site 5.

Plate 17 Another view of Site 5.

No mitigation measures are required.

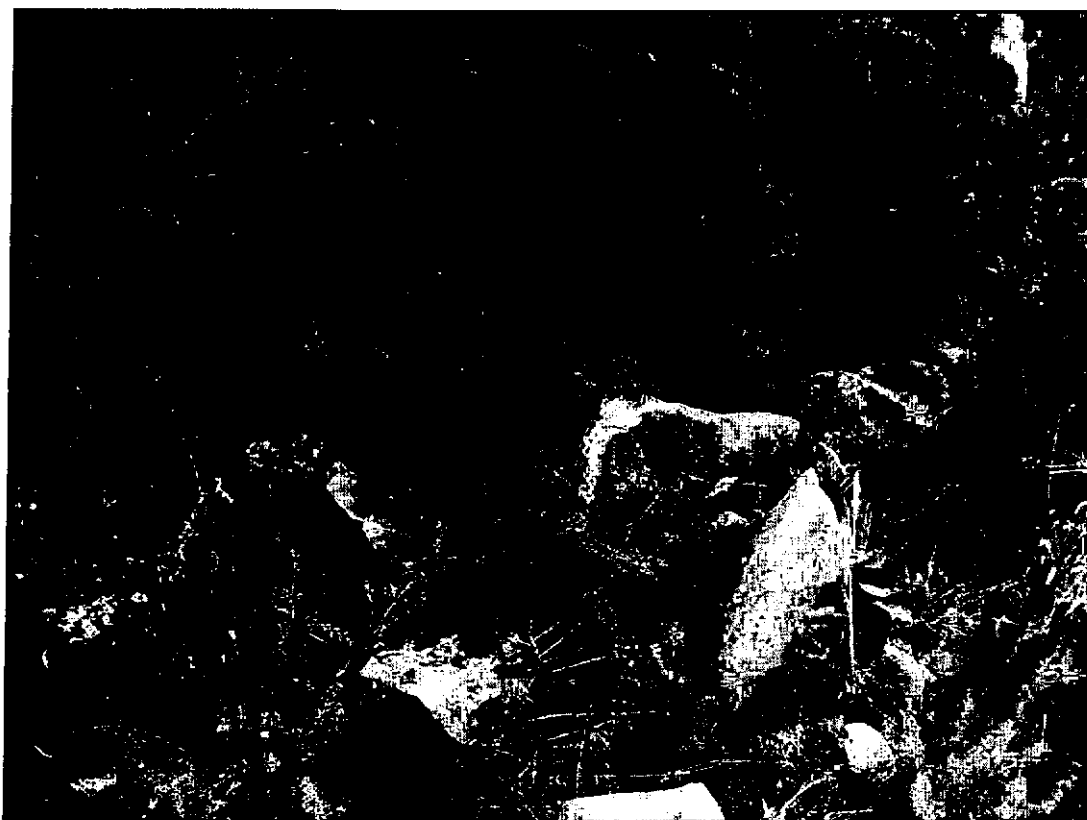
Plate 19 One of the rectangular structures at the foot of the ridge.

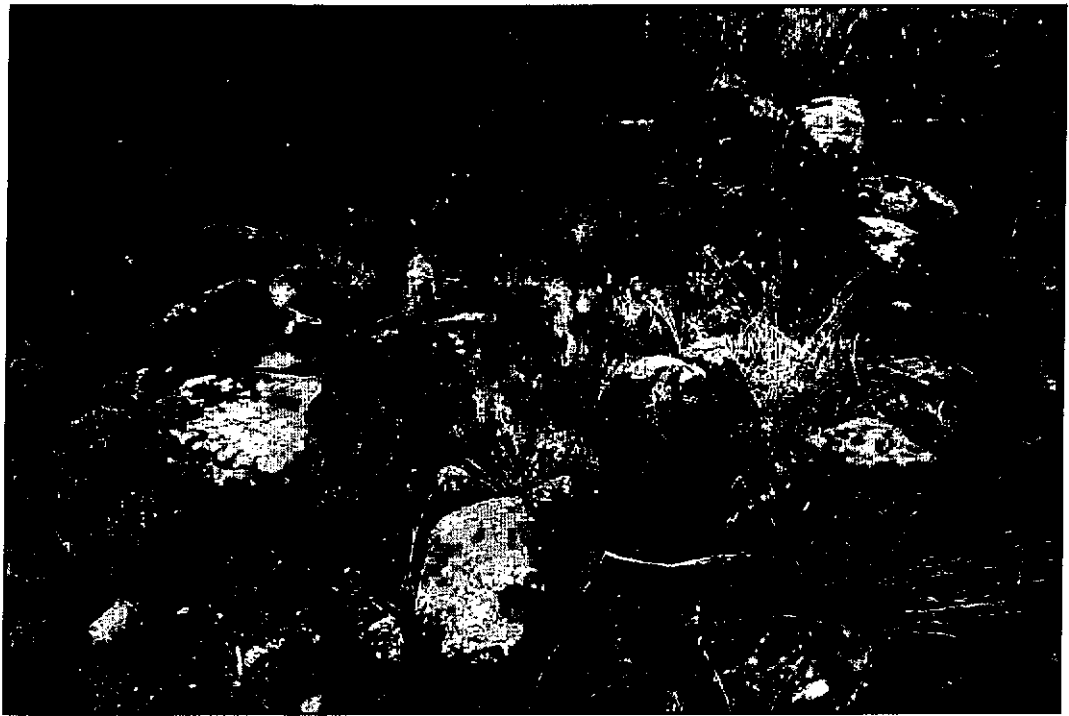
Plate 21 One of the circular enclosures from the higher slopes of the ridge. This enclosure is approximately 1.5m wide. These enclosures may represent the poorly preserved remains of a Late Iron Age component at the site.

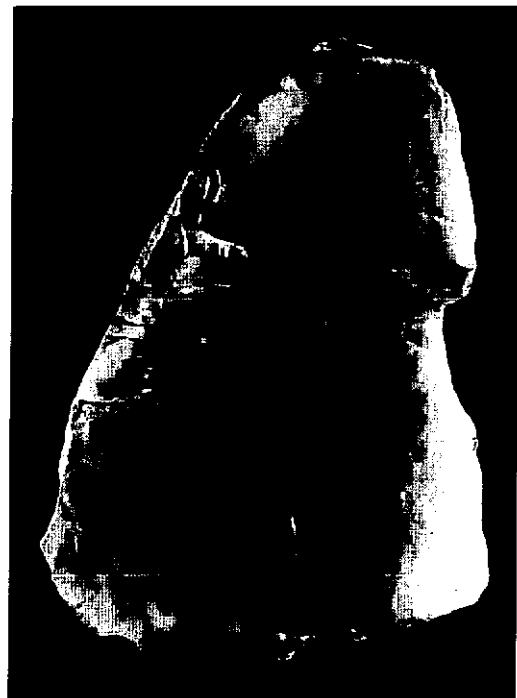
Plate 22 Two glass fragments observed on the surface of the site. The fragment on the left (18mm wide at its widest point) is a stopper finish of a mould blown wine, spirits or beer bottle. The fragment on the right (21mm at its widest point) is a down-tooled lip of a bottle that contained carbonated beverages or ginger beer. Both artefacts date from the late nineteenth to early twentieth centuries (Meyer, Pers. Comm.).

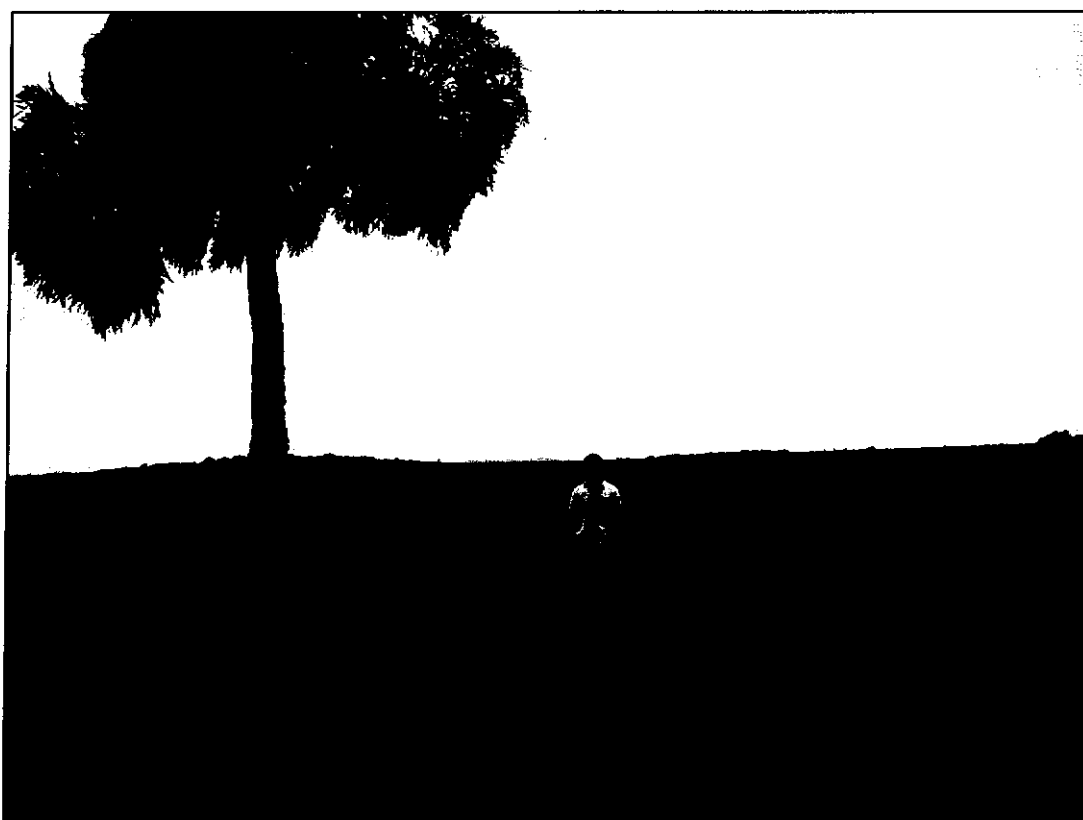
A small number of glass and porcelain fragments were observed on the surface of the site, without any evidence for an archaeological deposit.

Although no definite information with regards to the age of the structure could be found, it can certainly be considered as older than 60 years. The possibility also exists that the site is older than 100 years as well.

Plate 23 General view of Site 7.

The following mitigation measures are proposed:

- Measured drawing of a site layout plan.
- Measured drawing of the individual structures.
- Photographic recording
- Compiling the drawings, photographic recordings and descriptions into a report.
- Submission of the report to SAHRA with the permit application to have the site destroyed.

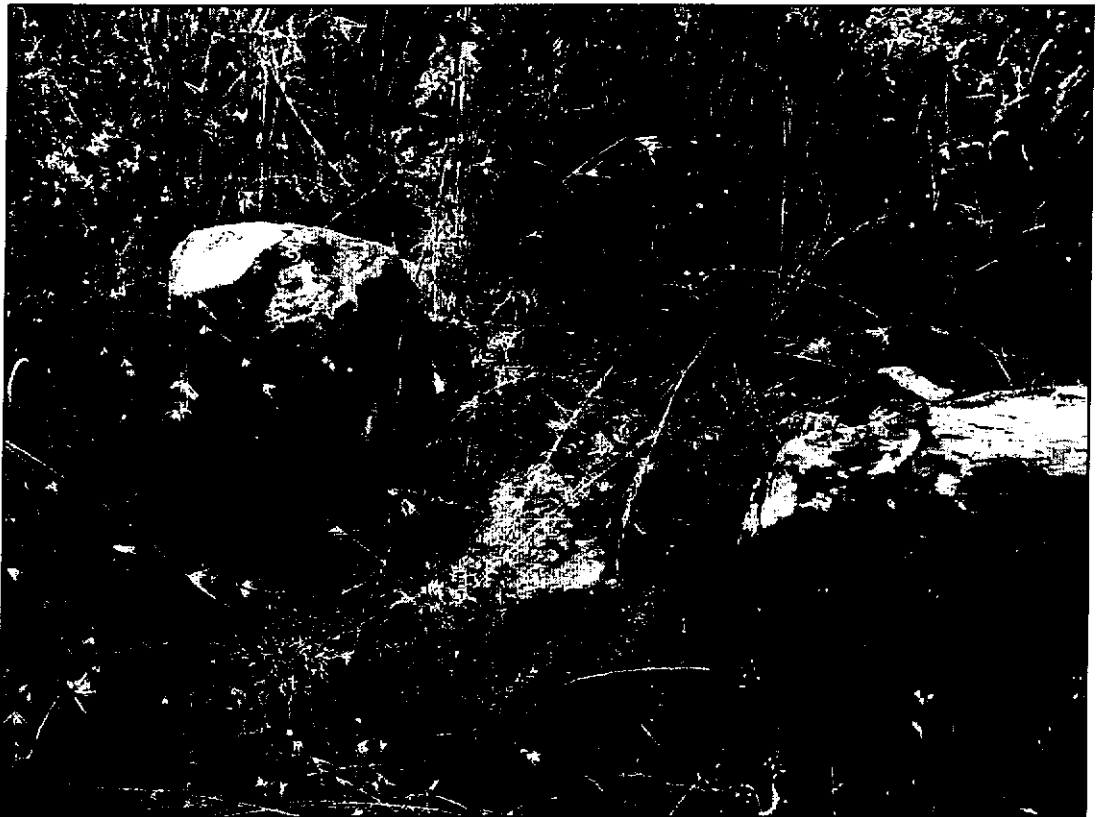
Plate 25 Possible entrance to the rectangular structure from Site 7.

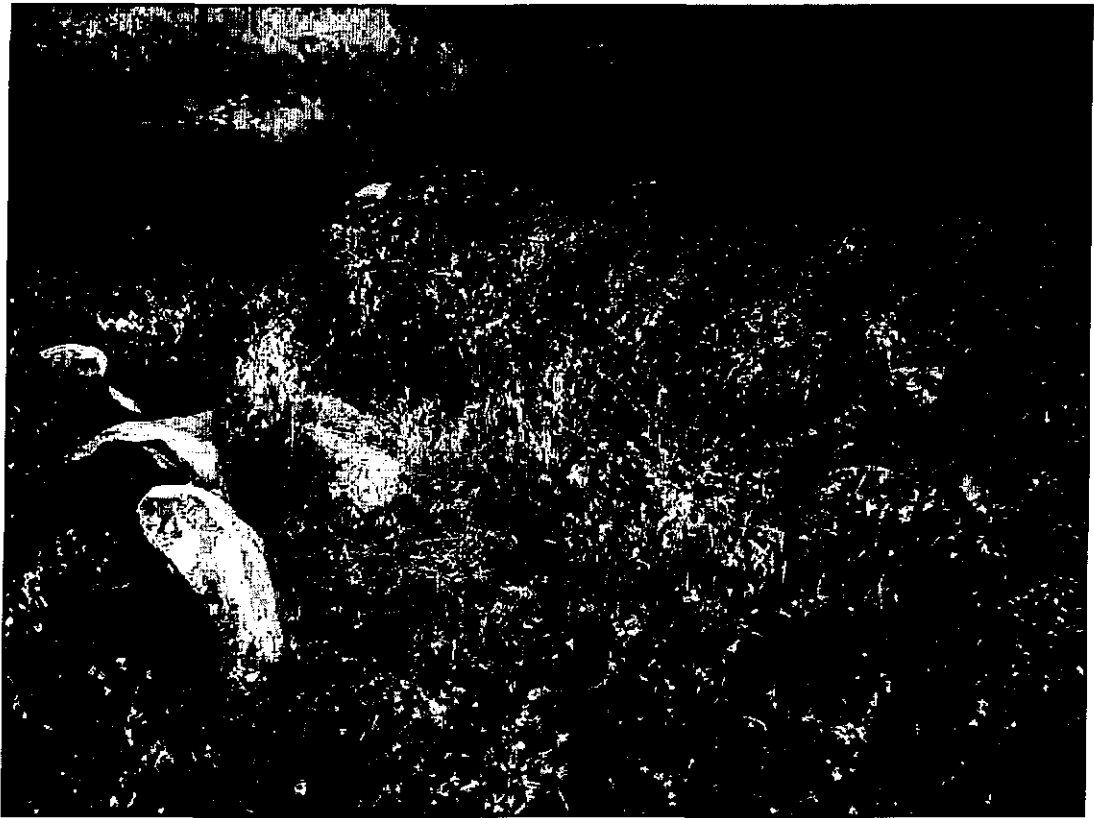
Plate 26 The circular structure from Site 7.
