**A REPORT ON A CULTURAL HERITAGE IMPACT ASSESSMENT ON A
PORTION OF THE FARM VAALDAM SETTLEMENT 1777, VAALDAM,
HEILBRON DISTRICT, FREE STATE PROVINCE**

REPORT: AE710

Work conducted: ***May 2007*** Date of report: ***May 2007***

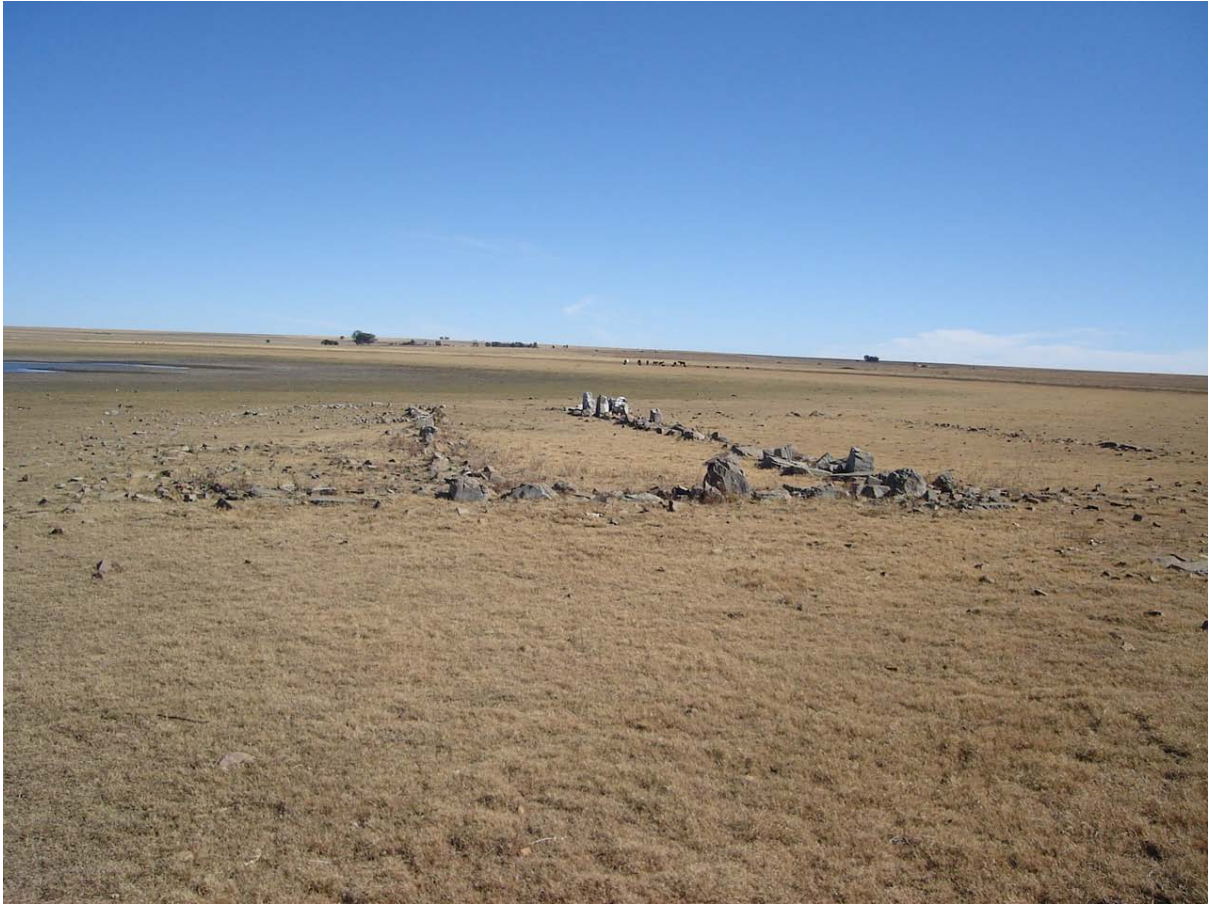
Fig. 1. Photograph of stone built structure. This site would be under water when water levels rise slightly as it is right on the banks of the Vaaldam

Only one site of cultural significance was located on the property. This is the remains of a fairly large stone built structure, possibly an old farmhouse, consisting of about five individual rooms. The site is located at **27. 02229° S 28. 15009° E**. It is also clear that this site would be consistently under water should the water levels only rise slightly. It is also for this reason that development is not currently considered on this portion of the property. Should this however be considered in future this structure would have to be assessed and researched in ore detail.

Secondly, we recommend that the stone built structure be assessed should any development in the area where it is located be considered in the unforeseeable future. This work should be conducted by an architectural historian. Lastly, in the light of comments made on reports of surveys in the Vaaldam area (by the same author) by SAHRA regarding possible palaeontological studies in the area, it is our believe that these studies would be unnecessary (see Letter to SAHRA dated (2007-04-10)).

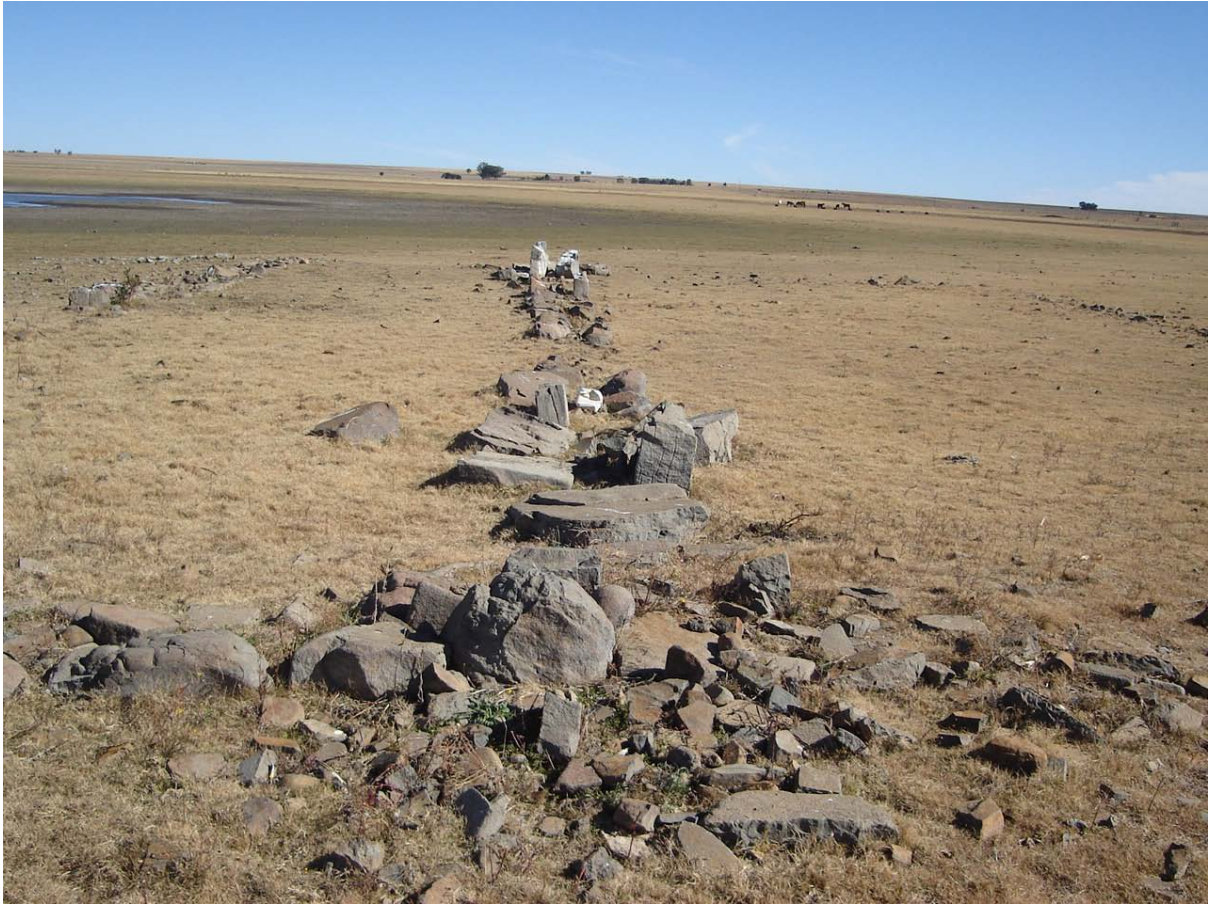
Fig. 2. Close-up of stone wall of structure. The brown line in the distance indicate the level of the water in wetter conditions
