PHASE I HERITAGE IMPACT ASSESSMENT

PROPOSED VLAKVARKFONTEIN COLLIERY EXPANSION PROJECT

Date: 10 May 2011

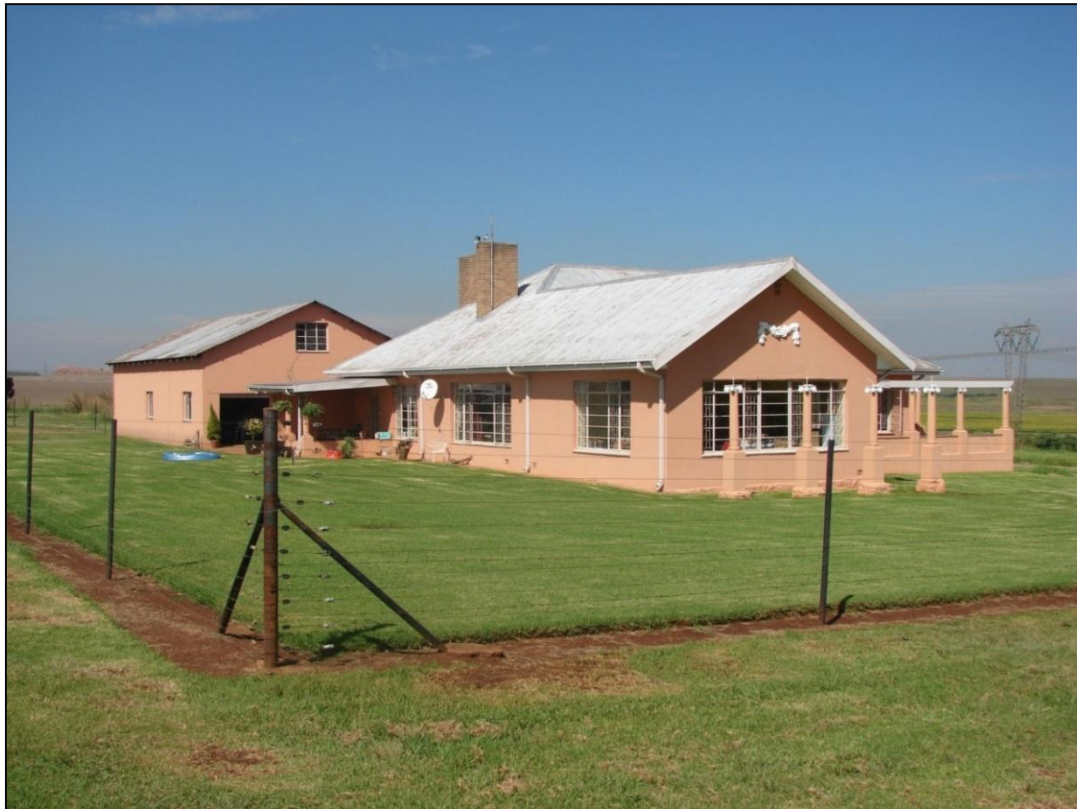
Figure 23 - VVF 02 Transvaal pitch-roof house. Note the shed south of the house. ©Tomose @ PGS

Proposed Management Measure: Currently None - However, should the mine wish to expand further into the area where the site is located - a Phase II HIA will need to be conducted before destruction.

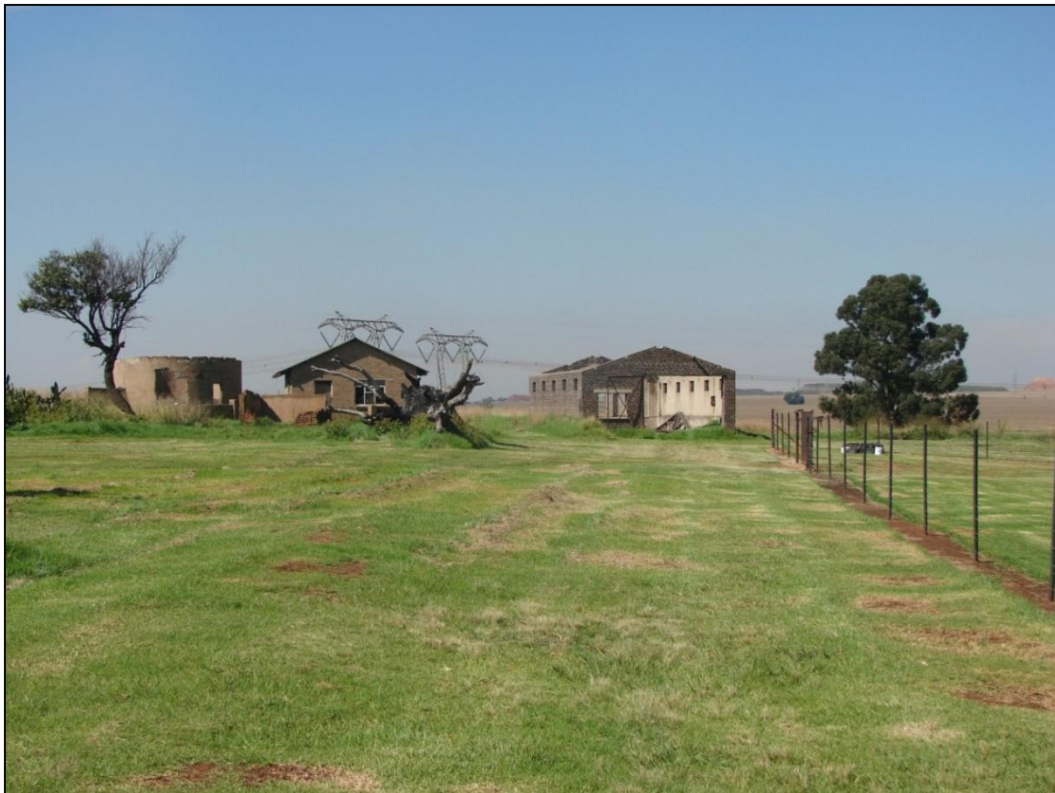
Figure 26 - Dilapidated roundavel, small square structure in front, a modern cottage & dilapidated old shed in fabricated brick- no roof, windows, and door. ©Tomose @ PGS

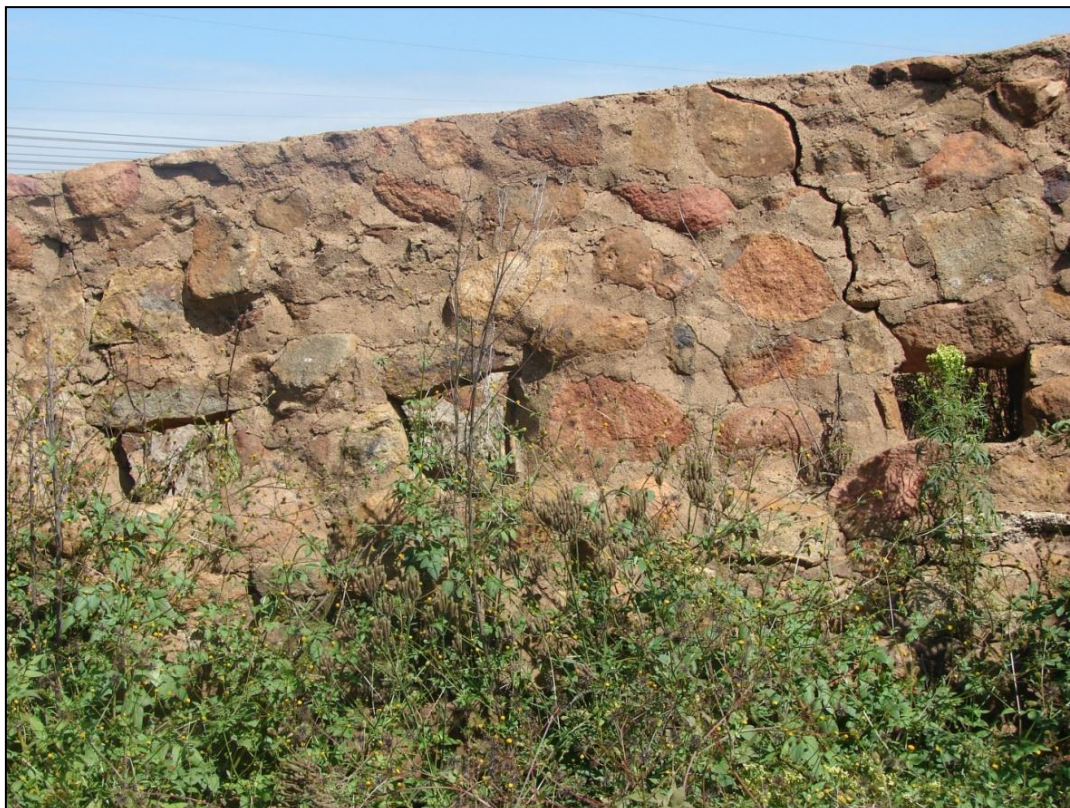
Figure 29 -Stone and mortar kraal, note small window openings on the side of the kraal wall. © Tomose @ PGS

Proposed Management Measure: Currently None - However, should the mine wish to expand further into the area where the site is located - a Phase II HIA will need to be conducted before destruction.

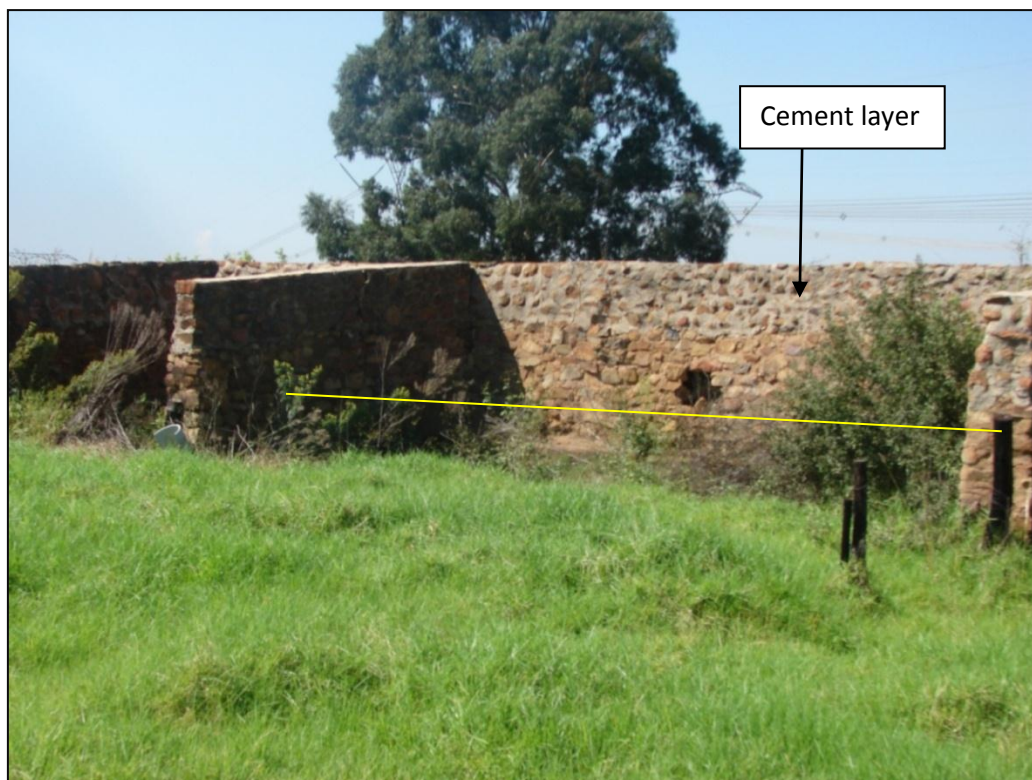
Figure 30 - Cement layer, north face of the kraal. Note the window opening; stones have fall on the window.

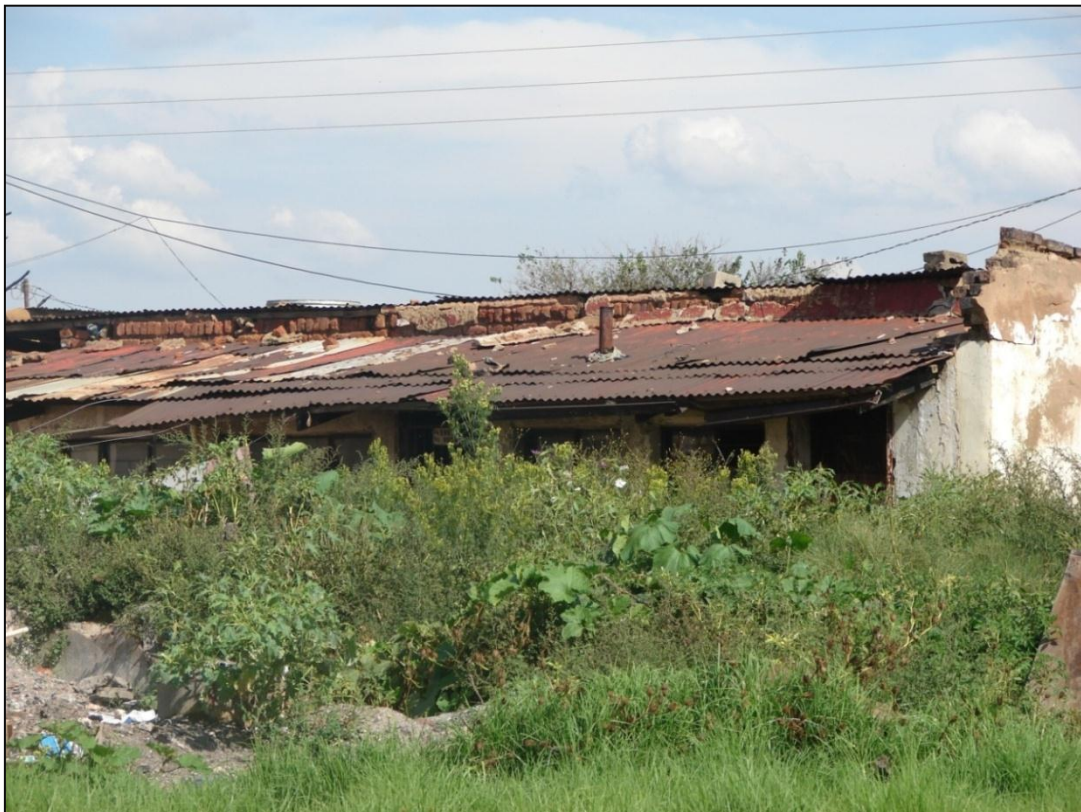
Figure 49 - Back cottage; note the Burnt clay bricks. © Tomose @ PGS.

Proposed Management Measure: Phase II HIA is recommended if the store is to be impacted by the mining activities at any stage – the site is unique and represent one of the old Transvaal stop stores/shops linking two or more towns. The material that it is made of is also of unique. It is, however, of local significance in terms of field rating.

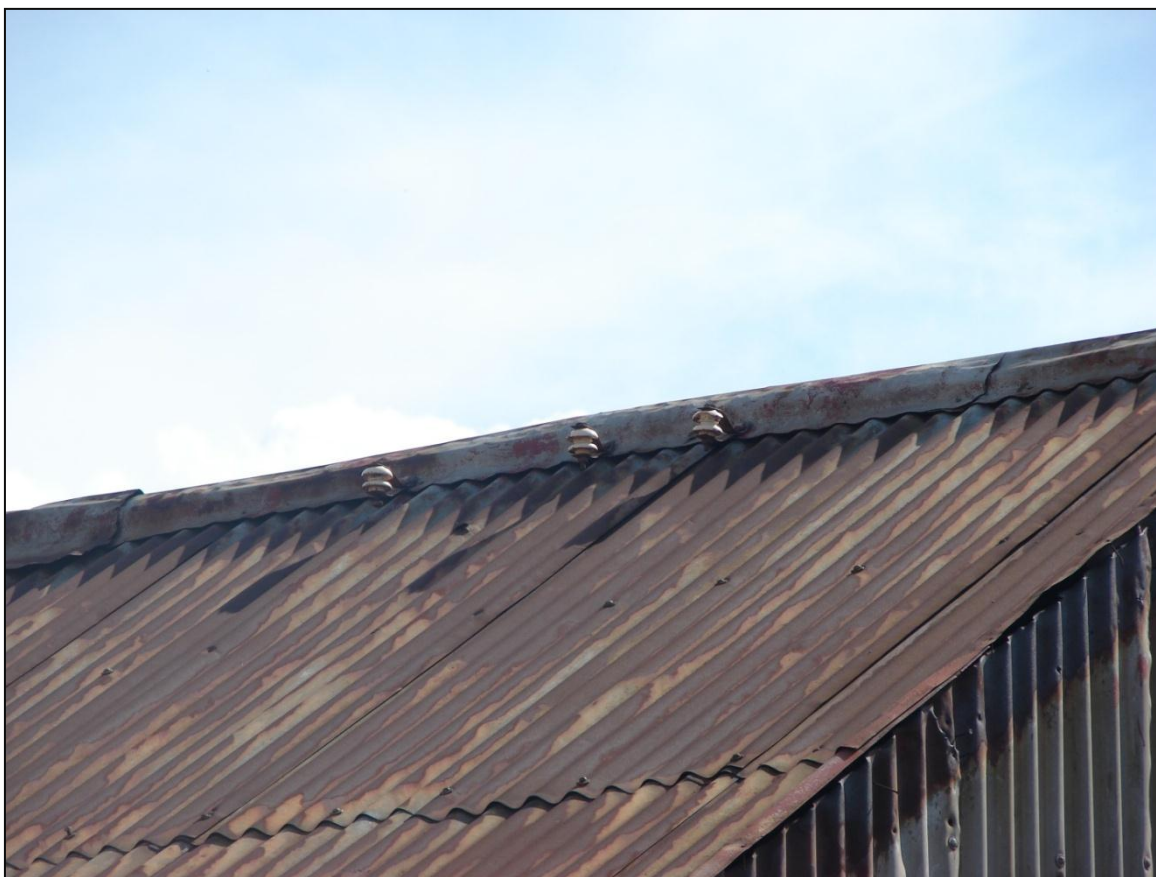
Figure 50 - Historic electricity port connections on the shop roof. © Tomose @ PGS.
