# HERITAGE IMPACT ASSESSMENT PROPOSED WIND ENERGY FACILITY

Ekkraal RE/199 Northern Cape Bon Esperance RE/73 Western Cape  
Wilgebosch Rivier 188 Northern Cape Rietfontein 197 Northern Cape  
Karreebosch RE/200 Northern Cape Ek Kraal 2/199 Northern Cape  
Klipbanks Fontein RE/198 Northern Cape Klipbanks Fontein 1/198 Northern Cape  
Bon Esperance 1/173 Western Cape Ek Kraal 1/199 Northern Cape  
Barendskraal 1/76 Western Cape Barendskraal RE/76 Western Cape  
Fortuin 1/74 Western Cape Brandvalley RE/75 Western Cape  
Hartjies Kraal 1/77 Western Cape Brandvalley 1/75 Western Cape  
Fortuin 3/74 Western Cape Fortuin RE/74 Western Cape  
Hartjies Kraal RE/77 Western Cape

(Assessment conducted under Section 38 (8) of the  
National Heritage Resources Act as part of an EIA.)

March 2011

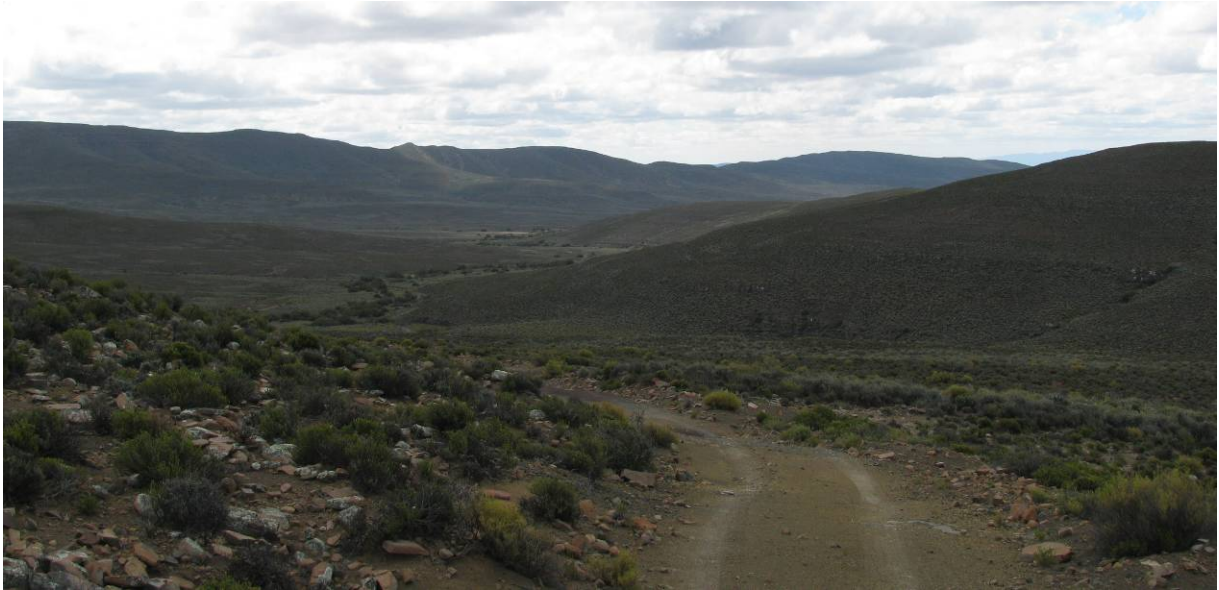
*Figure 2 Typical topography of the study area - Valleys and ridges*

It is a semi-arid region with rainfall mainly in the form of summer thunderstorms in recent years, some snow and precipitation in winter. The vegetation is characteristic of the Succulent Karoo biome (figure 2). The northern parts of the "site" straddles the foot hills (Kleinroggeveldberge) below the great escarpment. This area is characterised by a series of very high and long ridges with valleys in-between (anticlines and synclines). These contain acacia thickets in places, a number of farm buildings and local roads. The high ridges (figure 3) are windswept, dry, inhospitable and un-developed (apart from the recently constructed turbine site access roads). The southern portion which forms stage 2 of the proposal is slightly different - the linearity of the ridges is somewhat more varied and interspersed by vast flattish plains.

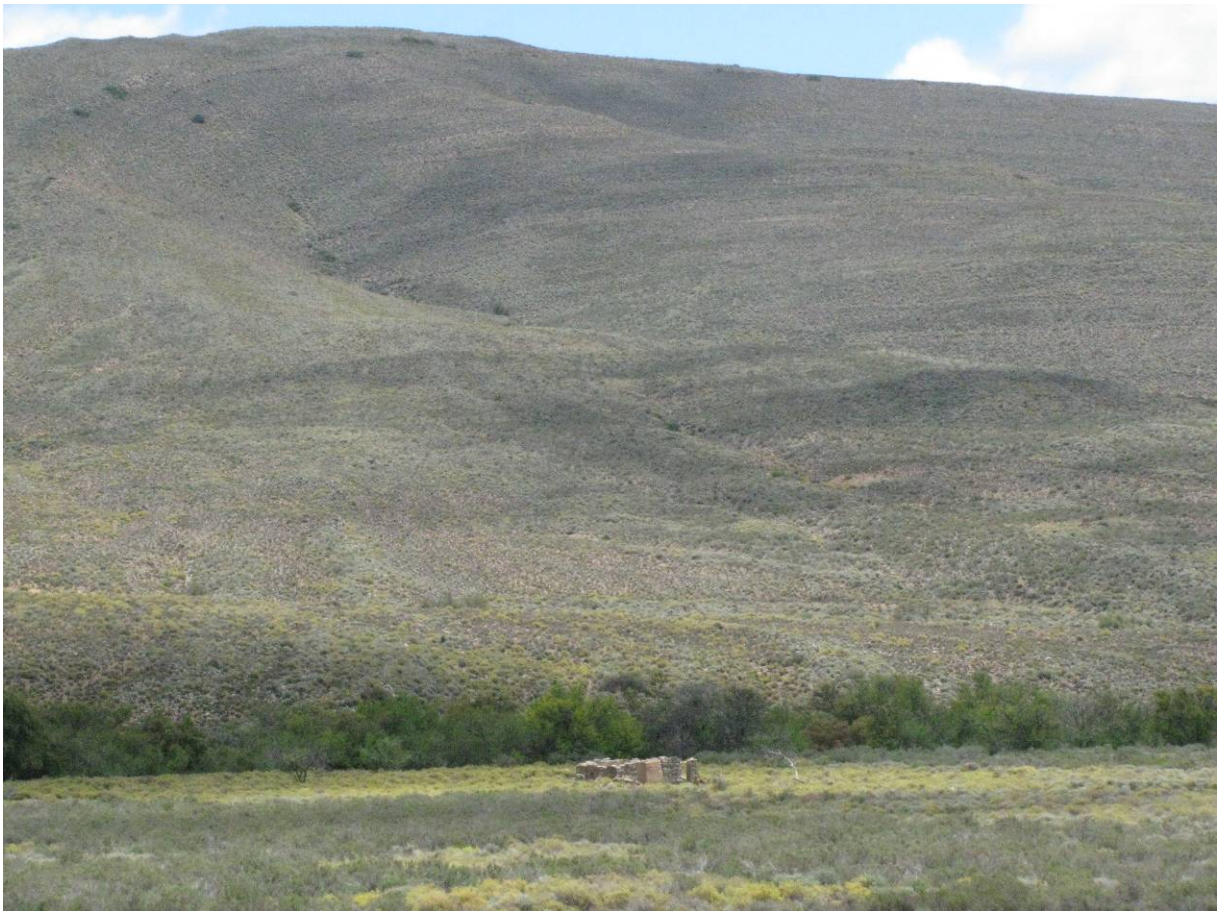
*Figure 3 The turbines are to be located on the high ridges, farming has historically taken place on the valley floors.*

The actual turbine sites are situated on the tops of very high ridges where the wind conditions are optimal. Within the study area the ridges are devoid of rock shelters, rock

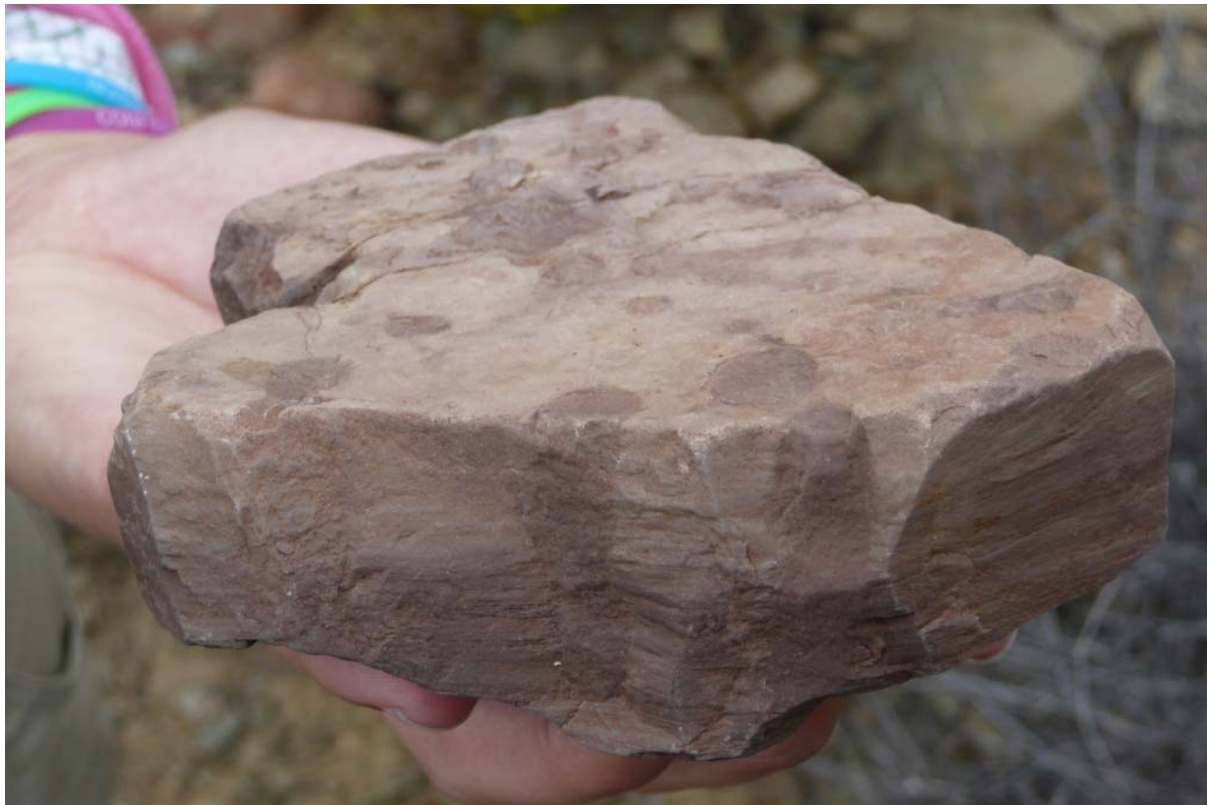
*Figure 4 Trace Fossils Consisting of Sand-filled Vertical Burrows in Sandstone, from Ekkraal Farm (width of rock ca. 200 mm)*

The only fossils found in the rocks of the Abrahamskraal Formation were trace fossils in the form of sand-filled vertical burrows in sandstone (*Figure 4.2.1*). These were in a loose block adjacent to a packed stone ruin in the Ekkraal valley) and may have been transported from elsewhere as building material (*figure 4*).

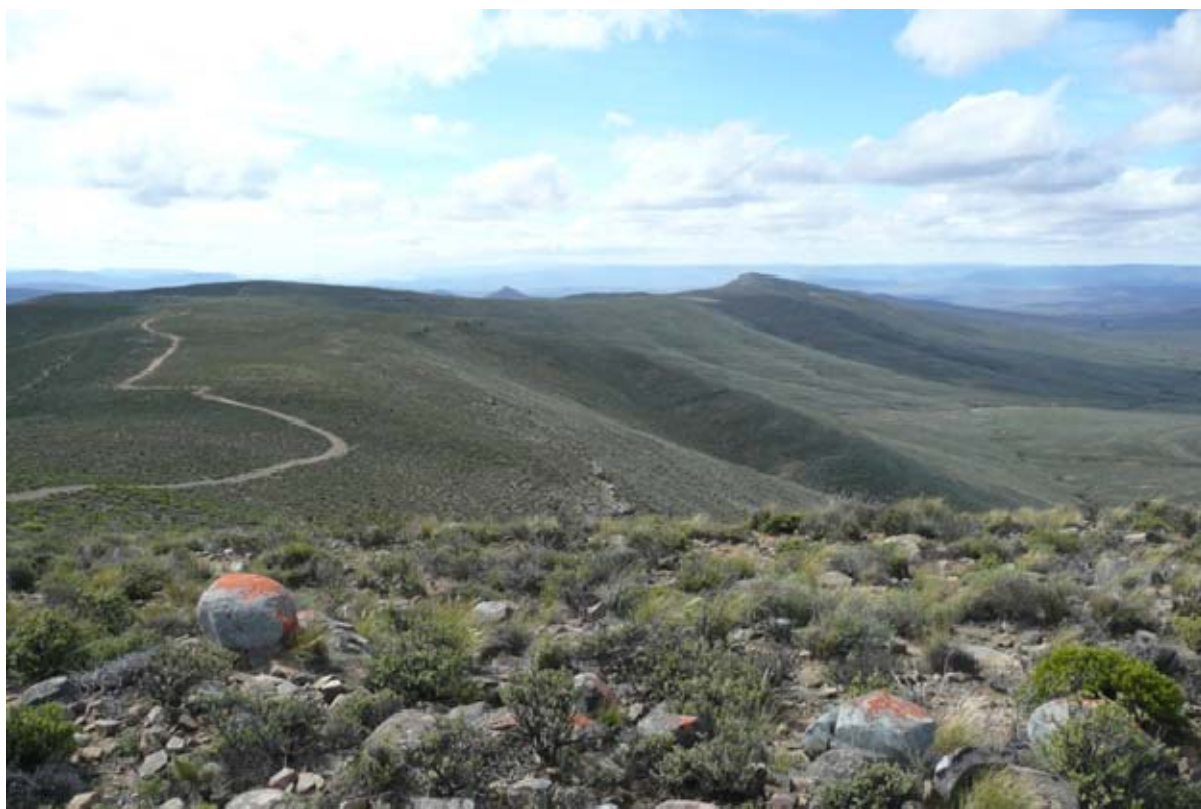
*Figure 5: Typical landscape of the study area – note the recently constructed access road over the tops of the ridges.*

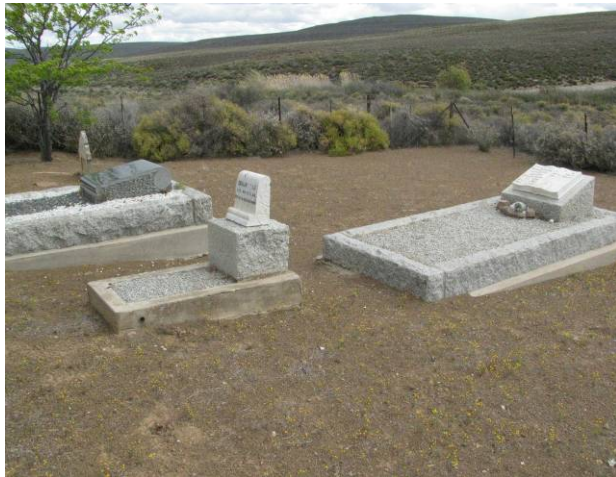
*Figure 5 Formal graves at Barendskraal cemetery*

A formal farm cemetery (figure 5) is situated on the farm Barendskraal not far from the farm buildings. The cemetery which contains about 20 visible graves is enclosed by a wire fence. The more formal graves are dated to the early – mid-20<sup>th</sup> century. There are a number of burials marked with simple natural stones. The cemetery will not be impacted by the proposed development activity.

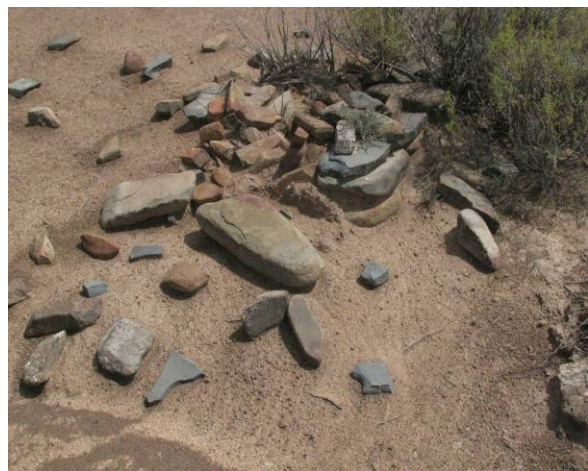
*Figure 6 Stone pile (possible grave) near Ekkraal.*

A collection of stone piles were recorded in the Ekkraal Valley (figure 6). These do not appear to be associated with any other archaeological material which would assist in identifying them. They are provisionally described as graves as they could be culturally associated with pre-colonial occupation. It is not expected that the stone features will be impacted by the proposed activity.

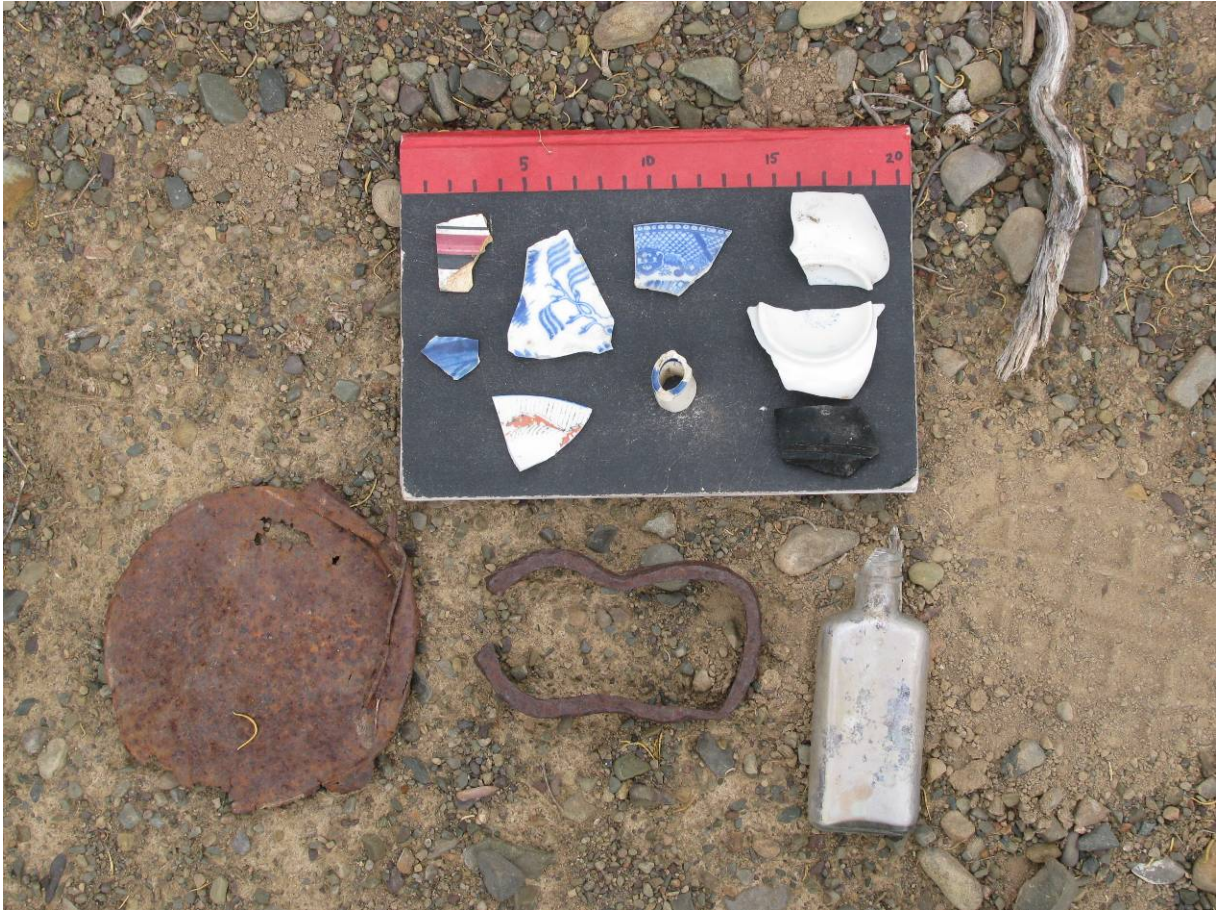
Figure 7 Artefacts of the mid-late 19<sup>th</sup> century found associated with ruins near Ekkraal.

The significance of Ekkraal valley lies in the intactness of the archaeological signature of early colonial occupation. The pattern of kraals, farm buildings, artefact scatters and walling remains highly legible. The area can be considered to be archaeologically sensitive and worthy of preserving in terms of its research potential. The heritage of the valley is not a tourism resource, and not well known to anyone other than the local populous. In these terms it does not constitute visually sensitive heritage. Of concern is that the existing track down the valley will be upgraded to provide access. This could physically impact ruins and archaeological sites that lie close to the track.

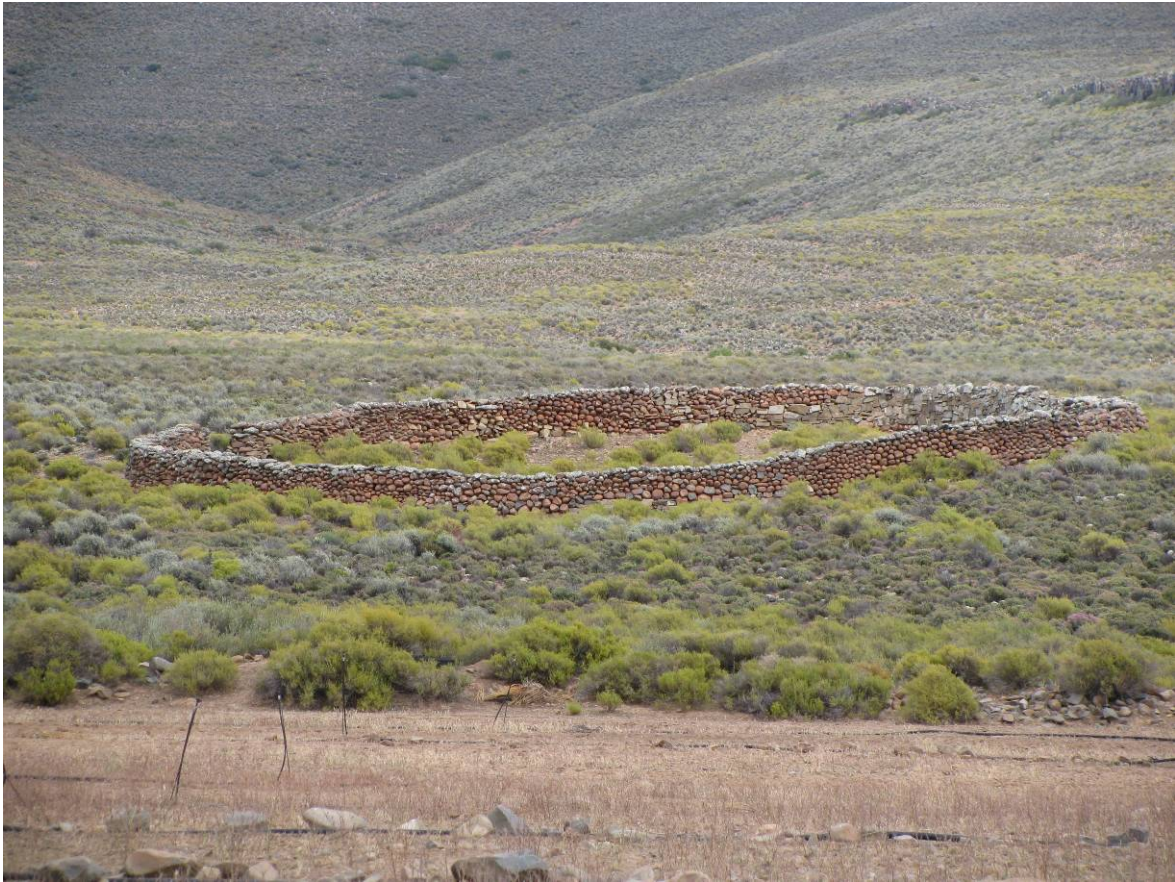
*Figure 11 Large stone kraal, Ekkraal.*

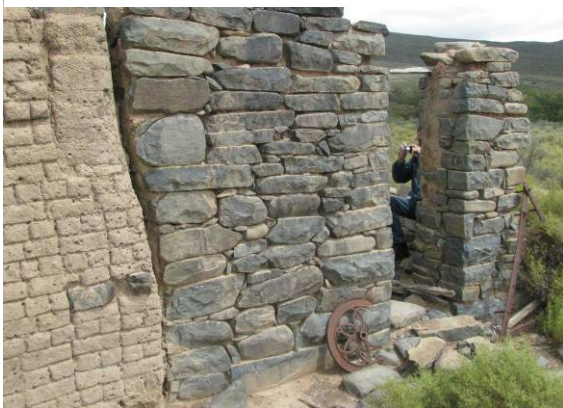
*Figure 10 19<sup>th</sup> century ruins, Ekkraal*

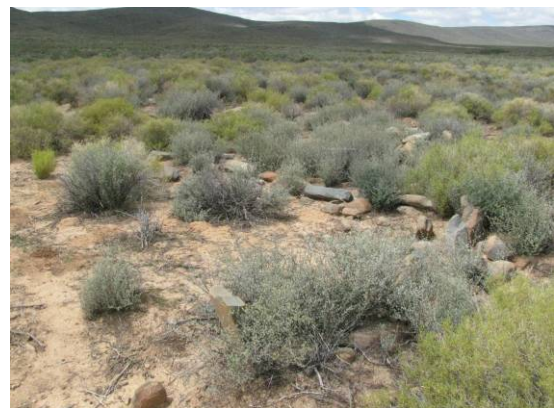
*Figure 9 Remnants of a threshing floor (trapvloer) associated with ruins in figure 10.*

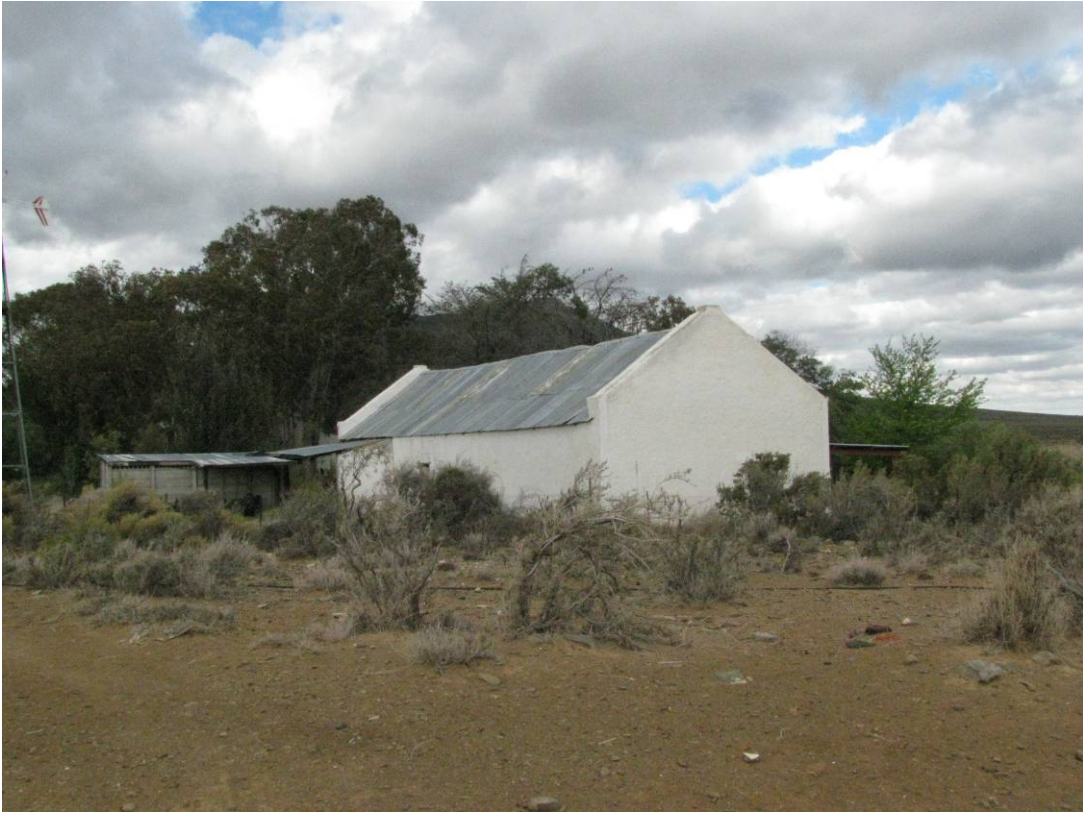
*Figure 13 Existing structure, Ekkraal.*

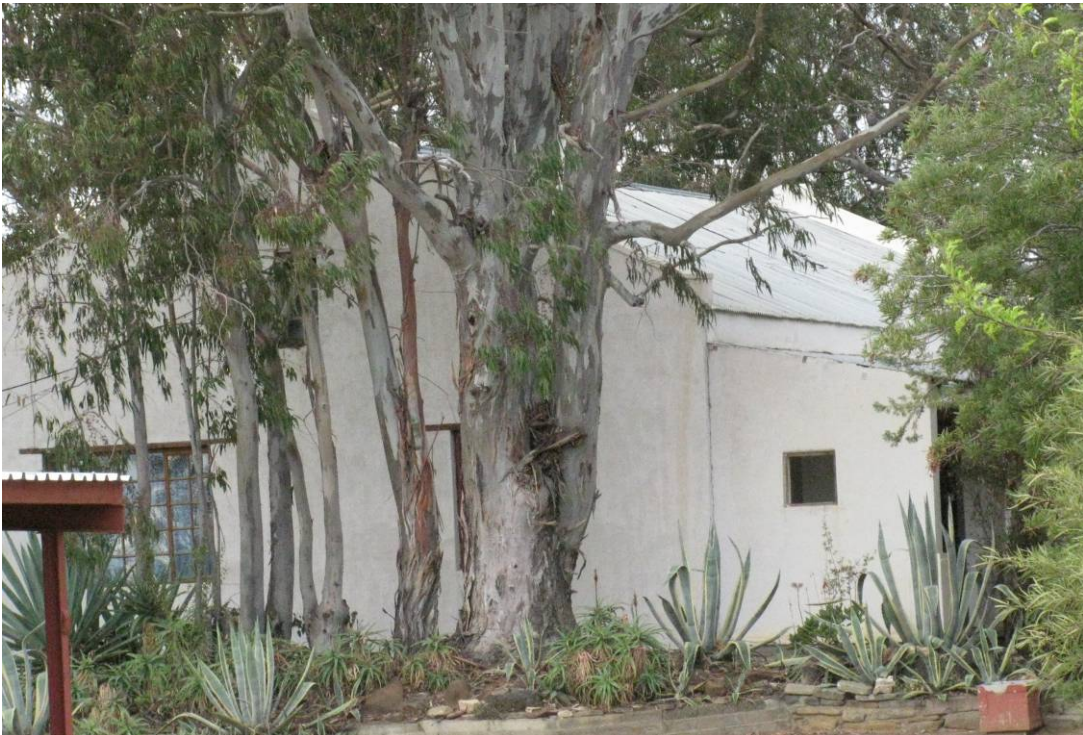
*Figure 12 Existing Farm House, Ekkraal.*

The existing Ekkraal Farm (absentee owner) is a humble corrugated iron roofed building which dates from the 19<sup>th</sup> century. It is probably worthy of Grade IIIC status. The structure is not under threat and evidently well maintained (figures 11-13). The closest turbine are well in excess of 1 km distant which means that no direct impacts will result from the turbines themselves. Other elements of the built environment consist of dams, kraals and two out-buildings, one of which is built from stone and has a Dutch hearth. The existing vehicle track up the valley will be upgraded and widened to allow heavy vehicles to pass. Since many of the ruined features lie very close to this track, impacts could occur

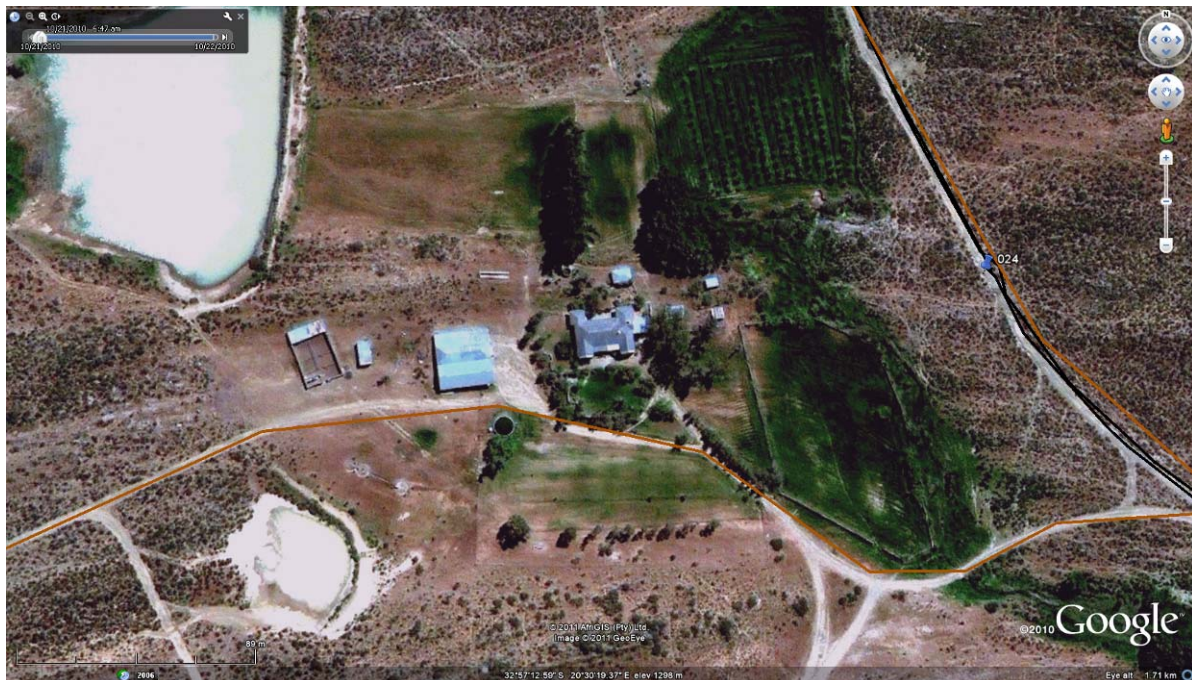
*Figure 14 View of the farm Ou Mure. Note the walled garden to the east of the farm house*

While it is not expected that Ou Mure will be directly impacted by the proposed activity, there will be periods in which the immediate surrounds of the farm we be subject to increased usage as a proposed access road into the turbine area will see upgrading of some of the roads around the farm.

The nearest proposed turbines to Ou Mure are to be constructed roughly 1km from the farm on surrounding ridges. This area may also be the recipient of a central substation which will evacuate power to the 400 kV transmission lines.

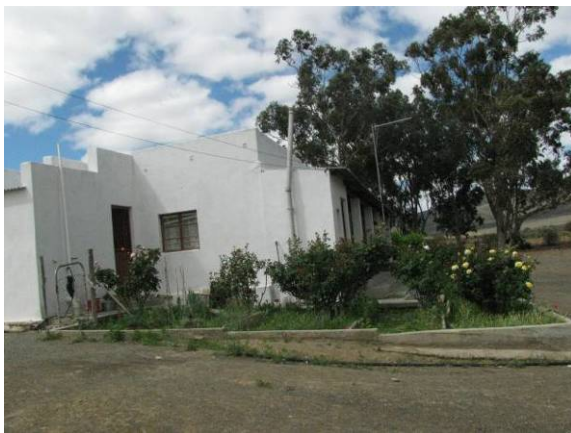
*Figure 16 Flat roofed farm house,  
Haartjieskraal*

*Hartjiekraal.* The main house at Hartejieskraal (figure 16) is clearly greater than 60 years of age retaining 19<sup>th</sup> century elements. It is a single story dwelling with an elongated veranda, single pitch corrugated iron roof. It was probably originally a 19<sup>th</sup> century *Brakdak* dwelling – an architectural style that is characteristic of the upper Karoo.. Much of the fenestration has been replaced and the building modernised in various ways.

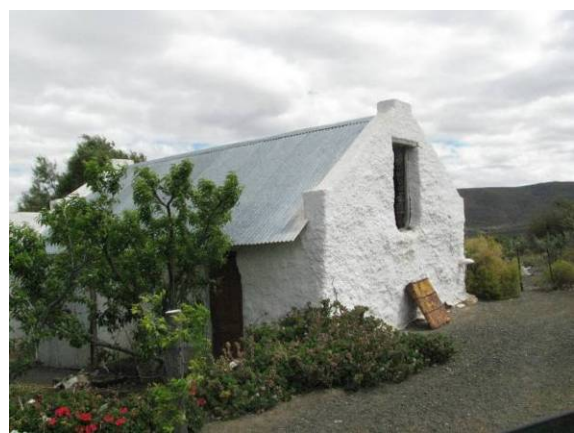
*Figure 15 Vernacular out-building at  
Hartjieskraal.*

Adjacent to the main house is a small gabled cottage/outbuilding (figure 15) of unknown age, but distinctly vernacular. It has a double pitch corrugated iron roof (originally thatch?), stone walls and a *solder* with an outside gable door. The structure is evidently well maintained.

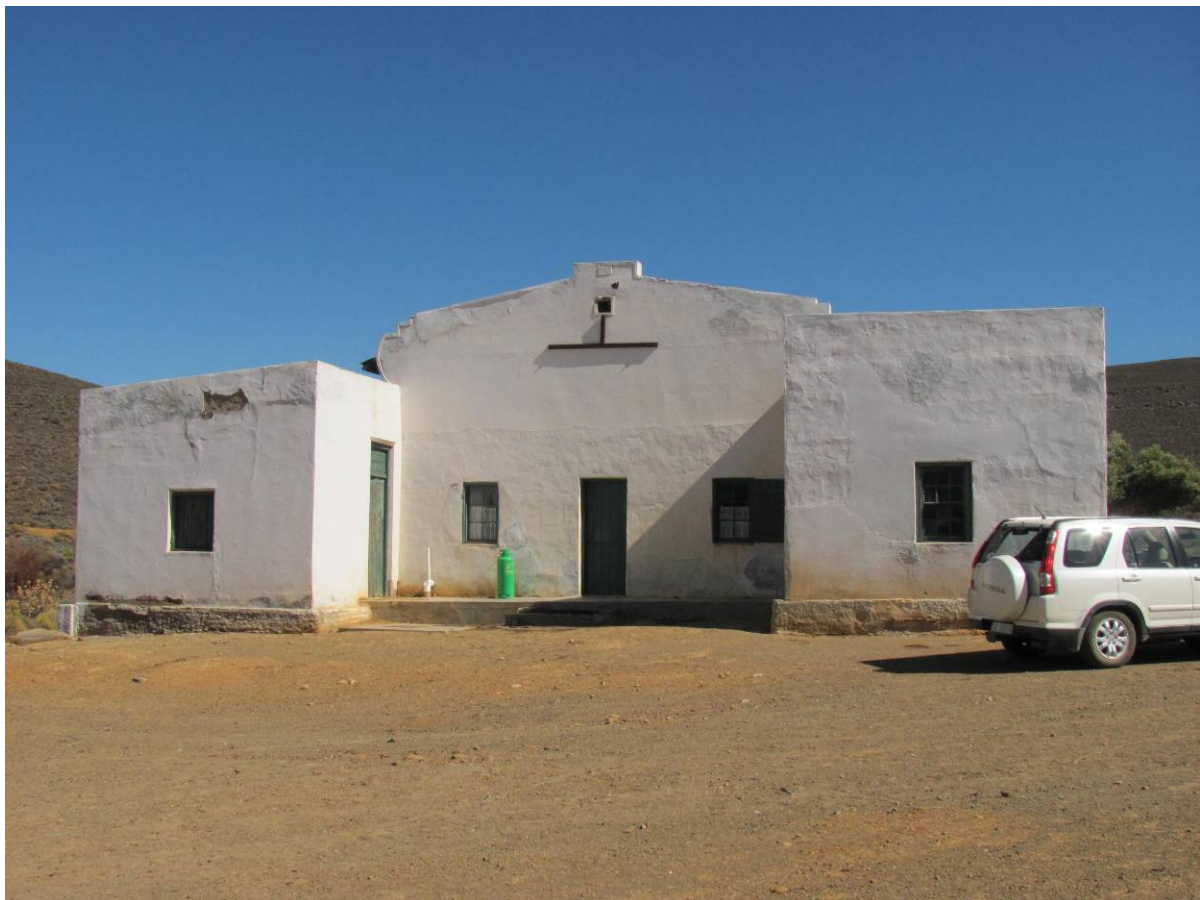
*Figure 17 De Libanon.*

The core of the building is vernacular and the interior is largely intact. Thick wooden ceiling beams, boards are visible, dating to Mid-19<sup>th</sup> century.. The kitchen is equipped with a traditional range. The exterior of the house appears to have been heavily modified in the 1930's, the rood height raised and the original straight gables adjusted to a crude Cape revivalist form. The structure of the original gable along with the gable door has evidently survived within the fabric. *Afdak* additions were added on both sides. The odd look of the building hides a vernacular interior that is essentially intact and has heritage merit. De Libanon is a seasonal farm which is utilised when grazing in the area is favourable.

The closest turbines to De Libanon are 1.8 km to the east on a very high ridge. Other than visual impact, no direct impacts to the property will occur.

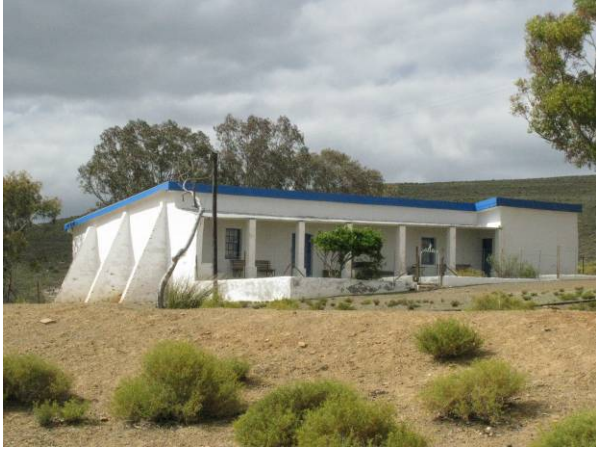
*Figure 19 Flat roofed farmhouse at Barendskraal*

The Barendskraal farm house and out buildings lies higher up the valley. The farm house is a flat roofed building with in all likelihood and historic core. It was probably originally a *Brakdak* structure which has been re-roofed and modernised. Since the landlord was absent at the time of inspection, it was not possible to view the interior. There are other outbuildings on property, some of which are greater than 60 years of age. Also present is the only formal Cemetery in the study area and the usual square stone stock kraals.

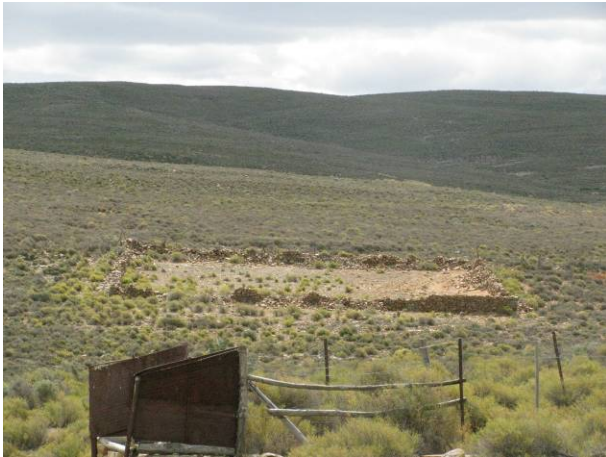
*Figure 22 Remains of a stone kraal at Barendskraal*

**Stone kraals:** The most common form of pre-colonial site on the upper plateau were stone kraals or kraal clusters, which according to Sampson's (2008) figures from the Eastern Karoo, could be between 300 and just over 1000 years of age. The kraal complexes (which are distinctly different from colonial period stock kraals) tend to be found along the leeward slopes of low ridges (or where minimal wind affects the area). These typically consist of dry stone piled wall enclosures in a roughly circular configuration, sometimes interlocking but not more than half a meter high, and ranging from 3 - 4 meters to 9 m in diameter. In the past they are likely to have been associated with reed mat huts or brush shelter/s), probably erected a few meters away from the main 'kraal' where small stock such as fat tailed sheep and goats were kept. Often found in proximity to the larger 'kraals' are lammerkraals (lambs' kraals), which are much smaller (about 1m in diameter) and a bit higher (usually a few more layers of stones added to the wall) than the adjoining larger 'kraal'. These small kraals are known to have been used to keep new born lambs or goats separate from their mothers so that the milk could be used rather by the people (Webley 1986). It was noted that kraals are arranged in complexes of up to 13 interlocking enclosures with adjoining lammerkraals. Notable complexes were recorded in the area of Hartebeestfontein and at Vinkekuil. Also associated with these 'kraals' is artefactual material, fine thin red burnished pottery, and ostrich egg shell. At a site alongside the access road to Waterval there is a remarkable complex of 'kraals' below and on top of a ridge.

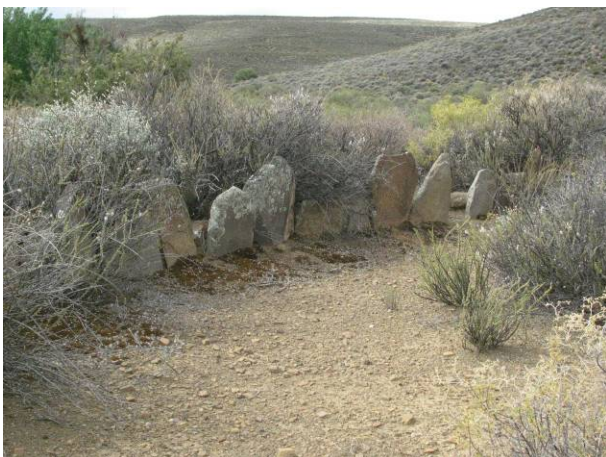
*Figure 20 Well-preserved threshing floor associated with Barendskraal ruins.*

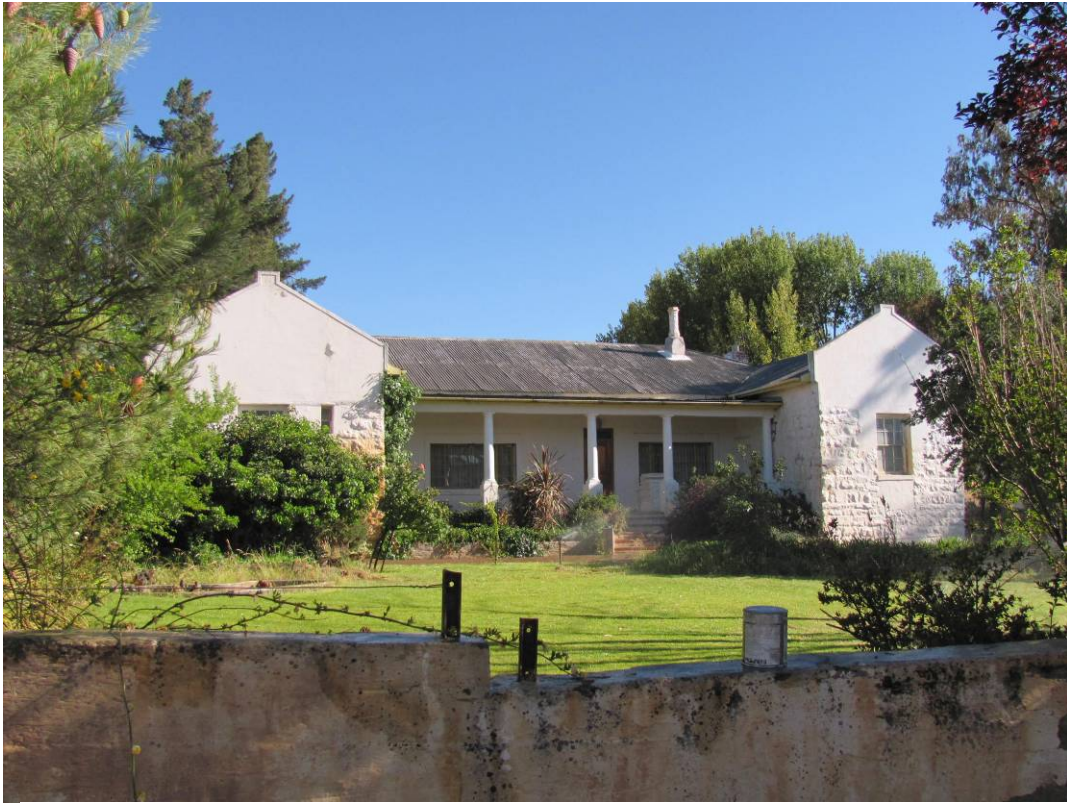
*Figure 23 Farm house at Ou Mure.*

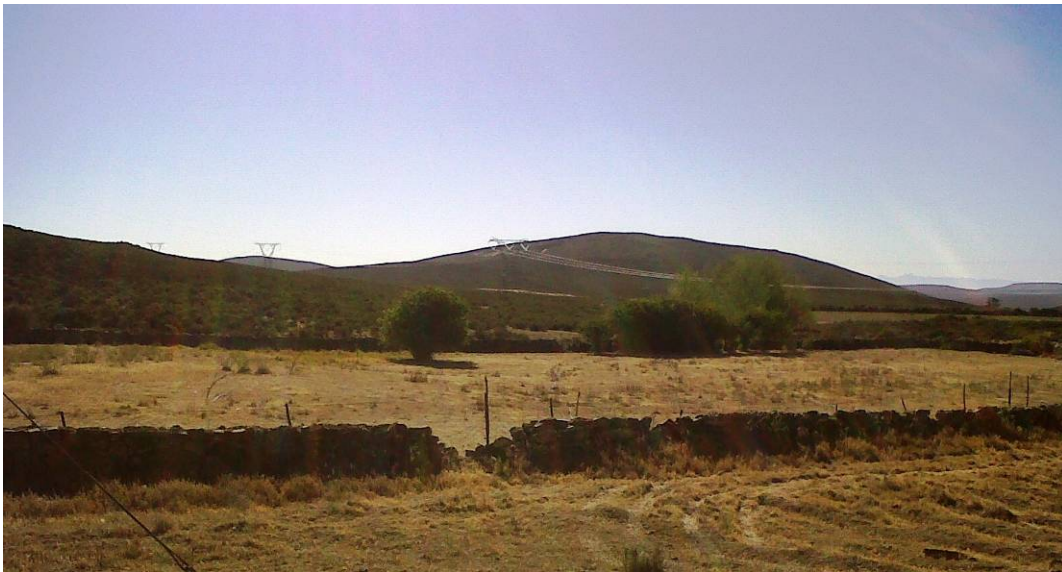
*Figure 24 Stone walled fields at Ou Mure.*

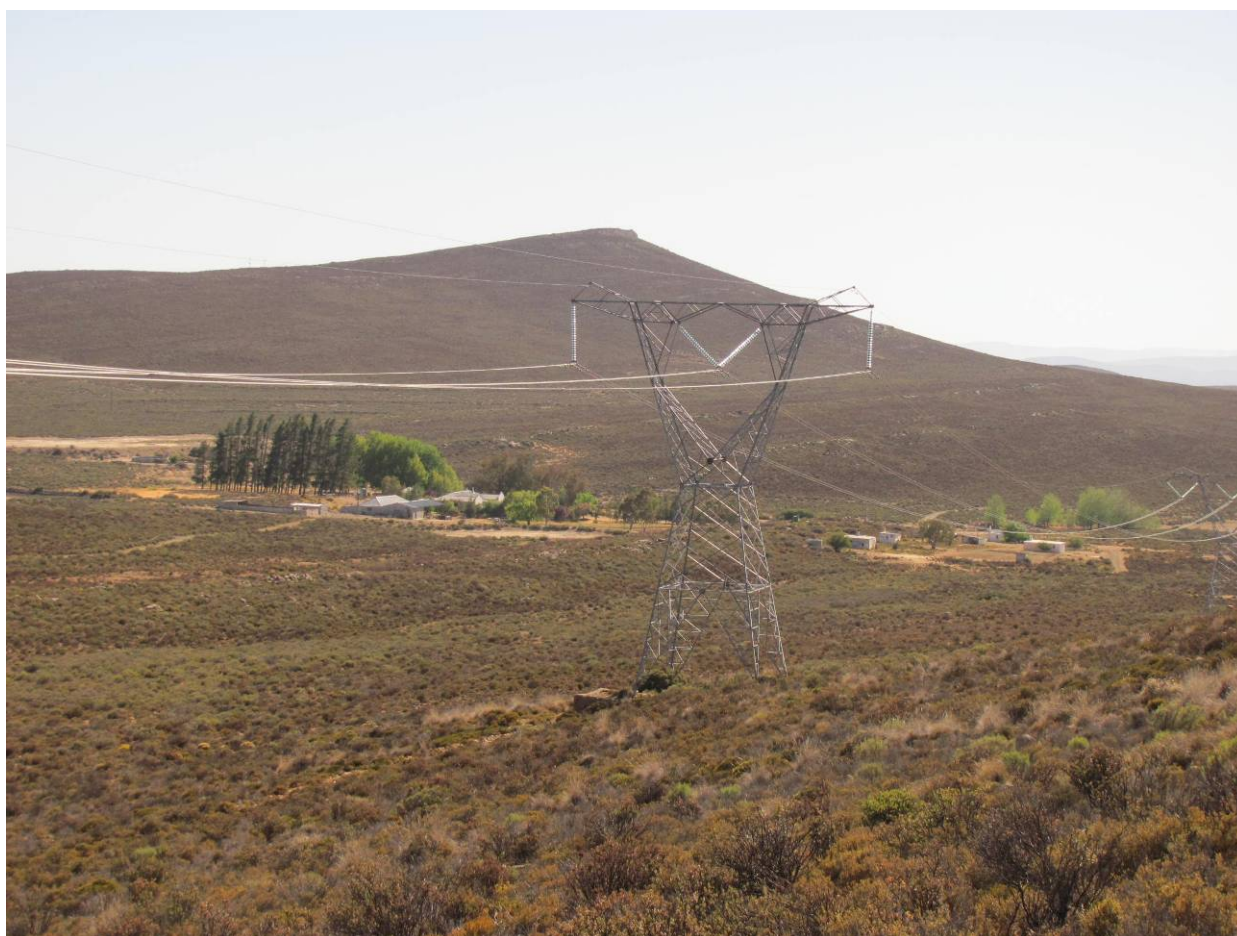
*Figure 25 Existing 400 kV transmission lines cross the landscape close to Ou mure*

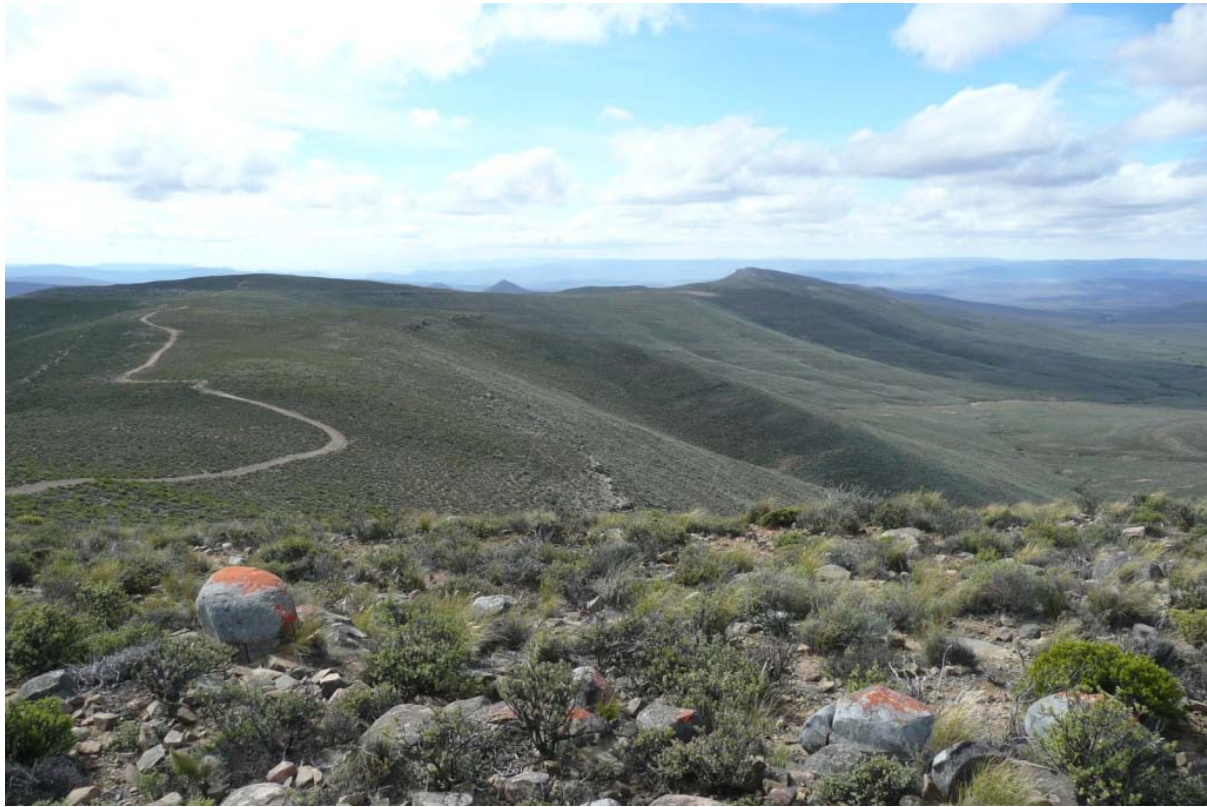
Figure 4.1.2 Typical Landscape of the Northern Area, Showing Ridges Supported by Resistant Sandstone Layers in the Abrahamskraal Formation (Looking North, Ekkraal Valley to the Right). Note the low bedrock exposure on the hillslopes.

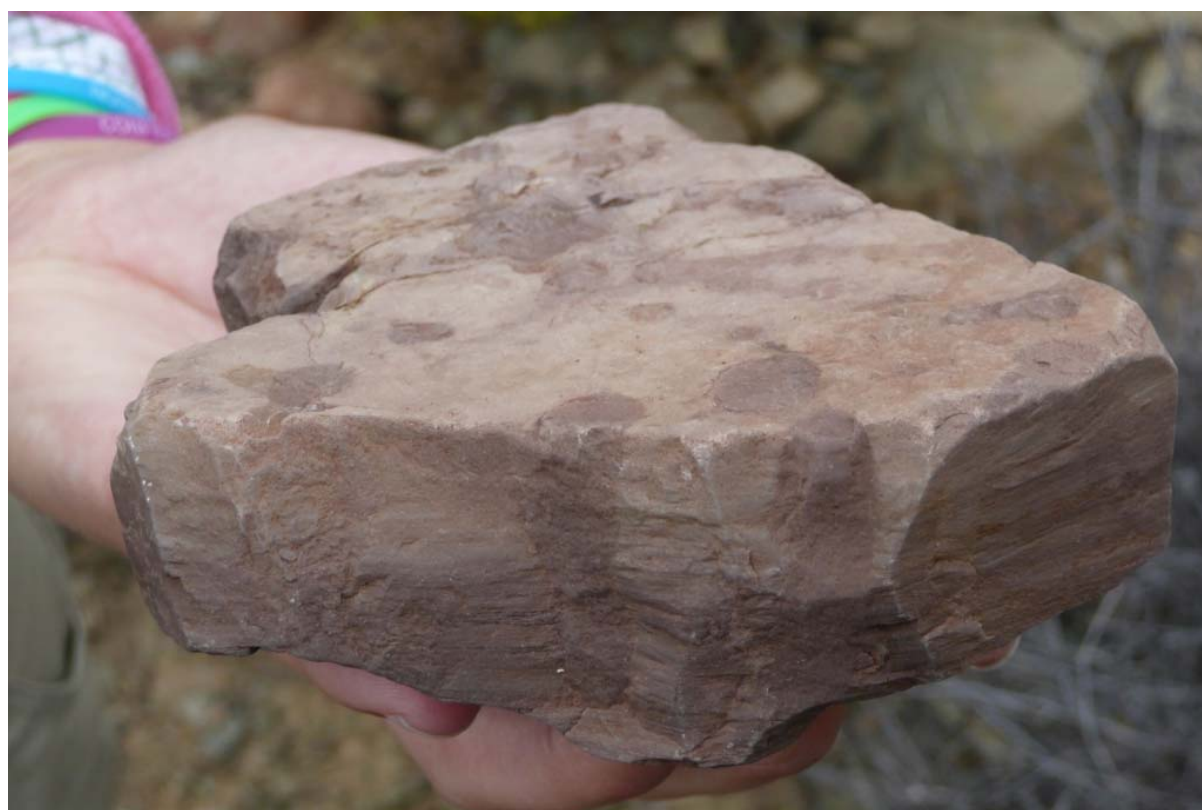
*Figure 4.2.1* Trace Fossils Consisting of Sand-filled Vertical Burrows in Sandstone, from Ekkraal Farm (width of rock ca. 200 mm)

The only fossils found in the rocks of the Abrahamskraal Formation were trace fossils in the form of sand-filled vertical burrows in sandstone (*Figure 4.2.1*). These were in a loose block adjacent to a packed stone ruin in the Ekkraal valley (Tim, please provide co-ordinates – it was at the ruin with the long wall adjacent to the river and the possible aqueduct/dam), and may have been transported from elsewhere as building material.
