# HERITAGE ASSESSMENT REPORT ZEUS SUBSTATION EXPANSION, VLAKFONTEIN 328, GERT SIBANDE (DC 30) DISTRICT, MPUMALANGA, SOUTH AFRICA

### REPORT FOR PBA INTERNATIONAL

# Zoë Henderson & Chriselle Koortzen 19 June 2007

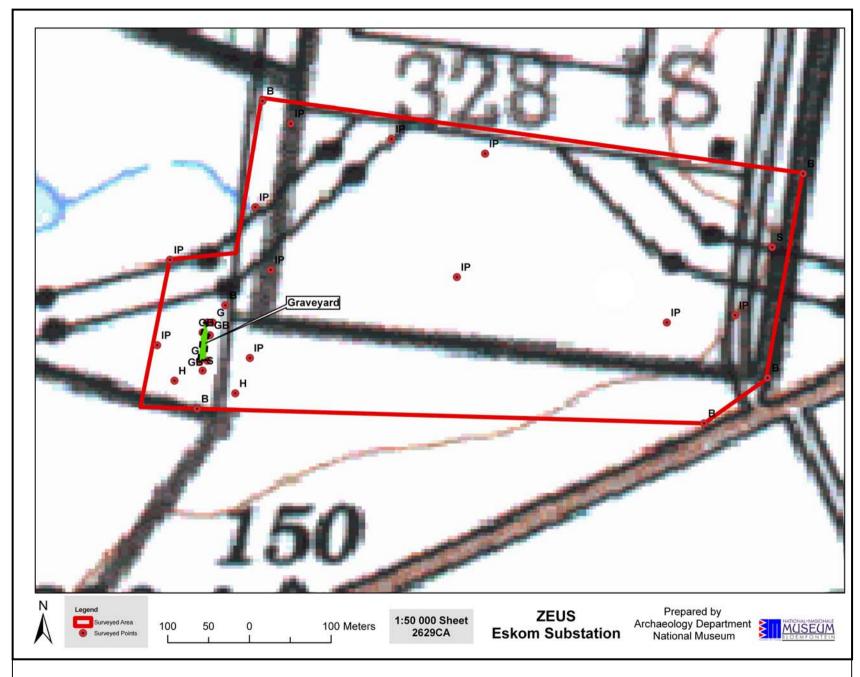
Map 2: CLOSE UP OF SURVEYED AREA, VLAKFONTEIN 328, GERT SIBANDE (DC 30) DISTRICT, MPUMALANGA, SOUTH AFRICA

No sites were found in the area surveyed. However, a graveyard was located in the western portion of the surveyed area. This graveyard lies either on the boundary of the area, or just within it. Three inspection pits were dug around the graveyard (see map),

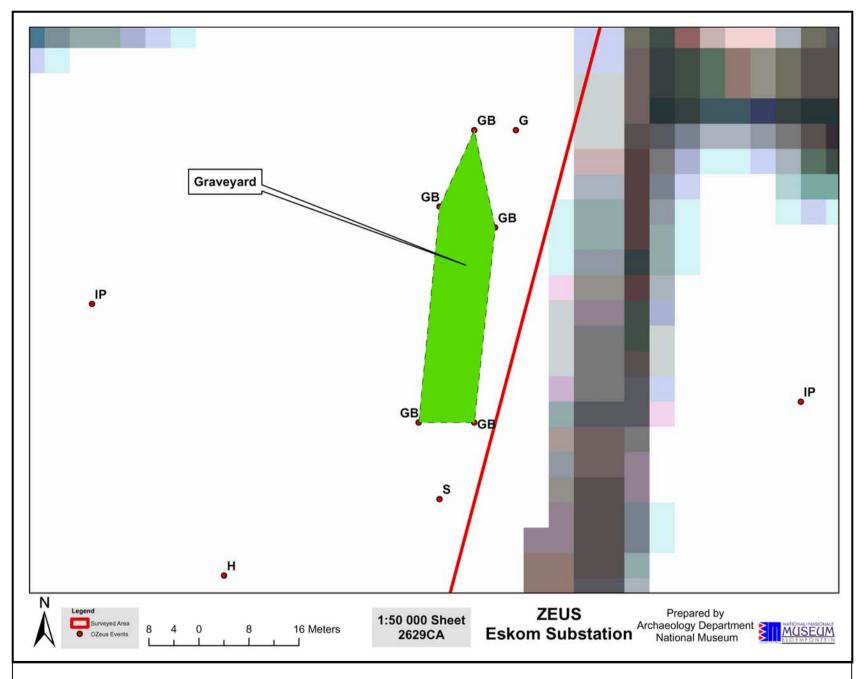
Map 3: CLOSE UP OF GRAVEYARD, VLAKFONTEIN 328, GERT SIBANDE (DC 30) DISTRICT, MPUMALANGA, SOUTH AFRICA

The graveyard consists of 56 graves (see graveyard plan). The distribution of the graves is indicated on the plan, but is basically linear in a north-south direction. Two of the graves (at the 'head' of the graveyard) face north, while the rest of the graves face east. The graveyard is located on a hillside, which slopes downhill towards the north. Three of the graves have gravestones or plaques with names on (although only two can still be read), and these indicate that the graves are probably those of local farm workers. Two of the graves have dates: 1922 and 1968. The 1968 grave is one of the two graves at the 'head' of the graveyard, while the 1922 grave is located near to the middle of the graveyard. This would appear to indicate that most of the graves are older than 1968. All graves older than 60 years outside a formal burial ground are protected by the National Heritage Resources Act (Act no. 25 of 1999).

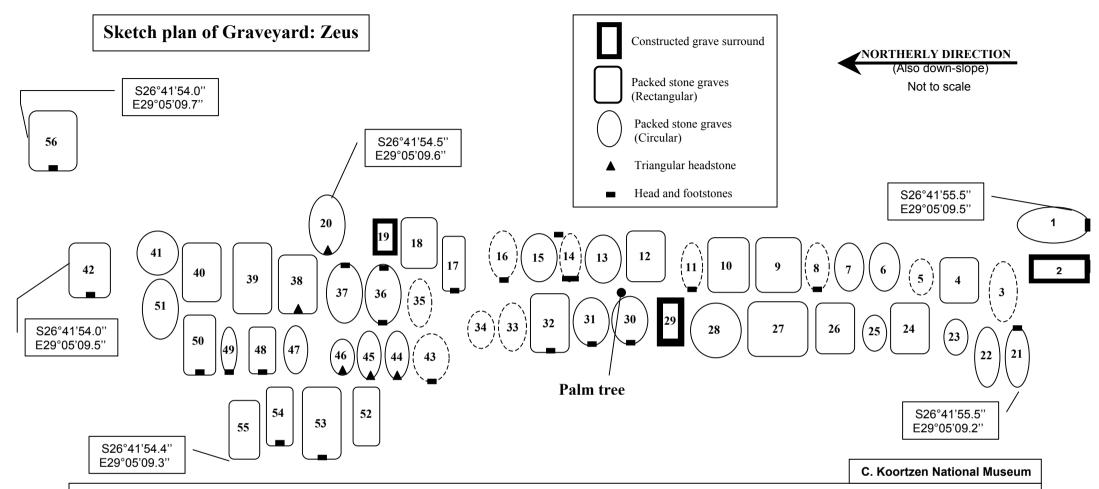
- 2- ABEL / KHANYE / 1968 MEI 2. Cement headstone, painted black. Name written in wet cement and then painted white on top of the black. Grave surround consists of two brick rows stacked on top of each other, plastered on top and on inside. Grave was fenced off originally, only 4 poles remain, 3 still standing, SW pole still has some barbwire attached (photo: 17,18)

- 17- Red granite-like headstone with cement on back, some white paint remains can be seen on top and on the back. Smoothed on sides (photo: 19)
- 19- Headstone missing. Grave surround consists of single brick row. Different types of bricks were used, some also had cement on them, indicating that the bricks were reused and collected from various sources. Inside of grave is covered with a roughly made cement slab. Grave diameters: +- 1.5mx0.8m. Possible child grave (photo:20)

- 29- II LOVING MEMORY OF / OUR LATE *OU PLAAITJIE* / MATHETSE MPATLANYANE / PASSED AWAY 1922 / EVER REMEMBERED BY OFFSPRING / REST IN PEACE. Rectangular gray granite headstone. Grave surround consists of 4 granite slabs. Grave covered with gravel embedded in cement. It appears that the headstone and grave surround was done afterwards, being placed on top of old grave cover (photo: 21)

- **32-** Square sandstone-like headstone
- **39** Very neatly packed with stones in rectangular shape (photo: 22)
- Two metal plaques. Same metal used. Names written in black paint on opposite sides of sheets. Possibly two individuals with same surname. Plate 1: NAME: A M O S? / M H 1 A N Q A Plate 2: NAME: P/M? A H/A? ? ? / M H 1? A? N? Q? A? (photo:23,24)

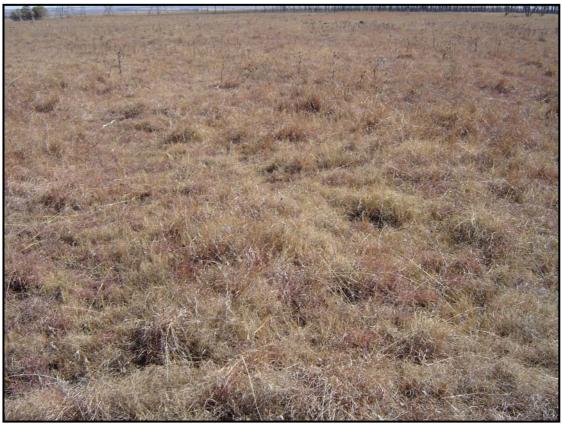
Visibility of the surface of the ground surface was low for most of the surveyed area as a result of the grass cover. However, there were areas where dolerite rocks and boulders were visible on the surface, and in these areas visibility was better.

Photo 3: Thick grass cover

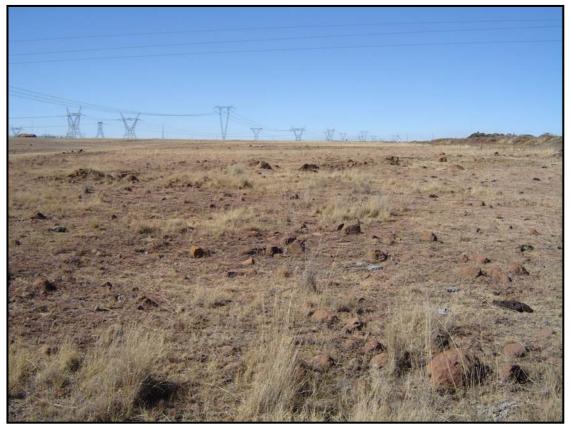
The surveyed area is grassland, with a clayey sandy soil. Numerous dolerite rocks are evident on the surface, often in discrete outcrops.

Photo 4: Natural distribution of rocks in southern section of surveyed area

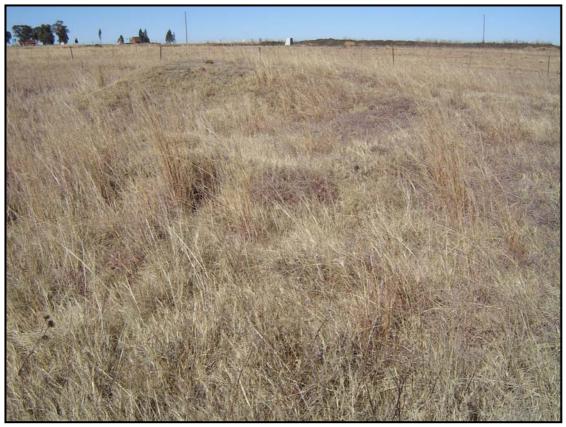
The area has been disturbed in the past, as evidenced by heaps of soil and rock, trenches and pits. Numerous pylons also occur in the area, and disturbance is related to the foundations of the pylons. Recent disturbance includes a new road along the eastern side of the expansion and the current substation, and a heavily disturbed area (possibly a pipe line) across the southern section of the surveyed area (see map). Further disturbance in the form of various inspection pits was noted in the area. The inspection pits appeared to have been dug with a back-actor and then refilled. All of the disturbed areas were also surveyed for subsurface material which had possibly been brought up to the surface. The inspection pits indicated that the surface soil layer was relatively thin (as would be consistent with the dolerite outcrops) and that the bedrock was decayed dolerite.

Photo 5: Evidence of previous disturbance

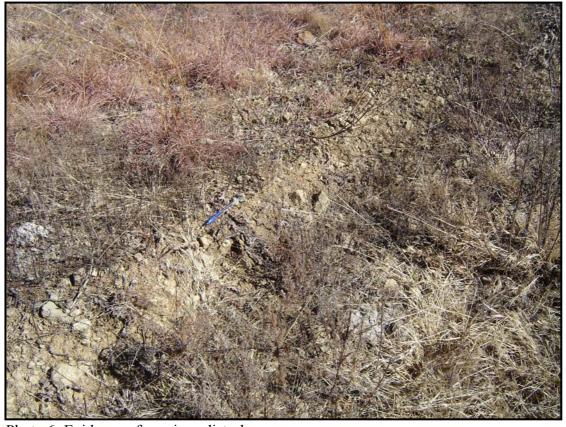
Photo 6: Evidence of previous disturbance

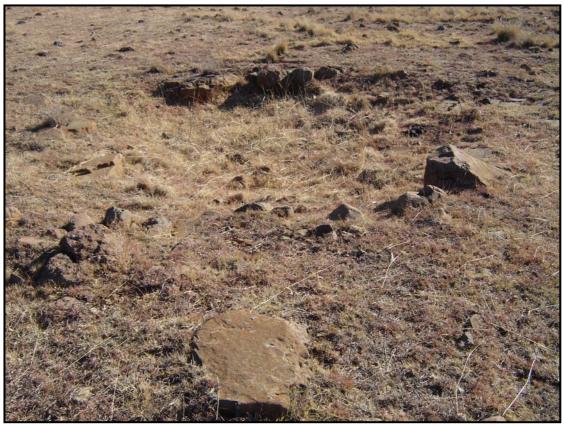
Two sets of hollows were observed near to the graveyard. These hollows (a set of three and a set of five) are circular, about 2 to 5 m in diameter, and appear to have been dug with the aid of a machine. Their purpose is unknown.

Photo 7: Hollows indicating previous disturbance

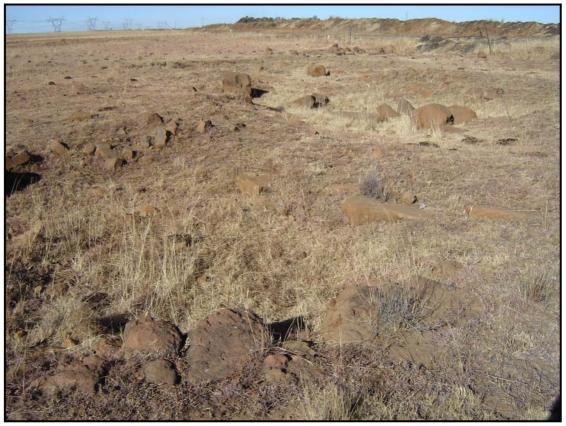
Photo 8: Hollows indicating previous disturbance

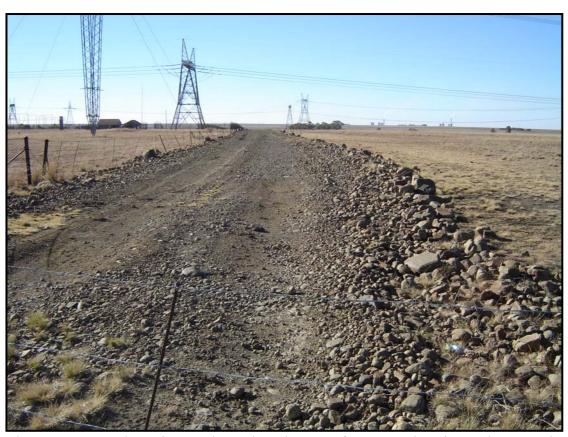
Photo 9: New road running north-south to the east of current substation and surveyed area - photo taken in a northerly direction

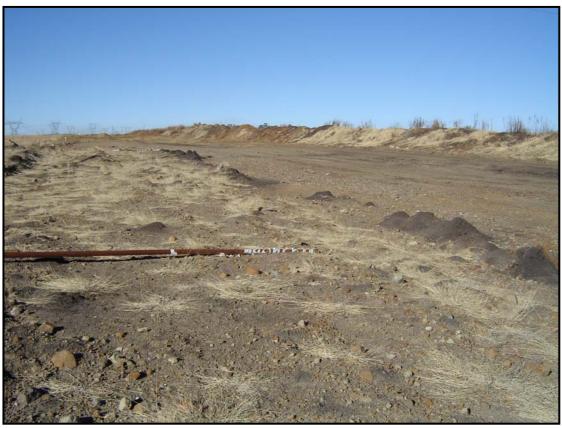
Various other indications of disturbance and digging in the ground were observed. Heaps of soil and rock were observed under the pylons on the eastern side of the surveyed area, and appear to relate to the digging of a ditch nearby.

Photo 10: Heavy disturbance south of surveyed area

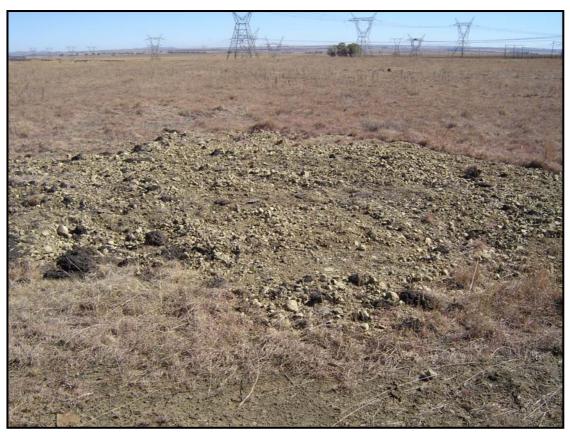
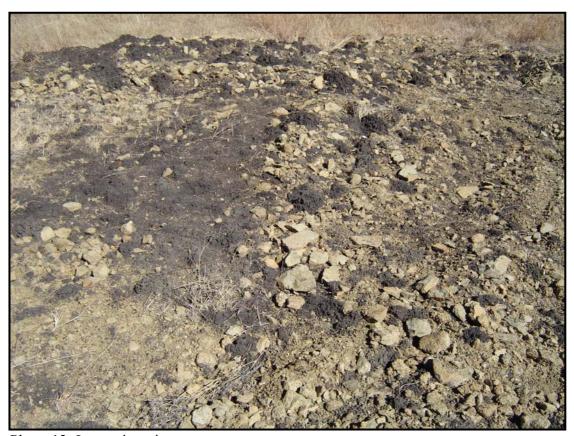
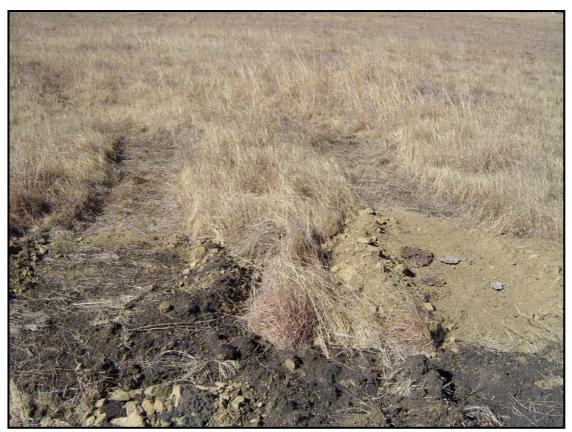
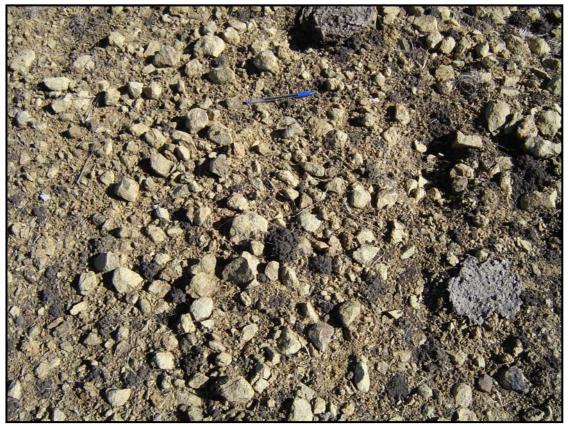
Photo 11: Inspection pit

Photo 12: Inspection pit

Photo 13: Inspection pits

Photo 14: Close up of inspection pit

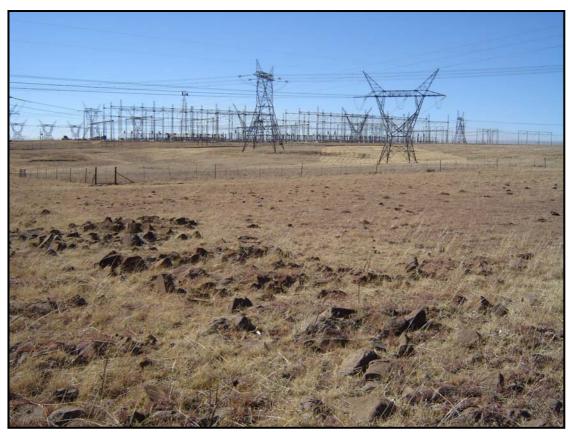
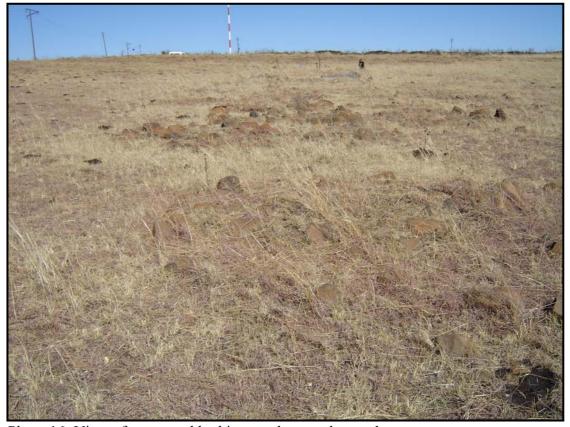
Photo 15: View of northern section of graveyard – photograph taken in a NE direction

Photo 16: View of graveyard looking up slope to the south

A management plan for the graveyard during and after construction needs to be in place. This is to ensure that the graves are not damaged during the construction phase, and that they are not inadvertently damaged in the future.

If the graveyard is to be relocated, a permit will have to be obtained from SAHRA for the purpose. Although on of the graves dates to 1968, and therefore technically falls outside the ambit of the Act, the probability is high that many of the graves will be older than 60 years. It may be possible to establish this through a process of community consultation and research.

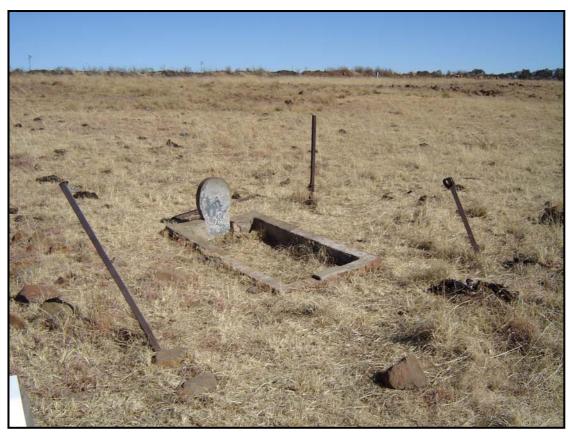
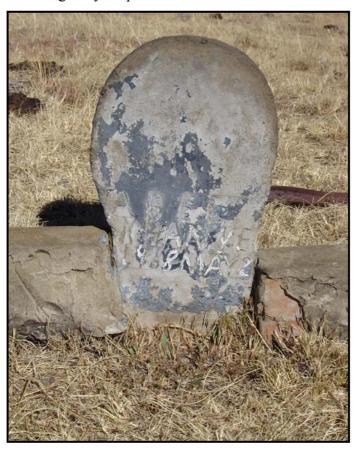
Photo 17: Grave 2 – see graveyard plan

Photo 18: Grave 2 – see graveyard plan

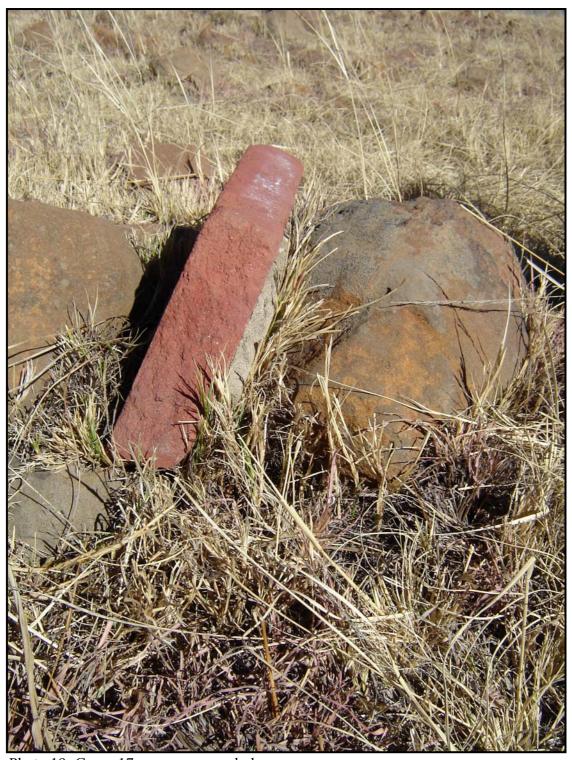
Photo 19: Grave 17 – see graveyard plan

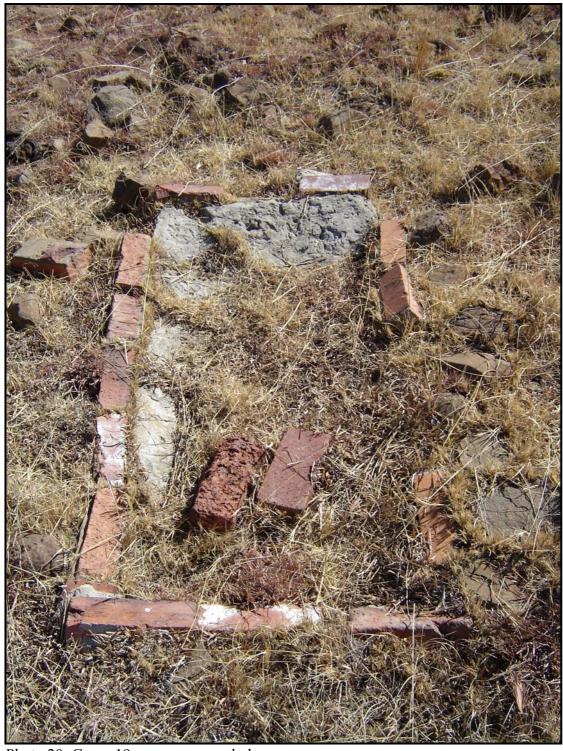
Photo 20: Grave 19 – see graveyard plan

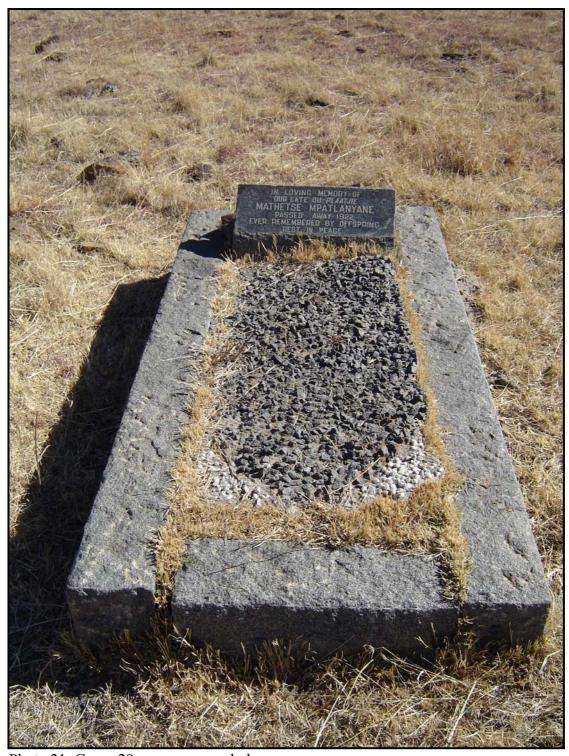
Photo 21: Grave 29– see graveyard plan

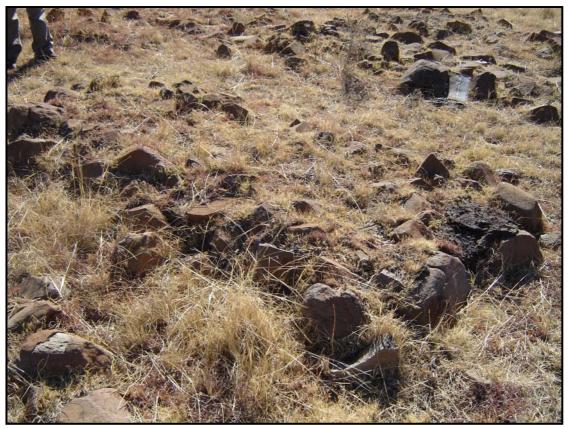
Photo 22: Grave 39 – see graveyard plan

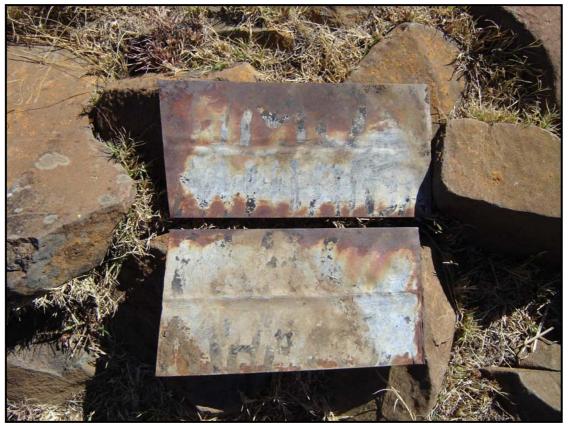
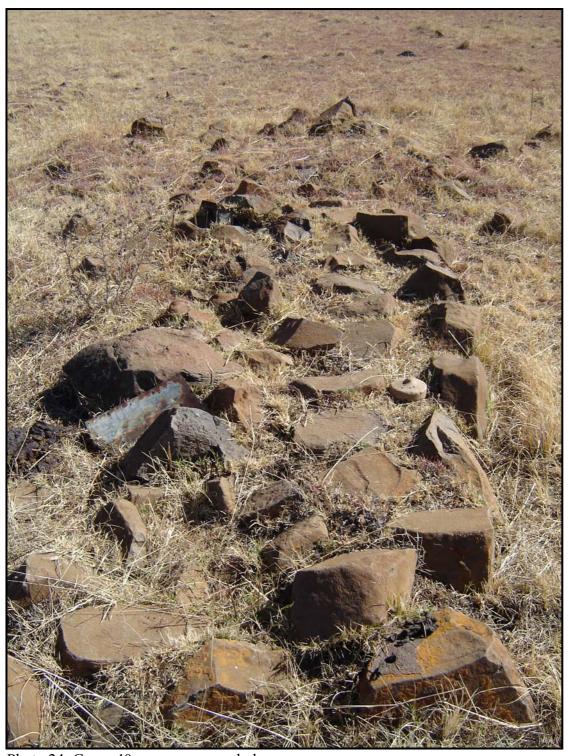
Photo 23: Grave 40 – see graveyard plan

Photo 24: Grave 40 – see graveyard plan

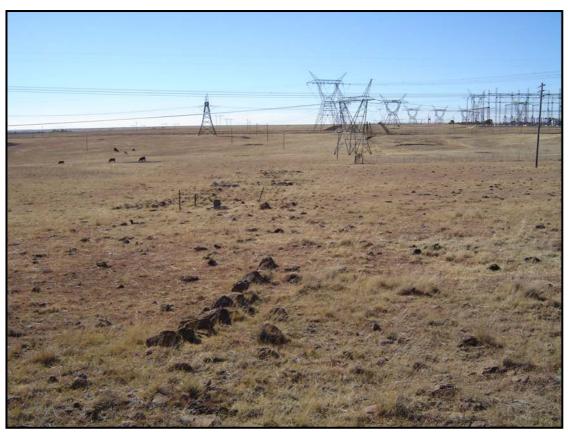
A line of packed rocks was observed near to the graveyard. The purpose of these rocks is difficult to determine.

The only other cultural material observed is the line of packed rocks, but this would be deemed of low significance, as the line is not associated with any other structure or cultural material, and its purpose cannot be determined.

Photo 25: Line of packed rocks to the south of graveyard

No further action is required for any of the occurrences observed apart from the graveyard.

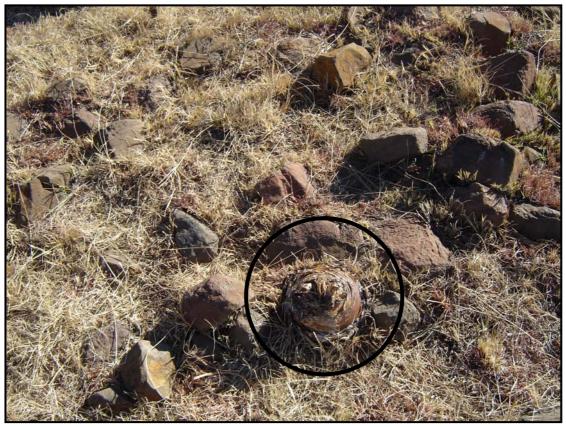
Photo 26: Palm tree stump at base of grave 30 – see graveyard plan

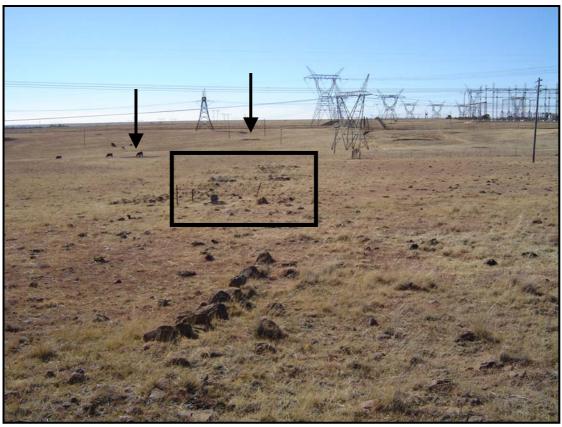
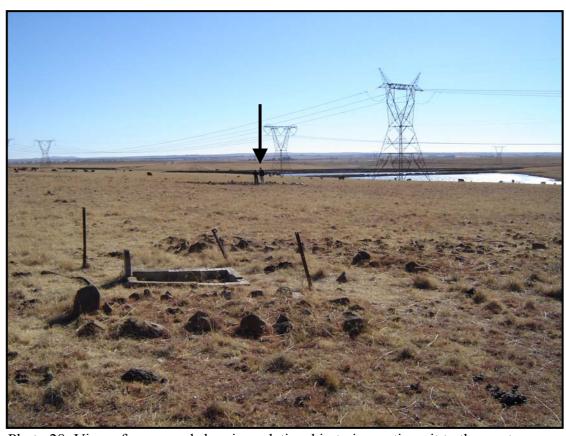
Photo 27: View of graveyard showing relationship to inspection pits to the north

Photo 28: View of graveyard showing relationship to inspection pit to the west
