PROPOSED APPLICATION: ZWARTKOPPIES EXTENSIONS 1 TO 26 ON THE REMAINDER OF PORTION 2 AND PORTIONS 8 AND 9 OF THE FARM ZWARTKOPPIES 364-JR

A CULTURAL-HERITAGE RESOURCES IMPACT ASSESSMENT OF THE FARM ZWARTKOPPIES, PRETORIA EAST

A CULTURAL HERITAGE RESOURCES IMPACT ASSESSMENT OF THE FARM ZWARTKOPPIES, PRETORIA EAST

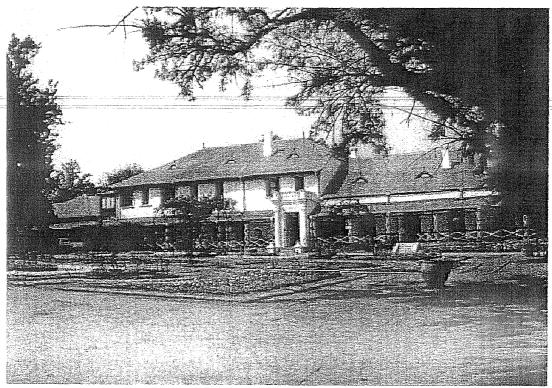
No. 1 Sammy Marks House with formal rose garden

The Sammy Marks Museum is a satellite of the Northern Flagship Institution and is funded by the Department of Arts and Culture. At present the main building and surrounding area, comprising some 4 hectares, is the only portion of the museum property, which has been developed. The house and garden is an excellent example of a late Victorian estate with a formal garden near the main house and an informal park landscape surrounding it. The main building has been restored and is at present being renovated. This includes the rewiring of the old house. The well-known architect Hannes Meiring declared that the main house and garden is a world-class heritage site (see photograph 1).

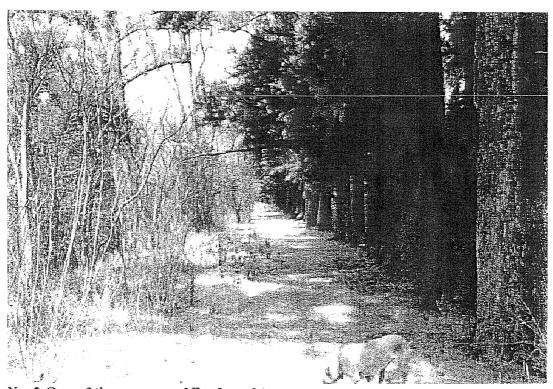
No. 2 One of the avenues of Beefwood trees

The park landscape extends far beyond the area of the main house, particularly the eastern side that includes two of the dams and the canal. The landscaping of the area is as typical of the period as are the buildings. There must only be very few estates left, which could be compared with that of the Sammy Marks estate. Unfortunately the landscape has been neglected for very long. Numerous invasive plants have intruded and spoiled the original design while many trees have died of drought and old age. The restoration and recreation of this landscape is as important as the historic buildings themselves (see photograph 2).

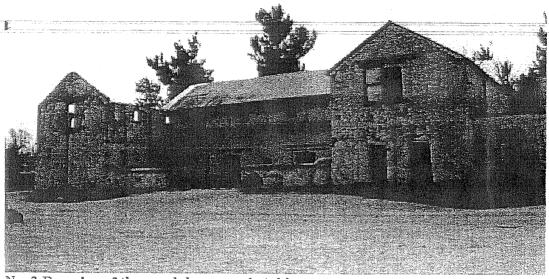
No. 3 Remains of the coach house and stables

A number of cottages as well as buildings and structures for farming purposes are situated on the rest of the Museum property. Although the Museum purchased this property in 1992 nothing has been done towards the upkeep of these structures or to restore them, except for the Dairy Cottage, which has recently been renovated. These buildings and structures are presently in an appalling state of disrepair. The five cottages are rented to private individuals and staff. The remaining buildings and structures are not used and are deteriorating progressively month by month (see photograph 3 & 4).

Based on a conservation management plan as specified by the Australian Burro Charter, the general conclusion of this survey is that all the buildings are in urgent need of repair. A cost analysis to restore all these buildings and structures was done by the National Public Works Department in 2002 and the cost of the work was then estimated at R18m. Since all the buildings belong to the Museum, and therefore the state, it is shocking that a heritage site can be allowed to degenerate to such a degree. The above figure does not include the restoration of the landscaped features.

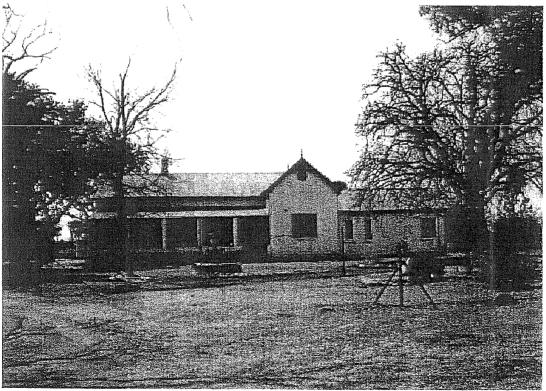
No. 4 Jill's Cottage

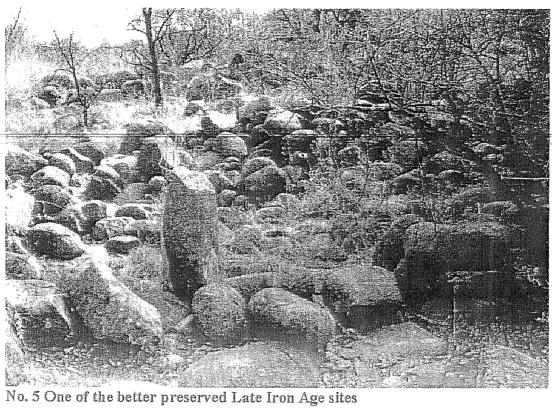
There are archaeological sites on the farm, particularly on the northern portion. The sites consist of a circular outer wall and a number of smaller circular walls in the centre. Stonewalls are seldom higher than 40 cm. This is because most of the sites were stripped of their stones that were removed to build large stonewalls for the garden of the main house, the cattle enclosures and other farm walls. Only in areas that are difficult to reach is the stonewalling still partially intact. This practice has occurred wherever white farmers found Iron Age stonewalling. These stonewalls were re-used for foundations and especially the building of cattle kraals. In some cases the sites were used for modern farming. Here square cattle kraals were built on the archaeological site (see photographs 5,6, & 7).

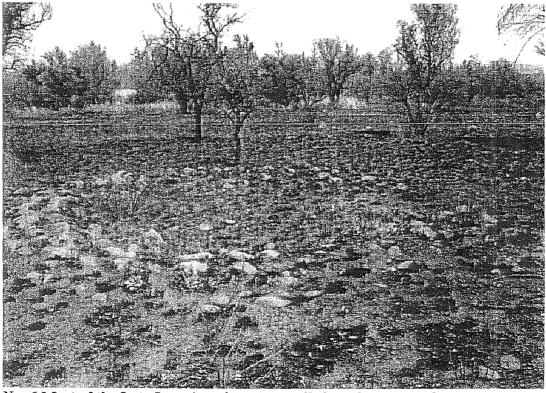
No. 6 Most of the Late Iron Age sites stonewalls have been reused

As far as the archaeological sites are concerned, not a single one could be found that has not been damaged. Removing the stones from stonewalls was unfortunate. The question arises whether these sites should be preserved or whether it would be better to document them fully and then to excavate them to retrieve whatever scientific information is left. The sites are not unique and similar, better-preserved sites are found on the farm Pienaarspoort and all along the Bronberg as well as in Dinokeng. The sites on Zwartkoppies are possibly associated with the Manala Ndebele who had their main settlement where the Silver Leaves security village is now situated.

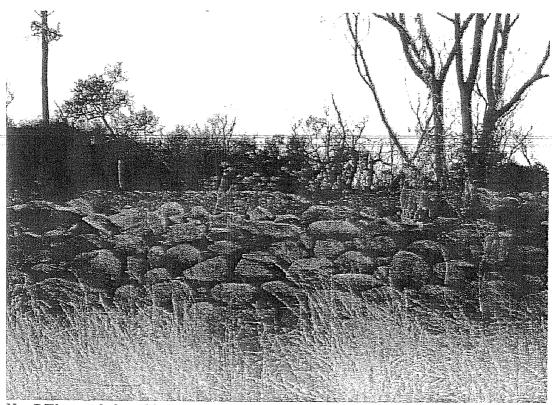
No. 7 The cattle kraal built with stones from the archaeological sites

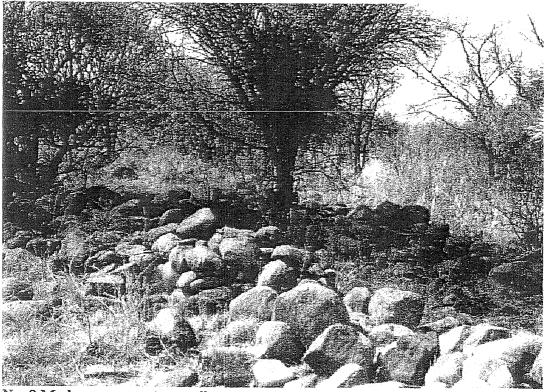
At S25° 45' 04.4 and E28° 23' 43,2" three square stonewalled structures were found. These were most probably cattle enclosures and workers houses (see photograph 8).

No. 8 Modern square stonewall structure.

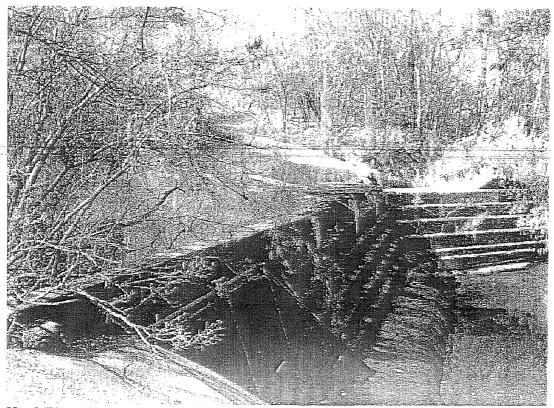
Two weirs were built in the Pienaars River. The first one was at S25° 45' 21.1" and E28° 24' 58.7". The second one was at S25° 45' 57.1" and E28° 24' 09.2". This weir is situated just north of the N4 Bridge over the Pienaars River (see photographs 9 & 10). From here a large canal took the water to a dam just east of the homestead and was then widened for some 200 m up to the boathouse. The water then flowed along this canal to the power station just west of the stables. Excess water was channelled to another dam just south of the homestead. The water released from this dam and the hydro power station was used for the irrigation of the fields between the homestead and the river.

No. 9 The main weir in the Pienaars River from were the water was channelled to the main settlement

On the rest of the farm, which is to be transferred to Zero Plus Developments, the most important features are the dams, weirs and canals, which supplied water to the main settlement. These should be preserved and re-commissioned to continue supplying the water as before. It will to a large degree enhance the historic authenticity of the site but will also contribute to the preservation of landscaped features like avenues, hedges and historic landscaping.

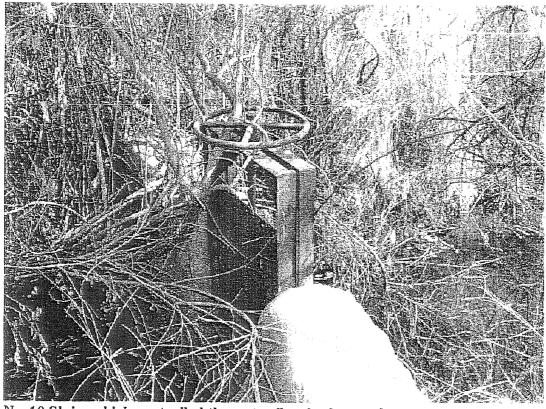
No. 10 Sluice which controlled the water flow in the canal

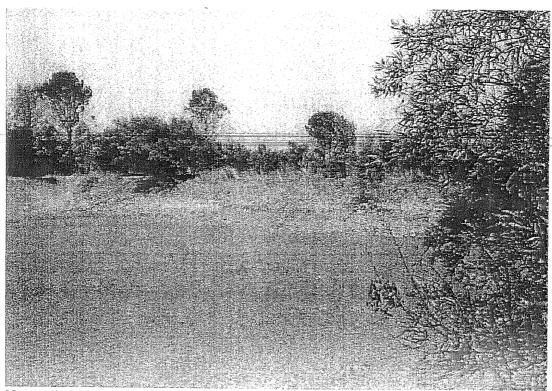
The Hoffman dams are situated on the northern side of the farm at S25° 44' 46.8" and E28° 23' 22.0" and at S25° 44' 48.6" and E28° 23' 20.2". These dams collected rainwater, which was taken by canals to the garden and fields (see photograph 11).

No. 11 One of the Hoffman dams

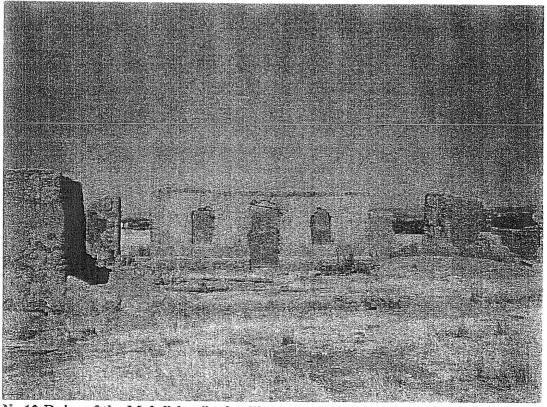
The ruins of the Molefi family house are at S25° 45' 30.1" and E28° 24' 13.9". The family has recently moved to S25° 45' 37.6 and E28° 24' 38.3". According to Juanitha Molefi the family had been living on the farm since 1902 (see photograph 12).

No 12 Ruins of the Molefi family dwelling

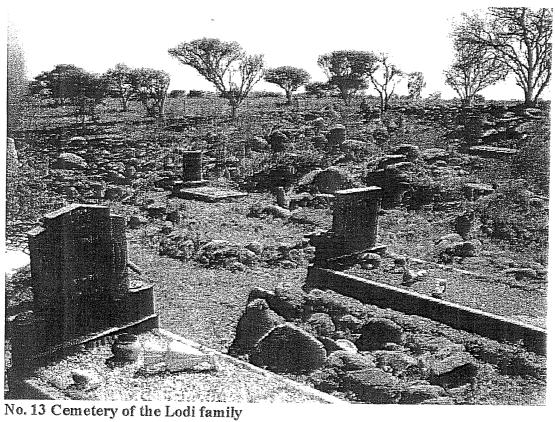
According to Emily Lodi they have been living here since the beginning of the 20th century. The house is situated at \$25° 45' 41.4 and £28° 24' 46.7". There are two graveyards near the house. One is at \$25° 45' 41.3" and £28° 24' 43.7" and has 41 graves. The inscription on the oldest grave dates to 1942. A second graveyard is situated at \$25° 45' 43.7" and £28° 24' 44.8". There are twelve graves here of which the oldest dates to 1934 (see photograph 13).

The workers' cottages on the farm are also of historical interest, particularly those of the Lodi and Manyaka families. Of these the Manyaka home is the best example of an early farm worker's house. The large cemeteries are also of importance and need a careful approach, as graves are a sensitive issue.

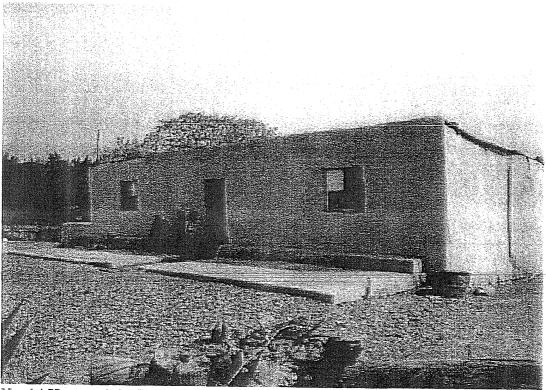
The Manyake family lived on the farm since 1921. There are two houses of which the oldest one is a good example of an early farm worker's house. The houses are at S25° 44' 39.0" and E28° 22' 35.4" (see photograph 14).

No. 14 House of the Manyake family who have been living on the farm since the beginning of the 20th century

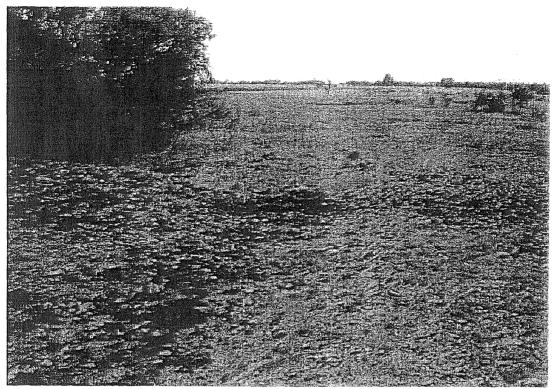
On a small koppie at S25° 44' 33.0" and E28° 22' 59.0" is a long trench on the eastern and northern side of the koppie. Just north of this koppie in the new township of Nelmapius is another koppie with trenches. The Zwartkoppies farm formed part of the Diamond Hill Battlefield during the Anglo Boer War. This was the last conventional battle between the Boers and British soldiers before the Boers turned to guerrilla warfare (see photograph 15).

No. 15 Anglo Boer War trench

The koppie with the possible remains of the Anglo Boer War trenches needs further investigation. If it turns out that these trenches are indeed Anglo Boer War trenches the site would be worth preserving.

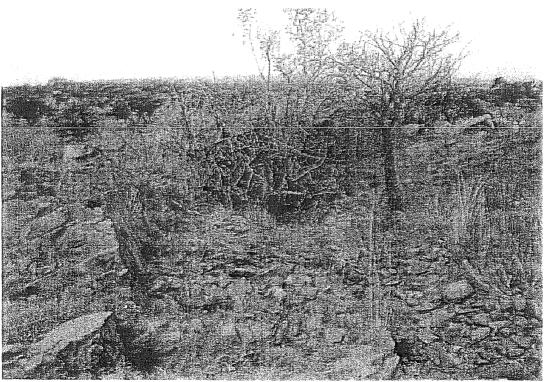
At S25° 44' 42.0" and E28° 22' 50.4" a shale quarry was found on a small hill. Shale was used as foundation stones in old buildings. It formed an excellent level to keep out moisture. The shale for all the foundations of the buildings on Sammy Marks was most probably quarried here (see photograph 16).

No. 16 Shale quarry
