**HERITAGE SURVEY OF THE N9 SECTION 7 FROM  
MIDDELBURG (km 0) TO CARLTON HEIGHTS (km 29)**

**FOR COASTAL ENVIRONMENTAL SERVICES**

**DATE: 26 August 2011**

**Umlando: Archaeological Tourism and Resource  
Management**

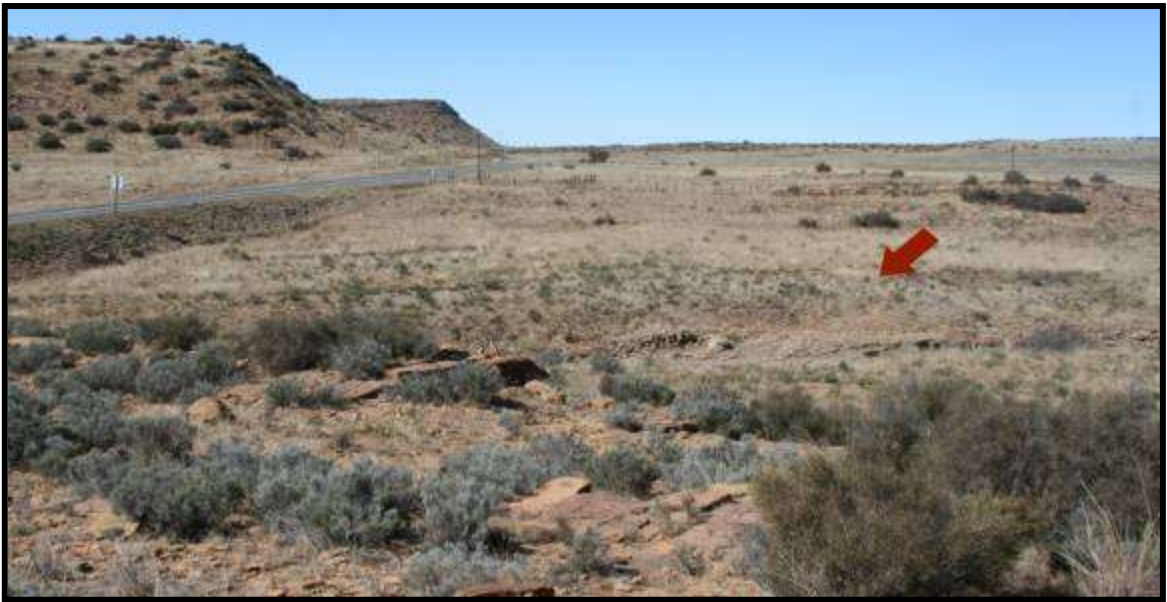
FIG.6 LOCATION OF MID01

MID01 is located to the south of the Flonkers Rail Bridge. The site occurs on the edge of a small rock outcrop overlooking a stream (fig. 6). More artefacts may occur further uphill. No artefacts were observed on the adjacent hills.

Mitigation: The site should be systematically sampled

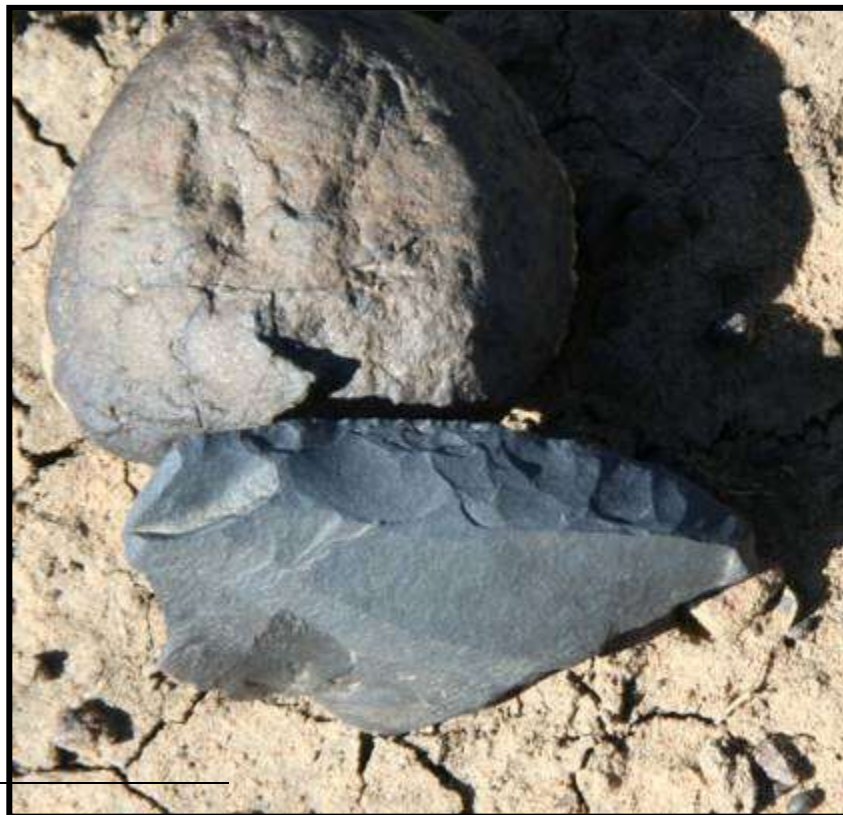
FIG. 7 LARGE END SCRAPER<sup>2</sup>

- Flakes
- Utilised flakes
- Cores
- One large scraper (probably duckbill scraper) (fig. 7).
- chunks

The site is a standard Late Stone Age site, however the occurrence of a duckbilled scraper allows for a tentative date of 12000 - 7000 years ago (See Deacon 1982; Parkington 1986, Mitchel 1989; Bosman 2005). This would relate to the old 'Smithfield Culture', the Oakhurst Complex or the Albany Complex. A more detailed sample study would need to be undertaken to determine the age of the site.

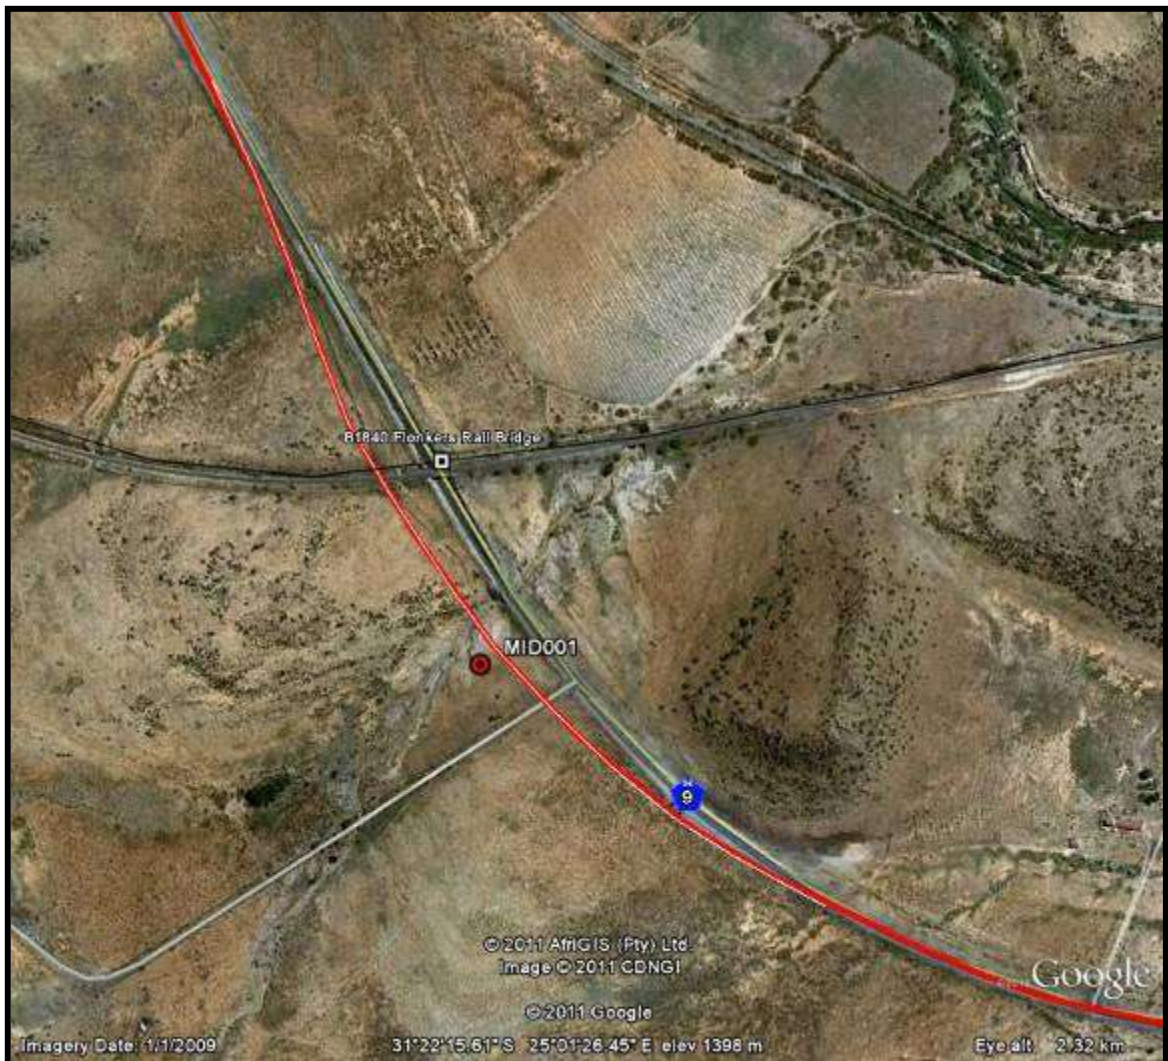
FIG. 8: POSSIBLE ROAD REROUTE AND LCOATION OF MID01

A proposed road deviation will directly affect the site (fig. 8).

Significance: The site is of low significance as it is a scatter of stone tools in an open area. However, the occurrence of the scraper and utilised flakes makes the site of low-medium significance, especially when the impact will occur over the entire scatter.

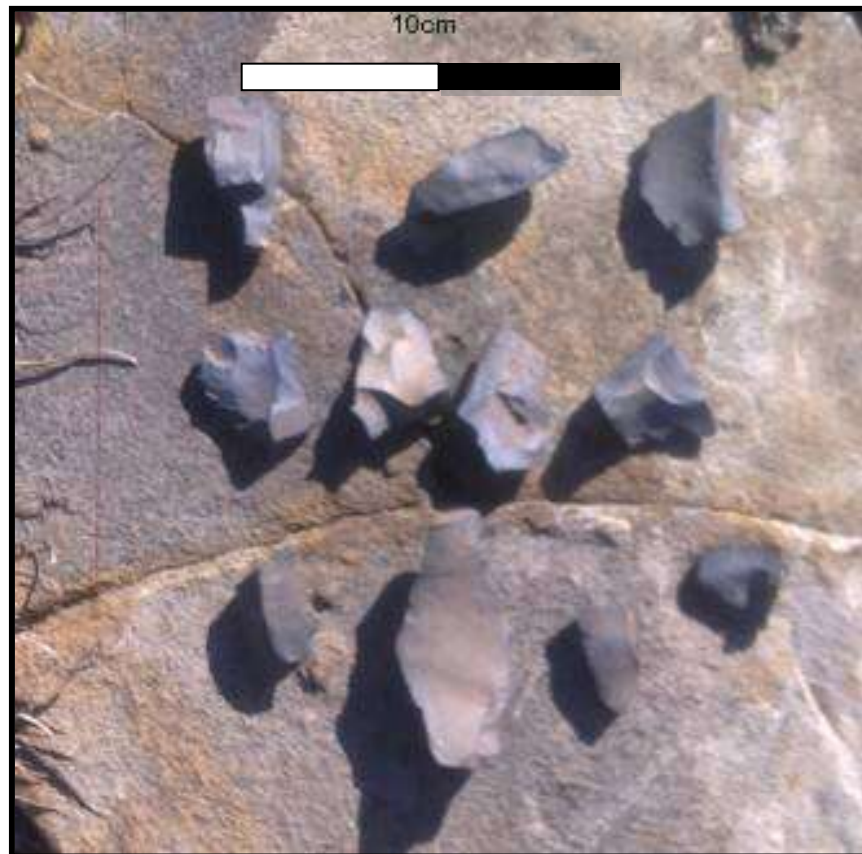
**FIG. 10: STONE TOOLS FROM MID02**

MID02 is located above the old borrow pit (fig. 9). The site consists of scatters of LSA tools (fig. 10), of which all appear to be on hornfels. The tools occur mostly on the top of the hill and along the gentle slope to the borrow pit. A few tools were observed along the track to the borrow pit.

- Flakes
- Utilised flakes
- Small end scraper
- Adze
- Irregular cores

Significance: The site is of low significance. However, the scatter is over a large area and may have research value.

Mitigation: If the area is to be disturbed, the stone tools should be systematically sampled.

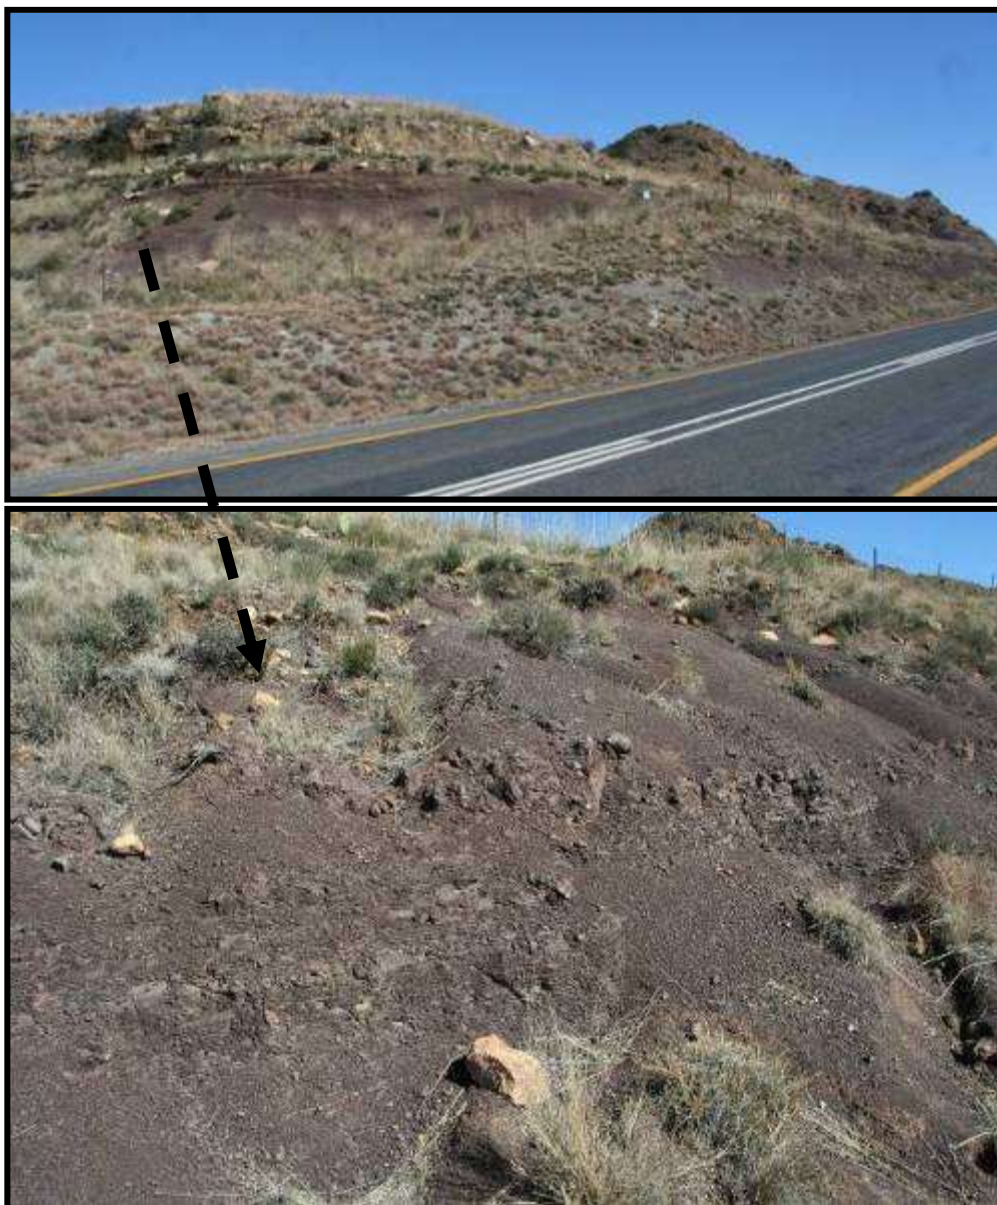
**FIG. 11: LOCATION OF PAL01**

PAL01 occurs within the road reserve and is likely to be affected by the increased road width (fig. 11). The site consists of several mudstone layers and is a palaeontological sensitive area.

Significance: The significance needs to be assessed by a palaeontologist.

Mitigation: to be determined

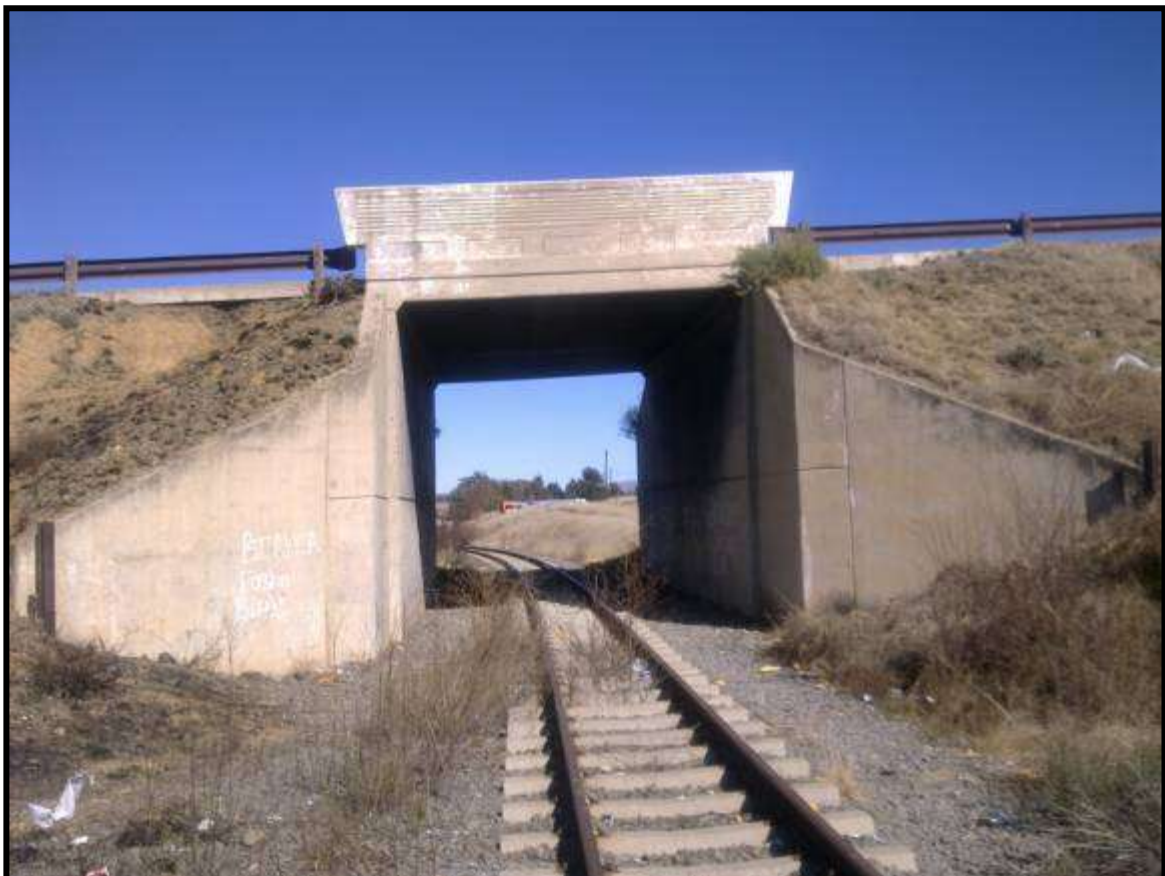
**FIG. 12: ROSMEAD ROAD GRADE SEPARATION BRIDGE**

The road underpass bridge was built in 1961. It is 33.2m long and consists of 3 continuous spans, 8.3m, 16.6m and 8.3m, supported on wall-type piers and spill-through abutments (fig. 12).

Significance: Significance for this bridge will require specialist architect input

Mitigation: The bridge is not older than 60 years and thus does not require a demolition permit from SAHRA if it is to be damaged or altered.

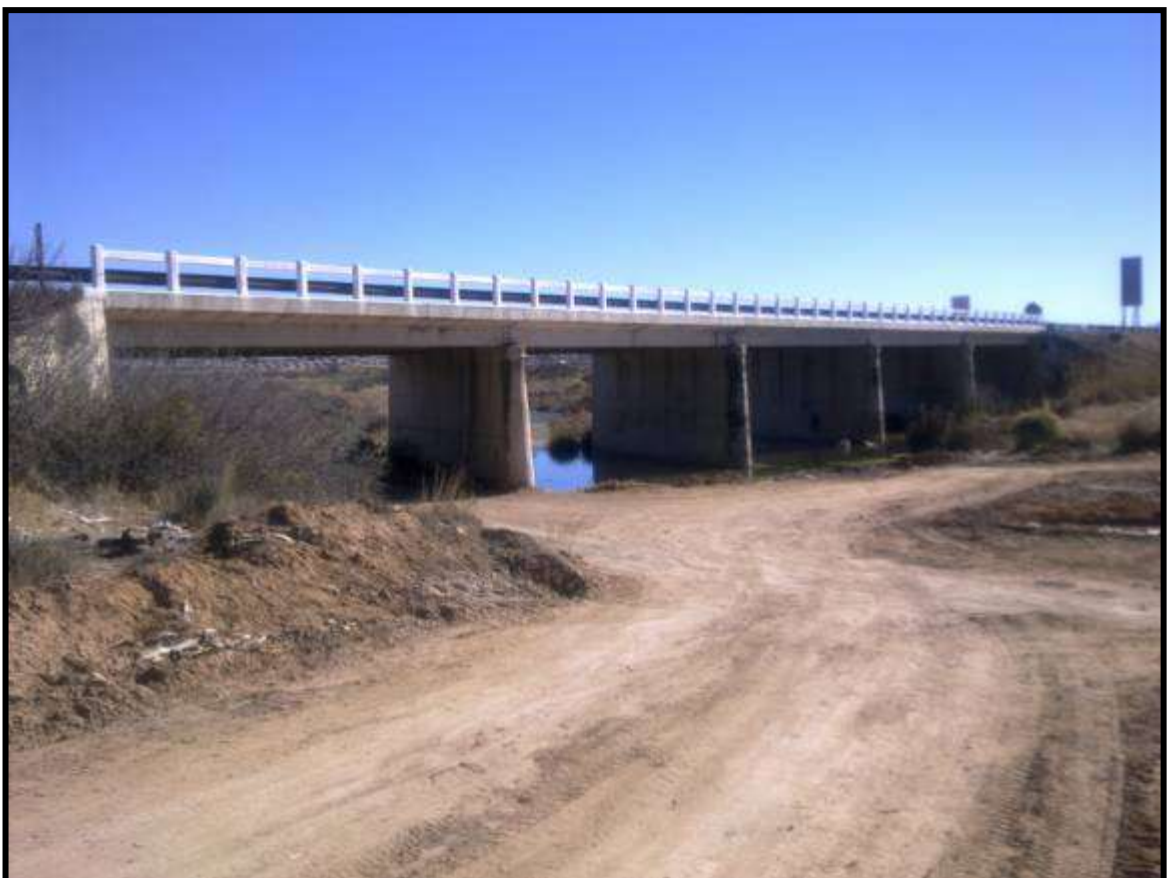
**FIG. 13: KLEIN BRAK RIVER BRIDGE**

The river bridge was built in 1965. It is 72m long and consists of 5 x 14.4m long simply supported spans on closed abutments and wall-type piers (fig. 13). The bridge appeared to be in a fair condition. There were no major defects visible.

Significance: Significance for this bridge will require specialist architect input

Mitigation: The bridge is not older than 60 years and thus does not require a demolition permit from SAHRA if it is to be damaged or altered.

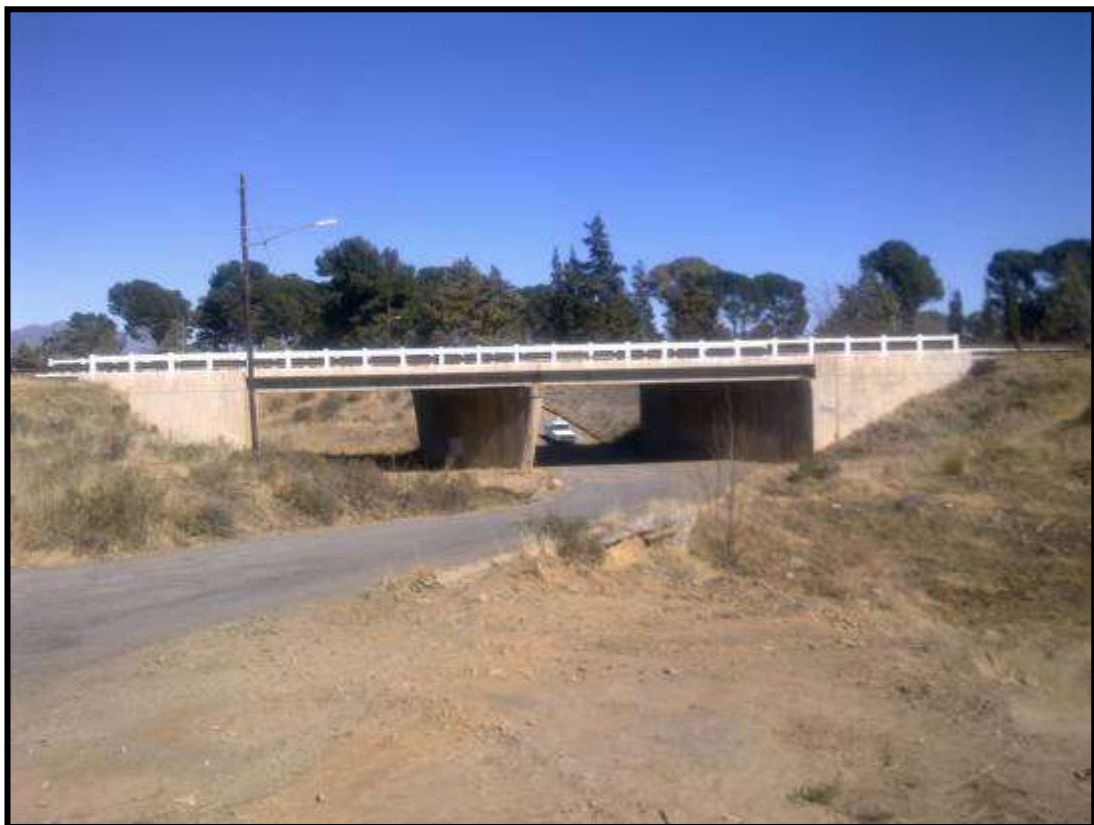
**FIG. 14: DROË RIVER BRIDGE**

The river (and combined underpass) bridge was built in 1964. It is 29m long and consists of 2 x 14.5m long simply supported spans on closed abutments and wall-type piers (fig. 14). The bridge appeared to be in a fair condition. There were no major defects visible apart from one damaged guardrail post.

Significance: Significance for this bridge will require specialist architect input

Mitigation: The bridge is not older than 60 years and thus does not require a demolition permit from SAHRA if it is to be damaged or altered.

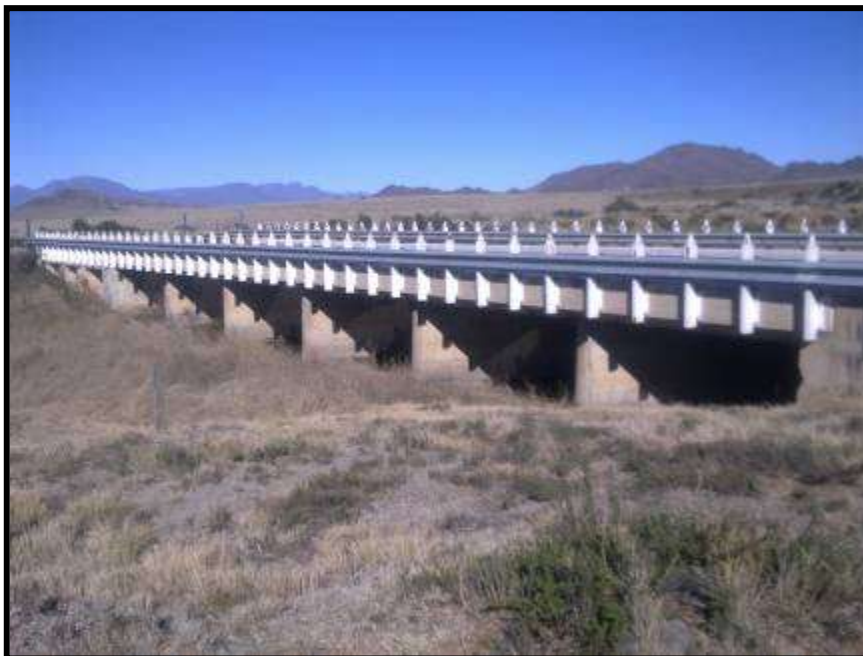
**FIG. 15: ELANDSKLOOF STREAM BRIDGE**

The river bridge was built probably originally in 1953 or earlier and subsequently lengthened (fig. 15). It is 38.9m long and consists of 9 spans, 6 x 4.9m length of simply supported and 3 x 3.2m length continuous, on closed abutments and wall-type piers. It appears that the 3 x 3.2m spans had been built originally and that the bridge had later been lengthened by the addition of the 6 x 4.9m spans. There are some small random cracks in the deck soffits together with one large concrete spall at the edge of the soffit of the first deck due to rusted reinforcement. The fixing of the parapets to the sides of the deck slabs has loosened in places.

Significance: Significance for this bridge will require specialist architect input

Mitigation: The bridge is 58 years old and thus technically does not require a demolition permit from SAHRA if it is to be damaged or altered. SAHRA Built Environment will need to state if a permit is required.

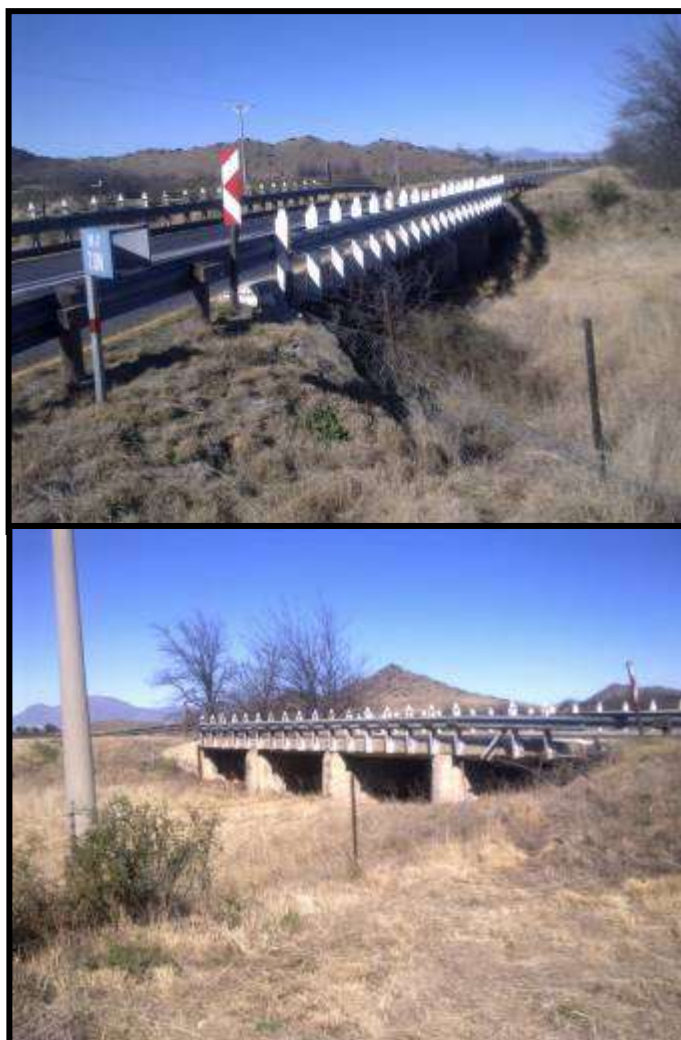
**FIG. 16 SELIGMAN BRIDGE: EAST & WEST VIEW**

The river bridge was built in 1941. It is 21.3m long and consists of 4 x 5.3m spans with two 10.6m continuous deck sections on closed abutments and wall-type piers (fig. 16). The parapets have suffered impact damage and some of the post connections are loose. The bridge deck soffits have widespread cracking, longitudinal and transverse.

Significance: Significance for this bridge will require specialist architect input

Mitigation: The bridge is older than 60 years and thus requires a demolition permit from SAHRA if it is to be damaged or altered.

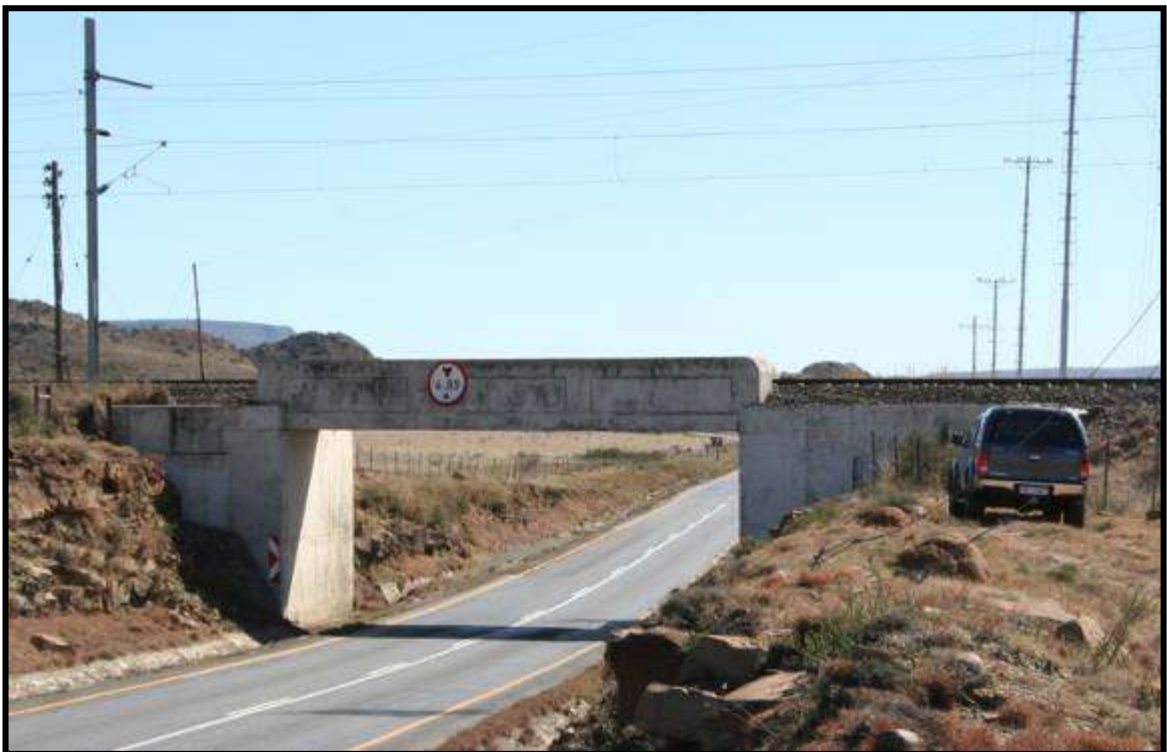
**FIG. 17: FLONKERS RAIL BRIDGE**

The rail overpass bridge was built 1959 (fig. 17). It consists of a single 14.6m long simply supported span on closed abutments (extended for a future rail track). The soffit of the bottom slab is substantially cracked and spalled due to rusted reinforcement and impact damage. Spalling of concrete is also visible on the sides of the upright section where reinforcement has rusted.

Significance: Significance for this bridge will require specialist architect input

Mitigation: The bridge is not older than 60 years and thus does not require a demolition permit from SAHRA if it is to be damaged or altered.

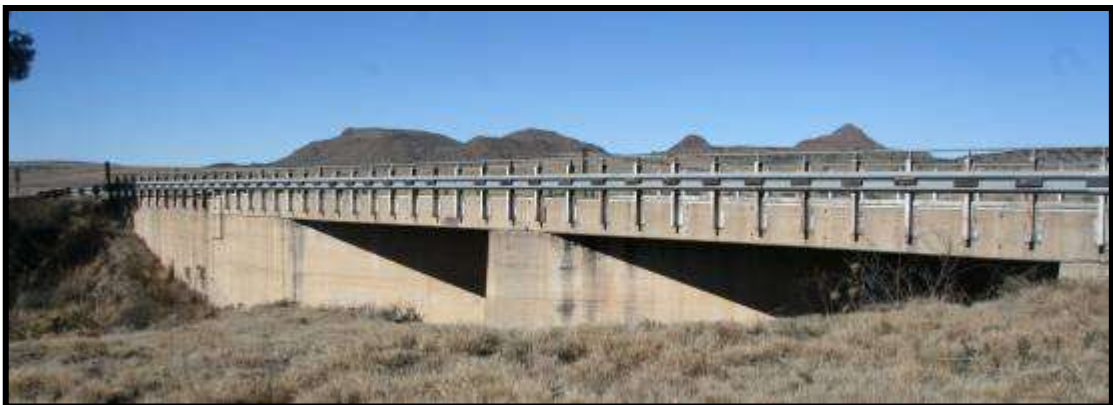
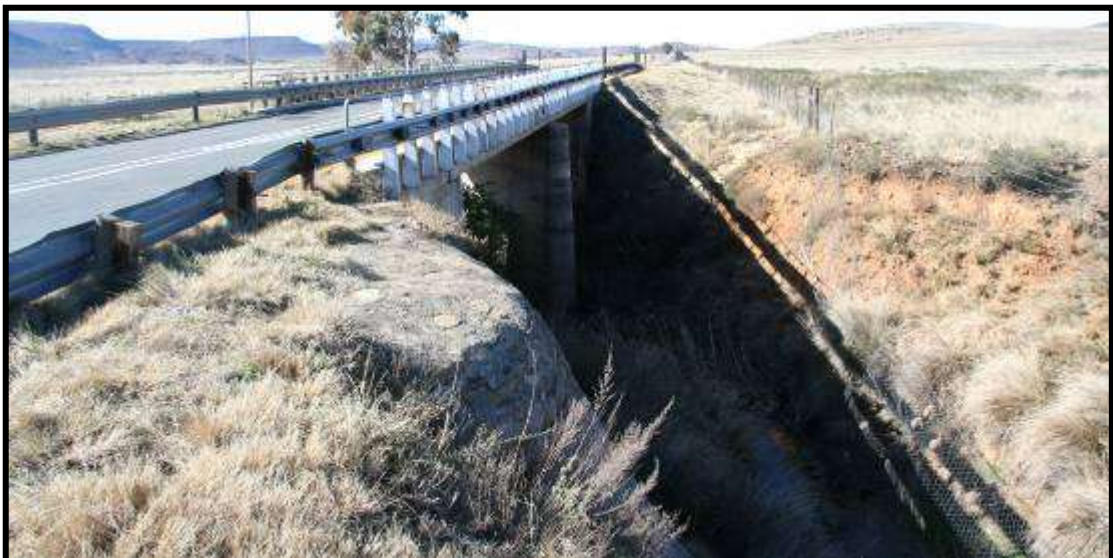
**FIG. 18: LUDLOW SPRUIT BRIDGE: EAST & WEST VIEW**

The river bridge was built in 1940. It is 24.4m long and consists of 2 x 12.2m simply supported spans, measured along the length of the road, 6.1m perpendicular to the abutments, on closed abutments and a wall-type pier (fig. 18). The bridge has steel posts/railings with double guardrails, attached to the outside of the headwalls. Some minor cracking is evident in the abutment walls and deck soffits. Embankment erosion is evident.

Significance: Significance for this bridge will require specialist architect input

Mitigation: The bridge is older than 60 years and thus requires a demolition permit from SAHRA if it is to be damaged or altered.

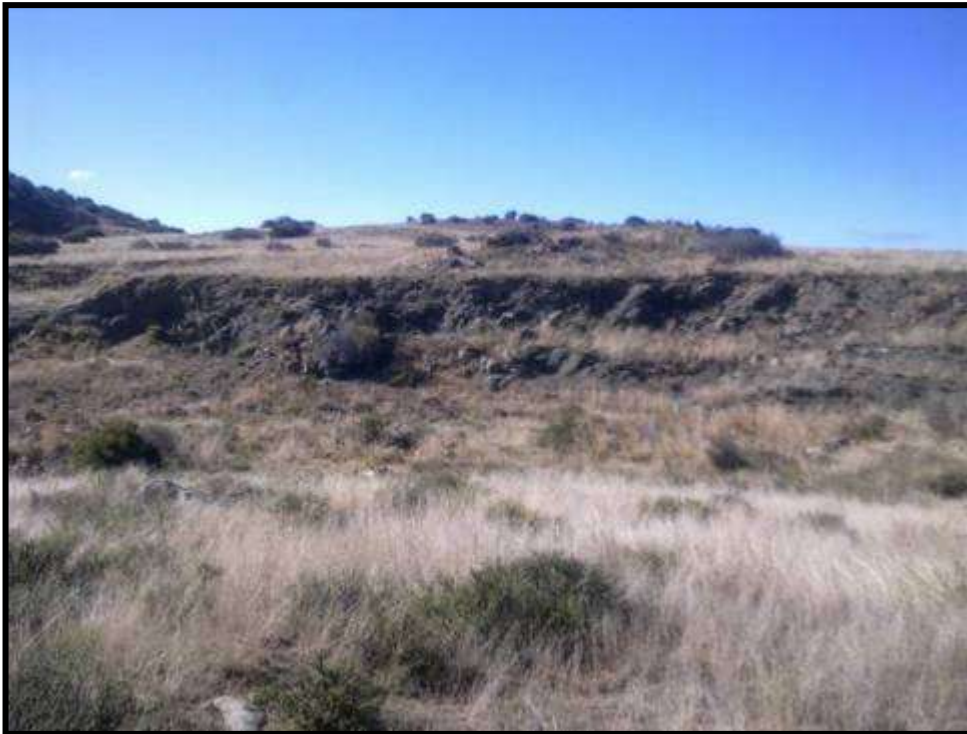
**FIG. 19: OLD BORROW PIT**

This borrow pit is located near MID02. The borrow pit has been used before and may be extended (fig. 19). The access road to the borrow pit has a few isolated stone tools. The deposit will need to be assessed by a palaeontologist.

Significance: The borrow pit has no heritage significance.

Mitigation: No mitigation is currently required, unless the borrow pit is extended. If MID02 is affected then some sampling should be required.

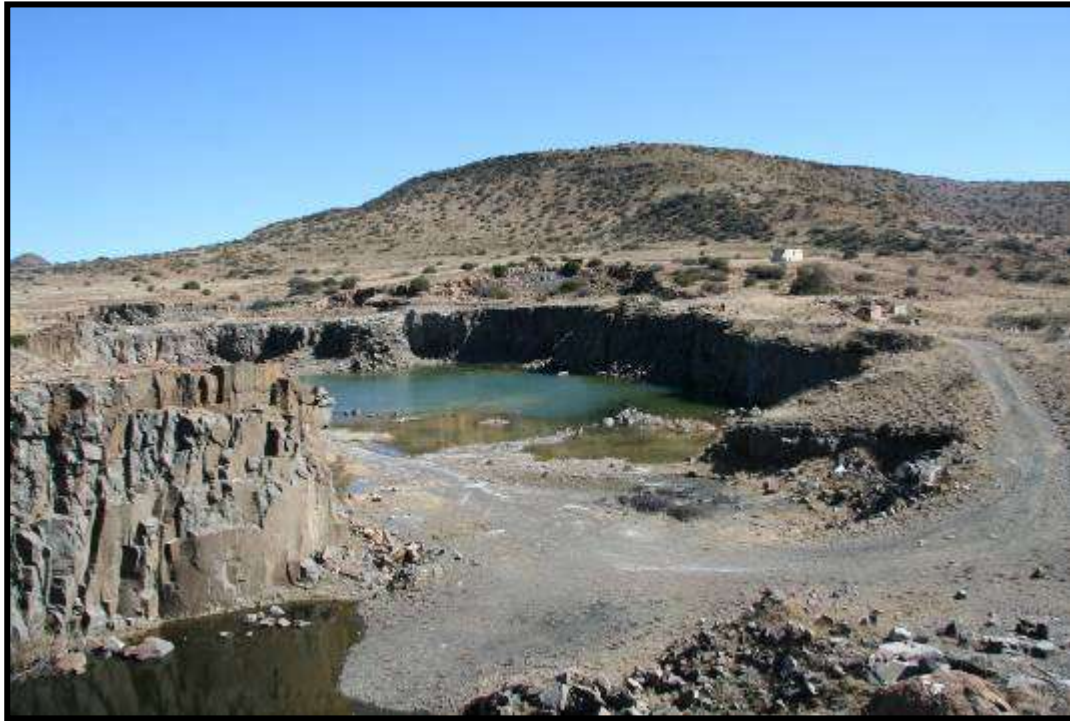
**FIG. 20: WOLWEKOP QUARRY**

The Wolwekop quarry has been in use for sometime although it is now abandoned (fig. 20). All of the buildings indicate that the quarry is not over 60 years in age. The entire hill has been severely disturbed. Three Late Stone Age stone tools were observed on the hill. Thus the area would have been an archaeological site in the past (hence it being called MID03). Only this specific hill was surveyed (fig. 21). If the quarry extends beyond this hill, then it will need to be surveyed.

Significance: The site is of low significance.

Mitigation: No further mitigation is required.

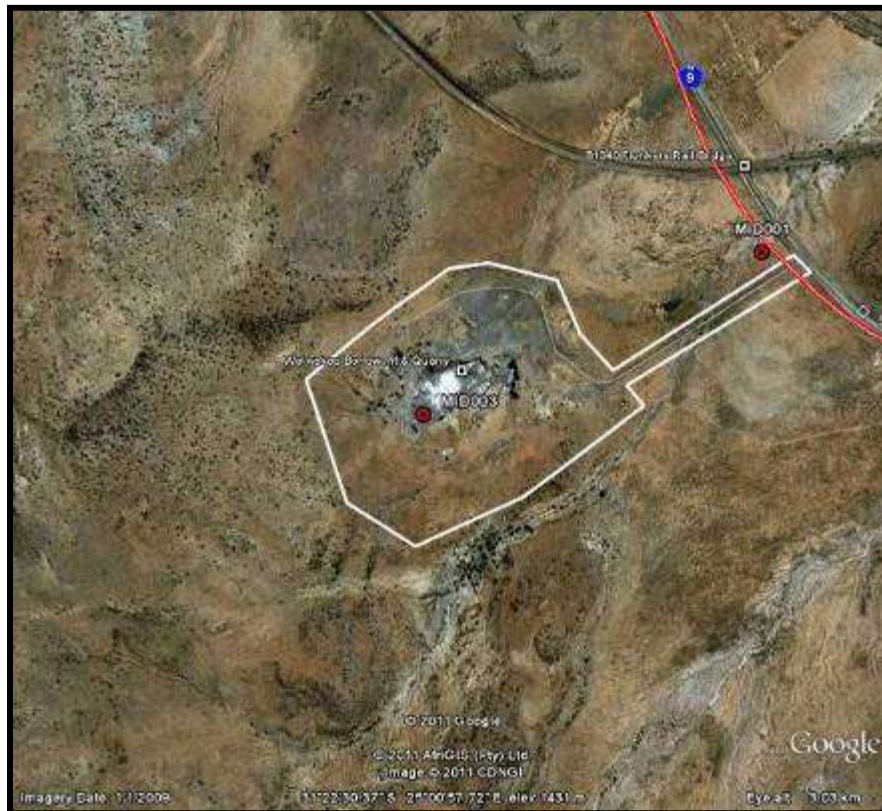
**FIG. 21: SURVEYED AREA OF WOLWEKOP QUARRY**

The Wolwekop quarry has been in use for sometime although it is now abandoned (fig. 20). All of the buildings indicate that the quarry is not over 60 years in age. The entire hill has been severely disturbed. Three Late Stone Age stone tools were observed on the hill. Thus the area would have been an archaeological site in the past (hence it being called MID03). Only this specific hill was surveyed (fig. 21). If the quarry extends beyond this hill, then it will need to be surveyed.
