PROPOSED PERIODIC MAINTENANCE OF SECTION 11 OF THE N10

**Documentation of
FOUR BRIDGES ON THE N10 NATIONAL ROAD BETWEEN UPINGTON AND
GROBLERSHOOP, NORTHERN CAPE PROVINCE**

Report No: 2012/JvS/018
Status: Draft
Revision No: 0
Date: April 2012

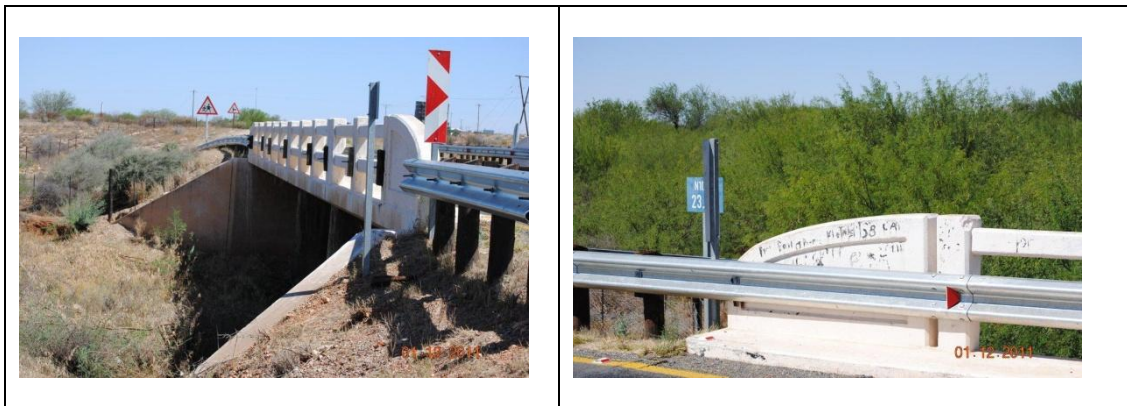
Fig. 2. Views of the bridge.

The Saalskop Rivier Bridge can be classified as a **three span** bridge as the spanning superstructure extends from one vertical support, called abutment, to another, being supported by two columns.

The walls are constructed from concrete that was cast in slabs.

The bridge deck seems to be a single concrete slab reinforced by girders. The top layer of the bridge deck consists of concrete, which is also part of the construction of the bridge and is then covered with a layer of tarmac.

Two columns support the bridge deck. They are all from cast concrete and are set at a slight angle to the bridge deck in order to be parallel to the stream bed. The foundations of the columns are boat shaped to accommodate the flow of water.

The guide rail is a raised platform of concrete, edged with angle iron that runs the length of the bridge.

The pylons are rounded shaped slabs of concrete located on the corners of the bridge. Usually the number of the bridge and the date of construction are added to this.

The original railings were of concrete consist of a number of uprights and two horizontal railings attached to them. The current railings are reinforced by Armco crash barriers.

The revetment walls are constructed from cast concrete. The base of the wings has a foundation that possibly extends down to the bedrock.

The bridge in itself is in good repair, showing no signs of natural decay or damage from plant life.

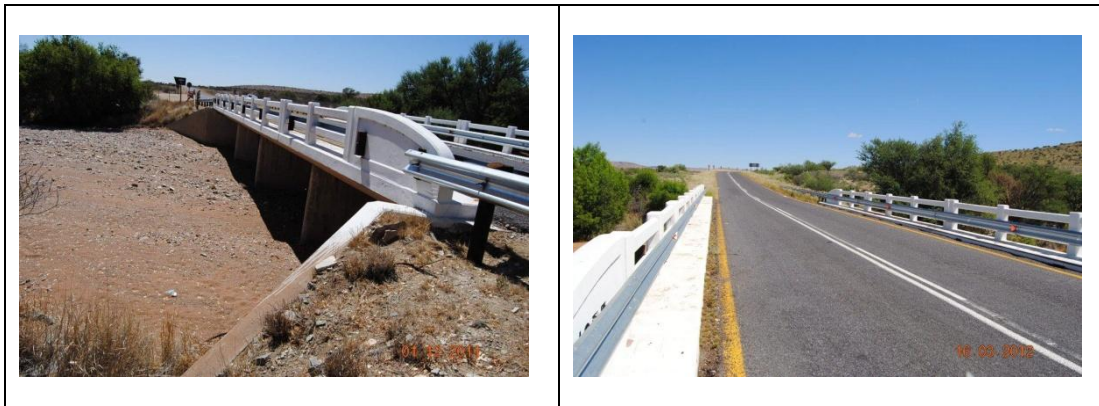
Fig. 3. Views of the bridge.

The Kalkwerfsloot Rivier Bridge can be classified as a **four span** bridge as the spanning superstructure extends from one vertical support, called abutment, to another, being supported by three columns.

The walls are constructed from concrete that was cast in slabs.

The bridge deck seems to be a single concrete slab reinforced by girders. The top layer of the bridge deck consists of concrete, which is also part of the construction of the bridge and is then covered with a layer of tarmac.

Two columns support the bridge deck. They are all from cast concrete and are set at a slight angle to the bridge deck in order to be parallel to the stream bed. The foundations of the columns are boat shaped to accommodate the flow of water.

The guide rail is a raised platform of concrete, edged with angle iron that runs the length of the bridge.

The pylons are rounded shaped slabs of concrete located on the corners of the bridge. Usually the number of the bridge and the date of construction are added to this.

The original railings were of concrete consist of a number of uprights and two horizontal railings attached to them. The current railings are reinforced by Armco crash barriers.

The revetment walls are constructed from cast concrete. The base of the wings has a foundation that possibly extends down to the bedrock.

The bridge in itself is in good repair, showing no signs of natural decay or damage from plant life.

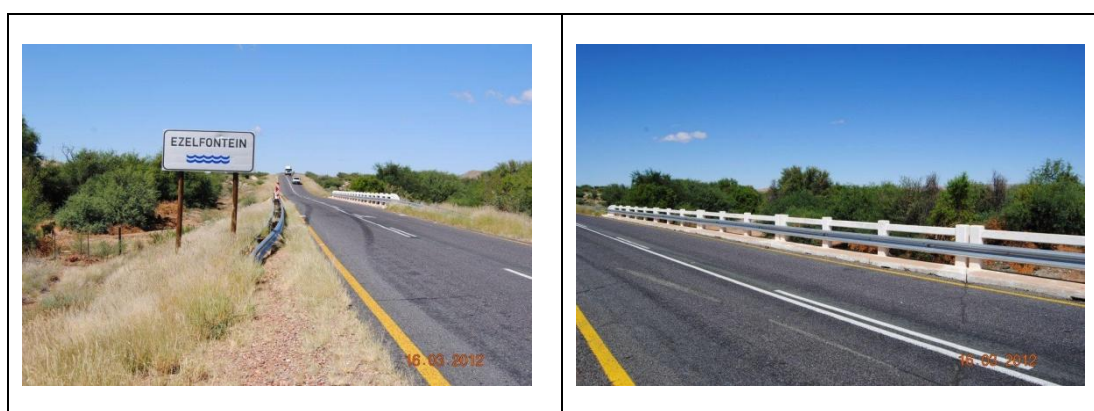
Fig. 4. Views of the bridge.

The Ezelfontein Bridge can be classified as a **three span** bridge as the spanning superstructure extends from one vertical support, called abutment, to another, being supported by two columns.

The walls are constructed from concrete that was cast in slabs.

The bridge deck seems to be a single concrete slab reinforced by girders. The top layer of the bridge deck consists of concrete, which is also part of the construction of the bridge and is then covered with a layer of tarmac.

Two columns support the bridge deck. They are all from cast concrete and are set at a slight angle to the bridge deck in order to be parallel to the stream bed. The foundations of the columns are boat shaped to accommodate the flow of water.

The guide rail is a raised platform of concrete, edged with angle iron that runs the length of the bridge.

The pylons are rounded shaped slabs of concrete located on the corners of the bridge. Usually the number of the bridge and the date of construction are added to this.

The original railings were of concrete consist of a number of uprights and two horizontal railings attached to them. The current railings are reinforced by Armco crash barriers.

The revetment walls are constructed from cast concrete. The base of the wings has a foundation that possibly extends down to the bedrock.

The bridge in itself is in good repair, showing no signs of natural decay or damage from plant life.

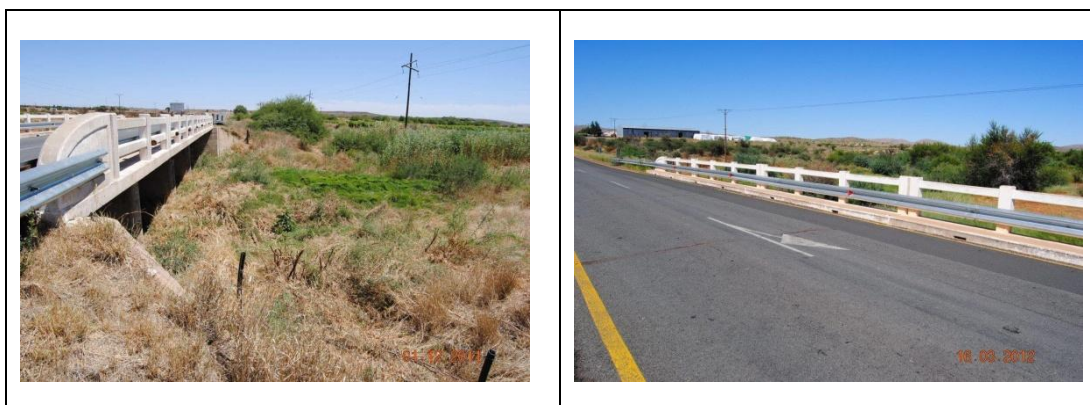
Fig. 5. Views of the bridge.

The Boom Rivier Bridge can be classified as a four span bridge as the spanning superstructure extends from one vertical support, called abutment, to another, being supported by four columns.

The walls are constructed from concrete that was cast in slabs.

The bridge deck seems to be a single concrete slab reinforced by girders. The top layer of the bridge deck consists of concrete, which is also part of the construction of the bridge and is then covered with a layer of tarmac.

Two columns support the bridge deck. They are all from cast concrete and are set at a slight angle to the bridge deck in order to be parallel to the stream bed. The foundations of the columns are boat shaped to accommodate the flow of water.

The guide rail is a raised platform of concrete, edged with angle iron that runs the length of the bridge.

The pylons are rounded shaped slabs of concrete located on the corners of the bridge. Usually the number of the bridge and the date of construction are added to this.

The original railings were of concrete consist of a number of uprights and two horizontal railings attached to them. The current railings are reinforced by Armco crash barriers.

The revetment walls are constructed from cast concrete. The base of the wings has a foundation that possibly extends down to the bedrock.

The bridge in itself is in good repair, showing no signs of natural decay or damage from plant life.
