DPR

Ecologists & Environmental Services

Report on the ecological and wetland assessment for the proposed alluvial diamond mining operations on a portion of the Remainder of the Farm Pniel 218 including a portion of the Vaal River near the town of Delportshoop, Northern Cape Province.

January 2019

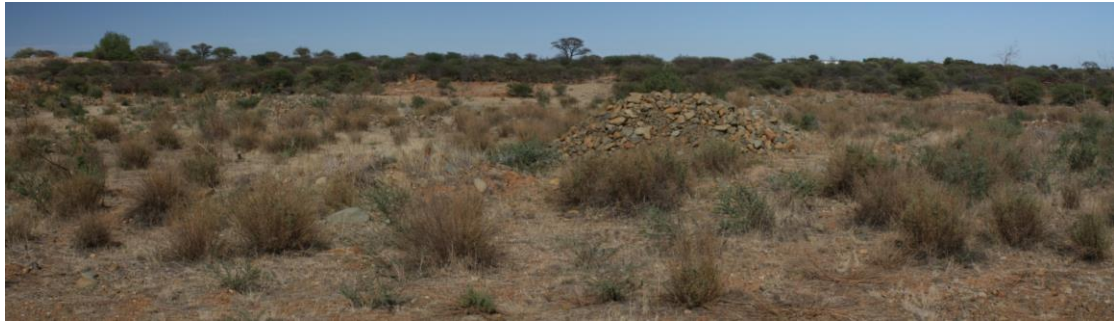
Figure 1: A pioneer vegetation layer has become re-established in many post mining areas though mining scars are evident almost everywhere.

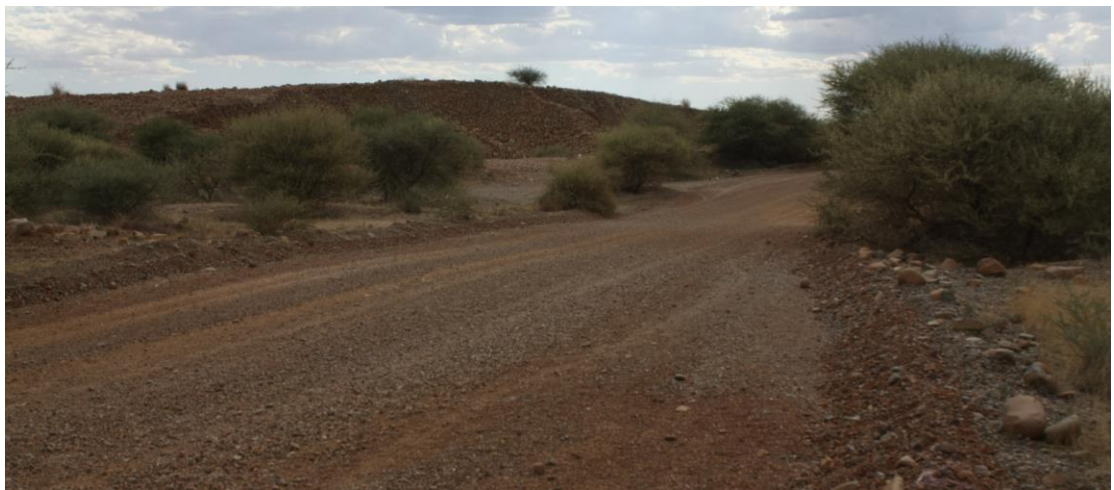
Figure 2: Gravel roads and dirt tracks are common in the study area and mine tailings such as visible in the background are common.

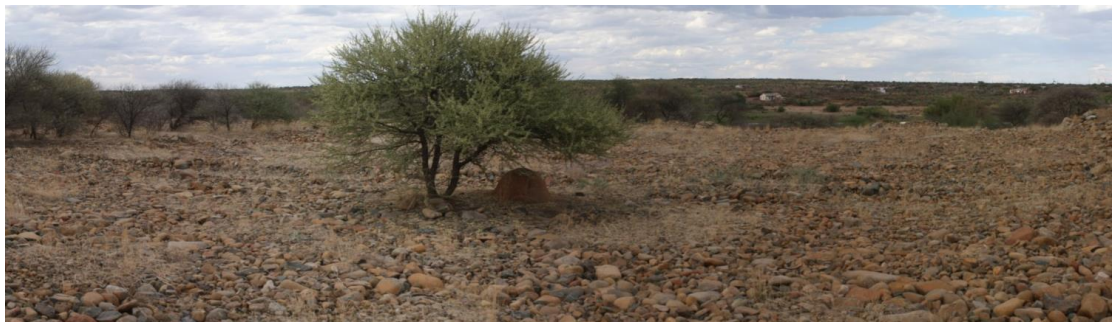
Figure 3: Areas where rehabilitation has been undertaken with mine tailings but without topsoil is unable to re-establish vegetation.

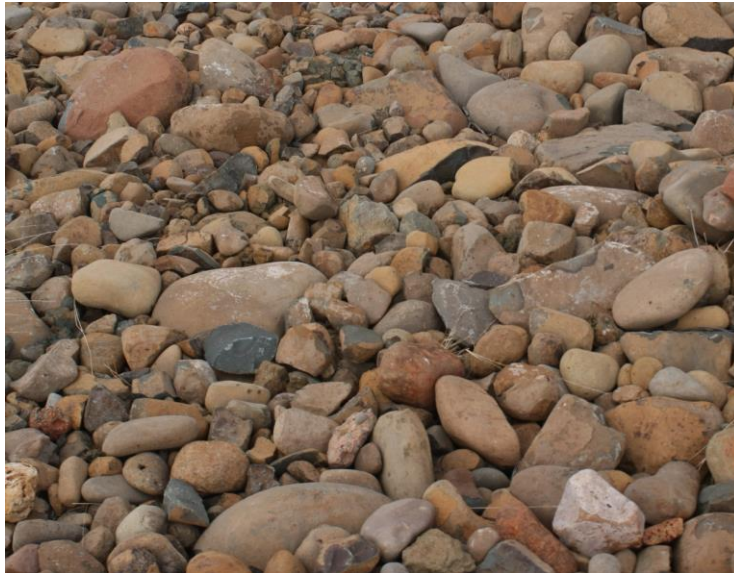
Figure 4: A close-up of the area in Fig. 3 indicating the absence of any vegetation.

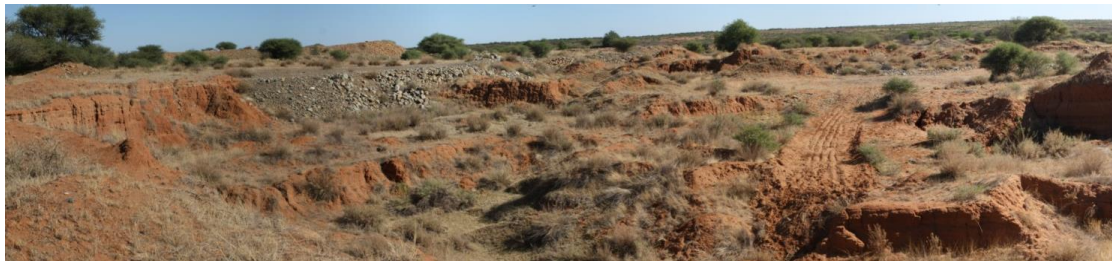
Figure 5: Large areas of the study area is affected by extensive mining scars where it is evident that little or rehabilitation was undertaken.

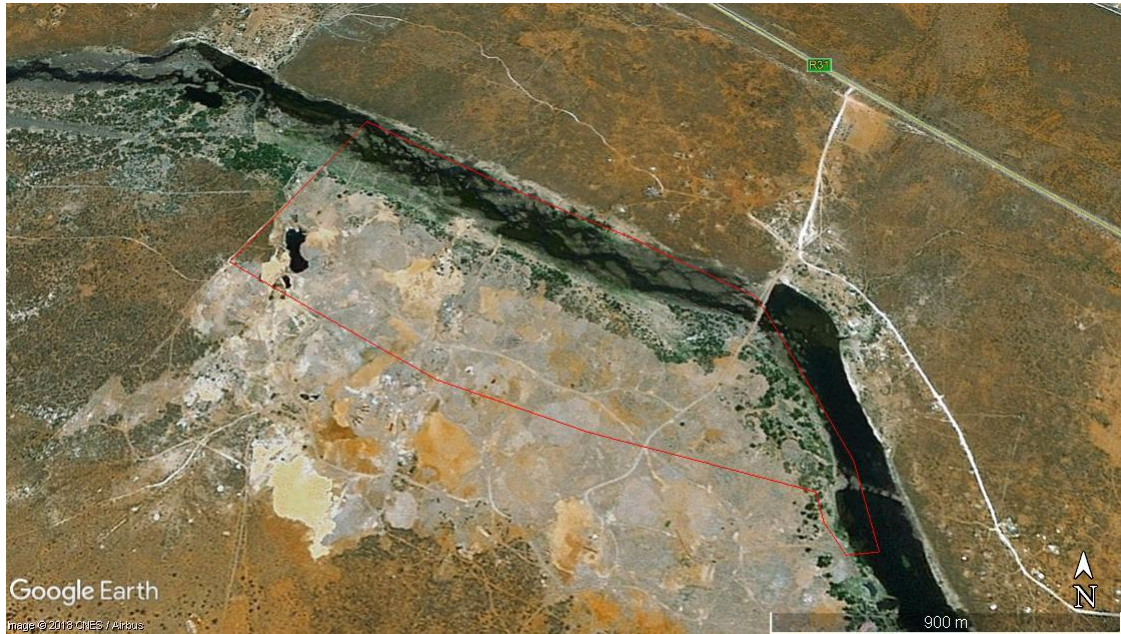
Figure 6: Aerial view of the proposed site (Google Earth 2006). Note that extensive mining operations are already in process.

From available aerial imagery (Google Earth 2006 – 2017) it is clear that previous mining activities has taken place for quite some time and it is also clear how vegetation has become re-established in many areas (Fig. 6 & 7).

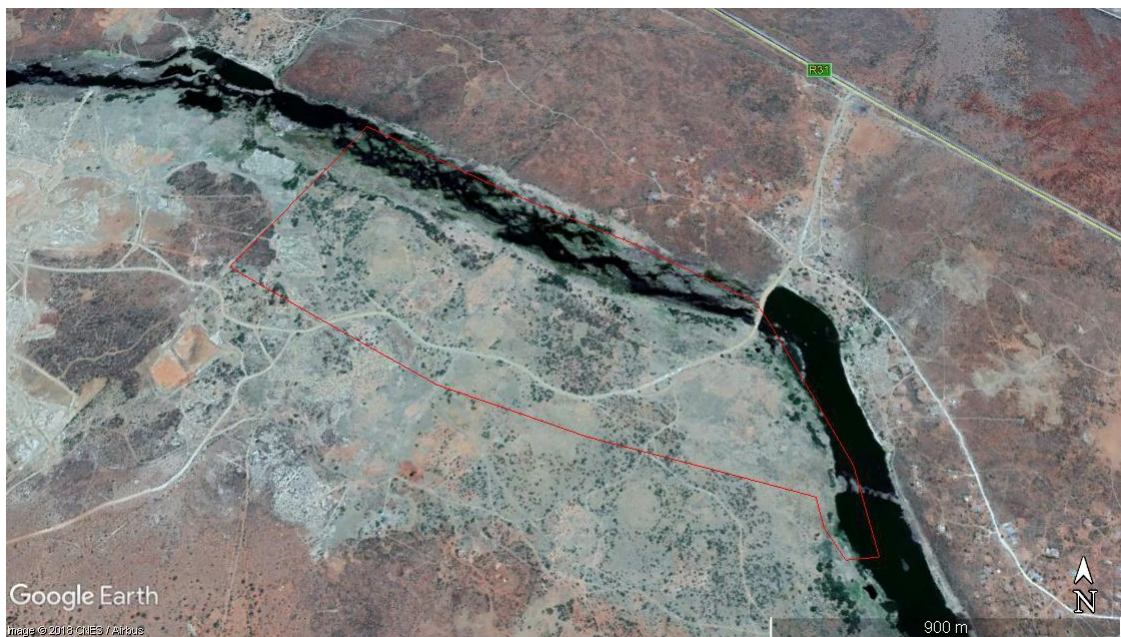
Figure 7: Aerial view of the proposed site (Google Earth 2017). Mining operations has ceased and the re-establishment of vegetation is visible in some areas.

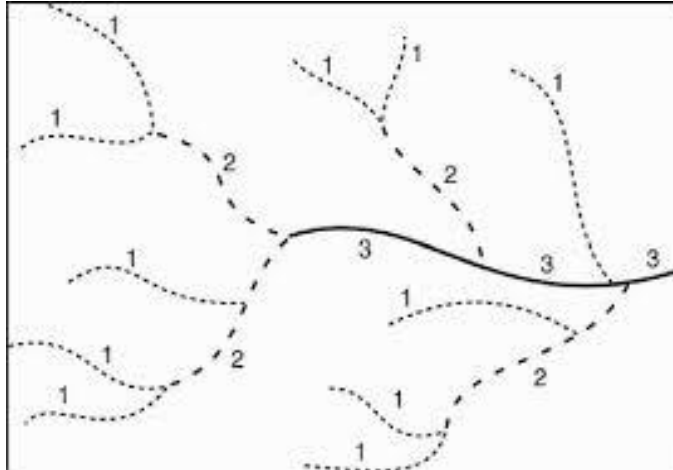
Figure 8: The classification of stream orders from 1 to 3 (Strahler 1952)

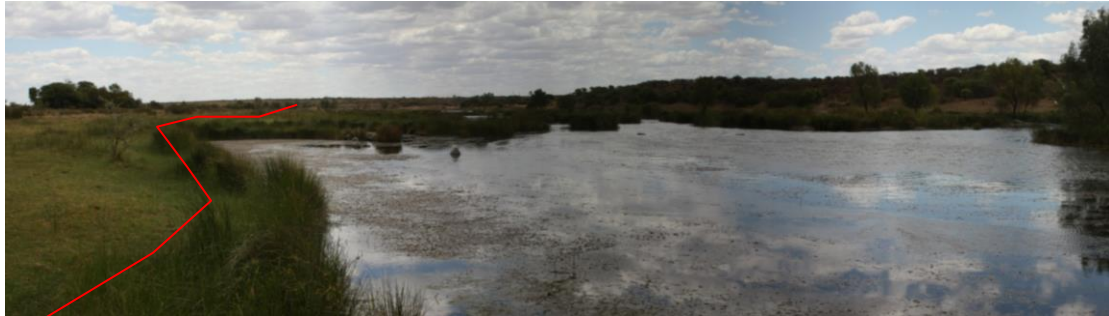
Figure 9: View of the marginal zone (red) in the northern section of the Vaal River in the study area. Note the extensive braiding visible in the background.

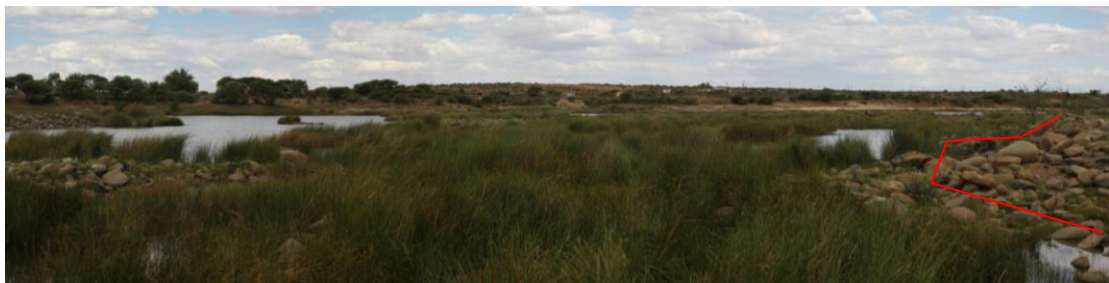
Figure 10: View of the marginal zone (red) in the northern section of the Vaal River in the study area. Again note the extensive marginal zone and braided nature of the main channel.

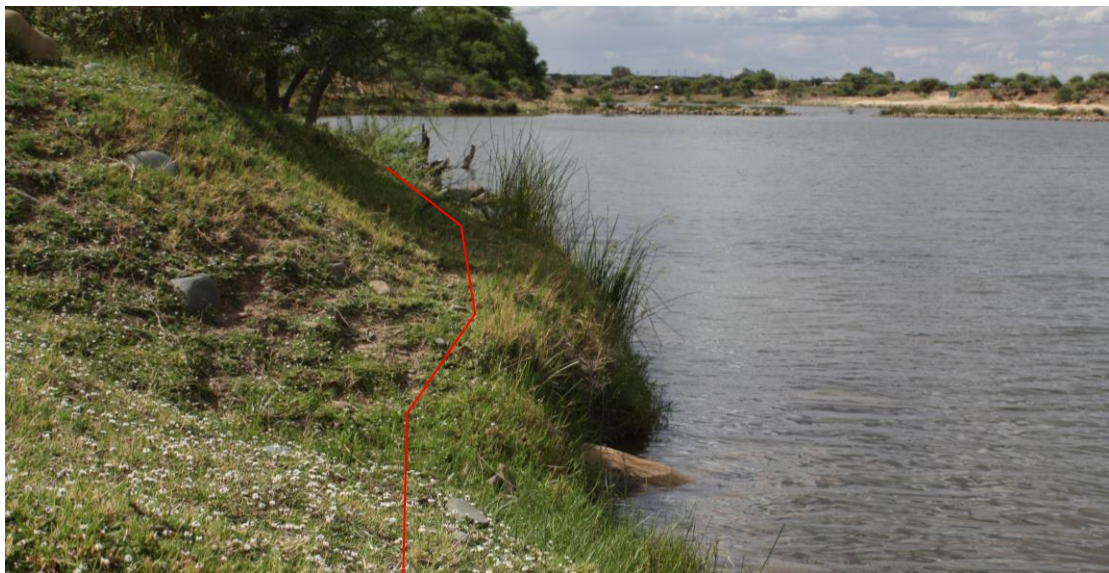
Figure 11: View of the marginal zone (red) in the eastern portion of the study area. Here the zone is clearly much narrower without braiding in the main channel.

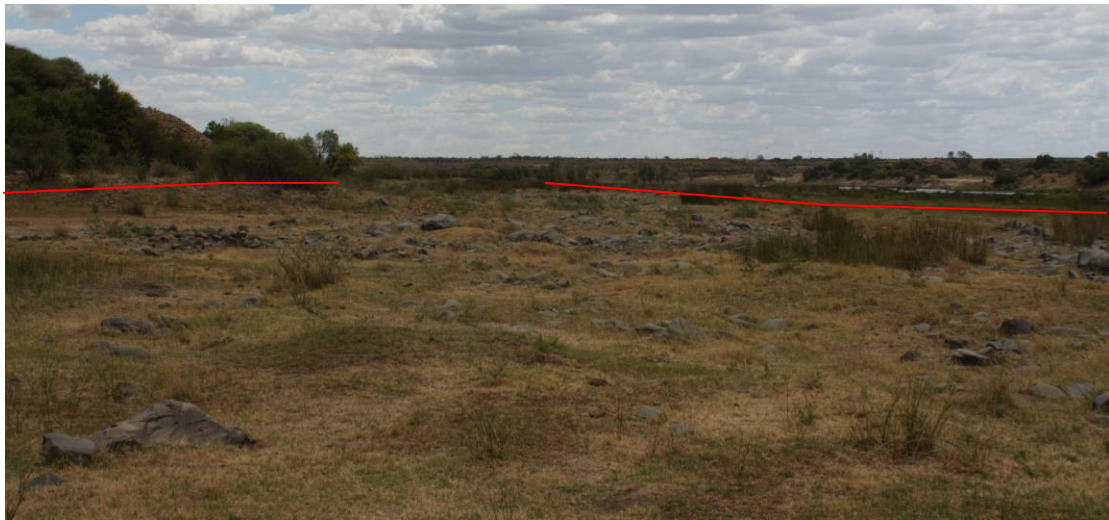
Figure 12: The lower zone (red) can be quite extensive in the northern portion of the study area and can be clearly differentiated from the marginal and upper zones.

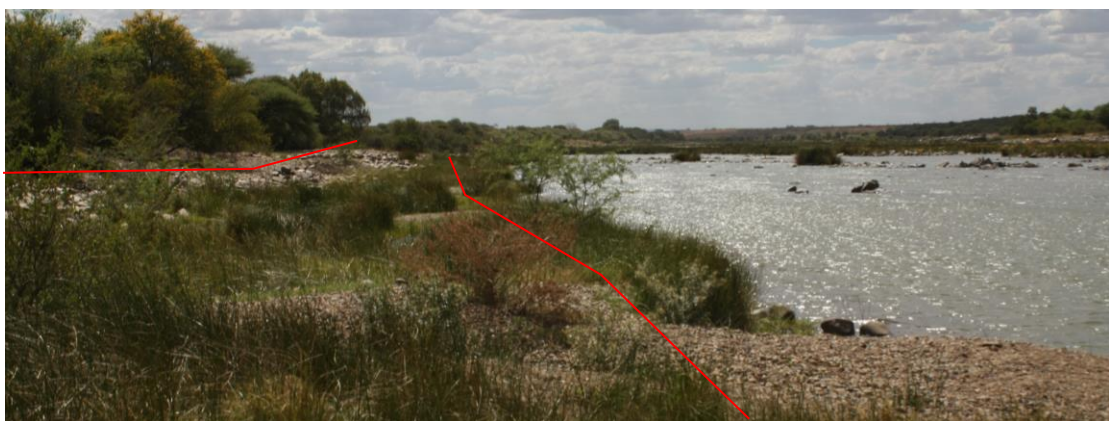
Figure 13: The lower zone (red) does however decrease in width toward the east of the study area.

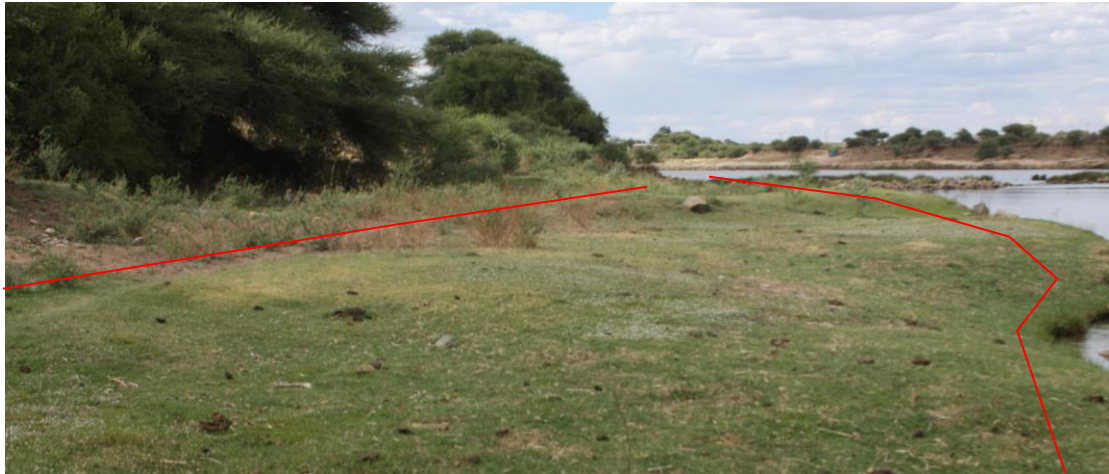
Figure 14: The lower zone (red) along the eastern portion of the study area.

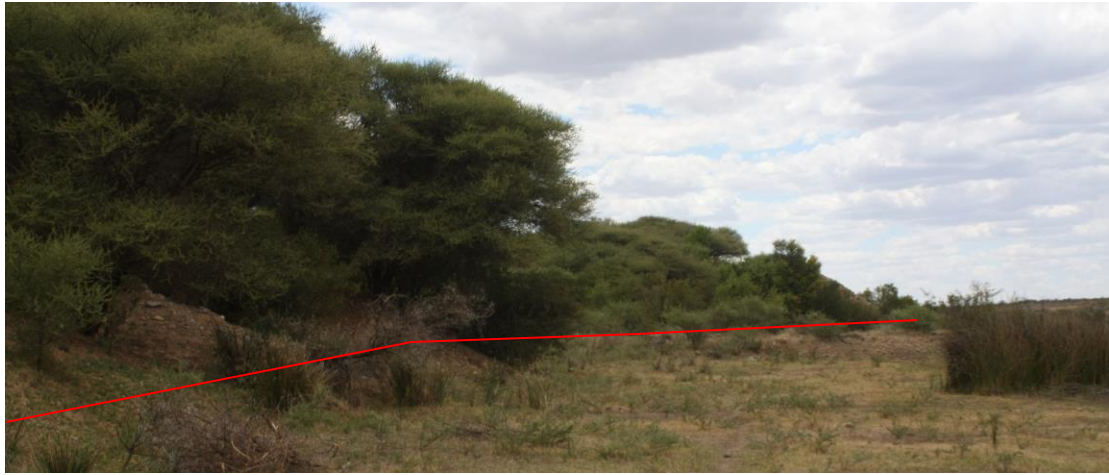
Figure 15: The upper zone (red) is clearly visible as an increase in slope and riparian woodland.

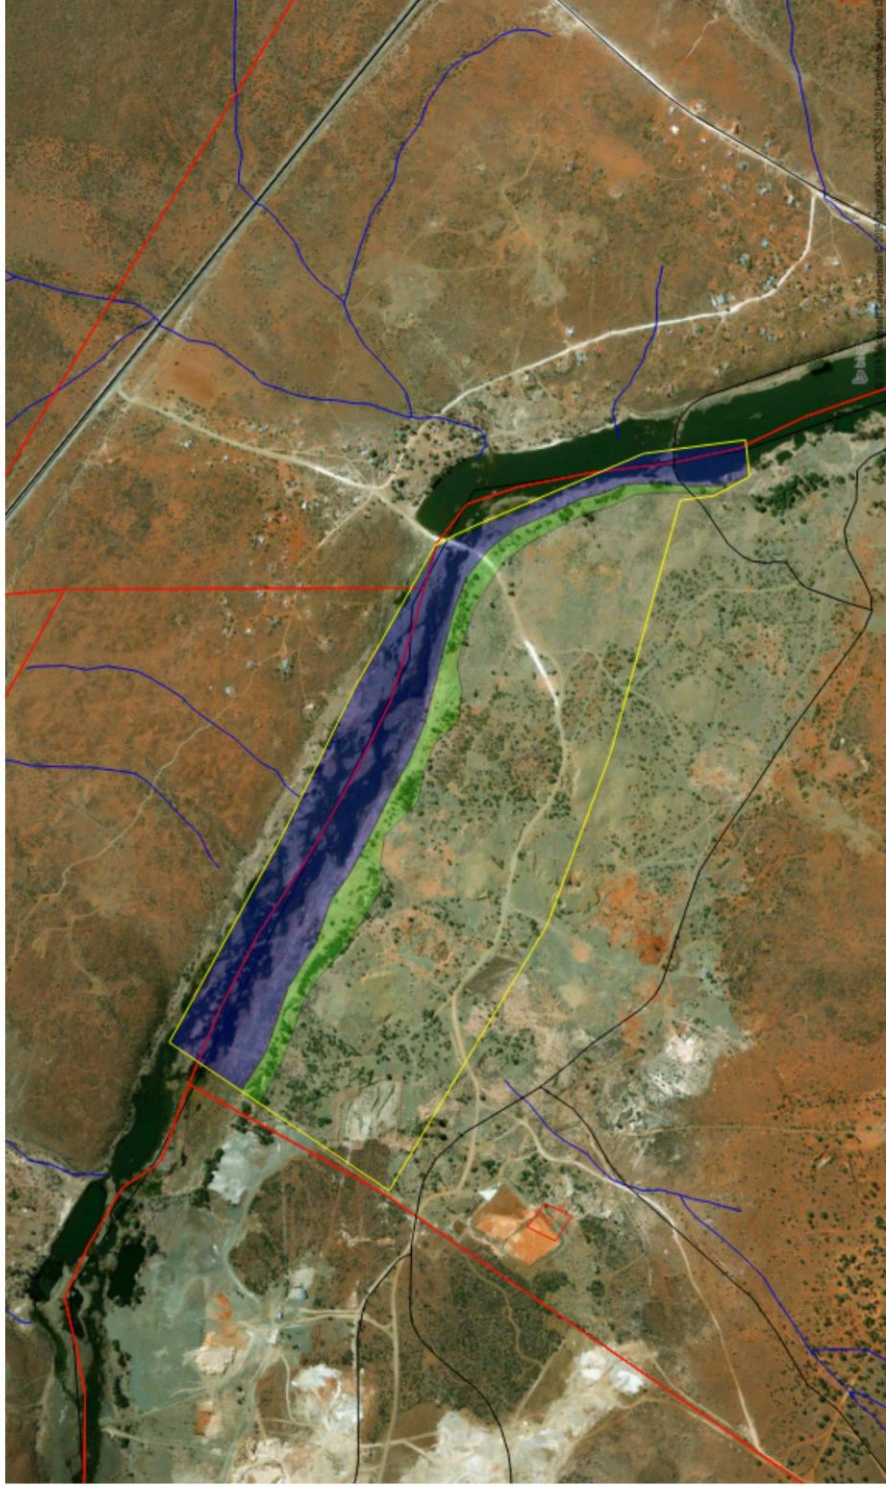
Wetland delineation of the alluvial diamond mining operations on a portion of the Remainder of the Farm Pniel 218 including a portion of the Vaal River near the town of Delportshoop, Northern Cape Province.

Map 1: Wetland delineation map for the proposed alluvial diamond mining operations near the town of Delportshoop. Note that the study area has been affected by previous mining which is clearly still visible. The wetland condition (Marginal and lower zones) along the river bank is indicated. The riparian zone (Upper zone) is also indicated. Note the braided river portion clearly visible along the northern section of the river. Mining should exclude the river (including riparian zone) as far as possible and should mining be desired in this area should be considered in order from low to high sensitivity, i.e. riparian zone, eastern river section, northern river section, braided main channel.

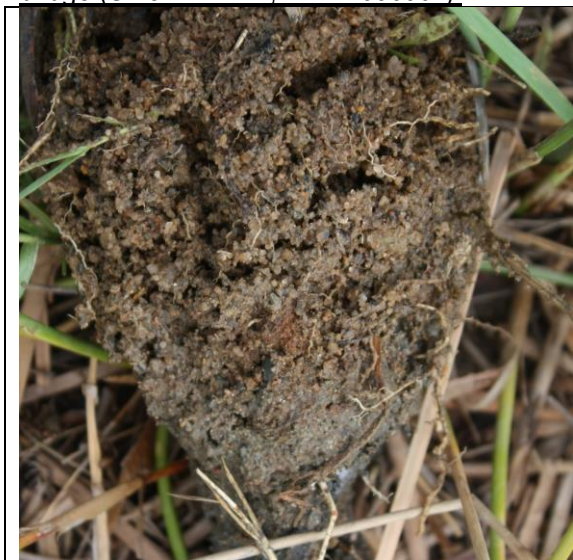
<p>Soil sample taken in the marginal zone of the river. A prominent grey matrix (>10%) is clear and mottling is present indicating a permanent zone of wetness. Wetland conditions are therefore clearly present.</p>	<p>Due to the gravel and rock covered lower and upper zones no soil sampling was possible in these areas although riparian vegetation was used to delineate the wetland zone.</p>

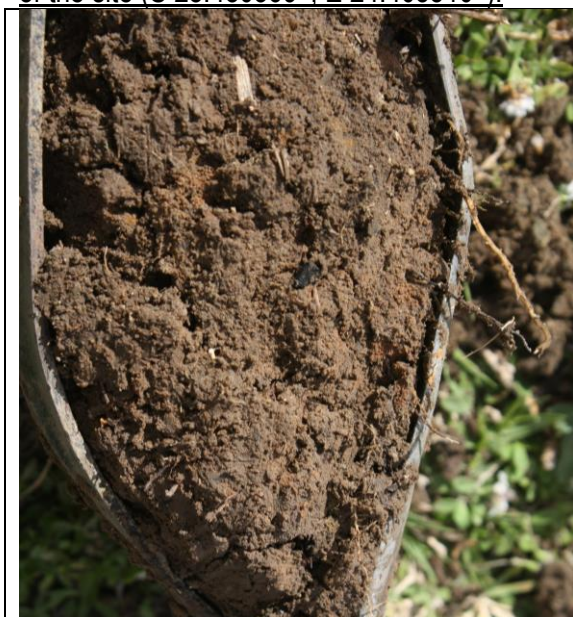
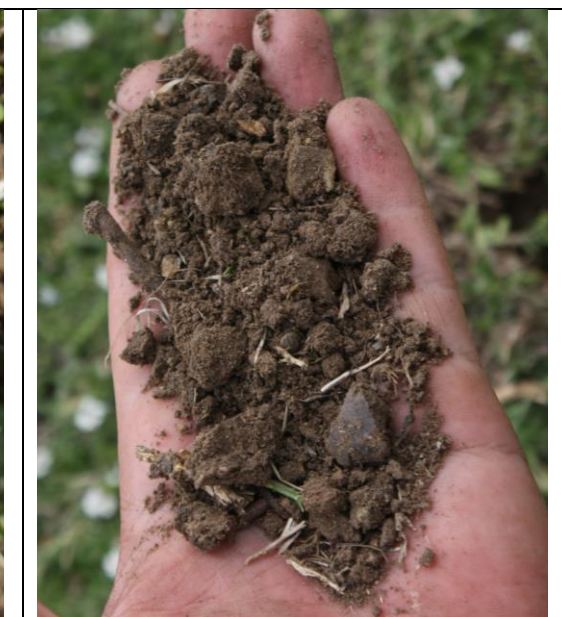
<p>Soil sample taken in the marginal zone of the river. A grey matrix (<10%) is present and mottling is prominent indicating a permanent zone of wetness. Wetland conditions are therefore clearly present.</p>	<p>Soil sample taken in the lower zone of the river bank. A feint grey matrix (<10%) is present as well as a few feint mottles. Wetland conditions are therefore not clearly present but is still considered as part of the seasonal zone of wetness.</p>

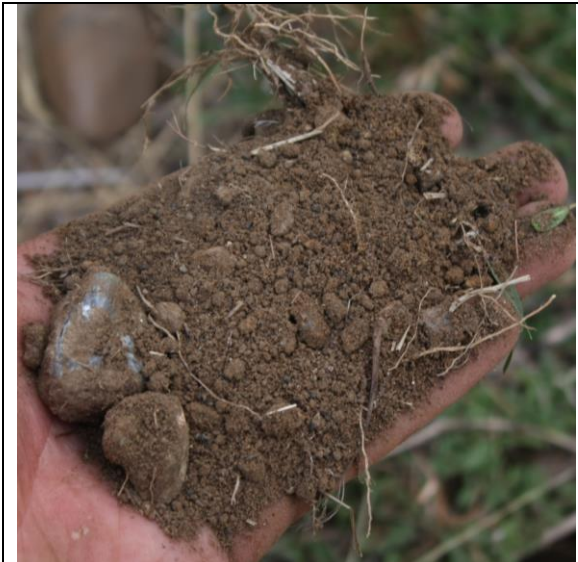
<p>Soil sample taken in the upper zone of the river bank.</p> <p>A grey matrix and mottling is clearly absent and wetland conditions are not present. A high silt content does indicate it still forming part of the floodplain.</p>
