HERITAGE IMPACT ASSESSMENT FOR THE PROPOSED CONSTRUCTION OF A FILLING STATION AND ASSOCIATED INFRASTRUCTURE ON A PORTION OF FARM 312, PAMPIERSTAD, SITUATED NORTH OF THE MR933 ROAD BETWEEN THE SETTLEMENTS OF PAMPIERSTAD AND HARTSWATER, NORTHERN CAPE PROVINCE

May 2023

Report Version	Version 1 Final Report		
Title	Phase 1 Heritage Impact Assessment report for the proposed Multi land-use development (filling station, truck stop, and associated infrastructure) on a portion of Farm 312, Pampierstad, situated north of the MR933 road between the settlements of Pampierstad and Hartswater, Northern Cape Province		
Author	Loudine Philip		22 May 2023

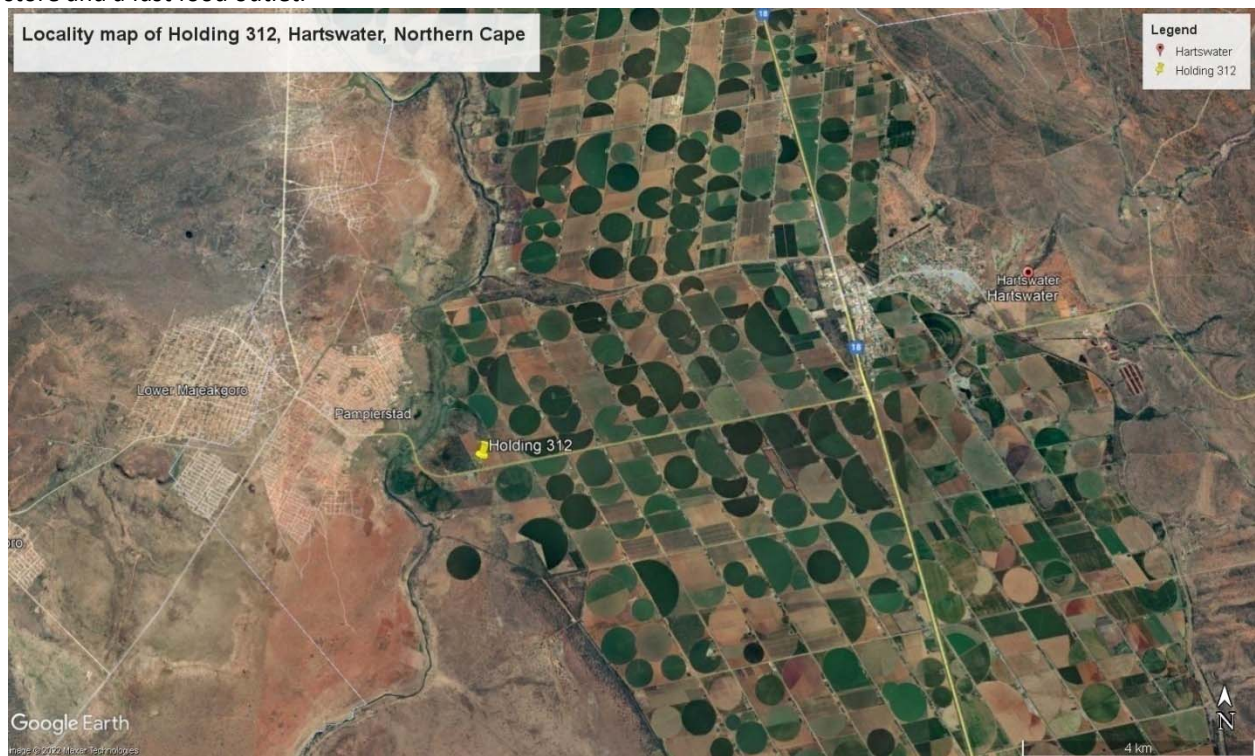
Figure 1: Proposed new development location (holding 312) in the agricultural area in relation to the towns Pampierstad (west) and Hartswater (east).

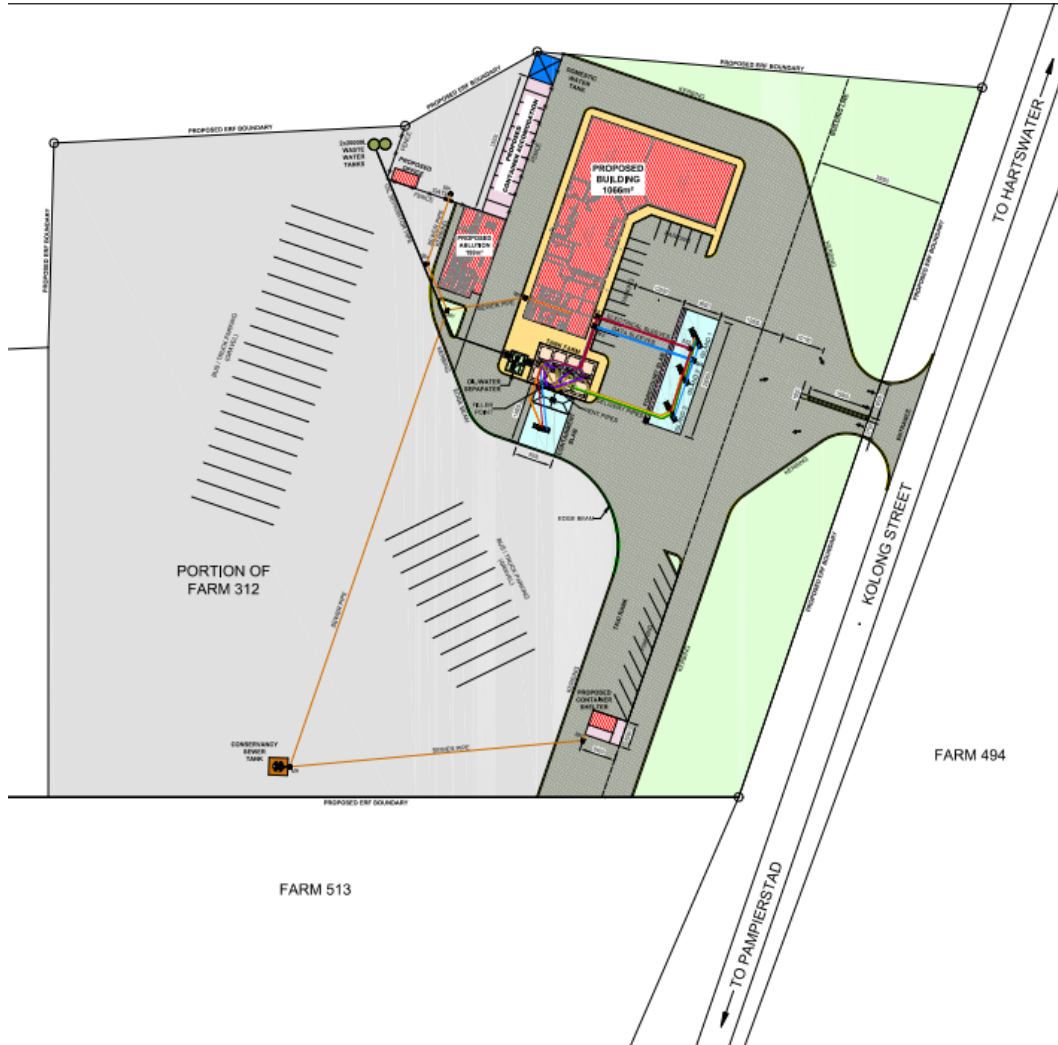
Figure 2: Preliminary layout of the proposed development. Refer to the uploaded document for a full-scale site development plan

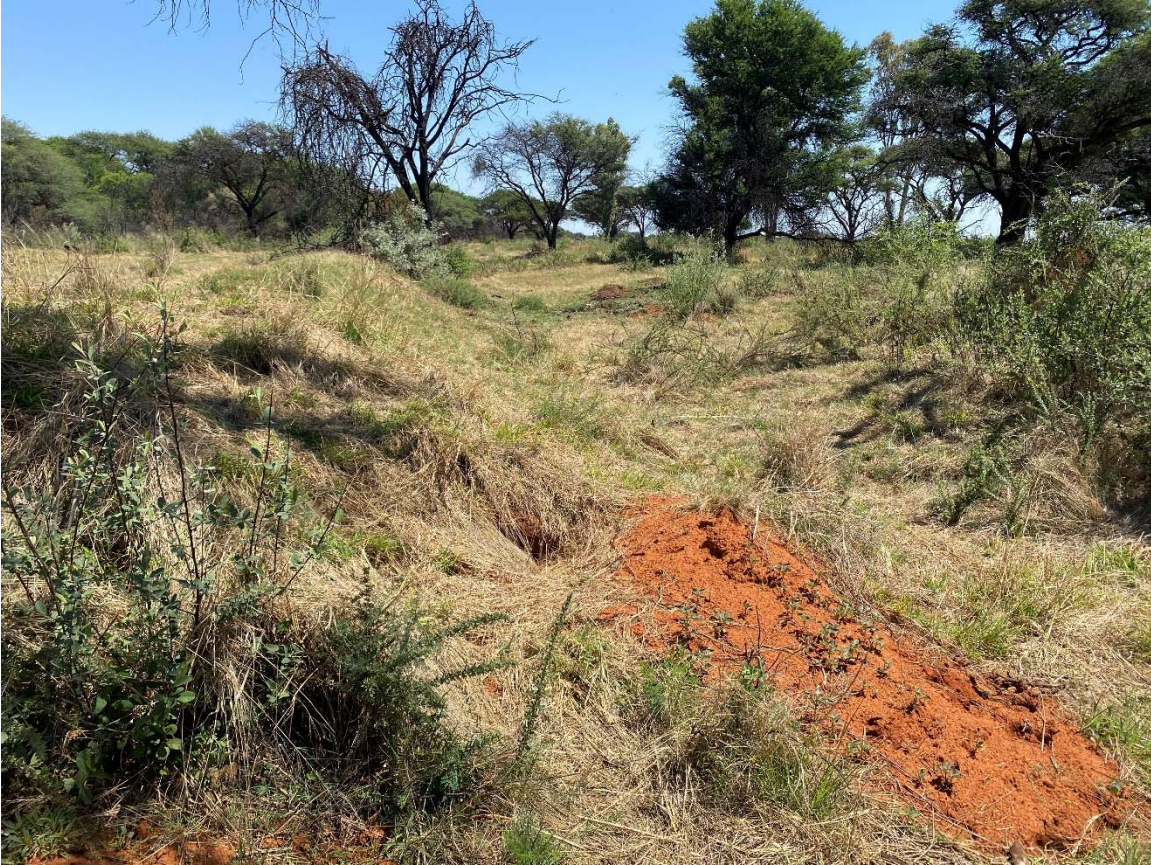
Figure 6: Older dumps (left) cover with dense vegetation. Relatively recent soil dump on the right.

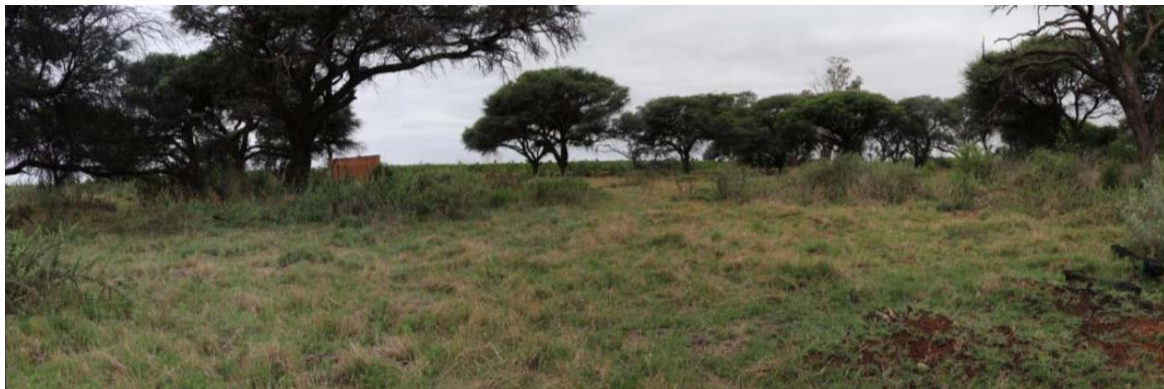
Figure 7: Panorama of the site which indicates a well-developed, but modified grass layer, a largely absent shrub layer and tree layer with several large specimens of protected Camel Thorn (*Vachelliaerioloba*) Photograph credit: Darius van Rensburg.

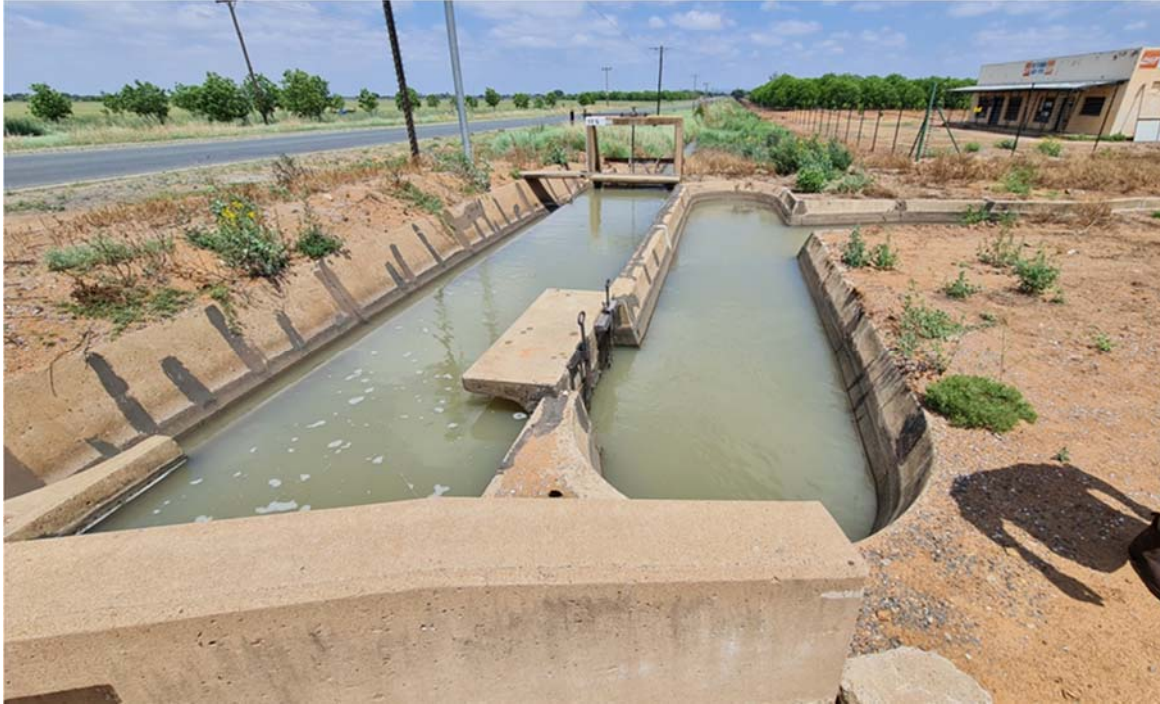
Figure 8: Example of a lot's feeding dam from a secondary canal

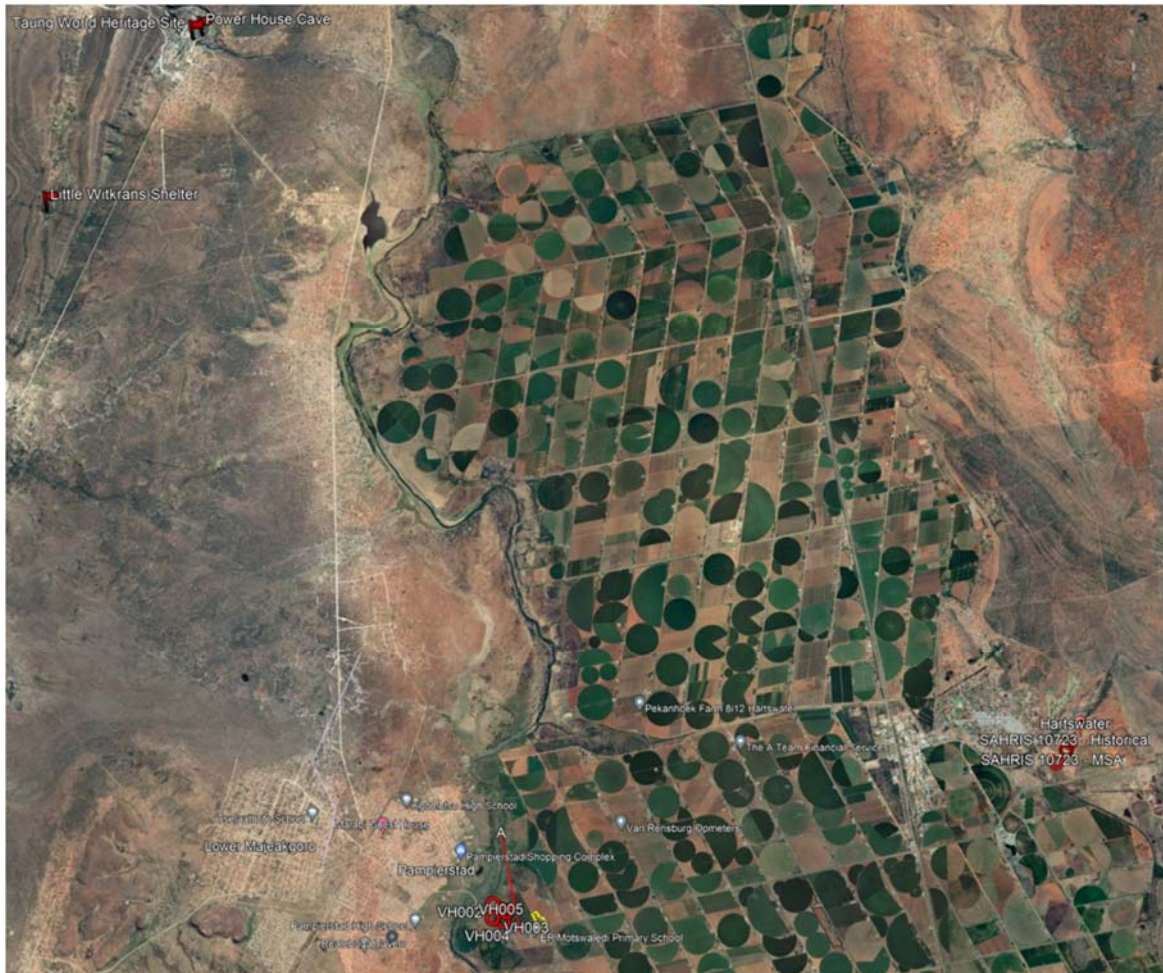
Figure 10: Relevant important sites marked with red flags, other finds in close proximity of the subject area marked with red circles

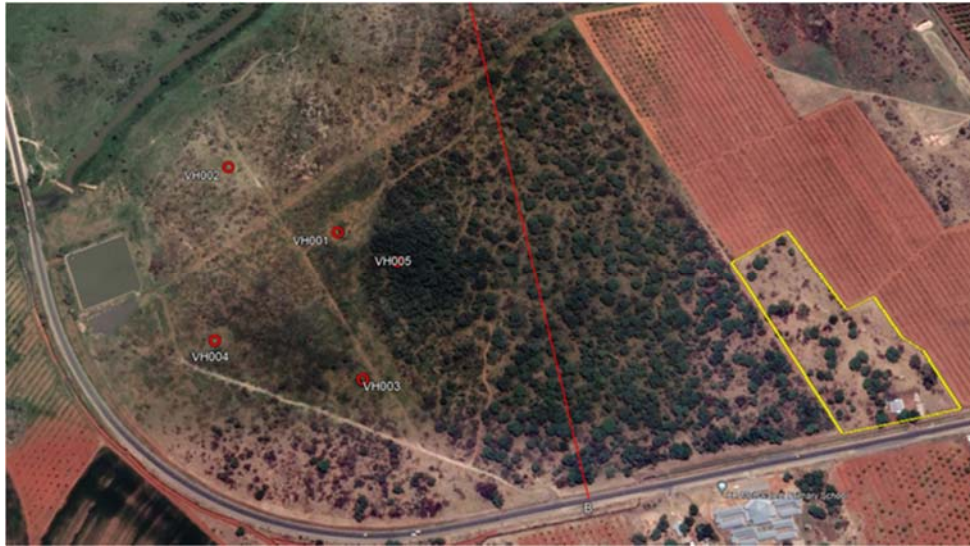
No SAHRIS CaseID: On the section bordering the western boundary of the subject property (yellow outlined), Erf 1, McGregor Contract Units (2005) identified four LSA sites marked as VH001 to VH004 and one historic site at VH005 (Refer to positions marked on the Google Earth in Image 9 below). Of importance are the following:

- 1) The historical structure VH001 was identified as the remains of a housing compound foundation dating to the 1970s for labourers working on the current tarmac road.
- 2) The depth of the exposed LSA deposits in old quarry pits varies between 0.4 and 2.5 m with part of the deposits visible on the surface level between VH001 AND VH004.

- 3) The area investigated falls west of the line A-B (see image below) and all sites are approximately within 500 m from the Harts River.

Figure 11: Proposed development area outlined in yellow (nearest fine is 550 m from subject site)

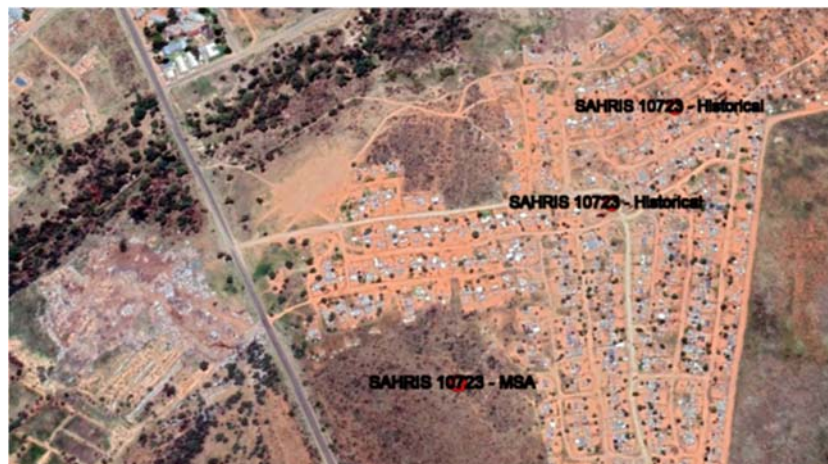
SAHRA CaseID 10723: (10.5 km North-east of the subject area.) In the proposed development area for the Nkandla Extension 2 Township Establishment development on the eastern side of Hartswater, N Kruger 9201 located a few MSA stone implements during his field investigation of the area. This appears to have been found on an unbuilt raised section within the proposed development area.

Figure 12: The finding place of the MSA stool implements are on an elevated unbuilt section of the study area

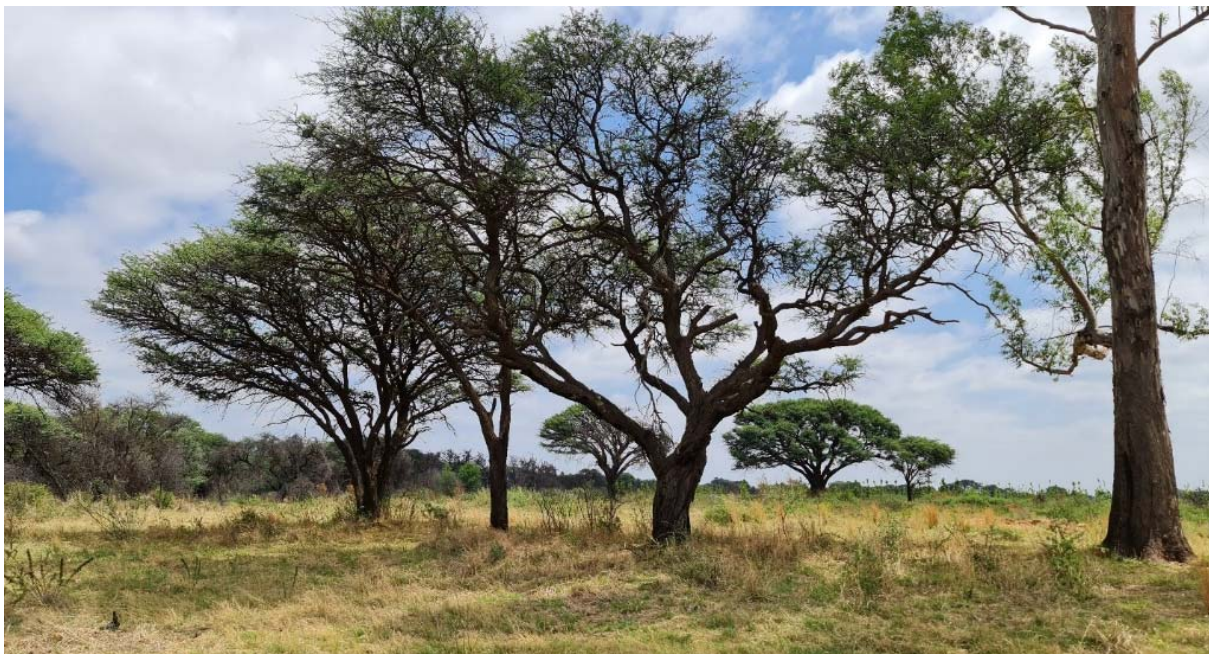
Figure 13: Density of grass at ground level close to the farmstead. This is similar over the majority of the development area with the exception of the enclosed area around the house which has been cleared of all vegetation.

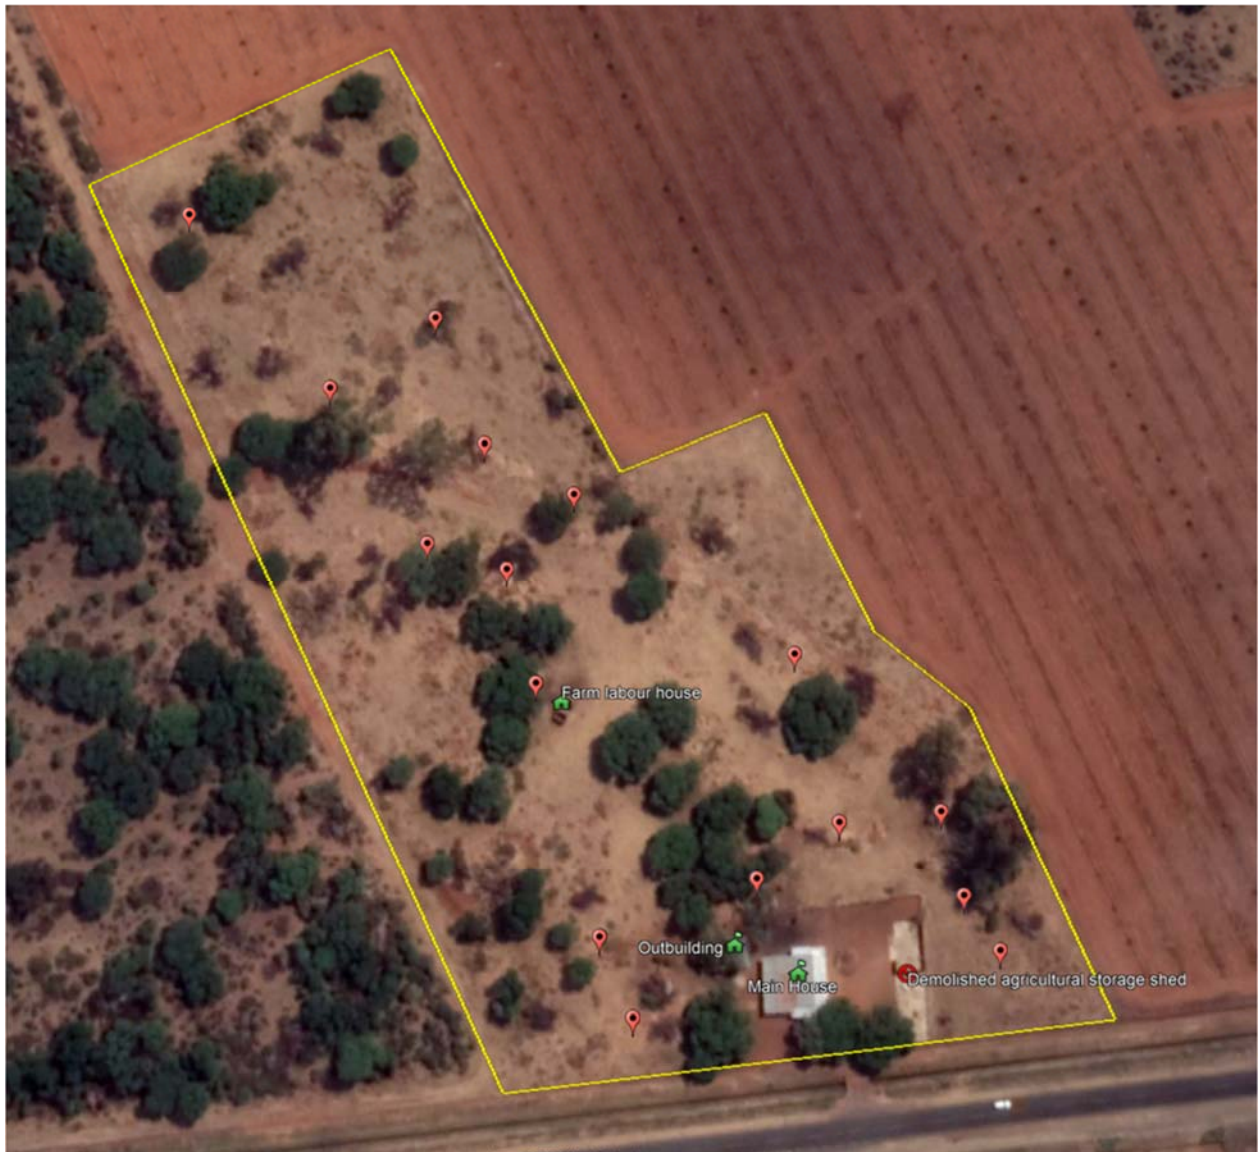
Figure 14: red balloons = dumping sites (building rubble, heaps of stones cleared from the surface areas, and mounds of soil); 3 existing buildings and the foundation of one two-roomed large agricultural storage shed:

Coordinates for dumping sites (concrete building rubble or heaps of stones of various sizes) Indicated with red balloon on Google Earth image below:	
27° 47.288'S; 24° 42.975'E	27° 47.315'S; 24° 43.004'E
27° 47.302'S; 27° 47.302'S	27° 47.322'S; 24° 43.033'E
27° 47.339'S; 24° 43.024'E	27° 47.329'S; 24° 43.050'E
27° 47.342'S; 24° 43.039'E	27° 47.360'S; 24° 43.046'E
27° 47.352'S; 24° 43.092'E	27° 47.375'S; 24° 43.120'E
27° 47.388'S; 24° 43.125'E	27° 47.396'S; 24° 43.132'E
27° 47.411'S; 24° 43.068'E	27° 47.399'S; 24° 43.061'E
27° 47.378'S; 24° 43.102'E	27° 47.388'S; 24° 43.088'E
Coordinates for buildings & windmill pump:	
Main House	27° 47.400'S; 24° 43.096'E
Outbuilding	27° 47.397'S; 24° 43.085'E
Labour House	27° 47.361'S; 24° 43.051'E
Demolished shed	27° 47.398'S; 24° 43.116'E
'Vintage' pump	27° 47.380'S; 24° 43.119'E

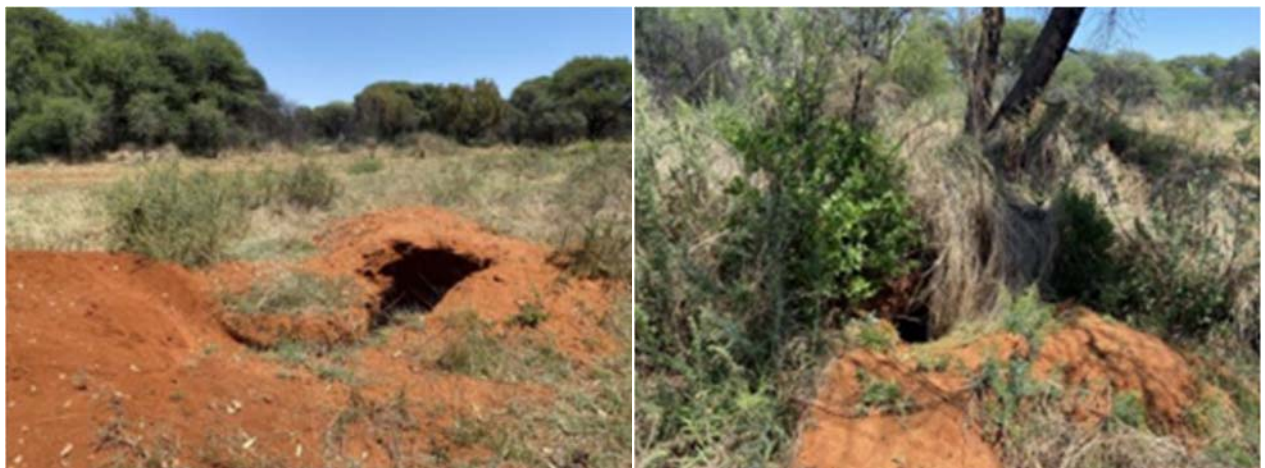
None of the animal burrows exposed any cultural material in the excavated soil.

Figure 15: Animal burrows

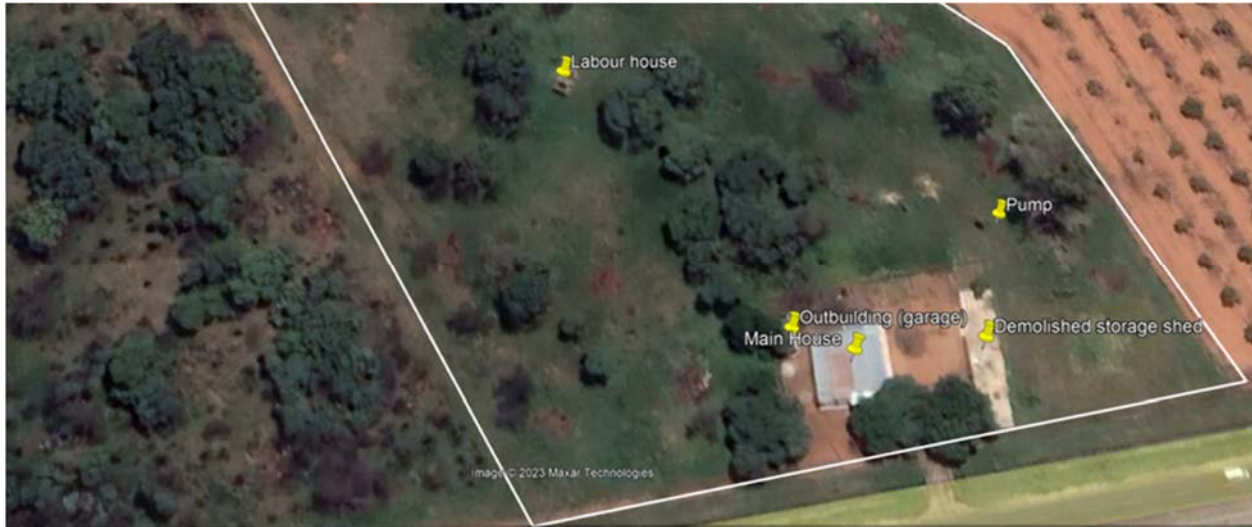
Figure 16: Areal view of the position of the built environment structures as well as the 'vintage' pump

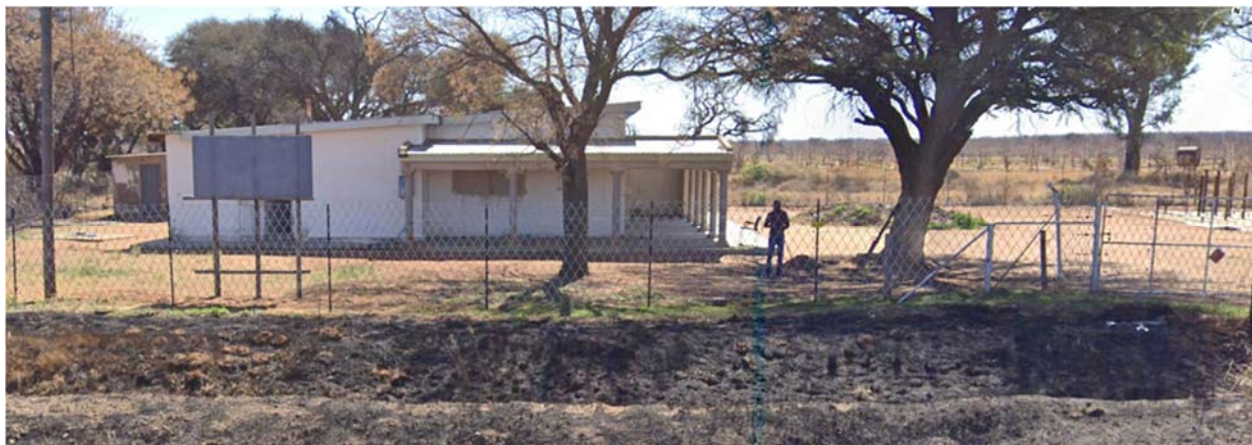
Figure 17: Southern facade of the main building - view from Kolong Street. Recent additions are the verandah on the right-hand side which continues along the eastern and western side. Orientation of picture is south to north.

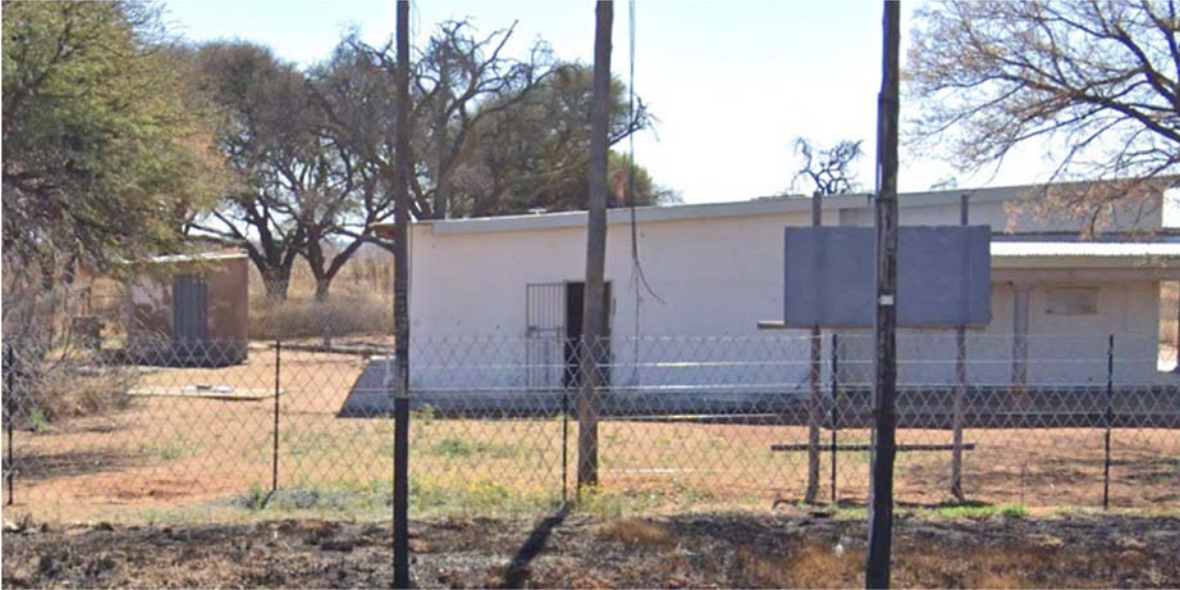
Figure 18: Small outbuilding on the western side of the main house – the windows on the right side of the main building were recently closed-up with bricks.

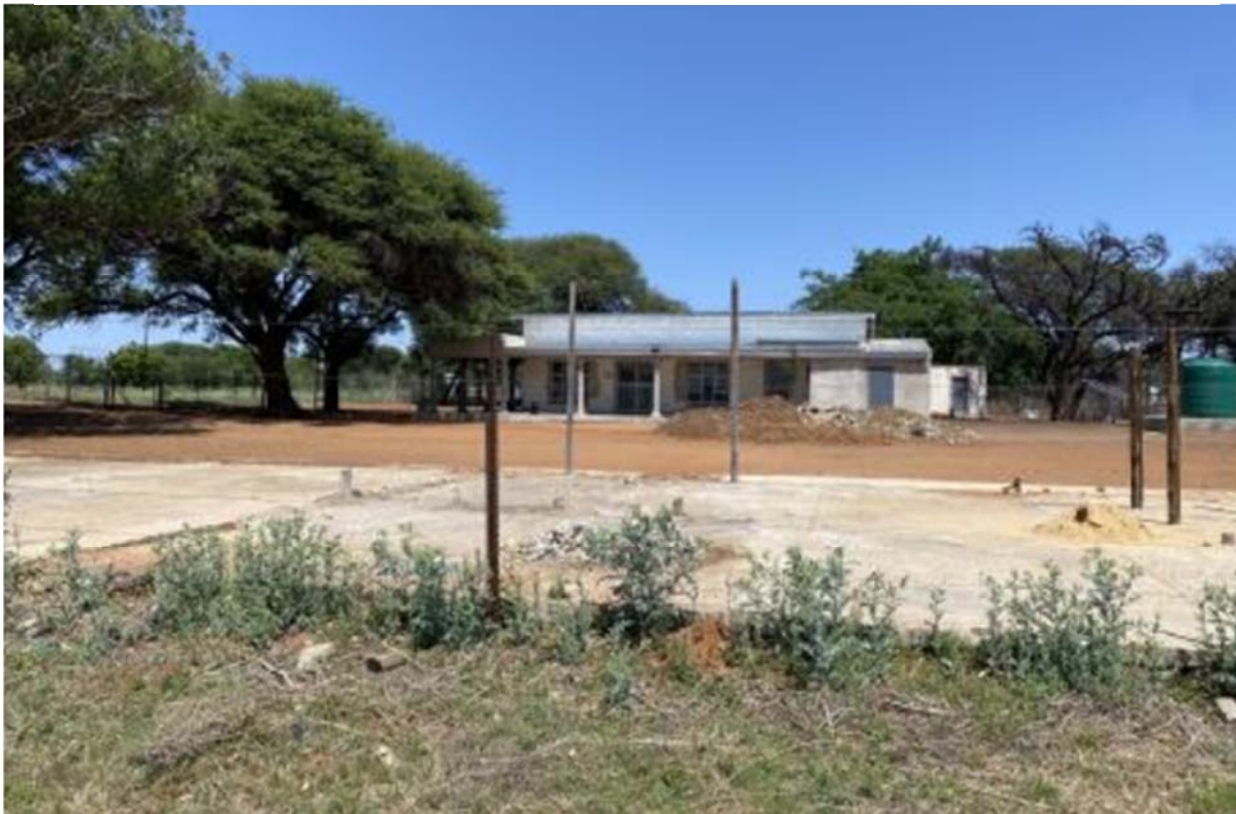
Figure 19: Eastern (and entrance side) façade of the farmhouse. Floor area of the demolished shed in the foreground. Note the dense vegetation at the bottom of the picture which is situated outside the cleared and fenced-in area. Building rubble of recent alterations to the house is visible in front of the house.

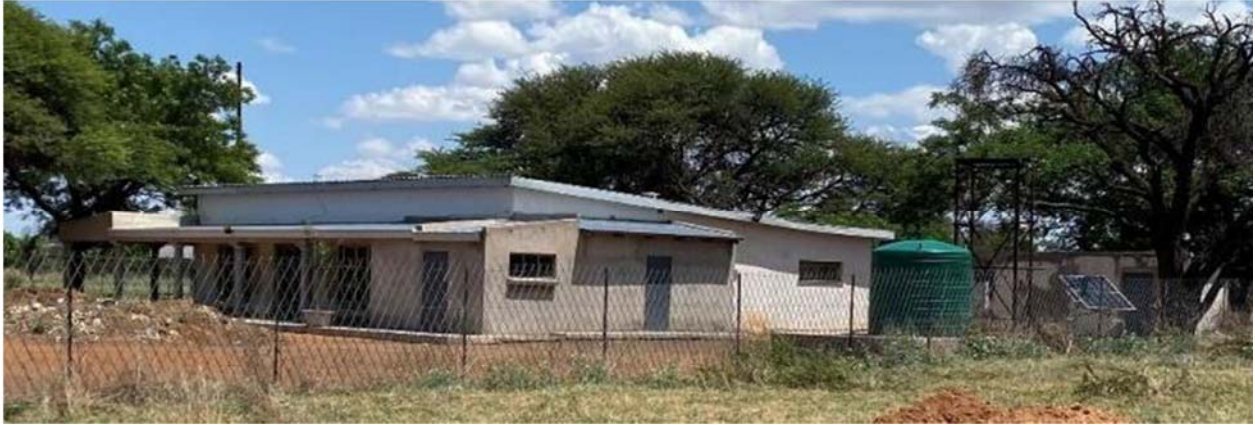
Figure 20: Eastern (left) and northern (right) facades of the main house showing recent additions of the verandah as well as the enclosed area at the northeastern corner.

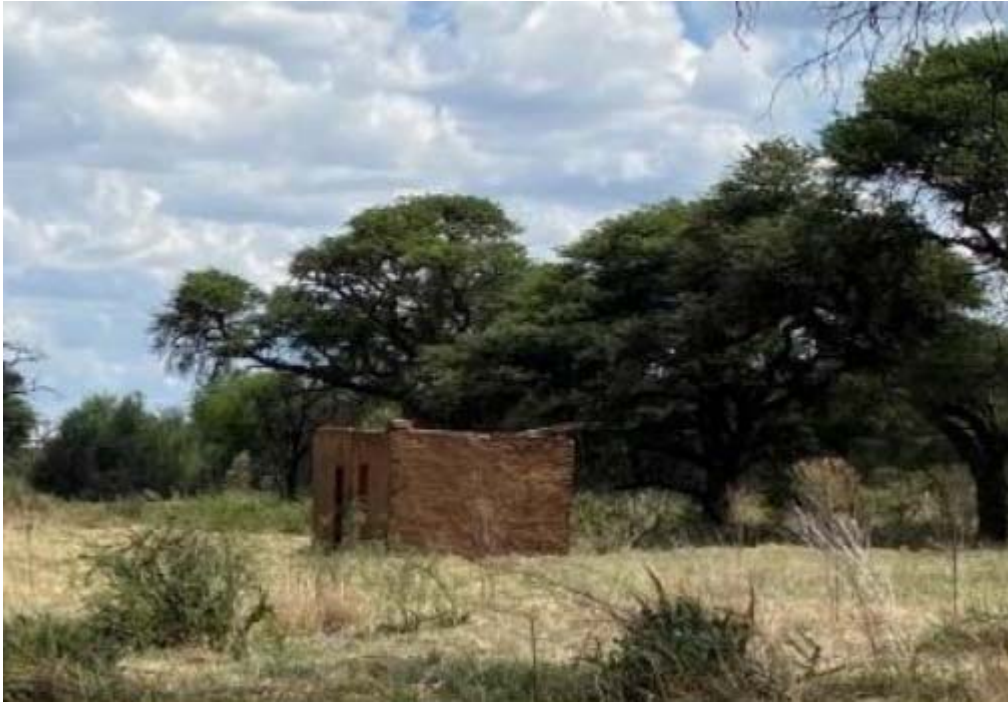
Figure 21: Labourer's house is a simple one-room flat-roofed structure of 5.5 X 4.5 m with a door and one window at its entrance facing north-west, situated approximately 9.5 m north-west of the main building.

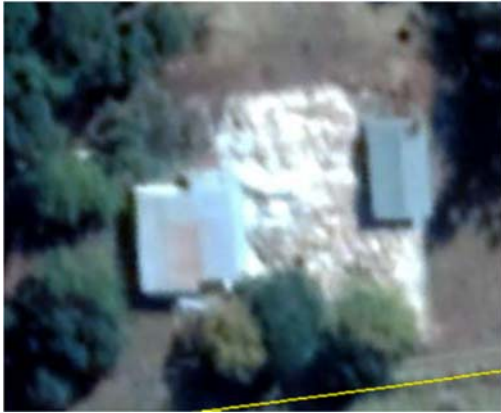
Figure 22: Google Earth image dating to June 2017.

The large number of small dumps of building material (mainly concrete slabs) could have come from this as a June 2017 Google image (see Figure 22 below) show the farmyard littered with what appears to be building material and the southern section of the shed demolished. In the 2016 Google image the shed is still intact and the farmyard clear although with considerably more trees on the entire development area (the natural landscape

reflects the natural area on the western side, including the presence of shrubs – in particularly on the southern third of the subject area and the area east of the farm road that cuts through the property on the eastern side - than in the 2022 Google images. This might indicate a post-1916 site clearance of the entire farm 312.

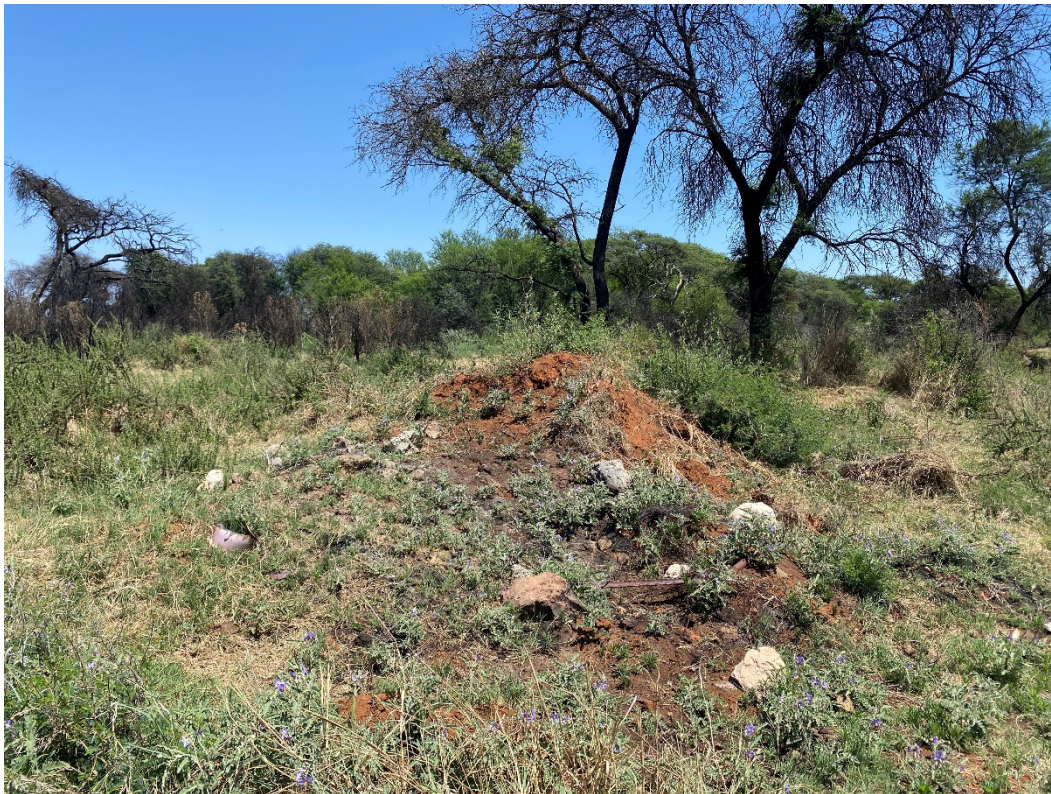
Figure 23: Dump containing soil and calcrete boulders

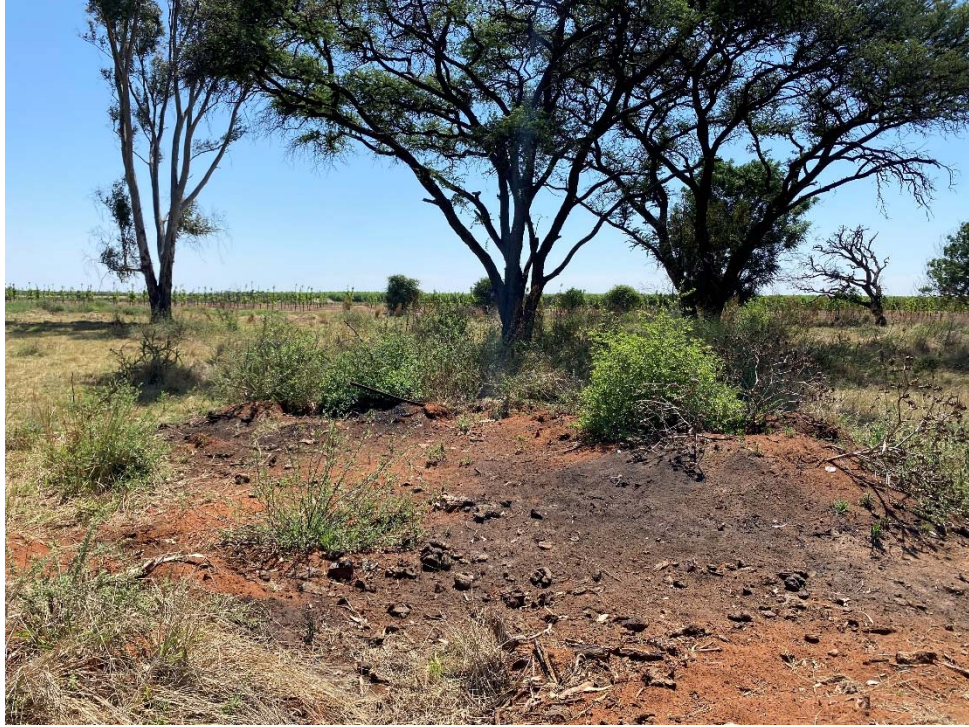
Figure 24: Soil dump with an ashy top layer

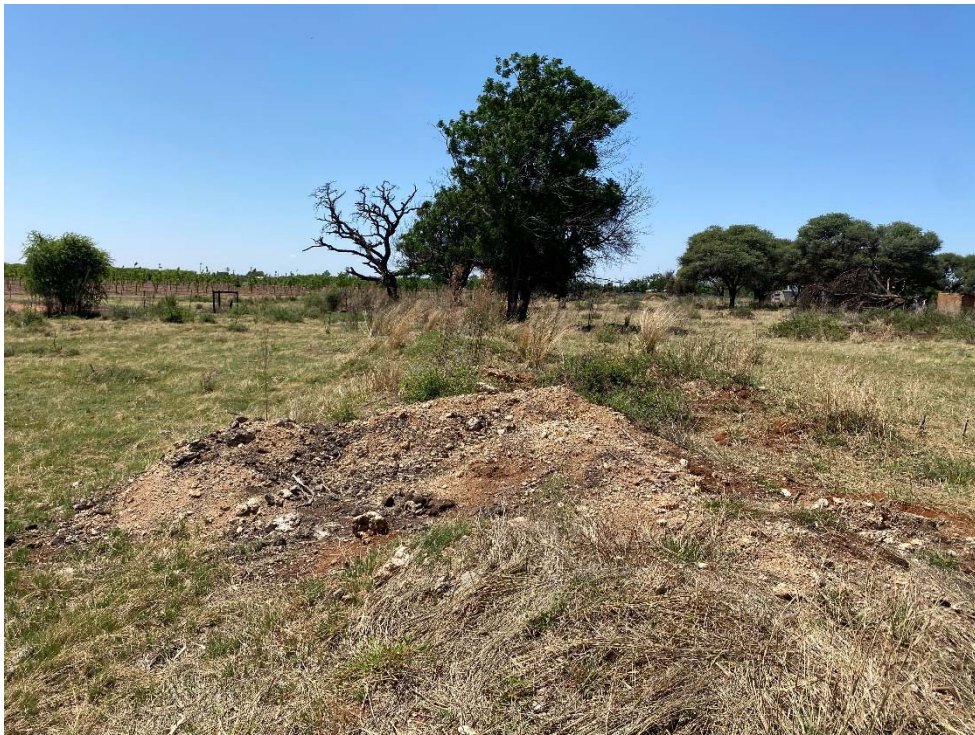
Figure 25: Building rubble

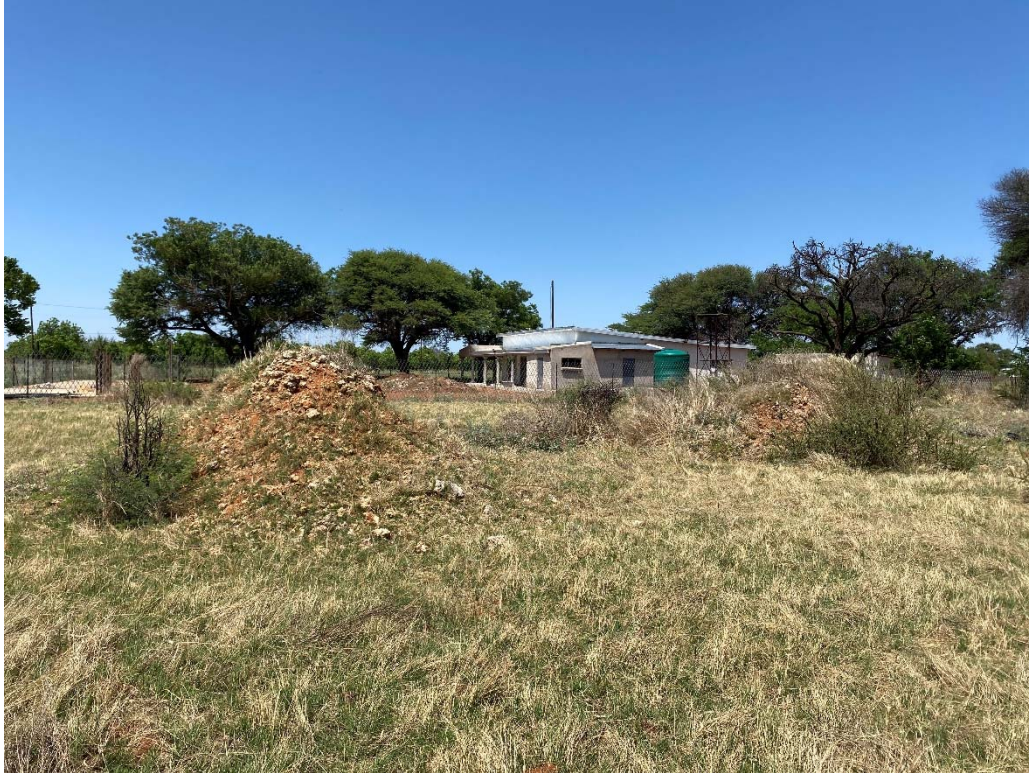
Figure 26: Two building rubble and soil dumps close to main house

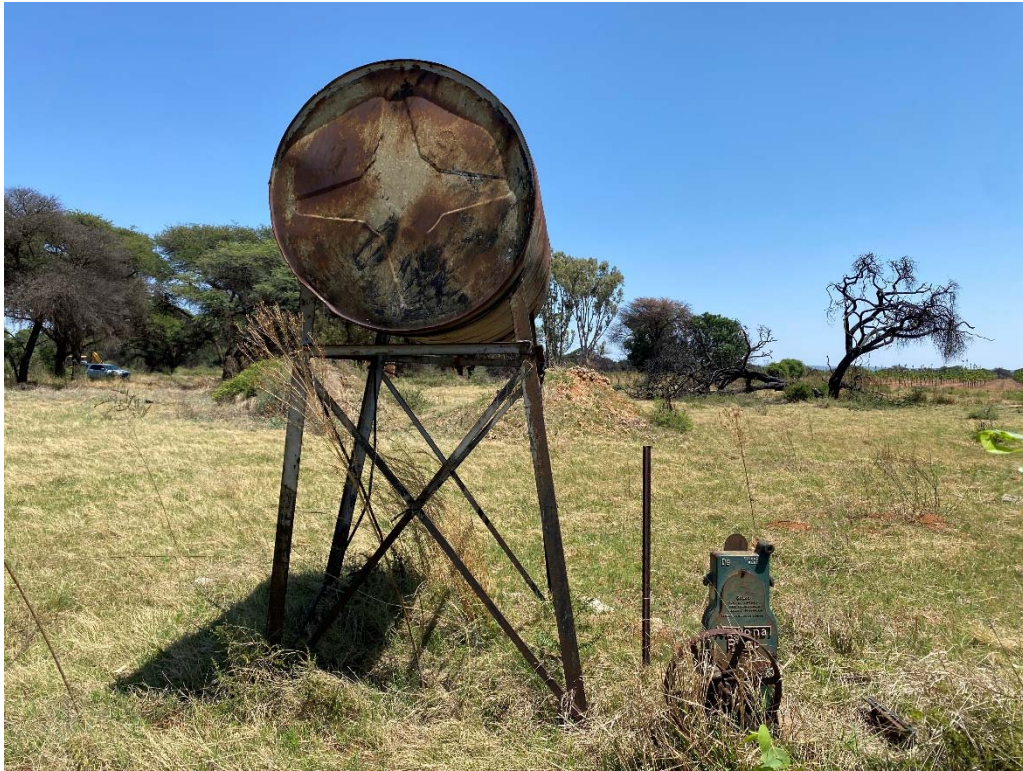
It's position close to the demolished shed, could indicate that at least some portion of the shed was used for farm such as tractors that would require fuel.

Figure 27: Fuel tank at pump

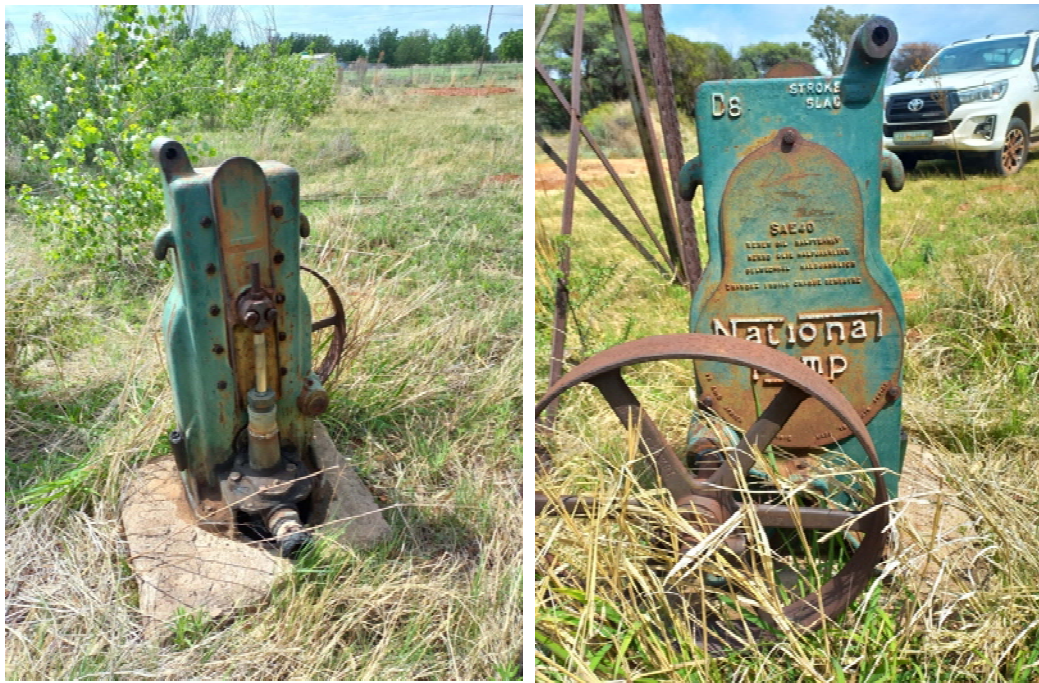
Figure 28: Close-up views back and front of the pump

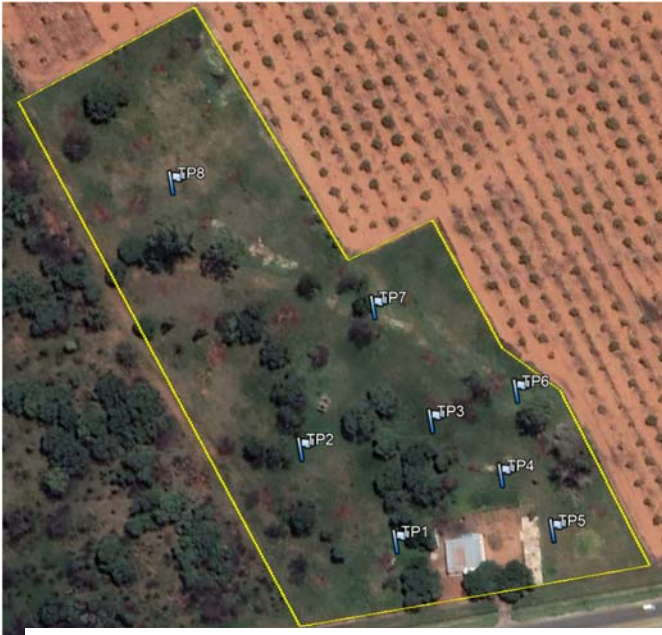
Figure 29: Positions of geotechnical test pits marked TP1 - TP8

The surface of the excavated soil from all eight geotechnical test pits were inspected and no cultural material was detected. As far as could be seen, also no visible artefacts in the walls of the excavated pits.

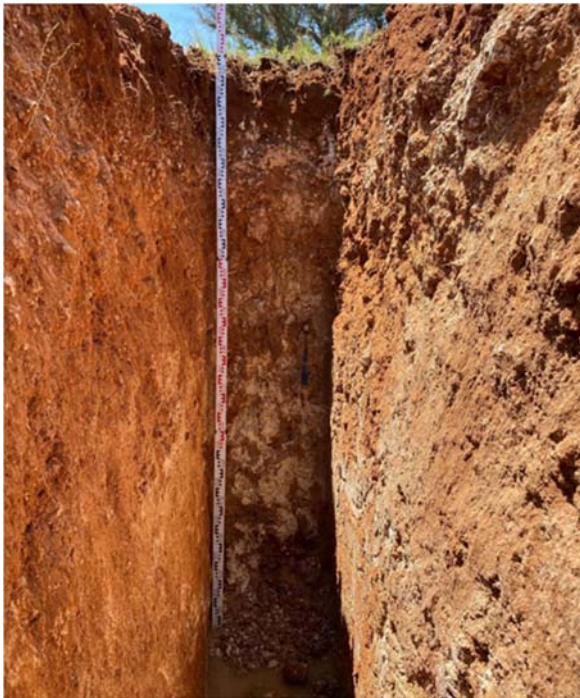
A comparison of TP4 on the southern side of the property and TP8 on the northern side demonstrate the change in soil composition over the proposed development area

Figure 30: Walls of TP4

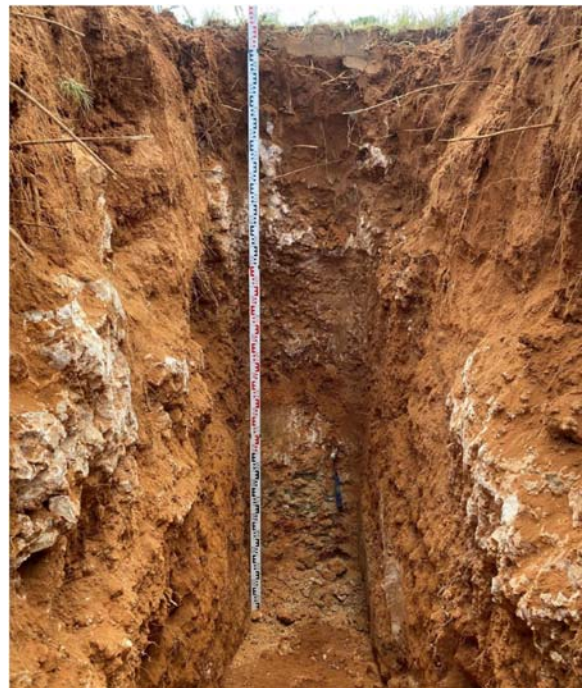
Figure 31: Walls of TP8

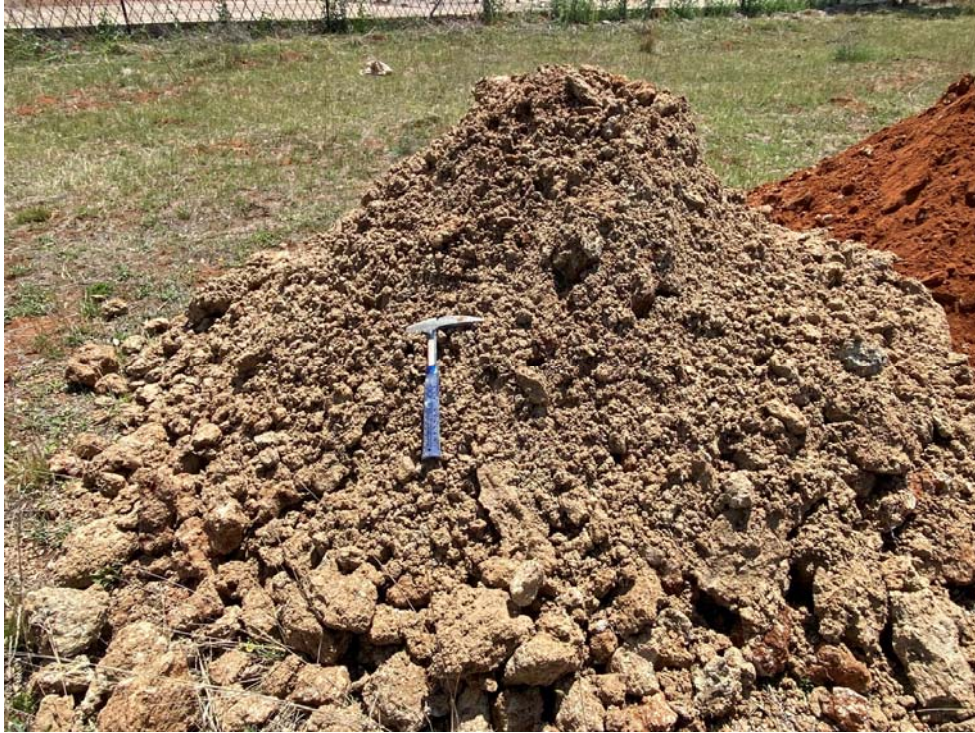
Figure 32: Calcified soil and clusters in foreground with Aeolian sand in background (from TP4)

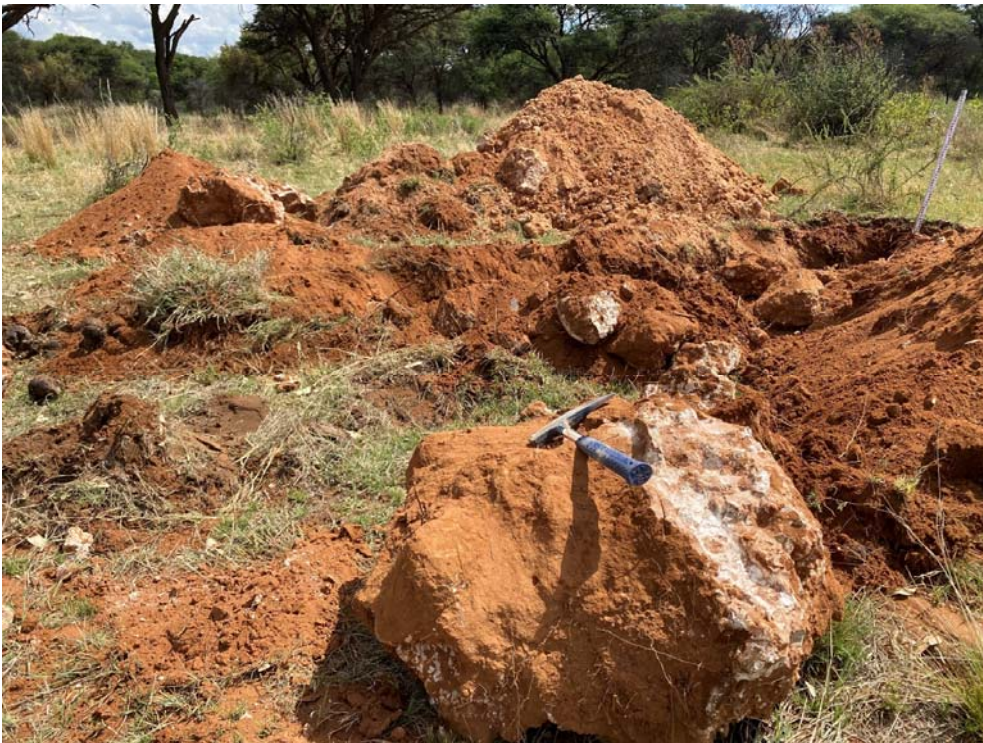
Figure 33: Concretionary Calcrete (from TP8)
