ARCHAEOLOGICAL IMPACT ASSESSMENT OF TWO BORROW PITS ALONG THE NATIONAL ROUTE 1 NEAR TROPMSBURG, FREE STATE

ACTIVE HERITAGE cc.

For: SRK

6 July 2014

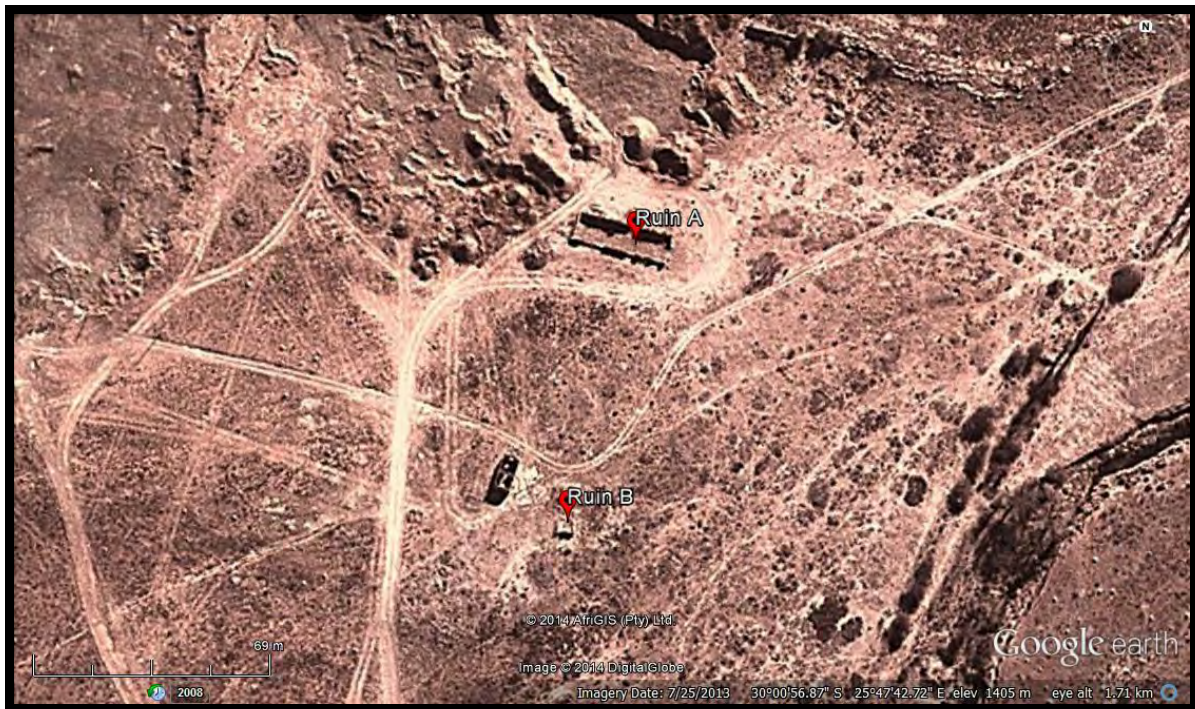
Two ruins occur outside of the footprint in the near vicinity of Borrow Pit A. A short description of each follows below:

Figure 4. Ruins A and B situated in the near vicinity of Municipal Borrow Pit A. However, none of these ruins are situated less than 40m from the footprint.

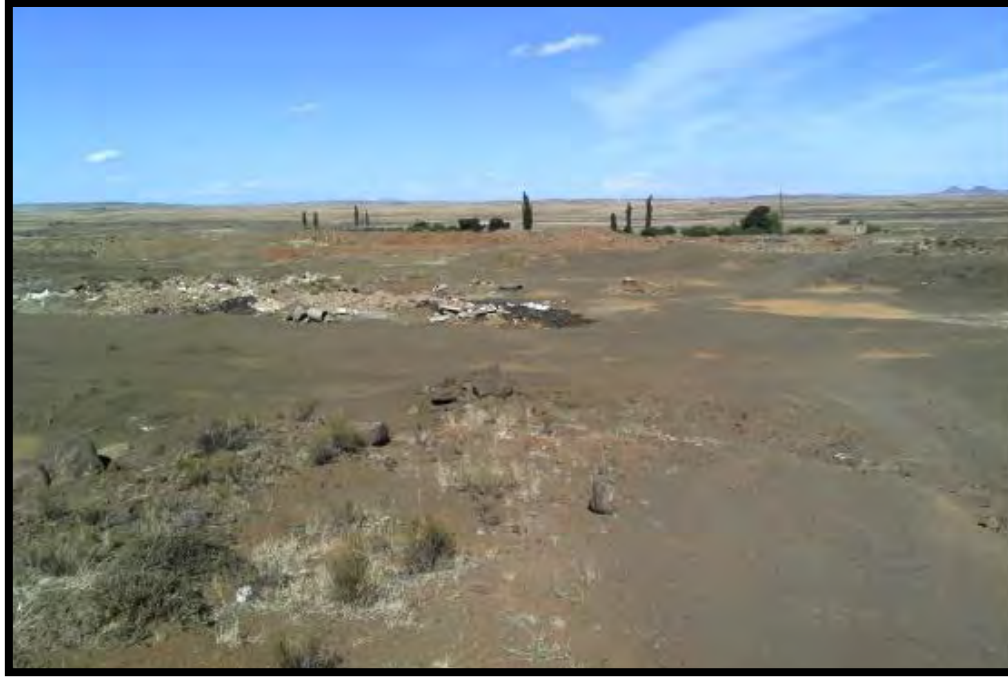
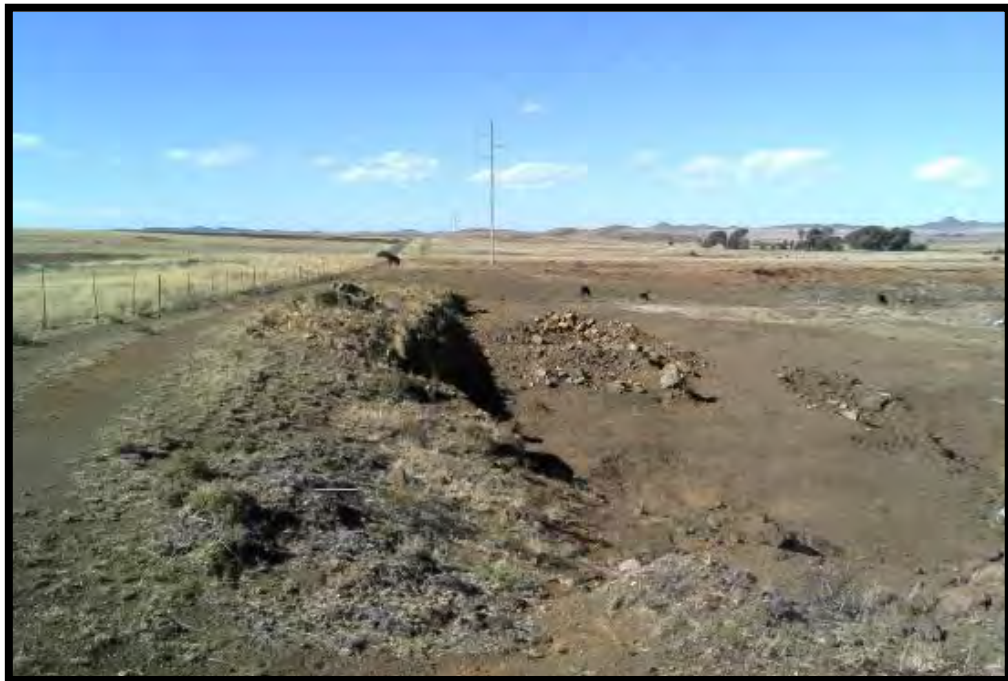
No archaeological or cultural heritage sites, as defined and protected under the NHRA 1999, were identified on the surface or within exposed sub-surface sections at this site. Exposed sections varied greatly in depth, ranging from 1- 2 m high across the widely utilised site. However, the site has been disturbed to such an extent that no cultural heritage sites or artefacts would have remained in situ (Figs 5 & 6).

Figure 6. View over Municipal Borrow Pit A

Figure 7. View over Municipal Borrow Pit A

It is recommended that the establishment of Municipal Borrow Pit A and Municipal Borrow Pit B proceed as applied for without the developer having to comply with additional compliance requirements. There is no archaeological reason why the proposed development may not take place on the footprint as planned. However, care must be taken not to damage or compromise Ruins A and B that are situated in the near vicinity of Borrow Pit A. A buffer of 25m must be strictly maintained around each Borrow Pit. It must also be pointed out that the South Africa Natal Heritage Act requires that operations exposing archaeological and historical residues should cease immediately pending an evaluation by the heritage authorities.

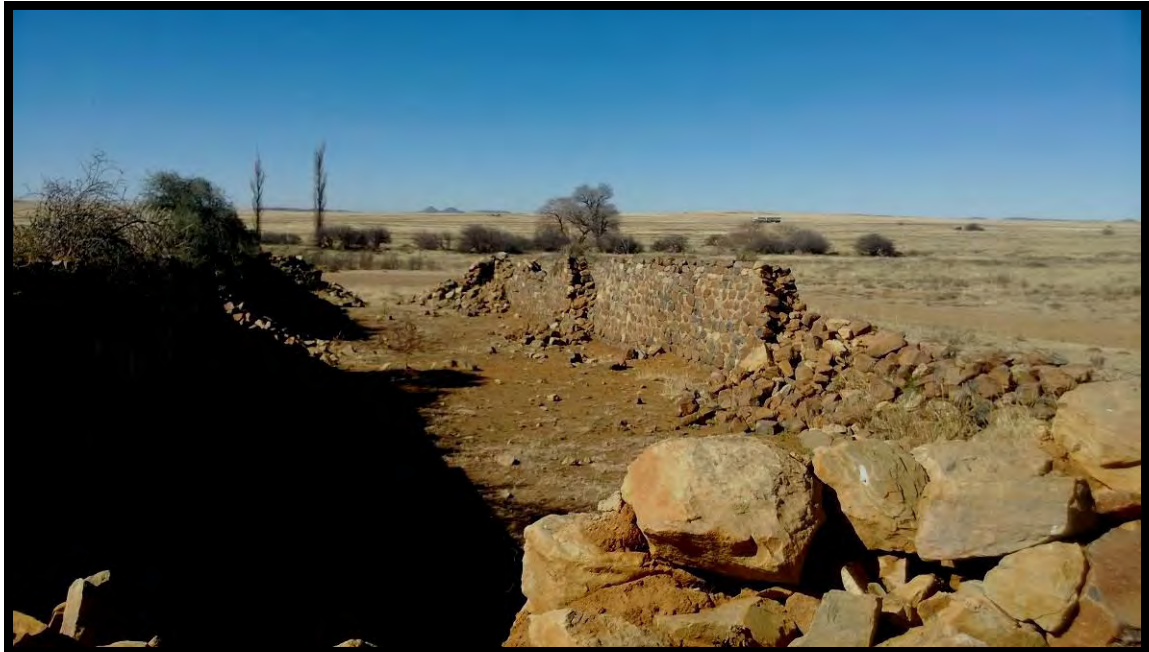
The first ruin, also called Ruin A, is a large rectangular enclosure measuring 30m x 10m (Figs 4 & 8). The GPS coordinates of the structure is: S 30° 00' 56.47" E 25° 47' 41.07". Portions of the wall has collapsed and the structure is dysfunctional. It most probably served as an enclosure for livestock in the past. The structure appears to be older than 60 years old.

Figure 8. Ruin A situated approximately 40m from the edge of Borrow Pit A.

The structure is rated as having medium heritage significance (Table 2). The site is protected by National Heritage Legislation and may not be damaged or altered without a permit issued by SAHRA. The developer is urged to maintain a buffer of 25m around this site. Should the developer wish to expand the Borrow Pit operations into this area

then a second phase heritage impact assessment, by a built heritage specialist, is called for. Applications for a permit to demolish or alter a portion of the structure would be an integral component of this second phase.

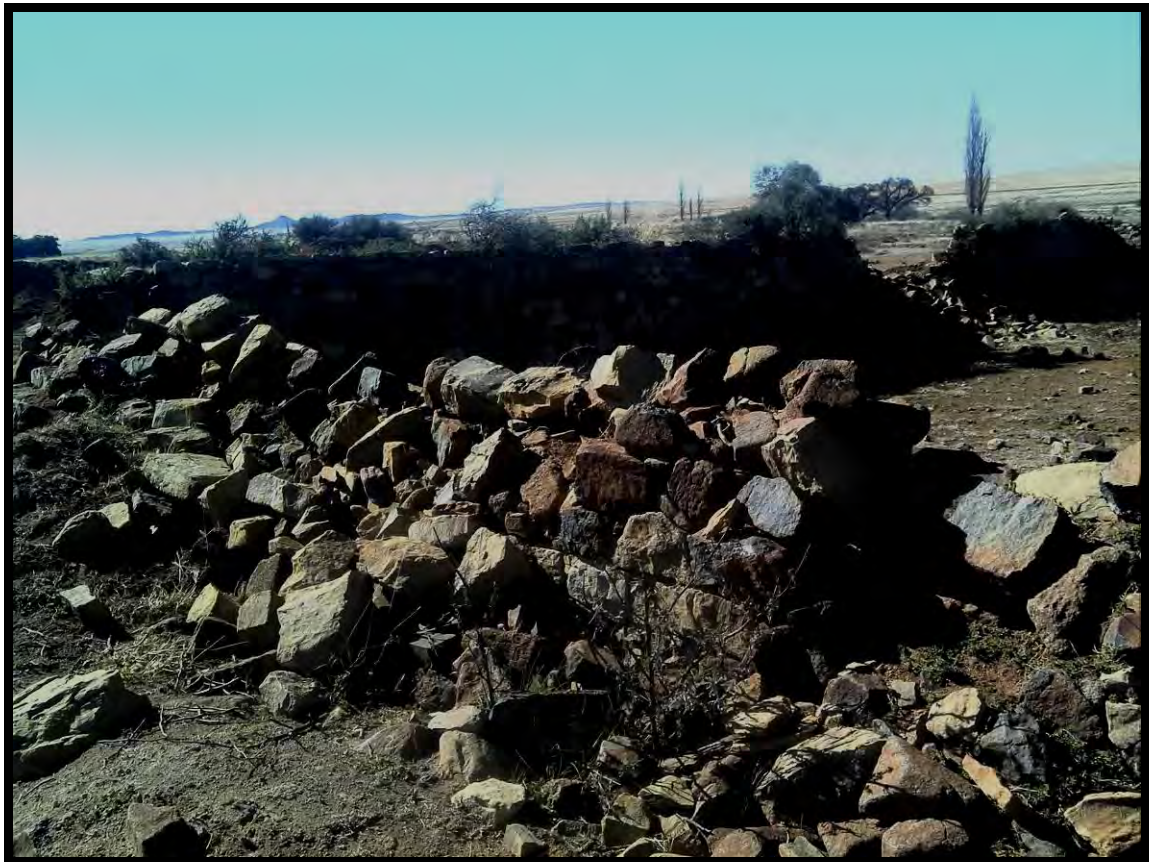
The second ruin, also called Ruin B, is a square enclosure measuring approximately 5m X 5m (Figs 4 & 9). The GPS coordinates of the structure is: S 30° 0' 58.46" E 25° 47' 42.45". The structure is dysfunctional as portions of its wall has collapsed. It most probably served as an enclosure for livestock in the past. The structure appears to be older than 60 years old.

Figure 9. Ruin B situated approximately 55m from the edge of Borrow Pit A.

The structure is rated as having medium heritage significance (Table 2). The site is protected by National Heritage Legislation and may not be damaged or altered without a permit issued by SAHRA. The developer is urged to maintain a buffer of 25m around this site. Should the developer wish to expand the Borrow Pit operations into this area then a second phase heritage impact assessment, by a built heritage specialist, is called for. Applications for a permit to demolish or alter a portion of the structure would be an integral component of this second phase.

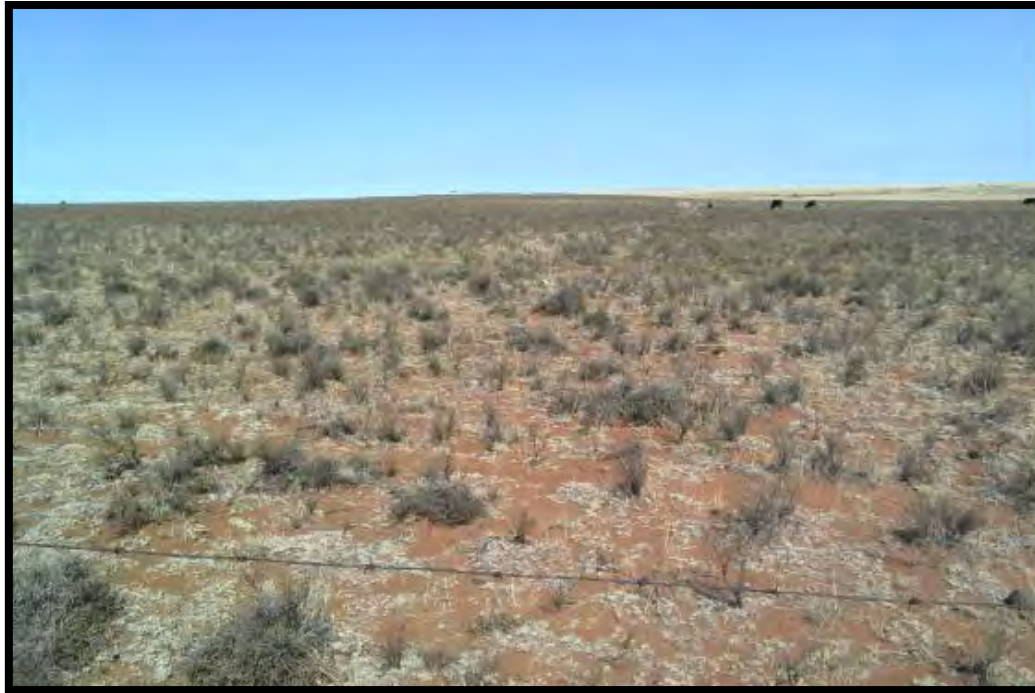
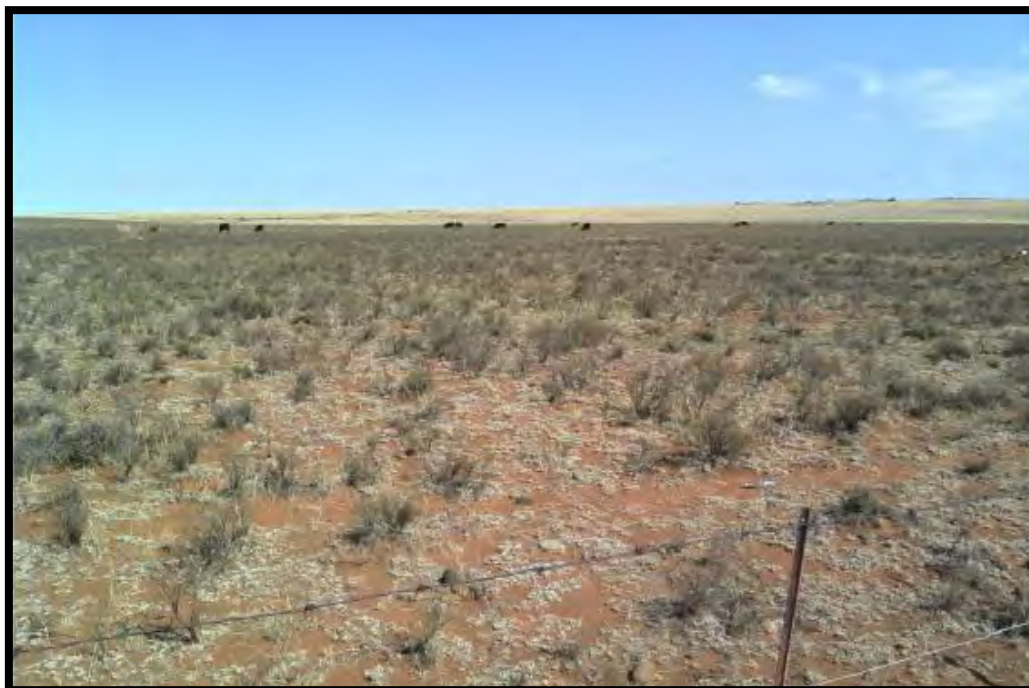
No archaeological or cultural heritage sites, as defined and protected under the NHRA 1999, were identified on the surface of this proposed Borrow Pit. The area has been used for grazing in the past and no features are visible (Figs 10 & 11).

Figure 10. View over proposed site for Municipal Borrow Pit B.

Figure 11. View over proposed site for Municipal Borrow Pit B.
