MEERRUST ESTATE: SIMONDIUM

HERITAGE IMPACT ASSESSMENT

March 2003

AIKMAN ASSOCIATES
HERITAGE MANAGEMENT
18 LEY ROAD
ST JAMES
7945
Tel/Fax: (021) 788 3078

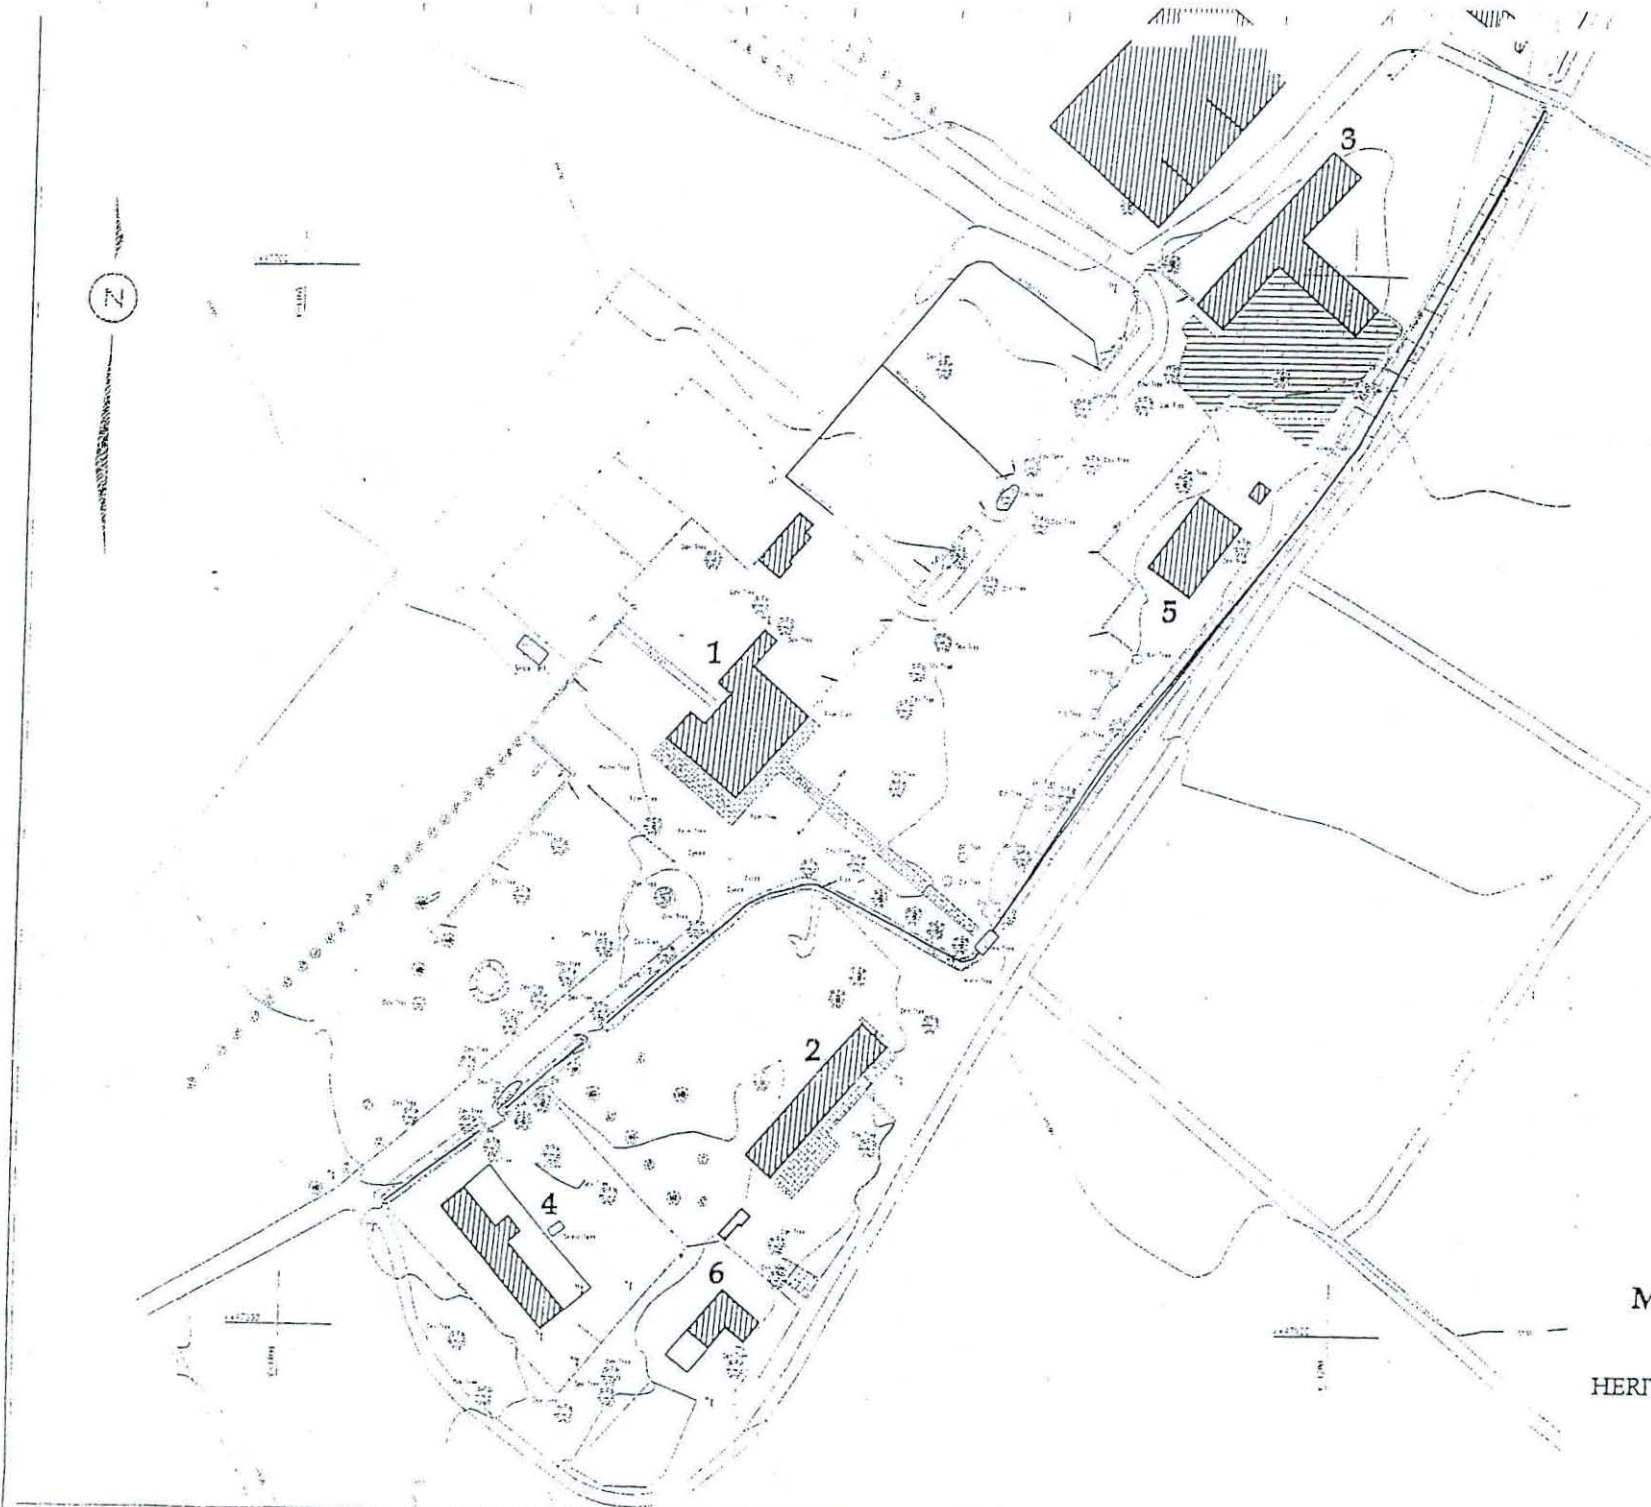
THE WERF

- 1. Manor House
- 2. Old Cellar
- 3. Administration Building
- 4. Gable House
- 5. Baker Cottage
- 6. Mill House
