HERITAGE IMPACT ASSESSMENT FOR A PROPOSED PHOTOVOLTAIC ENERGY PLANT ON THE FARM VOGELSTRUISBULT NEAR COPPERTON, NORTHERN CAPE

(Assessment conducted under Section 38 (8) of the
National Heritage Resources Act (No. 25 of 1999) as part of an EIA)

1st draft: 10 January 2012
Revised : 2nd February 2012

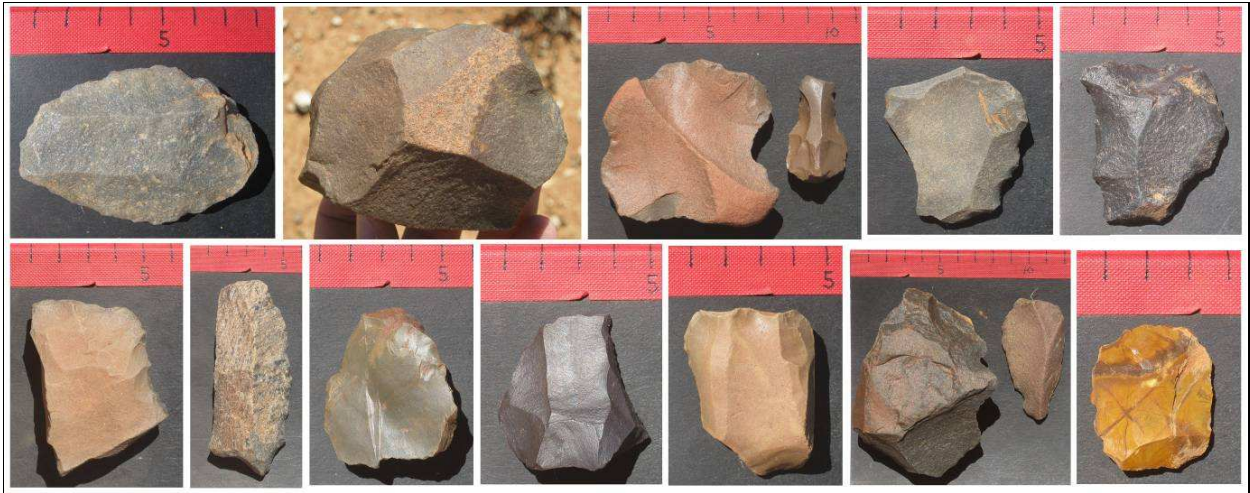
Artefacts were observed in low densities over much of the study area and Figure 8 shows a selection of these. Materials varied but quartzite was certainly most commonly encountered.

Figure 8: Selection of isolated artefacts from the background scatter on Vogelstruisbult showing the variability in materials and weathering states.

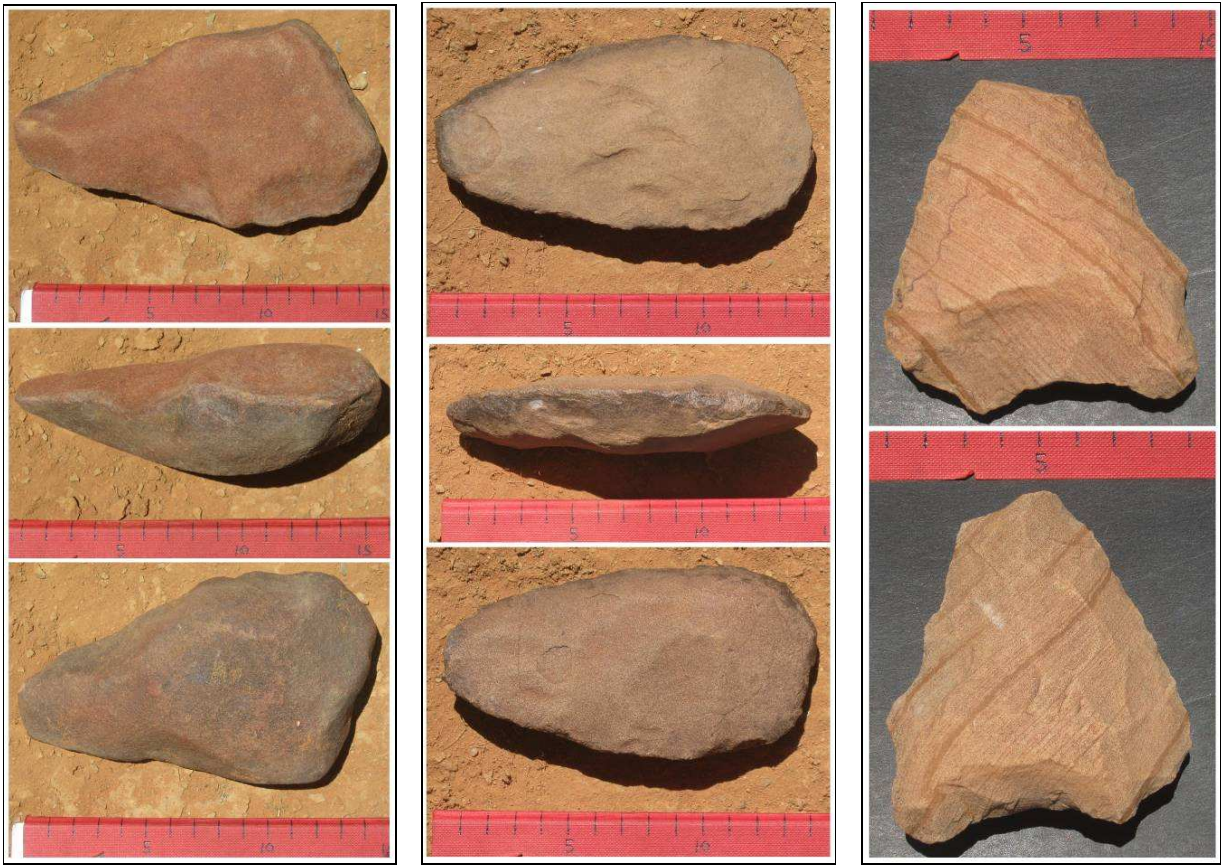
Among the background scatter were occasional hand-axes pertaining to the ESA. These were, without fail, heavily weathered testifying to the great length of time over which they have been exposed at the surface (Figures 15 & 16). One further bifacial artefact was rather different and might even represent a broken and reworked hand-axe (Figure 17). It is somewhat less weathered than the complete hand-axes.

Figure 15: Hand-axe from #074. **Figure 16:** Hand-axe from #R041. **Figure 17:** Bifacial artefact from #067.

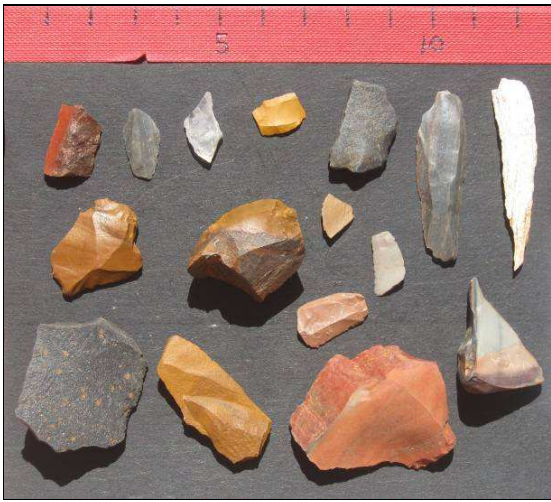
A number of LSA archaeological sites were found during the survey. These focus on the margins of the pans, particularly the larger one, Perdepan. Most were small and of limited importance. VSB2011/001 (found at points #049 & #050) is one such site where cryptocrystalline silica CCS, quartz and quartzite were found in a sandy area close to Perdepan. CCS was strongly dominant and one double-endscraper on this material was noted.

Figure 18: Artefacts from site VSB2011/001 (#049 & #050).

- VSB2011/001 (#049 – #050);
- VSB2011/002 (#056);
- VSB2011/003 (#057);
- VSB2011/004 (#058 – #059);
- VSB2011/005 (#060 – #065); and
- VSB2011/010 (#073).

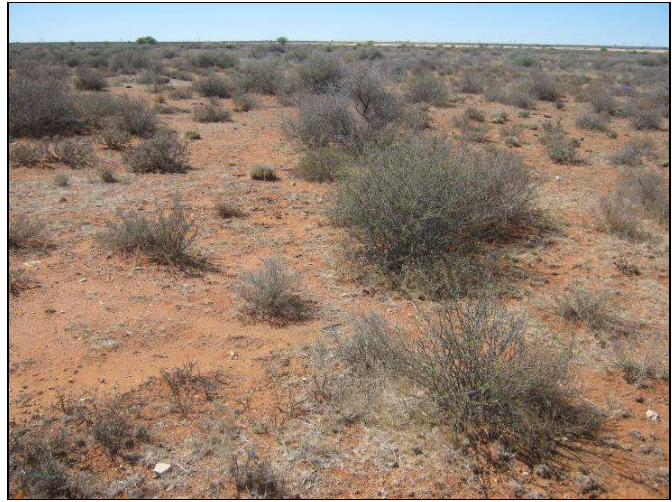
Figure 19: Location of VSB2011/001 in a sandy area to the south of Perdepan.

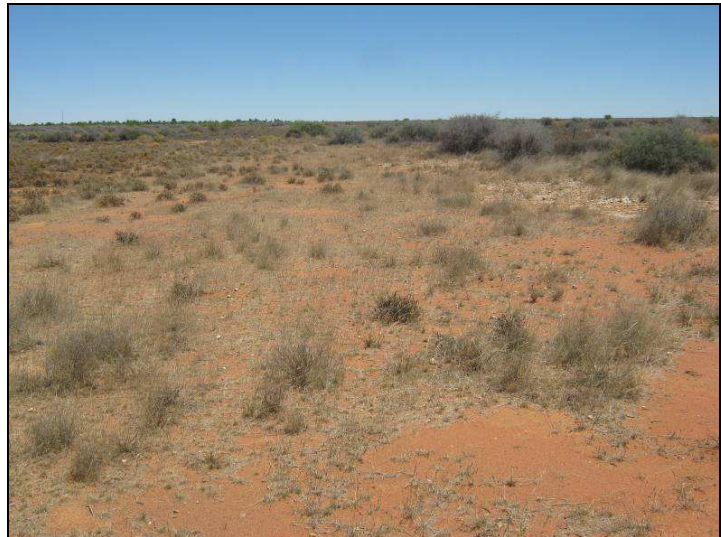
Figure 21: The situation of VSB2011/004. The site was found scattered in a sandy area along the edge of Perdepan (visible at far left as low, dense vegetation).

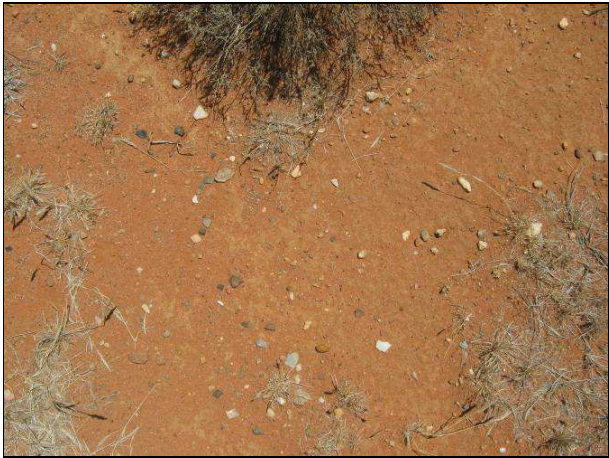
VSB2011/005 was the most significant site located on Vogelstruisbult. It is represented by field numbers #060 to #065. Several spatially related patches of dense artefact scatter were found, but the general scatter was fairly continuous over the whole area of the site. Due to the high degree of significance attached to this site no attempt was made to gather and photograph artefacts but Figure 22 shows a typical view of the surface with artefacts scattered about. The site covers some 100 m north-south by 90 m east-west and lies close to the margin of Perdepan (Figure 23). The western edge of the site, close to the pan, is quite well defined but the eastern side, where the density drops off, tends to just fade away. Potentially of very high significance were three 'piles' of stones. These were located in sandy areas and are quite obviously anthropogenic. The possibility exists that they are graves but this could never be verified without excavation. They could also represent some other type of feature (Figure 24). Two of these mounds were located at #063 while a third was found at #064.

Figure 22: View of the surface of VSB2011/005. Not everything visible is artefactual but many pieces are.

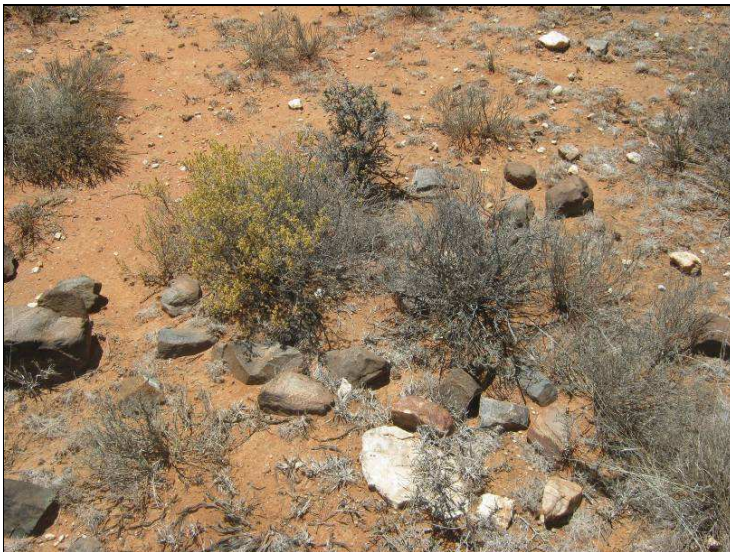
Figure 24: View of one of the stone mounds at VSB2011/005 (#063).
