## **ANNEXURE C4**

# HERITAGE IMPACT ASSESSMENT FOR MULTIPLE PROPOSED SOLAR ENERGY FACILITIES ON THE REMAINDER OF FARM KLIPGATS PAN 117, COPPERTON, NORTHERN CAPE

(Assessment conducted under Section 38 (8) of the  
National Heritage Resources Act (No. 25 of 1999) as part of an EIA etc.)

**Jayson Orton & Lita Webley**

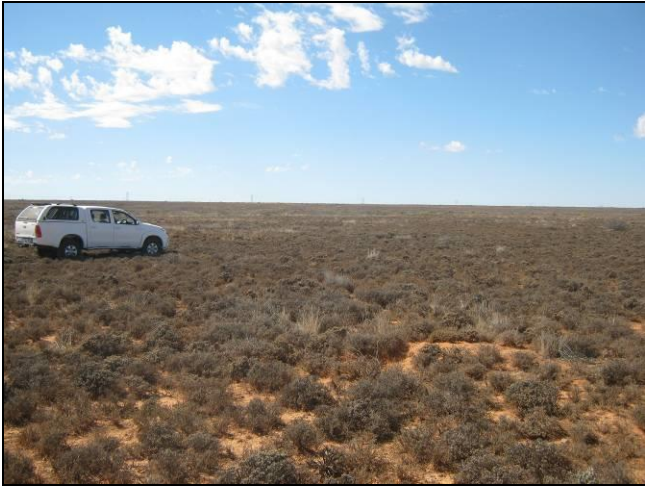
**Figure 2:** View across part of the Klipgats Pan study area showing vegetation in a silty, pan-like area.

The site is very flat with very low vegetation dominating but occasional plants do exceed knee height (Figures 2 to 5). Ground visibility was generally good owing largely to the many gravel areas where vegetation was often very sparse (Figures 3 to 5). Major landscape features present are the large pan and a slightly hilly area in the southern part of the site. The substrate varies from fine silt (Figure 2) to gravel (Figure 3).

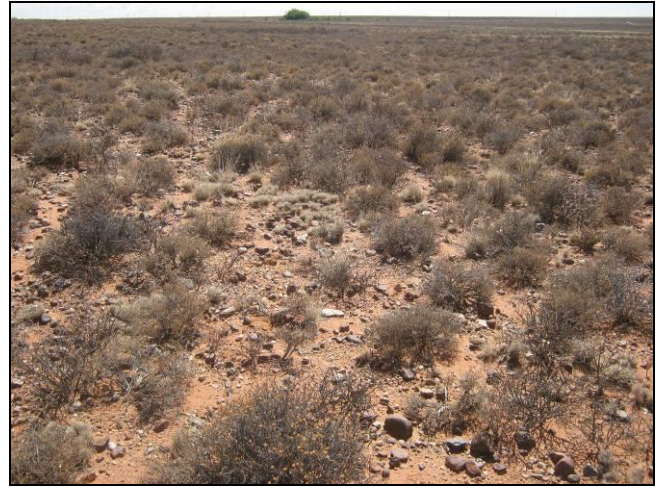
**Figure 3:** View across part of the Klipgats Pan study area showing vegetation in a gravel area.

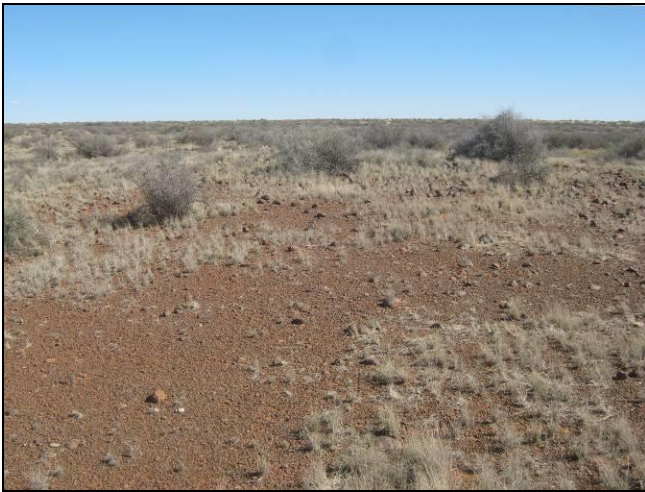
**Figure 4:** Part of the Klipgats Pan study area with sand and gravel and light vegetation cover.

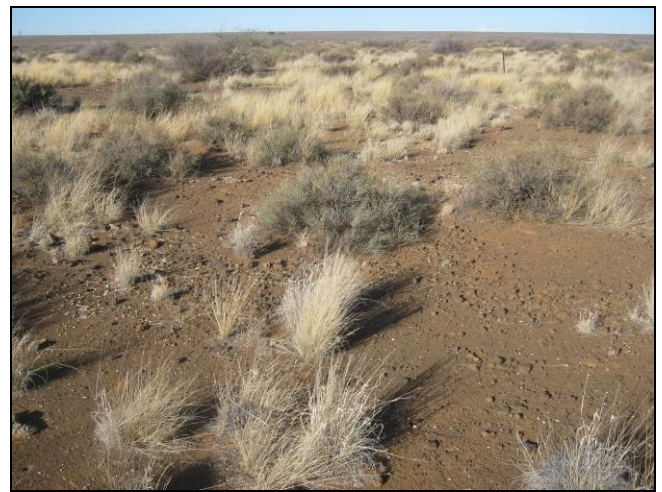
**Figure 5:** Sparse vegetation cover on a dolerite hill in the Klipgats Pan study area.

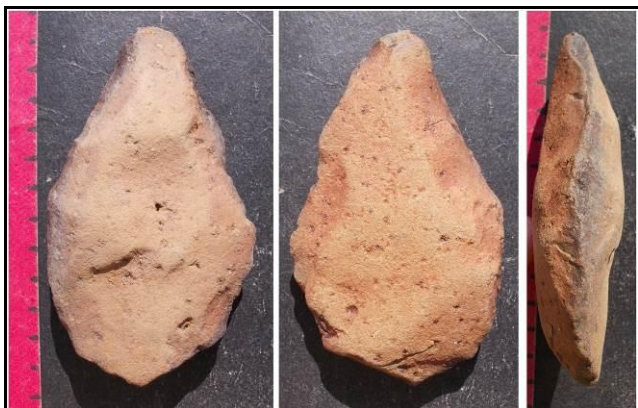
**Figure 6:** Hand-axe from Klipgats Pan. Scale in cm.

not readily assigned to one or other Age, some are highly weathered signifying great age while others are diagnostic. Relevant here are a number of hand-axes that were found across the study area, but usually associated with gravel areas. Figures 6 and 7 show two of these artefacts from the 2013 survey. Most were quite small, often around 12 cm in length. The smaller hand-axes are generally acknowledged to come from a period of the ESA referred to as Fauresmith (Goodwin 1926; Goodwin & Van Riet Lowe 1929; Van Riet Lowe 1927). Fauresmith artefacts from Kathu Pan to the north of the Orange River have recently been dated to about 500 000 years old (Porat *et al.* 2010). Much of the remaining background scatter is likely to be MSA in origin, with occasionally distinctive MSA artefacts noticeable (Figures 9 & 10). No proper MSA sites were recorded. It is quite possible that MSA material would be present beneath the surface close to pans though.

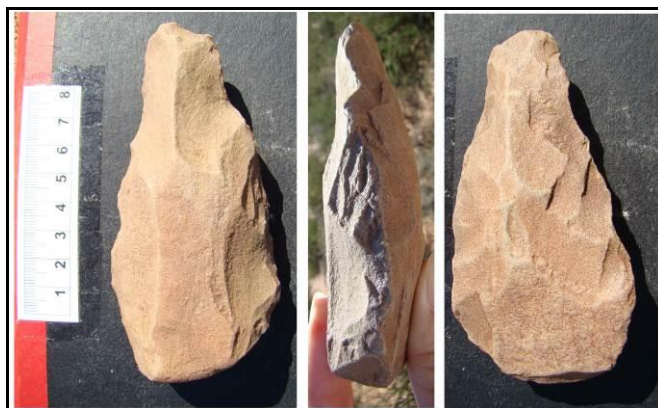
**Figure 7:** Hand-axe from Klipgats Pan. Scale in cm.

It was noticeable that LSA artefacts were often found in clusters suggestive of actual occupation sites. These artefacts are recognisable by their small size, their relatively unweathered surface appearance and the inclusion of quartz in the assemblages (Figures 7 & 8). Most LSA scatters were found to be on the hill in the south and around pans, either proper pans or the ephemeral ones that occur on flat ground from time to time. Details of these were included in the original report (Orton 2011). Few LSA traces were located during the present survey, since the obvious landscape features were all searched in 2011.

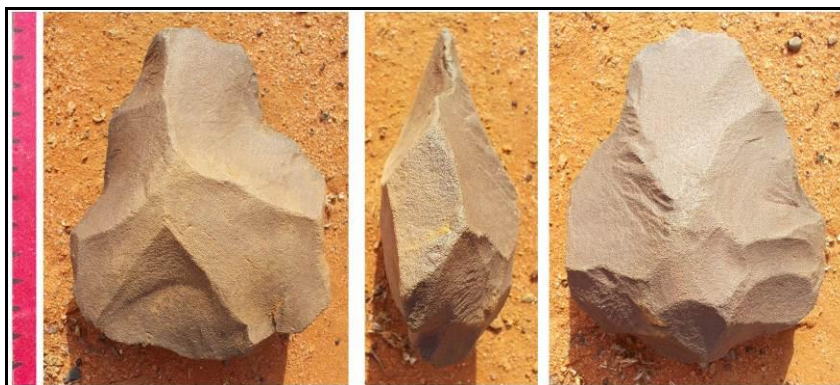
**Figure 8:** Hand-axe from Klipgats Pan. Scale in cm.

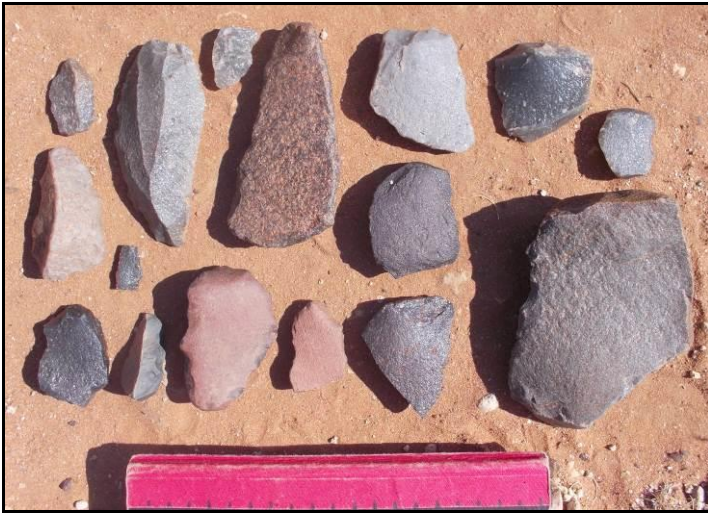
**Figure 9:** Artefacts from point J138. Note MSA blades. Scale in cm.

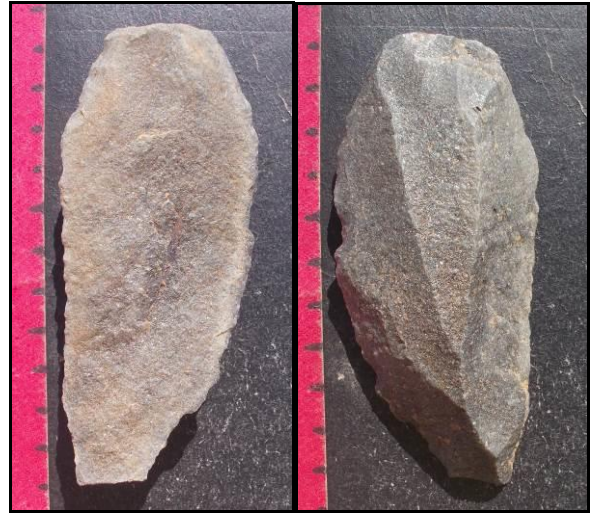
**Figure 10:** Ventral and dorsal surfaces of MSA blade. Scale in cm.

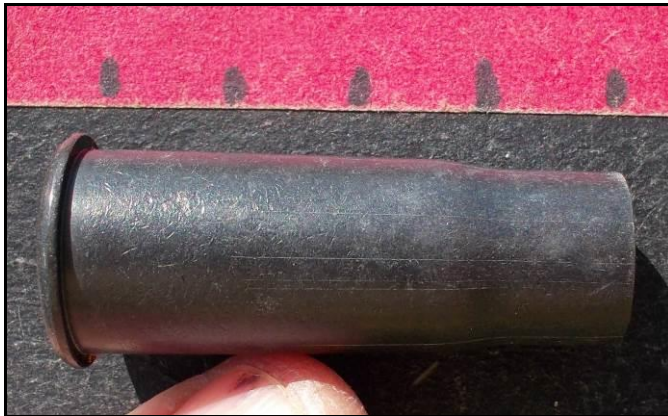
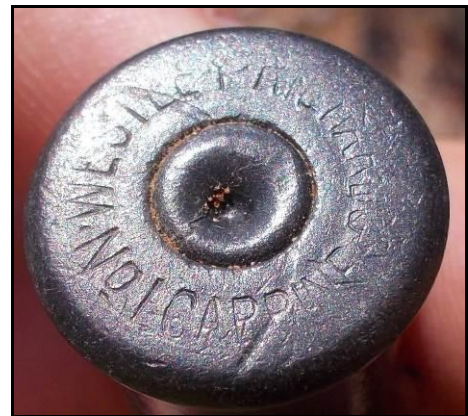
**Figures 11 & 12:** Isolated cartridge of a Westley Richards No 1 Carbine rifle, probably dating from around 1870.

Aside from the historical farm complex reported on in the earlier survey (Orton 2011), historical material was extremely rare. One notable find was an isolated Westley Richards rifle cartridge that must have been dropped during the last few decades of the 19<sup>th</sup> century.
