**PROPOSED ANNANDALE RESIDENTIAL
DEVELOPMENT, UMNGENI LOCAL MUNICIPALITY,
KWAZULU-NATAL**

Phase 1 Heritage Impact Assessment

1 March 2022

**AUTHOR: JLB Consulting
Jean Beater**

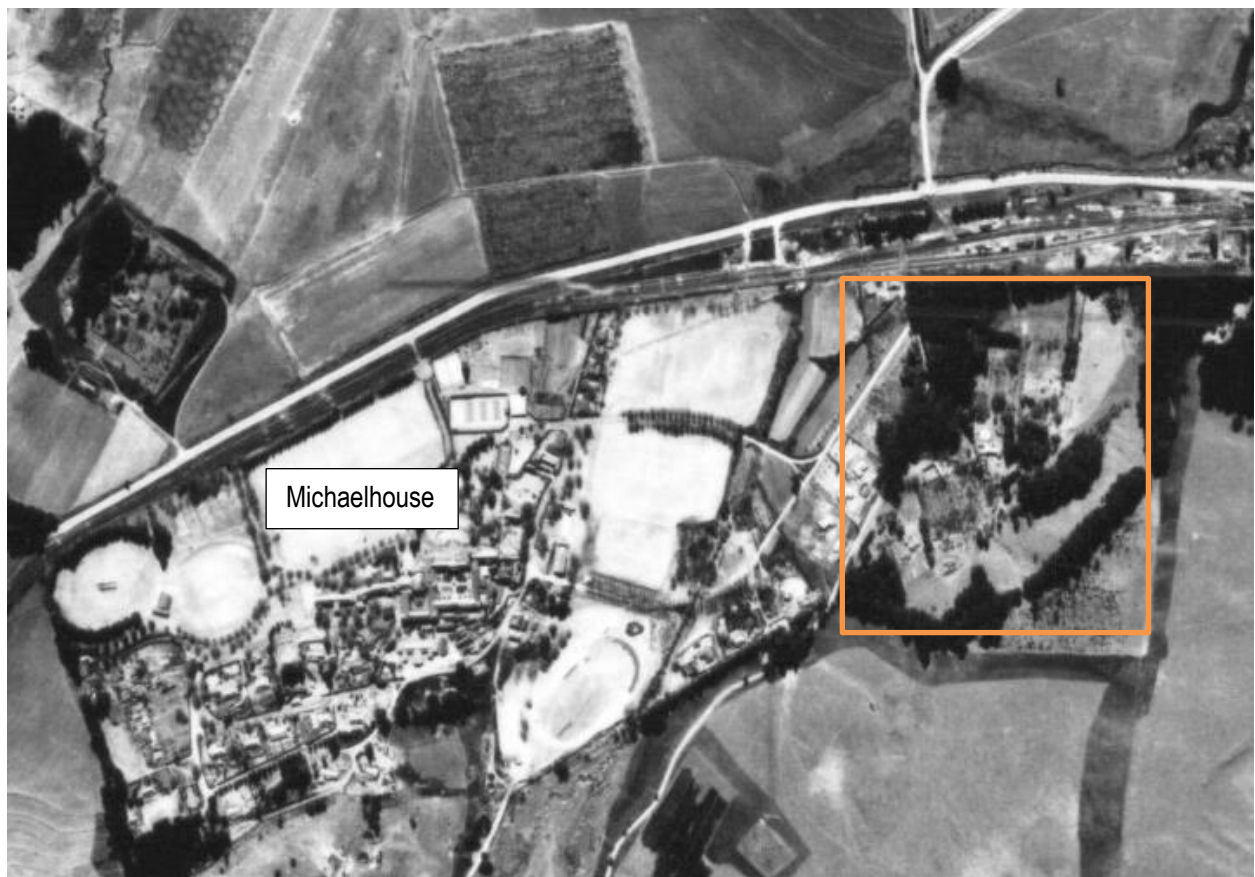
Figure 2: 1967 aerial image of project site and environs

The 1967 aerial image of the site shows the structures on the property under discussion as well as the structures associated with Michaelhouse, the R103 road and railway line which are all still in existence.

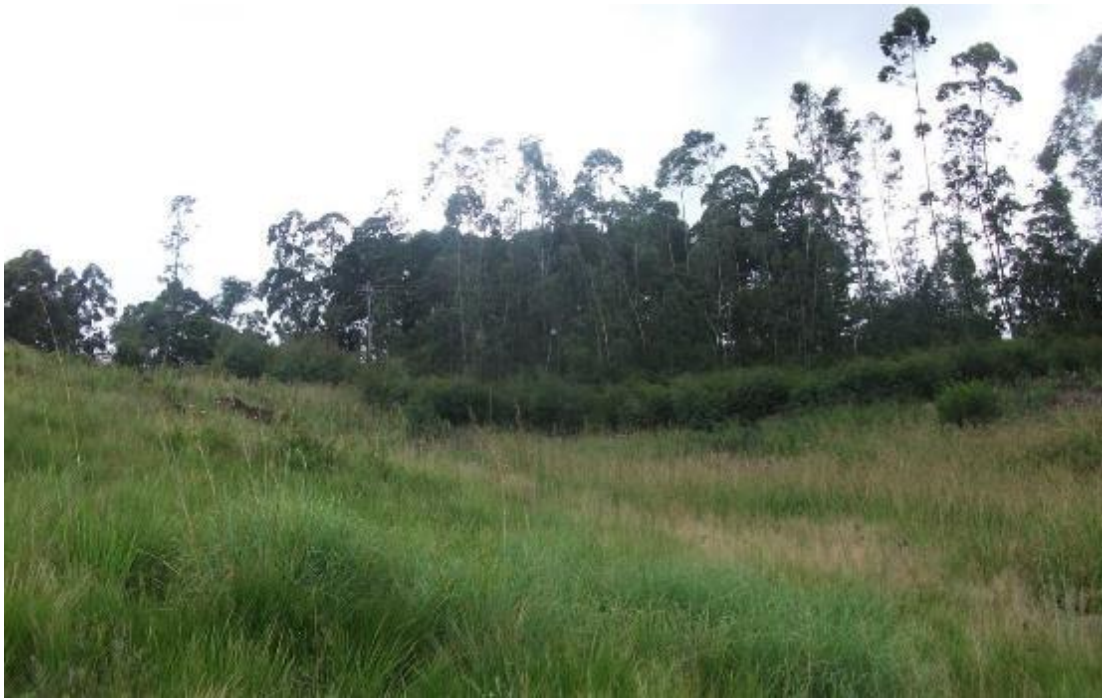
Figure 3: South-western boundary of project area

The project area was inspected on foot. A thick grass layer with pockets of dense vegetation covers the south-western section of the project area where there is a watercourse and the remains of a plantation of eucalyptus trees. There is also a rocky outcrop in this section of the project area.

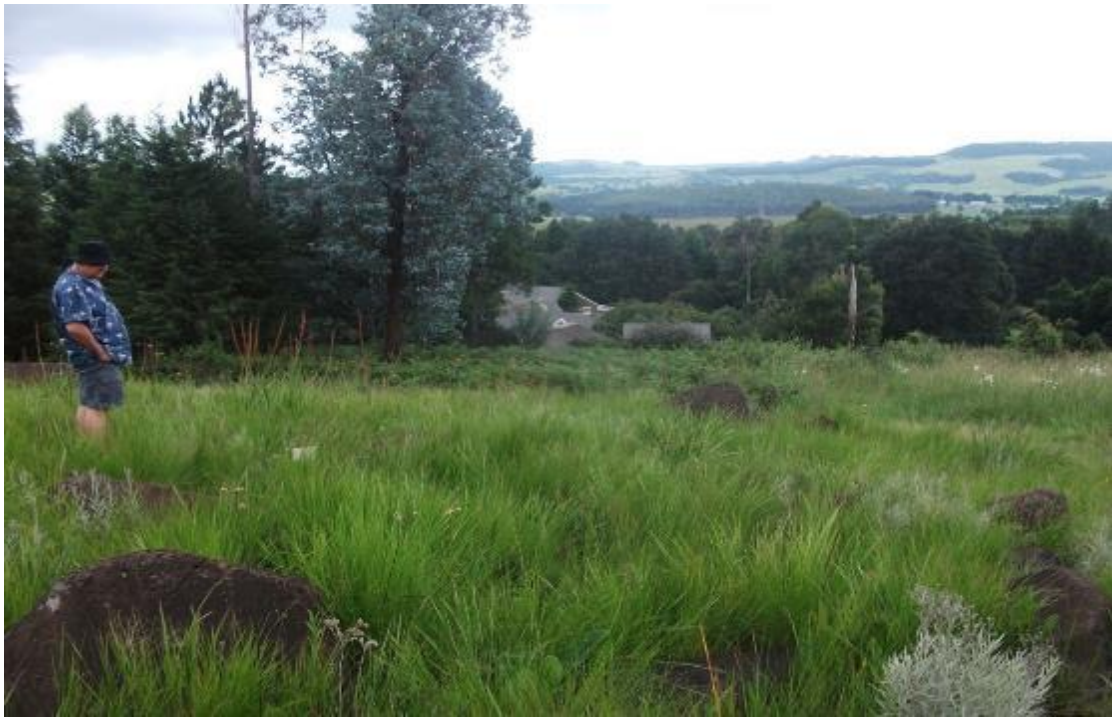
Figure 5: Rocky outcrop looking northwards with farmhouse roofs in background

Signs containing the names of the flowers and plants indicate that the rocky outcrop and area northwards towards the farmhouses was previously used as a nursery for plants. The remains of a structure covered with shade cloth was found east of the farmhouse. No heritage sites were found in this area.

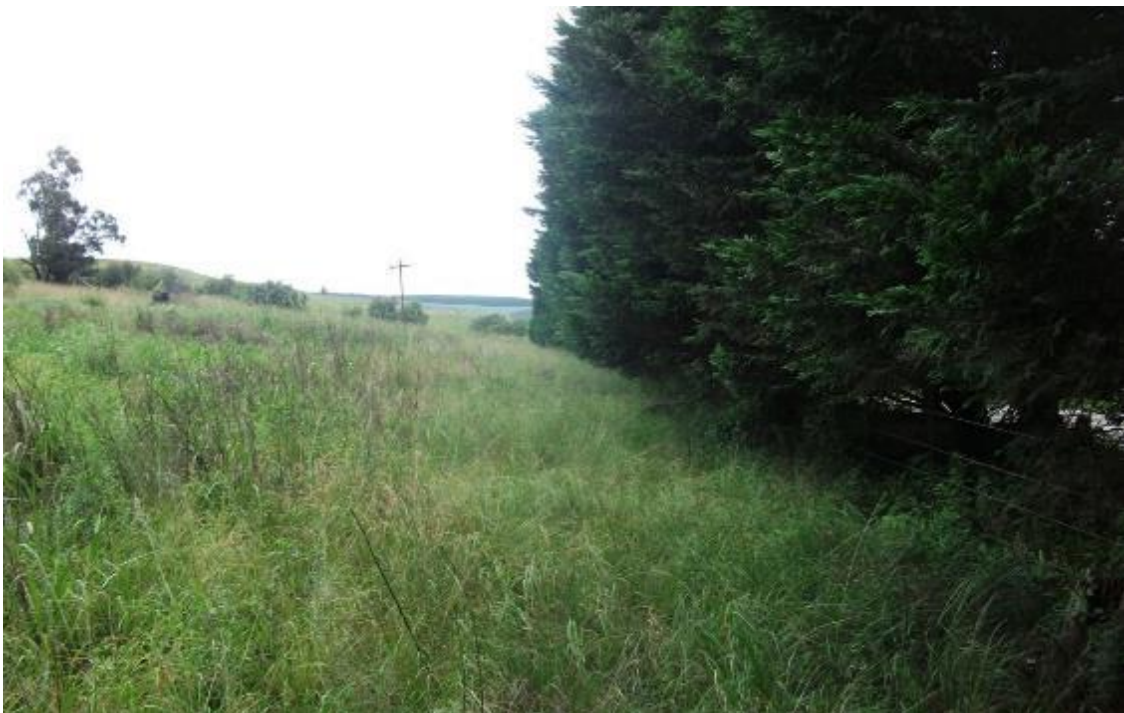
Figure 8: Western boundary of project area

The area along the western boundary of the project area has thickets of bush and a line of trees alongside the gravel road. A power line runs through this area. A dilapidated stone structure / enclosure was found in this area which will be assessed by the built heritage specialist.

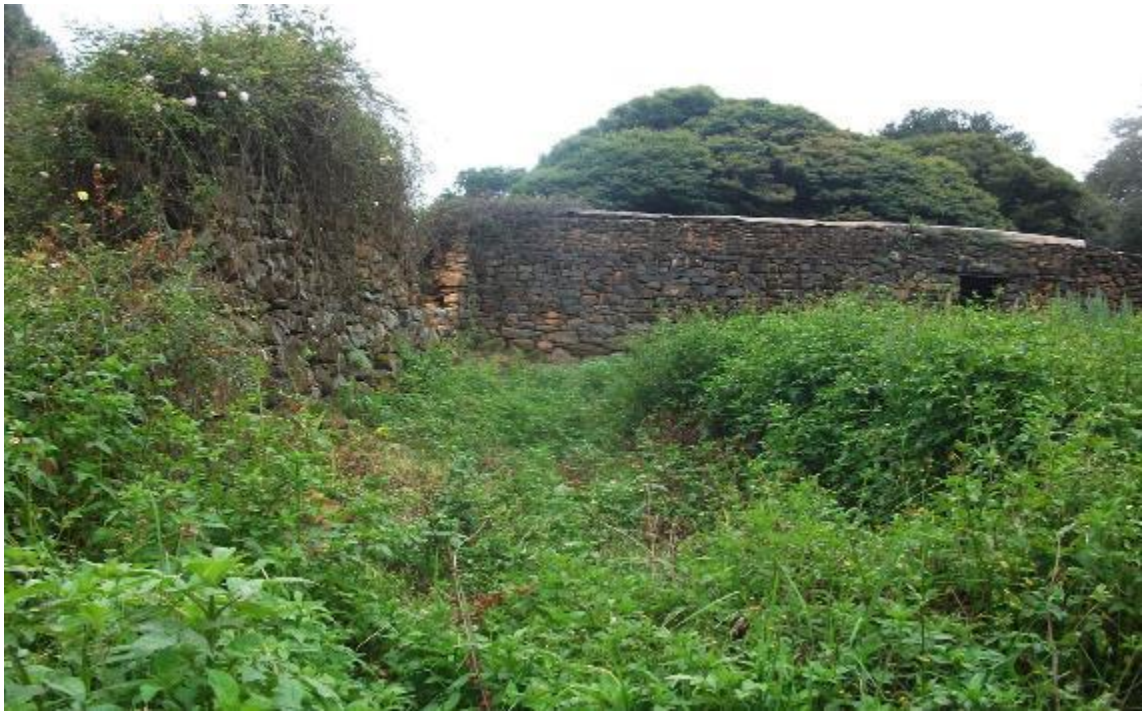
Figure 9: Stone structure / enclosure

The original farmhouse dates from the late 1800's. Other farm structures on the property may date from the late 1800's including the stone walls and shed between the west boundary and the

house. The stone gateposts and a wrought iron gate exist on the north boundary which was the original entrance from the station. Due to their age, these structures are protected in terms of section 37 (1)(a) of the KwaZulu-Natal Amafa and Research Institute Act, 2018 and permits will be required from the Institute if they are to be altered or demolished.

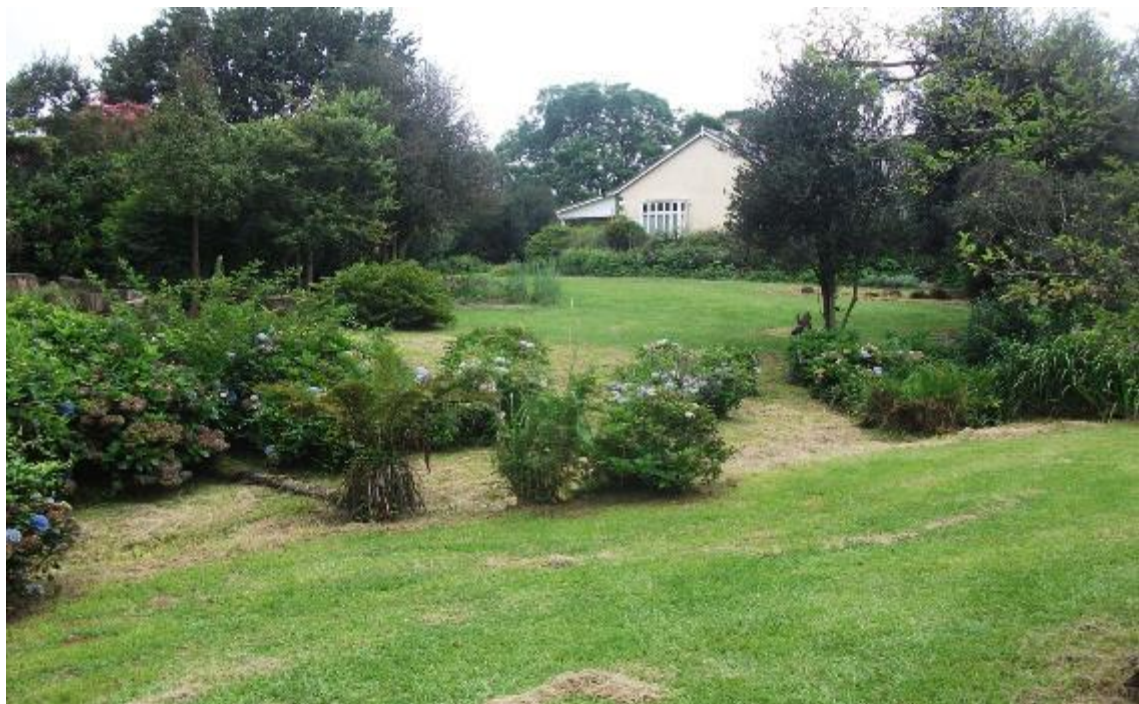
The area west of the farmhouse consists of manicured lawns and gardens.

Figure 10: Manicured gardens with farmhouse at rear of photograph

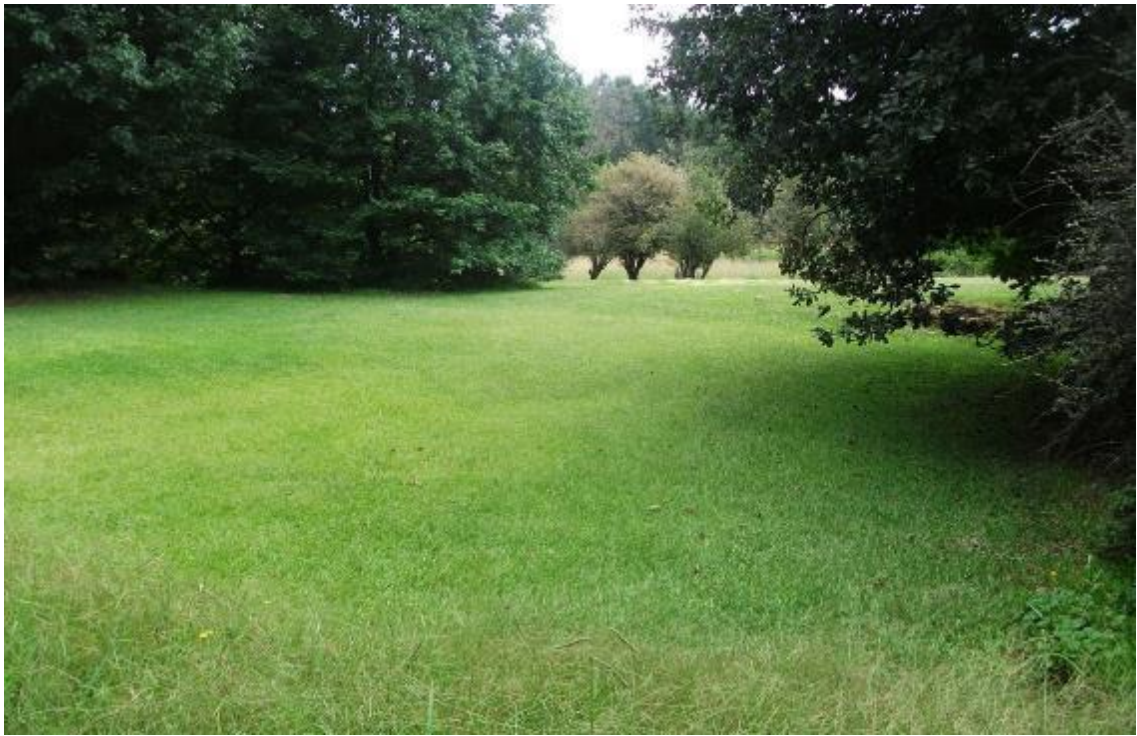
Figure 11: Manicured lawns amongst large trees

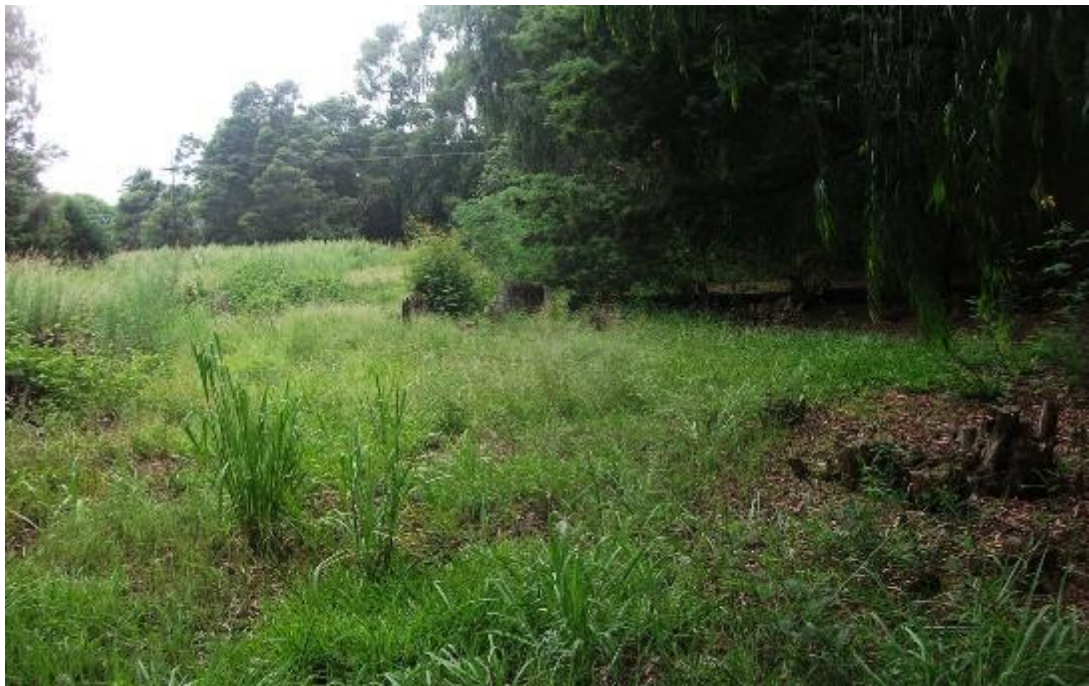
Figure 12: Northern edge of project area

The northern and central section of the project area is overgrown with vegetation and there are stands of eucalyptus trees and a field of mondo grass.

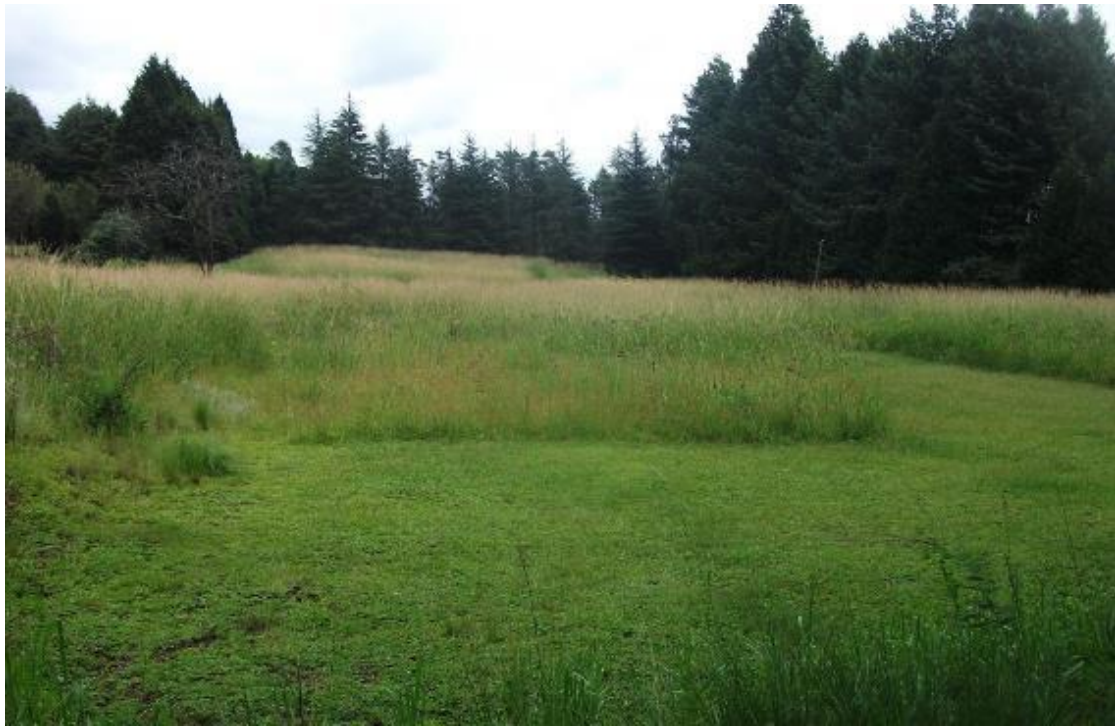
Figure 13: Area between farmhouse and northern boundary

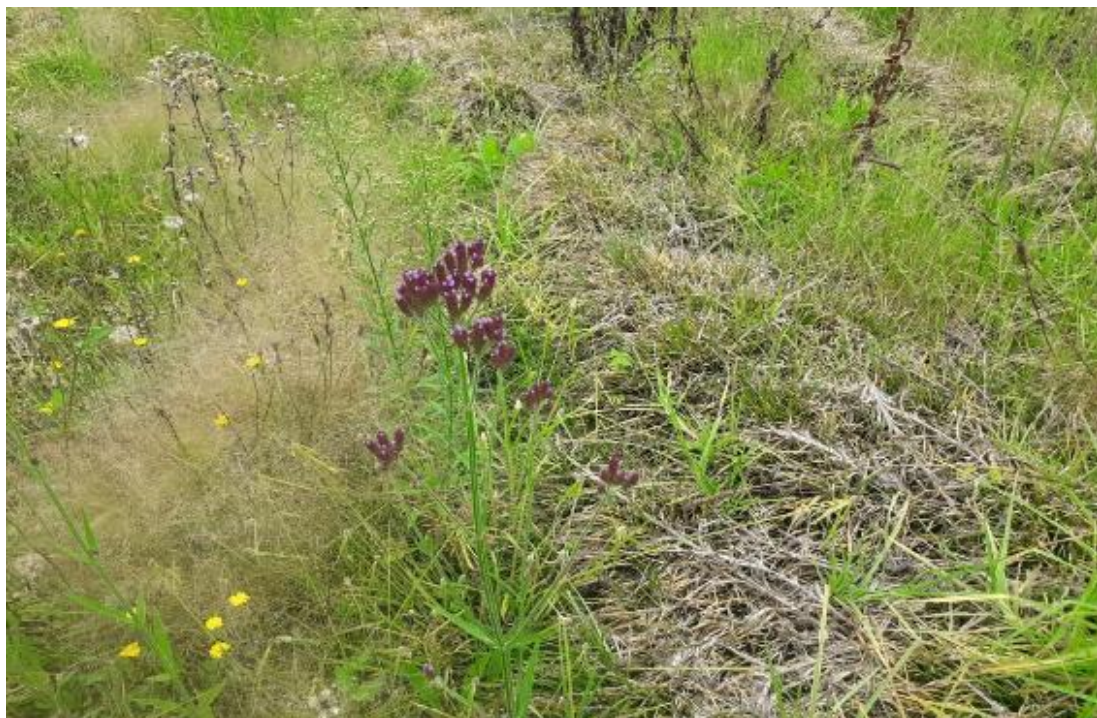
Figure 14: Rows of cut grass

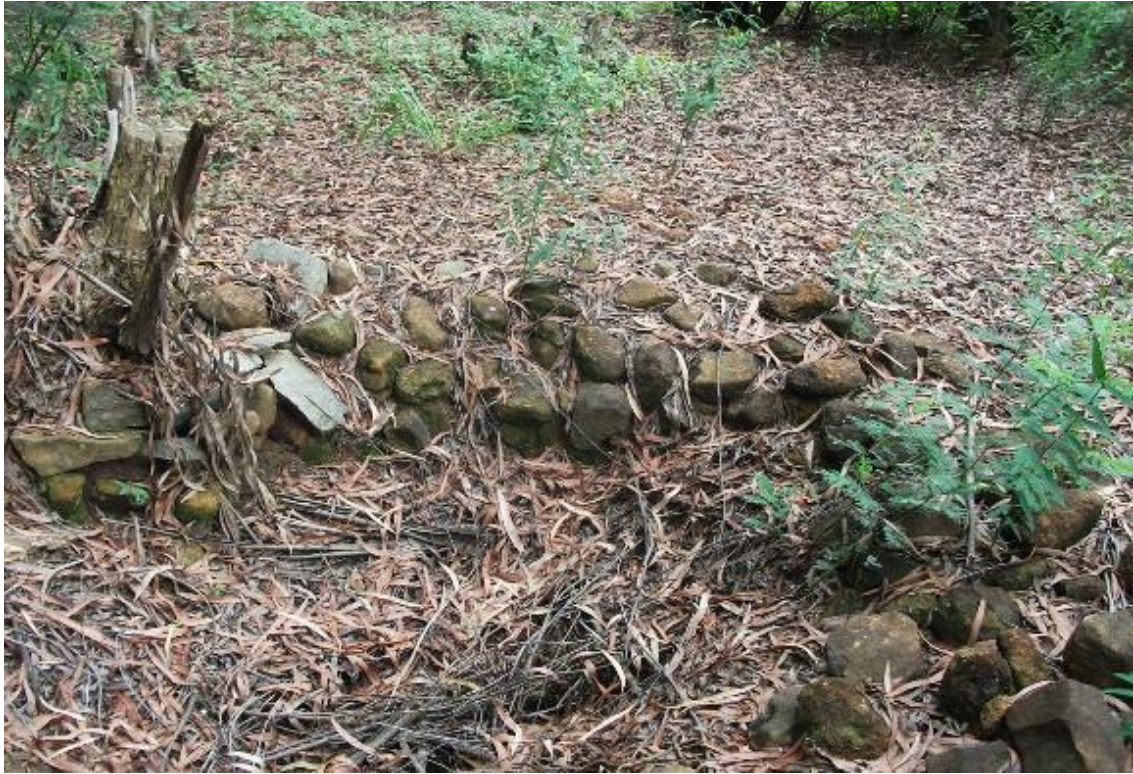
Figure 15: Stone lined hollow / depression

A hollow lined with stone was found in the eucalyptus plantation near the northern boundary of the property. It could have been a water well that has not been used for a long time and that has filled up with debris, soil and vegetation. It is unclear what the site is or what it was used for but is of negligible heritage significance as there are no other associated structures that could provide context to its use.

During the inspection a stone-lined hollow or indentation was found close to the northern boundary of the property. It is unclear what it was used for and there are no other structures related to it so its use or purpose cannot be determined. It is of negligible heritage significance.

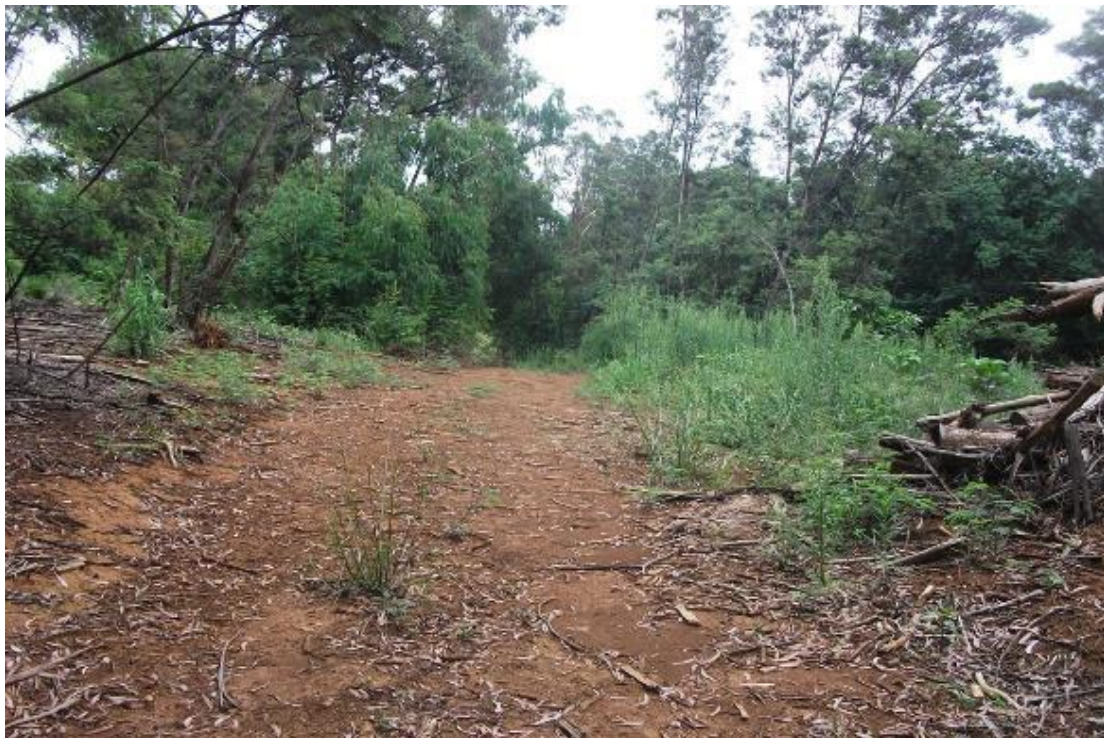
Figure 16: Eastern boundary of project area

The eastern boundary of the property consists of a road that ends at rocky outcrop and a mixture of eucalyptus and other trees covering the area.

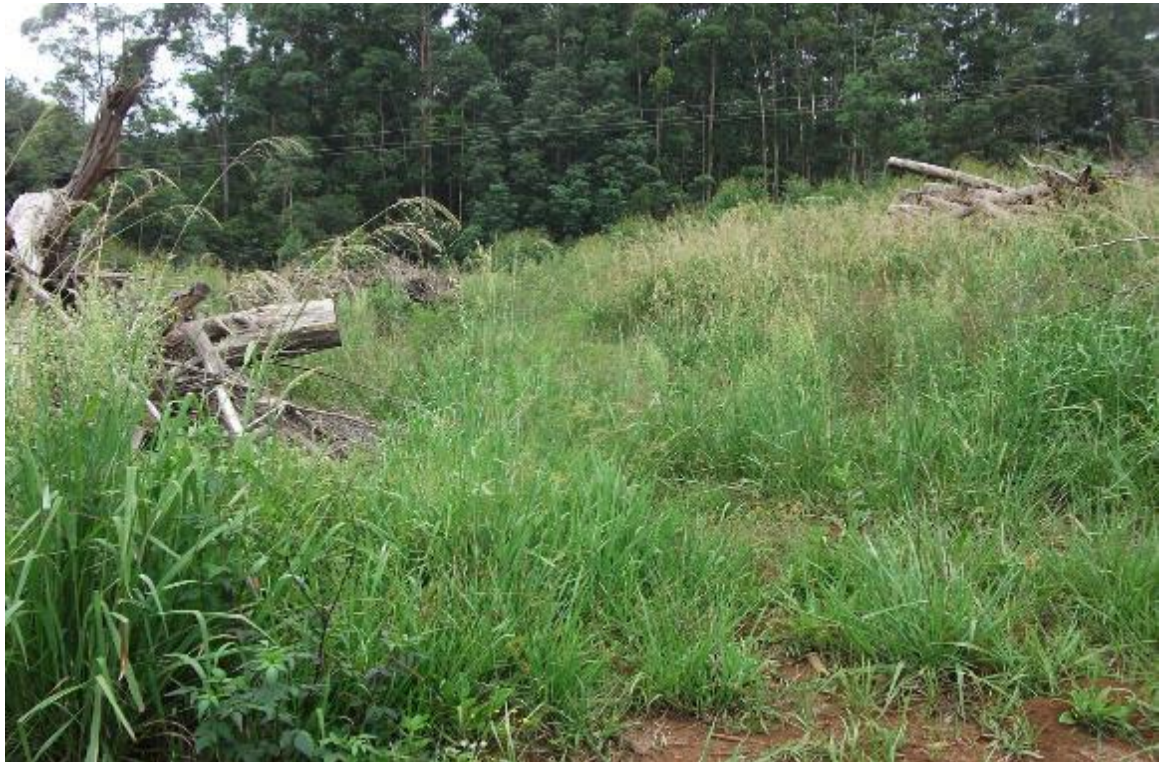
Figure 17: Eastern section of project area

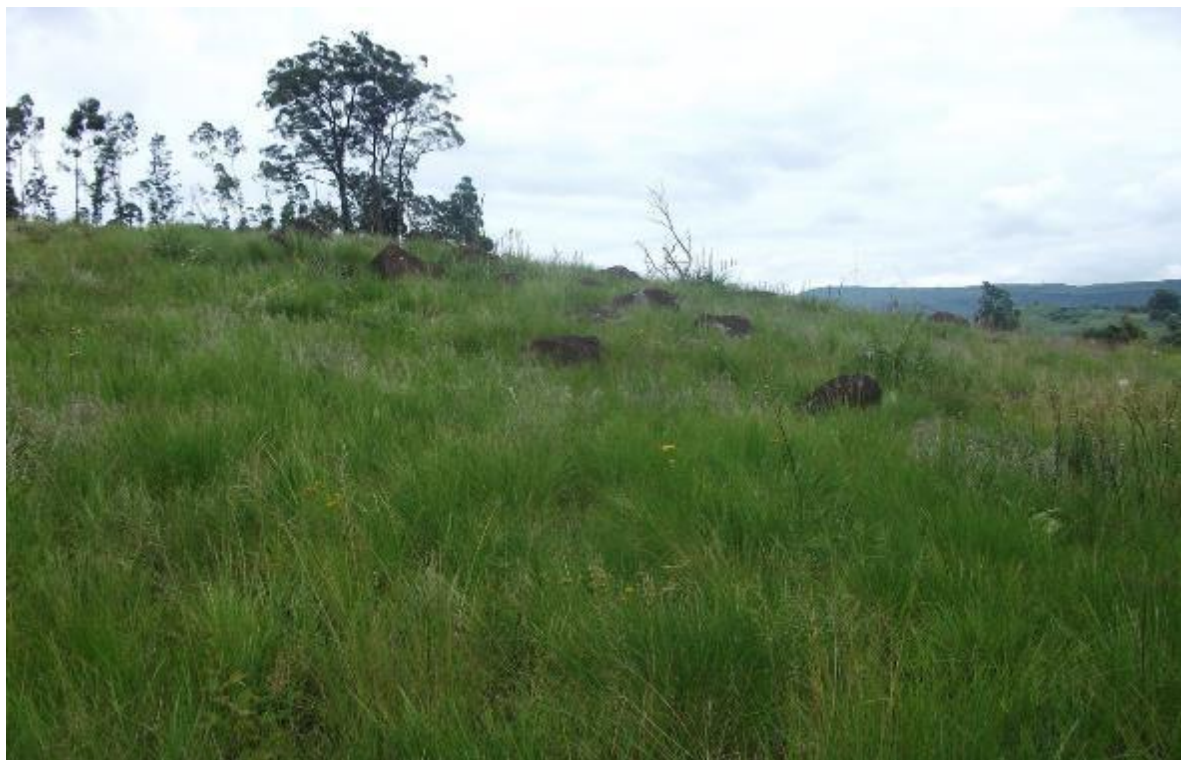
Figure 18: Rocky outcrop
