# **Phase 1 Heritage Impact Assessment with regard to planned Township development on the Farm Lilyvale 30/2313, Bloemfontein, Free State Province.**

Report prepared by Dr L. Rossouw, National Museum PO Box 266 Bloemfontein.

15 January 2017

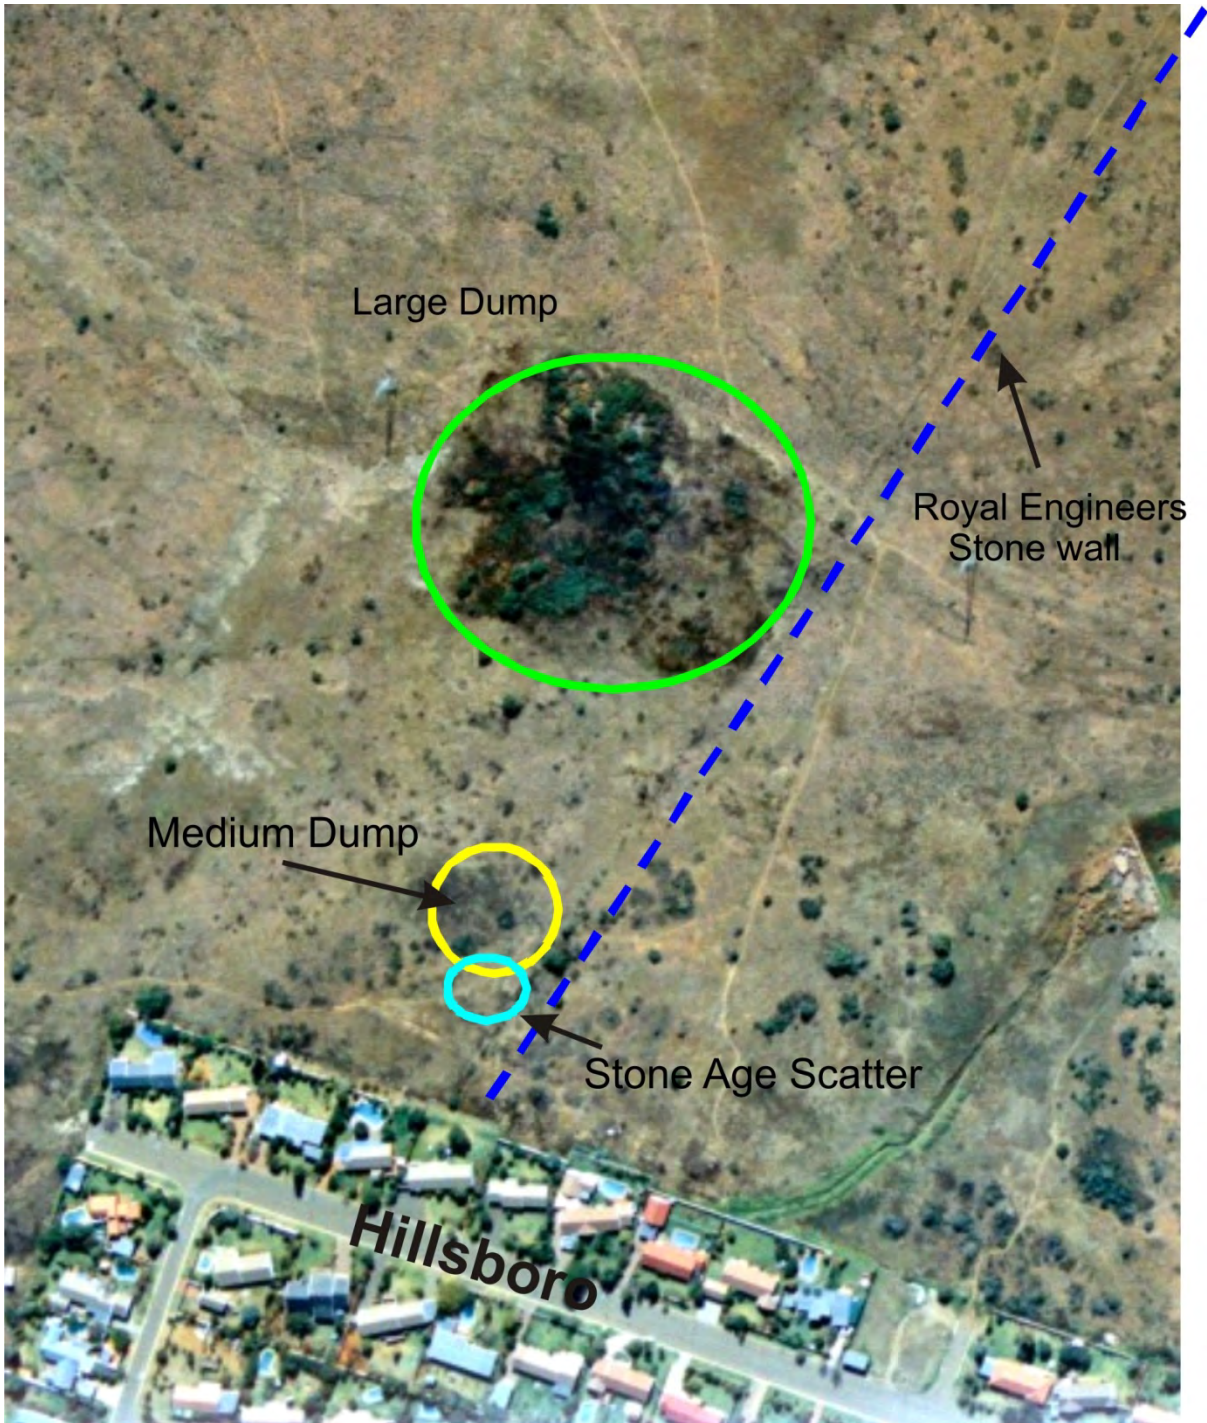
Figure 6. Aerial view and layout of Stone Age open sites, military rubbish dumps and associated stone wall structure recorded on Lilyvale 2313 about 700 south southwest of the study area.

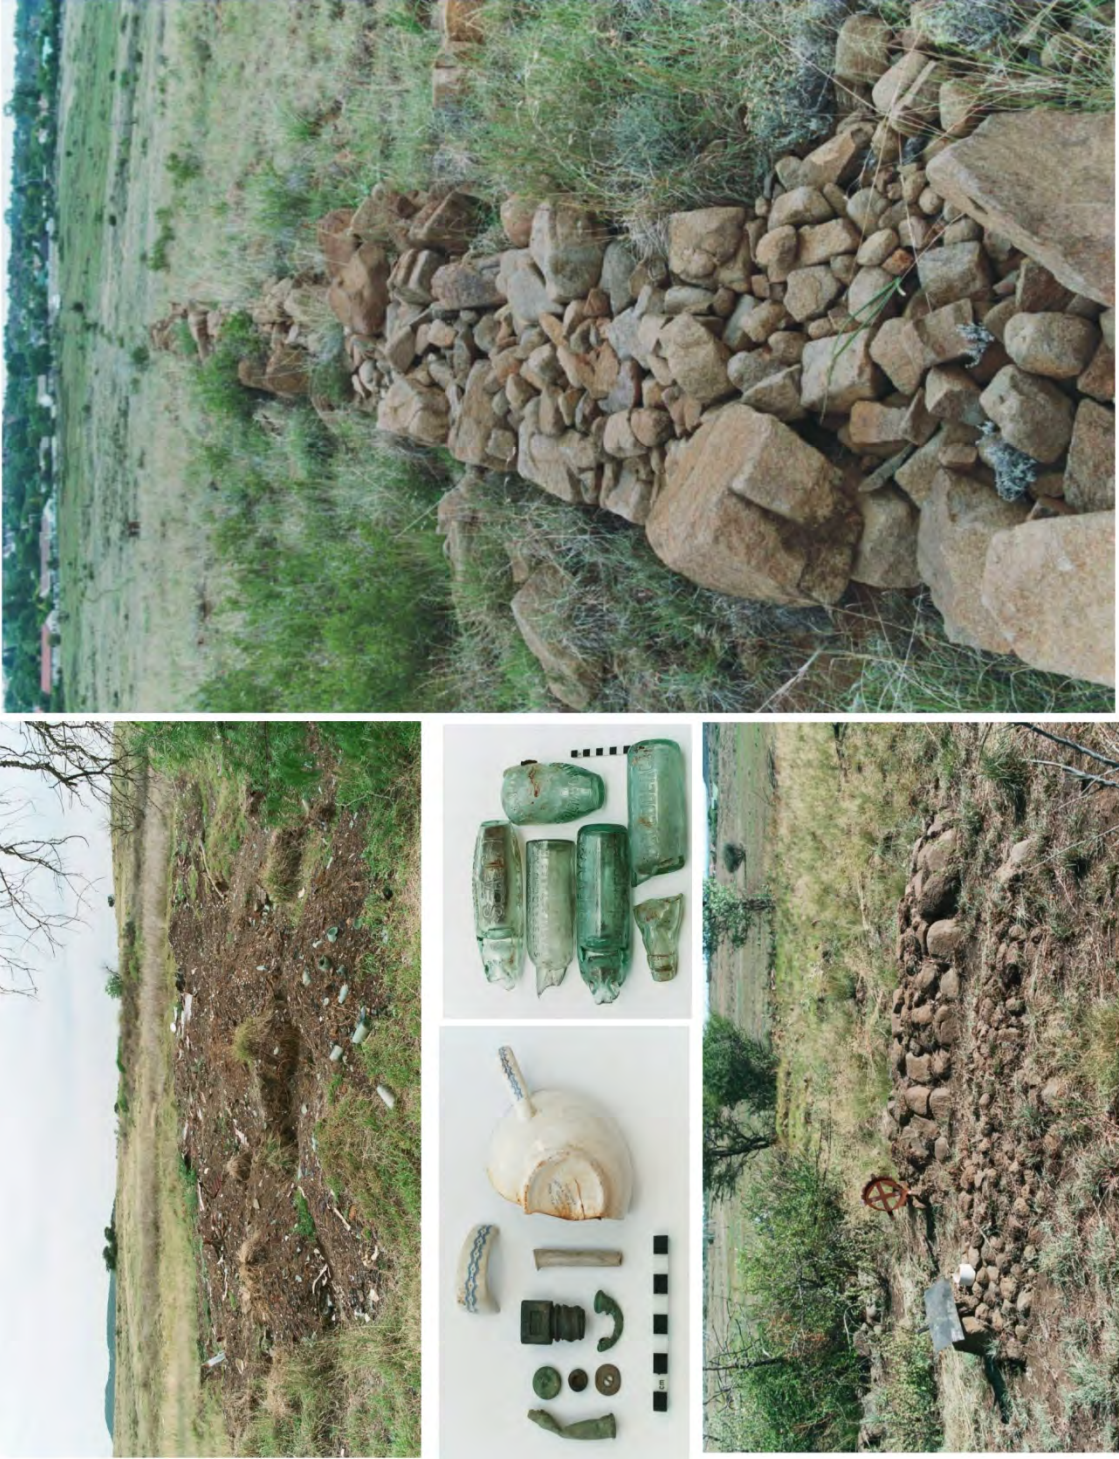
Figure 7. Military rubbish dump and its remains (top & center left), graves (bottom left) and stone wall structure (right) recorded south of the study area.

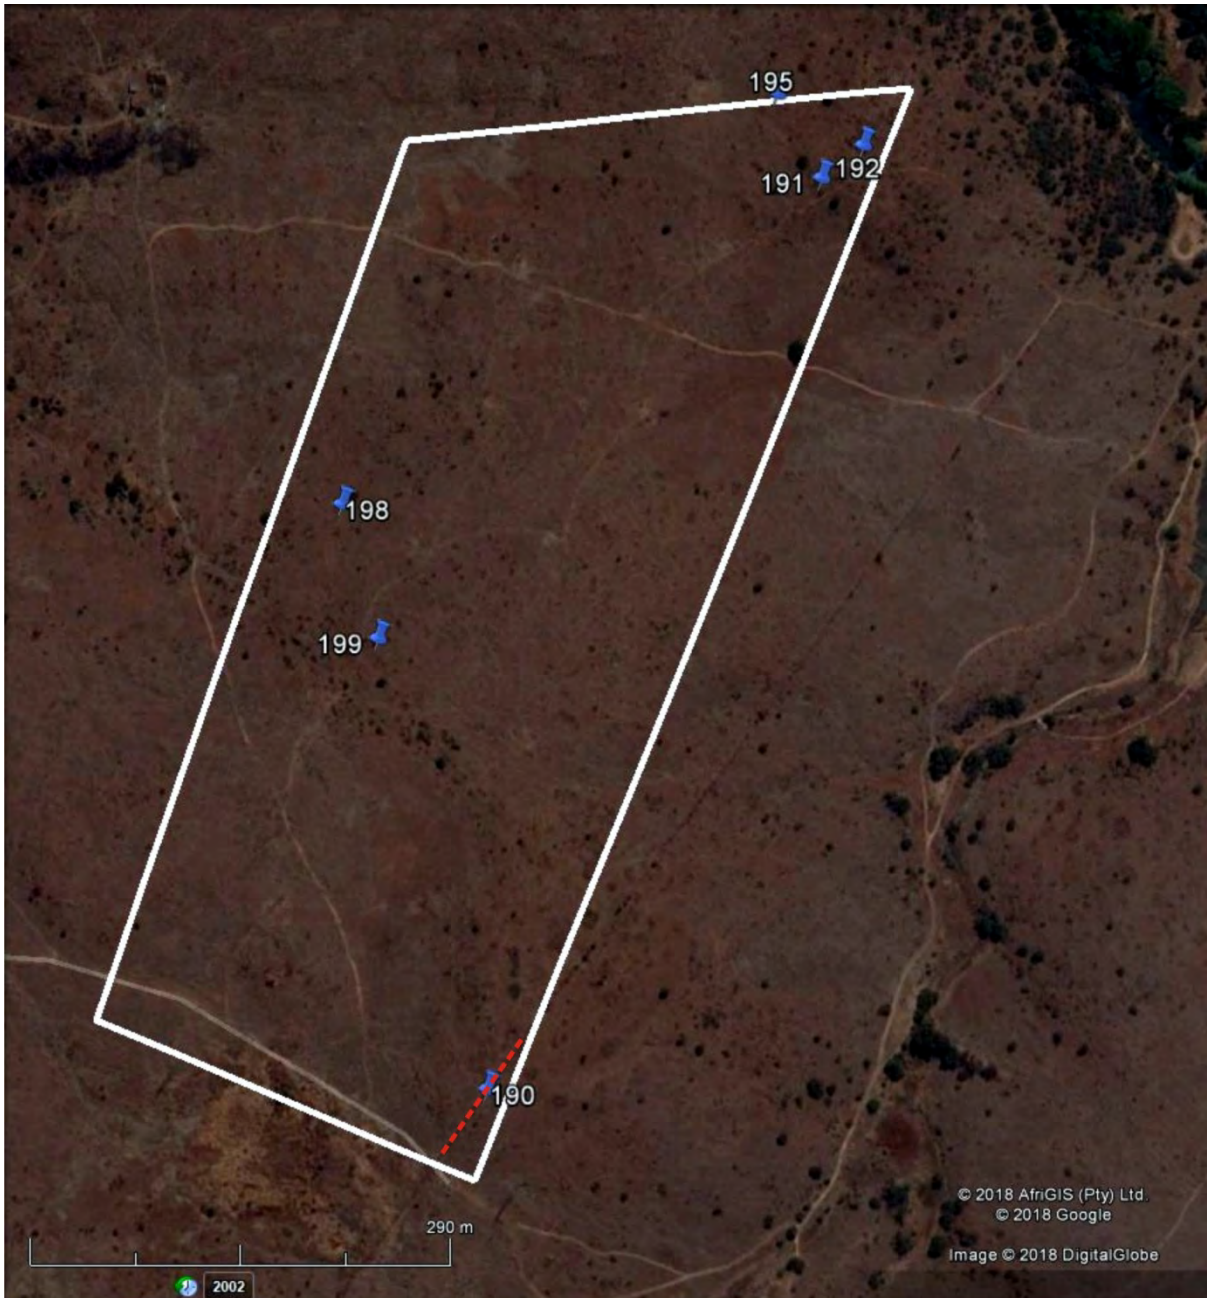
Figure 8. Map of historically significant structures identified during the survey.

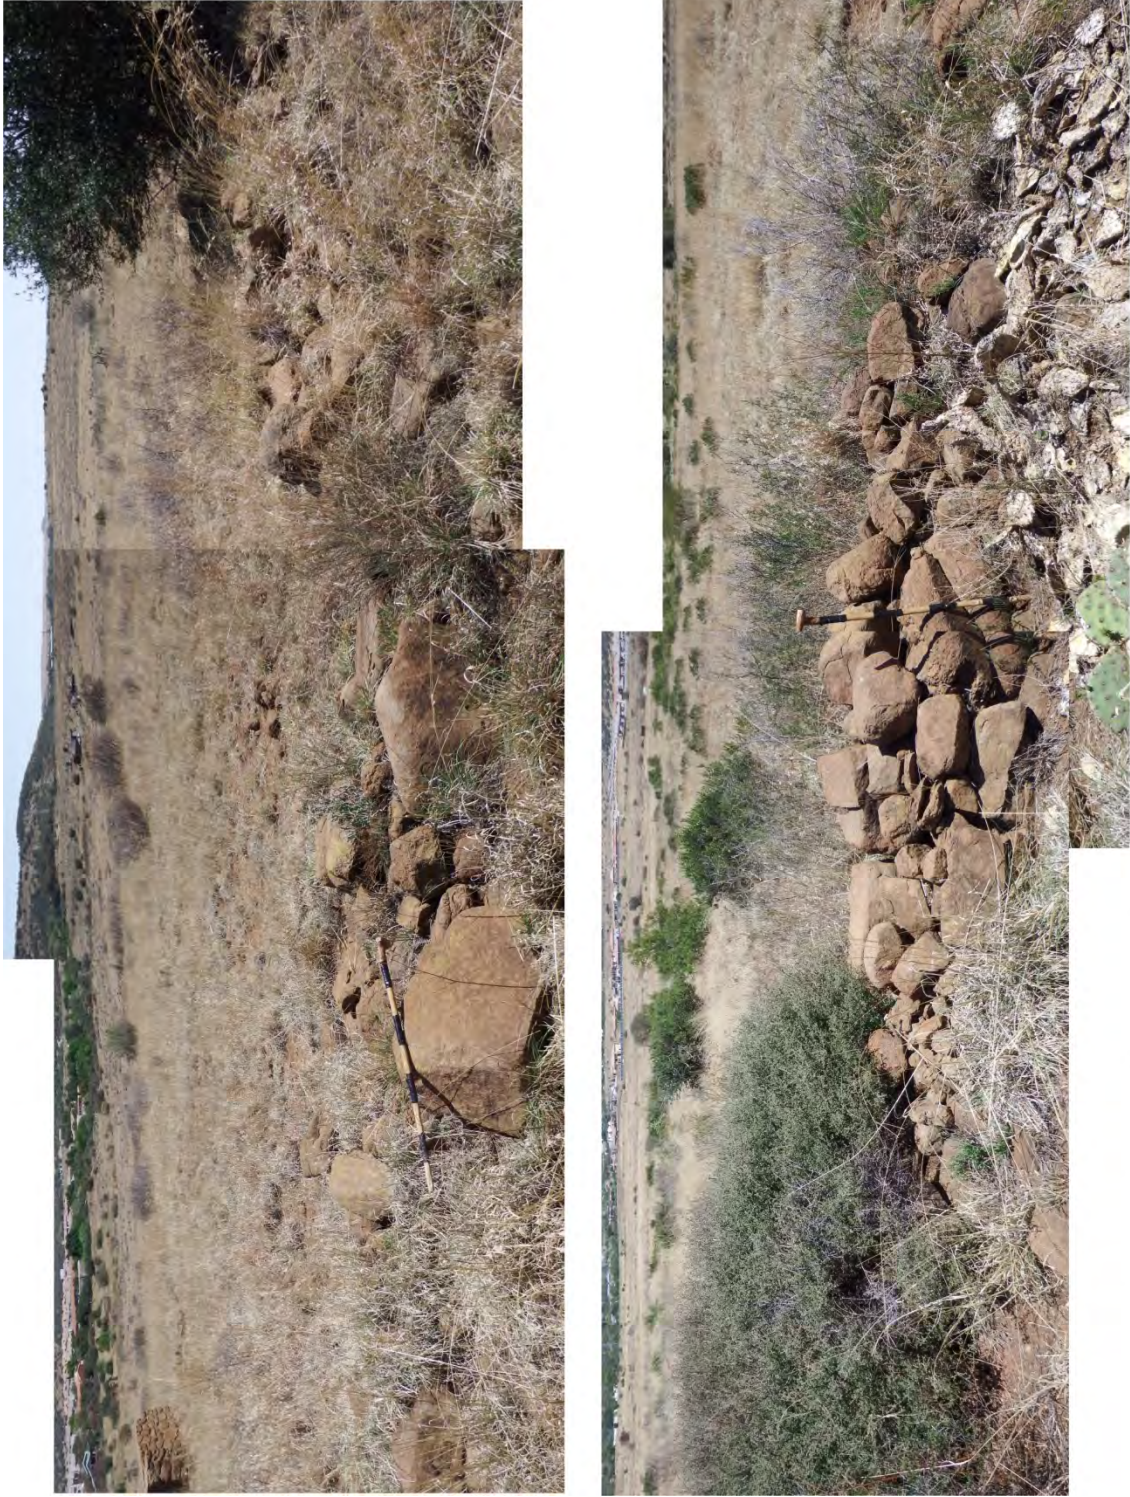
- The remains of two falcate-shaped sangars, about 2m-3m in length and 60 cm in height, respectively (Sites 198 and 199; **Fig. 8 & 9**). Both localities are assigned a site rating of Local Significance Grade 3B.
- The remains of a cluster of three of sangars located on a dolerite outcrop at the north-eastern boundary of the footprint (Sites 191, 192 & 195; **Fig. 8 & 10**). The localities are assigned a site rating of Local Significance Grade 3A.
- A 30 m - section of the stone wall located along the southeastern boundary of the footprint (**Fig. 8 & 11**). The section is assigned a site rating of Local Significance Grade 3B.

Figure 9. Remains of two more or less falcate-shaped sangars (sites 198 and 199), looking northwest (top) and west (below).  
Scale 1 = 10 cm.

- The remains of the two small falcate-shaped sangars are, pending permission from SAHRA, are removed and reconstructed within a designated open or green area within the footprint, before the start of the construction phase of the development and under supervision of a qualified heritage specialist. This process will require a removal permit from SAHRA. The reconstruction must be accompanied by appropriate information displays.

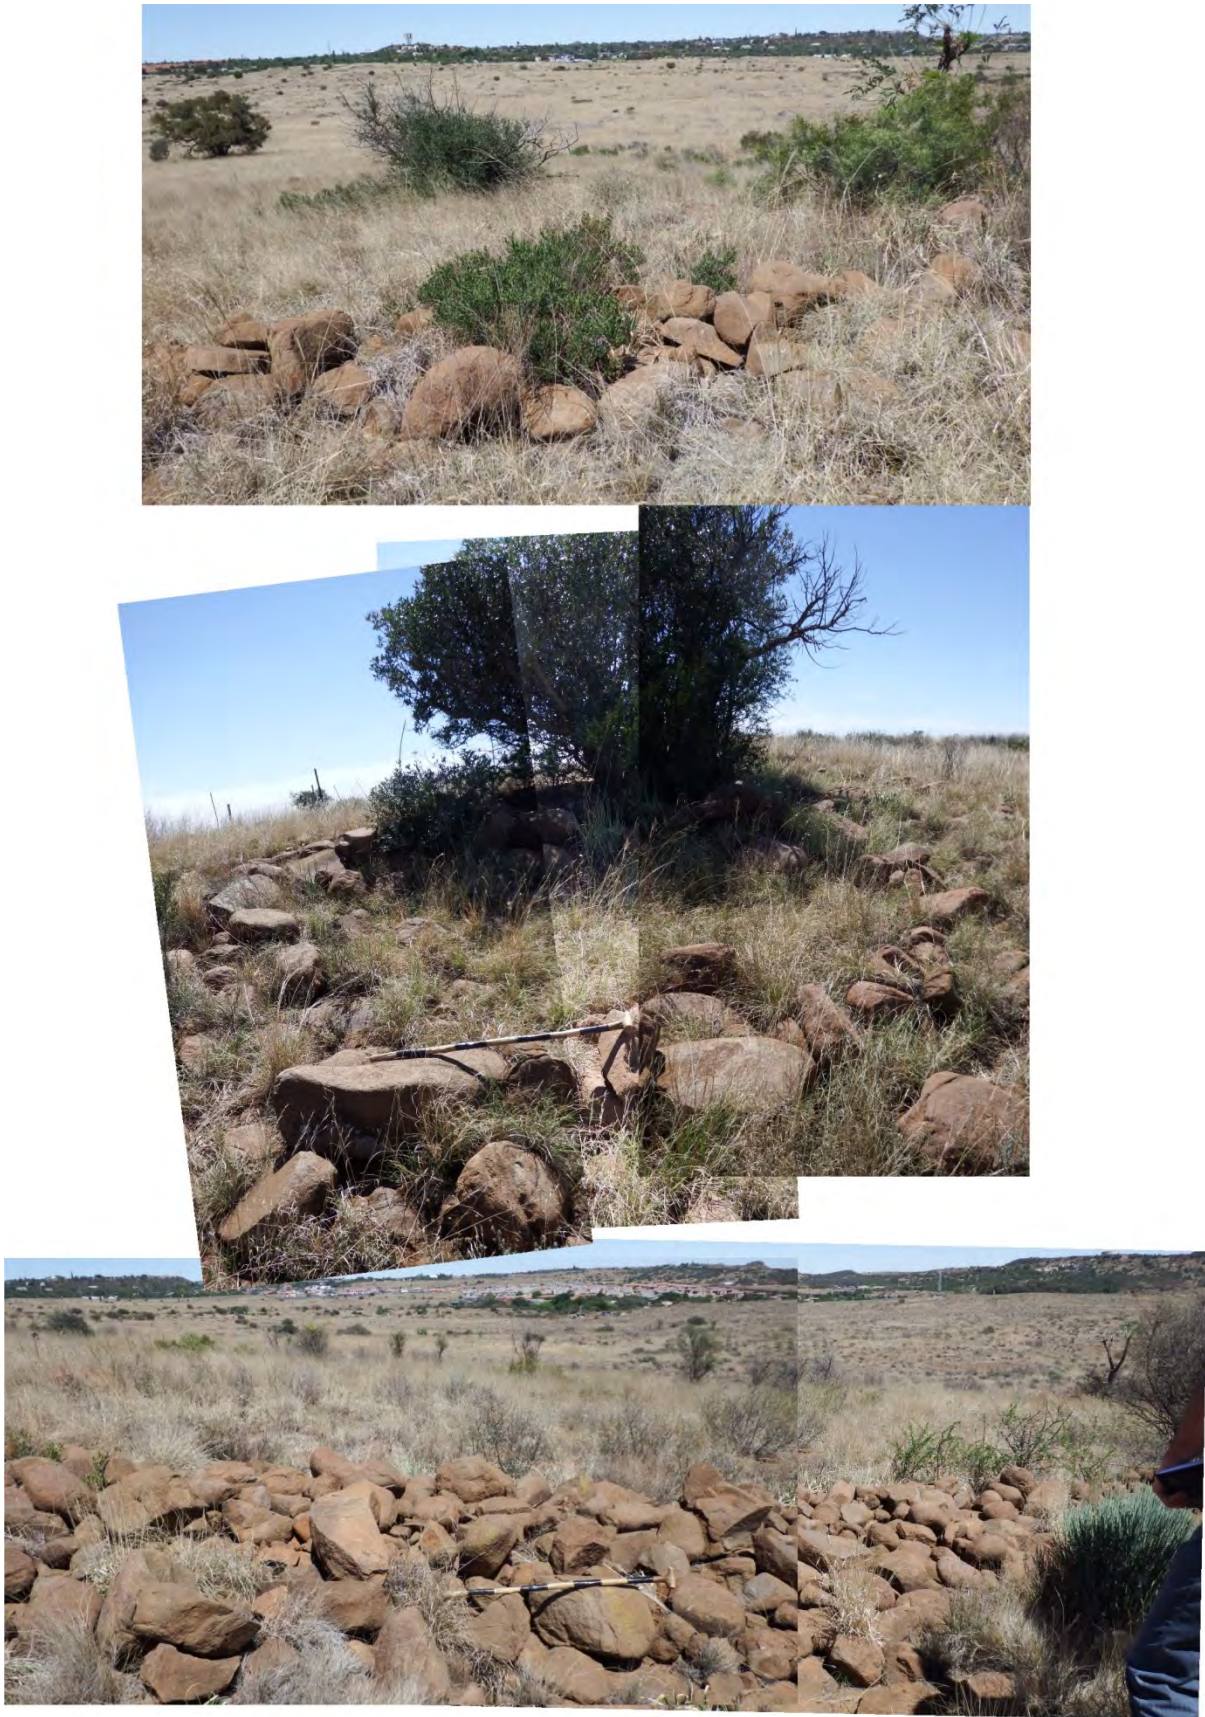
Figure 10. Remains of sangar structures located on a dolerite outcrop at the north-eastern boundary of the site. Scale 1 = 10 cm.

- The cluster of sangars located on a dolerite hill at the north-eastern boundary of the footprint is avoided and protected by a durable and clearly visible fence to be erected before the start of the of the development and under supervision of a qualified heritage specialist.

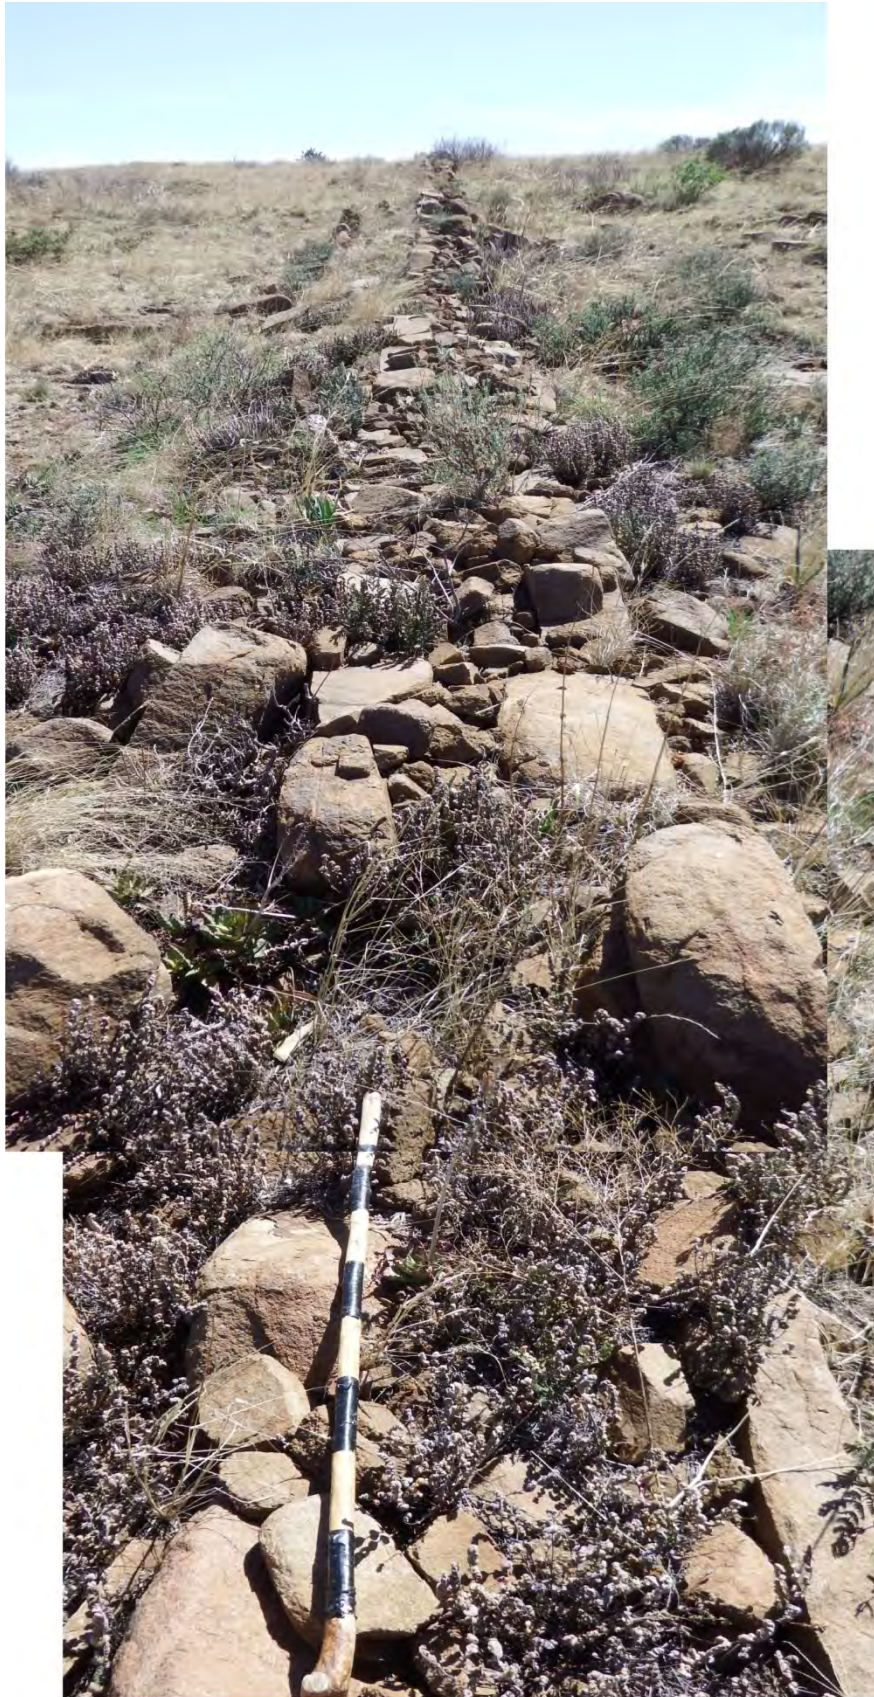
Figure 11. Remains of historical stone wall, looking north-northeast. Scale 1 = 10cm

- The 30 m – section of stone wall structure located along the southeastern boundary of the footprint is avoided and protected as part of a designated open or green area with a clearly visible fence in place for the period of construction or;  
the 30 m – section of stone wall structure is, pending permission from SAHRA, carefully removed and reconstructed within a designated open or green area within the footprint, before the start of the construction phase of the development and under supervision of a qualified heritage specialist. This process will require a removal permit from SAHRA. The reconstruction must be accompanied by appropriate information displays.
