The Workshop Building:

AMAFA Submission Research Document

Property: The Workshop - 99 Samora Machel (Aliwal) Street, Durban, 4001

Date: 25 May 2022

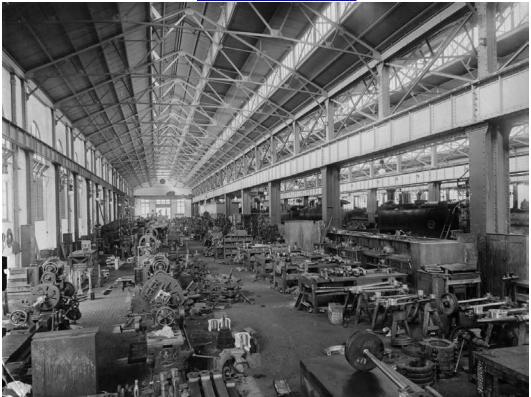
https://atom.drisa.co.za/ P1288.jpg - Internal Locomotive Shed

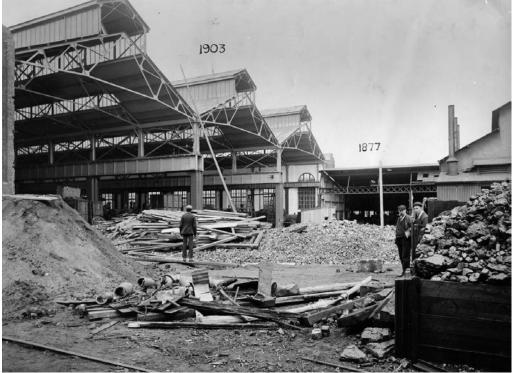
https://atom.drisa.co.za/ P1289-01.jpg – Internal Locomotive Shed https://atom.drisa.co.za/ P1346.jpg – Construction shed extension

Relevant in showing steel structure, clerestory lighting and roof sheeting as well as columns and support beams

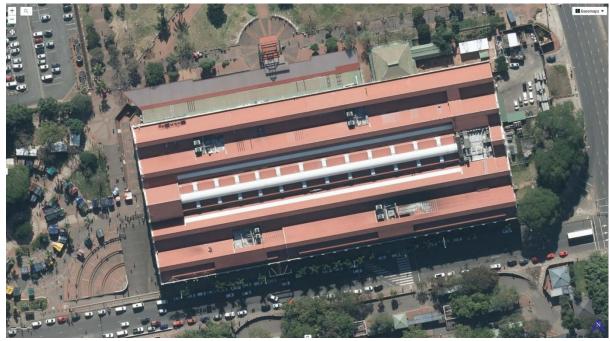
Existing Roof structure showing Polycarb sheeting
