# **A DESKTOP ARCHAEOLOGICAL IMPACT ASSESSMENT OF THE BOULEVARD PRECINCT, BRAM FISCHER AIRPORT, BLOEMFONTEIN**

(In terms of Section 38 of the NHRA of 1999)

## **Airports Company South Africa (ACSA)**

November 2013

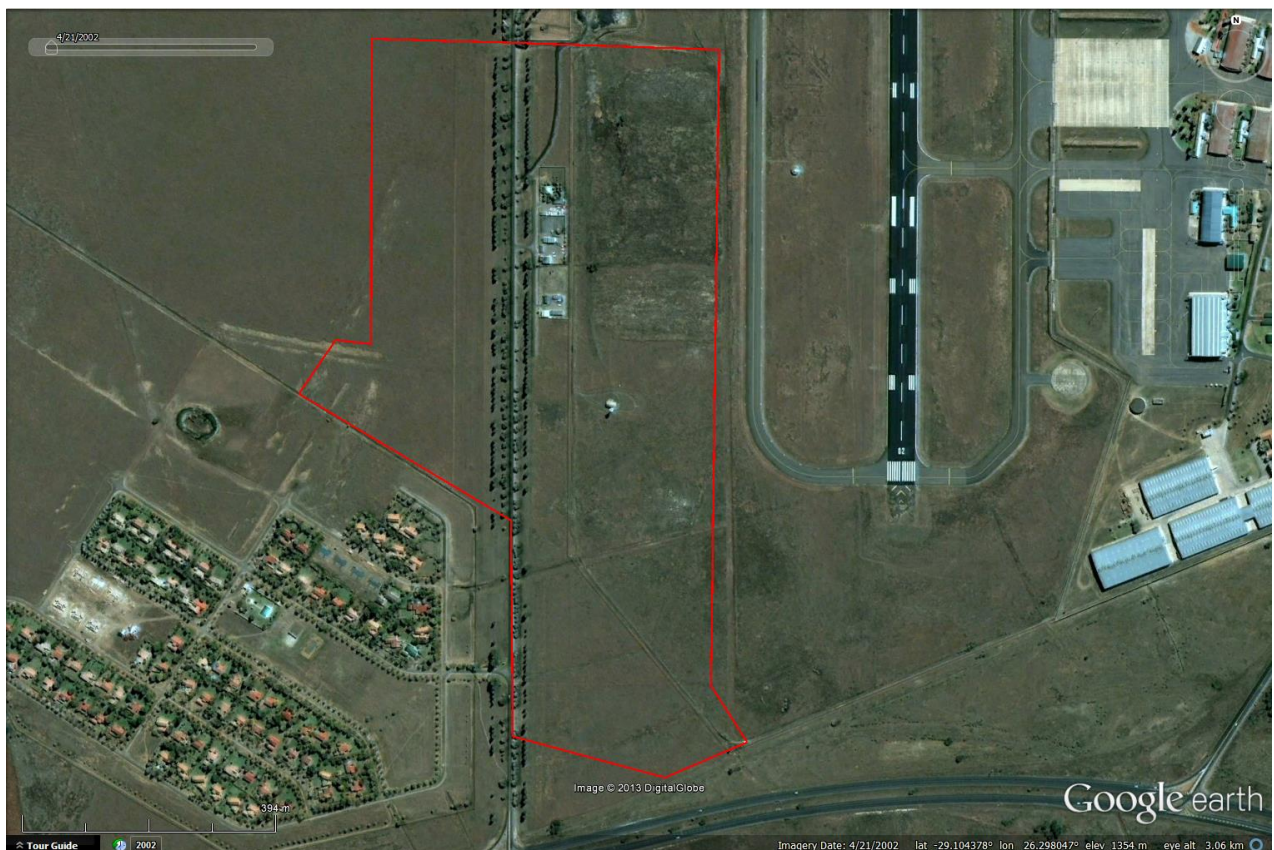
**Figure 2:** The site (red polygon) on 21 April 2002. The airport access road is well established and some minimal development is seen to the east. Possible pre-existing disturbance to the east of the buildings may relate to airport construction?

In the study of new roads around Bloemfontein airport, which appear on the aerial photos of 2010 were probably built to coincide with the Fifa World Cup Soccer Tournament (see figures 4-8). Dreyer notes: “many developments and upgrading took place over the years and numerous alterations had been done, resulting in severe damage to the environment. No archaeological and cultural remains or historical material were found in the proposed areas of development” (Dreyer 2008c:2). These comments concur to some degree with the disturbances that are evident on the aerial images as described in the captions of Figures 2-8.

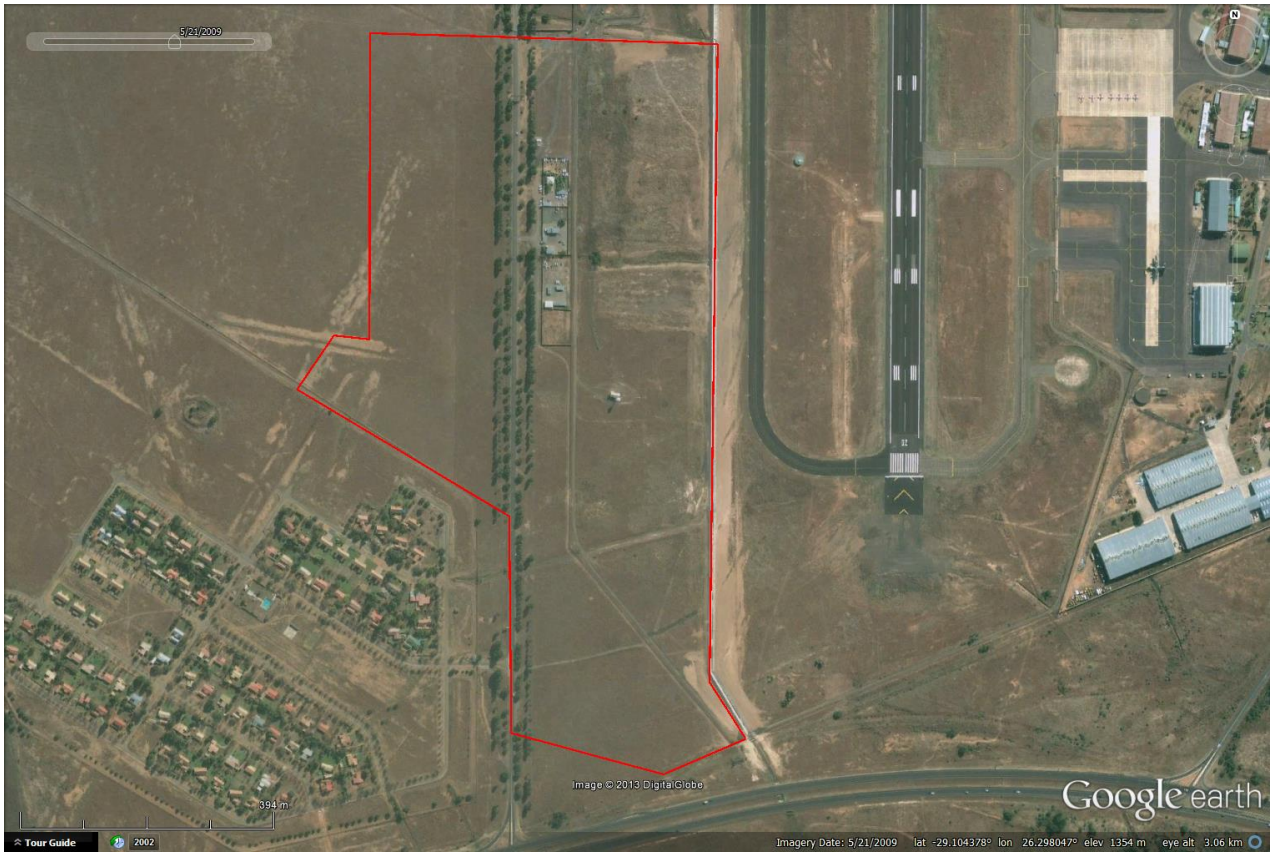
**Figure 3:** The site (red polygon) on 21 May 2009 shows some addition to the built area. Pre-existing disturbance is more evident in this image. Airport security fence has shifted to the east.

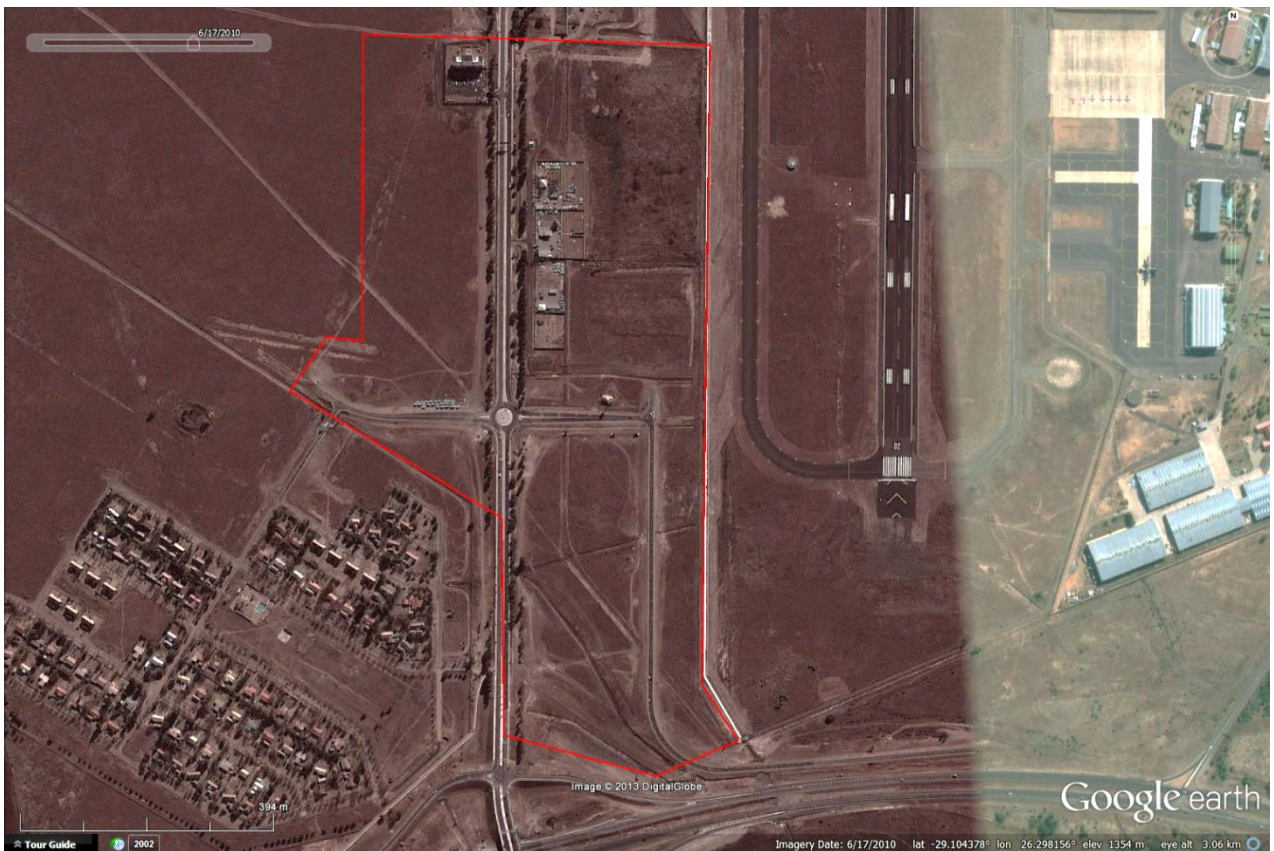
**Figure 4:** The site (red polygon) on 17 June 2010. Considerable changes are evident both to the built environment and to road infrastructure. A new building (hotel) is added to the west of the road, and the approach road has been converted to dual carriageway with traffic circle. New roads feed off the circle to east and west.

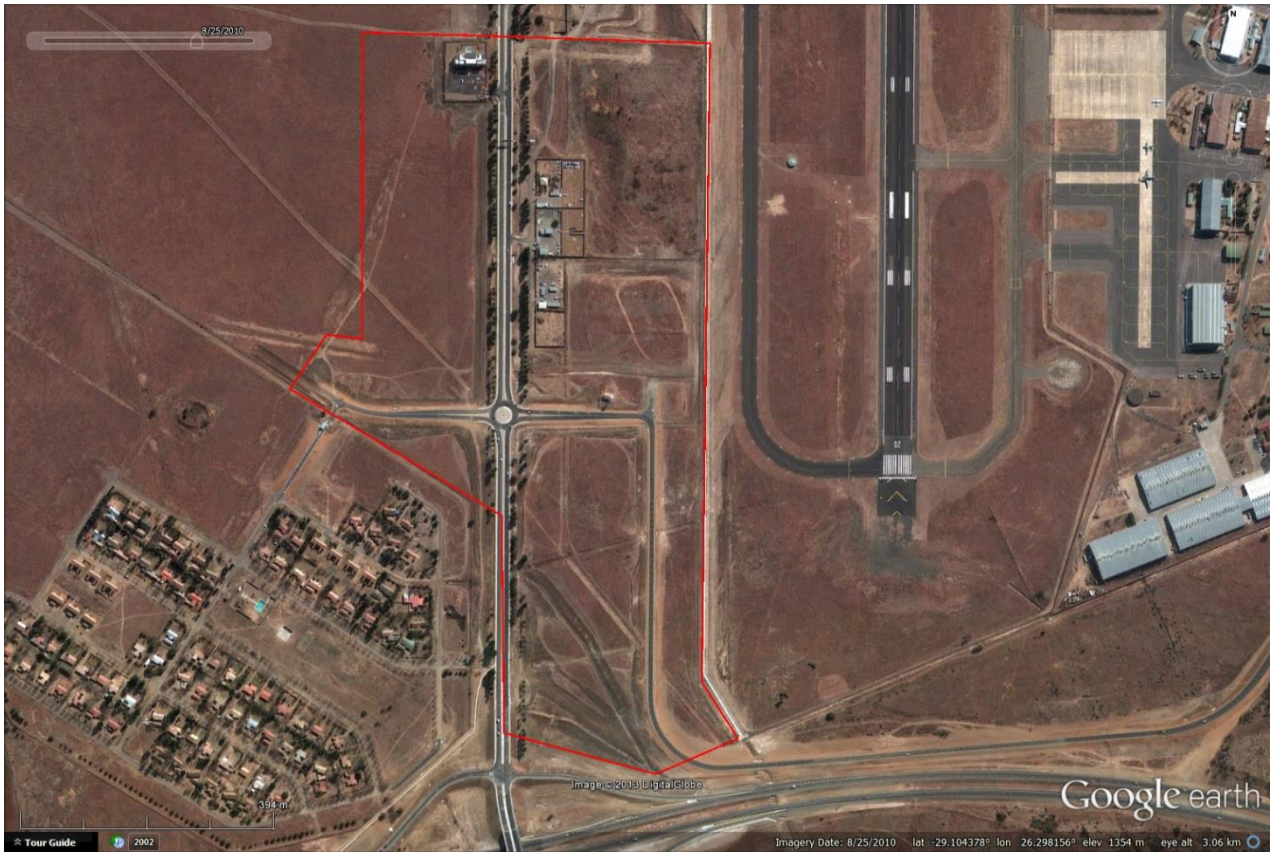
**Figure 5:** The site (red polygon) on 25 August 2010. Much the same as in June with additional earthmoving in the south of the site.

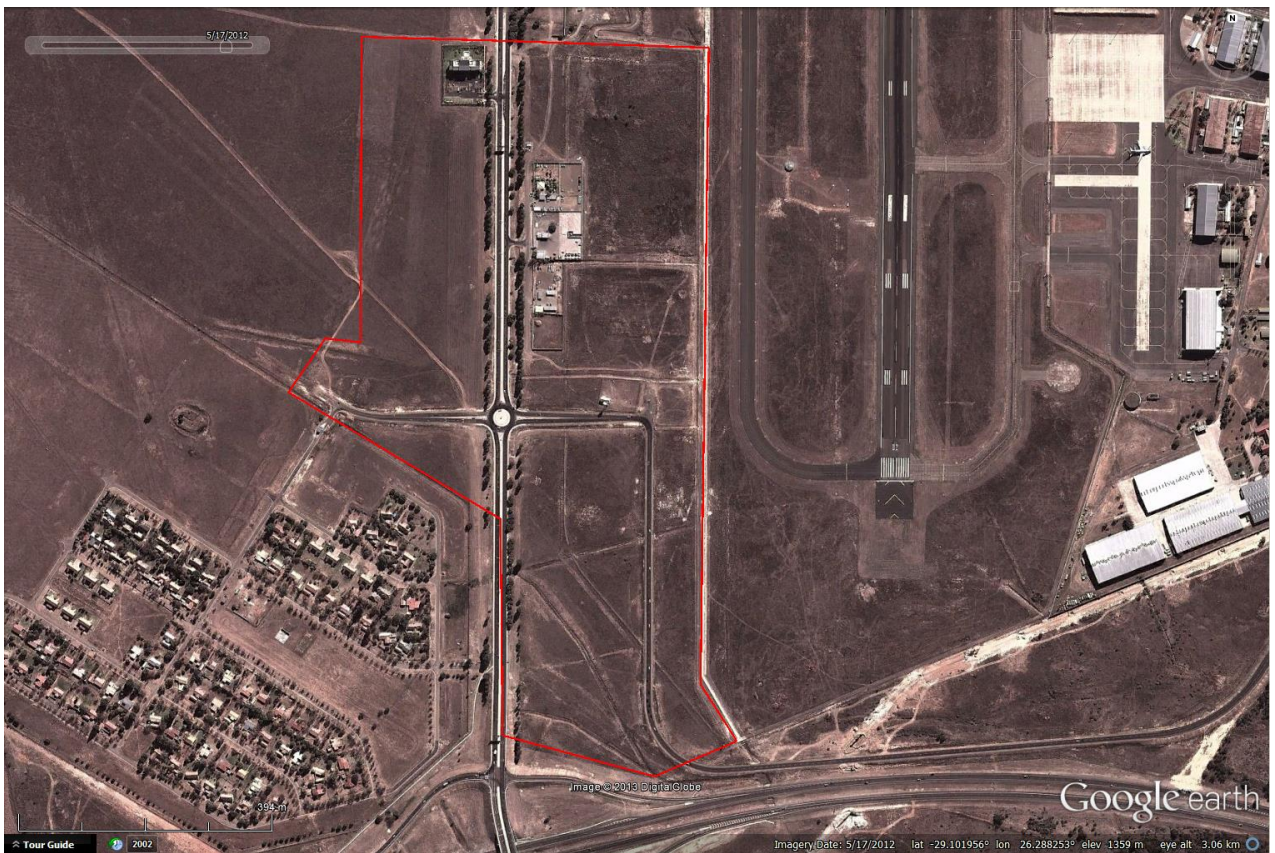
**Figure 6:** The site (red polygon) on 17 May 2012. Much the same as in 2010.

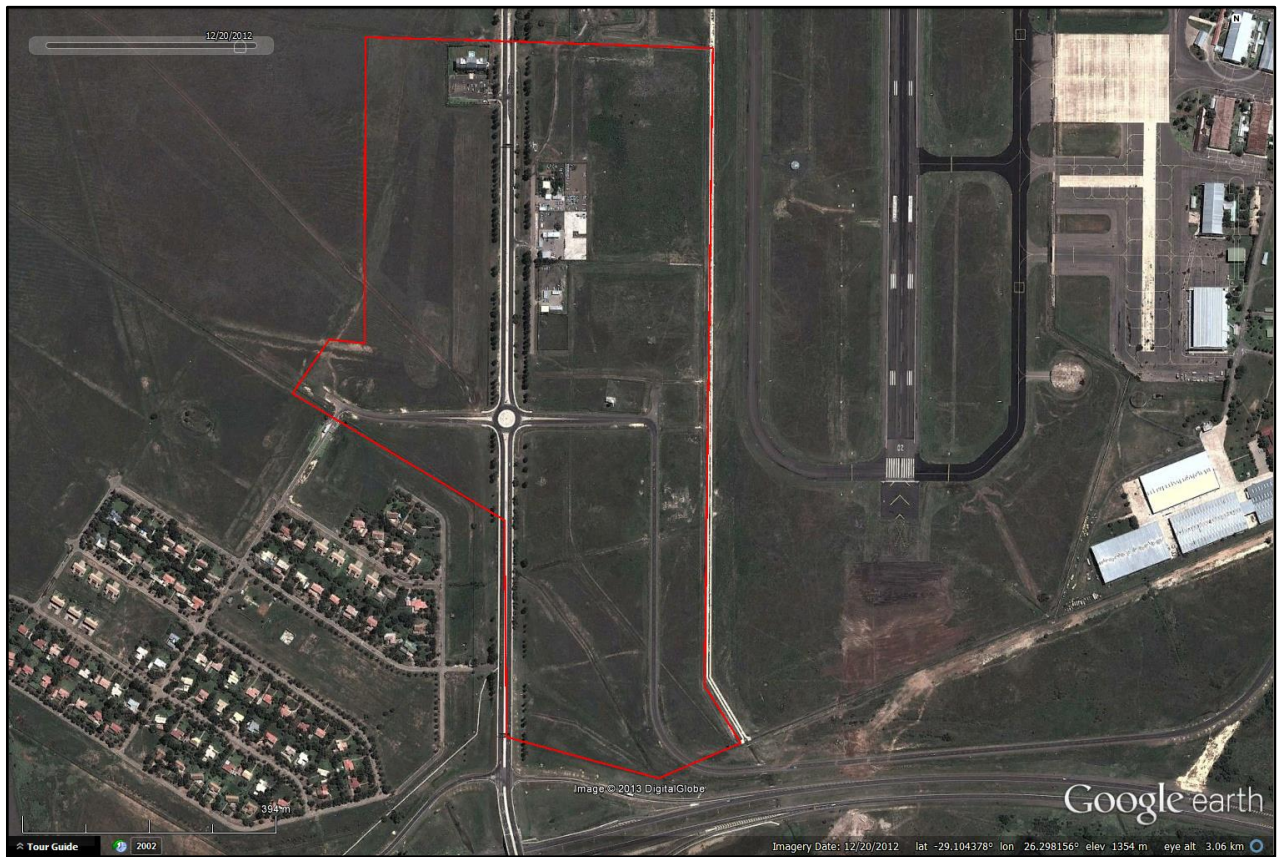
**Figure 7:** The site (red polygon) on 20 December 2012. Much the same except crop marks visible on the upper western part of the site suggesting previous agriculture.

In our opinion, the eastern part of the site has been heavily disturbed, and is unlikely to contain archaeological or historical material. The land to the west appears to have been used for agriculture in the past and is therefore also unlikely to preserve any in situ archaeological or historical remains. We have taken cognisance of Dreyer’s observations of a general paucity of heritage remains in the area in coming to our conclusion. We believe that, based on the balance of probabilities, there is a very low likelihood of impacting heritage resources on the Boulevard Precinct site.
