The proposed hydropower station and associated infrastructure at Boegoeberg Dam on the Orange River, near Groblershoop, Northern Cape

HERITAGE IMPACT ASSESSMENT FOR THE PROPOSED BOEGOEBERG HYDROPOWER STATION NEAR GROBLERSHOOP, NORTHERN CAPE

(Assessment conducted under Section 38 (8) of the
National Heritage Resources Act (No. 25 of 1999) as part of an EIA)

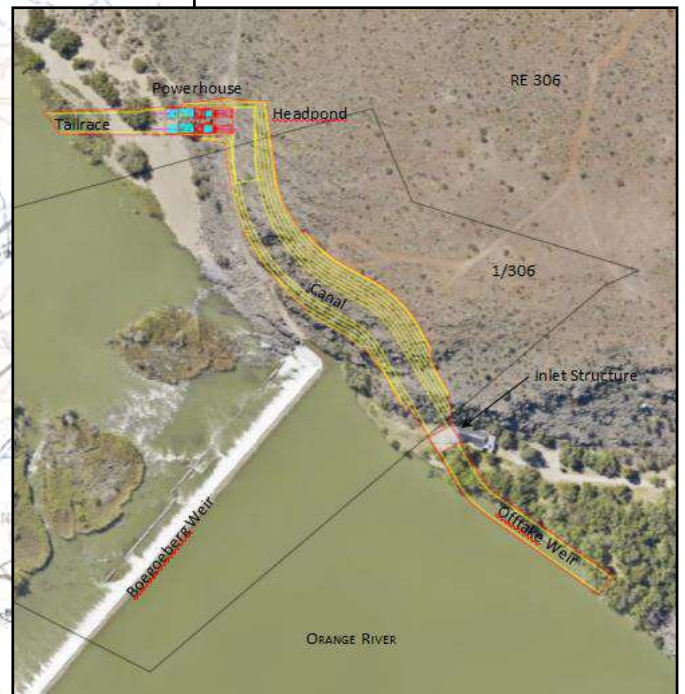
Figure 1: Map showing the location of the proposed project. The thick red line denotes the position of the canal and turbines while the thin line represents the transmission line which would continue southwards to the Fibre Substation just north of Marydale. The inset shows a site plan (Source: Aurecon 2013).

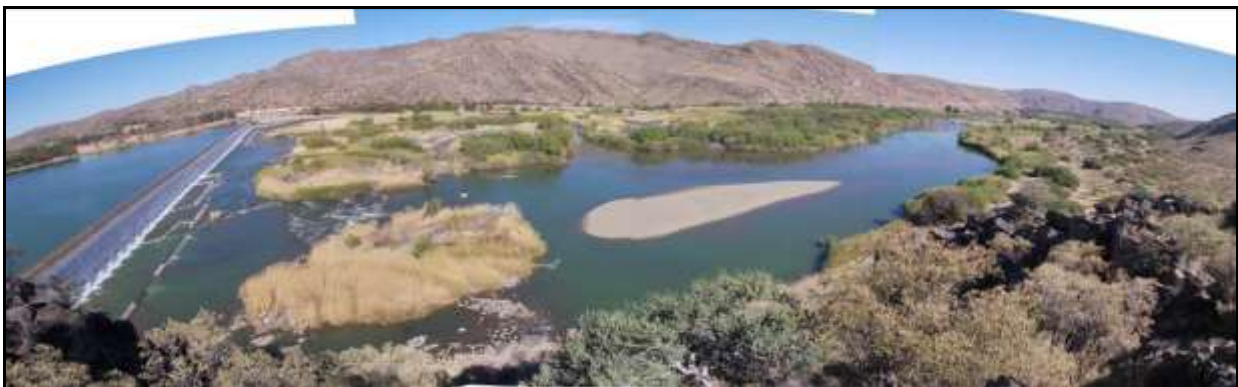
Figure 2: View from above the Boegoeberg weir showing the character of the river valley at this point. The photograph is taken from the top of the small cliff below which the power station would be built.

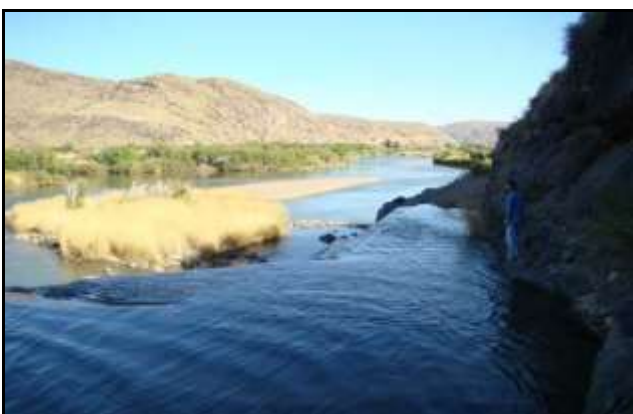
Figure 3: View of the small cliff at the north-eastern end of the weir.

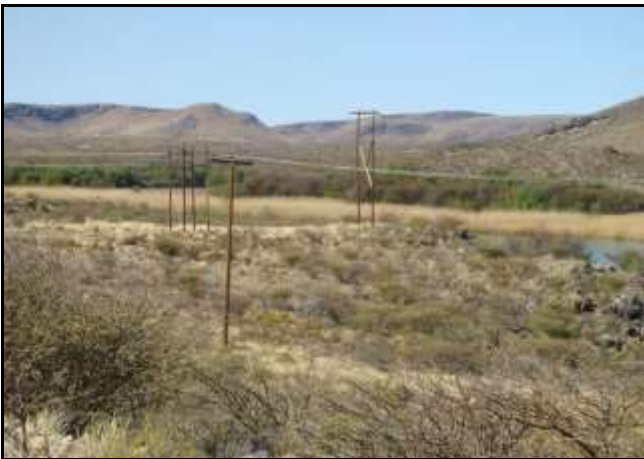
Figure 7: The point where the power line would cross the river alongside an existing line.

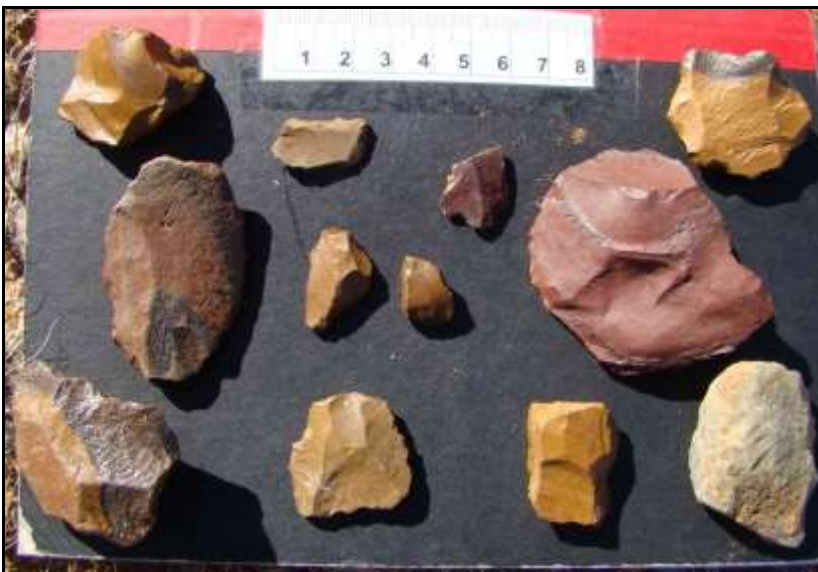
Above the cliff at the Boegoeberg Weir an extensive scatter of stone artefacts was recorded (site ZKB2013/001). Most are likely to be MSA in age (Figure 12 & 13) but a few grindstones (Figure 14 & 15) and other isolated flaked artefacts are probably LSA. There is no obvious occupation site but the position offers an excellent view over the valley and was no doubt repeatedly used for short periods. One area of this scatter (point 014) was particularly dense. Similar, but less dense and more weathered material was recorded on the hill where the proposed transmission line would cross the river (point 076).

Figure 12: Banded ironstone artefacts from ZKB2013/001.

- Archaeological mitigation should be carried out at site ZKB2013/001 on the platform at the top of the cliff prior to construction; and
- The stone structures at BDW2013/001, specifically the one near the road, should be avoided during and after construction. Careful placement of pylons will be required to ensure that these structures are spanned but care should be taken to avoid damage to them during construction.

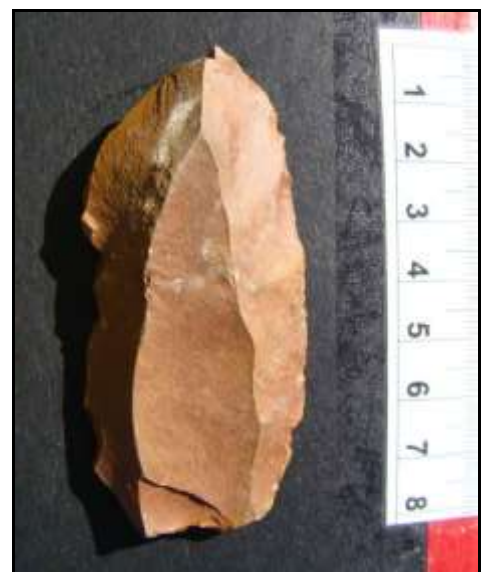
Figure 13: Typical MSA blade from ZKB2013/001.

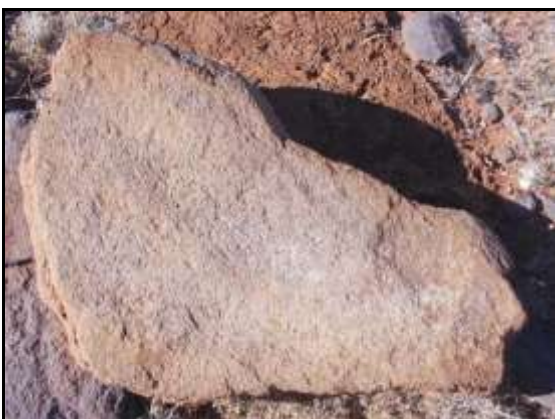
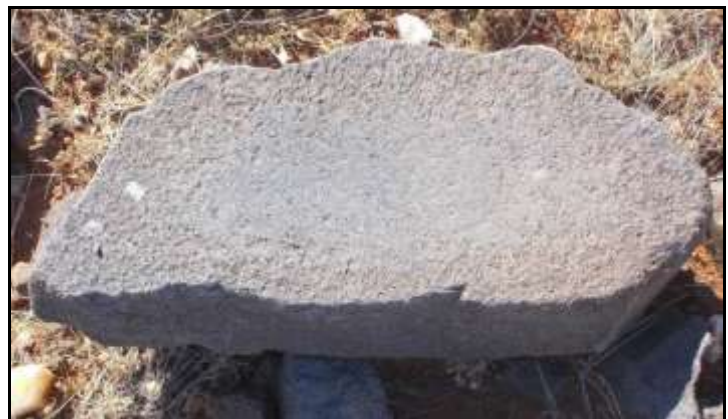
Figures 14 & 15: Two quartzite lower grindstones from ZKB2013/001.

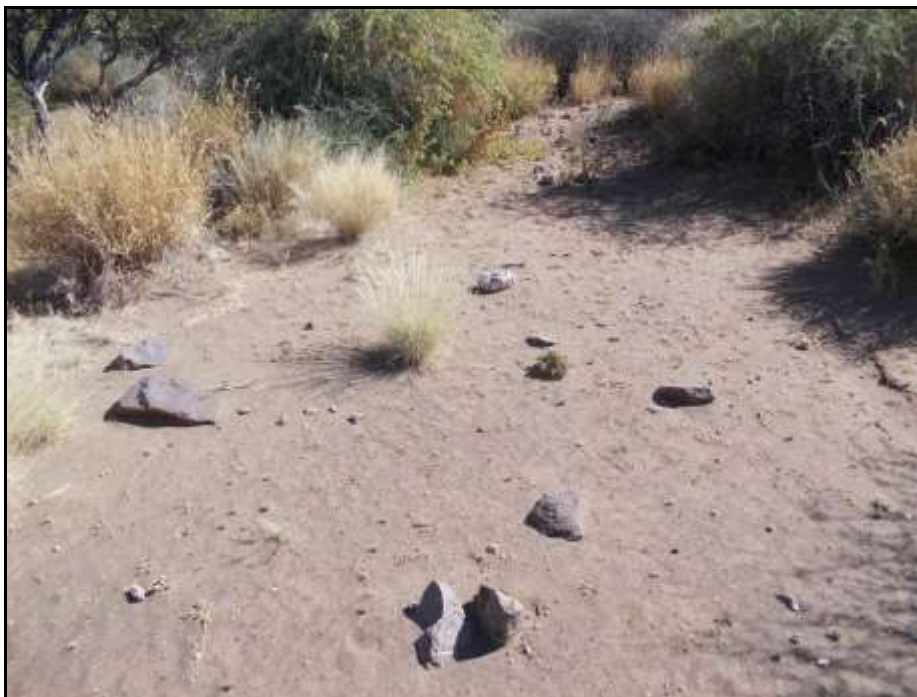
On the sandy floodplain just downstream of the weir was a small and very ephemeral archaeological site (site ZKB2013/006). It consists of a scatter of rocks that may well have been used to anchor a hut (Figure 16). Just two artefacts and one fragment of ostrich

Figures 16: The scatter of rocks at ZKB2013/006.

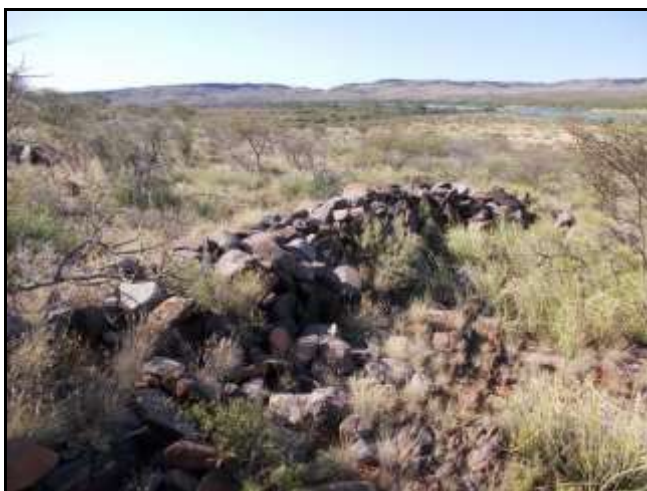
The most interesting archaeological site was a cluster of low stone walls on the south side of the river and on the mountain slope close to the power line crossing point. A total of twelve features were recorded at the site, named BDW2013/001 (points 24, 52-62). The features included straight walls, semi-circles, L-shapes and small mounds of rocks (Figures 17-21). Only one flaked stone artefact was found associated and this was within the semi-circle at point 024. It was a banded ironstone flake. These stone walls are fairly typical of pre-colonial walling from the Karoo (Hart 1989; Sampson 1984, 1985) and some may have been hunting blinds – that they face down towards the river valley offers further support for this.

Figures 17: The L-shaped stone walling at BDW2013/001 (point 052).

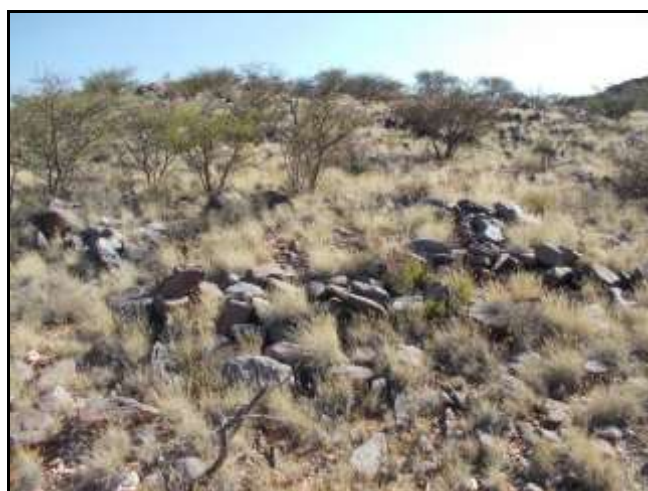
Figure 18: A semi-circular stone feature at BDW2013/001 (point 057).

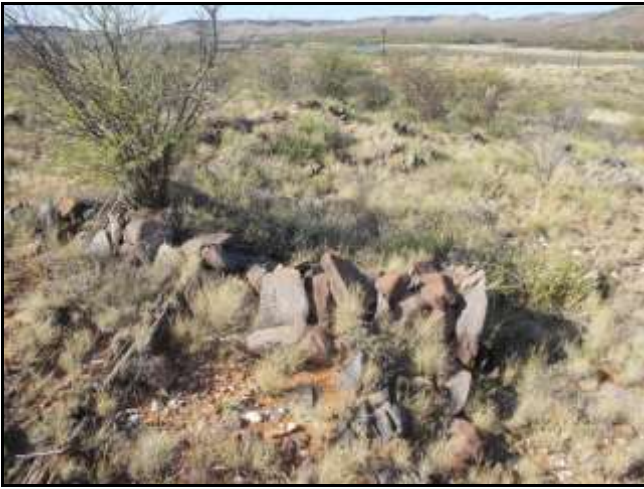
Figures 19: The L-shaped stone walling at BDW2013/001 (point 062).

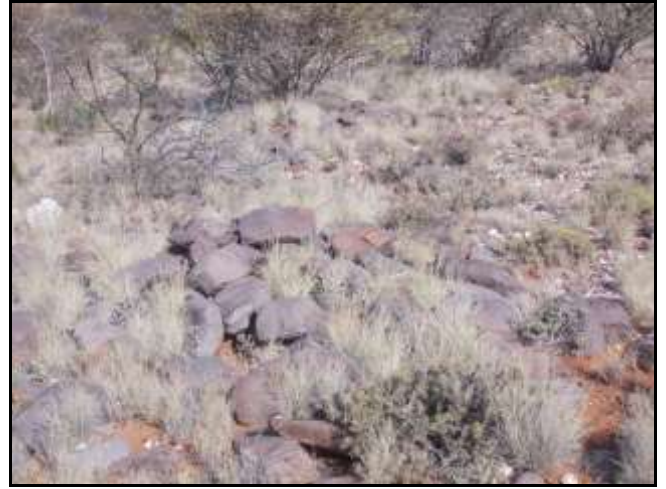
Figure 20: A stone mound at BDW2013/001 (point 057).

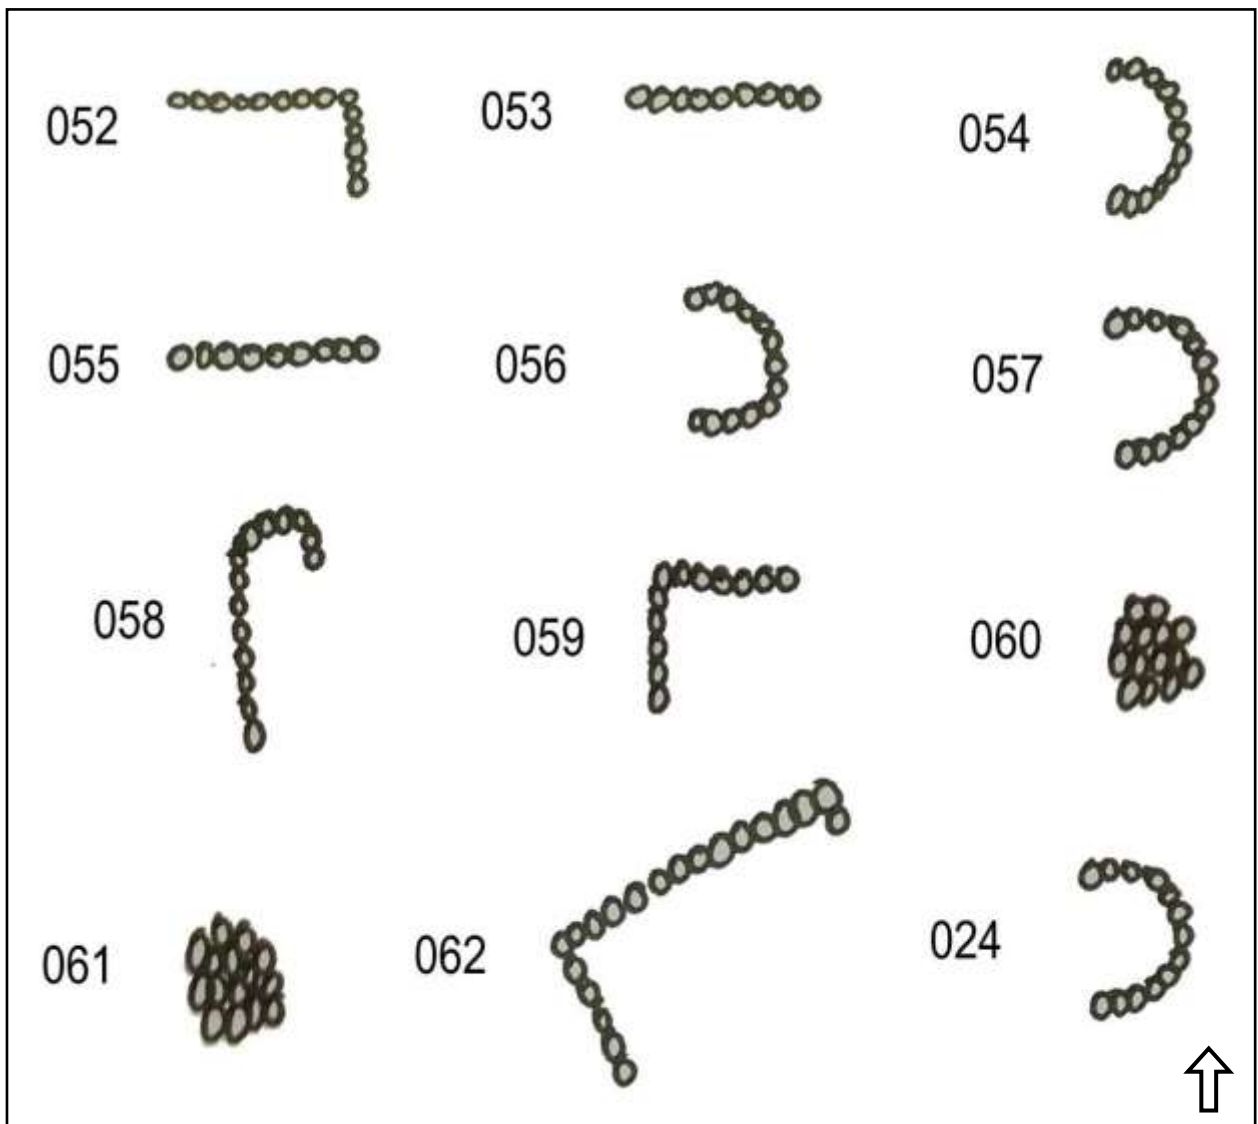
Figure 21: Schematic plans of all the stone features at BDW2013/001. Scales vary, GPS points as labelled, the arrow indicates north.

- Archaeological mitigation should be carried out at site ZKB2013/001 on the platform at the top of the cliff prior to construction; and
- The stone structures at BDW2013/001, specifically the one near the road, should be avoided during and after construction. Careful placement of pylons will be required to ensure that these structures are spanned but care should be taken to avoid damage to them during construction.

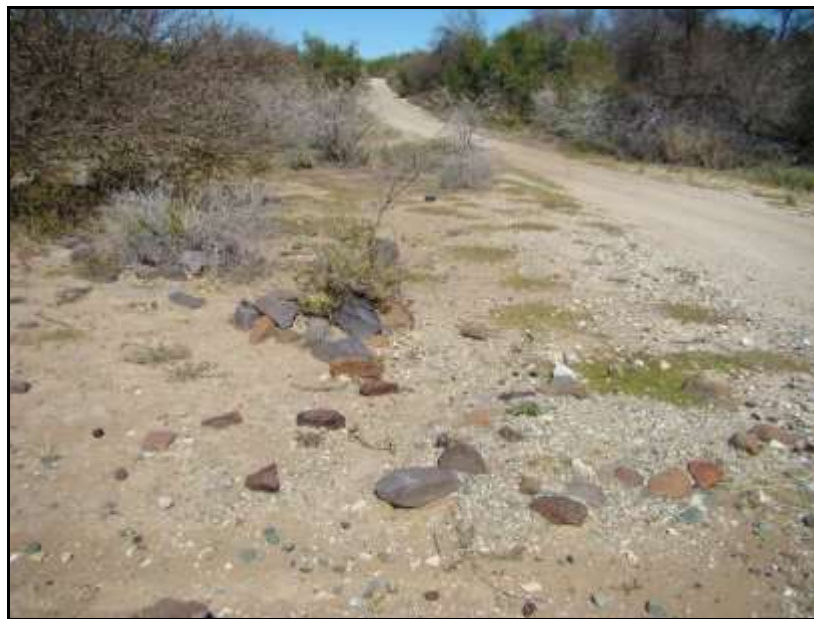
One informal graveyard and two isolated graves/probable graves were located. The graveyard lies alongside the access road to Zeekoebaart and one grave is within about one metre of the edge of the road (Figure 22). There are at least eight graves all placed in a single row. They are aligned east west. In the sandy floodplain just downstream of the cliff where the weir is are two possible graves – the authors are confident that at least one of them will be a grave. One is a cement headstone seemingly propped up in the sand (Figures 23 & 24). Its caption reads: “Rus in vrede Gert Peters oorlede die 10 April 1953, 62 jaar, die seun van die mens.” The authors were told by the land owner that the person had drowned upstream but had been buried on the spot where his body washed up. It is possible that this headstone is out of position and might even have been moved downstream from another location in the approximately 130 m of silts between it and the weir. Nearby, some 50 m to the northwest, is a stone cairn that seems very much like a burial cairn (Figure 25). Whether the cement headstone in fact belongs with this cairn is unknown, but it is possible that two graves are represented. Many people died during construction of the Boegoeberg Weir (see below) but it is not known where they were buried.

Figure 22: Graves at ZKB2013/004. The circle of rocks on the right is the grave lying closest to the road. The line of graves extends into the bush on the left.

- If the road passing the graveyard at ZKB2013/004 is to be used for access to the transmission route then the graves must be cordoned off and avoided during and after development (due to its generally sensitive location, erection of a permanent fence around this graveyard could be considered);

For graves, mitigation will involve temporary fencing and complete avoidance of all known and possible graves. Since the small graveyard is in such a vulnerable position immediately alongside a gravel access road, a permanent fence and gate could be considered there. Detailed recommendations are provided in Section 9.

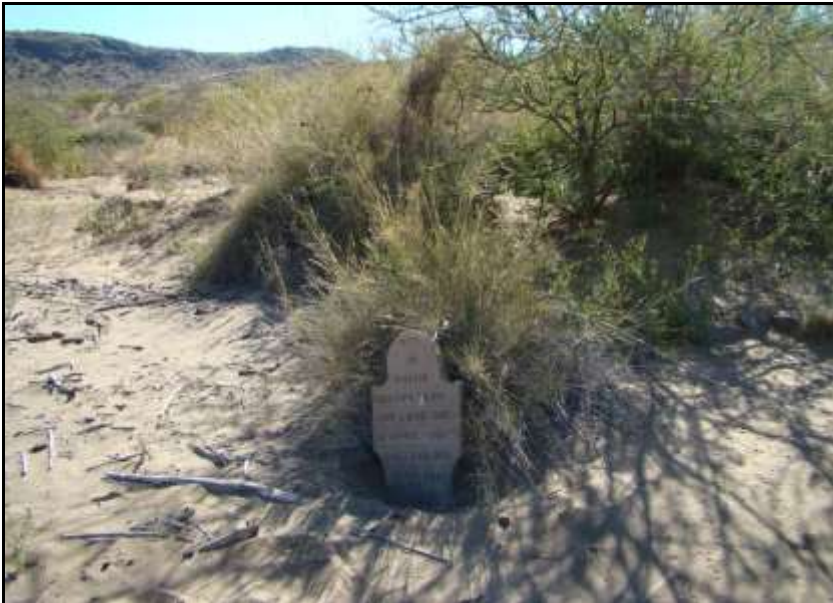
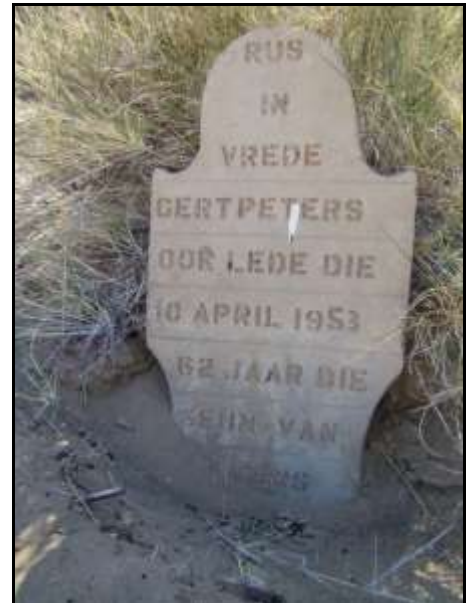
Figures 23 & 24: Headstone at ZKB2013/003.

| Field Number | Site Name | Co-ordinates | Description | Significance / Mitigation |
|---|---|---|---|---|
| 017 | ZKB2013/003 | S29 02 18.8 E22 12 06.5 | A headstone in the loose river sand which reads: "Rus in vrede Gert Peters oorlede die 10 April 1953, 62 jaar, die seun van die mens ...". According to Mr Fourie, this was someone who had died/drowned upriver and whose body had washed down river. He was buried where found on the river banks. | High Avoid / test / exhume & relocate |

- The gravestone (ZKB2013/003) and stone cairn (ZKB2013/002) immediately downstream of the power station site should be cordoned off for the duration of the construction phase and carefully avoided throughout construction work;

- Excavation in the silts immediately below the weir should be carefully monitored by the ECO just in case there are other burials, or the cement headstone has been washed downstream from another location during floods;

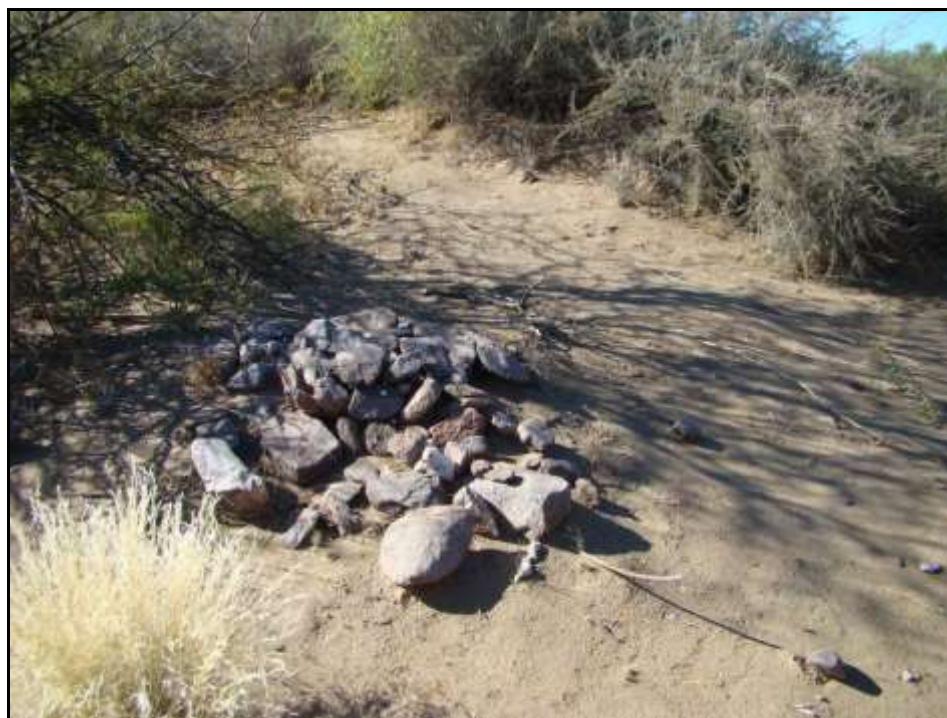
Figure 25: Stone cairn at ZKB2013/002.

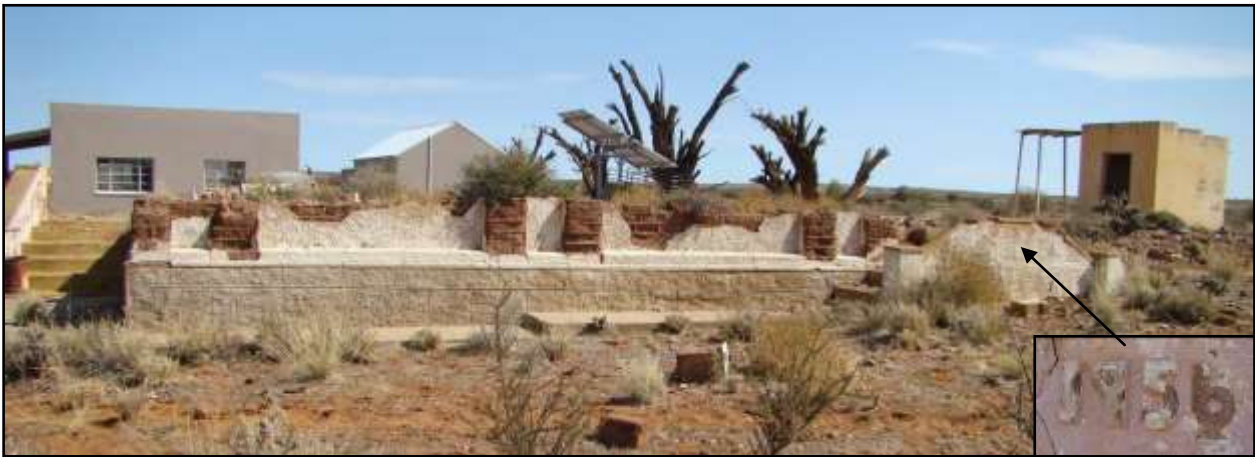
Further north, at point 023, was the remains of a house that had been intentionally demolished (Figure 32). Much rubble was piled nearby. Interestingly, this house was built of traditional materials (sun-dried bricks and mud mortar) but was plastered with modern cement, seemingly in 1956 judging by the date placed on the front of the entrance steps. It is unknown whether it was an old house that got refurbished in the mid-20th century or if it was built in the mid-20th century of traditional materials to save money with just the outer face finished in proper cement. This latter does seem likely. The ruin is about 90 m from the proposed transmission line and will not be directly affected.

Figure 32: Ruin at BFT2013/002. Inset shows the date on the front of the steps.

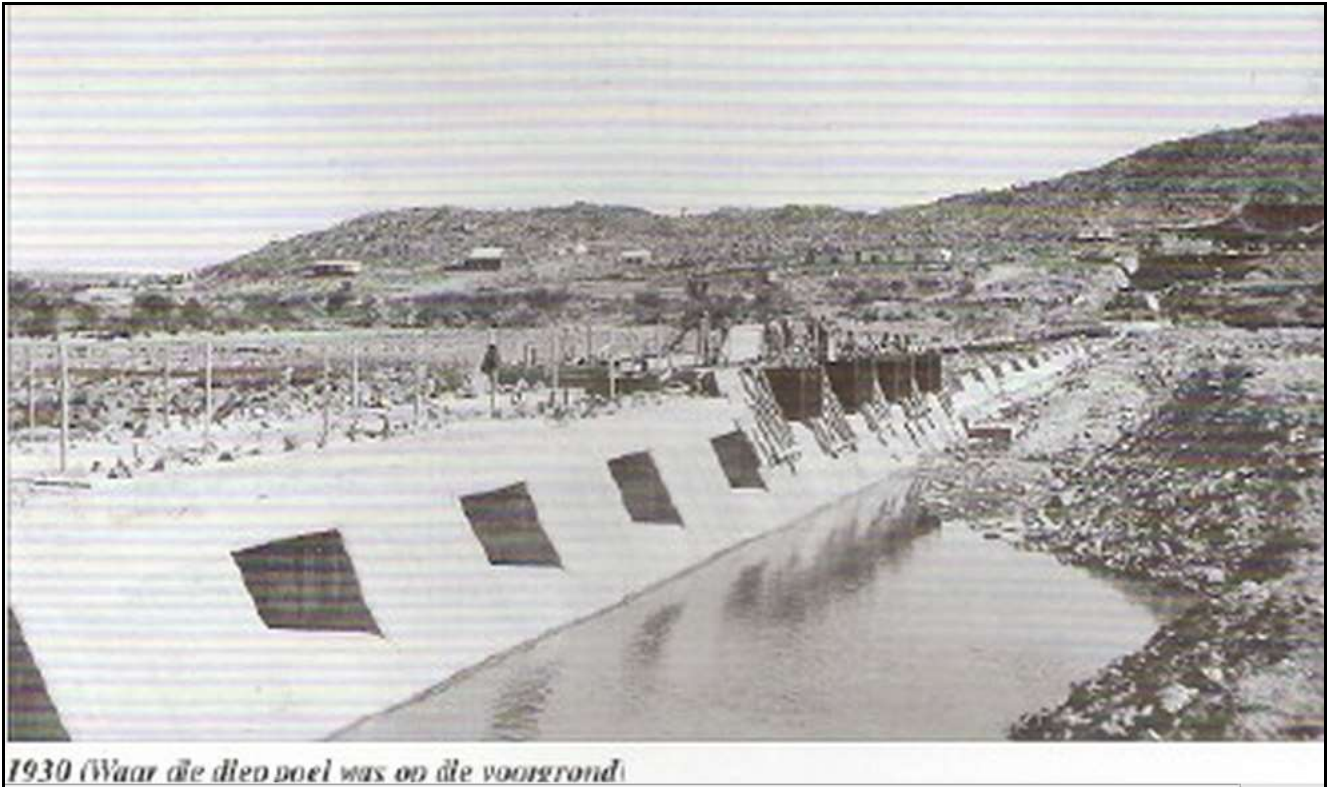
Figures 33 and 34 show historical photographs of the weir under construction.

Figure 33: Boegoeberg Weir during construction in 1930. Source: www.boegoebergecoroute.co.za.

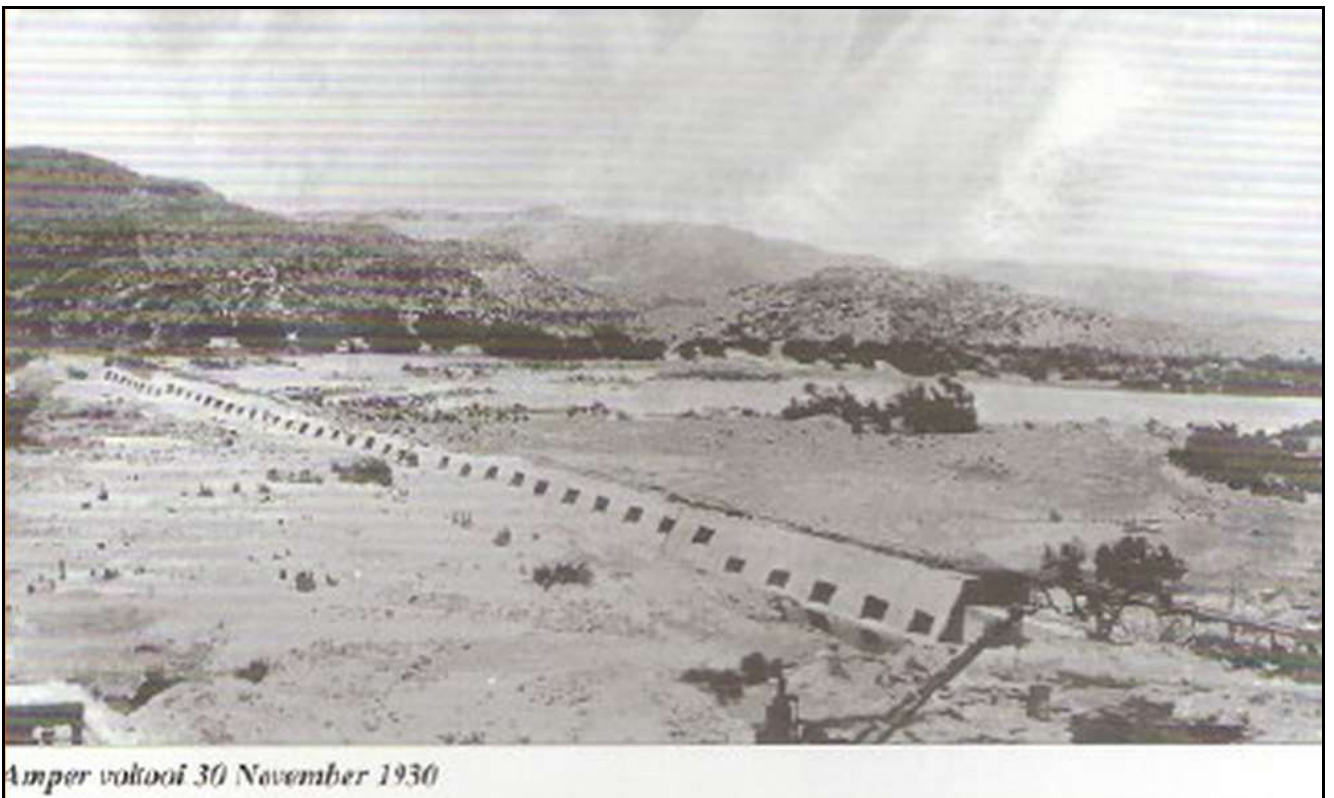
Figure 34: Boegoeberg Weir during construction in 1930. Source: www.boegoebergecoroute.co.za.

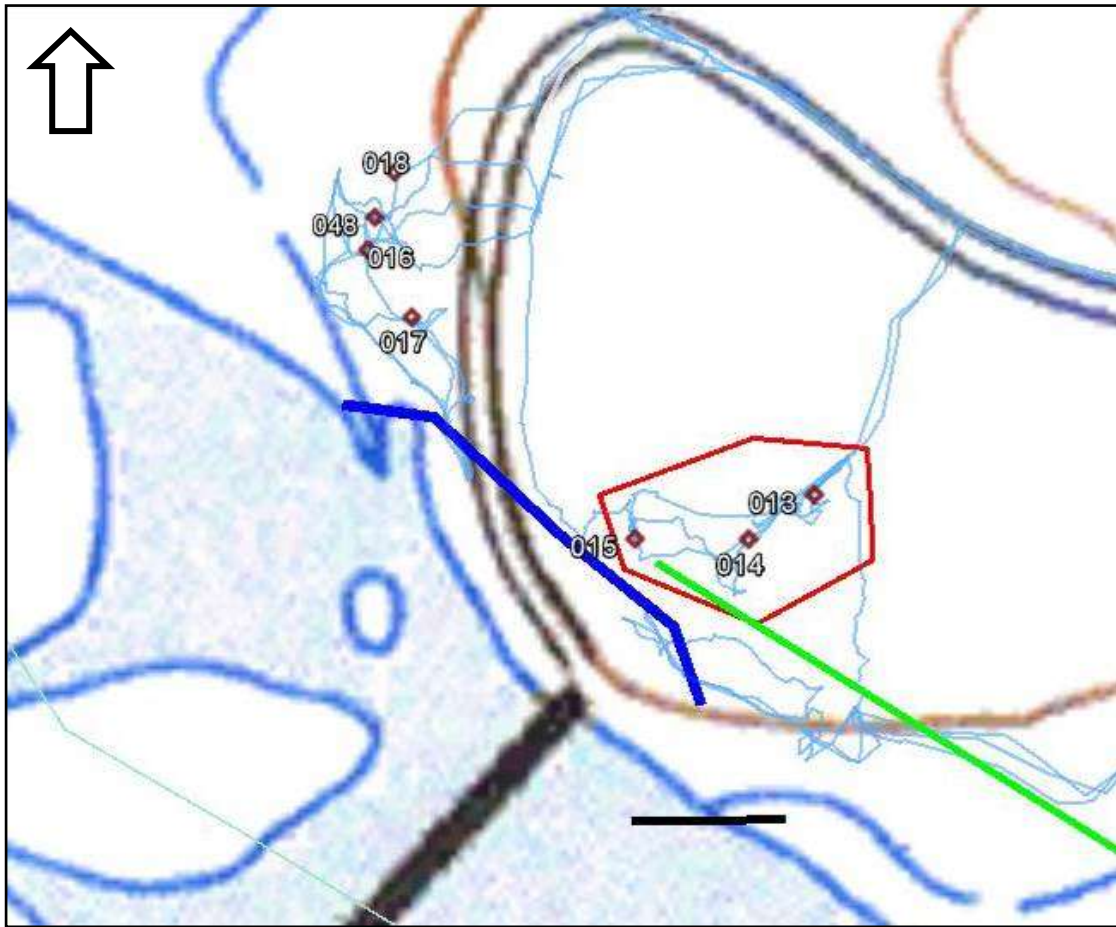
Figure A1: Map showing the location of heritage resources in the vicinity of the canals and power station. Black scale bar = 100m.

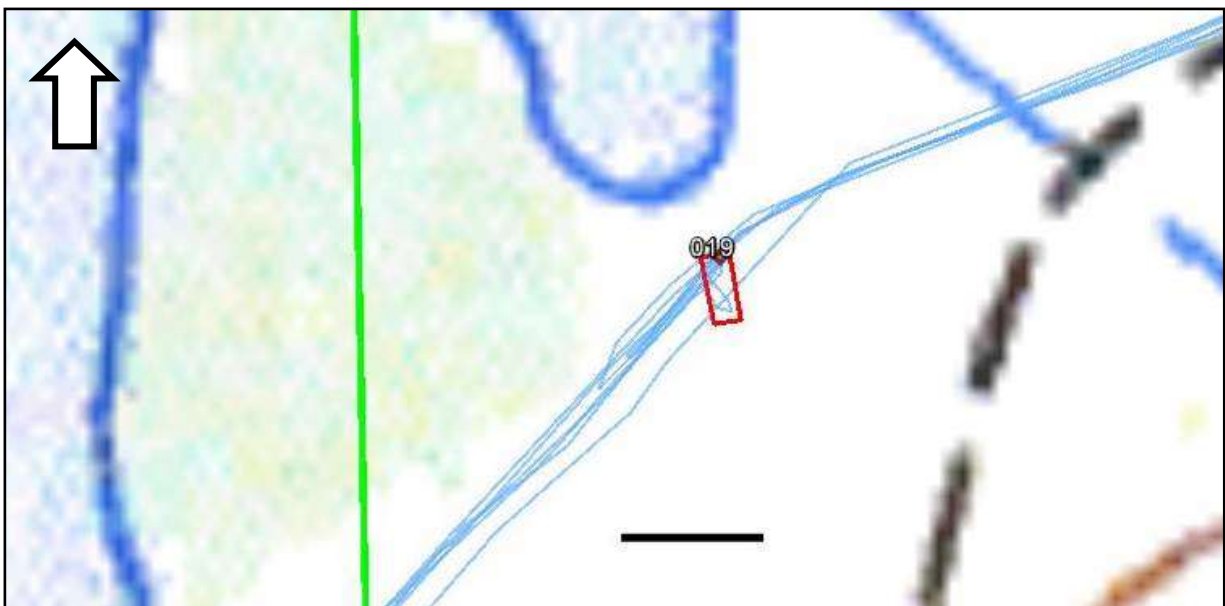
Figure A2: Map showing the location of heritage resources (ZKB2013/004) in the vicinity of the canals and power station. Black scale bar = 50m.

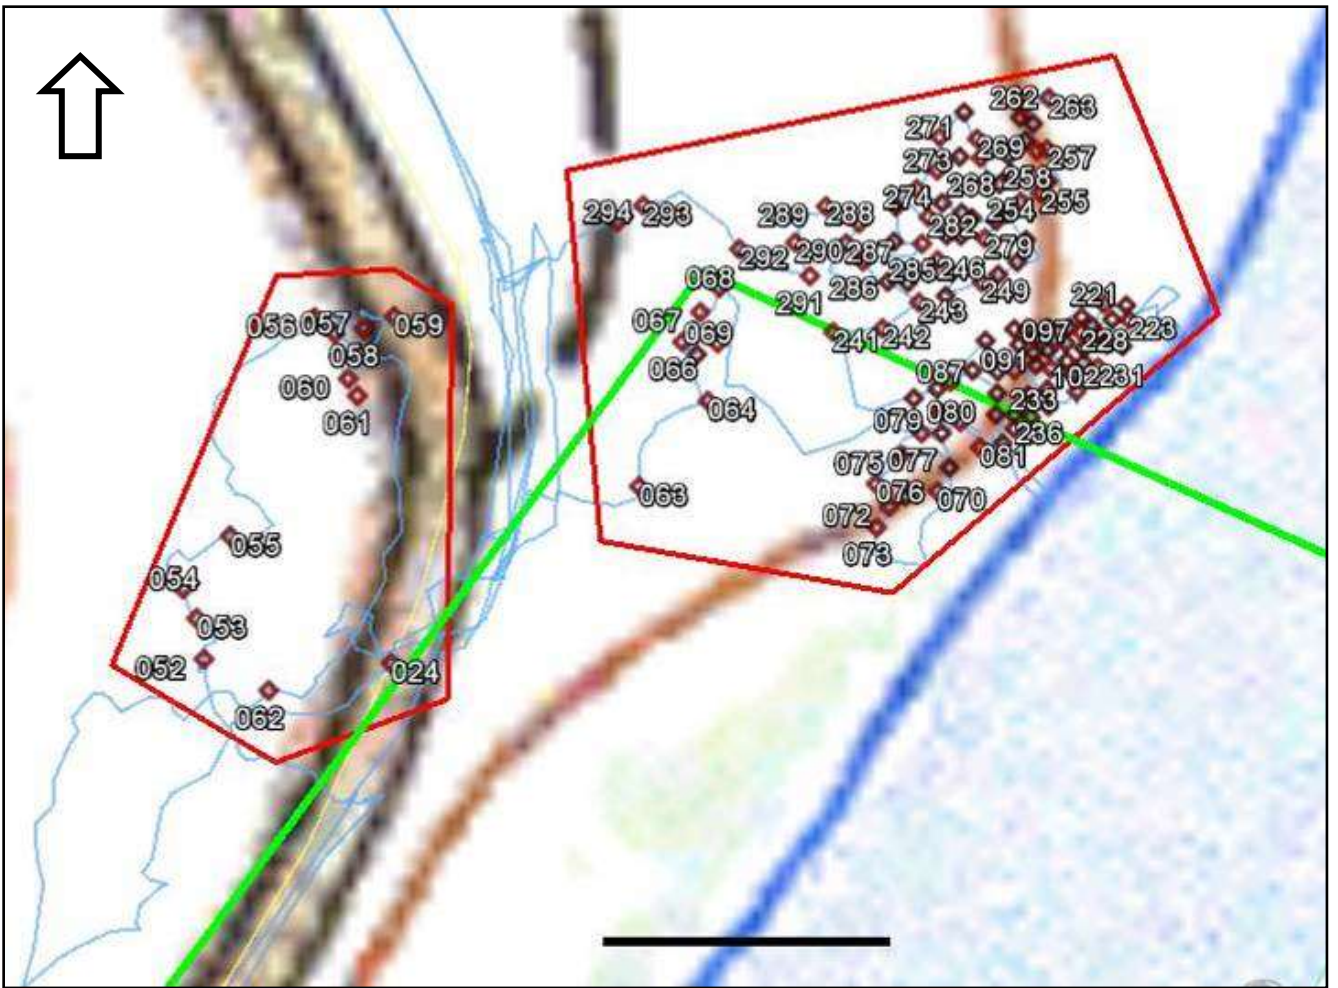
Figure A3: Map showing the location of heritage resources (BDW2013/001 on the left and BDW2013/002 on the right) in the area where the transmission line crosses the river. Black scale bar = 100m.

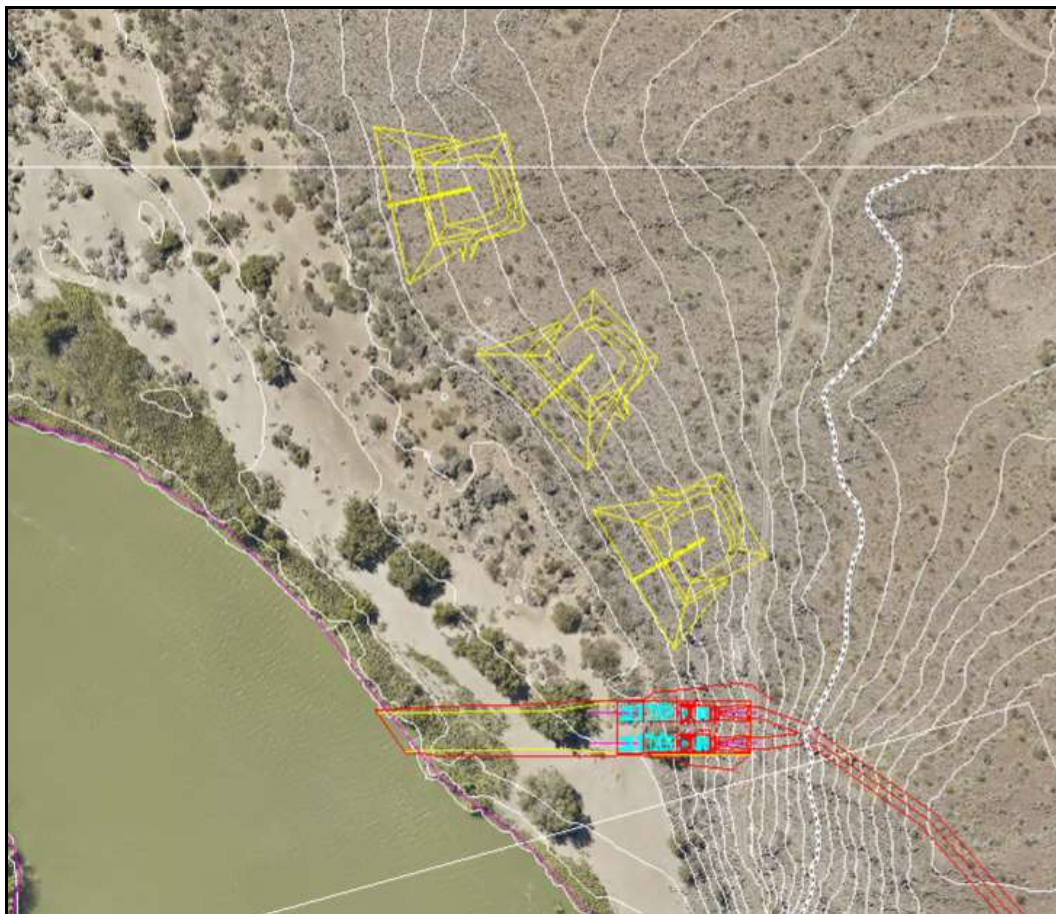
The Boegoeberg Dam will require dredging in order to maintain the water supply to the agricultural canals. At present this silt is scoured through sluice gates but this activity would have a negative effect on the feasibility of the hydropower station due to the large amount of water 'lost' during this action. It is thus proposed to dredge the silt, store it to allow the water to drain off, and sell it on to an appropriate third party. Three storage areas have been identified immediately north of the proposed hydro-electric generator (Figure A3.1). The site walk paths crossed through the southernmost site but the other two remain unsearched. Based on observations it is not believed that any significant archaeological impacts are likely in any of these three locations. However, there is a concern that the draining water might result in erosion of the margins of the floodplain where archaeological sites might be found (only one ephemeral site was noted in the survey just downslope of the storage areas) and where the known grave lies. It has been proposed that the draining water could be conveyed back to the river through pipes and, if this is done, then there should not be any further heritage concerns regarding this aspect of the project.

Figure A3.1: Aerial photograph with the three proposed silt storage areas indicated in yellow.

Since mitigation measures can be implemented for the silt storage areas and the chances of finding significant heritage resources both there and at the borrow pits and construction camp is extremely slim, it is recommended that development of these areas be allowed to continue. The only requirement is that the proposed pipes to carry draining water from the silt storage areas to the river must be installed and that these pipes should avoid the already identified heritage resources in the area.

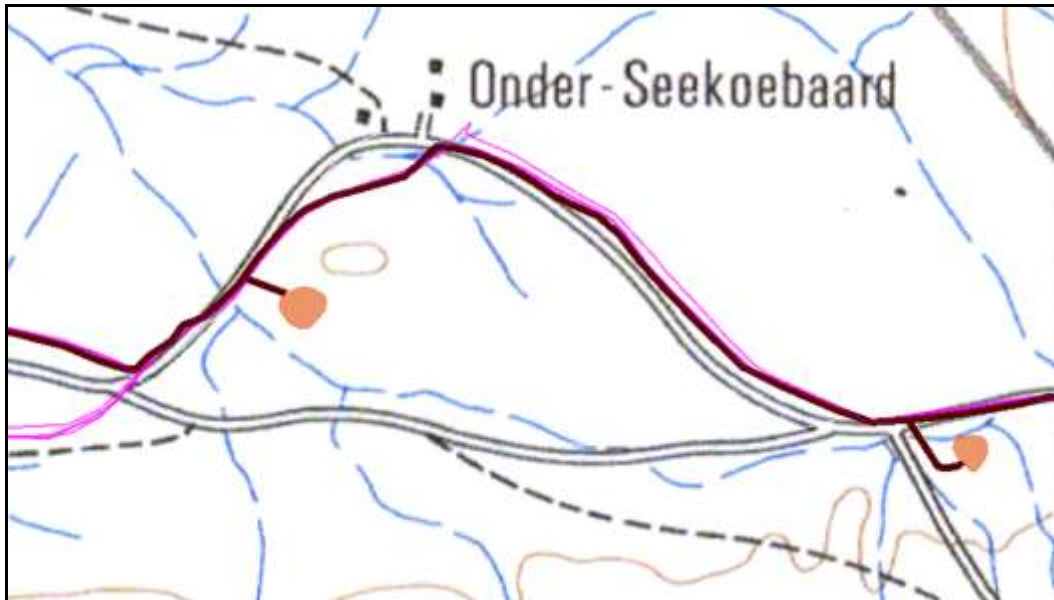
Two existing borrow pits are located in the area (Figure A3.2). These will be reused during the course of the proposed project but it is not certain whether expansion of the surface area of each will be required or not. However, it was deemed prudent to consider the possibility here. Based on observations in the general area the chances of finding archaeological or other heritage resources in these locations is extremely small. Both are close to stream beds which means that erosion could have revealed isolated stone artefacts.

Figure A3.2: Map showing the two existing borrow pits in orange along the southern side of the access road to the hydro-electric site. Their maximum dimensions are currently 90 m and 70 m respectively.

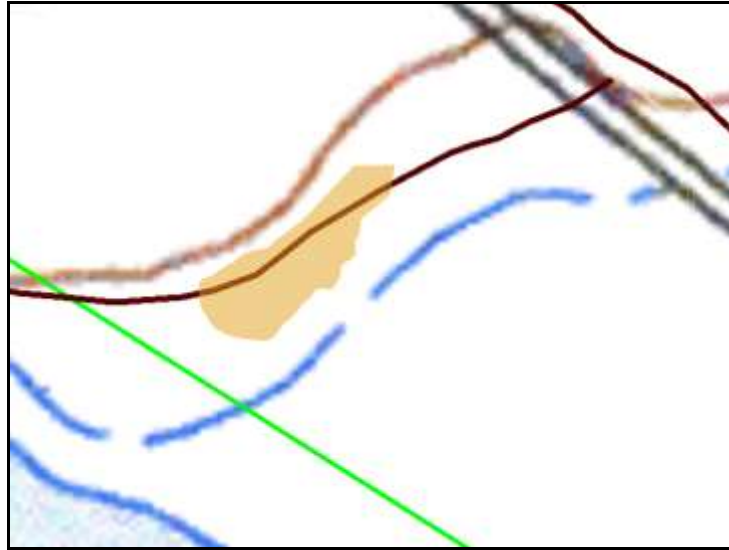
The location of the proposed construction camp is now also available. This will be in the valley on the way in to the campsite that lies at the northeast end of the weir. Much of this area has been transformed and it is not likely that significant heritage resources will be present there.

Figure A3.3: Map showing the location of the proposed construction camp in orange. It is 170 m long.
