**1<sup>st</sup> phase H.I.A. of a study area that includes portion 3 (Bergville) of the farm  
Hondefontein 216, portion 2 of the farm Vogelfontein 176 and a portion of Erven 4  
Delportshoop, Kimberley district Northern Cape  
for: AfriSam – Ulco. Northern Cape**

**Date. July 2018.**

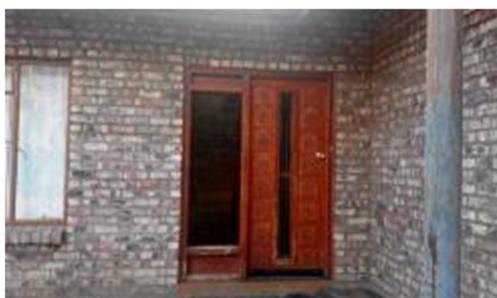
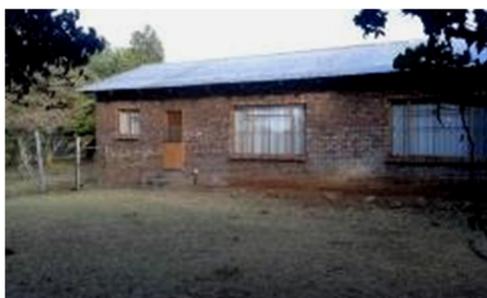
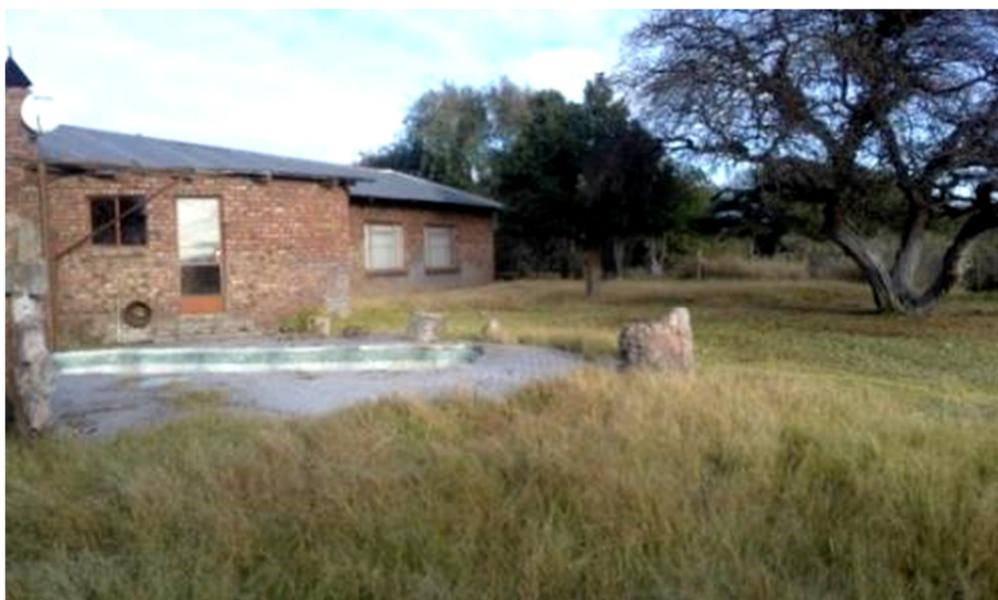
*Figs. 10 to 12. Aspects of the present farmhouse that dates to the 1970s or 1980s. This building is not protected by act 25 of 1999. (Photos S.M. Miller 2018.)*

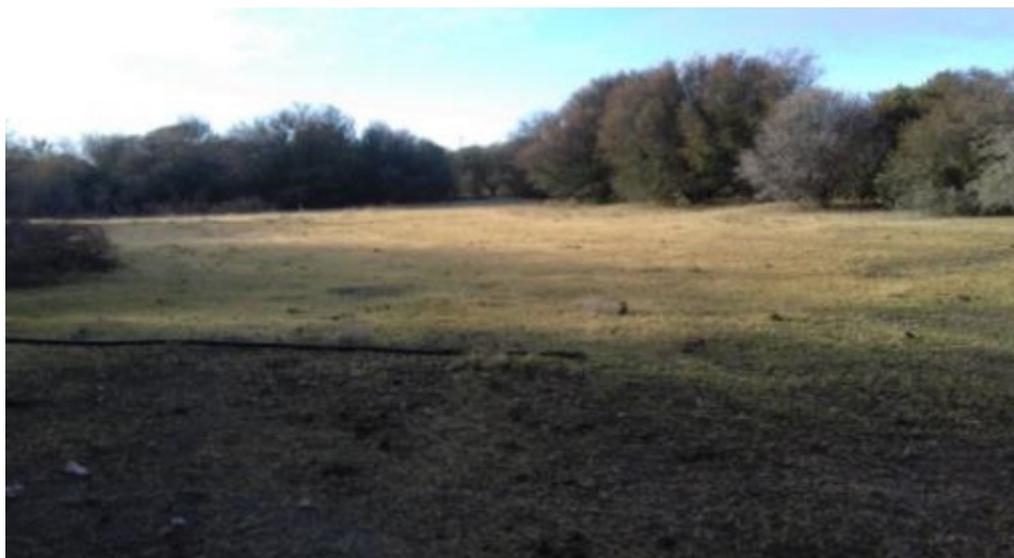
*Fig. 19. This area of approximately half a hectare in extent was cultivated in the past. Its proximity to the well and the reservoir may indicate that it was one of the first pieces of land to be cultivated on the property. (Photo S.M. Miller 2018.)*

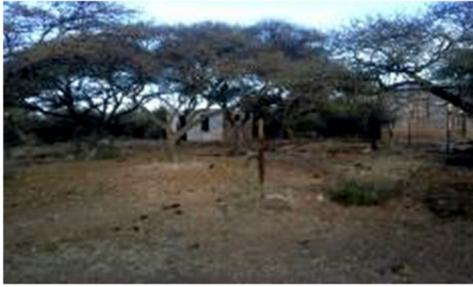
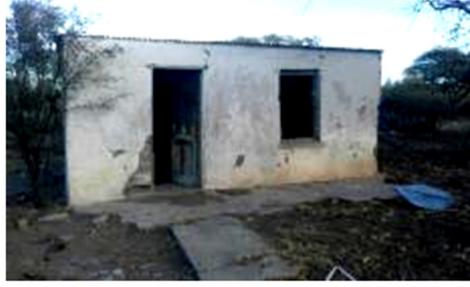
*Figs. 20 and 21. General aspect of the labourers quarters on the left and detail of the oldest of the three buildings. (Photos S.M. Miller 2018.)*

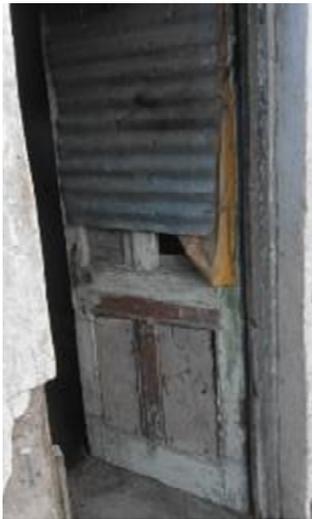
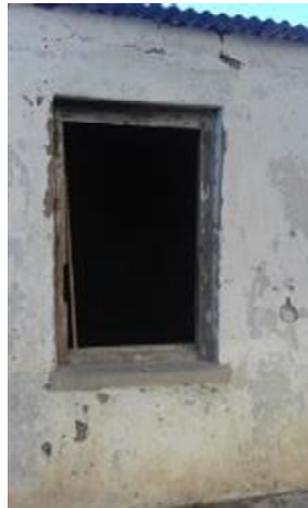
*Figs. 22 and 23. Detail of 1930s door and sash window. It is not clear if these fittings were recycled or part of the original building. (Photos S.M. Miller 2018.)*

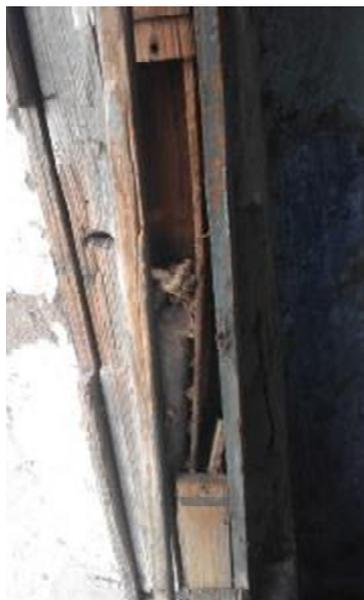
*Fig. 24. Detail of the frame of the sash window with cavity for counterbalancing weights which can still be seen. (Photo S.M. Miller 2018.)*

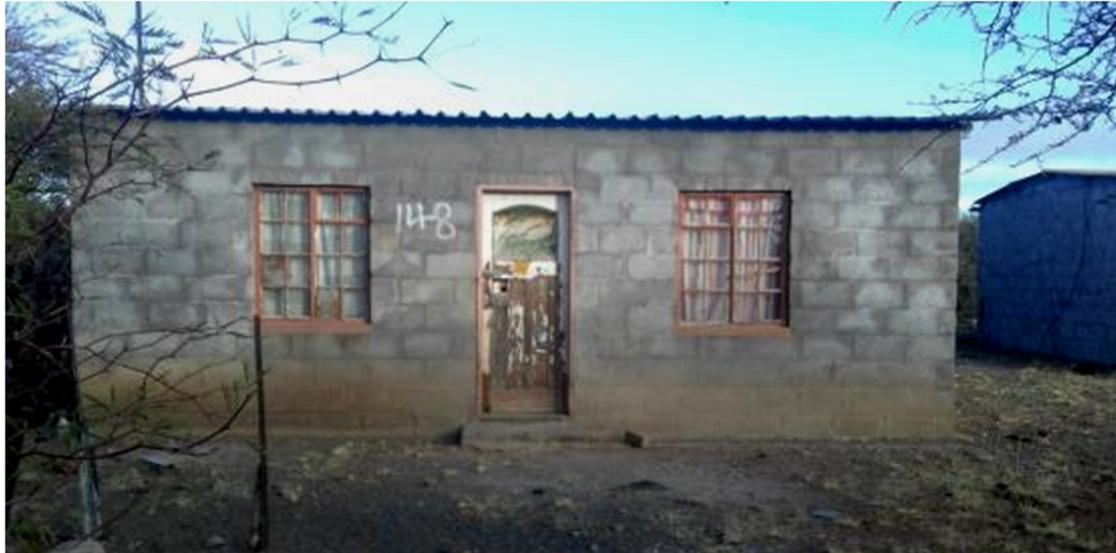
*Fig. 25. In the two other labourers quarters buildings we again find the anomaly of an old door and frame possibly dating to the 1930s with modern cement bricks and modern steel frames as part of the building. (Photo S.M. Miller 2018.)*

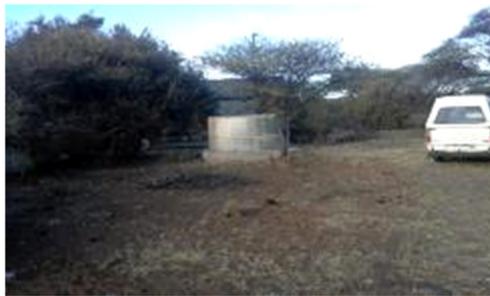
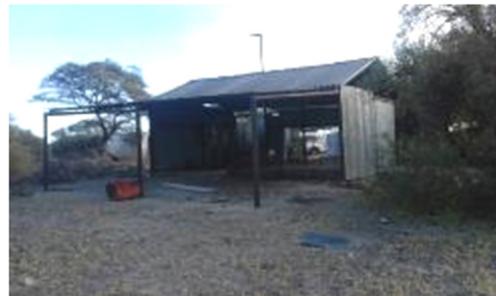
*Figs. 26 and 27. Water reservoir and corrugated iron building possibly associated with slaughtering. (Photo S.M. Miller 2018.)*

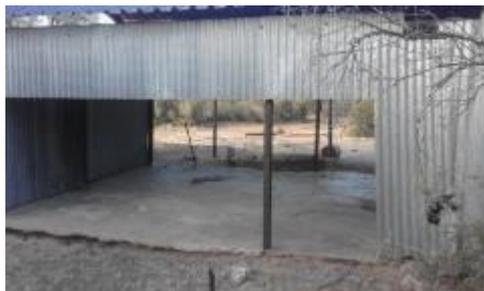
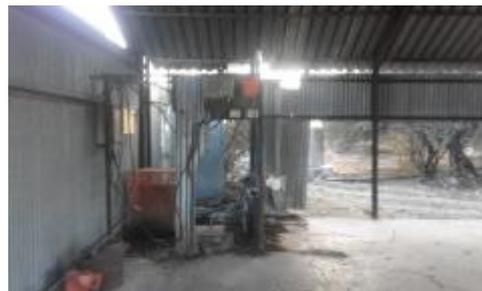
*Figs. 28 and 29. North and south aspects of the corrugated iron building adjacent to the labourers quarters. This building and machinery are obviously modern and are not protected by act 25 of 1999. (Photos S.M. Miller 2018.)*

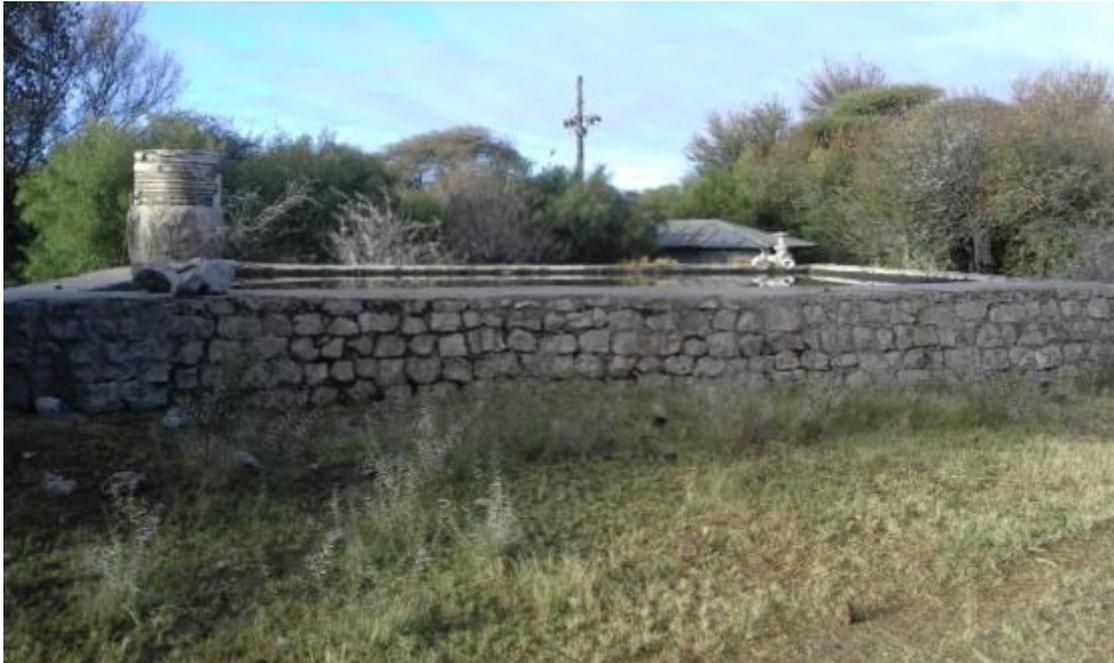
*Fig. 30. Northern aspect of the water reservoir. Even though if it is difficult to place the structure beyond the 60 year rule, it is still a remarkable structure associated with farming in the Northern Cape. Local limestone blocks rather than concrete or bricks were used for its construction. The reservoirs position, adjacent to the well and the original water source, points in the direction that it was one of the first structures erected for the management of water resources of the farm in the beginning of the 20<sup>th</sup> century. (Photo S.M. Miller 2018.)*

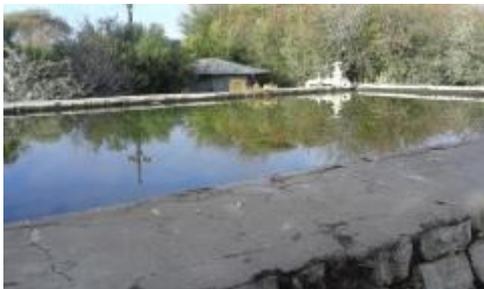
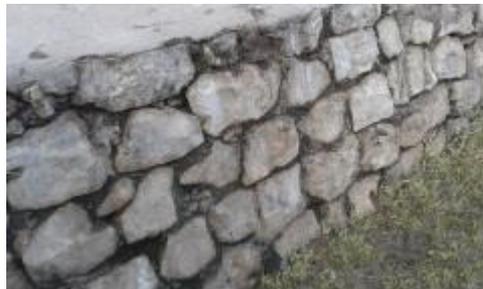
*Figs. 31 to 32. Detail of the reservoir (Photos S.M. Miller 2018.)*

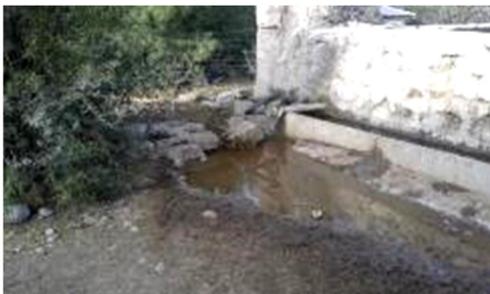
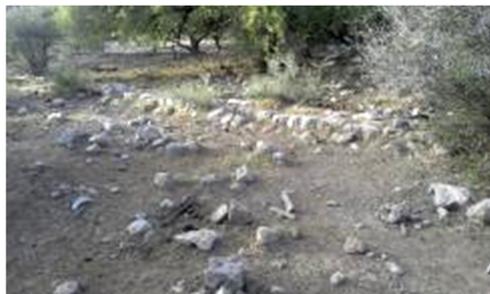
*Figs. 33 and 34. Original outlet of reservoir and drinking crib as well as irrigation furrow now in disuse (Photos S.M. Miller 2018.)*

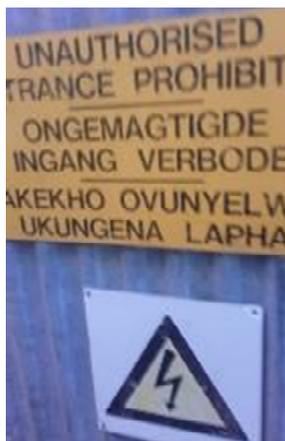
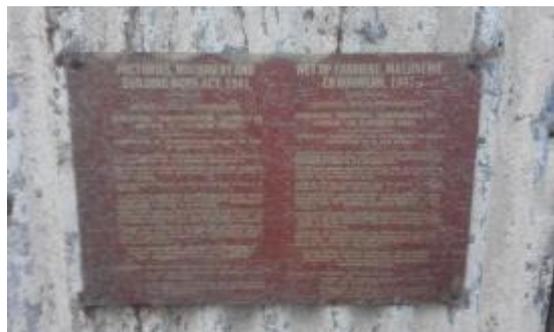
Figs. 35 and 36. A corrugated iron building was erected over the old well as well as to accommodate the farms Escom transformer. (Photos S.M. Miller 2018.)

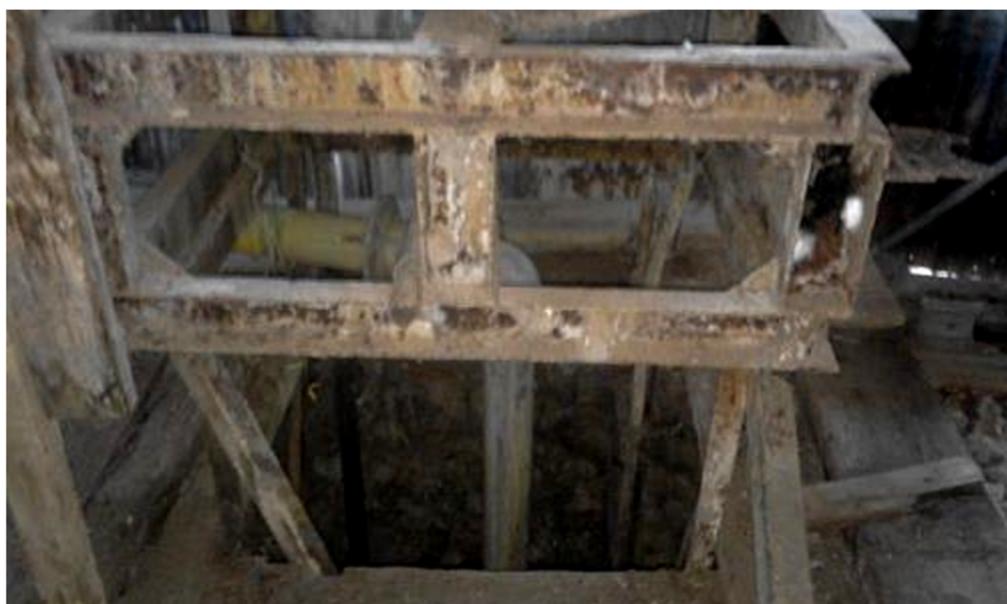
Fig. 37. The original farm well now enclosed in this corrugated iron building. As can be seen water is now being directly pumped from the well for the cattle on the farm. This well is protected under the 60 year rule of act 25 of 1999. (Photo S.M. Miller 2018.)

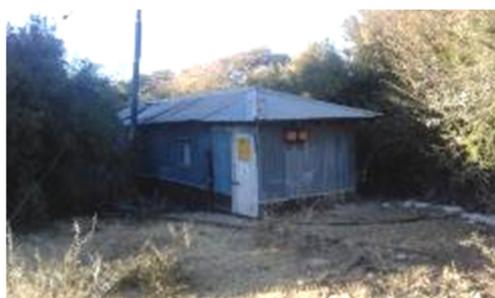
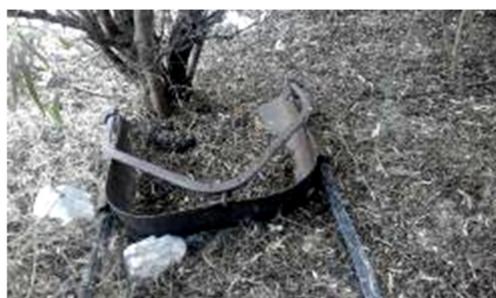
Figs. 38 and 39. The corrugated iron building that was erected over the old well. Adjacent to this building hidden under the vegetation is an implement that in Afrikaans is known as a “damskrop”. (Earth-scoop.) Basically it is a scoop drawn by draft animal used to shift soil for an array of purposes. (Photos S.M. Miller 2018.)

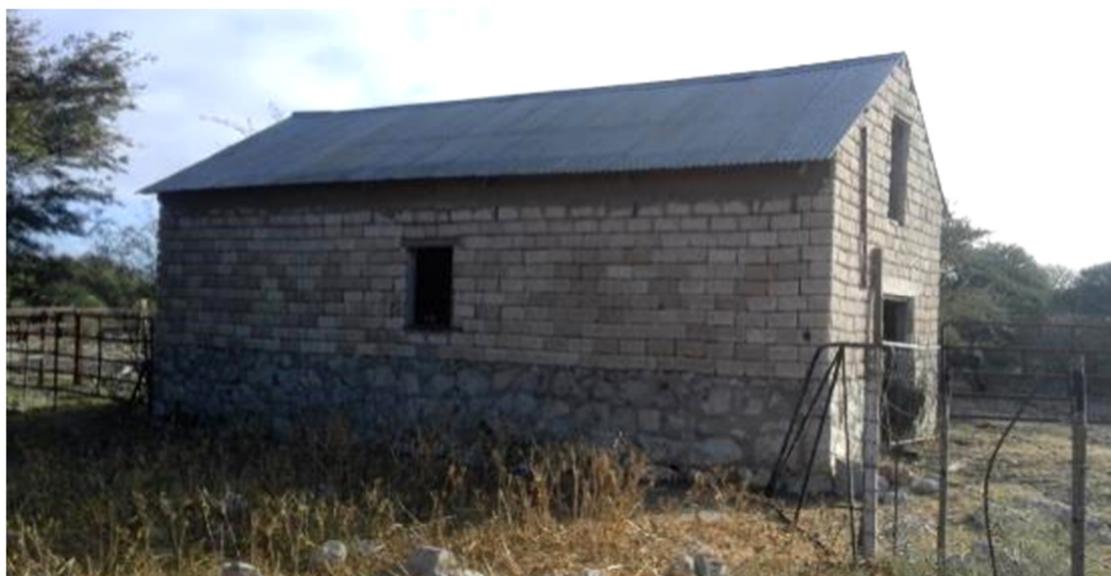
*Fig. 40. Apart from the graves on Bergville this milking shed is most probably the most important heritage relic on the farm. It is difficult to actually date it on architectural features only. It is certainly related to the construction of the reservoir and the early part of flood irrigation. Very few of this type of structures survive in the general area. This is a protected building under the heritage Act. (North elevation.) (Photo S.M. Miller 2018.)*

The milking shed is located a short distance to the east of the well and the original water source of the farm. It is constructed from limestone blocks up to plinth height. Upper walls are built from home for limestone building blocks. Roofing is corrugated iron but it could not be determined from what period these date. The corrugated iron sheets are laid on pine trusses and purloins appearing to be in good repair. Even though it is difficult to determine its original date of construction regarded as a protected building. It is therefore regarded as a protected structure under act 25 of 1999. In the possible event of mining operations proceeding a full second phase study should be compiled, and on the results of that study further decisions may be made. ***It is a protected structure under act 25 of 1999. An application for a demolition permit will be necessary.***

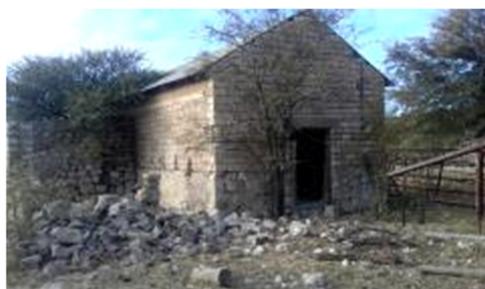
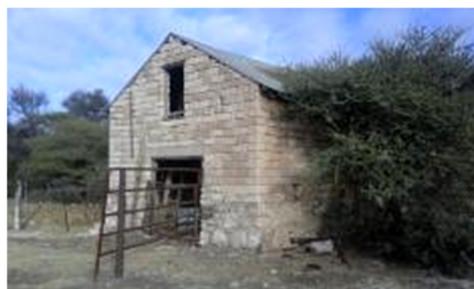
*Figs. 41 and 42 Western and Eastern elevations of the Milk shed. (Photos S.M. Miller 2018.)*

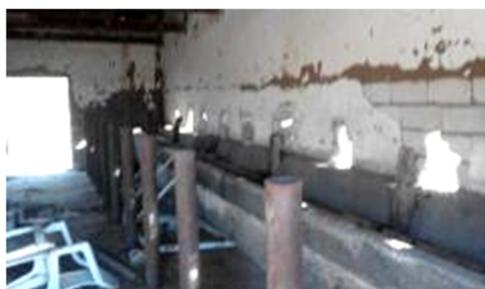
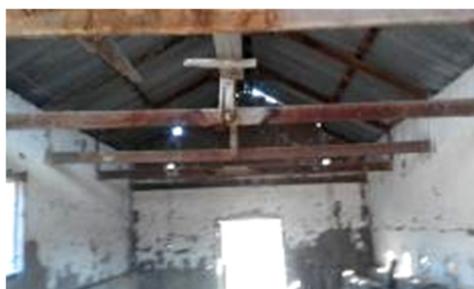
*Figs. 43 and 44. Interior of the milk shed on the left is the remains of the milking stalls for 10 animals. On the right can be seen the roof construction. (Photos S.M. Miller 2018.)*

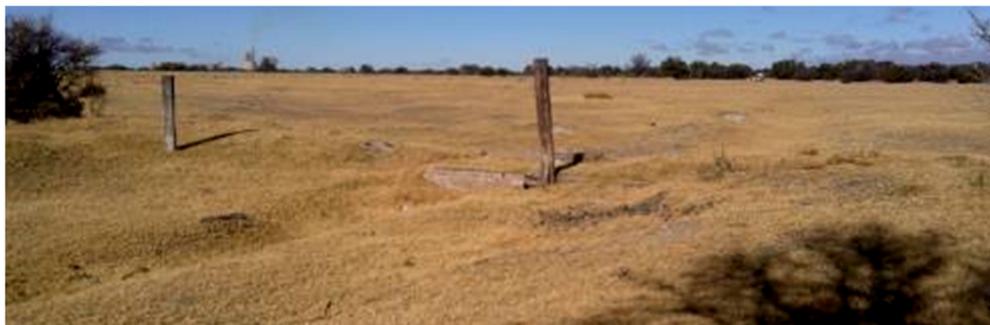
Fig. 46. The sluice gate control from the pans to the irrigation fields on the eastern part of the property. (Photo S.M. Miller 2018.)

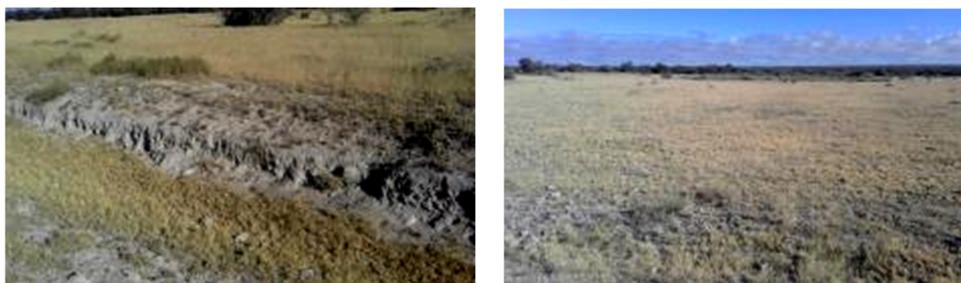
Figs. 47 and 48. Above is the large irrigation canal leading from the pans to the field in the right-hand photograph. (Photos S.M. Miller 2018.)

The larger irrigation canal is also generally in a bad maintenance condition. Even so it is most probably not older than 60 years and therefore does not enjoy the protection of act 25 of 1999.

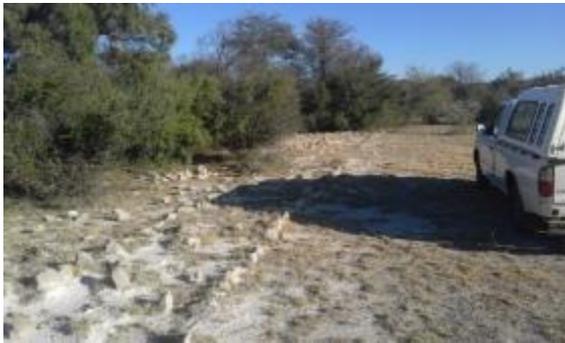
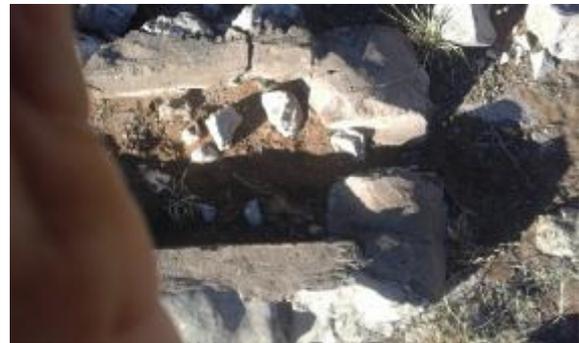
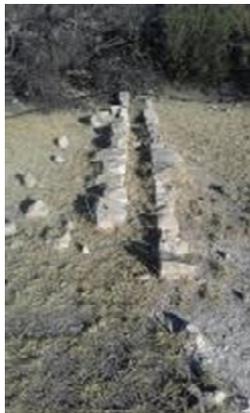
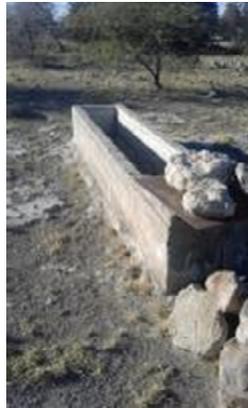
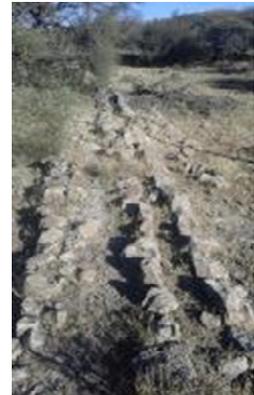
*Figs. 51 to 52. General images of the irrigation canals located to the east of the well and milking shed towards the fields. The actual general function of these cannot be determined by this first phase heritage assessment. However if these are documented in a second phase study and a permit for their demolition is provided by the local Heritage Resources Agency then they may be demolished. (Photos S.M. Miller 2018.)*

The smaller irrigation canals are generally in a bad maintenance condition. Even so they are most probably older than 60 years and therefore enjoy the protection of act 25 of 1999. In the possible event of mining operations proceeding a full second phase study should be compiled, and on the results of that study further decisions may be made. *It is a protected structure under act 25 of 1999. An application for a demolition permit will not be necessary.*

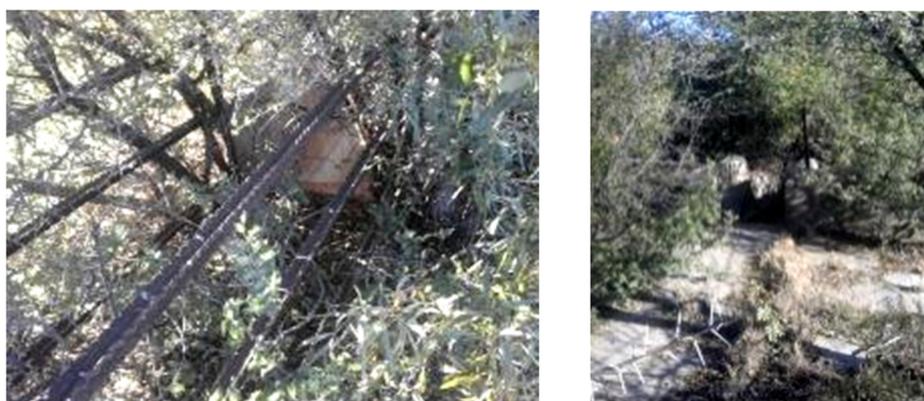
*Figs. 53 and 54. This is the remains of a sheep dip that is obviously constructed of modern materials and is not related to the first phase occupation of the farm. This is not a protected structure. (Photos S.M. Miller 2018.)*

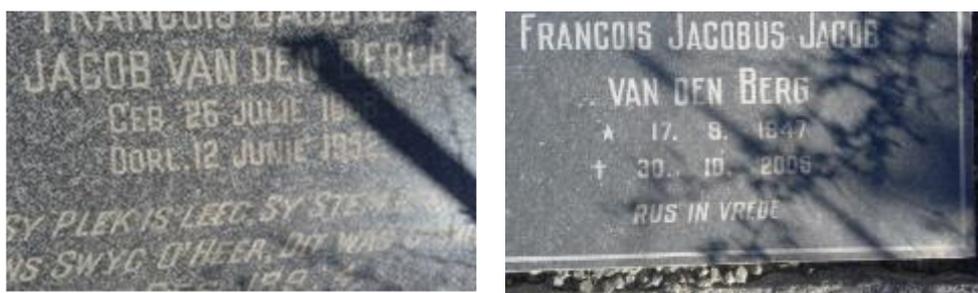
*Figs. 55 and 56. The gravestones of Françoise Jacobus Jacob van den Berg senior, which lived between 1888 and 1952, and possibly his grandson of the same name that lived between 1947 and 2005. (Photos S.M. Miller 2018.)*

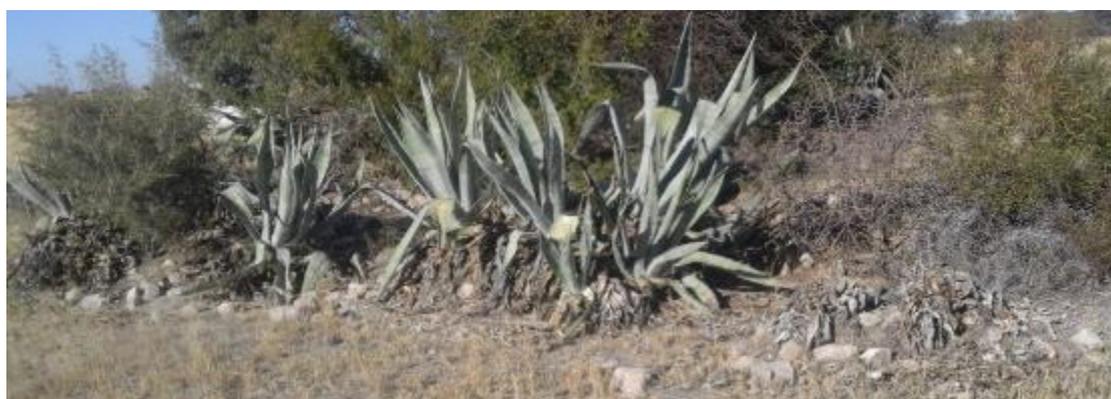
*Fig. 57. These sisal plants also known as Agave mark the location of approximately 20 unmarked graves. It is the opinion of the author that these are the graves of labourers and their families that has worked on the farm over the last century (Photo S.M. Miller 2018.)*

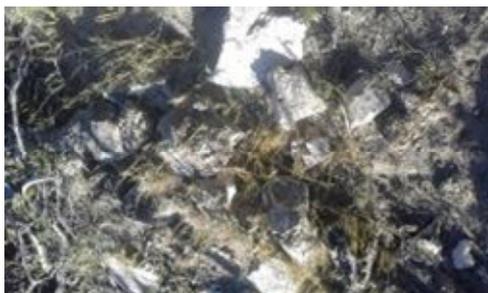
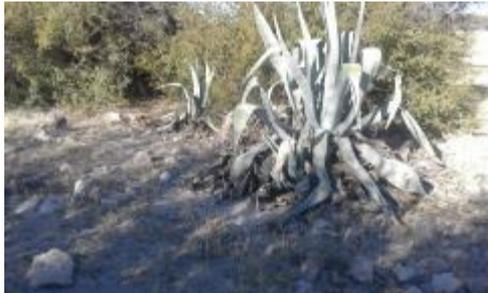
*Figs. 58 and 59. The appearance of the graves is rather ragged. This can be ascribed to the fact that they have been untended for a long time and the passage of wild animals and cattle have disturbed the regular features of the graves. For initial protection it is suggested that the vegetation is removed and that the area is fenced off in an appropriate manner. (Photos S.M. Miller 2018.)*

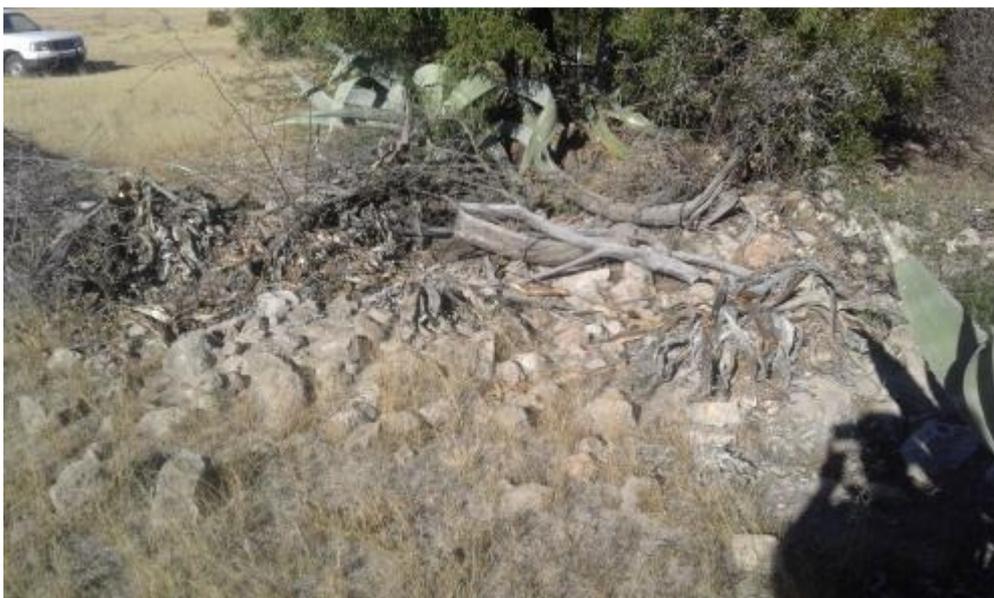
*Fig. 60. For the layman’s eye is difficult to identify these graves. Once the vegetation has been removed then it will become clear how many graves are located in this position. (Photo S.M. Miller 2018.)*

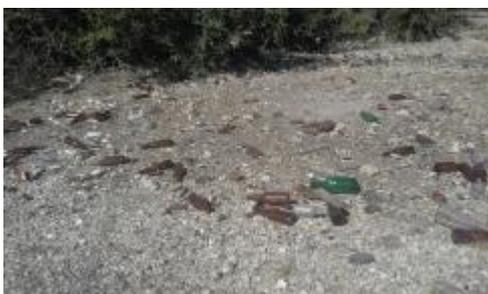
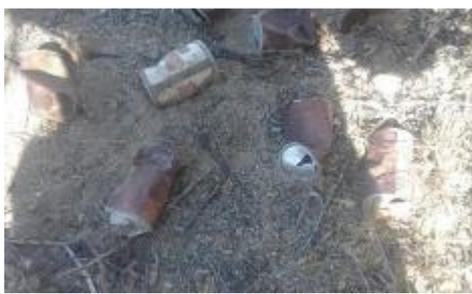
*Figs. 61 and 62. In the dumping site large numbers of artefacts and debris from the modern farm can be seen. All of these relate to the period younger than 60 years. (Photos S.M. Miller 2018.)*

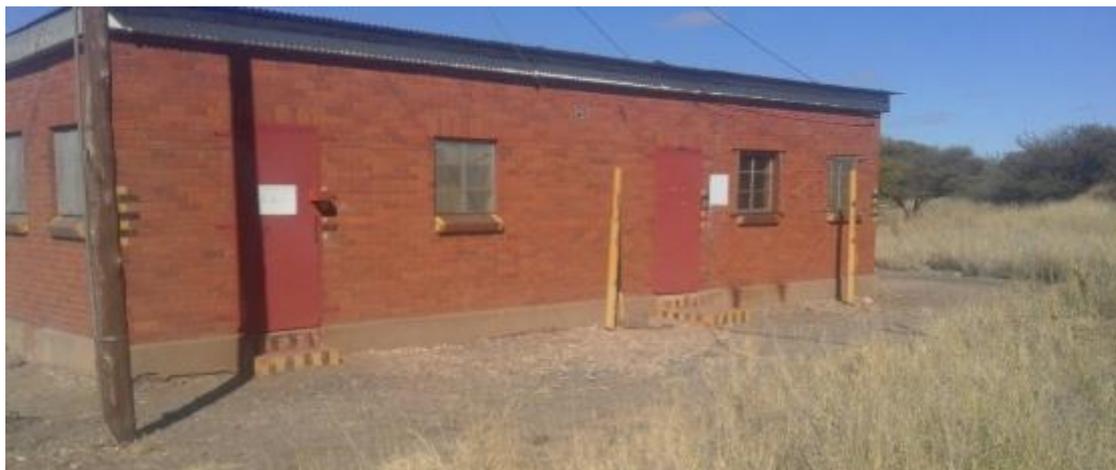
Fig. 64. Ghaap station. This is not a station building but merely a building containing the signal control system for this section of the railway line. (Photo S.M. Miller 2018.)

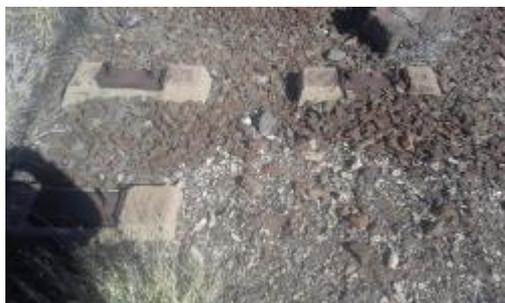
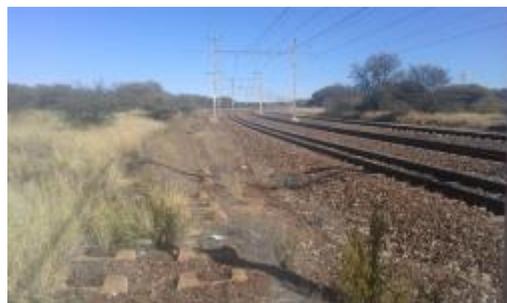
Figs. 65 and 66. Somewhere in the distant past there used to be an official siding at the Ghaap station for the use of the farm. (Photos S.M. Miller 2018.)

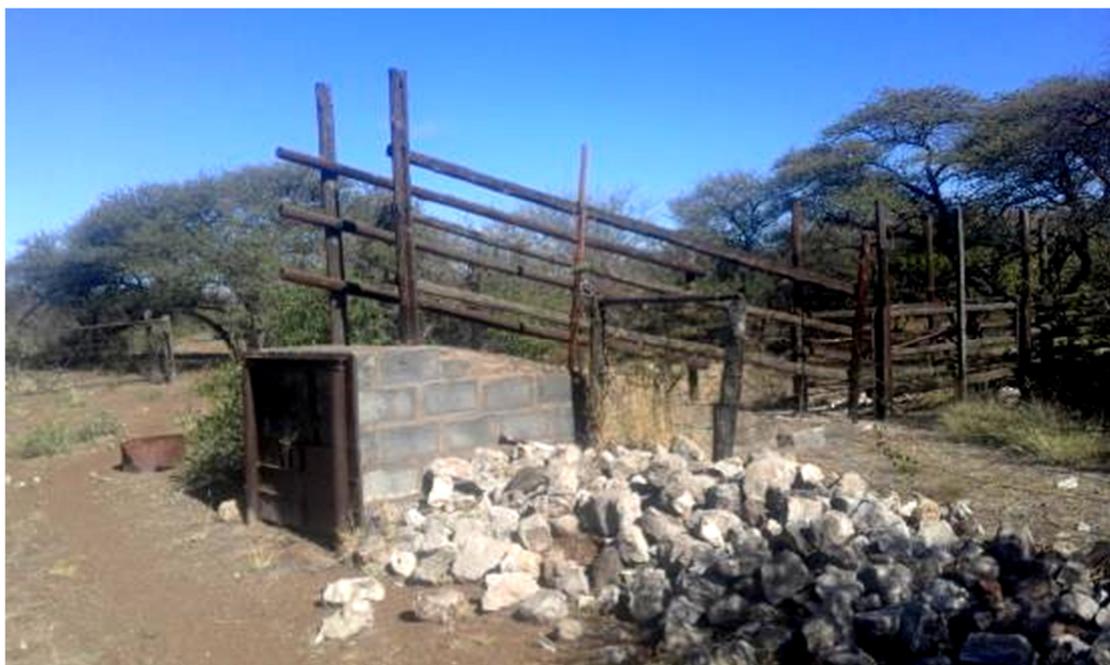
Fig. 64. Cattle loading platform adjacent to the Ghaap station. This is a modern construction but the limestone blocks suggest that there was an earlier structure year as well. (Photos S.M. Miller 2018.)

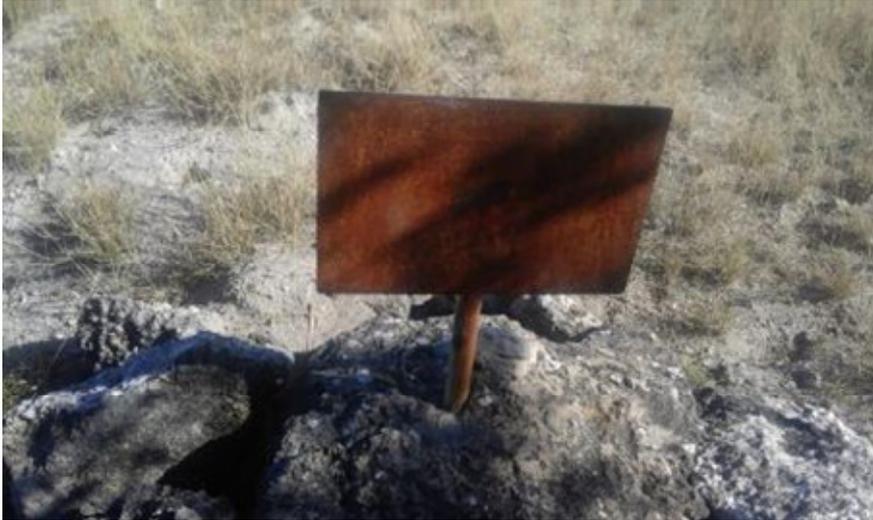
*Fig. 78. In the pan area in the eastern portion of the study area several of these drill hole markers were observed. This specific one was marked B243. Approximately ten of these were observed during the foot survey. (Photo S.M. Miller 2018.)*

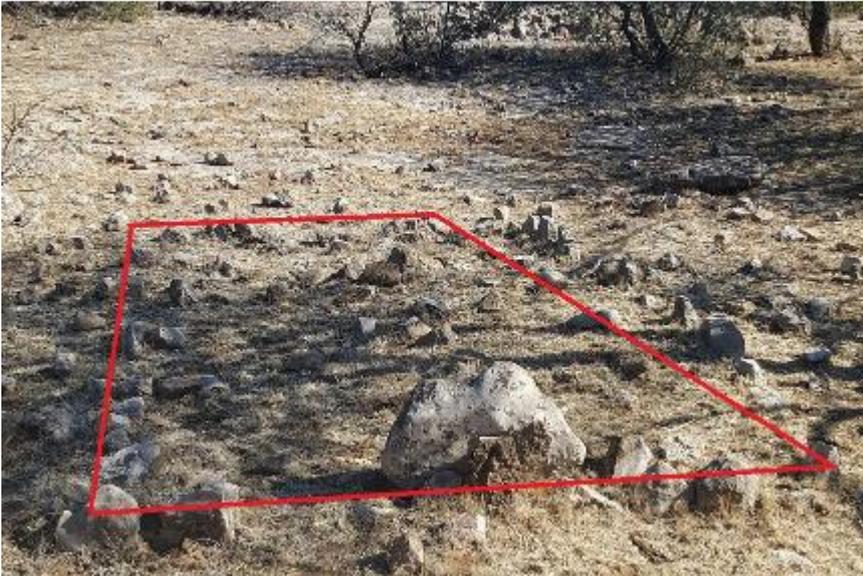
*Fig. 79. This grave was observed by personnel of Afrisam after initial impact assessment was completed this. (Photo Afrisam2018.)*

**9.12.7.3.** This grave was not observed by the author of this report. After the initial review of the report this grave was reported by personnel of Afrisam. As there is no headstone is not clear who the deceased was. In the event of mining relocation will be necessary.
