**A REPORT ON A CULTURAL HERITAGE IMPACT ASSESSMENT FOR THE  
PROPOSED EXPLORATION ACTIVITIES AT THE JACOMYNSPAN PROJECT,  
NORTHERN CAPE PROVINCE**

***GCS Project no.: 12-139***

**REPORT: AE01406V**

***February 2014***

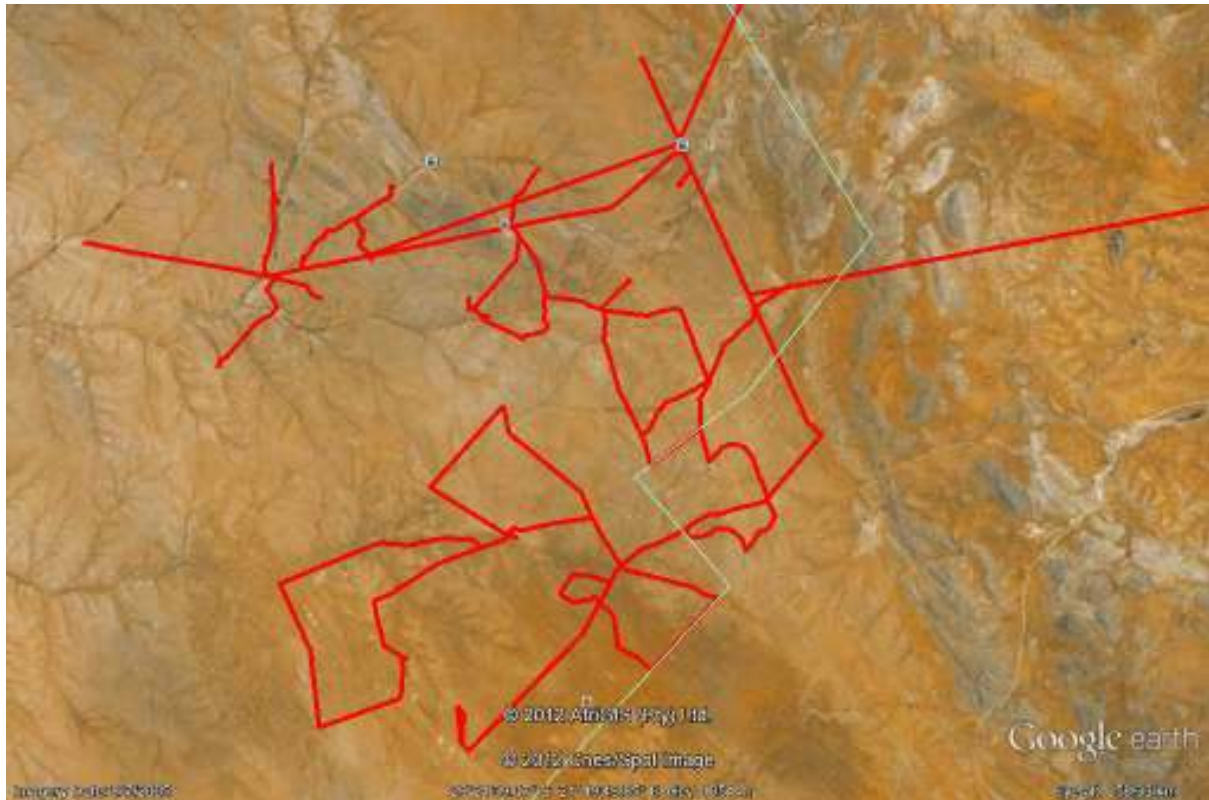
If required, the location/position of any site was determined by means of a Global Positioning System (GPS)<sup>1</sup>, while photographs were also taken where needed. The survey was undertaken by a physical survey via off-road vehicle and on foot (Figure 4). Sixty hours were spent in the field.

**Figure 4 GPS track of the surveyed area<sup>2</sup>. North reference is to the top.**

<sup>2</sup> It needs to be noted that the site was visited twice. A GPS track was not taken during the first visit as this was before this became common practice. Therefore this track may seem to exclude certain areas, but these were covered during the first visit.

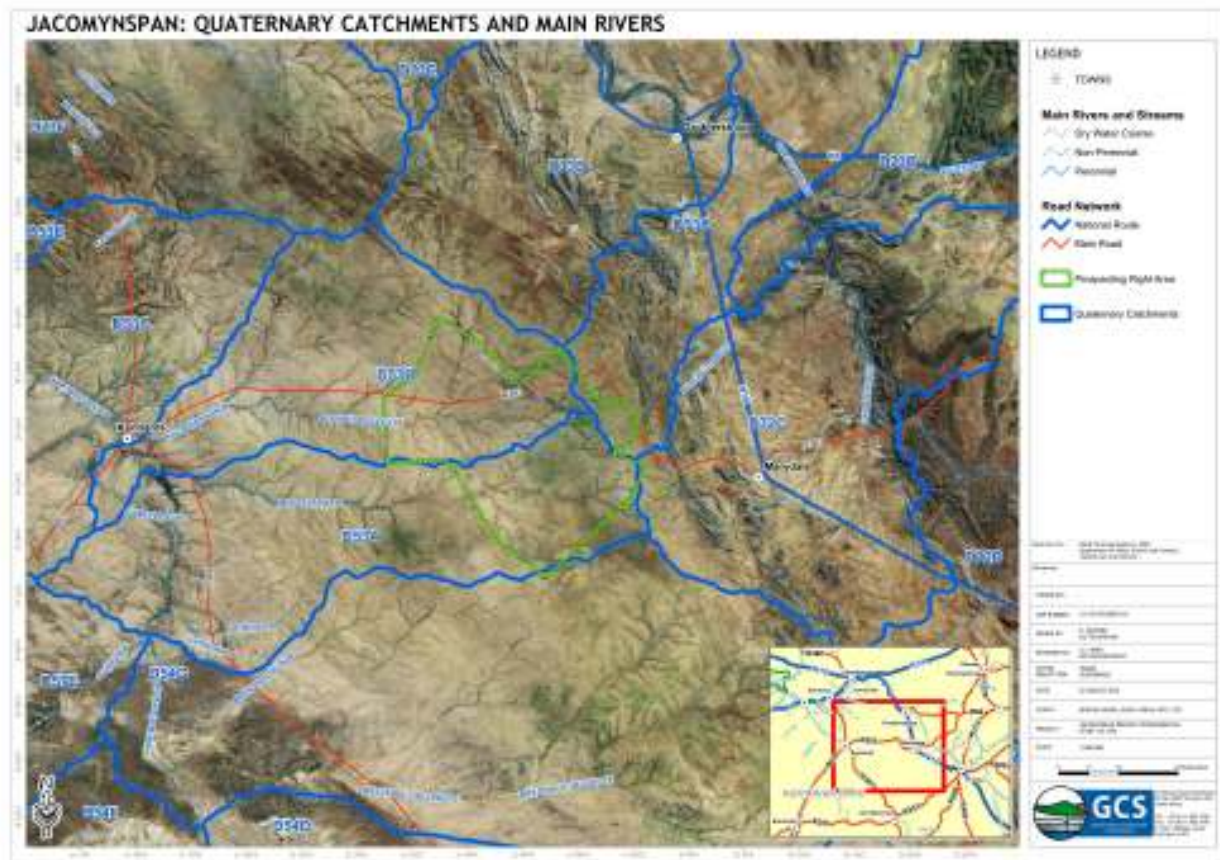
The surveyed area is drained by various non-perennial streams. Since this is very dry country these rivers runs very seldom. Although some of these catchments can be seen on the map (Figure 8) these are almost not visible in the field. The Orange River is the large water

**Figure 8 Map indicating the water sources in and around the surveyed area.**

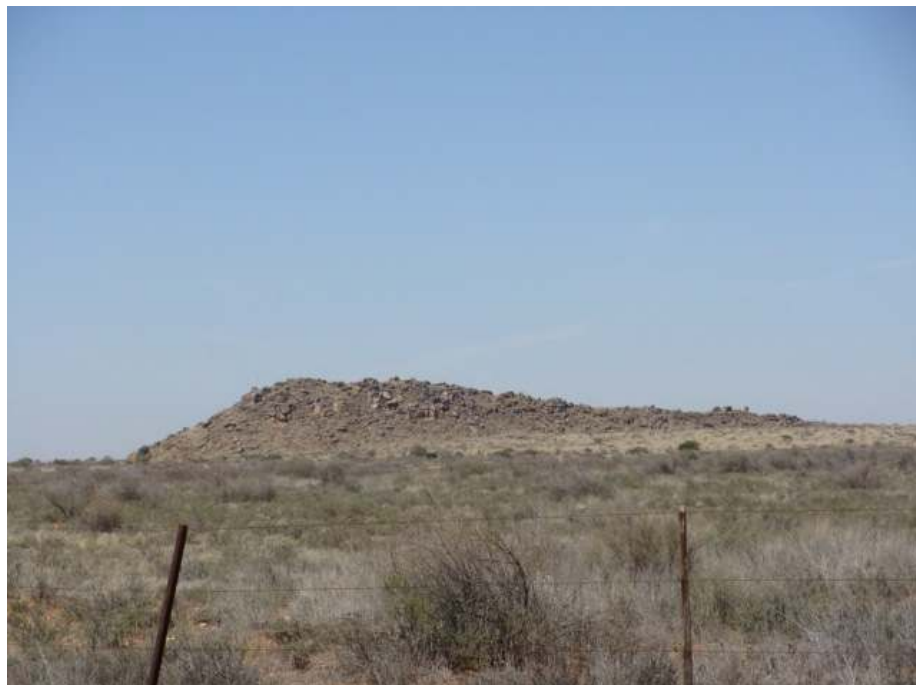
The topography of the area basically is flat (Figure 9), but one can understand that over such a large area there has to be height differences. These however are not very prominent. A few hills, consisting mostly of boulders do however occur here (Figure 10). In one instance two small hills close to each other, are completely composed out of quartzite (Figure 11).

**Figure 10 One of the small hills, consisting of large boulders, found in the surveyed area.**

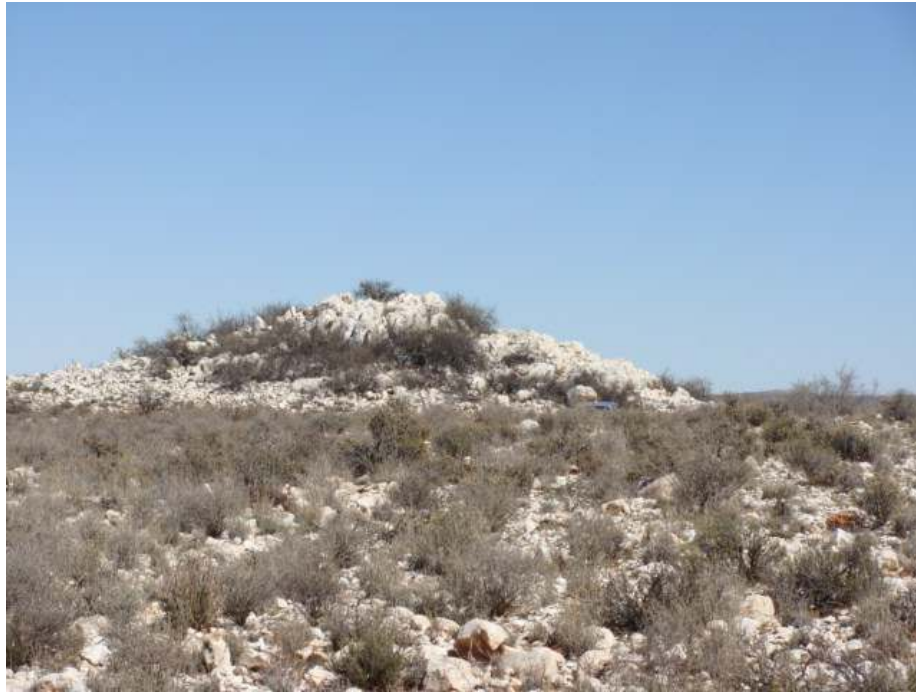
**Figure 11 One of the two small quartzite hills in the surveyed area.**

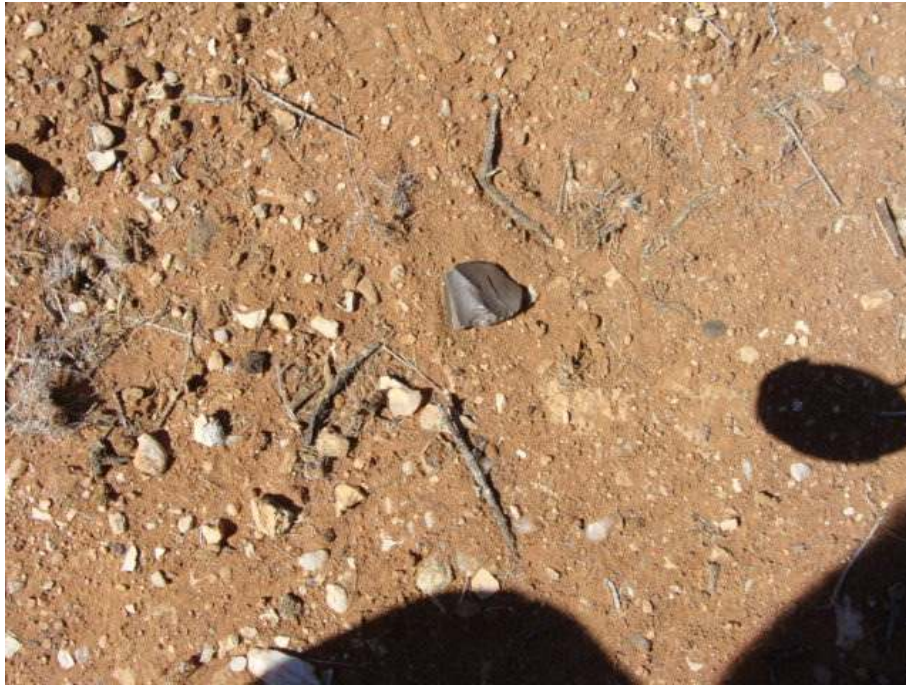
The environment here seems very similar to that at the study area, indicating that Stone Age material is likely to also be found within the Jacomynspan study area. This was indeed the case (Figure 12-13; also see later discussion).

**Figure 12 MSA scraper, one of many isolated stone tools found during the survey.**

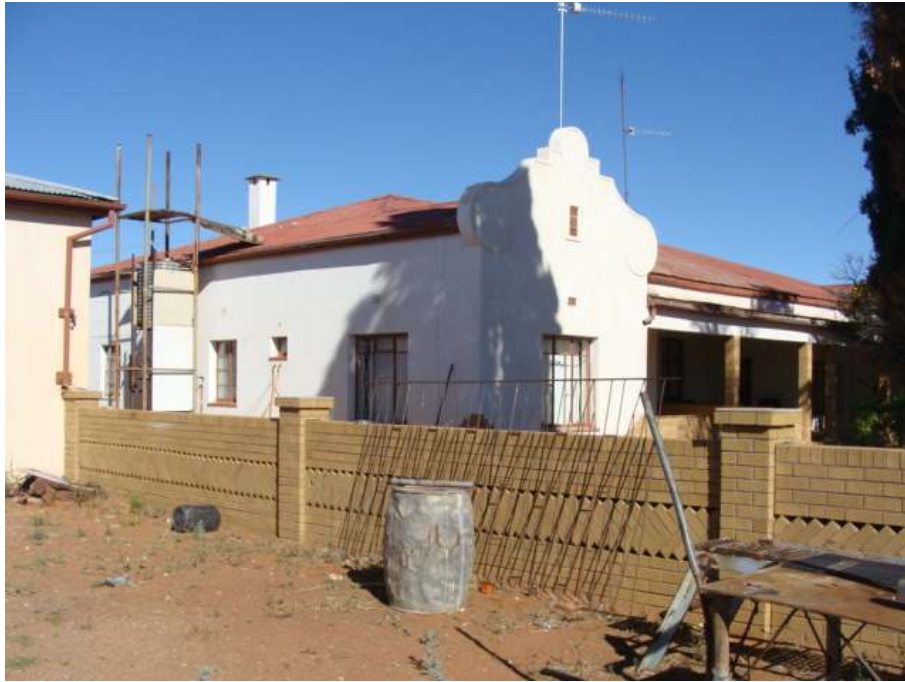
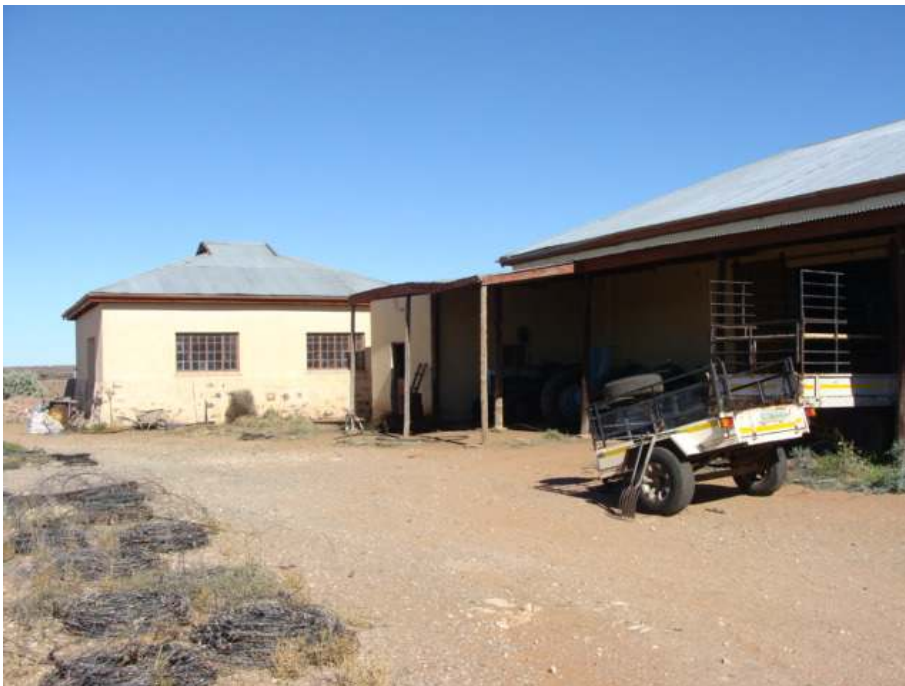
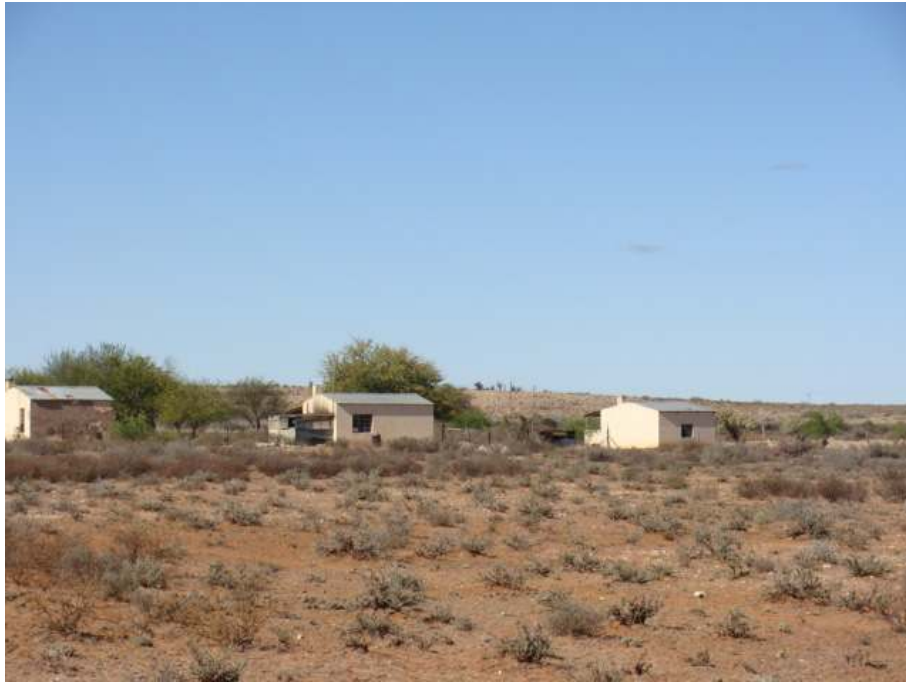
**Figure 16** The main house and other farm buildings at site no 1.

**Figure 17** Outbuildings at site no. 1.

**Figure 18 Workers houses at site no. 1.**

The buildings may therefore be demolished during development activities on site and this report is seen as ample mitigation in this regard. However, if the buildings are not to be directly affected by the development, it should be left as it is. The site is right on the edge of the development, and therefore this should indeed be possible. It may even be re-used for another purpose such as offices.

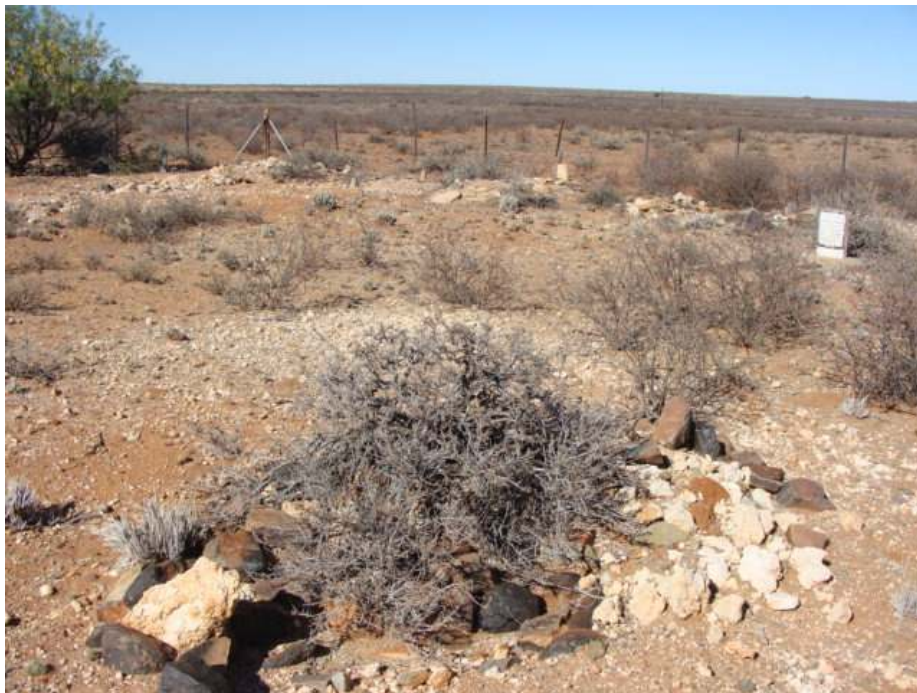
**Figure 19 Graves at site no.2.**

Since there will be no direct impact, option 1 is recommended, just to ensure that secondary impact is minimized.

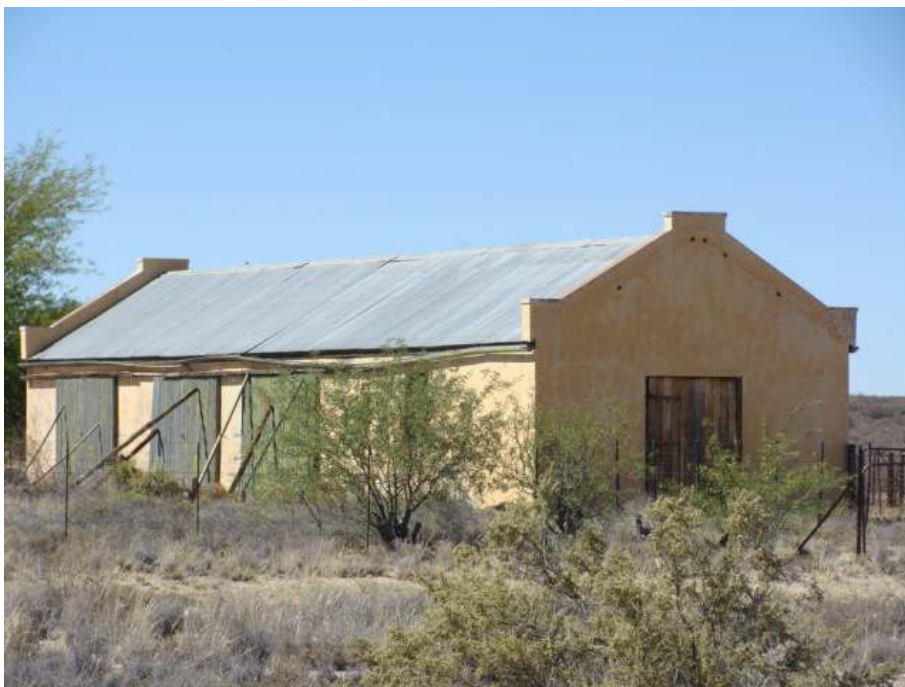
**Figure 20 Outbuilding at site no. 3.**

There will be no impact on the site. It therefore needs to be left as it is.

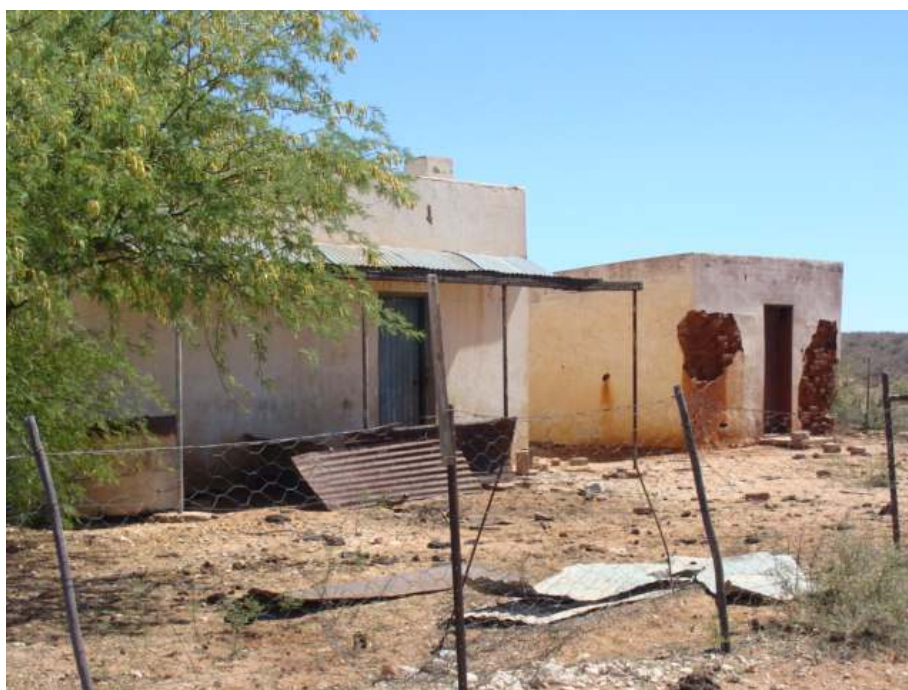
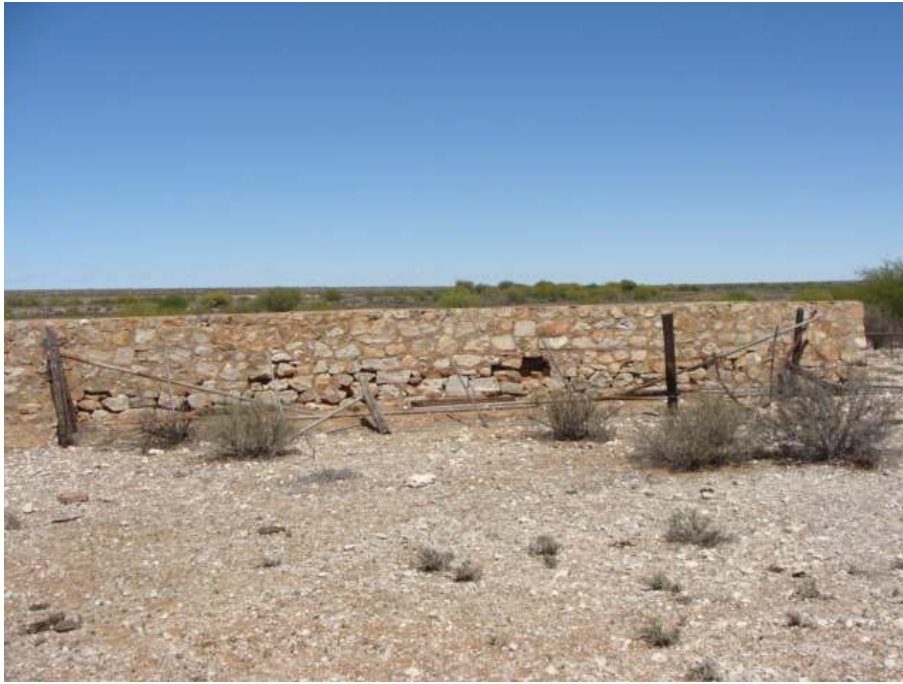
**Figure 21 Buildings at site no. 5.**

**Figure 22 Stone sheep kraal at site no. 5.**

The buildings and kraal may therefore be demolished during development activities on site, but should be recorded first. However, since the buildings are not to be affected by the development, it should be left as it is.

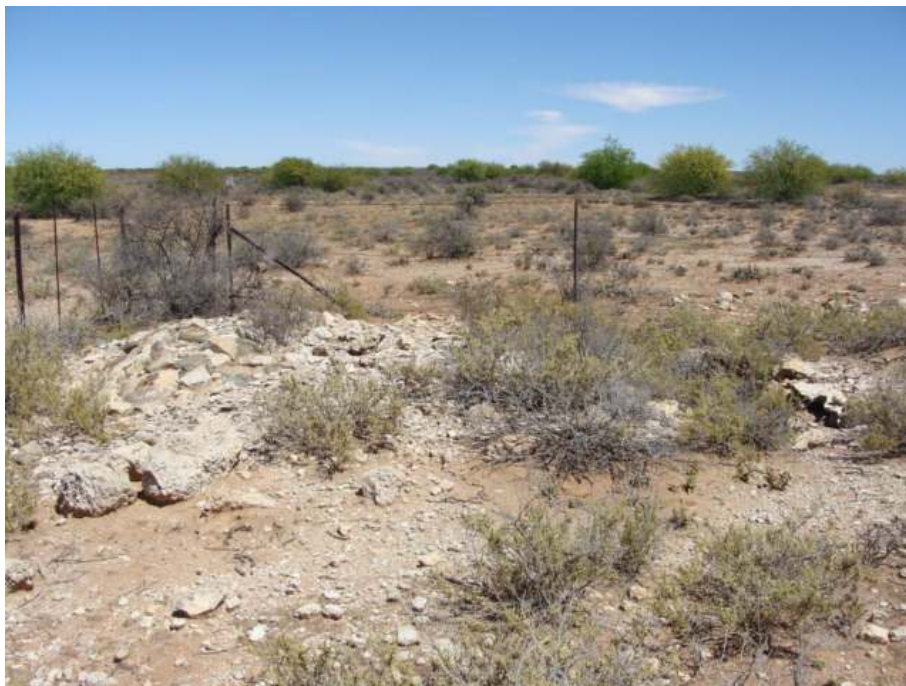
**Figure 23 Graves at site no. 6.**

Since the site will not be impacted on, it should be left as it is.

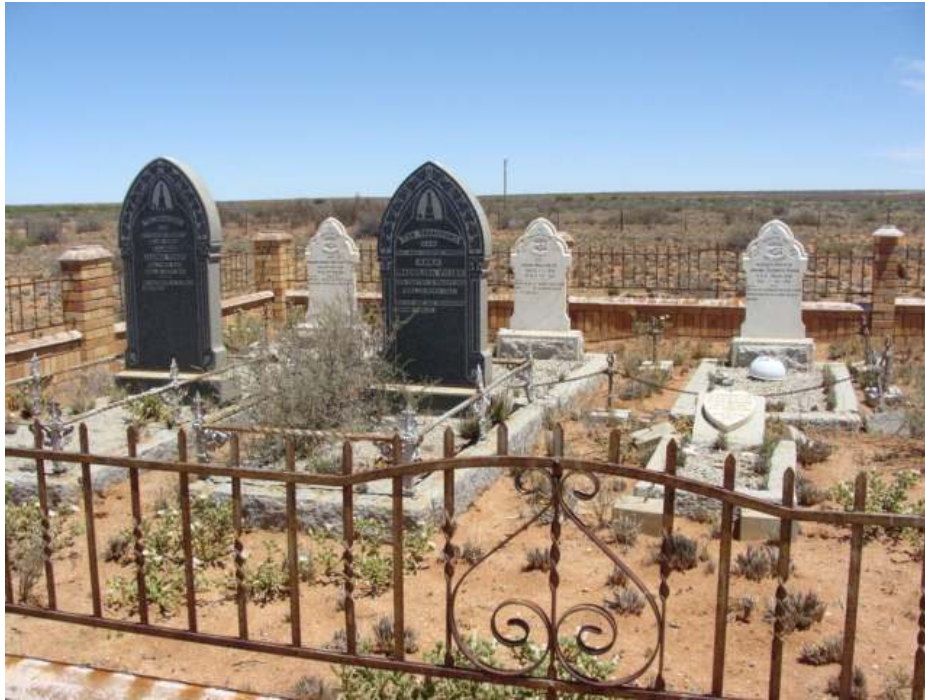
**Figure 24 Graves at site no. 7.**

Usually there are two options when dealing with graves. The first option is to leave the graves *in situ*. This would be possible should there be no direct impact on the graves. However, there always is a secondary impact as descendants may find it difficult to visit the site once mining has commenced. Therefore the site should be fenced in and a management plan should be written for the preservation and maintenance thereof. Such a fence should be erected at least 50 m from the perimeter of the site as blasting closer than that will definitely have a negative impact on the graves.

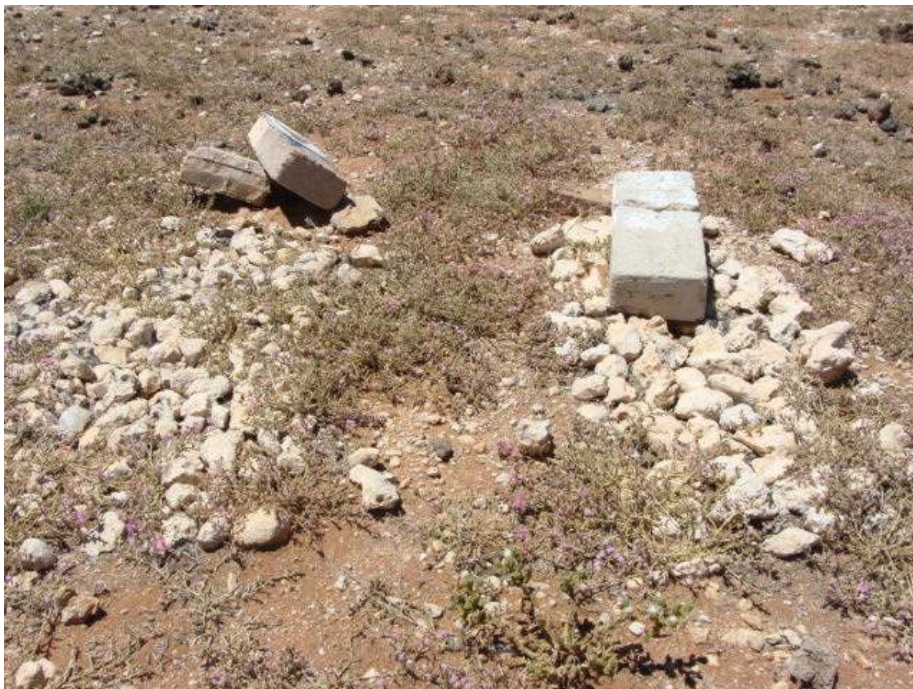
**Figure 25 Graves at site no. 8.**

Since the site will not be impacted on, it should be left as it is.

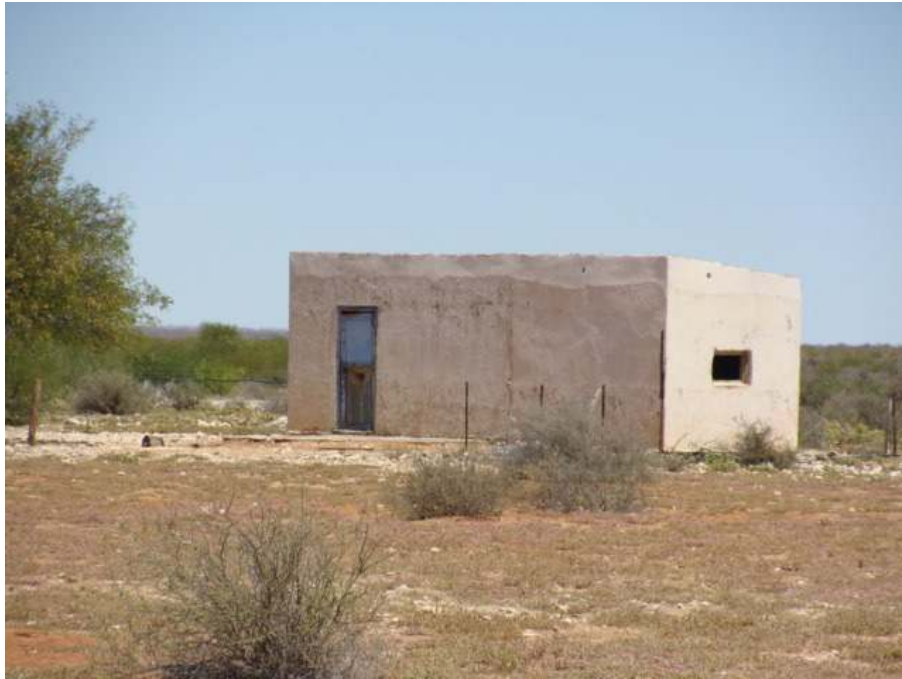
The graves are close to another workers house (Figure 26) similar to others described in this report. Therefore the building is given a rating of **medium** cultural significance. The field rating given is General protection B (IV B) which means it should be recorded before destruction. However, there will be no impact on these and therefore it should rather be left **in situ**.

**Figure 26 Farm workers house at site no. 8.**

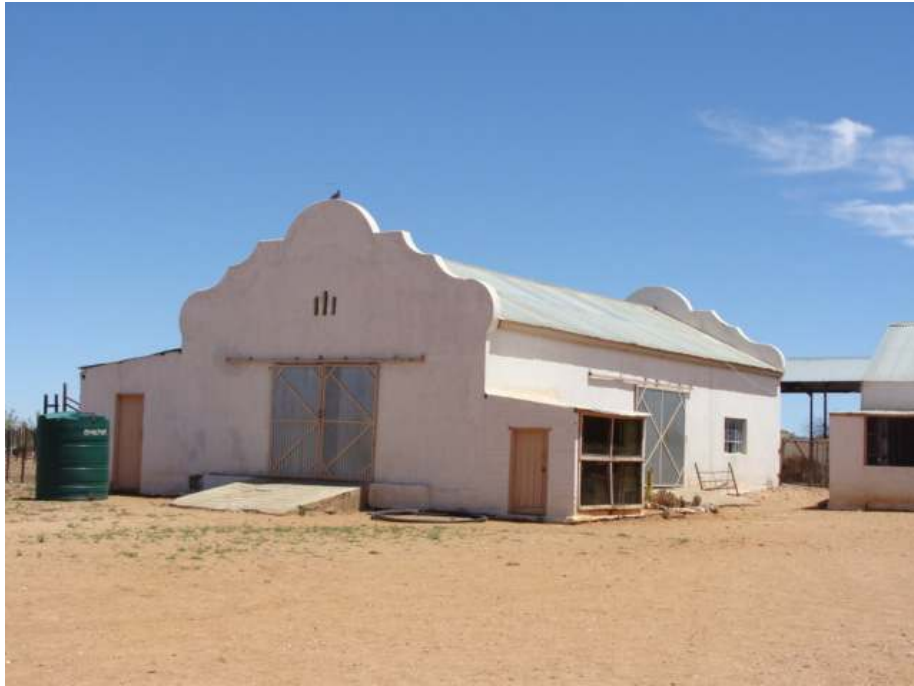
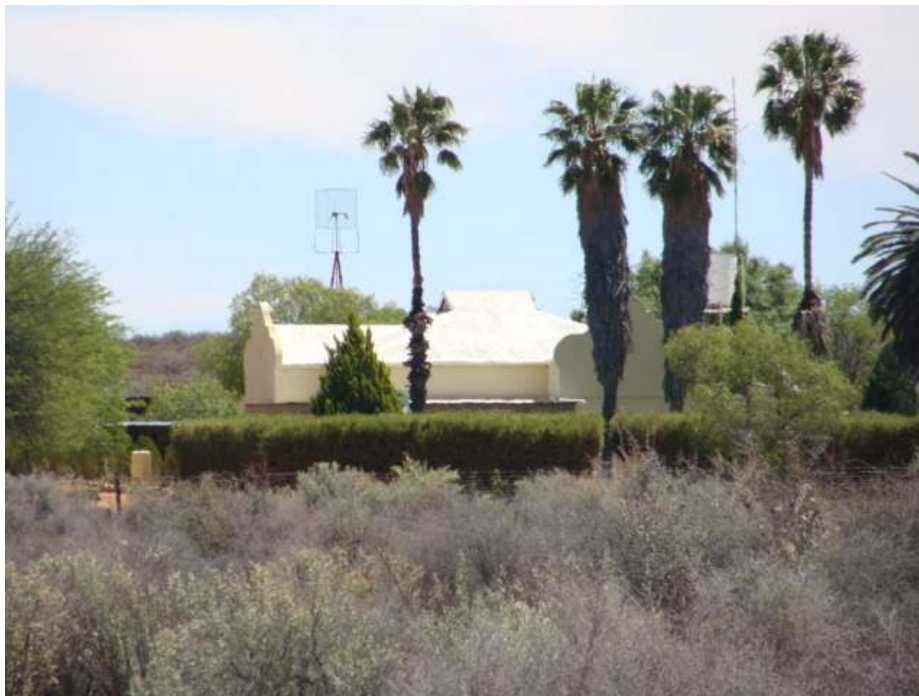
**Figure 27** Wagon house/ store buildings at site no. 9.

**Figure 28** Main house, unfortunately hid by a fence, at site no. 9.

The buildings may therefore be demolished during development activities on site, but should be recorded first. However, the buildings will not be affected by the development and it should be left as it is.

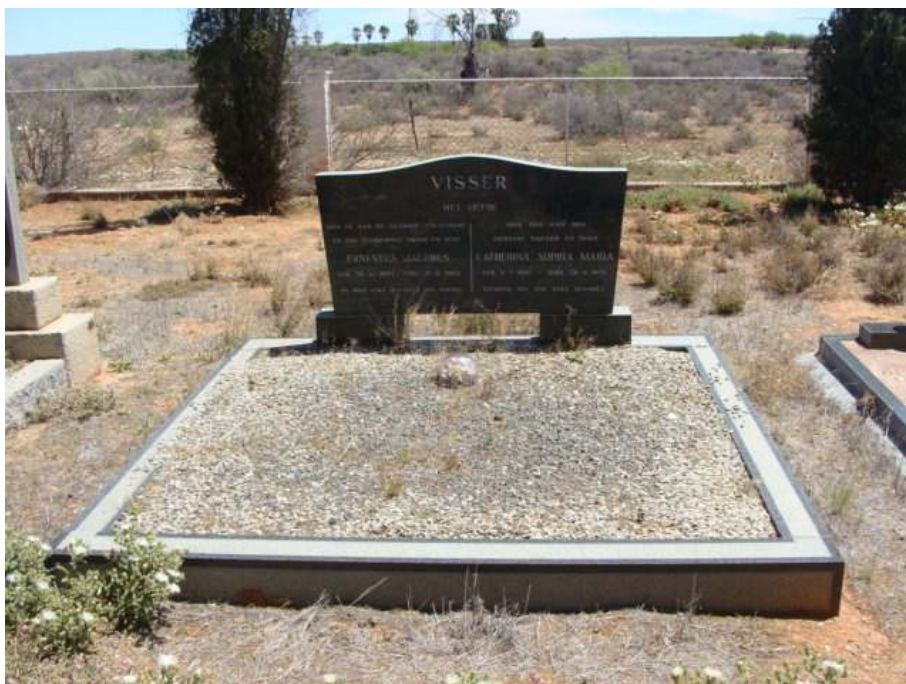
**Figure 29 Graves at site no. 10.**

Usually there are two options when dealing with graves. The first option is to leave the graves *in situ*. This would be possible should there be no direct impact on the graves. However, there always is a secondary impact as descendants may find it difficult to visit the site once mining has commenced. Therefore the site should be fenced in and a management plan should be written for the preservation and maintenance thereof. Such a fence should be erected at least 50 m from the perimeter of the site as blasting closer than that will definitely have a negative impact on the graves.

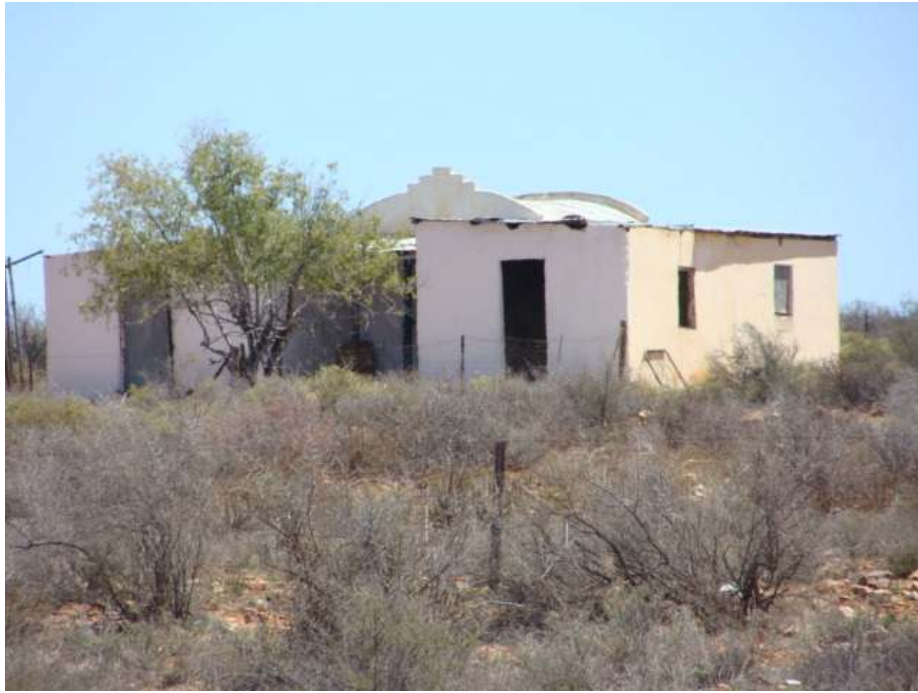
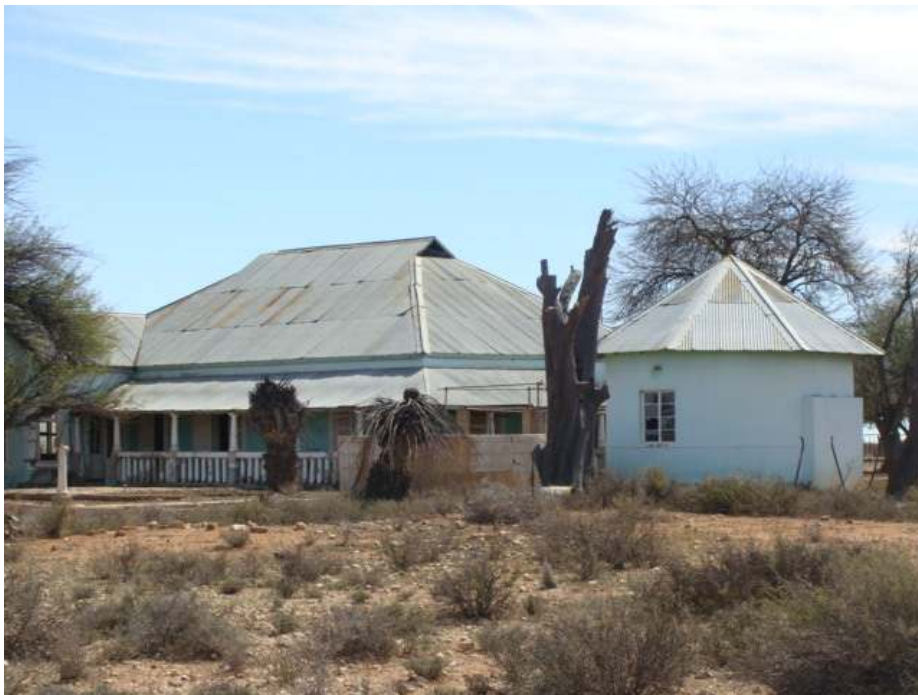
This is a farm yard consisting of various buildings. These are very typical of the other farm buildings in the area (Figure 30-31). It seems as if these are not in use any more and therefore it shows signs of deterioration. The buildings are older than 60 years and most likely were built during the 1930's.

**Figure 30 Buildings at site no. 11.**

**Figure 31 Main house and outbuilding at site no. 11.**

The buildings may therefore be demolished during development activities. However, the buildings are not to be directly affected by the development and should be left as it is.

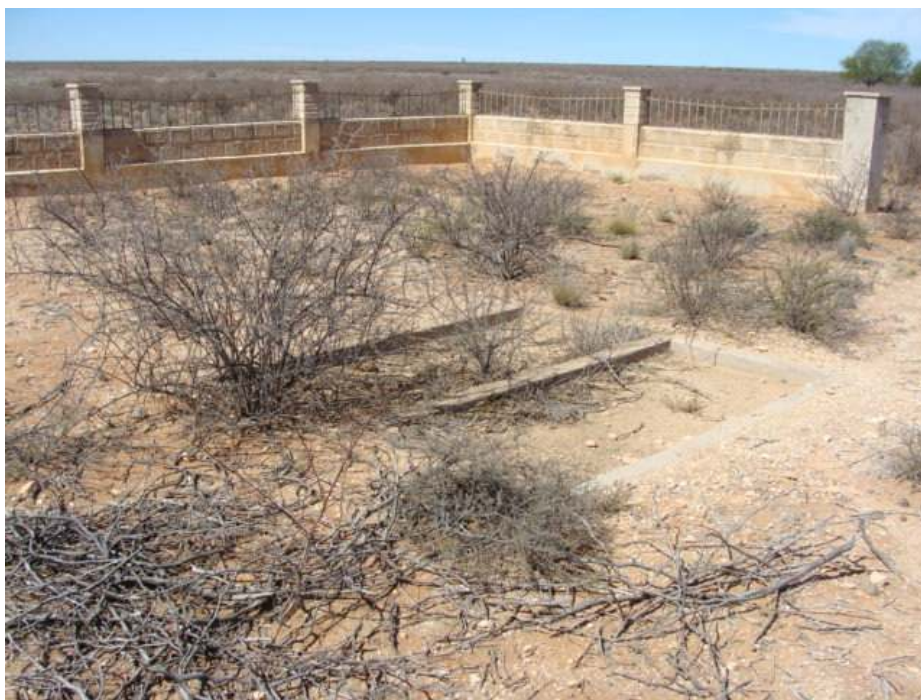
**Figure 32 Graves at site no. 12.**

Since the site is reasonably close to the development area and may be impacted on indirectly, option 1 is recommended.

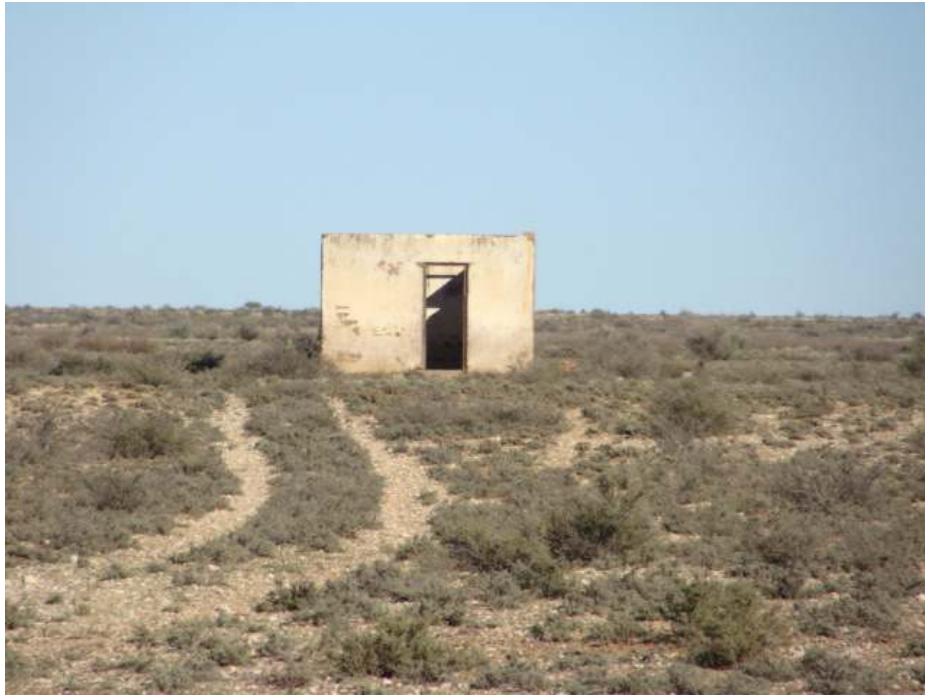
It is not very unique, since almost all the buildings on other farms are similar. It also seems not be in use any more and therefore shows signs of deterioration. It therefore is regarded as having **low** cultural significance. It received a field rating of General protection B (IV B).

**Figure 33 Farm workers house at site no. 13.**

The building will not be impacted on and therefore it should be left as it is.

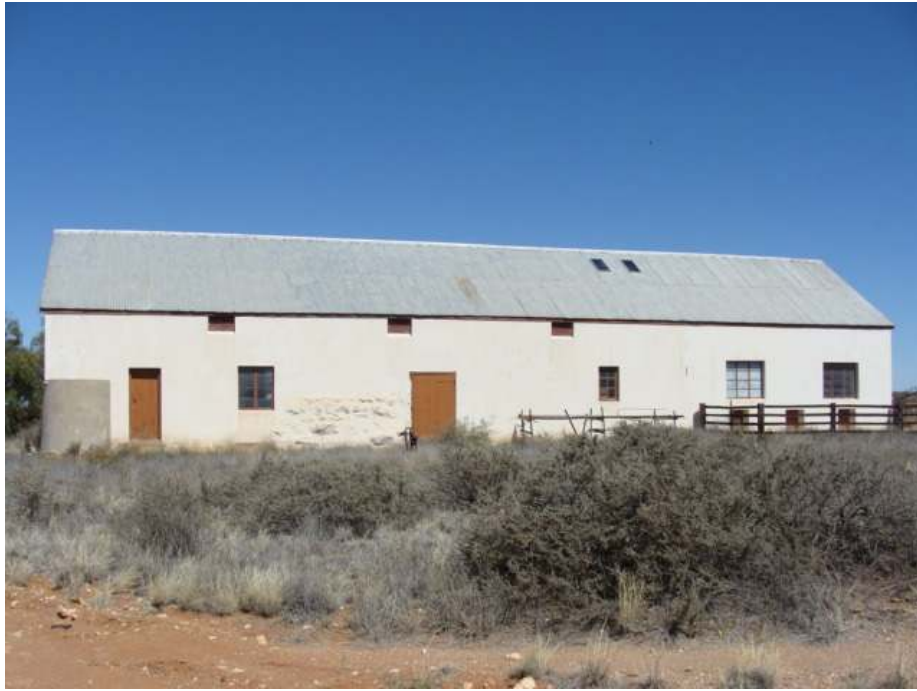
It is not very unique, since almost all the buildings on other farms are similar. It also seems not be in use any more and therefore shows signs of deterioration. It therefore is regarded as having **low** cultural significance. It received a field rating of General protection B (IV B). There also are some much younger buildings which have no heritage significance.

**Figure 34 Outbuilding at site no. 14.**

The building will not be affected by the development and should therefore be left as it is.

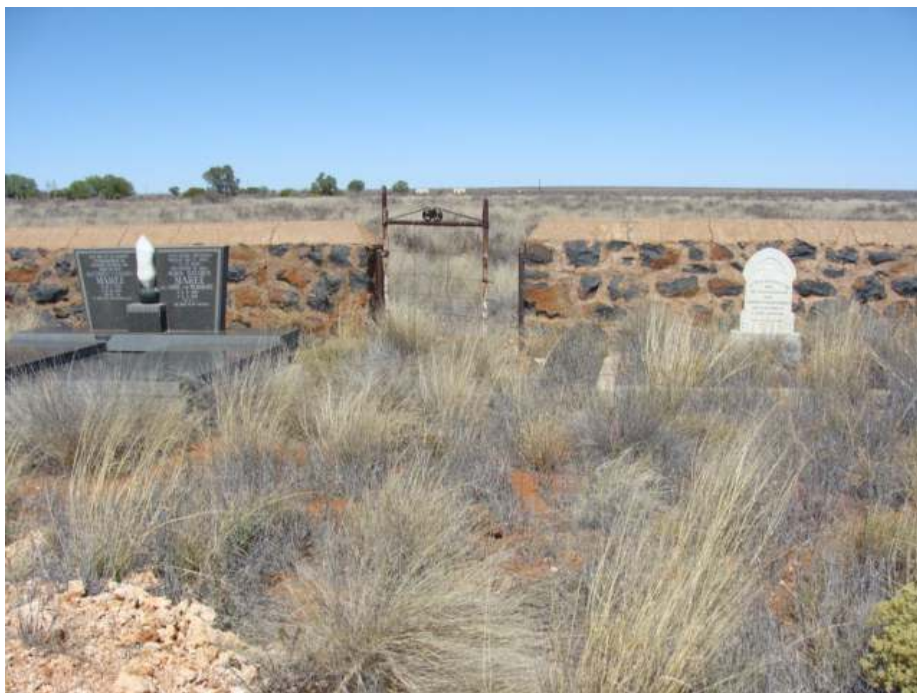
**Figure 35 Graves at site no. 15.**

Since the site will not be impacted on, it should be left as it is.

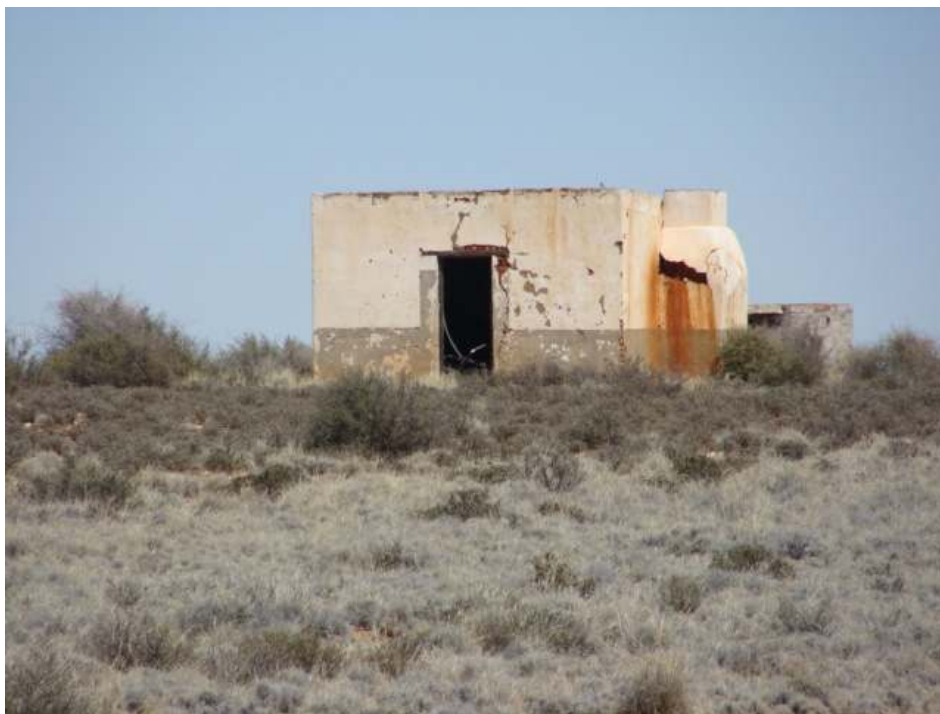
This house is not very unique, since almost all the farm workers houses on other farms are similar. It also seems not be in use any more and therefore shows signs of deterioration. It therefore is regarded as having **low** cultural significance. It received a field rating of General protection B (IV B). There also are some much younger buildings which have no heritage significance.

**Figure 36 Farm workers house at site no. 16.**

The building will not be affected by the development and it should therefore be left as it is.

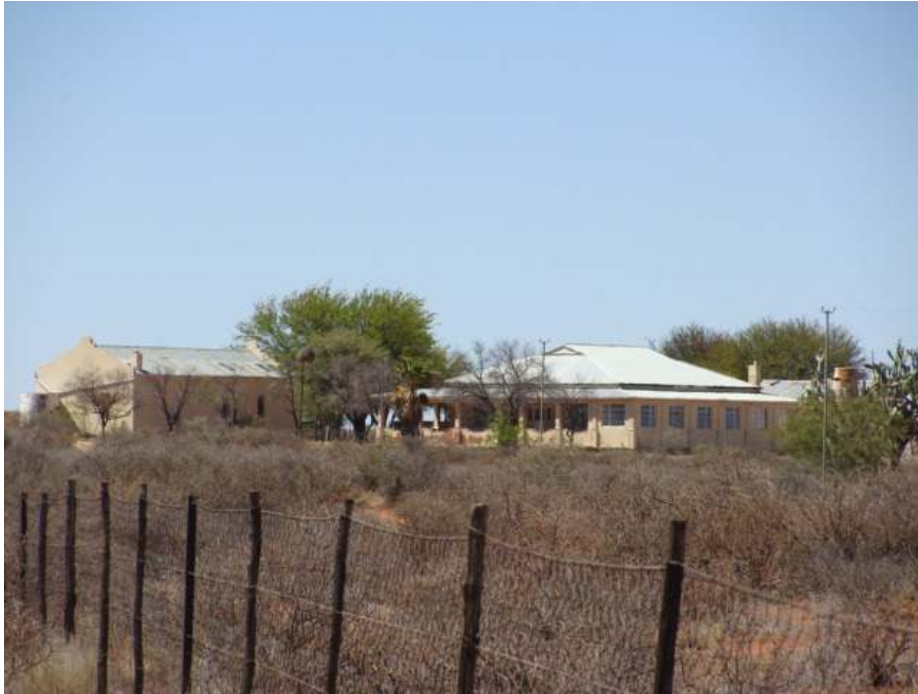
It is not very unique, since almost all the buildings on other farms are similar. It also seems not be in use any more and therefore shows signs of deterioration. It therefore is regarded as having **low** cultural significance. It received a field rating of General protection B (IV B). There also are some much younger buildings which have no heritage significance.

**Figure 37 Farm yard with buildings at site no. 17.**

The buildings will not be affected by the development, and it should therefore be left as it is.

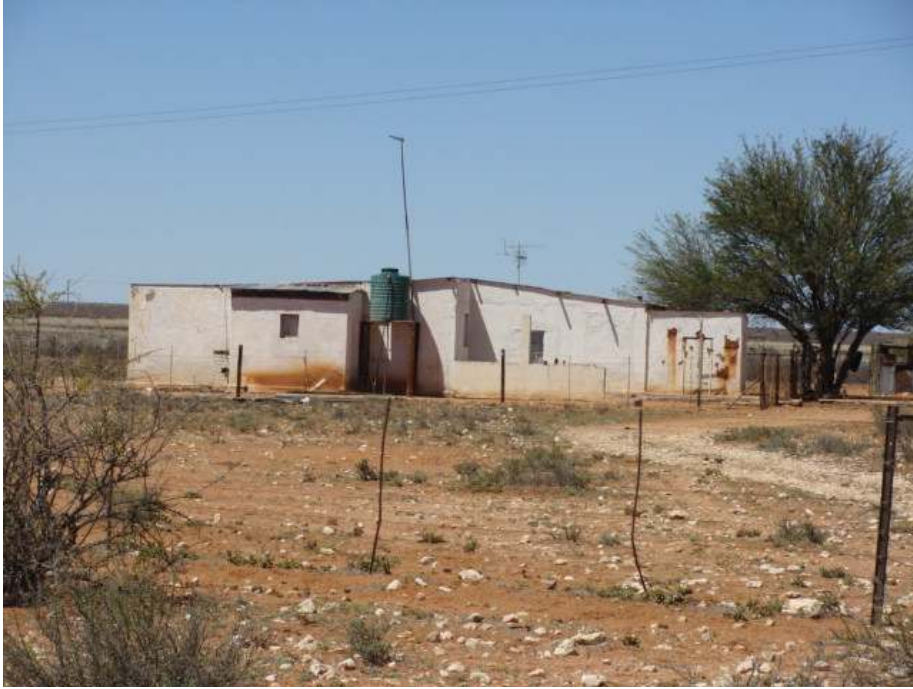
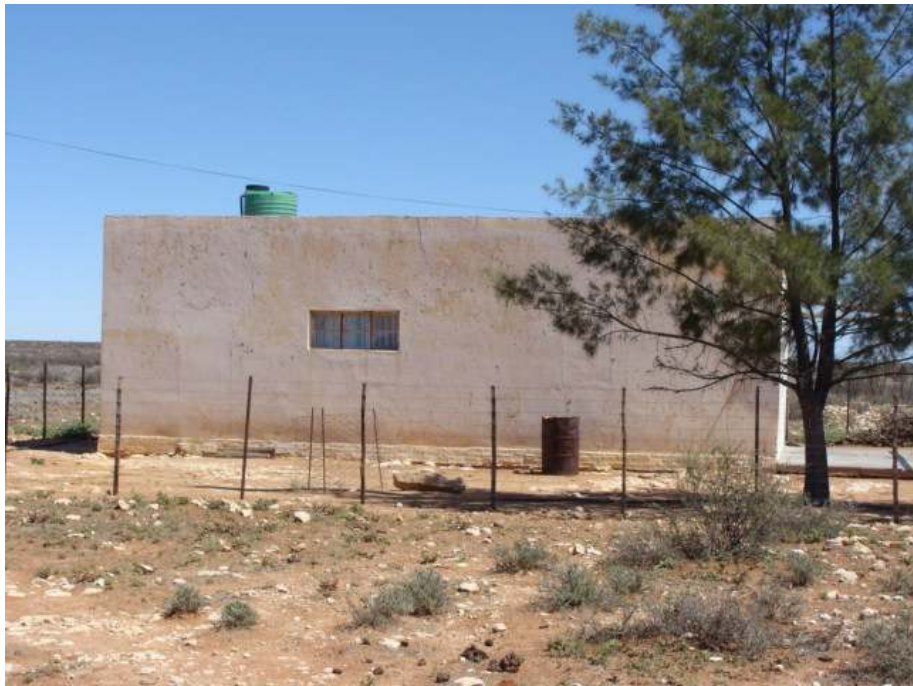
**Figure 38 Main house at site no. 18.**

**Figure 39 Workers house at site no. 18.**

The buildings will not be affected by the development and therefore it should be left as it is.

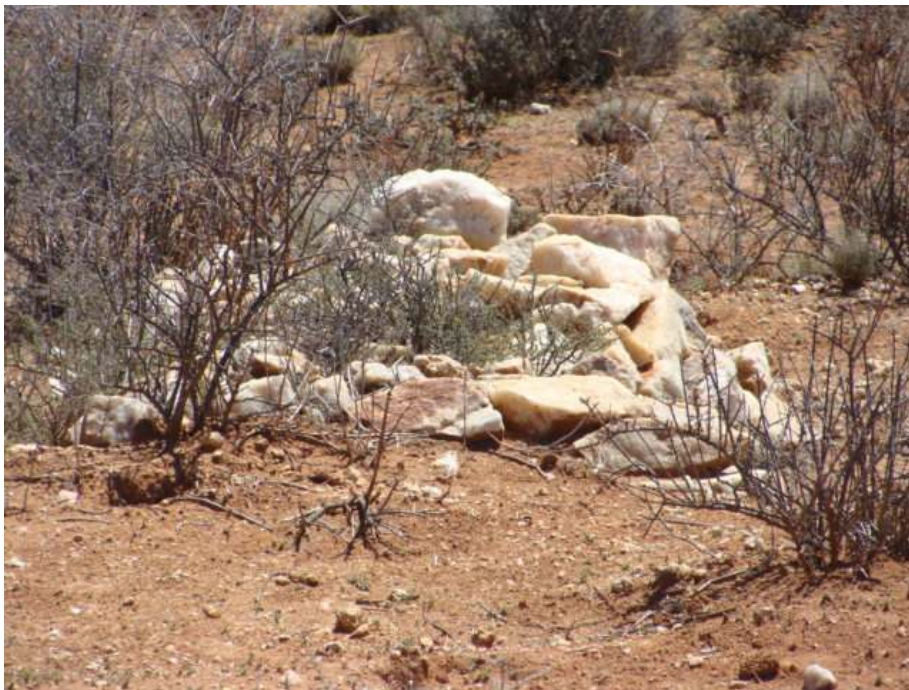
The site consists of at least four graves (Figure 40). They are all stone packed with white quartzite stones. No legible information is available as no headstones are visible. The graves therefore are unknown.

Graves are always given a rating of **high** cultural significance due to it being a sensitive matter. Graves with an unknown date are always handled as if older than 60 years. Graves older than 60 years are regarded as heritage graves. The graves receive a field rating of Local grade III B.

**Figure 40 One of the graves at site no. 19.**

Usually there are two options when dealing with graves. The first option is to leave the graves *in situ*. This would be possible should there be no direct impact on the graves. However, there always is a secondary impact as descendants may find it difficult to visit the site once mining has commenced. Therefore the site should be fenced in and a management plan should be written for the preservation and maintenance thereof. Such a fence should be erected at least 50 m from the perimeter of the site as blasting closer than that will definitely have a negative impact on the graves.

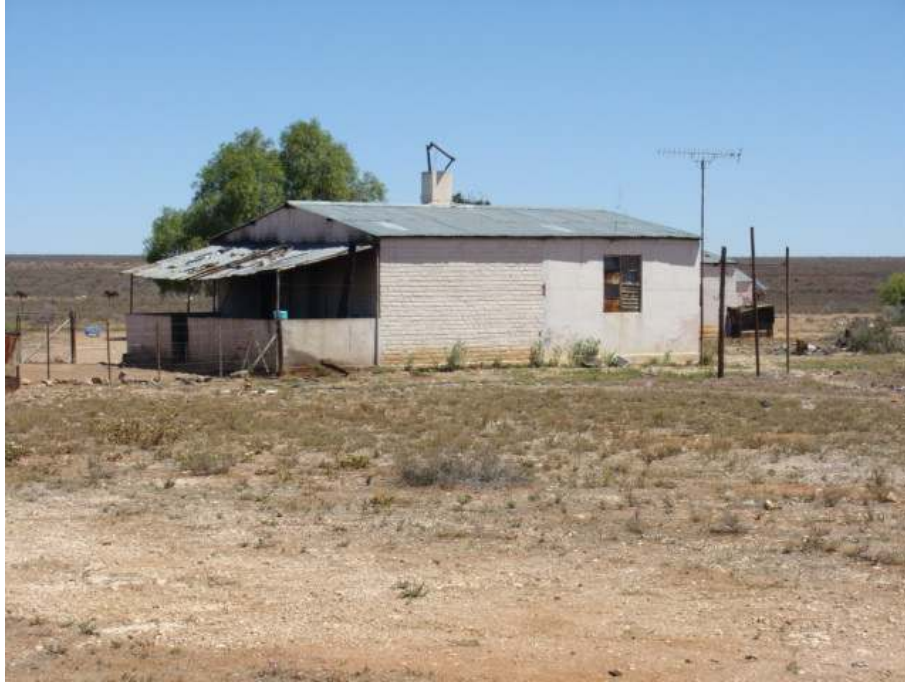
**Figure 41 One of the farm workers houses at site no. 20.**

The buildings will not be affected by the development and it should therefore be left as it is.
