**A REPORT ON A CULTURAL HERITAGE IMPACT ASSESSMENT FOR THE  
PROPOSED EXPLORATION ACTIVITIES AT THE JACOMYNSPAN PROJECT,  
NORTHERN CAPE PROVINCE**

***GCS Project no.: 12-139***

**REPORT: AE01406V**

***February 2014***

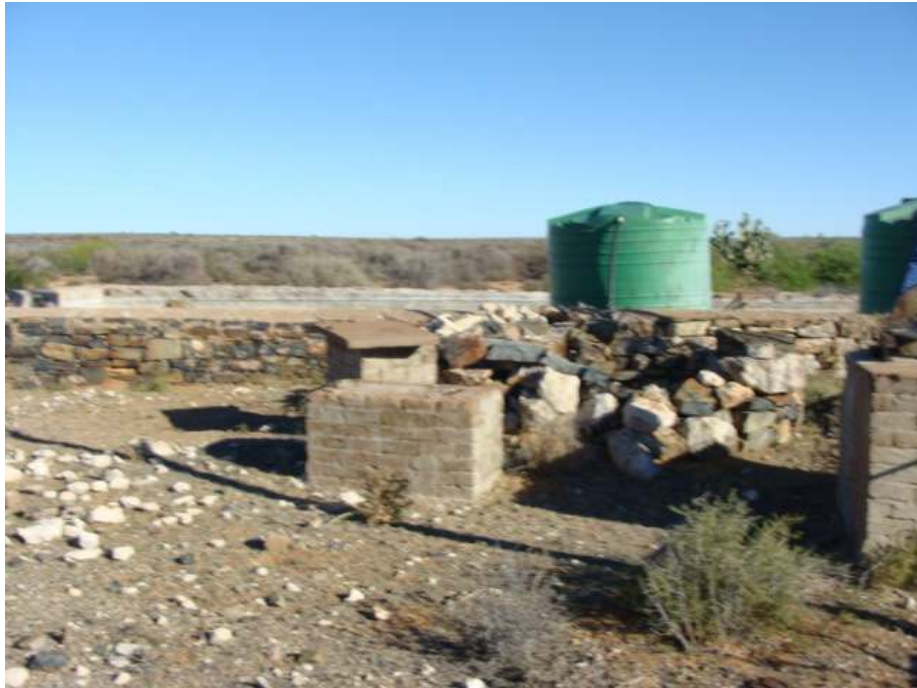
**Figure 42 Stone well and kraal at site no. 21.**

The structures will not be affected by the development and it should therefore be left as it is.

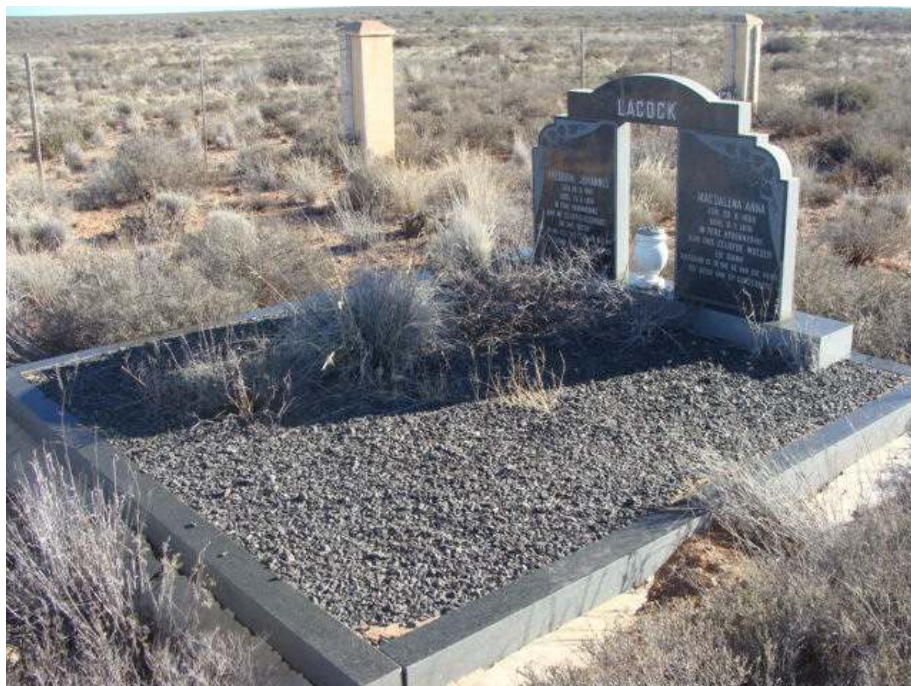
**Figure 43 Double grave at site no. 22.**

Since the site will not be impacted on, it should be left as it is.

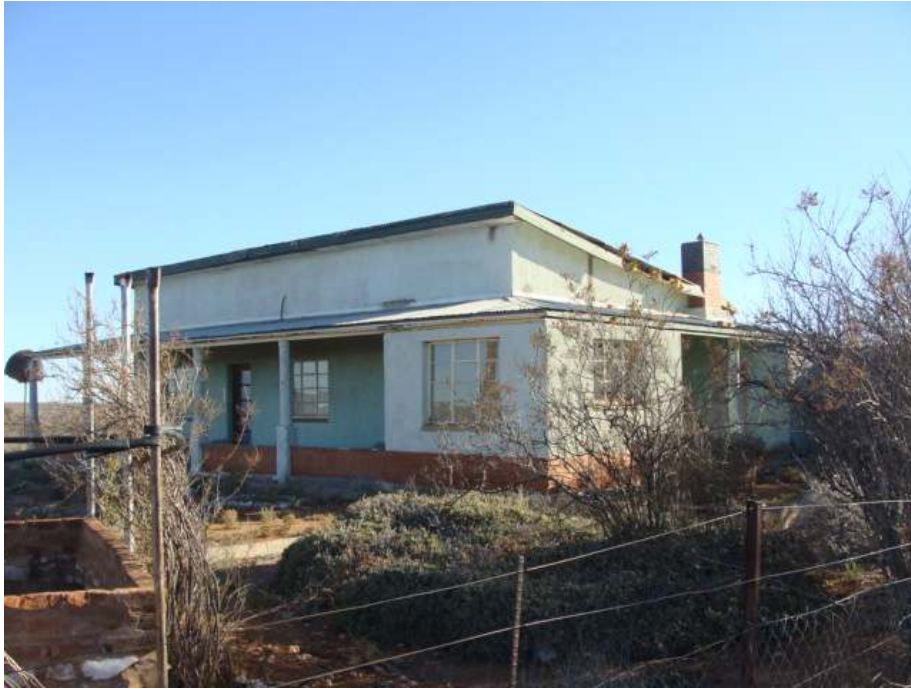
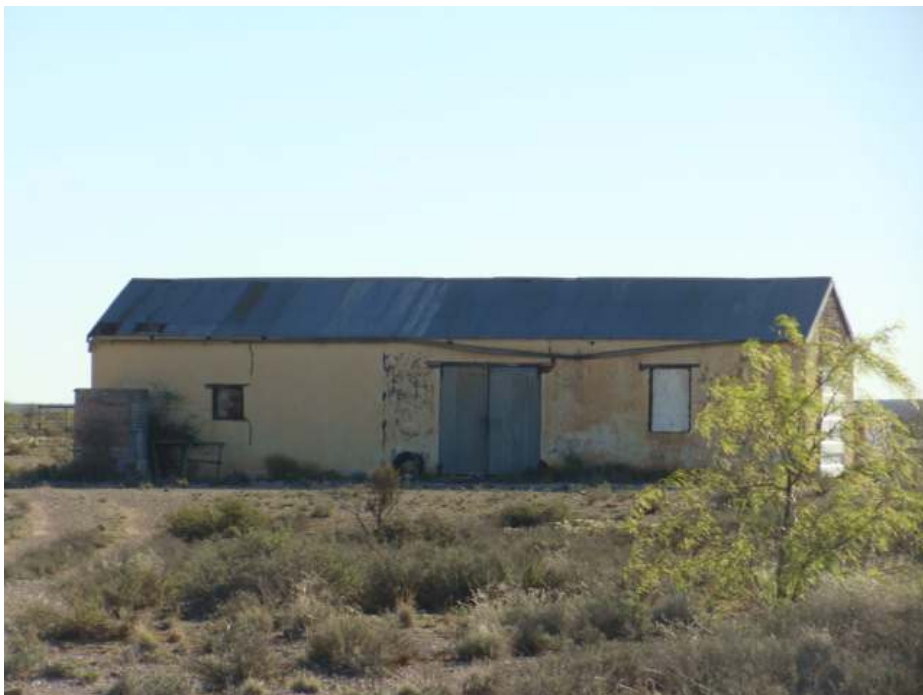
It is not very unique, since almost all the buildings on other farms are similar. It also seems not be used very frequently and therefore shows signs of deterioration. It therefore is regarded as having **low** cultural significance. It received a field rating of General protection B (IV B). There also are some much younger buildings which have no heritage significance.

**Figure 44 Main house at site no. 23.**

**Figure 45 Outbuilding at site no. 23.**

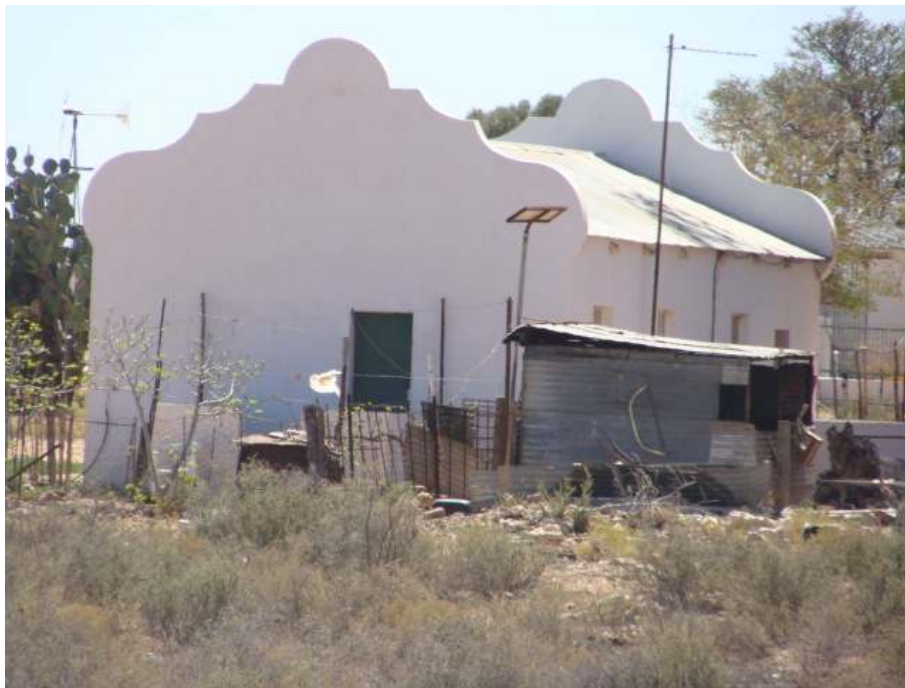
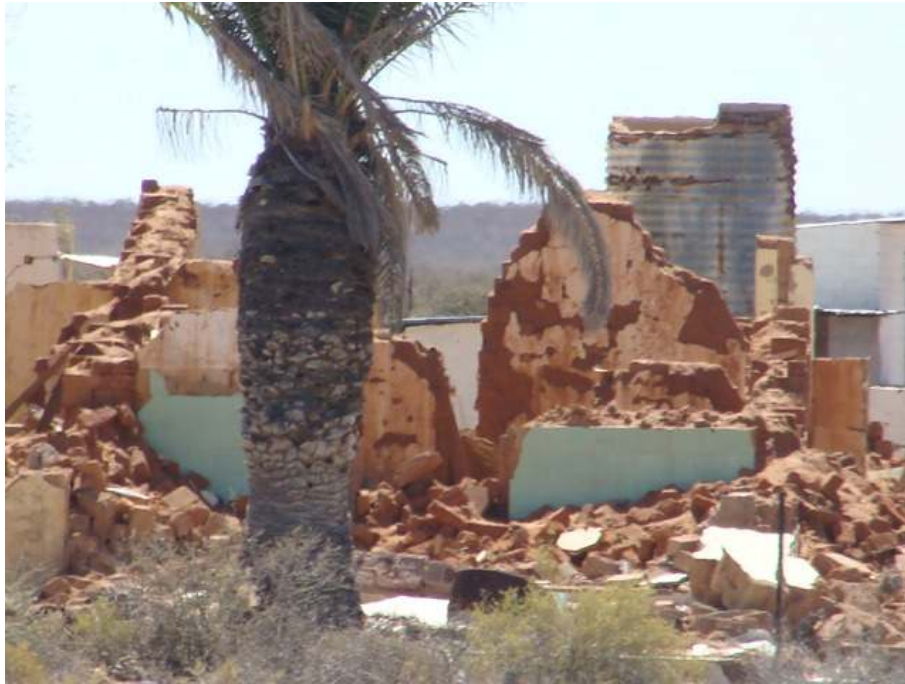
**Figure 46 Outbuilding at site no. 24.**

**Figure 47 Partially demolished building at site no. 24.**

The buildings will not be impacted on by the development and therefore it should be left as it is.

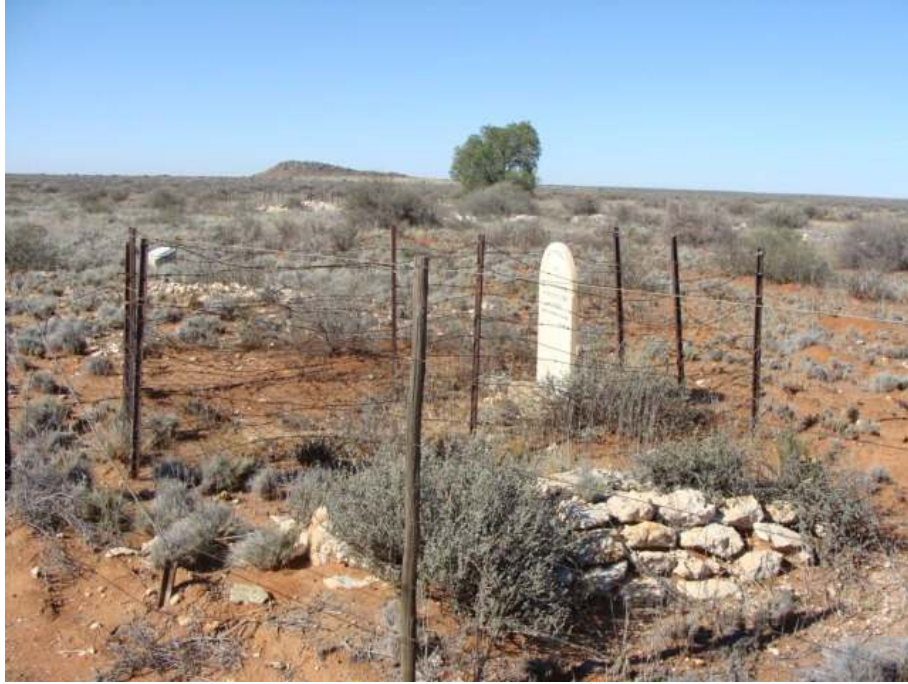
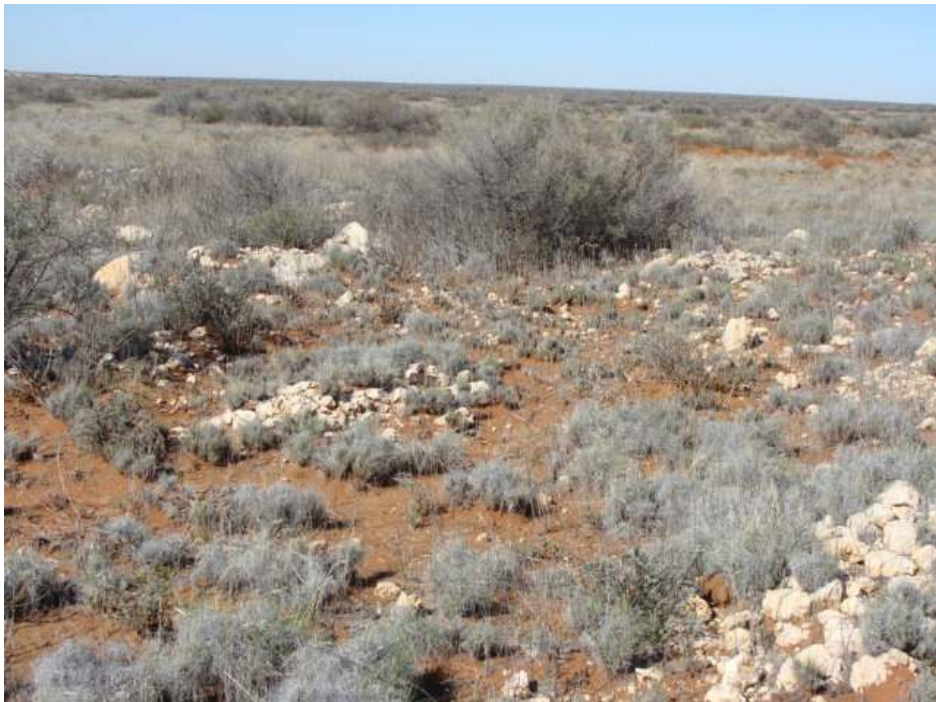
**Figure 48 Graves at site no. 25.**

**Figure 49 Stone packed graves at site no. 25.**

The plan will have to be approved by the Burial Grounds and Graves Unit (BGG) of the South African Heritage Resources Agency (SAHRA). SAHRA has specific guidelines for management plans and these will have to be followed.

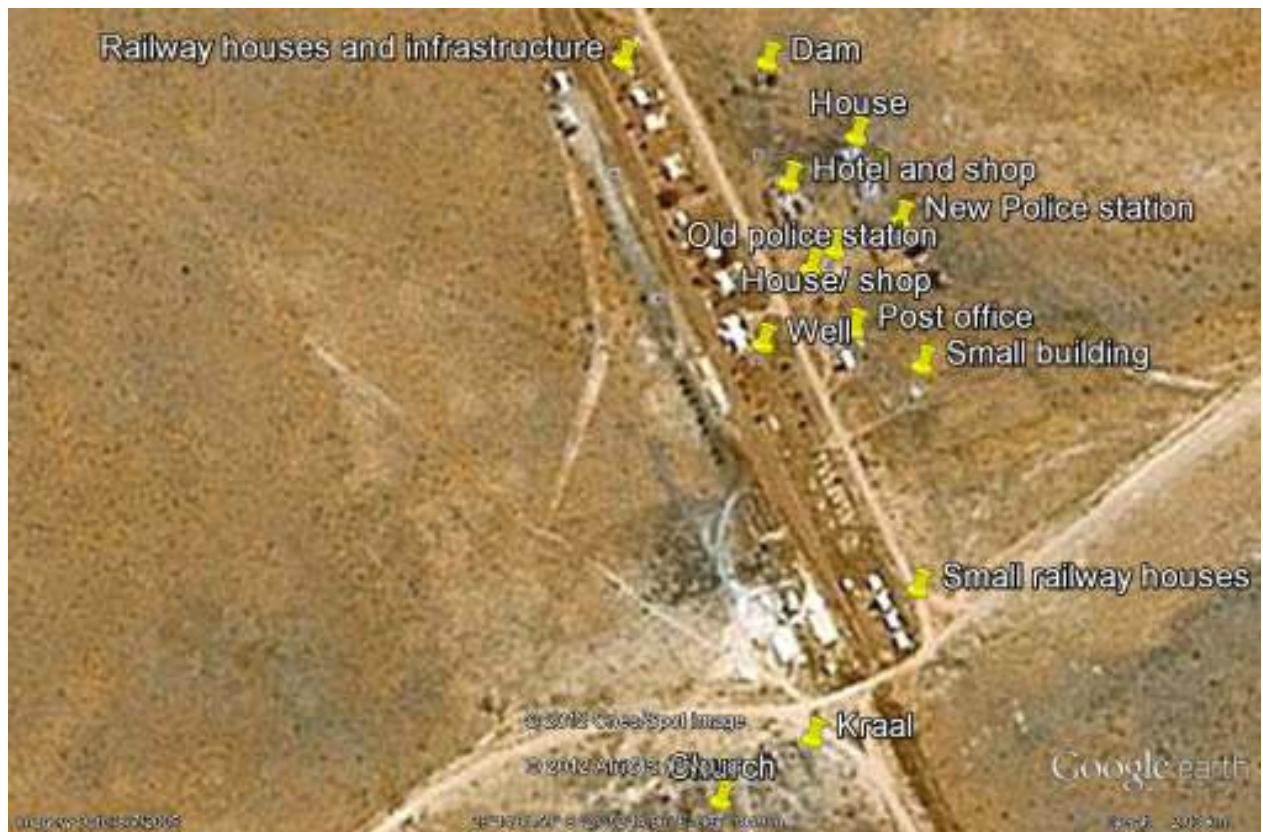
The town receives a rating of **high** cultural significance. The field rating is Local Grade IIIA. However a complete documentation of the site is needed and it may even be of Provincial Grad II significance. Not only is it a very good example of a small frontier town during the early 20th Century, but also an example of our railway heritage.

**Figure 50 Google image of the town of Putsonderwater. North reference is to the top.**

The site should therefore be documented in full and then re-assessed. Permission for any possible changes to any building or structure should be obtained from the Provincial Heritage Resources Agency of the Northern Cape before any work may be done. Therefore a proper Phase II report and cultural heritage management plan for the town is needed as this will give guidance in this regard.

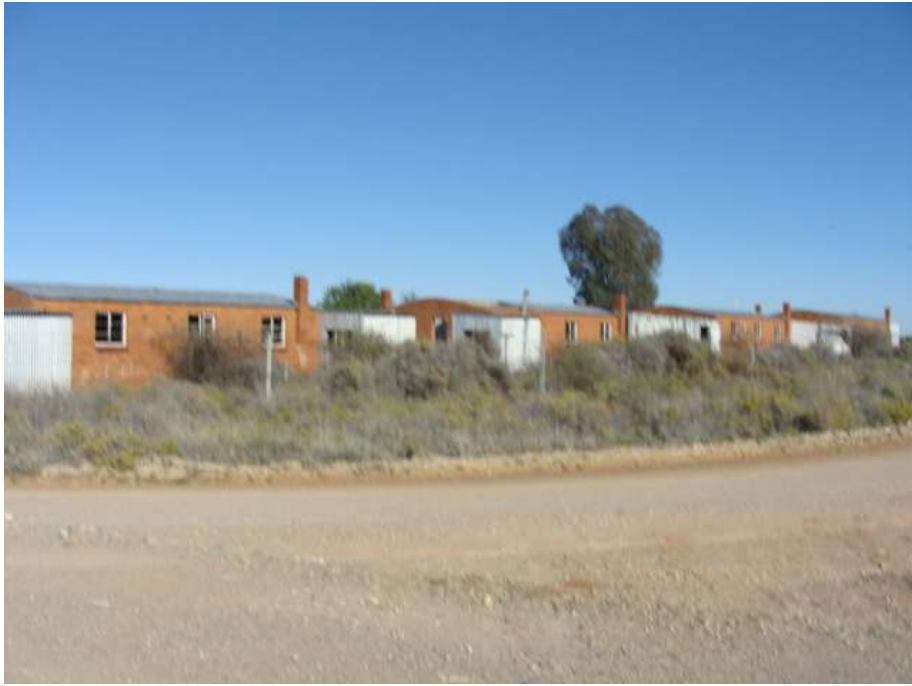
**Figure 51 Railway houses at the Putsonderwater station.**

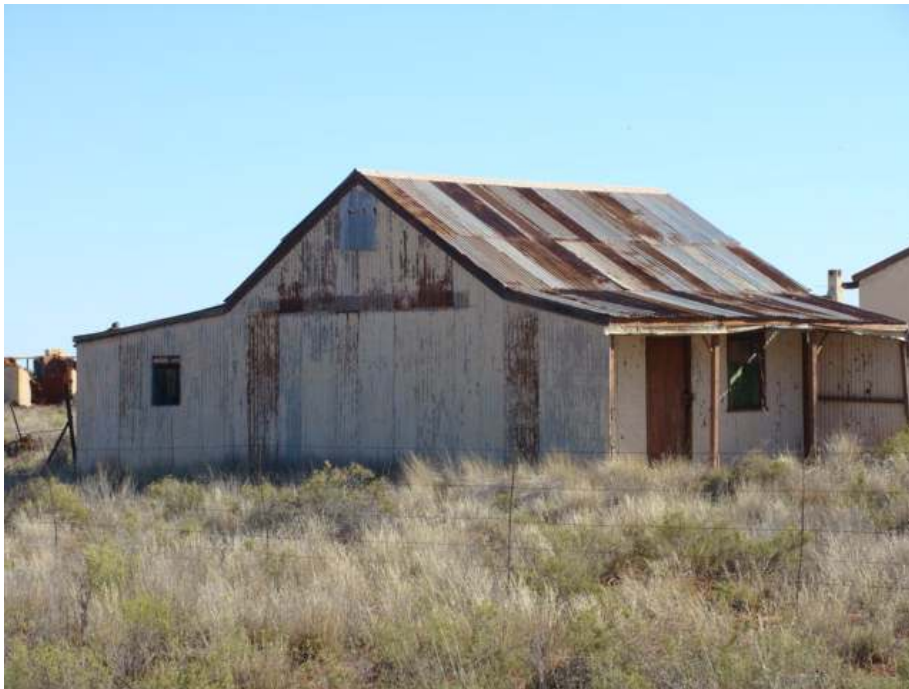
**Figure 54 The old police station at Putsonderwater.**

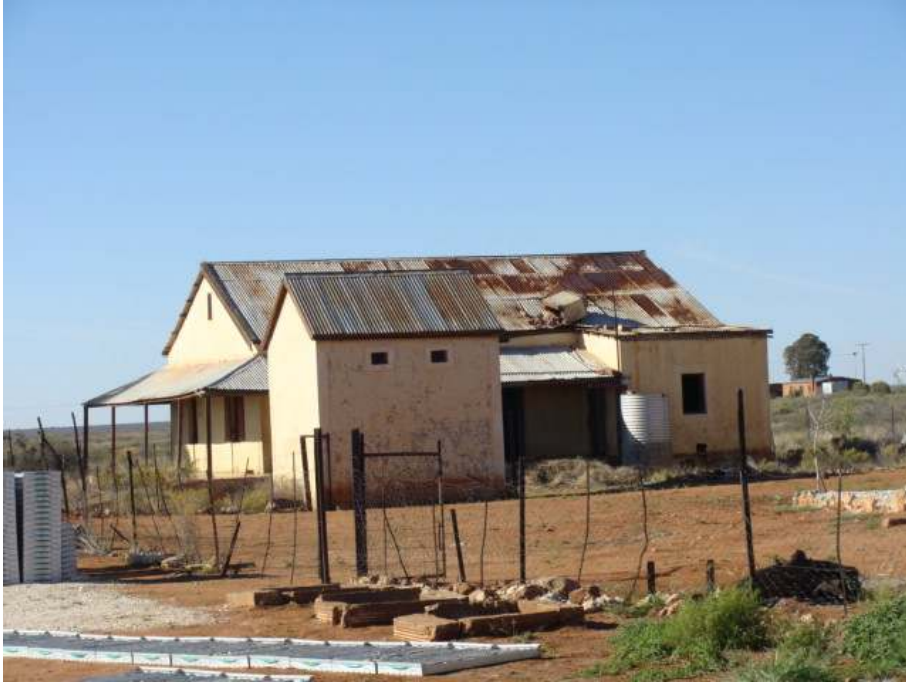
**Figure 55 The new police station and jail at Putsonderwater.**

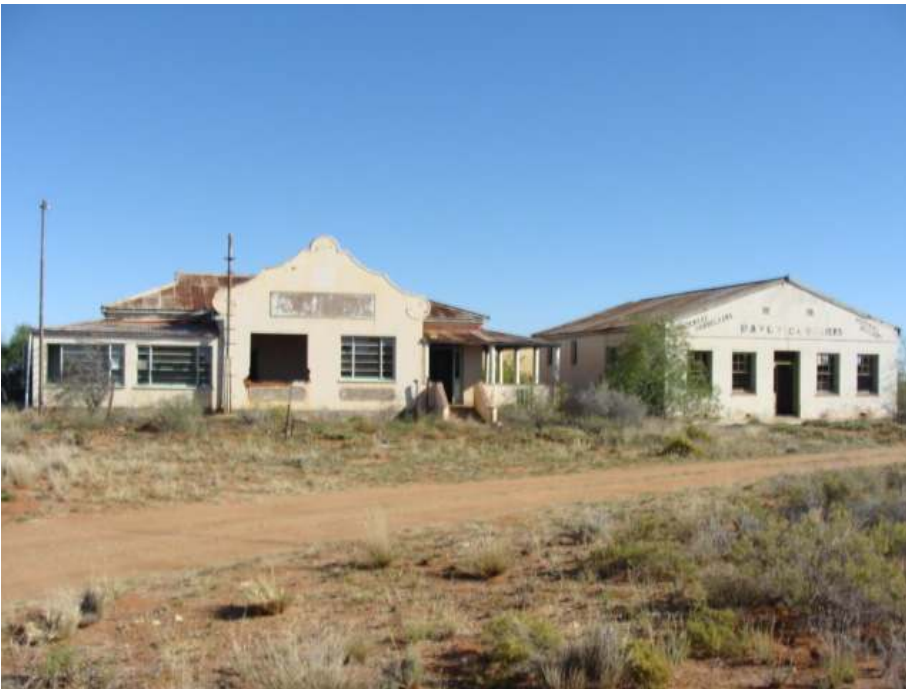
**Figure 56 The hotel and general dealer at Putsonderwater.**

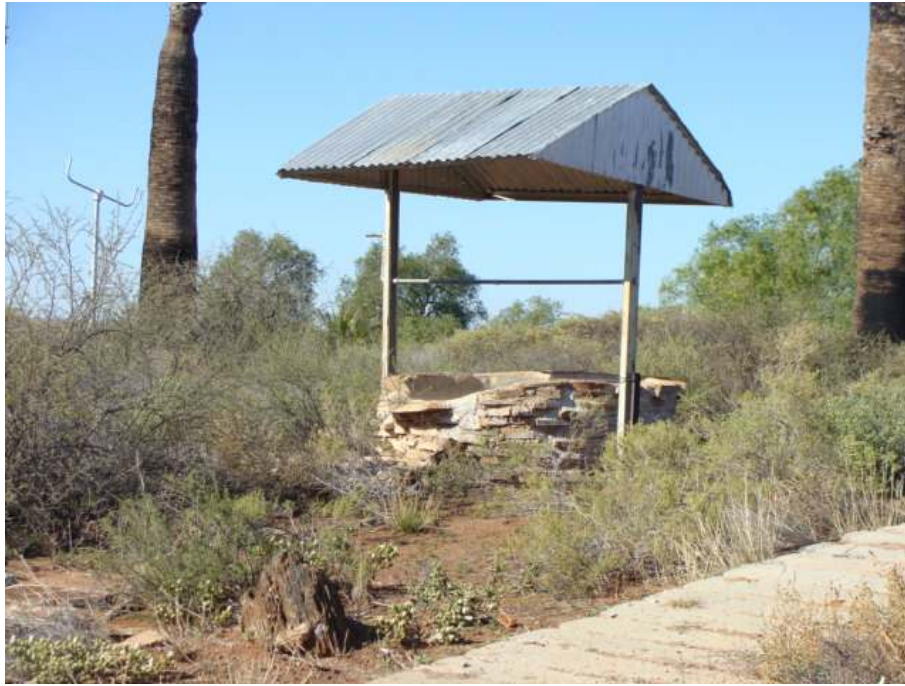
**Figure 57 The well at Putsonderwater from which the town got its name.**

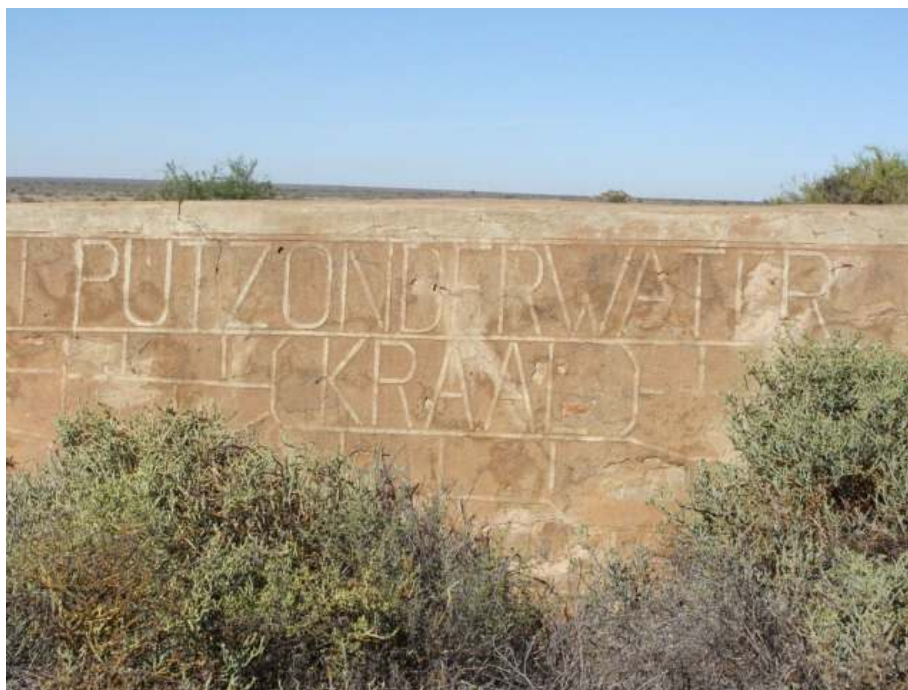
**Figure 58 The livestock kraal at Putsonderwater.**

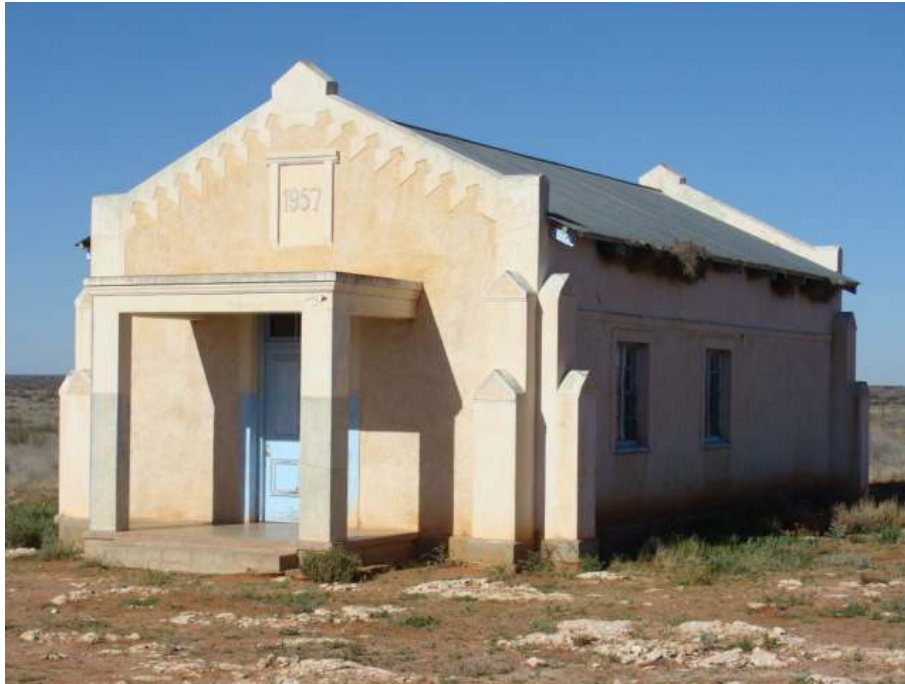
**Figure 59** The church, dating to 1957, at Putsonderwater.

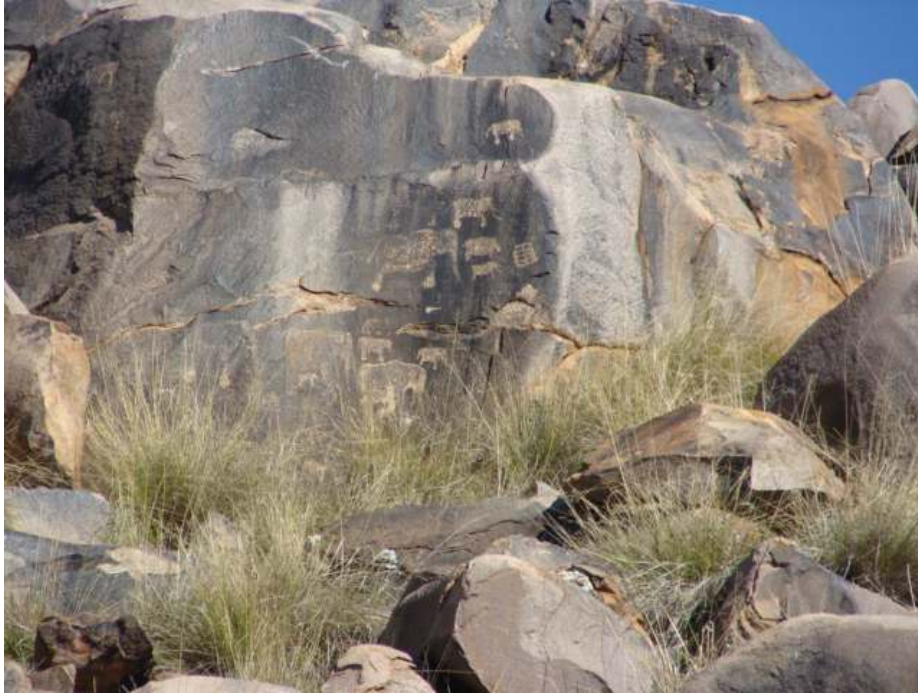
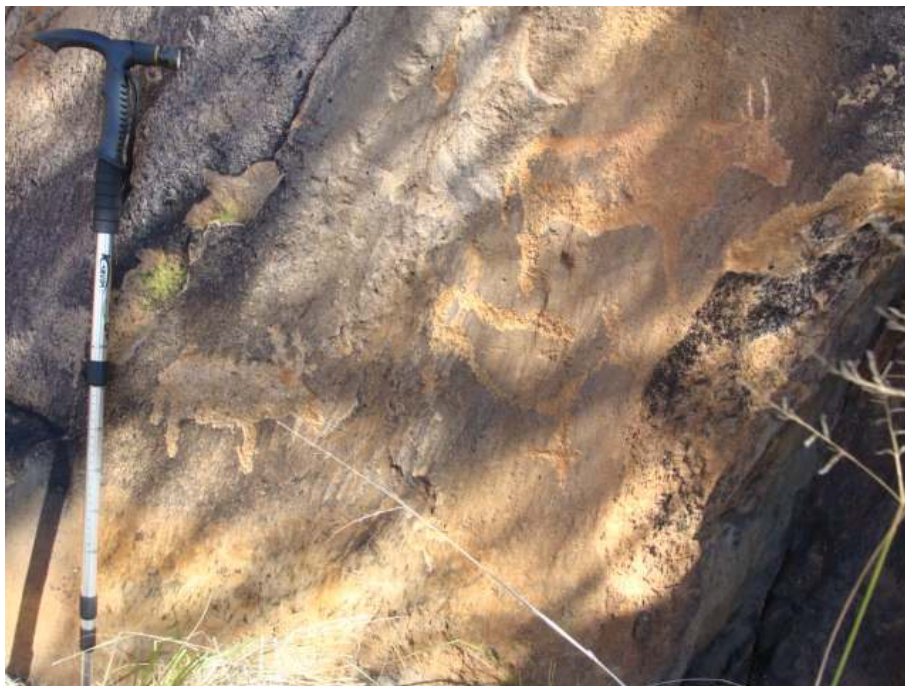
The site receives a rating of **high** cultural significance. The field rating is Local Grade IIIB. Although it may be mitigated, the best would be to preserve the site **in situ**. There will however not be any impact and therefore it should just be left as it is.

**Figure 60 Rock engravings at the Elephant Site.**

**Figure 61 Other animals depicted on the rock at the Elephant site.**

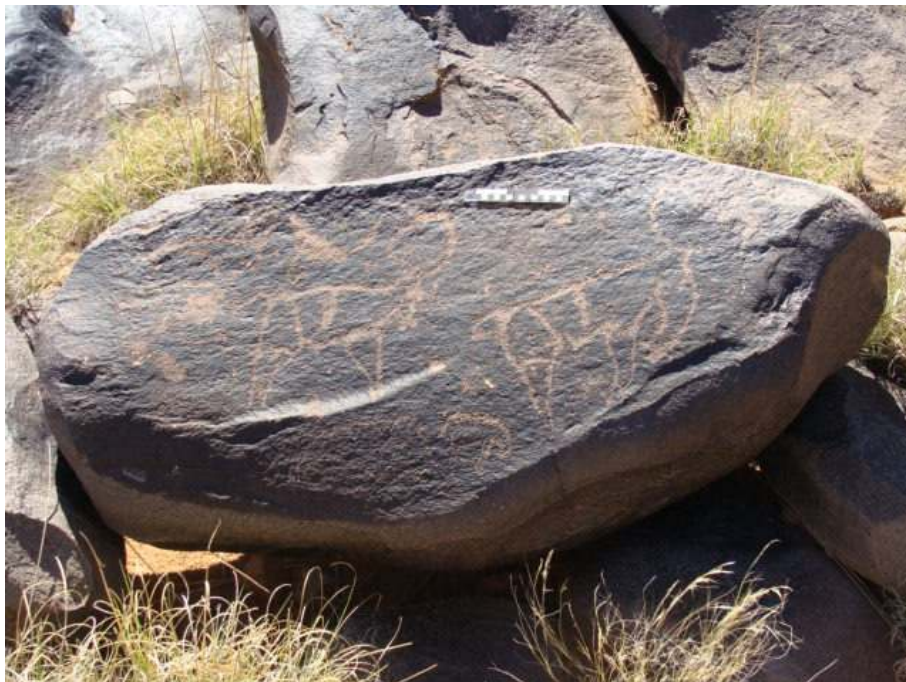
The site receives a rating of **high** cultural significance. The field rating is Local Grade IIIB. Although it may be mitigated, the best would be to preserve the site **in situ**. There will however not be any impact and therefore it should just be left as it is.

**Figure 62 Rock engravings at the Antelope Site.**

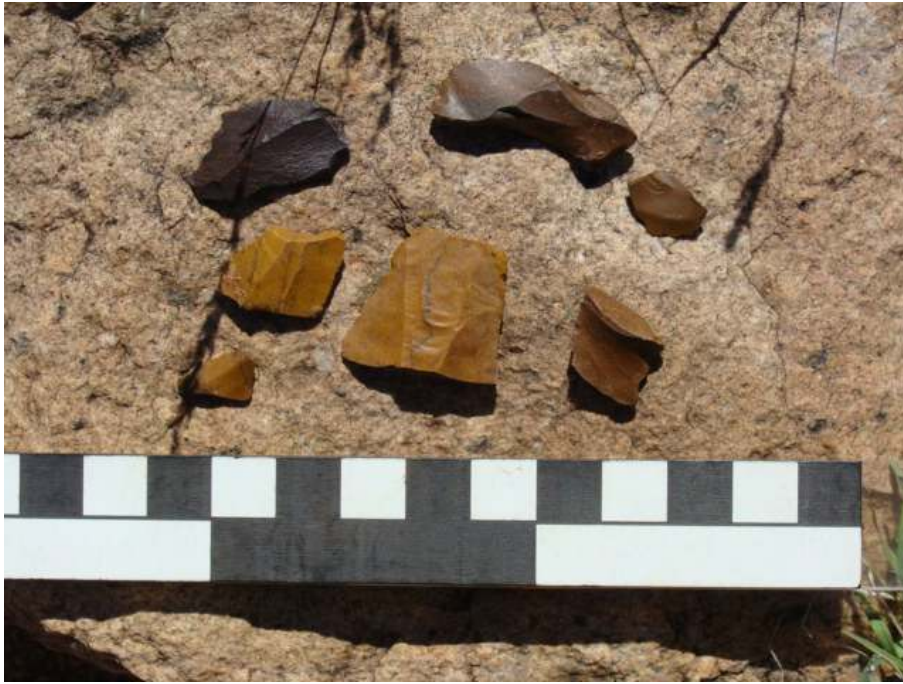
The engravings are found on rocks on top of the same small hill as the Elephant Site. In fact, pictures on the internet indicate that there may be more sites on this hill. Different animals, mostly some kind of antelope are depicted (Figure 62). Therefore the site is given the name of Antelope site. Rock engravings are usually associated with LSA San people. Some LSA tools were indeed identified nearby on top of the hill (Figure 63).

**Figure 63 LSA tools found nearby.**

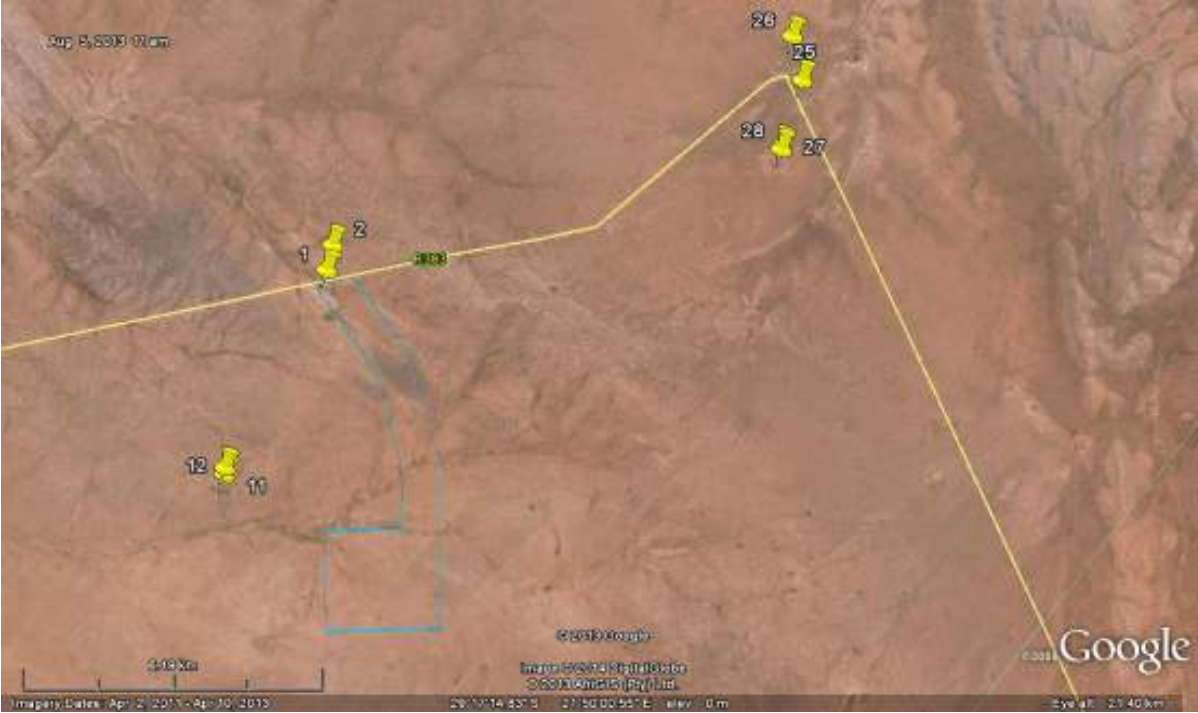
**Figure 65 Google image of the project boundary (in blue) indicating site no. 1 within it and the other nearby sites. North reference is to the top.**

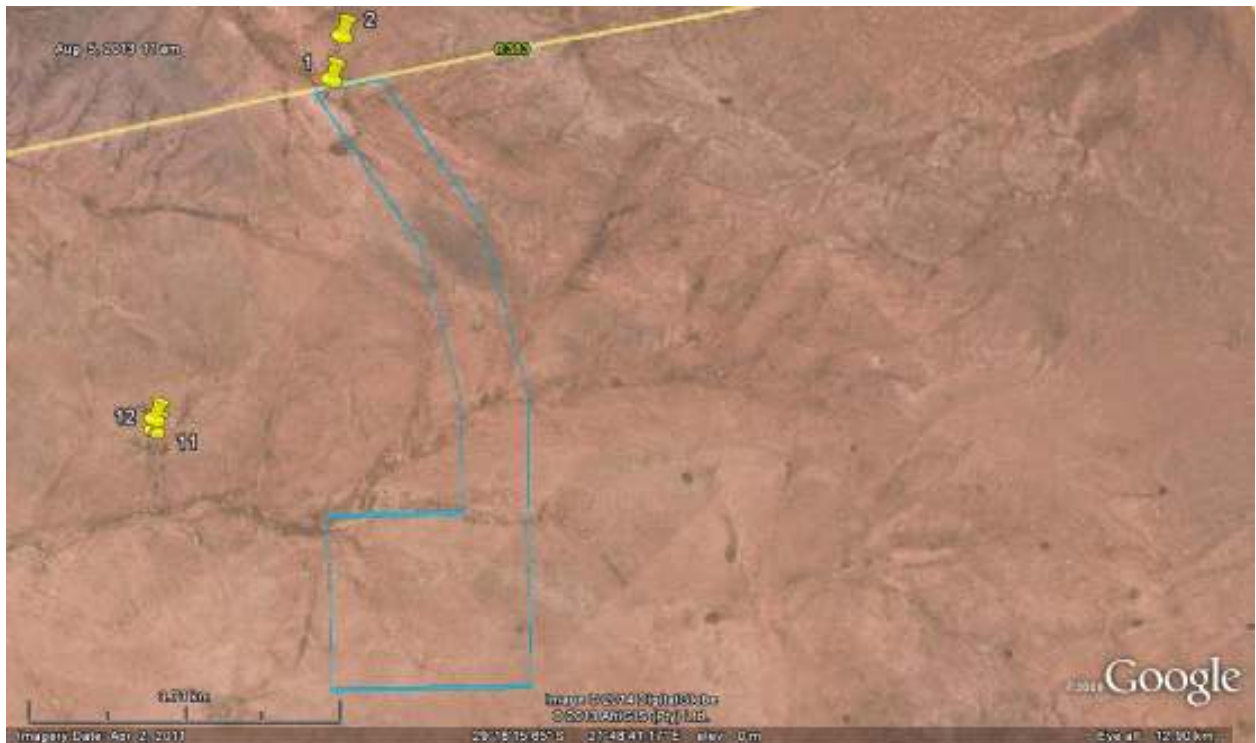
**Figure 66 Google image of the project boundary with site no 1 indicated. North reference is to the top.**
