HERITAGE IMPACT ASSESSMENT FOR THE PROPOSED IMPROVEMENTS TO THE R44 ROAD BETWEEN SOMERSET WEST AND STELLENBOSCH, WESTERN CAPE

(Assessment conducted under Section 38 (8) of the
National Heritage Resources Act (No. 25 of 1999) as part of an EIA)

1st draft: 14 November 2013
Final report: 26 February 2014

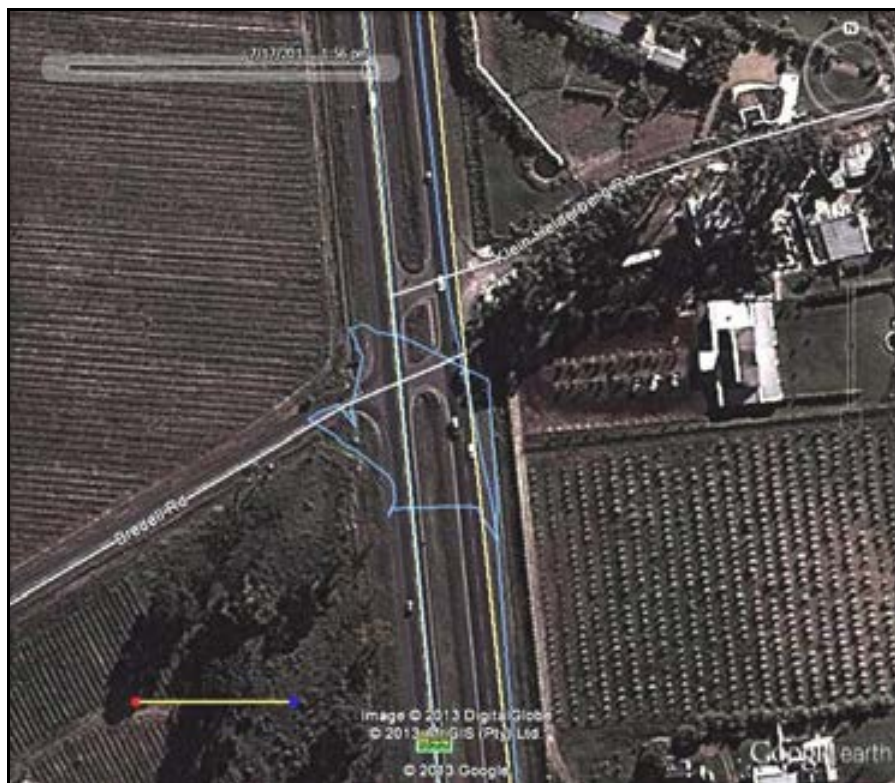
Figure 13: Aerial view of the Bredell Road Intersection. The blue lines are walk- and drive-paths, the yellow bar for scale at lower left is 50 m long.

All recorded heritage features are mapped along with the walk- and drive-paths in Figures 13 to 16. They are described by category below.

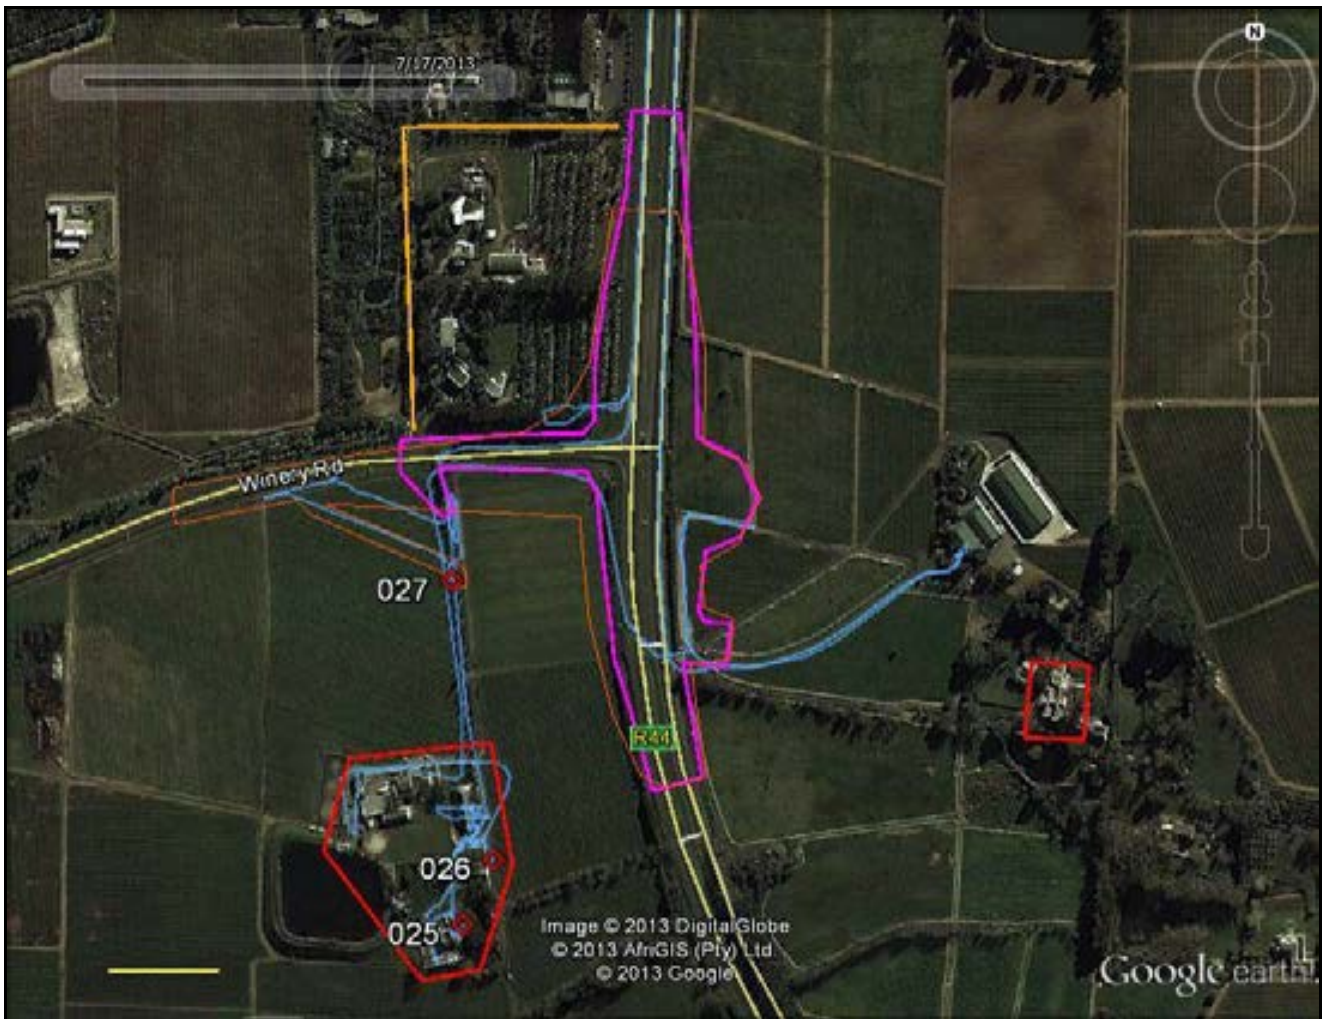
Figure 14: Aerial view of the Winery Road Intersection. The pink outline indicates the overall footprint including all new infrastructure, temporary bypass lanes and the current road surface where this will be removed. The fine orange lines indicate the earlier, larger footprint. The thick orange line indicates an existing side road that will be used as a bypass route during construction. The numbered red symbols and red polygons are heritage features, the orange line the original access to the Scholtzenhof (Ken Forrester) werf, the brown line an earlier road alignment, the blue lines are walk- and drive-paths, the yellow bar for scale at lower left is 100 m long.

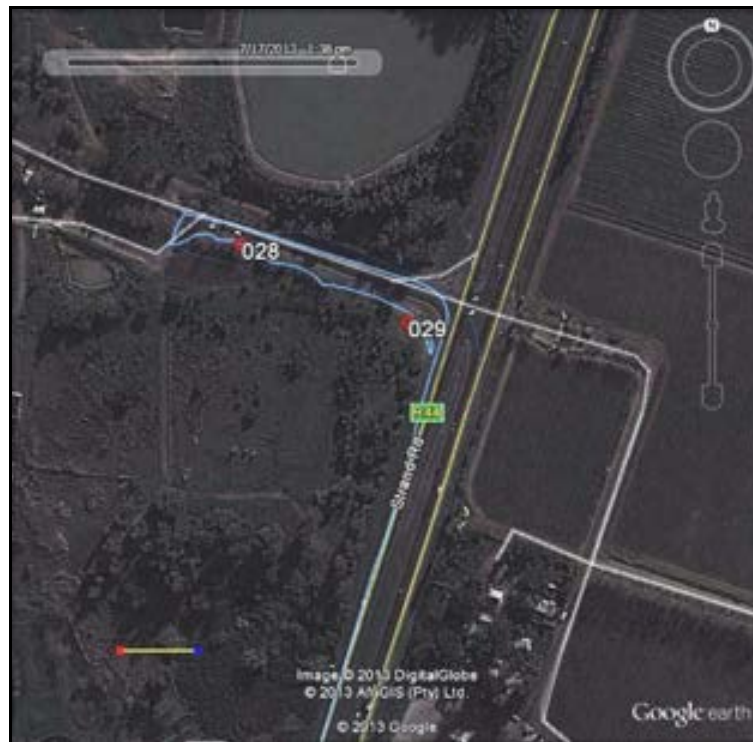
Figure 16: Aerial view of the Techno Road Intersection. The blue lines are walk- and drive-paths, the yellow bar for scale at lower left is 50 m long.

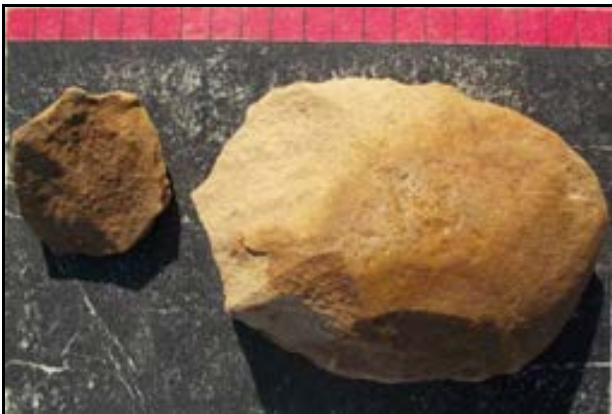
Figure 16: Flake and radial core from point 013. Scale in cm.

Archaeological resources were found in a few places, but in very limited density. On Farm 37/20 and Farm 540/rem stone artefacts were located close to the edge of Annandale Road (Figure 15). These were ESA artefacts, although one historical plate fragment was also noted (Figure 17 & 18). They occurred in sandy soil but clearly associated with ferruginous gravel nodules. Along Techno Road a very ephemeral scattering of similar artefacts was noted in the ferruginous gravel (Figure 16). These artefacts include one incompletely flaked radial core on a river cobble (Figure 16) and the tip of a hand-axe (far right in Figure 17). A further isolated artefact in the same field also appeared to be a hand-axe tip.

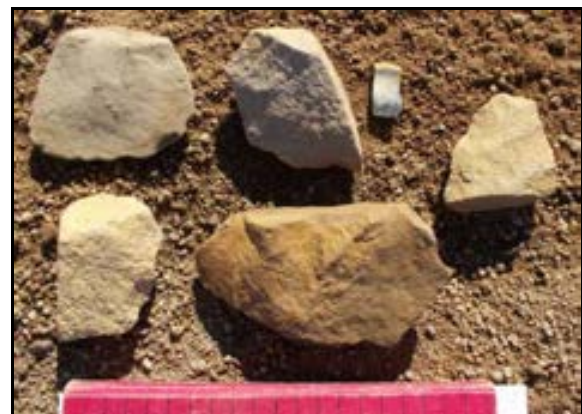
Figure 17: Stone artefacts and plate fragment from point 018.

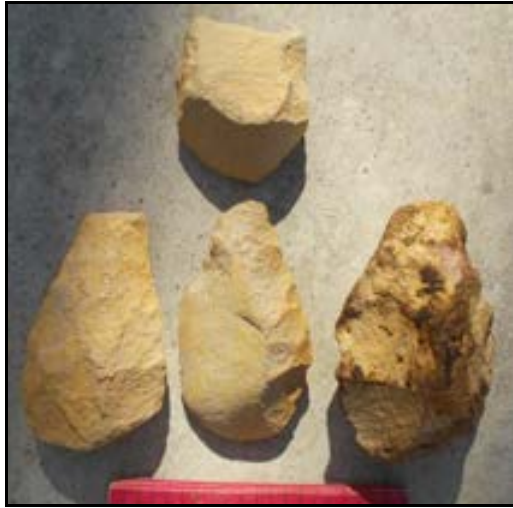
Figure 18: ESA hand-axes collected by the land owner on erf 169, alongside Winery Road. The artefact at the top and that on the right are hand-axes with their tips missing. The left hand-axe shows no evidence of a break and has a sharp upper edge. Scale in cm.

While no Stone Age material was found during the survey on erf 169 (largely due to the surface being vegetated), the owner has collected a number of artefacts from the fields through the years. The majority of these were said to have come from the area close to the entrance to the property. These artefacts included several ESA hand-axes (Figure 18 & 19). The ESA material in this area is likely not very dense because it is expected that even with the vegetation a few artefacts would otherwise have been visible.

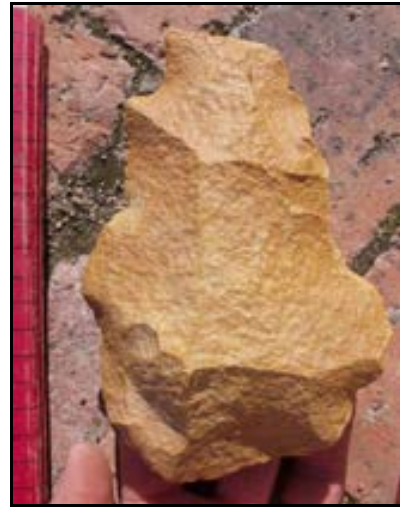
Figure 19: ESA hand-axe with its tip missing from erf 169. Scale in cm.

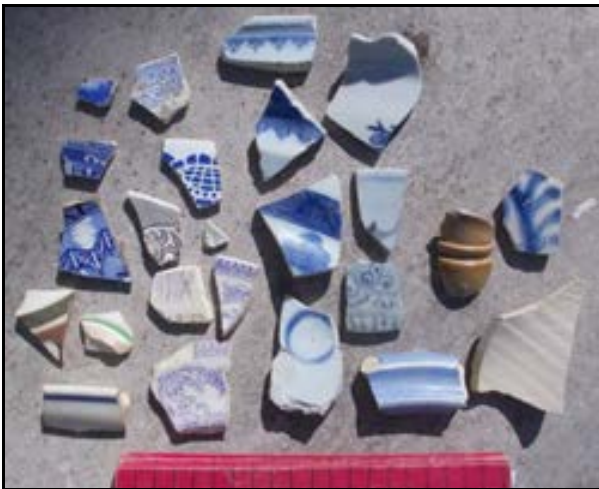
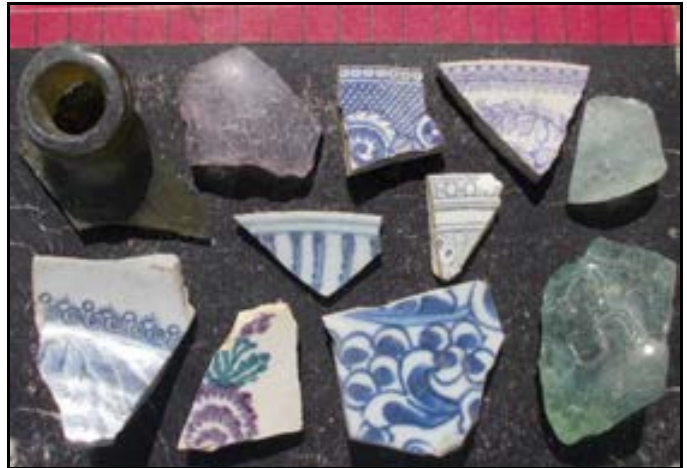
Figures 20 & 21: Historical artefacts of glass and ceramic from erf 169. Scales in cm.

The one small ceramic fragment found on Farm 540/rem was the only historical artefact found during the ground survey. This was surprising because of the many historical buildings present in the study areas. Kitchen dumps would often get disturbed in later years and the material spread around through ploughing and other agricultural activities. However, the owner of erf 169 has, over the years, assembled a large collection of ceramic and glass fragments found on the farm (Figures 20 & 21). These ceramics include coarse porcelain, transfer-printed refined earthenware, sponge-printed refined earthenware and stoneware (Figure 19). The bottle neck in Figure 20 is probably from a case bottle, while the embossed glass fragment is of the sort normally from soda or mineral water bottles.

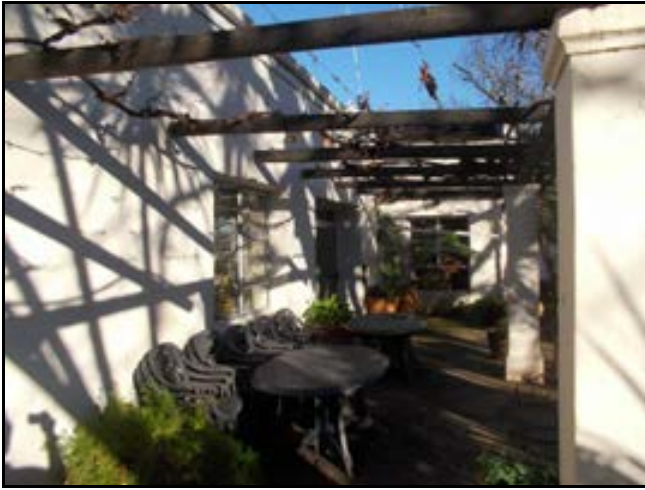
This structure lies in the northwest quadrant of the Annandale Road Intersection and has been much altered. According to the owner its core may date to the late 1700s (D. Zettler, pers. comm. 2013) but there is no way to prove this. However, the north-facing wall of the house (Figure 35) was found to be about 600 mm in thickness, a sure sign of some antiquity. Wooden ceilings present inside the core section have neatly worked beams that do not betray any great age (Figure 36). Given all the modifications to the house, these may have been added as replacements for older woodwork in the late 19th or early 20th centuries. The house is likely to have been an outbuilding or worker's cottage when originally constructed but given the extensive modification and addition (Figures 37 and 38) it is no longer possible to visually determine its original age. The small addition to the north-western corner of the house might date to the 1930s or 1940s while the double storey section to the east end is more modern. The nature of the modifications has rendered the house of very little heritage value in terms of architectural merits. The little value that can be attached to it is mostly archaeological and relates to any buried remains that might be present in and around the house and to an understanding of the construction materials and methods.

Figure 35: View of the north-facing aspect of the structure at point 011.

Direct impacts to the built environment and associated buried archaeological resources will occur with either roundabout alternative through demolition of the historic cottage at the Annandale Intersection. Mitigation here would involve plaster sampling and test excavation to document the building sequence and any other information that can be gained regarding the history of the structure, its architectural features and any related subsurface archaeological remains associated with it. It should be noted that HWC may well request that this exercise be carried out before they issue their final comment on the matter. This is because the structures could be found to be of higher significance than previously estimated and they may then choose to withhold permission for their demolition. Alternatively, the structures should be avoided if possible.

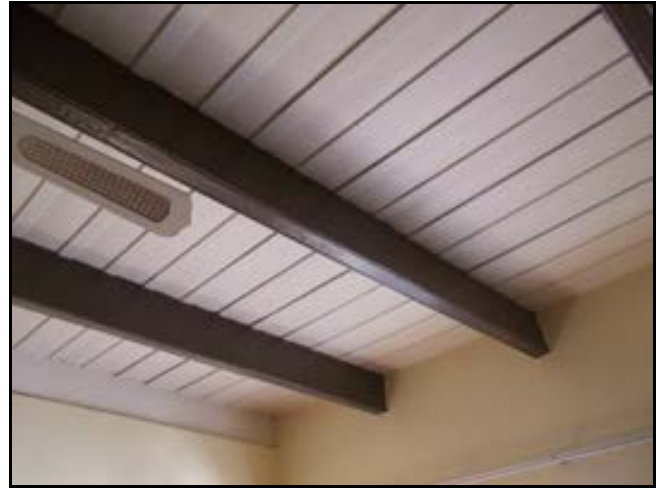
Figure 36: Ceilings inside the old core of the structure at point 011.

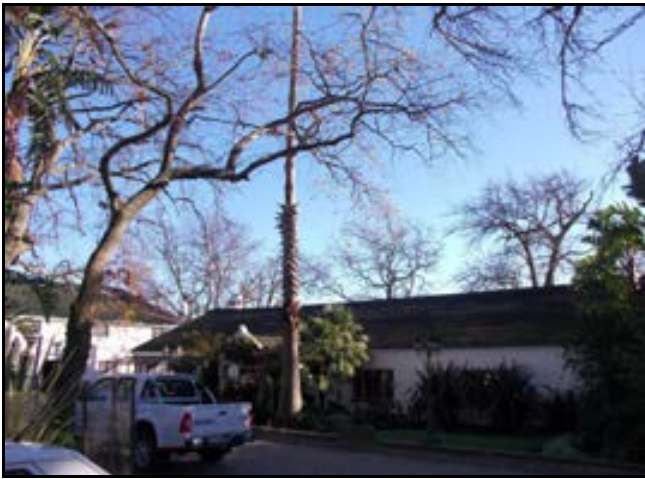
Figure 37: View of the south-facing aspect of the structure at point 011.

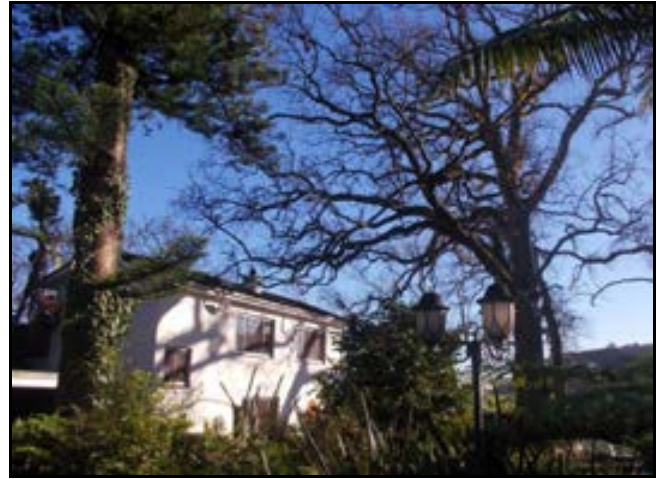
Figure 38: View of the east-facing aspect of the structure at point 011.

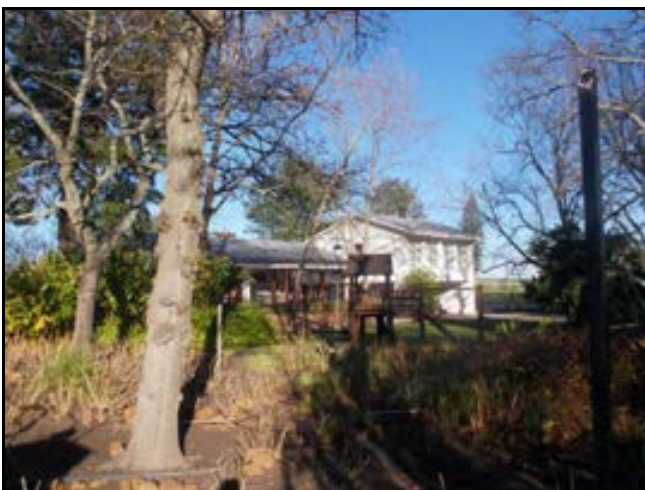
This house is also in the northwest quadrant of the Annandale Road Intersection and is said by the owner to have been built in the 1940s. Historical aerial photography shows that it did not yet exist in 1944. While the 1953 image is inconclusive, there is a house visible on the 1966 aerial photograph. While it may thus be greater than 60 years of age, triggering Section 35 of the NHRA, it has no special architectural characteristics and thus is of no heritage value as a structure (Figures 39 & 40).

Figure 39: north-facing aspect of the house at 012.

All the external doors and the windows have been replaced during the 20th century with steel windows likely dating after about 1930. At least two phases of 20th century cement plastering of the house are visible. In places this cement plaster has fallen off revealing the older and weaker bricks and mud mortar to which it does not adhere well (Figure 40). This building

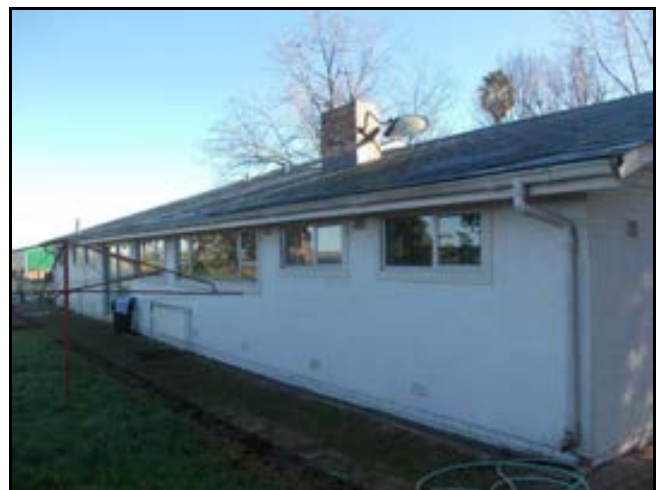
Figure 40: South-facing aspect of the house at 012.

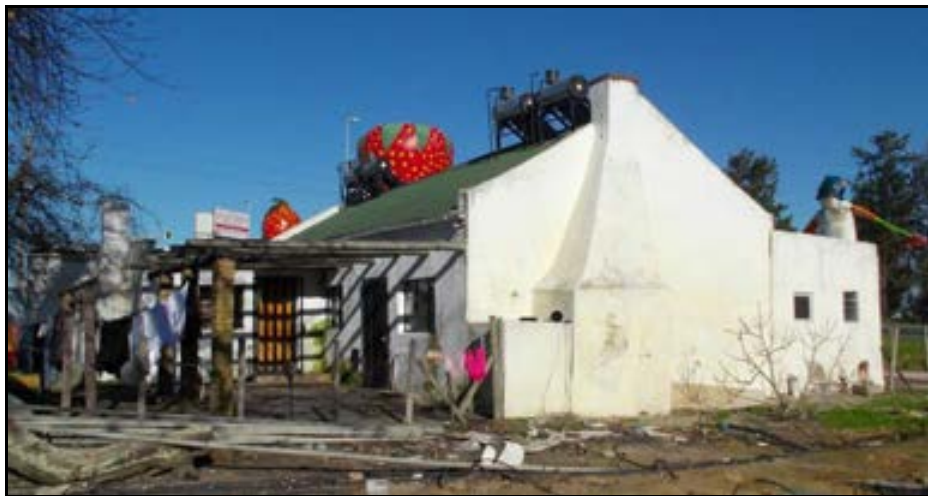
This little cottage is said by the land owner to date to the late 1700s but a visual inspection suggests this to be unlikely. It is certainly at least 19th century and seems to have started out as a simple rectangular cottage of some 13 m by 6 m built of fired clay bricks and mud mortar on a stone foundation. It had an external hearth and chimney stack on its northern end gable (Figure 41). Subsequent additions were made to both the east (Figure 41) and west (Figure 42) sides of the southern end creating a T-shape. Both these additions were present prior to 1925 when a survey diagram was drawn for the creation of the property (Farm 538) from two earlier land parcels (Figure 43). A unique feature of this little house is that it has three hearth and chimney stacks, one original and one on each of the two later (but pre-1925) additions. This could suggest multiple families sharing the house with each having their own domestic space.

Figure 41: View of the northern end of the house at point 015 showing the external hearth and chimney stack. The small addition to the right is a modern bathroom.

clearly has substantial amounts of original fabric and the majority is well over 60 years old. Although it is generally in very poor condition, it does have heritage value, primarily for its vernacular architectural characteristics (including its typically organic growth) and the value it imparts to the local cultural landscape. Its context among the strawberry fields and with two accompanying old oak trees (Figure 44) adds to this value (see further discussion below).

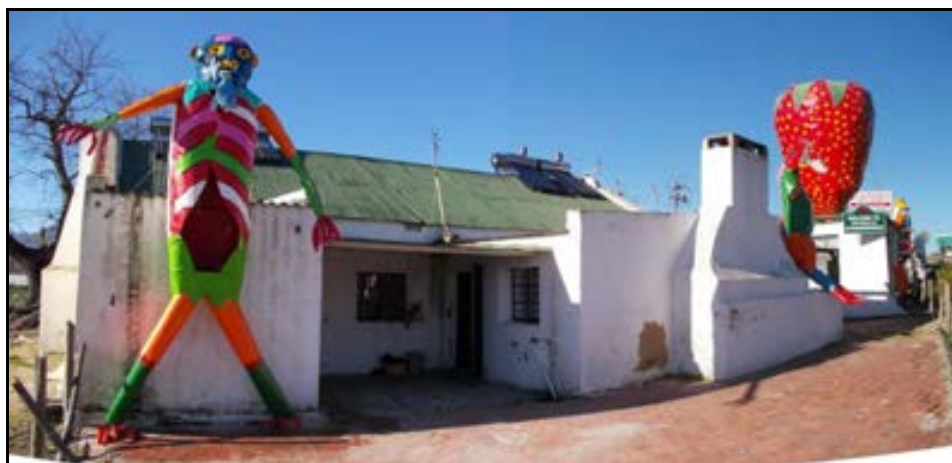
Figure 42: View of the western aspect of the house at point 015 showing the added section with external hearth and chimney stack to the right and modern bathroom addition to the left.

Also indicated on the 1925 survey diagram is another structure of similar dimension to the core of the existing building. This building is no longer present and would have been where the current R44 (which was built in the early 1960s) now lies. Mr D. Zettler also pointed out the remaining foundations of a house that he said dated to the 1930s. Although it appears not to be visible in the 1938 aerial photograph, the house can be seen in 1944 (Figure 45) so must have been built before that date. The small structure right against the road reserve fence (and now hosting the large strawberry as seen in Figure 42) was apparently related to or part of that house.

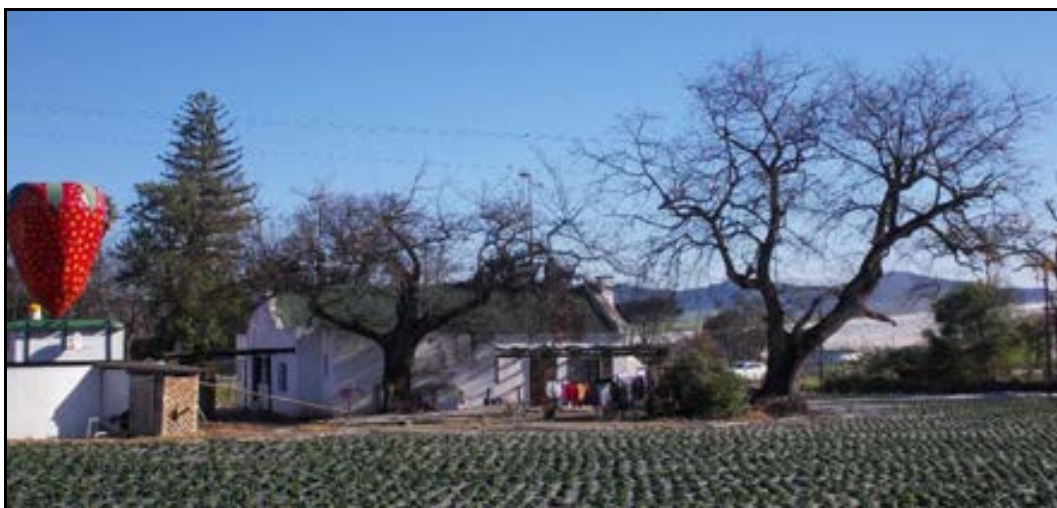
Figure 44: View towards the west showing the cottage at point 015 and its accompanying oak trees.

There are a number of old trees in the general vicinity of the Annandale Road Intersection that contribute to the cultural landscape. A neighbouring land owner who conducted her own archival research, notes that a condition of the original land grant to Jan Wismaar was that any oak trees cut down for domestic use were to be replaced with young trees (E. Du Plessis, pers. comm. 2013). Although most of the old trees currently present in the vicinity of the Annandale Road Intersection lie around the original Brakelsdal werf, there are a few other trees of relatively old age located to the west around the house at 011. They include at least one oak tree and a palm tree (Figures 37 & 38) of which the oak may need to be removed for the proposed grade-separated roundabout.

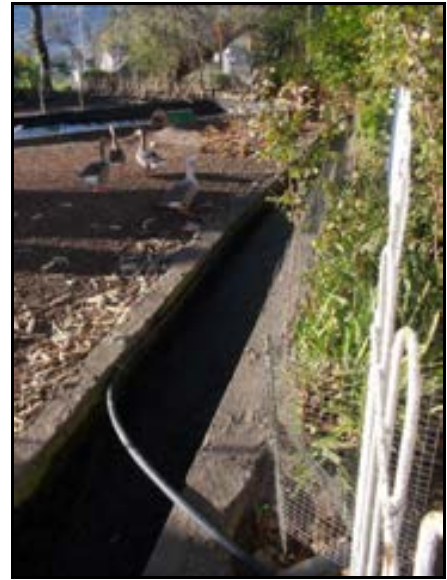
This canal crosses the R44 just north of the Annandale Road Intersection and carries river water from upstream. It is traceable on aerial photography for at least two kilometres to the east of the R44 but it is uncertain where it runs on the west side. Mr D. Zettler commented that it supplies farms to the north of his farm. The canal takes two forms: for much of the length examined during the field survey it was an open furrow in the soil (Figure 46), but immediately to the east of the house at point 011 it is a cement canal (Figure 47). Beneath the R44 the water is carried by a modern pipe.

Figure 47: The formal canal in front of the house at point 011.

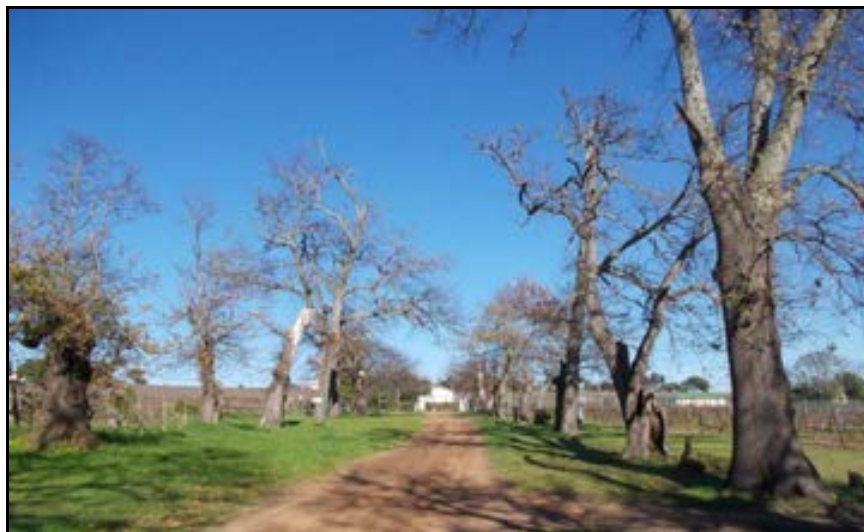
An old tree lined avenue leads to the present Annandale farm (the original Brakelsdal werf; Figure 48). Although it has heritage significance for its contribution to the cultural landscape, it is not under direct threat from the proposed project.

Figure 48: View south along the tree lined avenue leading in to the Annandale werf.

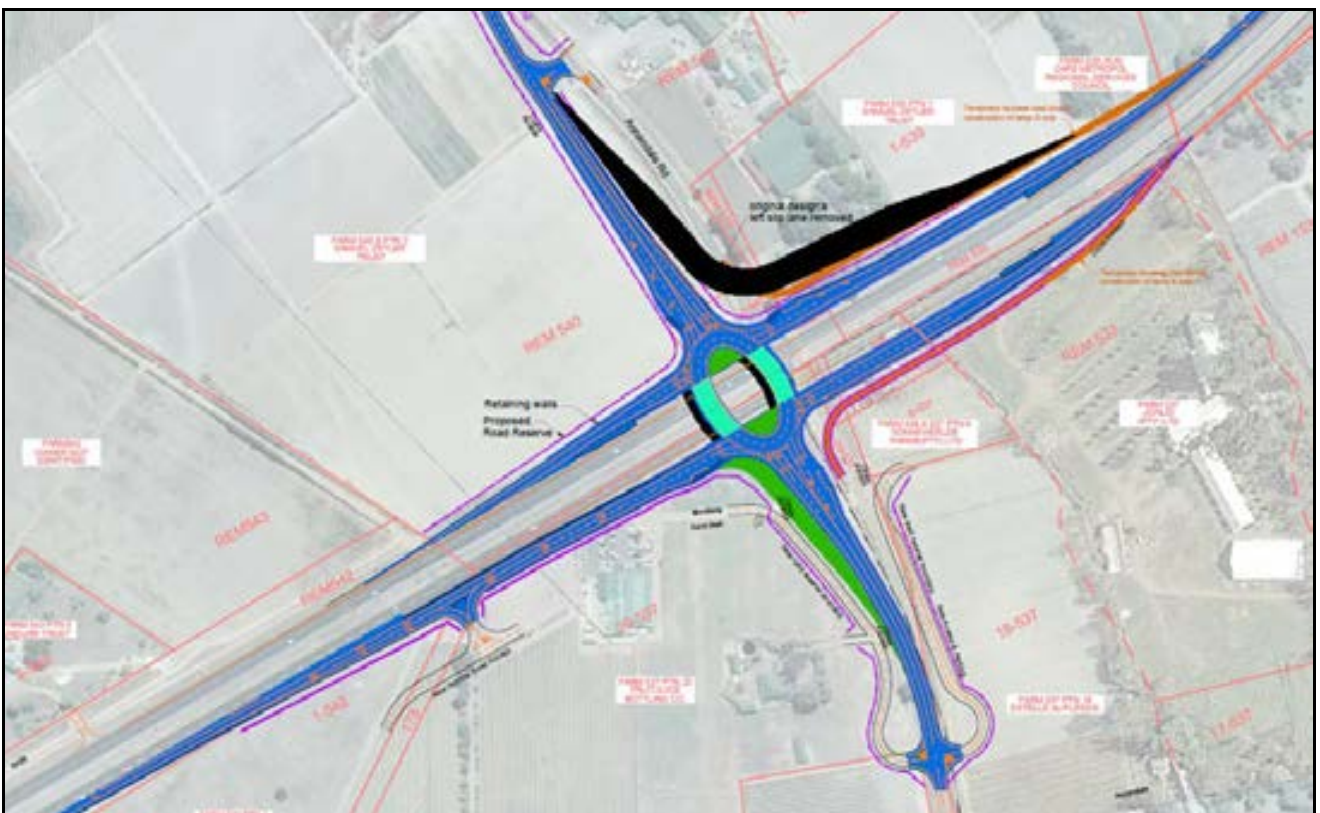
Annandale Road revised grade-separated roundabout proposal (retaining walls) as assessed by this HIA. The black area shows the earlier footprint after the roundabout was centred onto the current intersection.
