PGS
HERITAGE & GRAVE
RELOCATION CONSULTANTS

Lambda 400/765kV Substation and Associated 400kV and 765 kV lines

Heritage Impact Assessment

Issue Date: 12 July 2012

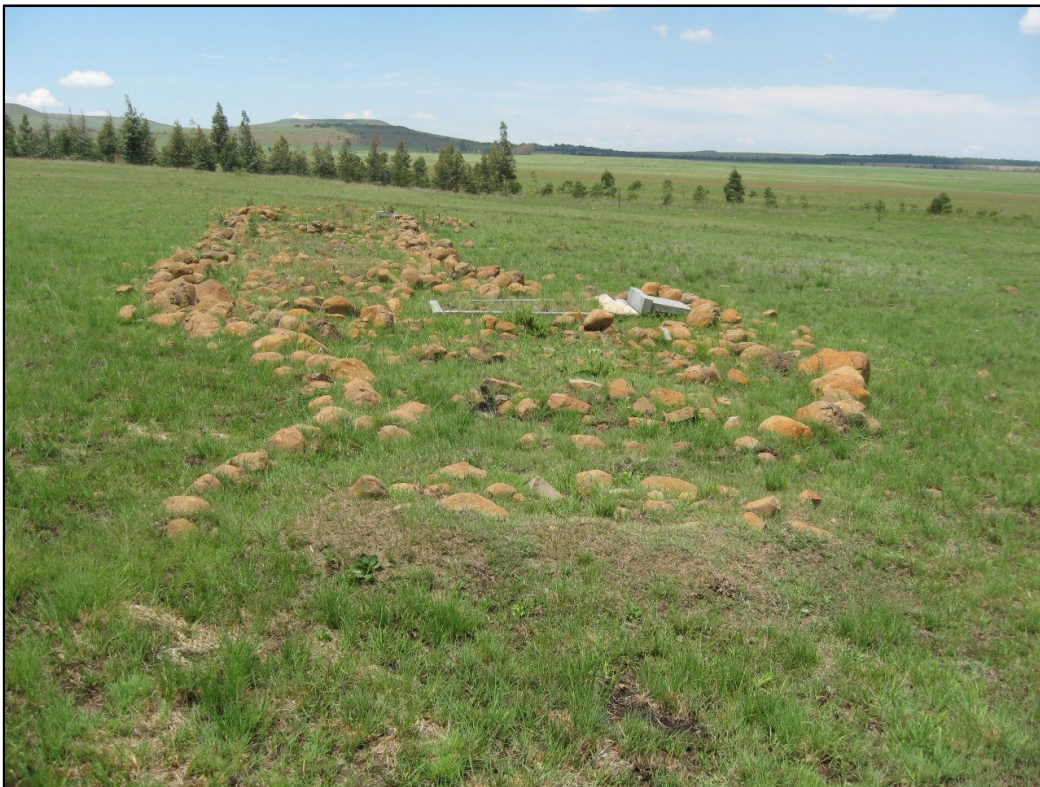
Figure 10–View of cemetery (Low stone walling on both sides clearly visible)

A small informal cemetery with 26 graves was identified at this location. The cemetery was demarcated with a low stone packed wall. The cemetery was situated right on the proposed transmission line route. The graves were placed in one line next to each other and all were orientated from west to east. A few small (children) graves were placed at the feet of some of the larger (adult) graves. Two of the graves had formal granite dressings which were filled with soil and gravel. These graves also had inscribed granite headstones, but they had fallen over. The one grave dated from 1959. The rest of the graves had informal oval shaped or rectangular shaped mounds of packed rocks as dressings. The cemetery seemed to be maintained by the family as the grass cover on the graves was only from the last season.

Site size: Approximately 30m x 15m.

Heritage Significance: GP.A – High Significance

- Fence and demarcate as no-go area during construction;
- Fence must be placed with a 10 meter buffer from the closest grave;
- If it is found that the alignment and pylon positions cannot be moved, a full grave relocation process must be followed.

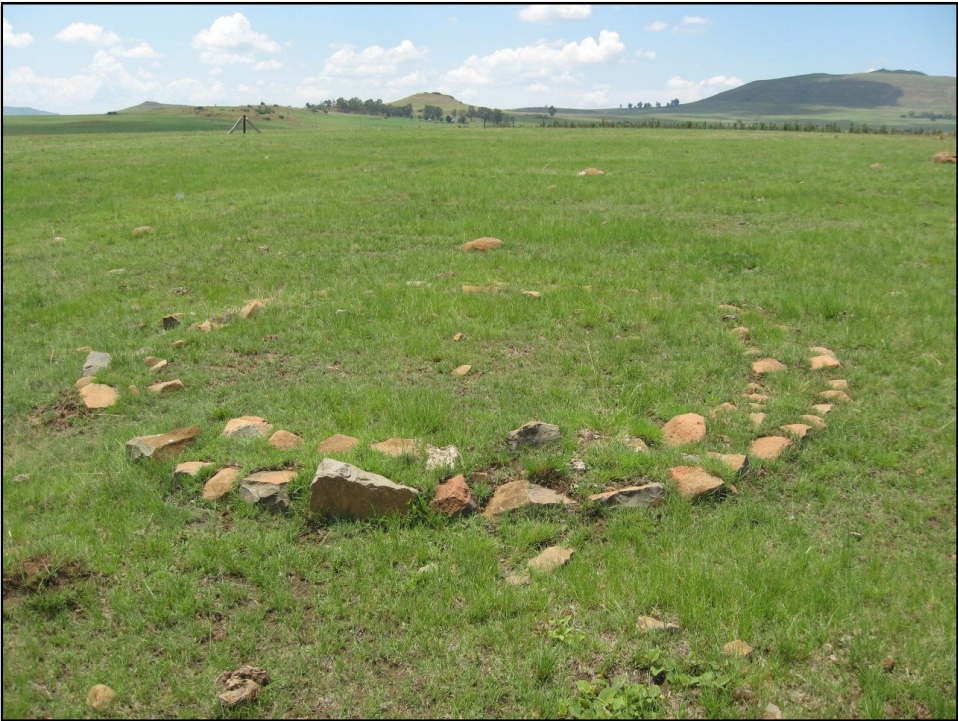
Figure 11–Foundation of hut

The remains and the foundations of a cluster of dilapidated structures were identified at this location. These dilapidated structures formed part of an abandoned homestead which was most probably occupied within the last 60 years. The remains consisted basically of packed lines of rocks which were used in the foundations of these structures on which mud-brick walls were built. These structures were predominantly square or rectangular in shape and the rooms measured approximately 5m x 5m. Two of the structures were round (rondawels) and were most probably used as a kitchen and/or storeroom. A few metal artefacts such as wire and cans were observed amongst the remains of the structures.

The exact age and time span of occupation of the above mentioned site are not known. The architectural design, construction techniques and the artefacts found on the site were used to assume a relative age for the site. These structures and thus the identified homestead seem to be from within the last 60 years and are therefore not protected under the National Heritage Act (Act 25 of 1999). The structures themselves have little or no heritage value or significance due to their relevant recent origins from within the last 60 years.

Customs and traditions like these were common in the rural African communities during the earlier parts of the 20th century. It is therefore not only possible, but rather likely that some of these structures may be on top of some of these infant remains.

Site size: Approximately 60m x 30m.

Heritage Significance: GP.B - Low/medium significance.

- Fence and demarcate as no-go area during construction; and
- If it is found that the alignment and pylon positions cannot be moved, a qualified archaeologist must monitor construction activities as stipulated in Section 4.2 must be followed.

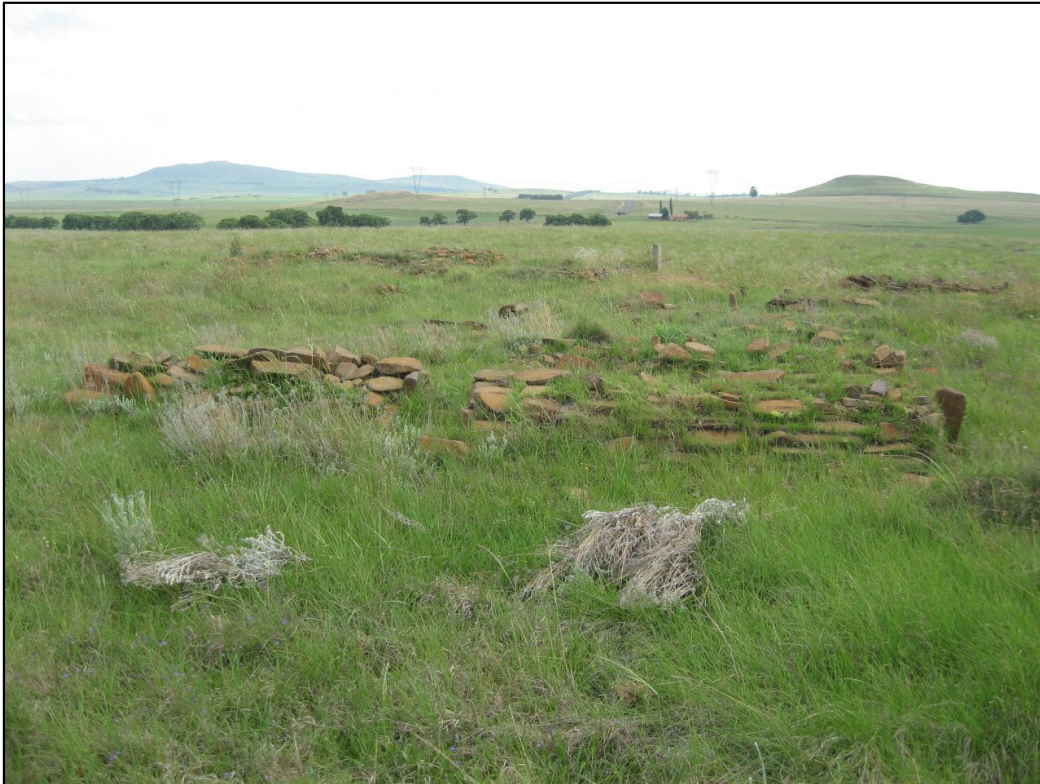
Figure 13– View of cemetery

The identified cemetery falls within the proposed area for Alignment 3.

Site size: Approximately 20m x 30m.

Heritage Significance: GP.A - High significance.

- Fence and demarcate as no-go area during construction;
- Fence must be placed with a 10 meter buffer from the closest grave; and
- If it is found that the alignment and pylon positions cannot be moved, a full grave relocation process must be followed.

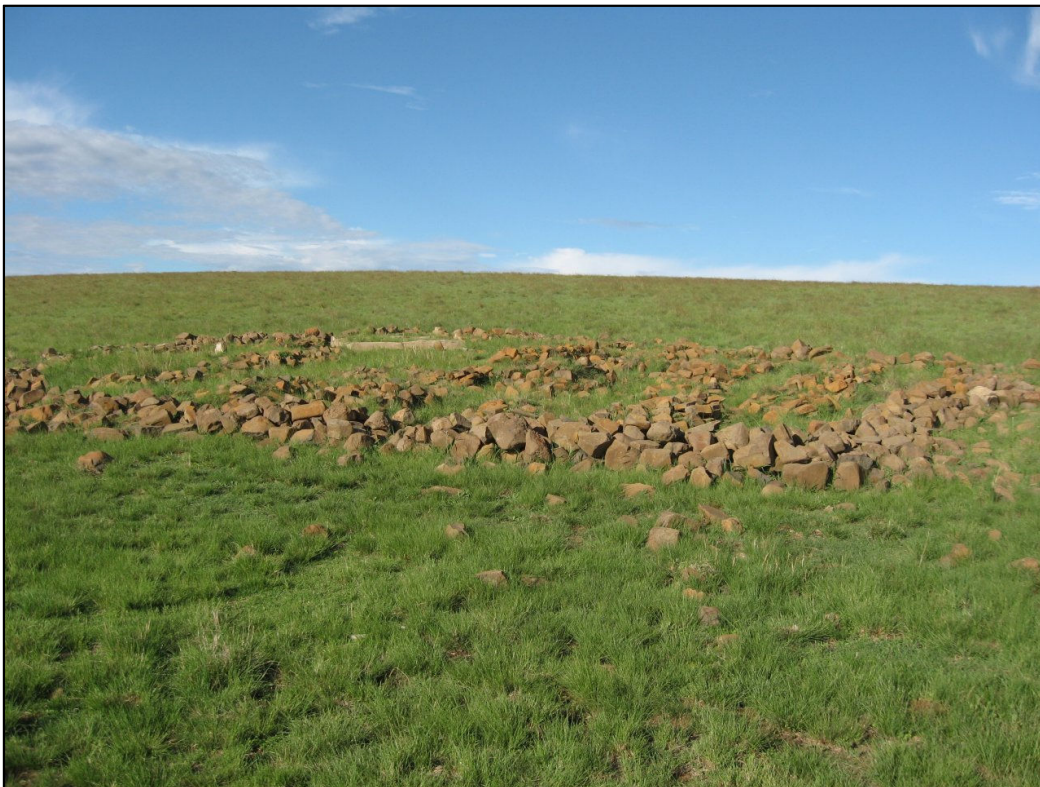
Figure 14– Cemetery with surrounding wall

The identified cemetery within the proposed area for Alignment 3.

Site size: Approximately 15m x 25m.

Heritage Significance: GP.A - High significance.

- Fence and demarcate as no-go area during construction;
- Fence must be placed with a 10 meter buffer from the closest grave; and
- If it is found that the alignment and pylon positions cannot be moved, a full grave relocation process must be followed.

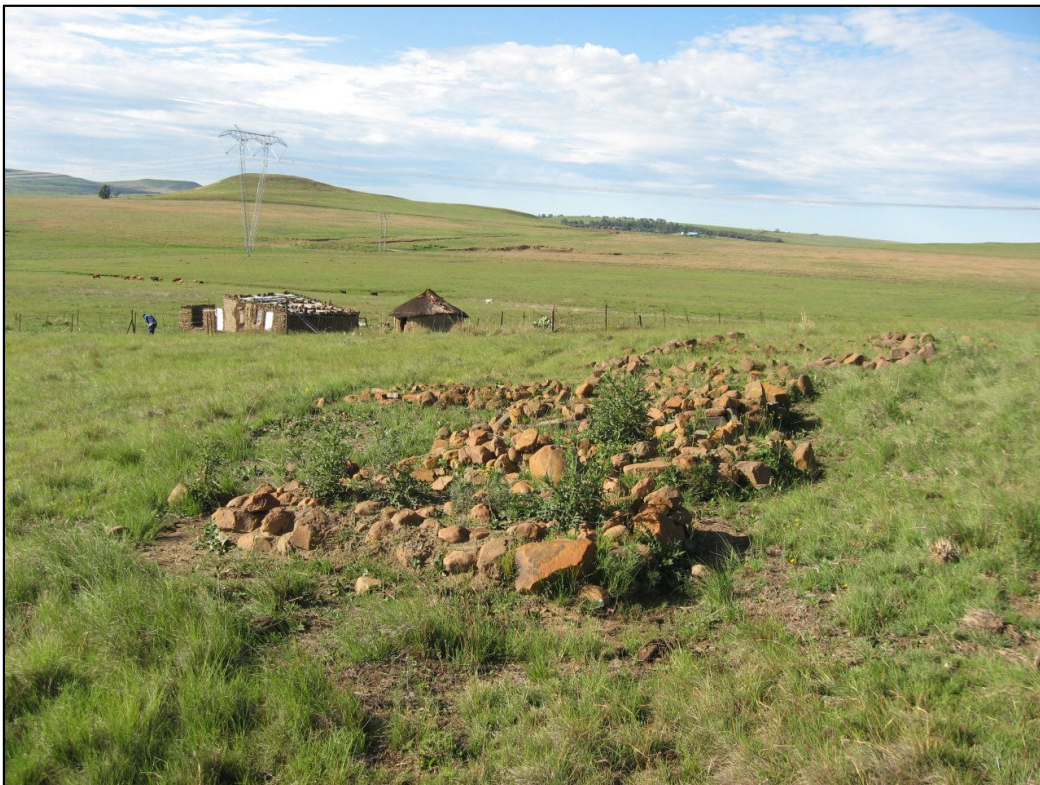
Figure 16– Cemetery close to homestead

The identified cemetery falls within the proposed area for Alignment 3 and 4.

Site size: Approximately 20m x 10m.

Significance: GP.A - High significance.

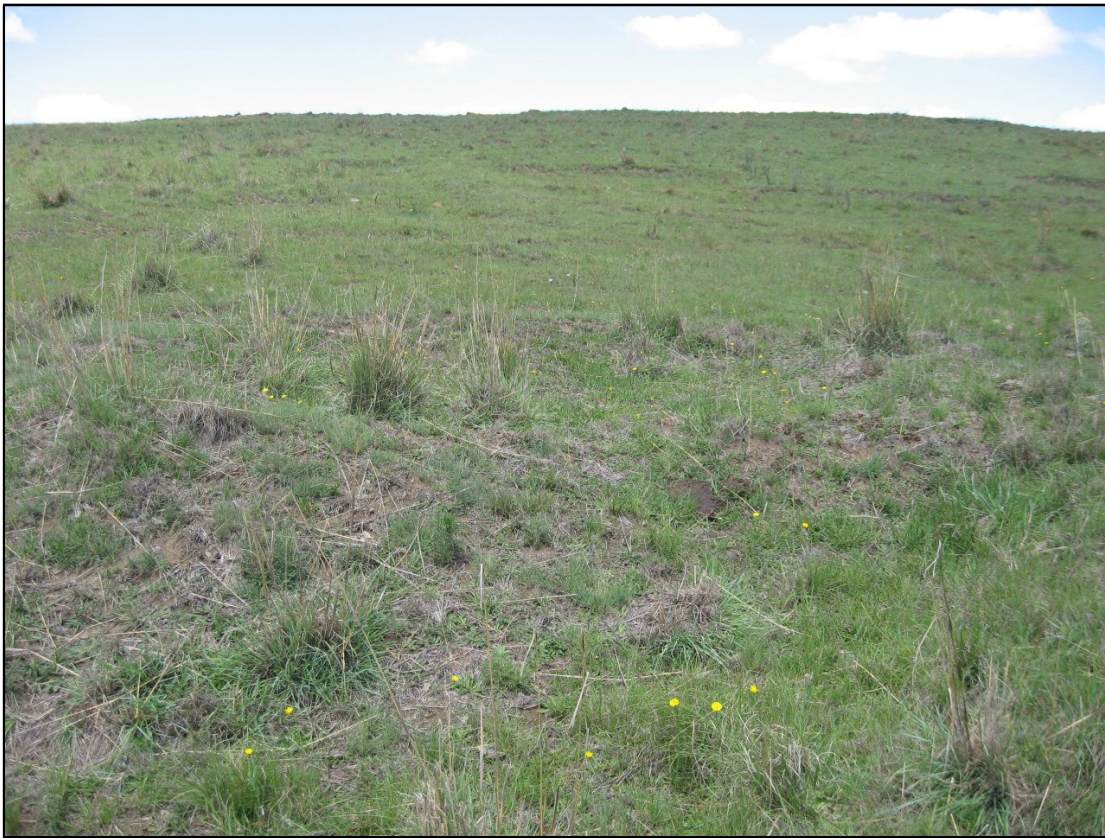
Figure 17– View of site

The remains and the foundations of a cluster of dilapidated structures were identified at this location. These dilapidated structures formed part of an abandoned homestead which was most probably occupied within the last 60 years. This abandoned homestead was situated near or possibly inside of the indicated reserve for the proposed Alignment 5. The remains consisted basically of packed lines of rocks which were used in the foundations of these structures on which mud-brick walls were built. These structures were predominantly square or rectangular in shape and the rooms measured approximately 5m x 5m. A few metal artefacts such as wire and cans were observed amongst the remains of the structures.

The exact age and time span of occupation of the above mentioned site are not known. The architectural design, construction techniques and the artefacts found on the site were used to assume a relative age for the site. These structures and thus the identified homestead seem to be from within the last 60 years and are therefore not protected under the National Heritage Act (Act 25 of 1999). The structures themselves have little or no heritage value or significance due to their relevant recent origins from within the last 60 years.

Customs and traditions like these were common in the rural African communities during the earlier parts of the 20th century. It is therefore not only possible, but rather likely that some of these structures may be on top of some of these infant remains.

Site size: Approximately 50m x 30m.

Heritage Significance: GP.B - Low/medium significance.

- Fence and demarcate as no-go area during construction;
- If it is found that the alignment and pylon positions cannot be moved, a qualified archaeologist must monitor construction activities as stipulated in Section 4.2 must be followed.

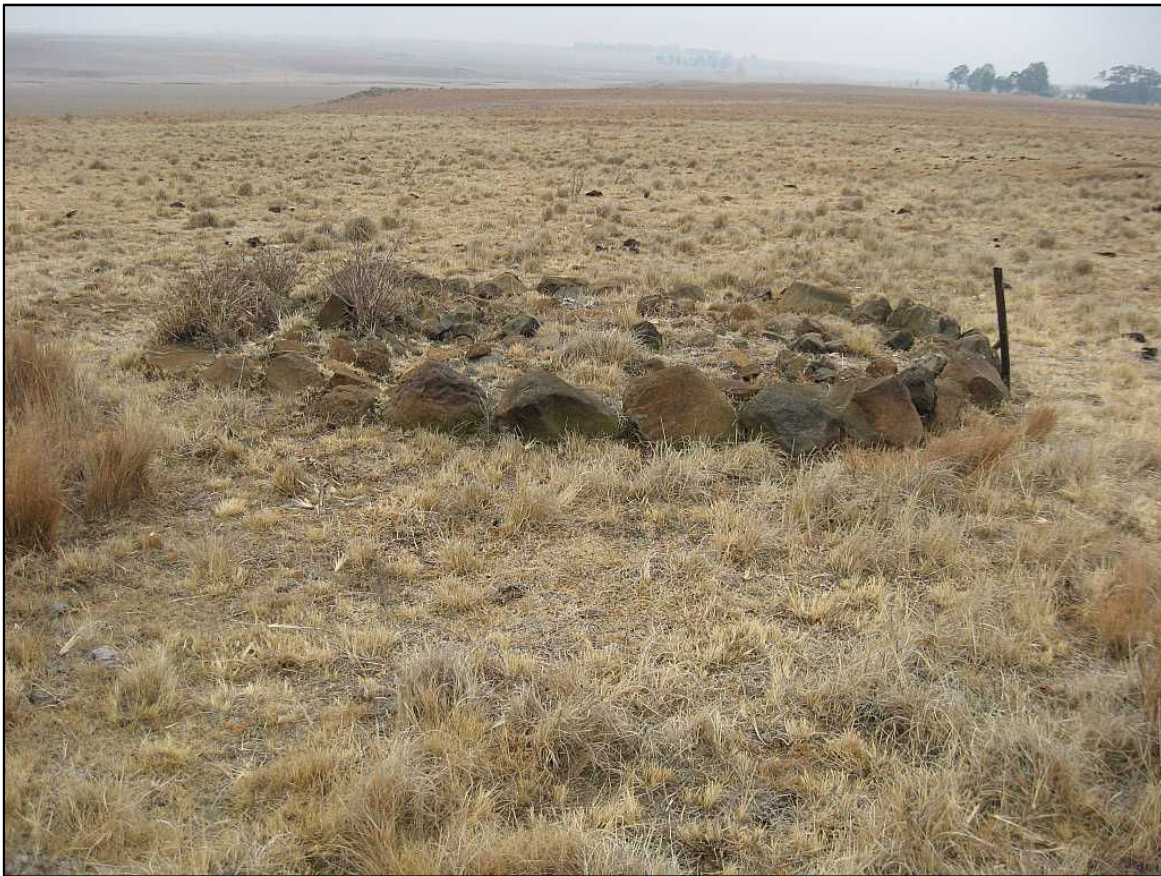
Figure 18 – View of site

The remains and the foundations of two dilapidated structures were identified at this location. These dilapidated structures formed part of an abandoned homestead which was most probably occupied within the last 60 years. This abandoned homestead was situated near, but most probably outside of the indicated area for the proposed sub-station. The remains consisted basically of packed lines of rocks which were used in the foundations of these structures on which mud-brick walls were built.

The second structure was the remains of a circular hut. It measured approximately 3m in diameter. Mud brick walls were placed on top of a stone lined foundation. An ash midden with glass fragments, ceramic pot shards and various metal artefacts was situated approximately 20m to the north of the hut structure.

The exact age and time span of occupation of the above mentioned site are not known. The architectural design, construction techniques and the artefacts found on the site were used to assume a relative age for the site. These structures and thus the identified homestead seem to be from within the last 60 years and are therefore not protected under the National Heritage Act (Act 25 of 1999). The structures themselves have little or no heritage value or significance due to their relevant recent origins from within the last 60 years.

Customs and traditions like these were common in the rural African communities during the earlier parts of the 20th century. It is therefore not only possible, but rather likely that some of these structures may be on top of some of these infant remains.

Site size: Approximately 50m x 30m.

Heritage Significance: GP.B - Low/medium significance.

- Fence and demarcate as no-go area during construction; and
- If it is found that the alignment and pylon positions cannot be moved, a qualified archaeologist must monitor construction activities as stipulated in Section 4.2 must be followed.

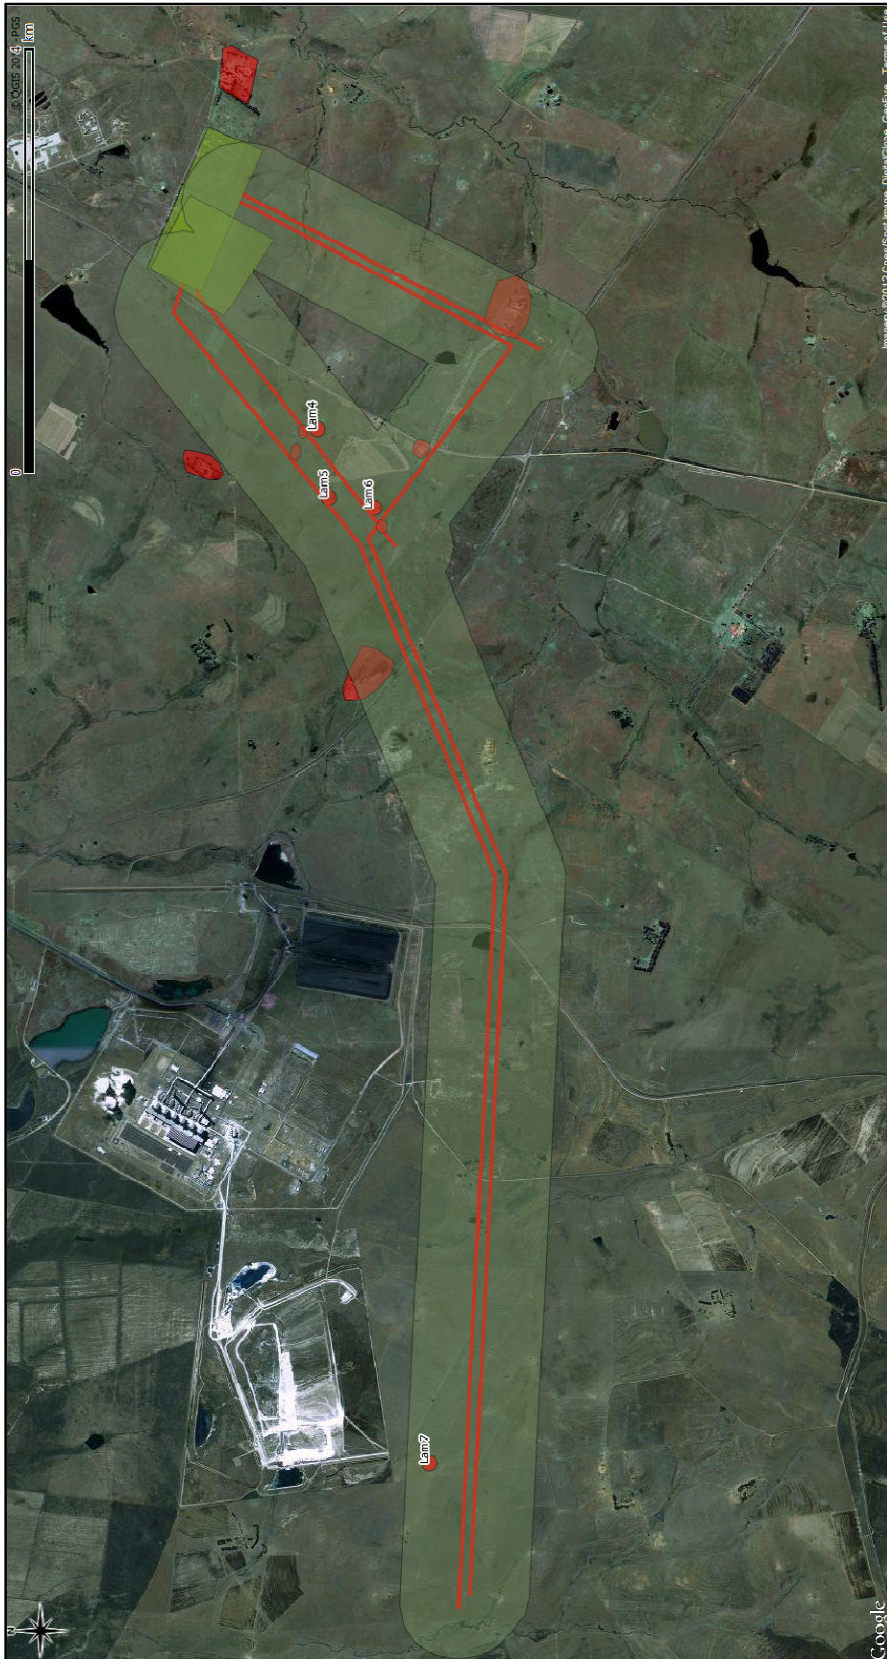
Figure 19– Alignment 3 with 500m buffer and farmsteads/homesteads and other heritage sensitive area indicated in red

Impact name:	<i>Impact on cultural landscape</i>				
Alternative:	<i>Alternative 3</i>				
Description of impact:	<i>Placement of new substation and transmission lines can have an impact on cultural landscape and its views from vantage points</i>				
Environmental Risk					
Attribute	Pre-mitigation	Post-mitigation	Attribute	Pre-mitigation	Post-mitigation
Nature of Impact	-1	-1	Magnitude of Impact	3	2
Extent of Impact	3	3	Reversibility of Impact	3	2
Duration of Impact	4	4	Probability	4	3
Environmental Risk (Pre-mitigation)					-13
Environmental Risk (Post-mitigation)					-8.25
Degree of confidence in impact prediction:					Medium
Impact Prioritisation					
Public Response					1
Cumulative Impacts					3
<i>The larger study area is already impacted and sensitised towards transmission lines and power generation structures, notably the Amajuba Power Station as well as the UGG infrastructure close to Alternative 3 However the addition of the new alignments and substation may aggravate the cumulative effect of this infrastructure type on the landscape</i>

Degree of potential irreplaceable loss of resources					2
<i>If the additional infrastructure is planned to be grouped with current transmission lines and other infrastructure the impact on the cultural landscape will not be as high</i>					
Prioritisation Factor					1.5
Final Significance					-12.375

Evaluation of the alternative alignments 3 and 8 has shown that although the visual impact on Alternative 3 and 8 may seem high, the existing power and transmission lines and infrastructure has sensitised the area and residents to such infrastructure.
