**APPENDIX  
PLASTER STRIPPING**

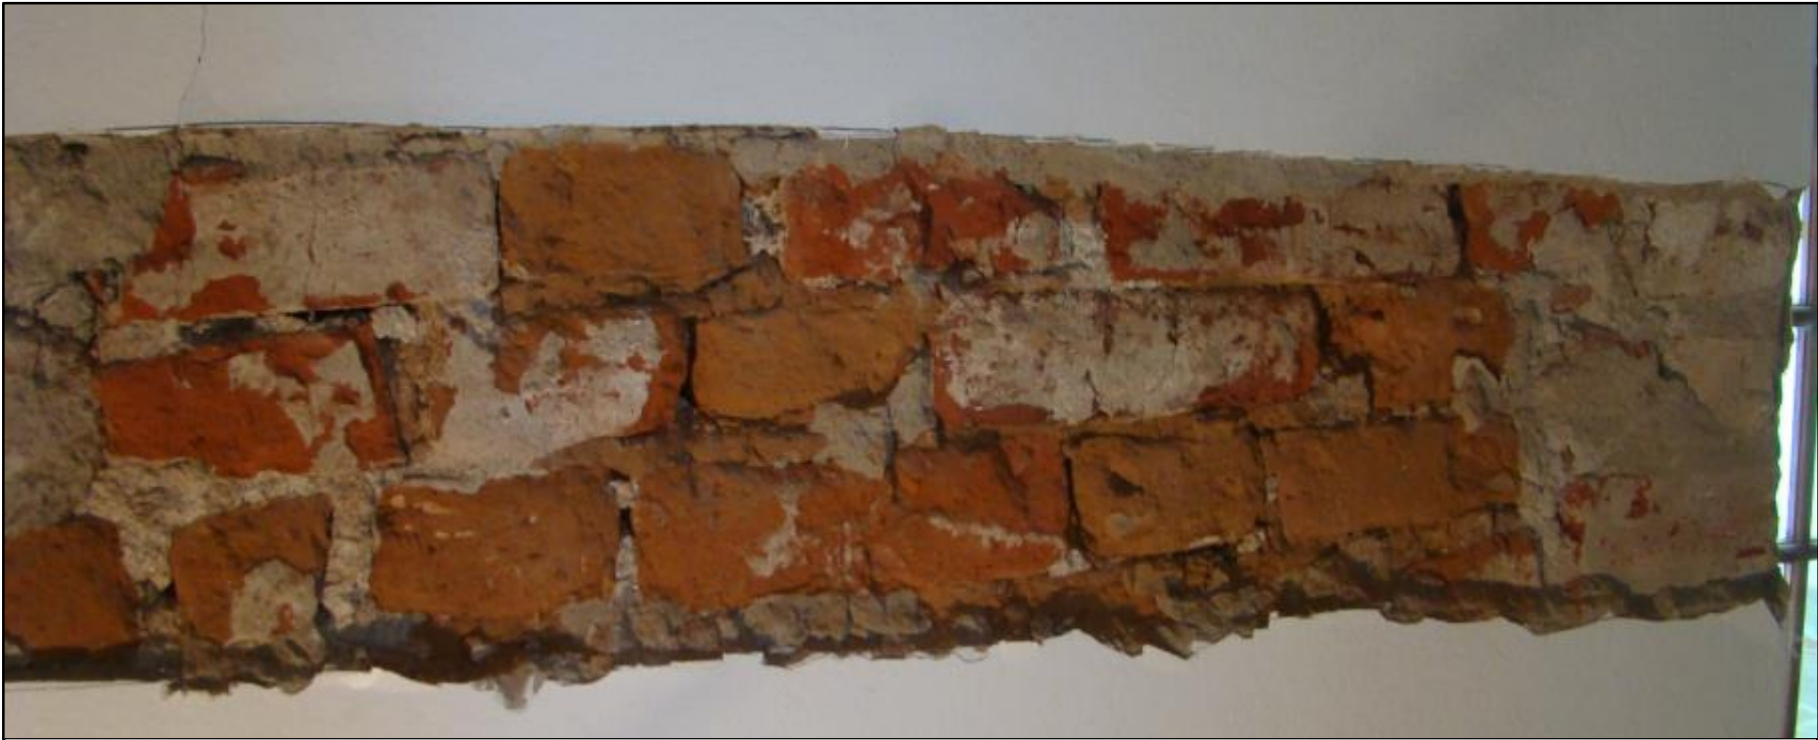
Figure 22: Plaster Strip A between the window and the door on the north facing wall of the southern wing. Note the standard-shaped, fired bricks and grey cement work around the window and door, but the larger and softer red bricks and red clay mortar between them.

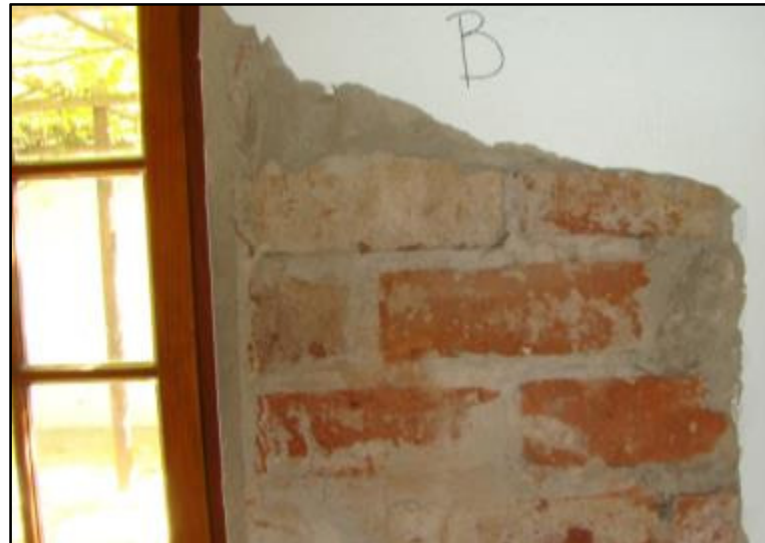
Figure 23: Plaster Strip B showing the fired red brick and grey cement mortar used to insert the window at a later date.

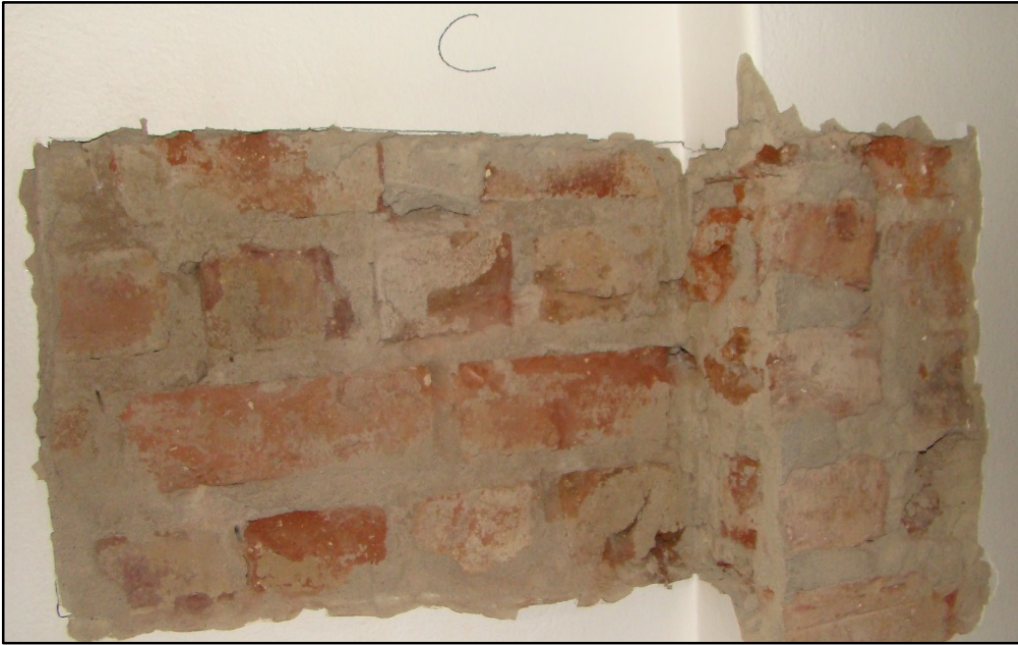
Figure 24: Plaster strip C shows the join of the internal courtyard wall with the original U-shaped building. The bricks are red with white flecks and bonded with grey cement mortar.

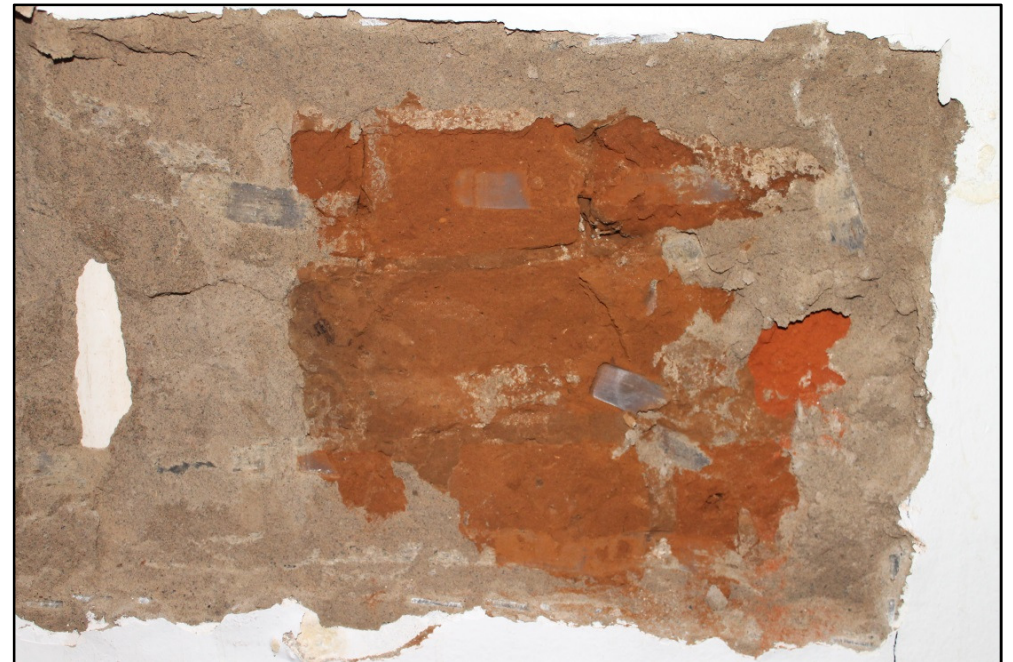
Figure 25: Right Plaster Strip D on the north facing wall of the southern wing, showing the soft red bricks and red clay mortar with recent insert of a pipe.

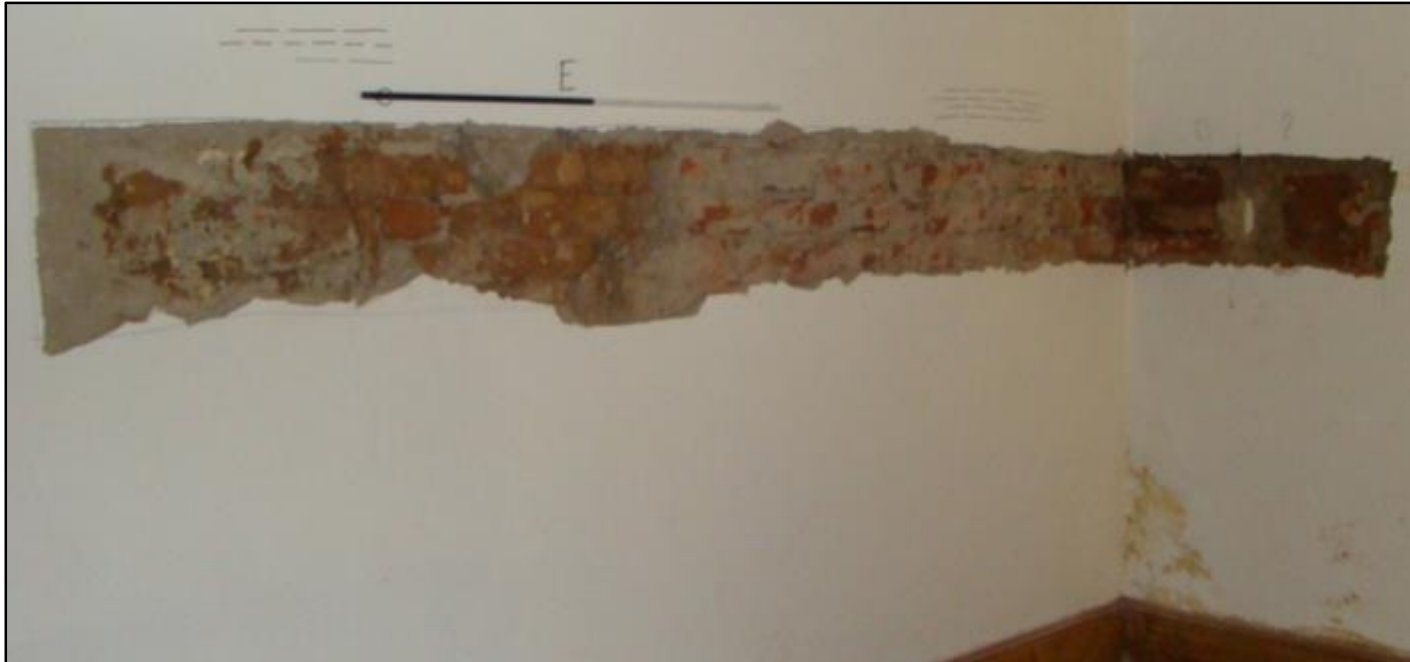
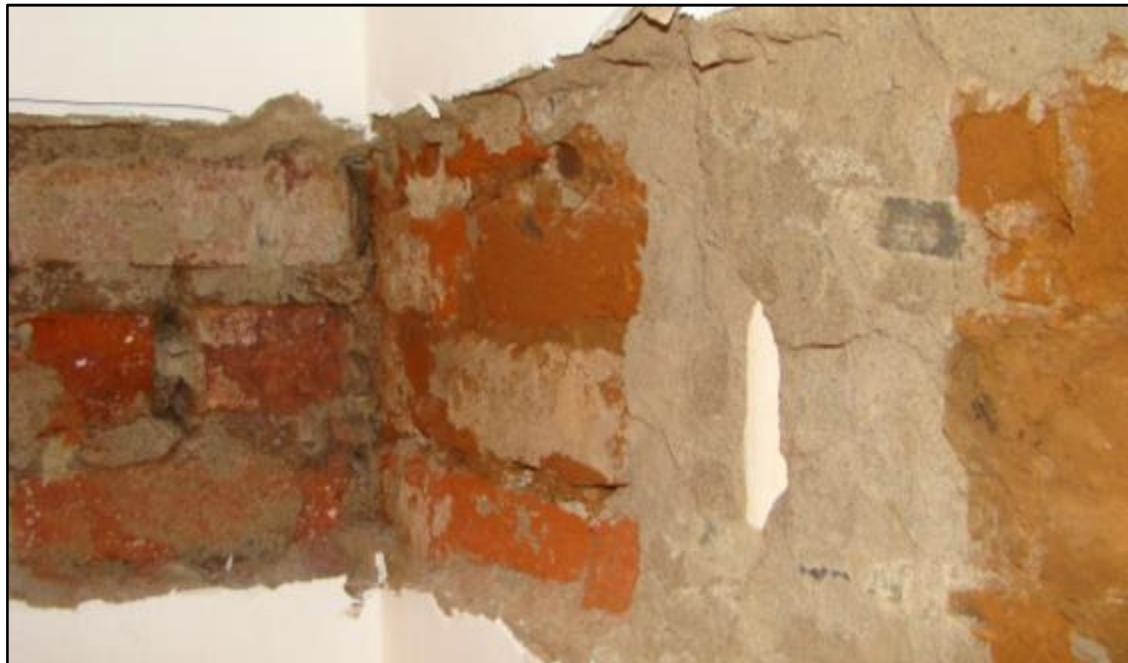
Figure 26 (Above): Showing the location of Plaster Strips D and E. Figure 27 (Below) shows the uneven join between the northern and eastern walls, indicating that a section of the eastern wall was added later.

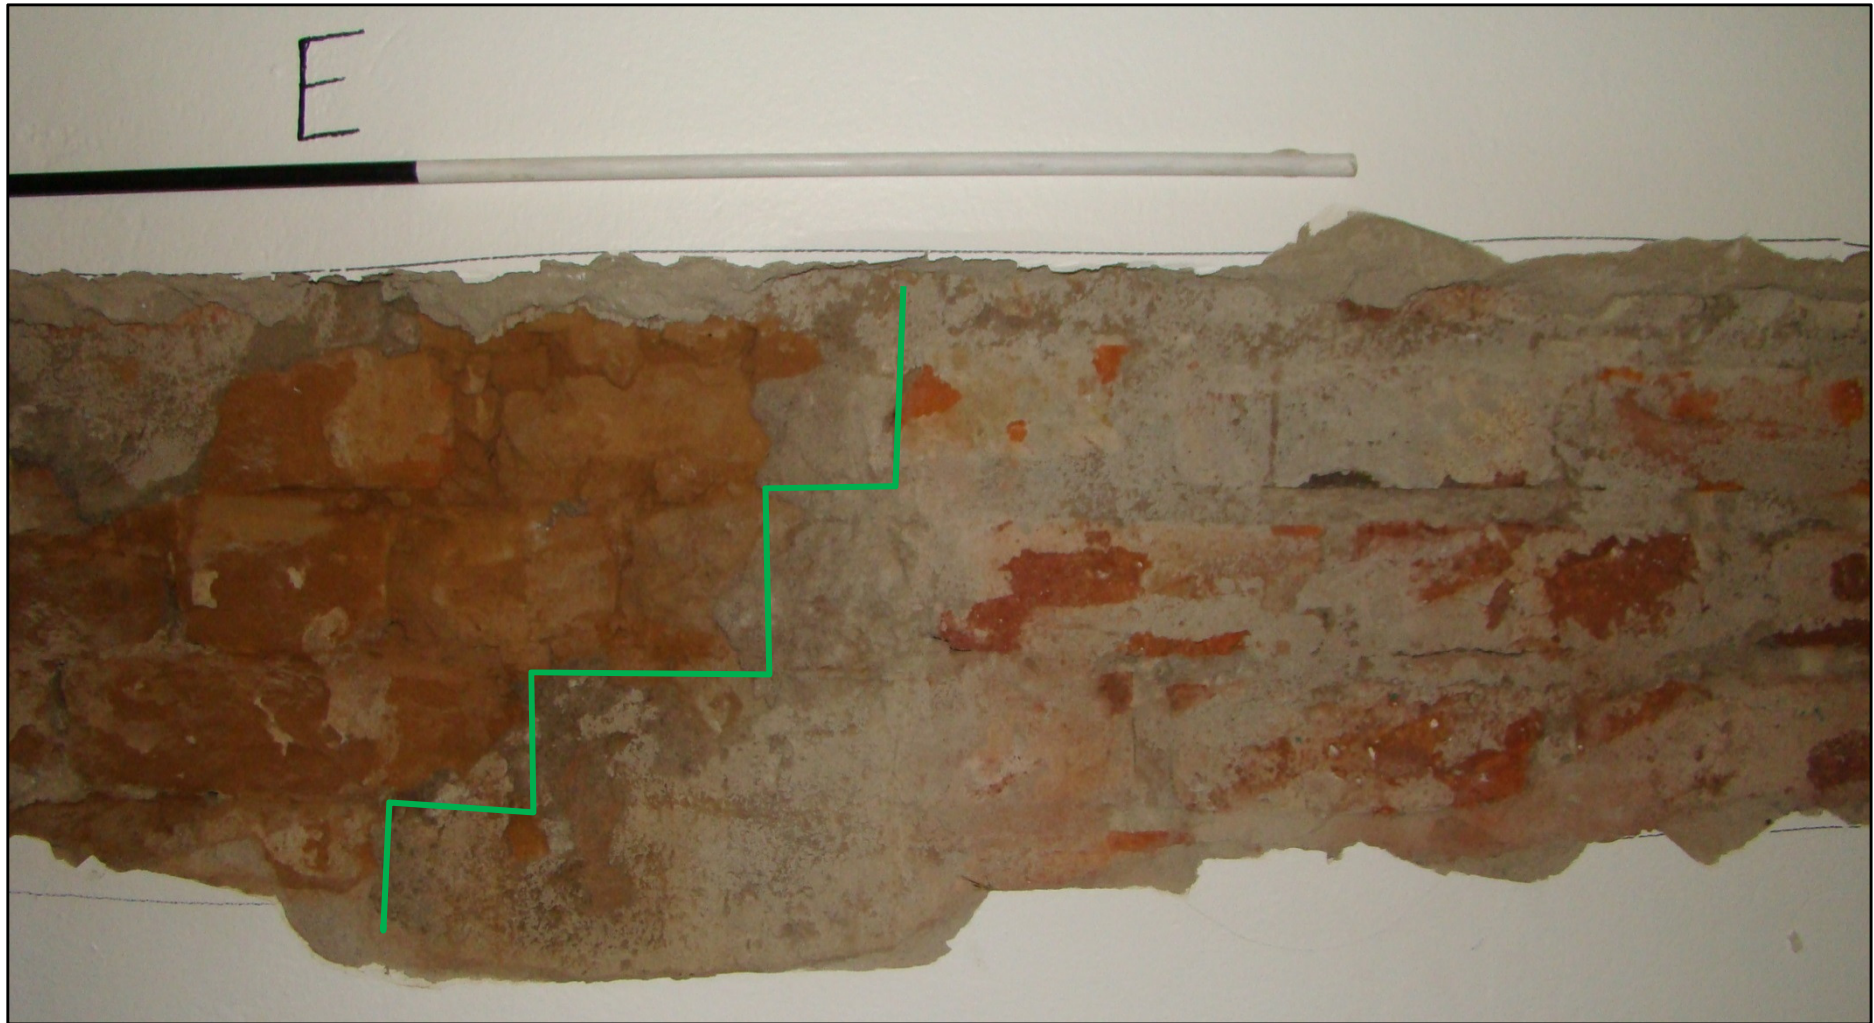
Figure 28: Plaster Strip E – the join between the red brick and grey cement mortar on the right, and the older and softer red mud brick and red clay mortar on the left.

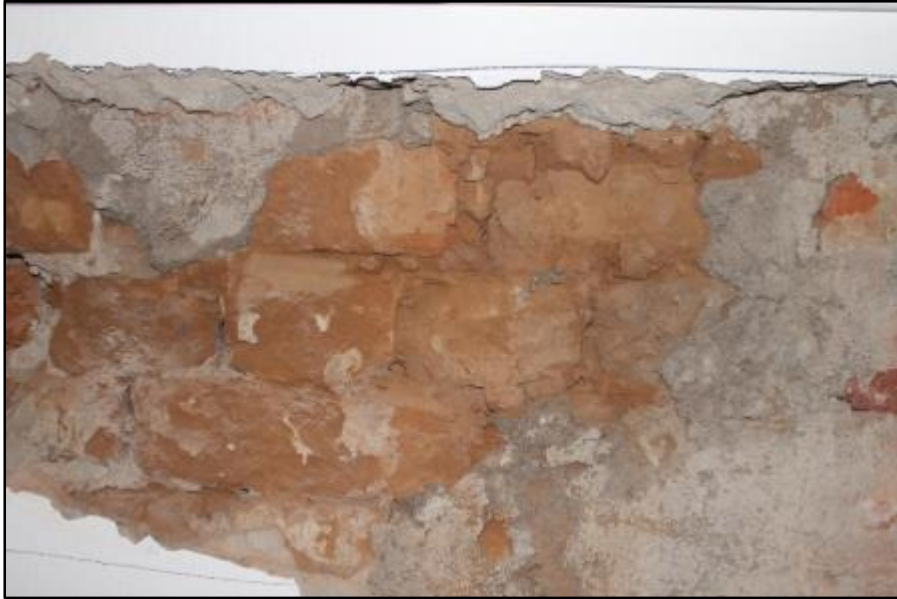
Figure 29: Indicating the soft red brick with soft clay mortar.

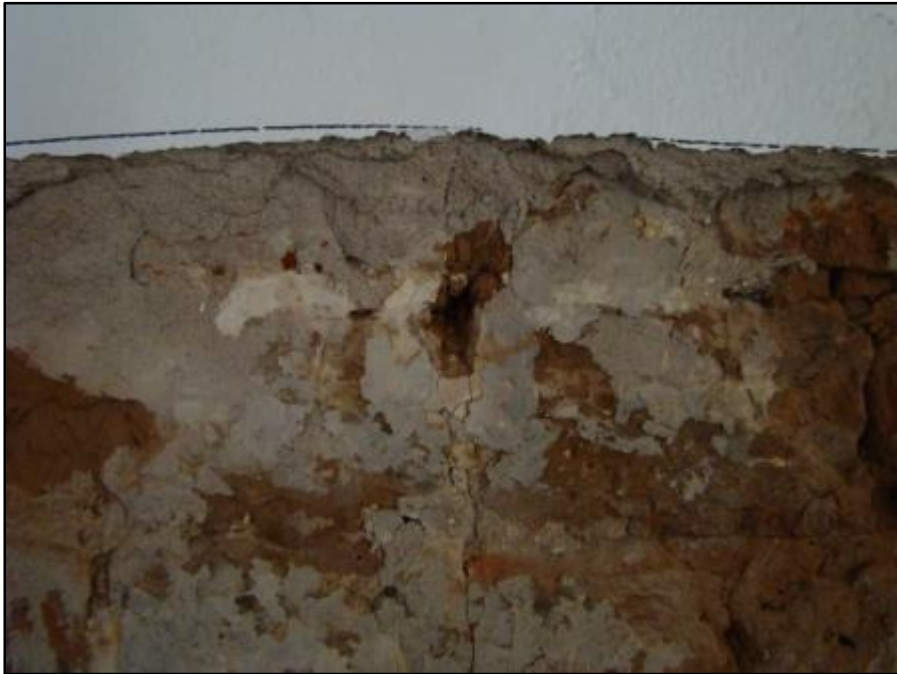
Figure 30: There appears to be a thin layer of white lime wash or lime plaster adhering to the mud brick under the grey cement mortar.

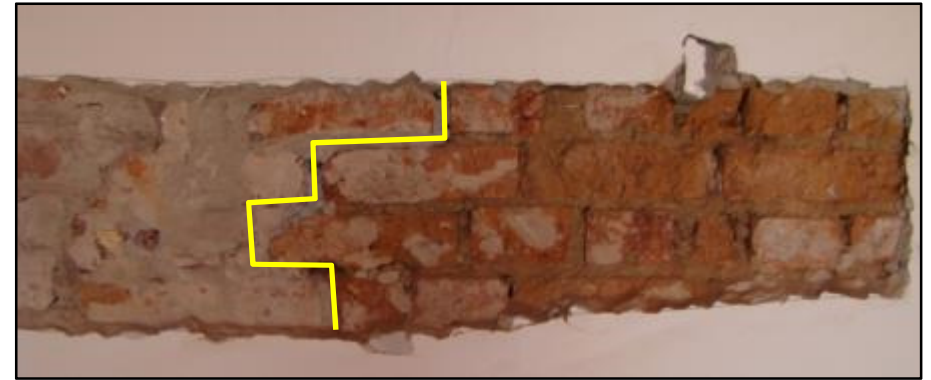
Figure 31: Plaster Strip 3A shows the older red mud bricks with mud mortar to the right of the yellow line and the clear break to the left with hard red brick and grey mortar.

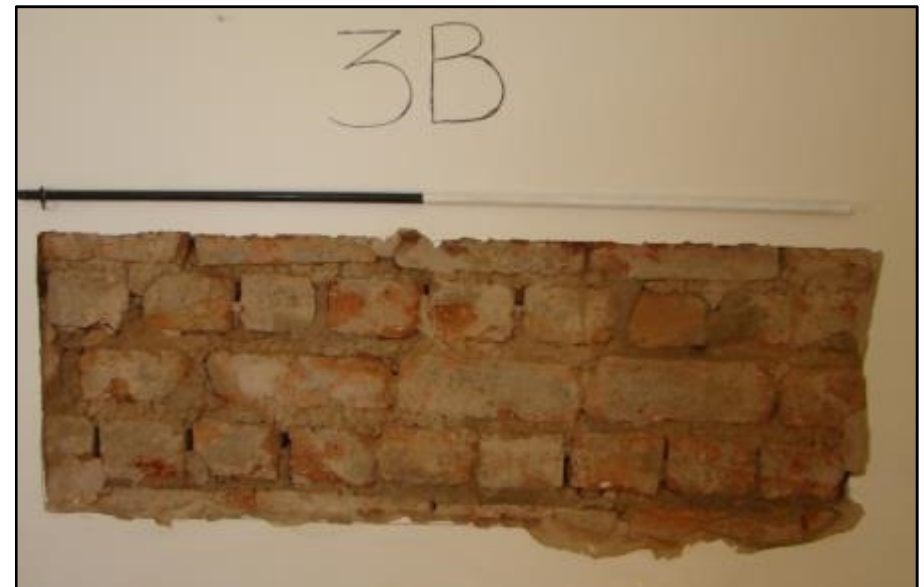
Figure 32: Standard size red brick with grey mortar – English bond.

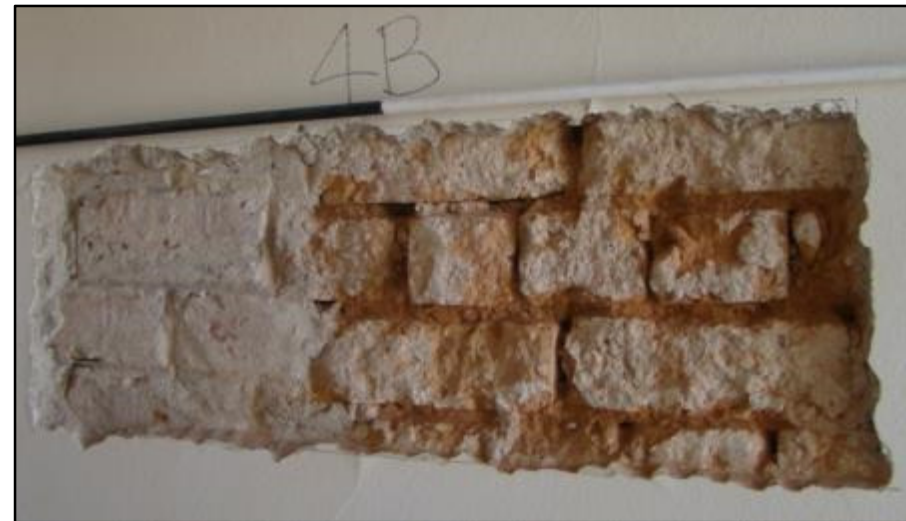
Figure 34: Older red brick and red mortar to the right, recent alteration to left.

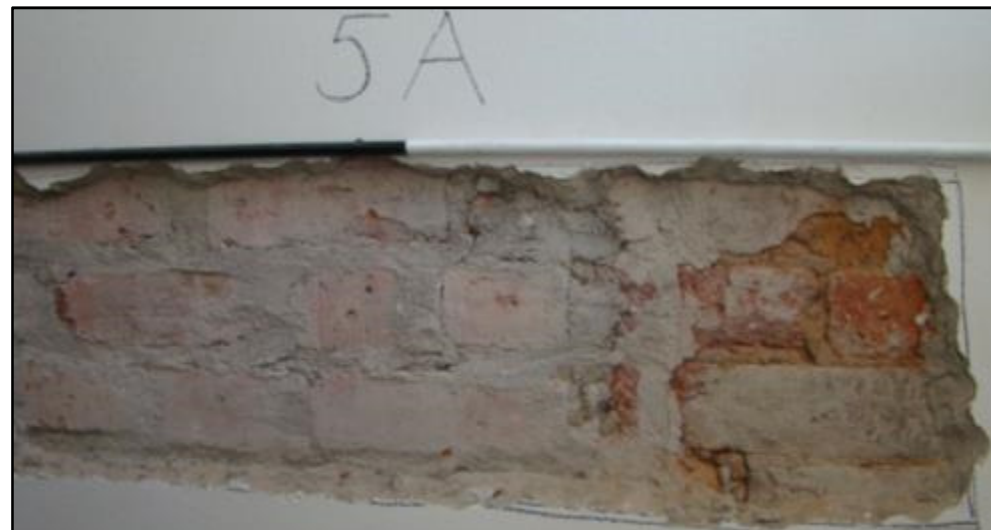
Figure 35: Strip 5A above shows sections of soft red brick and clay mortar to the right while the left consists of a harder red brick and grey cement mortar. Figure 36 below from Strip 5B shows mud brick walls and plaster which is held together with chicken wire.

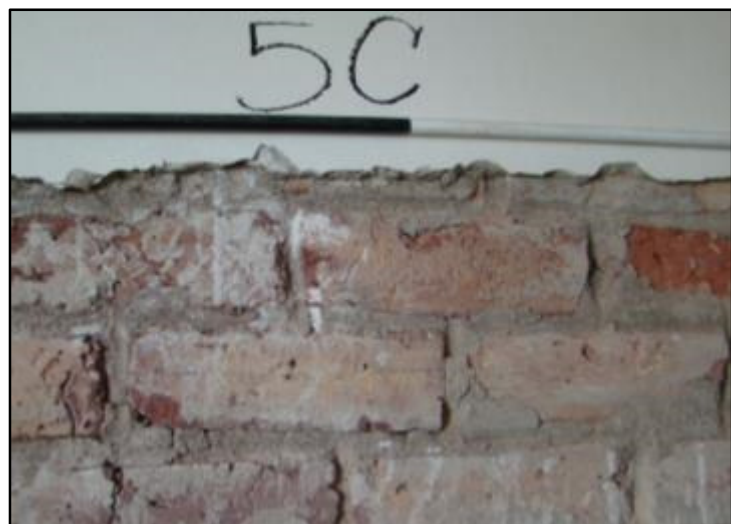
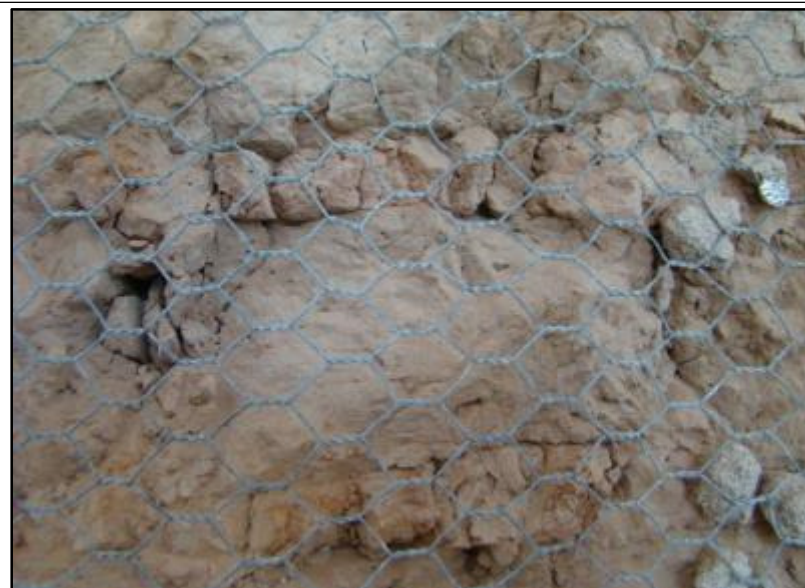
Figure 37: Strip 5C to the left shows a fired red brick wall with grey cement mortar.

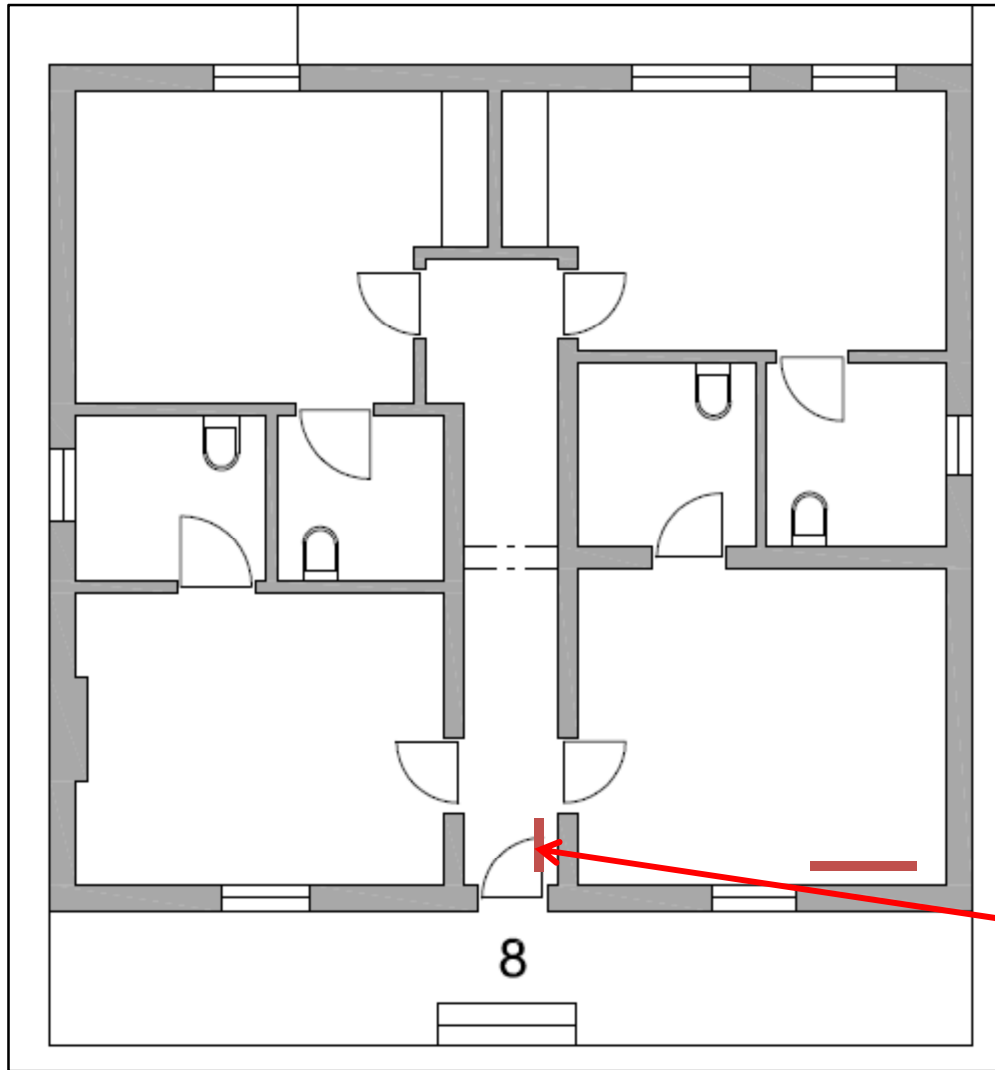
Figure 39: The mud bricks found in the entrance wall to the right are different from the external walls.

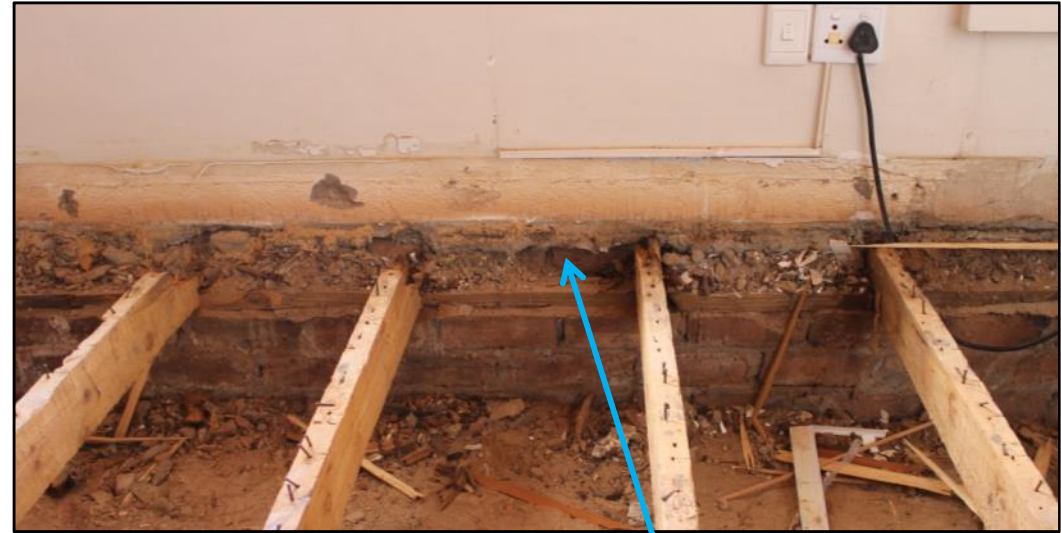
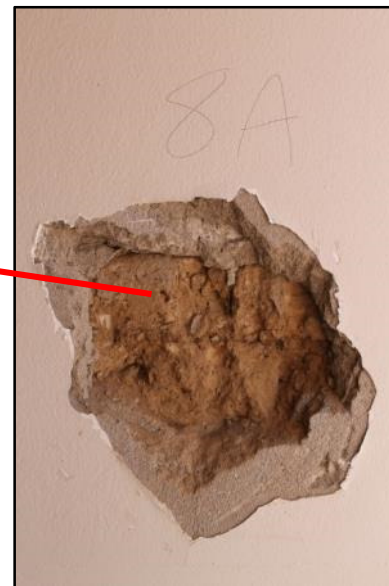
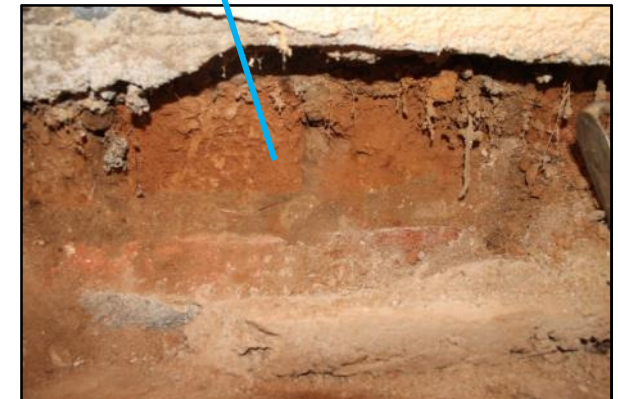
Figure 38: The floor beams are resting on a newly constructed wall in front of the original wall of the cottage. The enlargement shows red mud brick and red mud mortar.

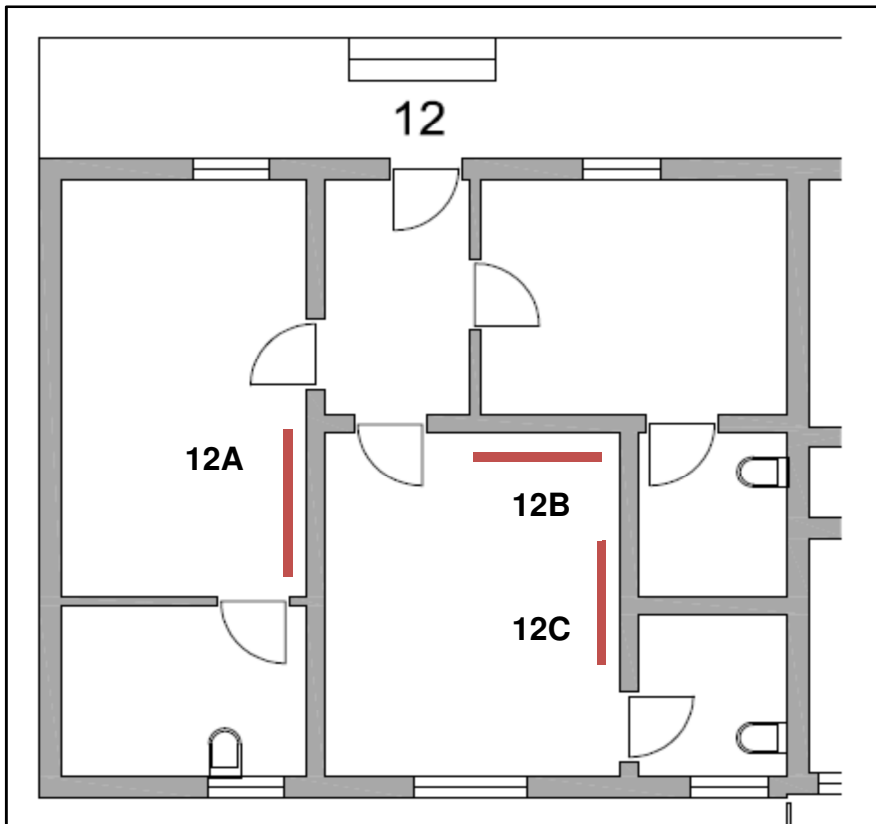
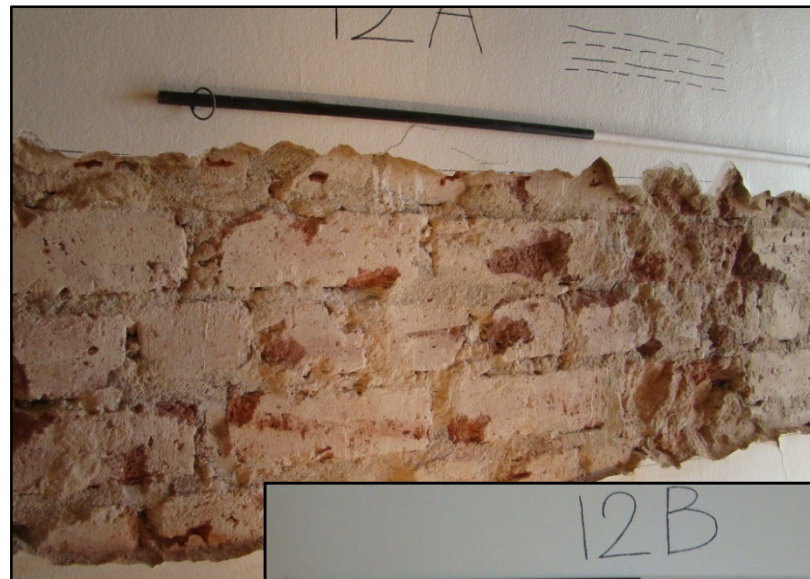
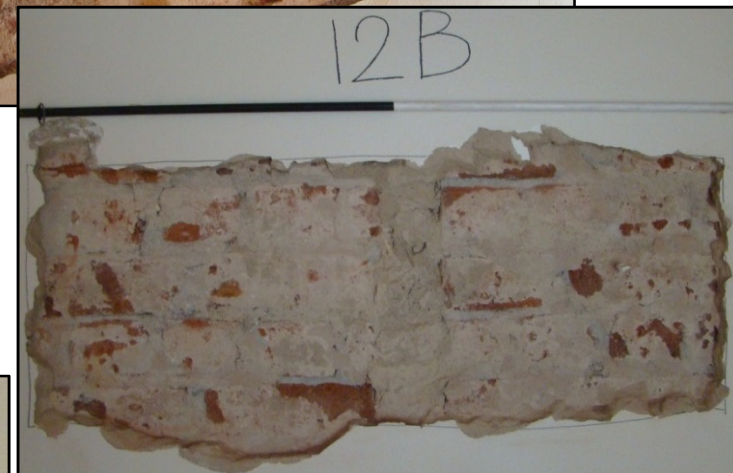
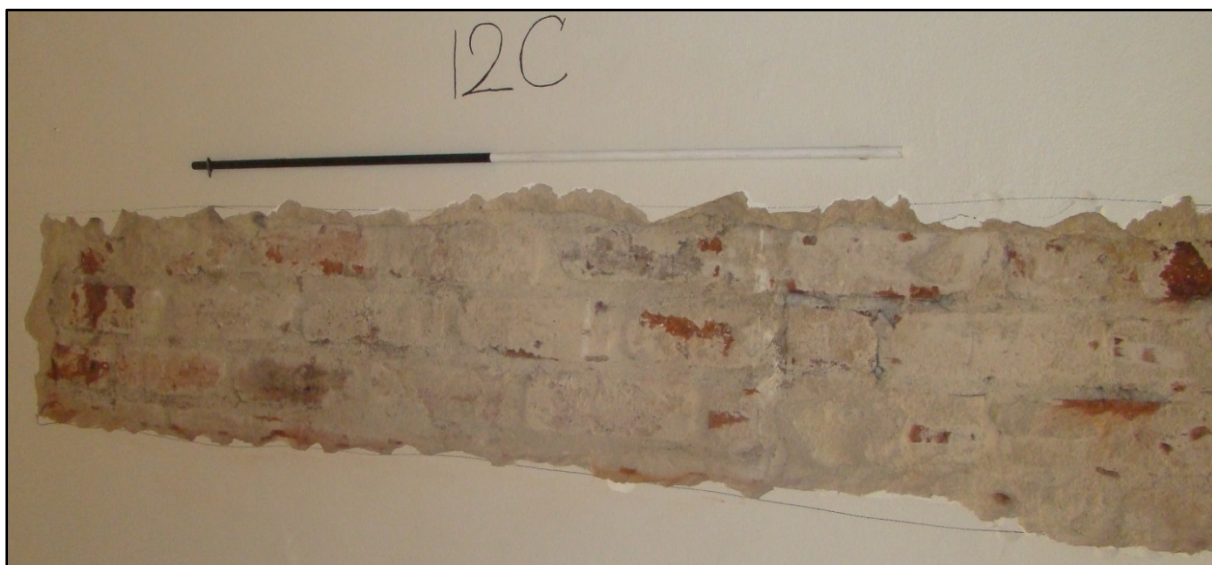
Figures 40: Plaster strips in Cottage 12. All reflect recently constructed walling.

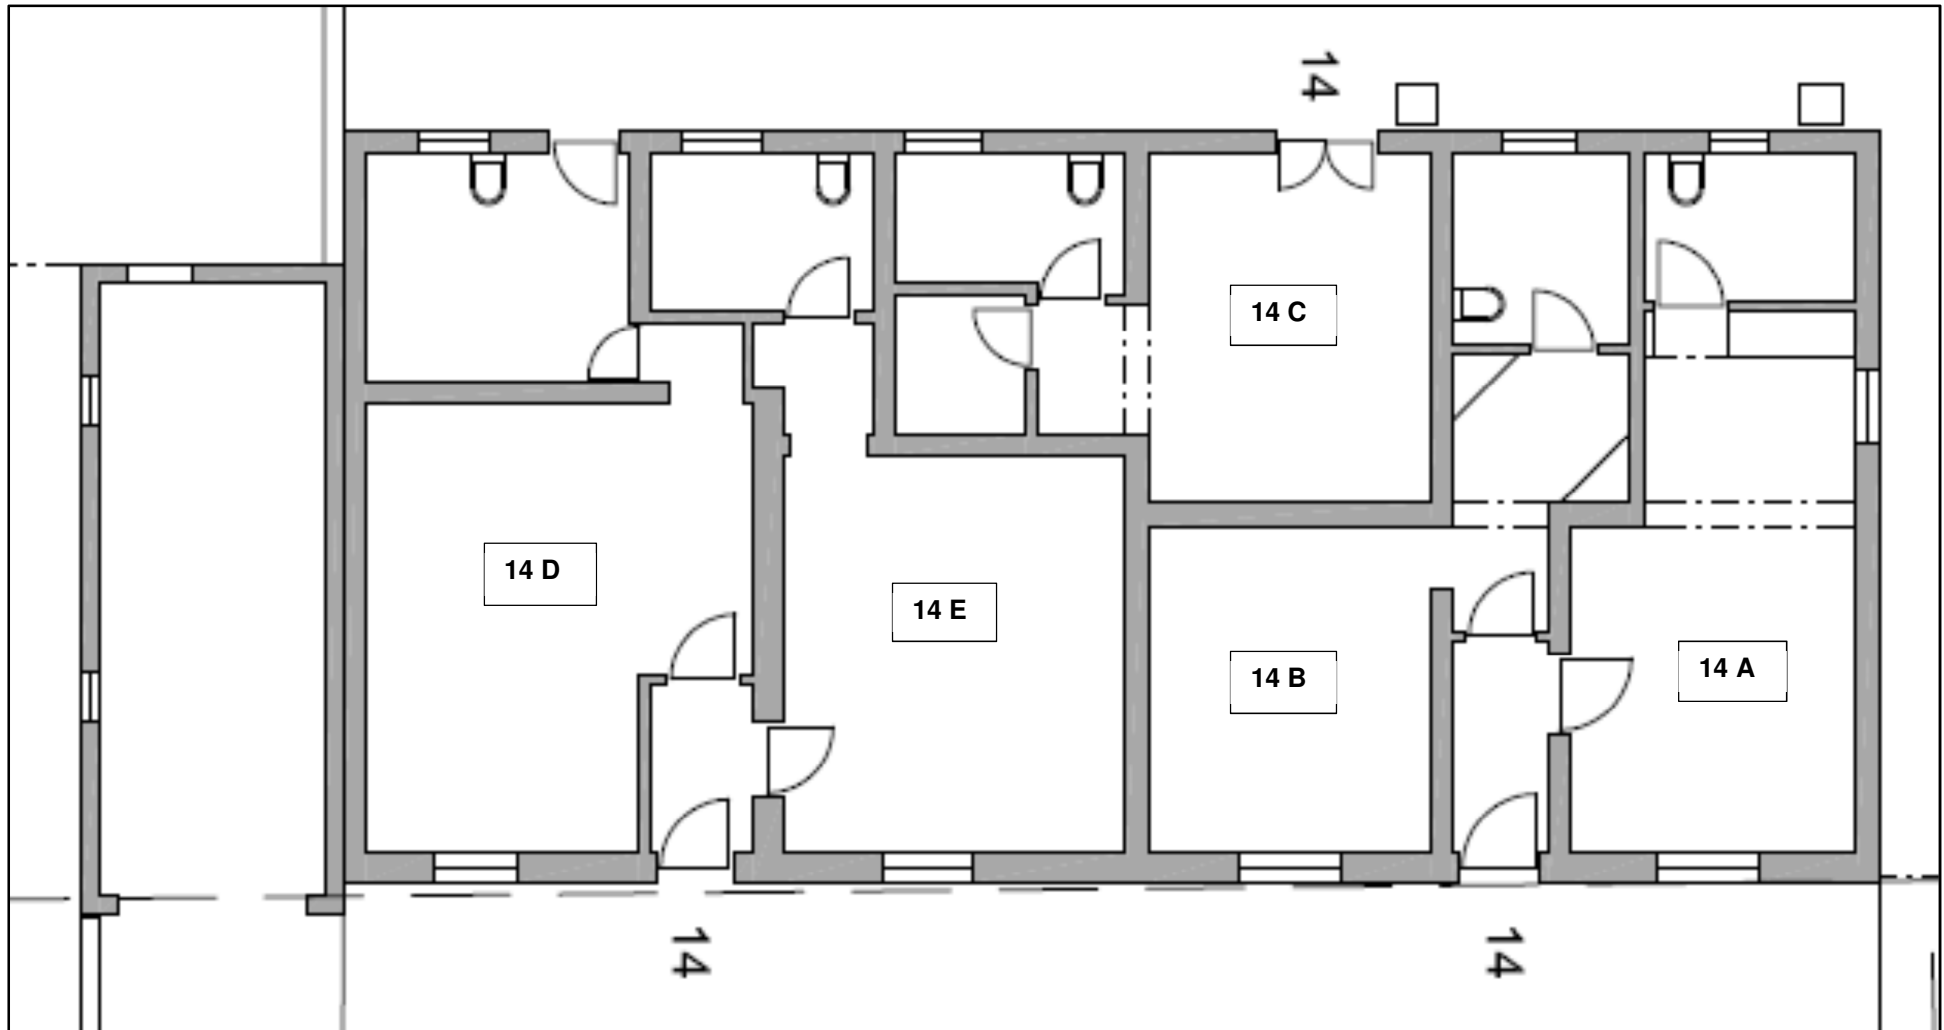
Figure 41: Existing Cottages 14 (A-E) prior to renovation, looking eastward from Bourke Street.

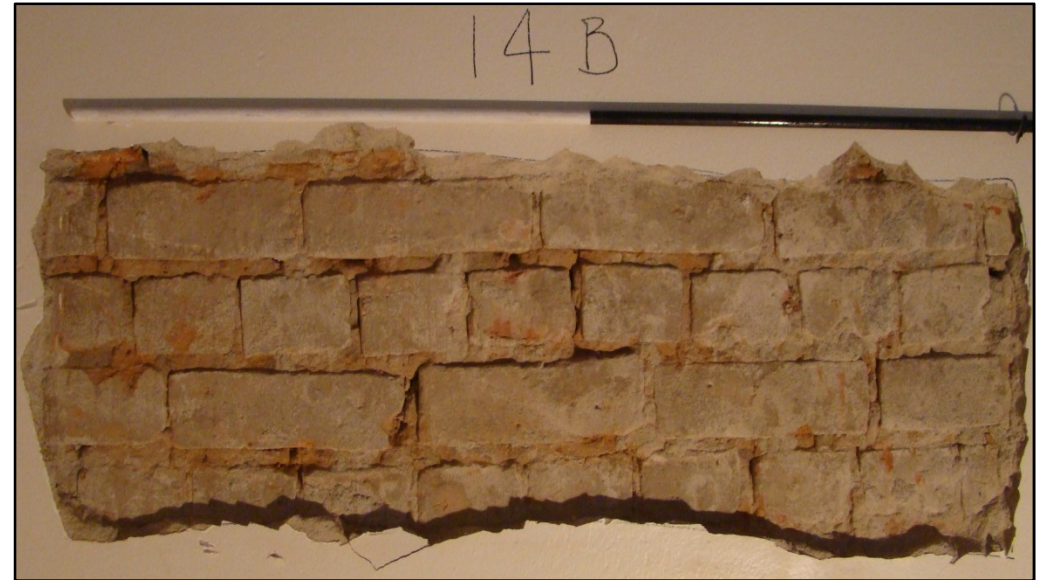
Figure 43: Fired regular red bricks with red mud mortar from plaster strip 14B (same as 14 A). The wall is built in English bond.

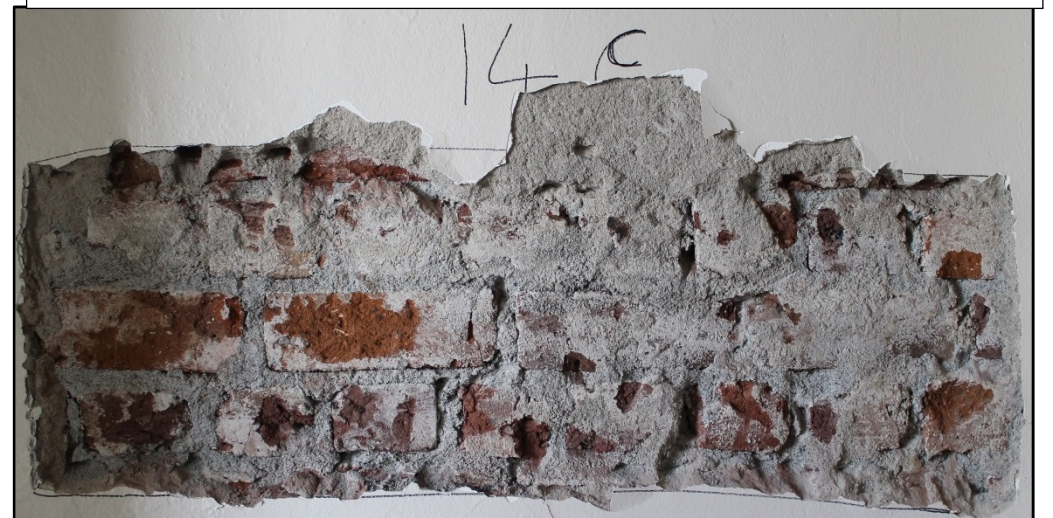
Figure 44: Plaster strip 14C showing fired red brick with grey cement mortar.

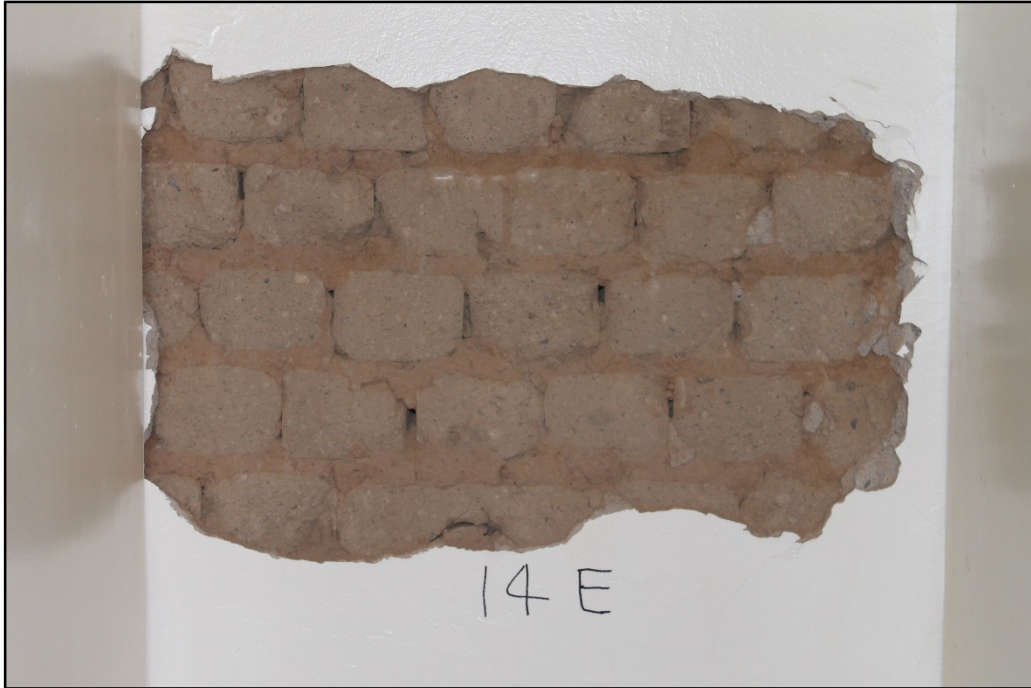
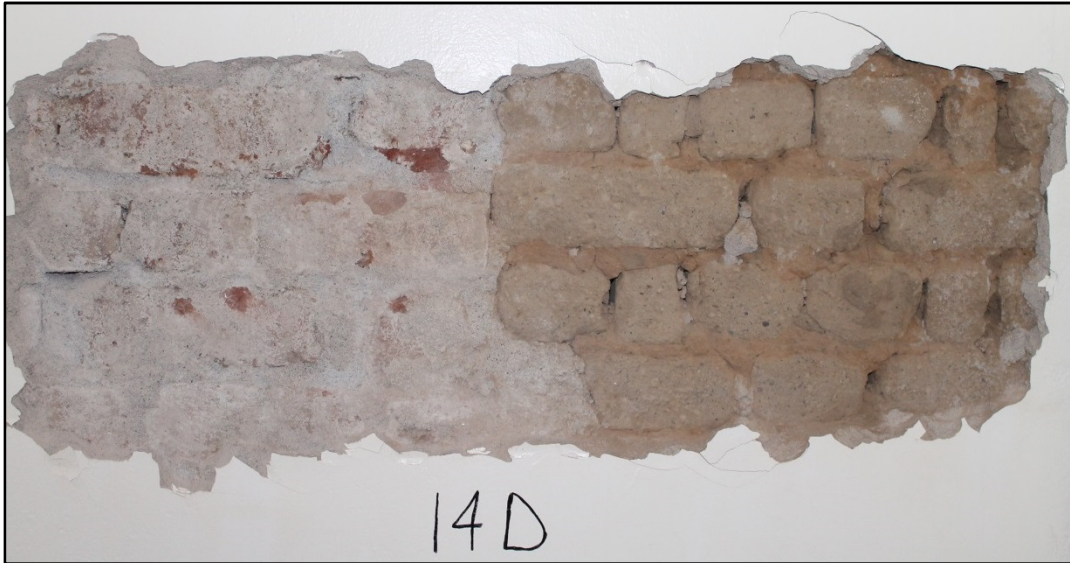
Figure 46: Plaster strip 14D (in the cupboard to the right), shows that an opening in the mud brick and mortar wall was filled with hard red brick and grey cement mortar. Plaster strip 14E (above) shows that the wall comprises a mixture of mainly headers, but also some stretchers and also some broken brick.

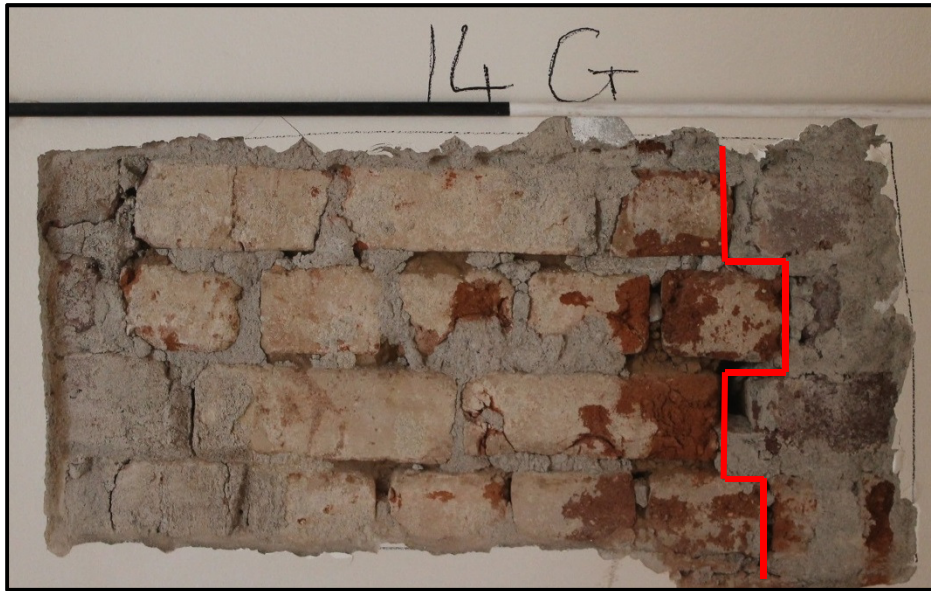
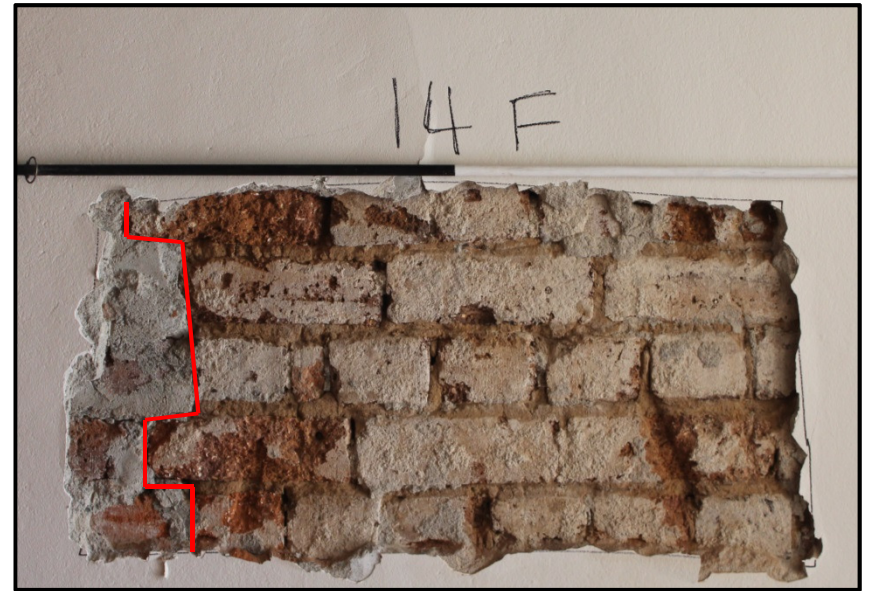
Figures 47: Plaster strips 14G and 14F indicating an aperture in the wall which has been filled with red brick and grey cement mortar. Figure 48 (below) shows the hard red brick and grey cement mortar exposed by plaster strip 14H. Strip 14I reveals a similar wall.

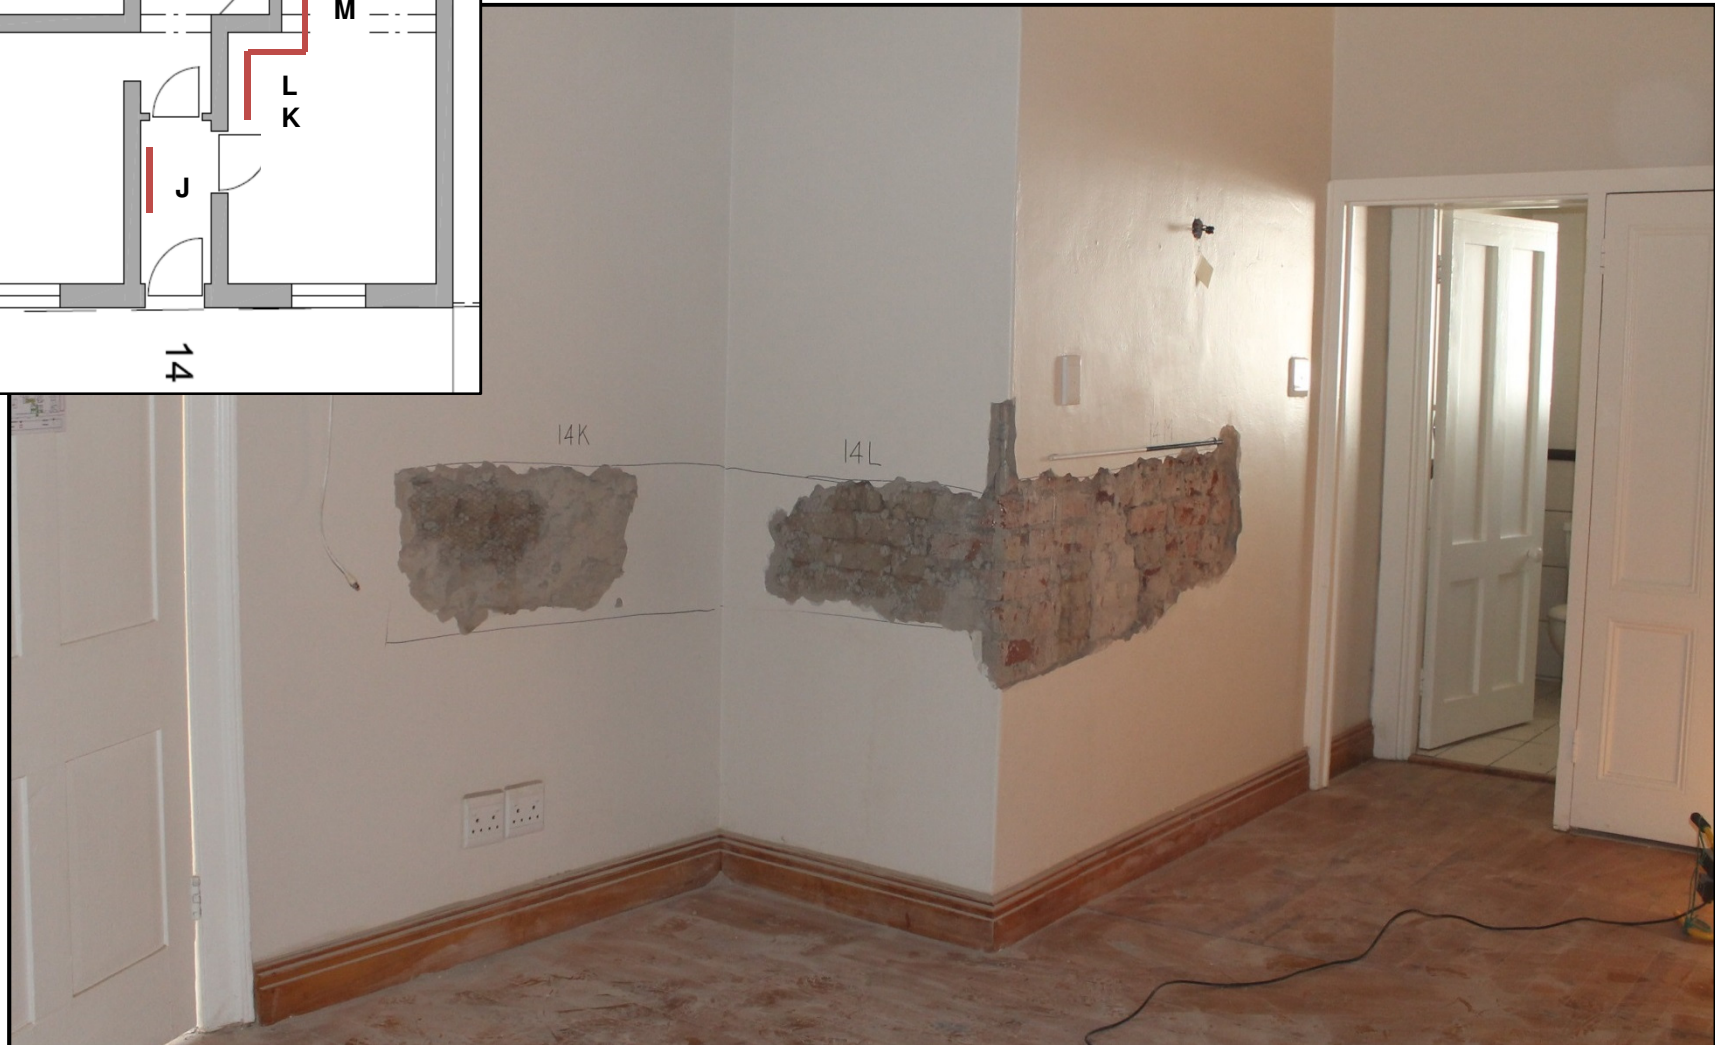
Figure 51: Thick plaster over chicken wire. The bricks are a pale olive brown bricks with red mud mortar.
