**APPENDIX  
PLASTER STRIPPING**

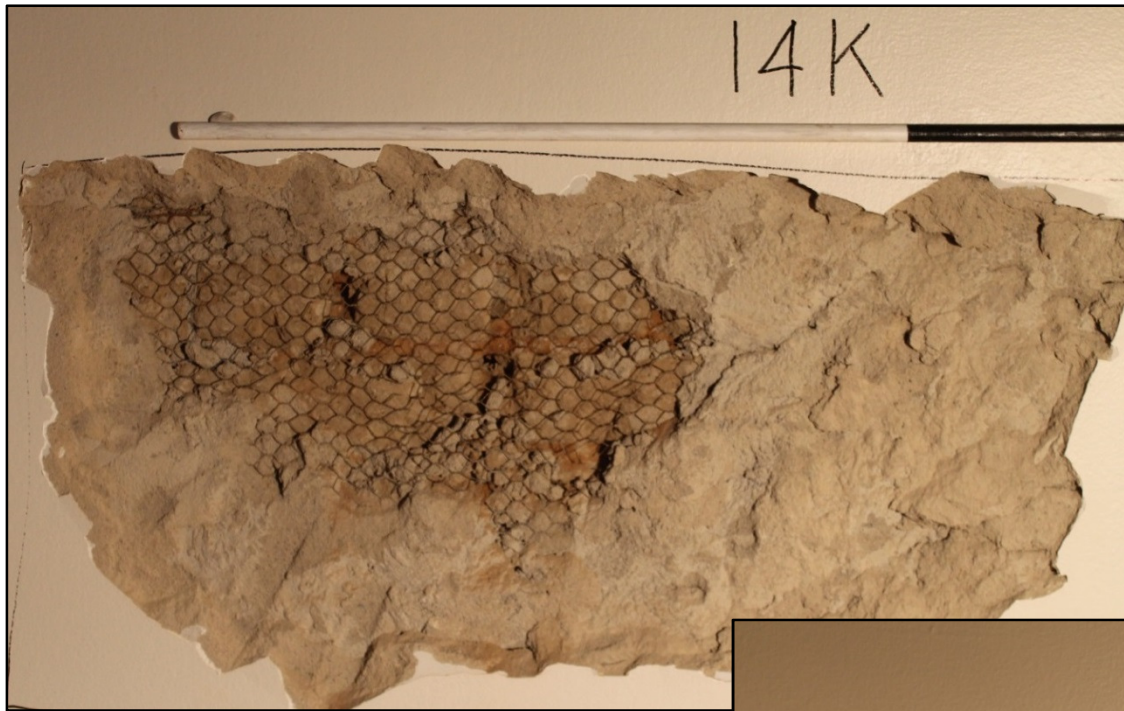
Figure 52: Soft olive brown bricks with red mud mortar under chicken wire. The corner of the wall has been strengthened with a harder red brick.

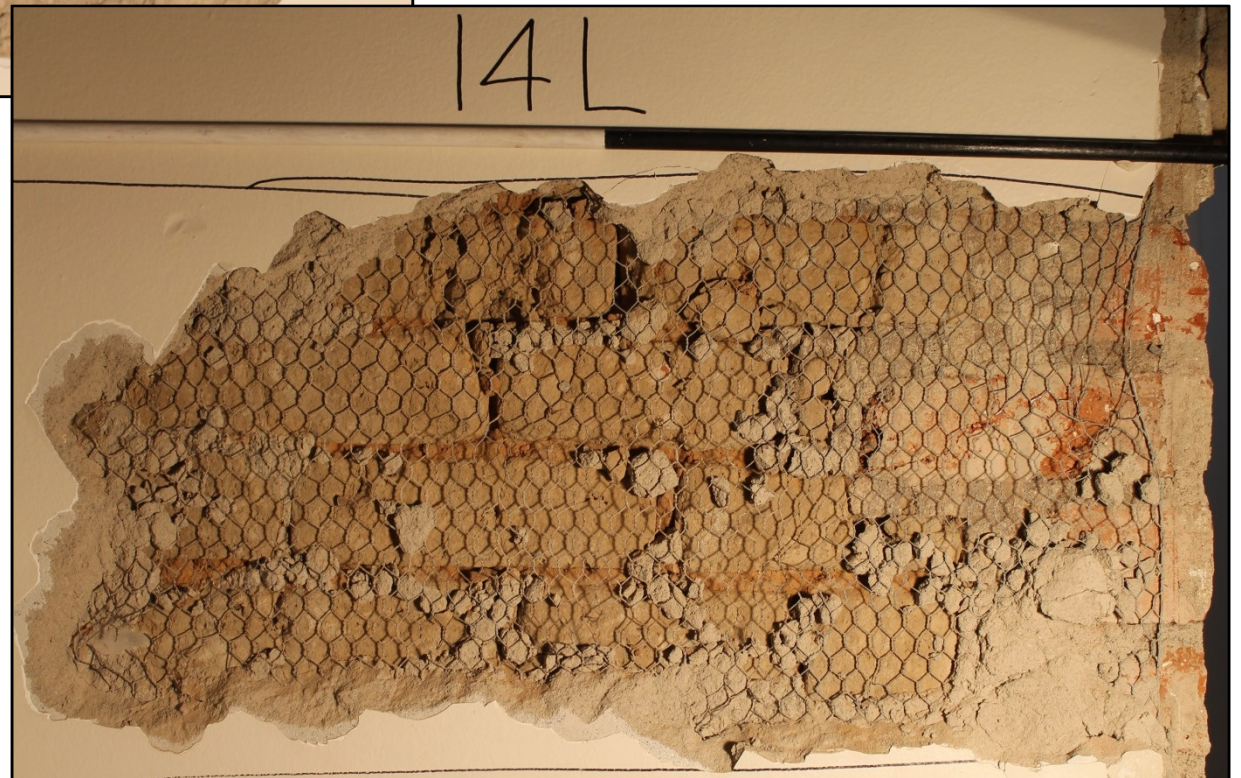
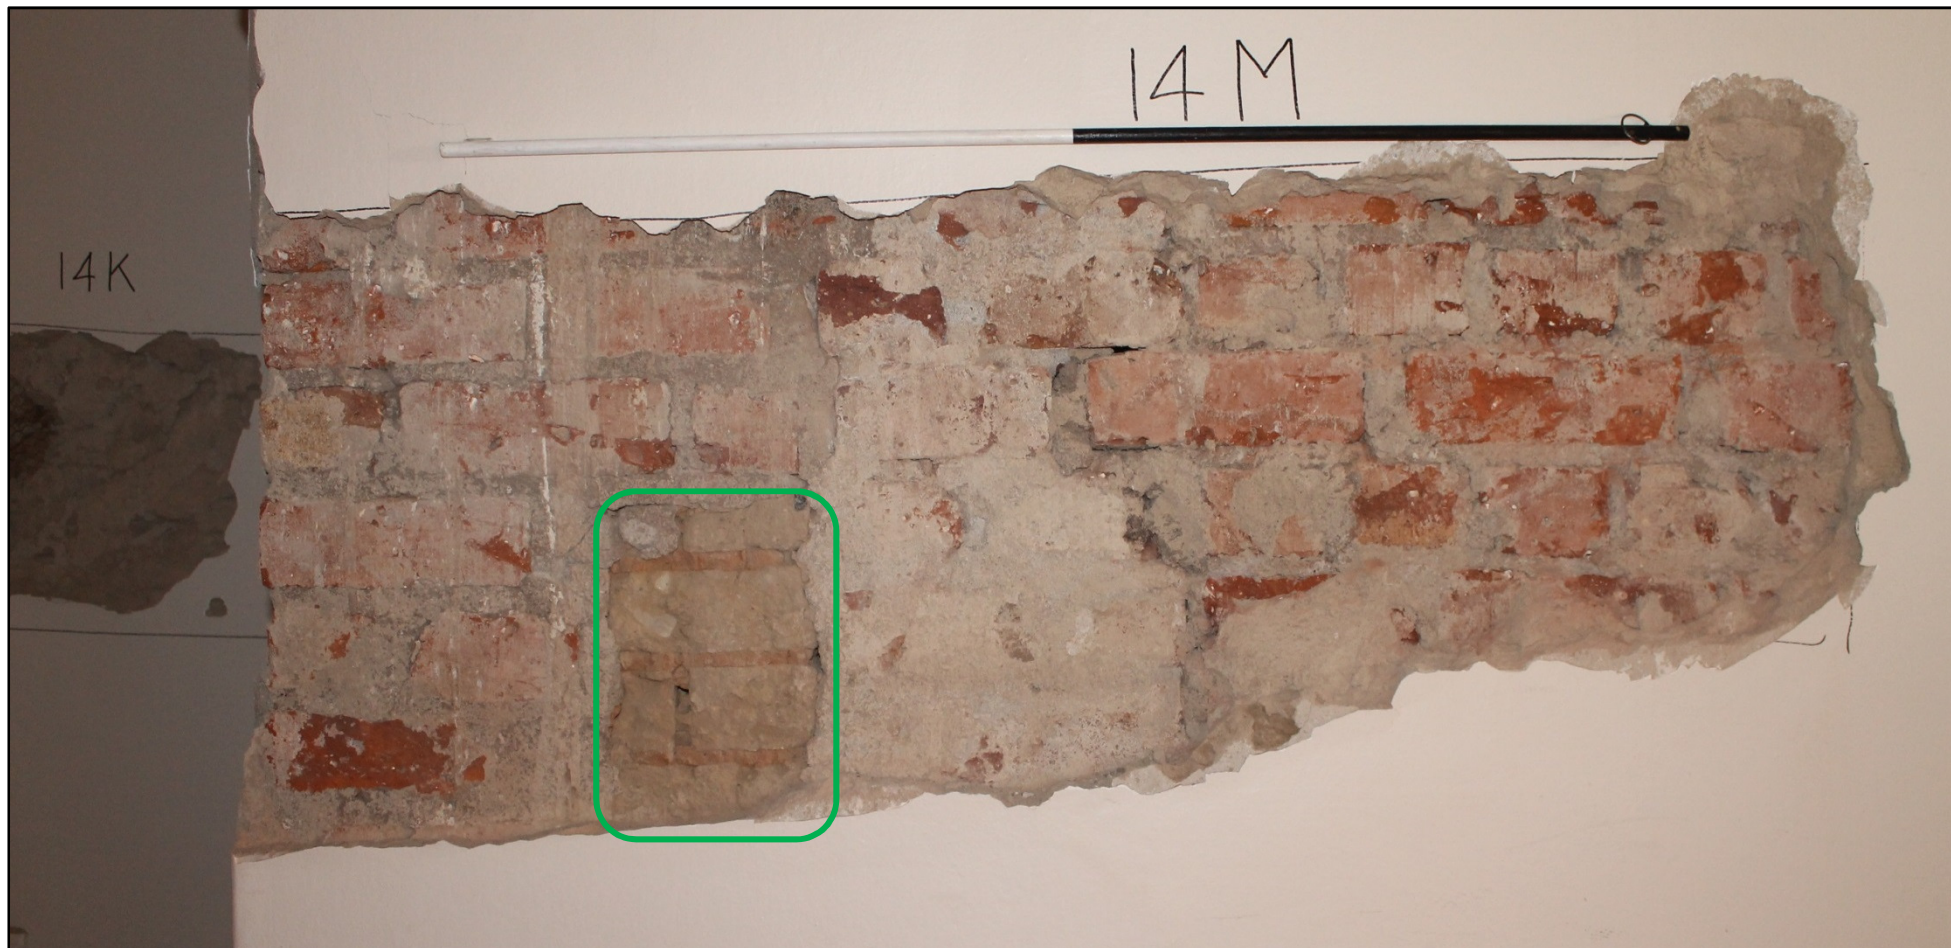
Figure 53: Strip 14M is comprised predominantly of fired red brick with white flecks and grey cement mortar, but there is evidence of a small section of olive brown bricks and red mud mortar inside the green rectangle.

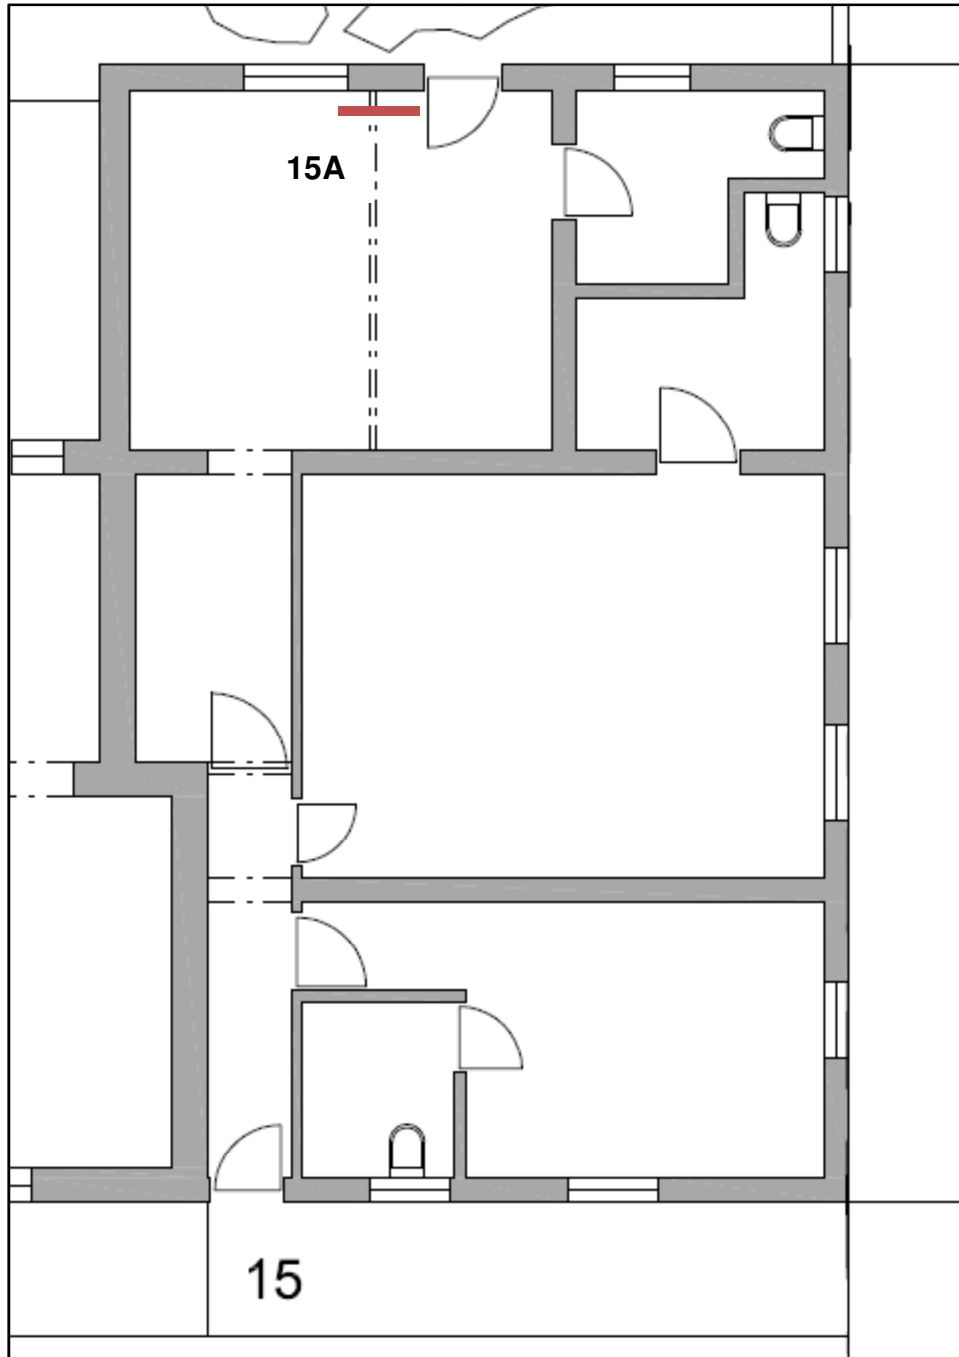
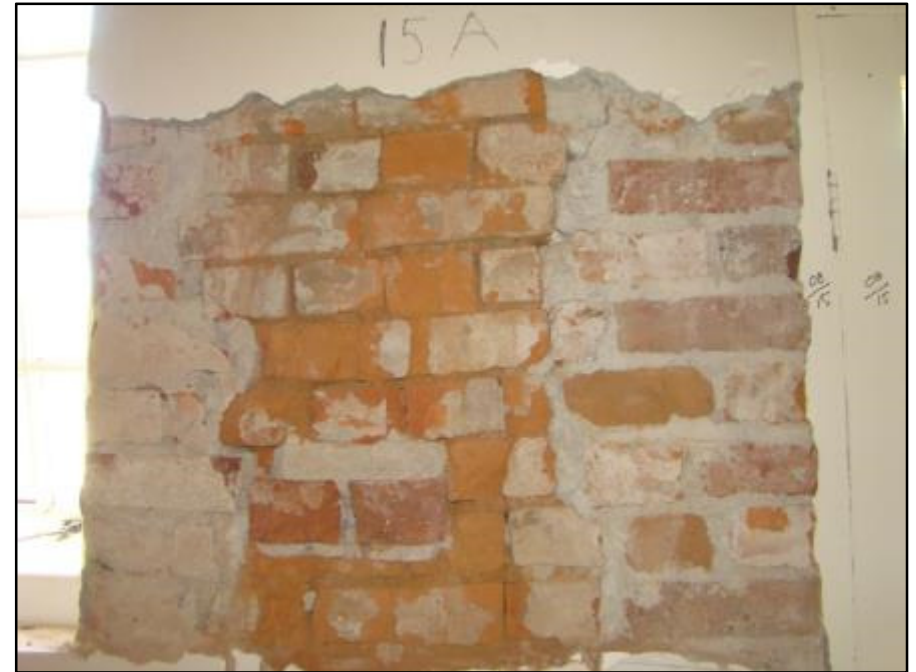
Figure 54: Section of walling between existing door and window shows the original wall of red brick and mud mortar and recent alterations to insert the window and door.
