A PHASE 1 ARCHAEOLOGICAL IMPACT ASSESSMENT (AIA) FOR THE PROPOSED N2 NATIONAL ROUTE (N2-13) BETWEEN GRAHAMSTOWN AND THE FISH RIVER BRIDGE AS WELL AS SIX BORROW PITS AND THREE QUARRIES, EASTERN CAPE PROVINCE.

Compiled by: Ms Celeste Booth
Department of Archaeology
Albany Museum
Somerset Street
Grahamstown
6139
Tel: 046 622 2312
Fax: 046 622 2398
Email: C.Booth@am.org.za

Date: September 2013

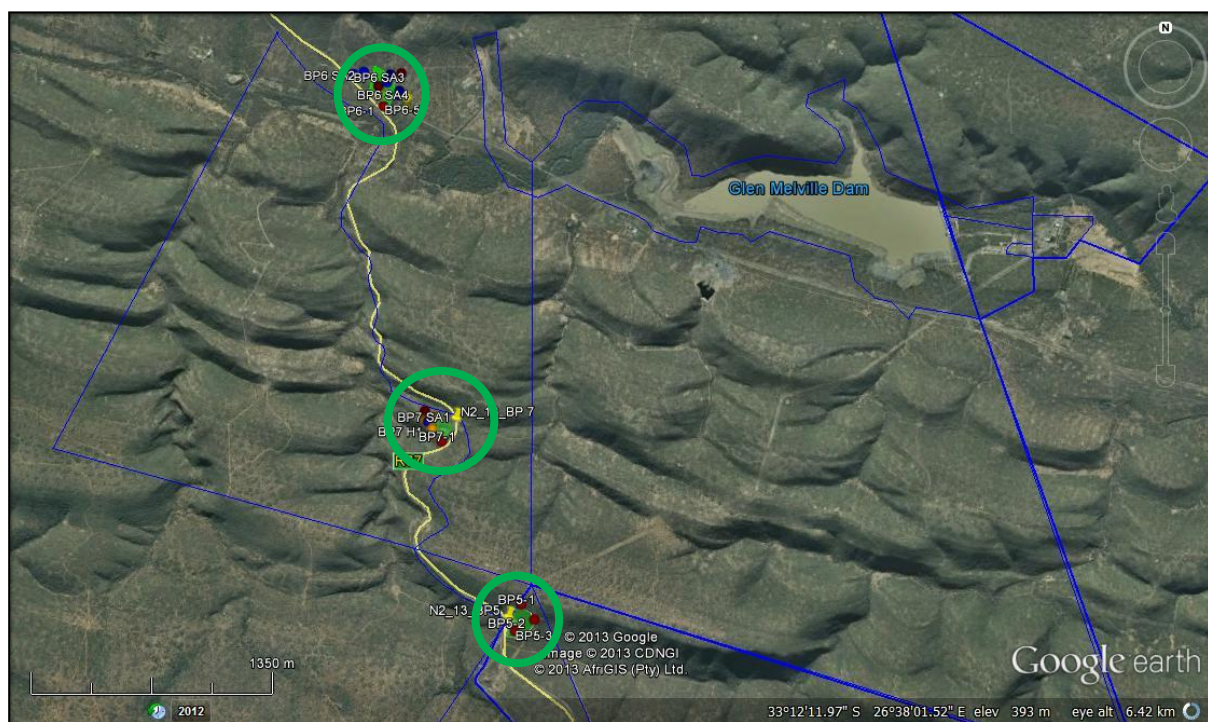
Figure 3. Aerial view showing the locations of Borrow Pit 6 (BP6), Borrow Pit 7 (BP7), and Borrow Pit 5 (BP5) situated along the R67 road.

Borrow Pit 6 (BP6), Borrow Pit 7 (BP7), and Borrow Pit 5 (BP5) are situated along the R67 road between Grahamstown and Fort Beaufort (Figure 3). All three borrow pits are located within the extent of the Ecca Pass.

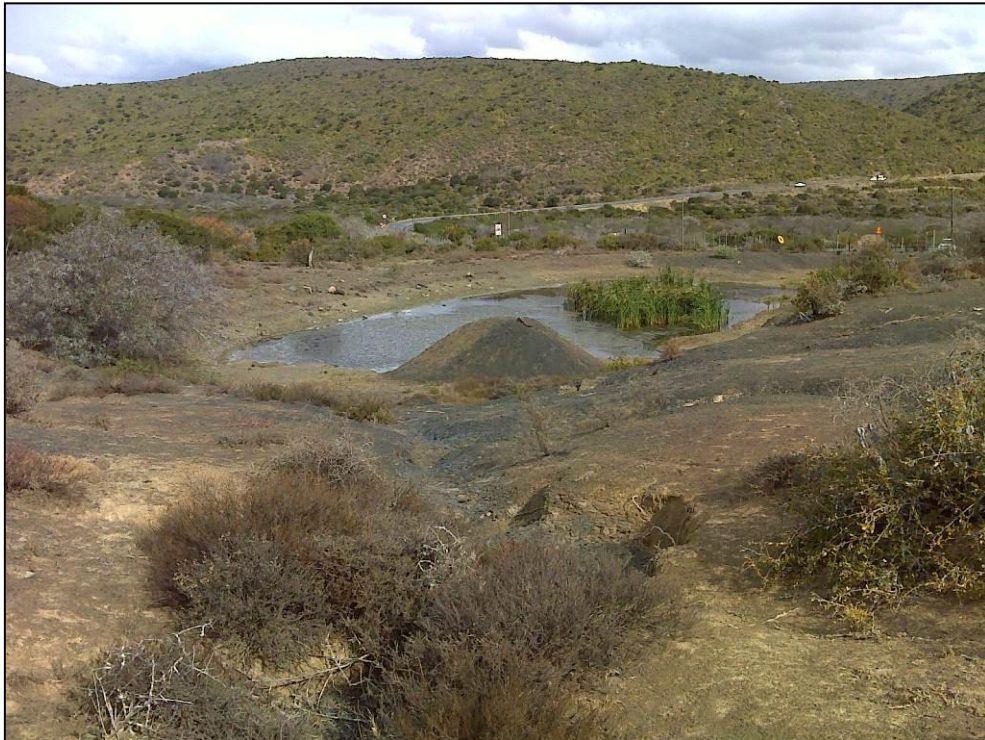
The intention is to expand and deepen the existing borrow pit area. The existing borrow pit area is approximately 130 m x 70 m in extent and a maximum of 2.5 m in depth (Figure 5). The proposed borrow pit area including the existing borrow pit is approximately 180 m x 170 m in extent. The geological make-up is a dark grey, very loosely jointed, fissile to fragmentary mudstone shale.

Figure 5. View of the existing borrow pit at the area proposed for Borrow Pit 6 (BP6).

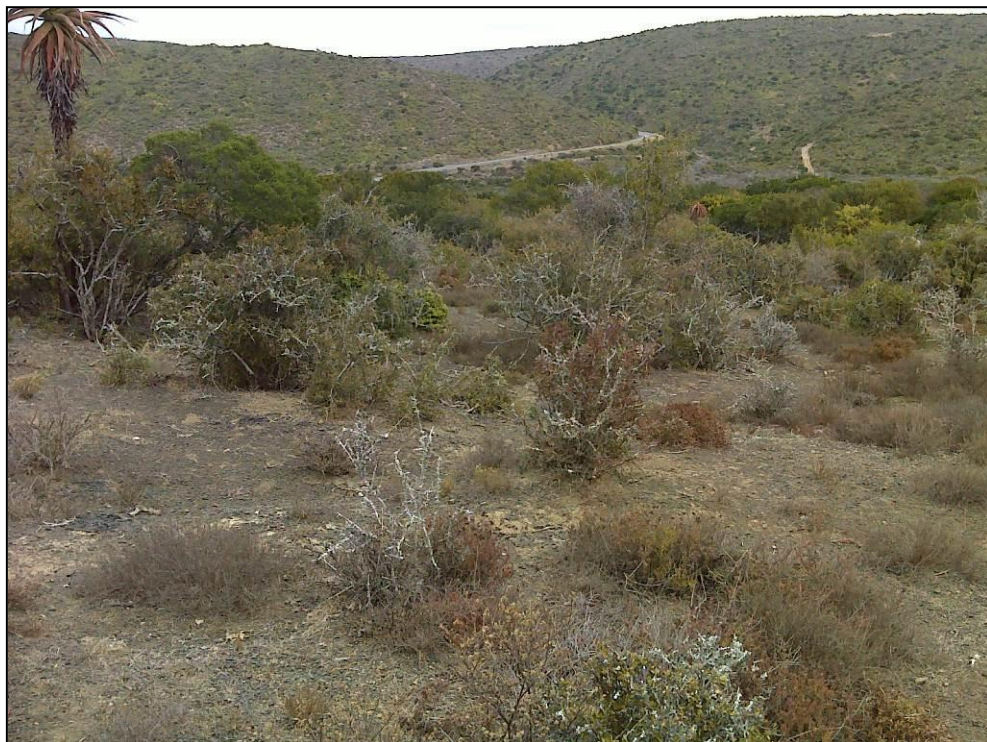
Figure 6. View of the general landscape and dense thicket vegetation on site.

The vegetation cover is dense Great Fish Thicket that obscured archaeological visibility (Figures 6-7). An Eskom power line and associated service road runs along the northern boundary of the proposed site (Figure 8). The exposed and disturbed surface and soil eroded areas were investigated for the possibility of encountering archaeological heritage remains (Figure 9).

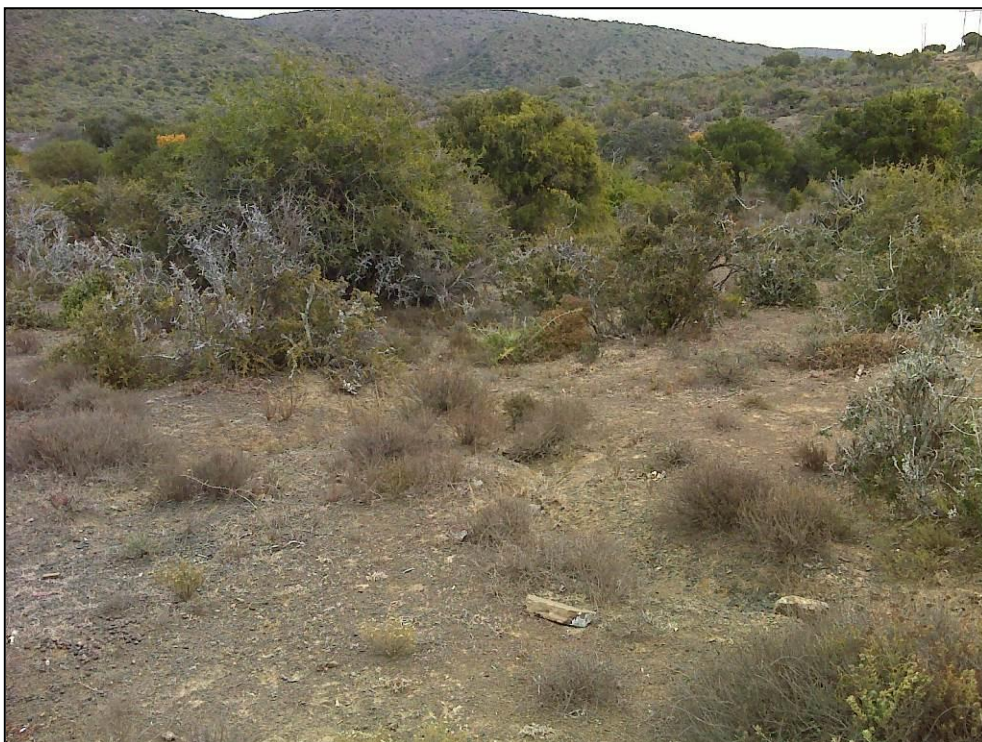
Figure 7. View of the general landscape and dense thicket vegetation.

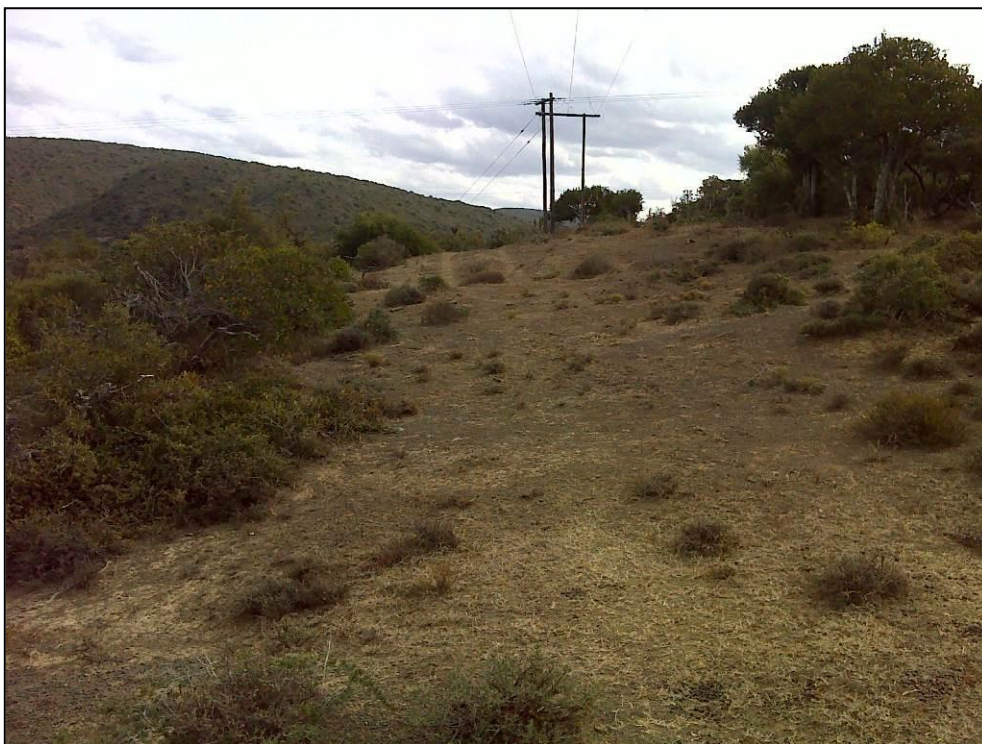
Figure 8. Eskom power line and service road on northern boundary of the proposed site.

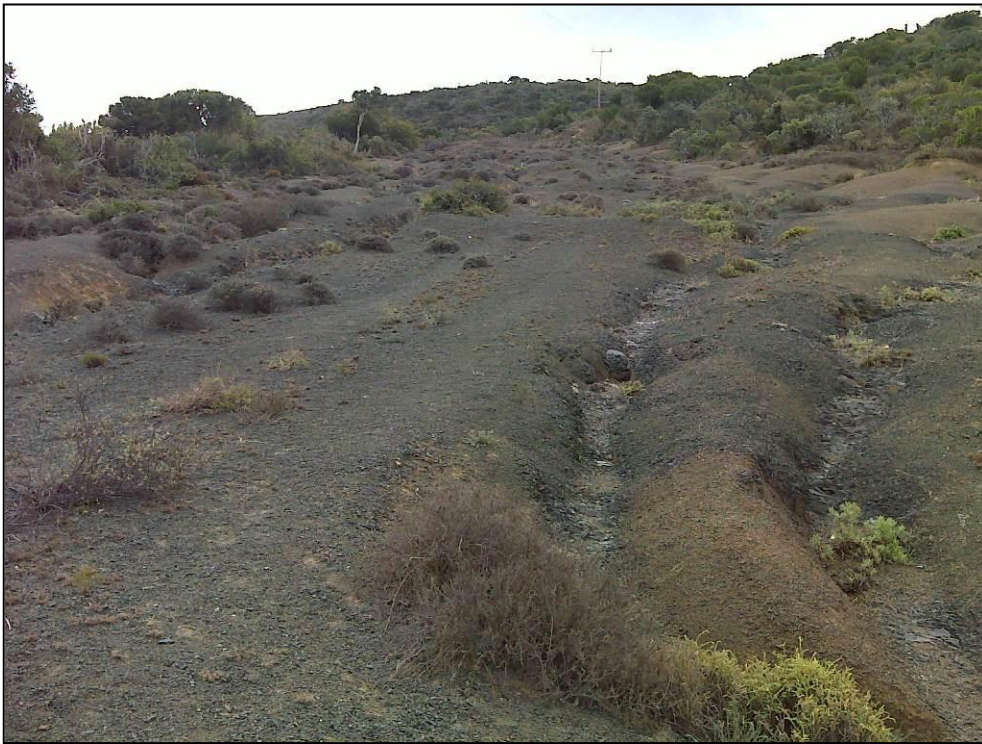
Figure 9. View of the results of the soil erosion occurring on site.

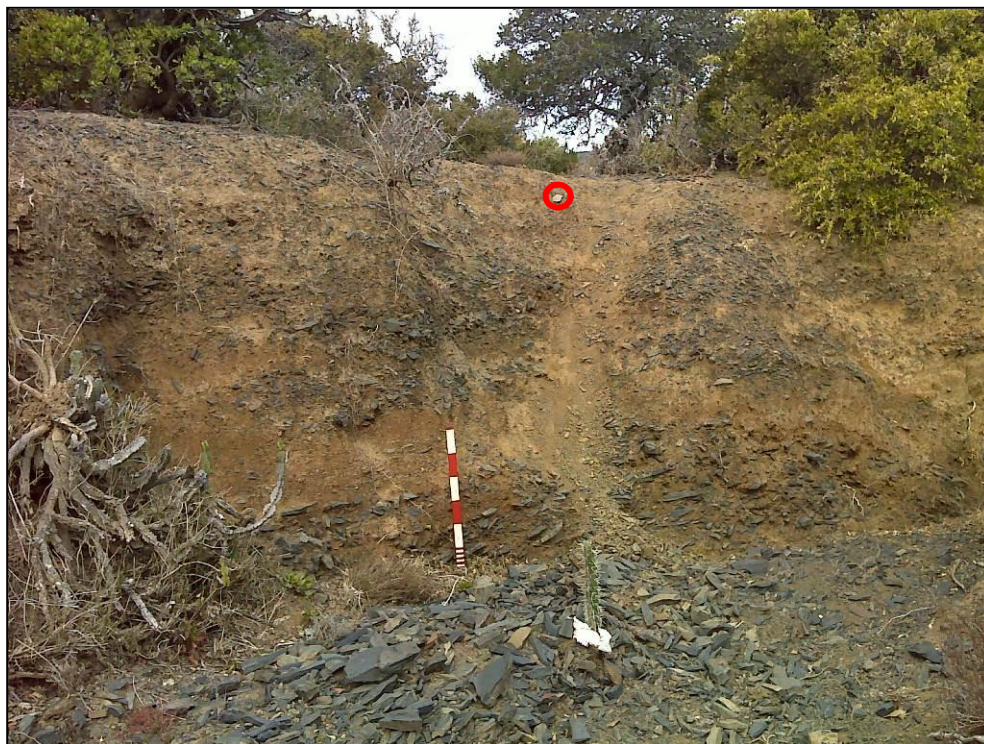
Owing to the dense vegetation that obscured archaeological visibility only stone artefacts that occurred in the exposed and surface disturbed areas could be identified during the survey. It is highly probable that the stone artefacts encountered occur in a secondary (*ex situ*) context and yield very little primary archaeological information. However, it is possible that stone artefacts may occur in primary context (*in situ*) 50 cm – 80 cm underneath the dense vegetation.

Figure 10. View of a stone artefact eroding out of the side of a 1.8 m deep donga (red circle, see Figure 14 for an example of the stone artefact).

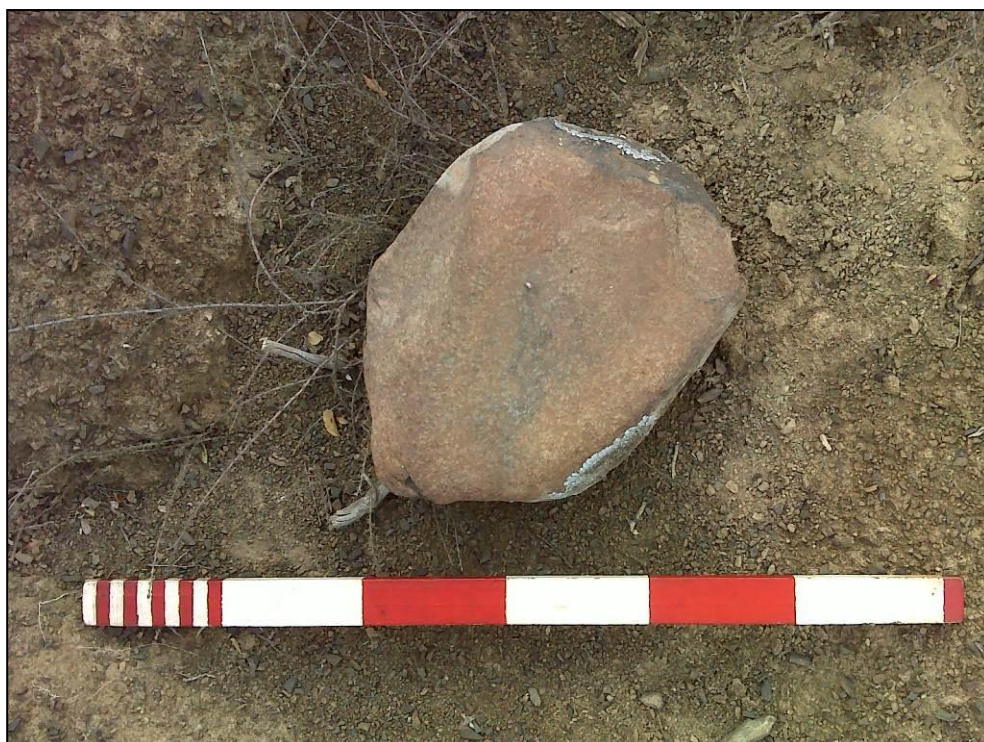
Figure 11. An example of a possible slightly smoothed lower grinding stone.

Isolated occurrences of stone artefact scatters were encountered during the survey (BP SA1 – BP SA6). Most of these stone artefacts were encountered outside of the proposed site within the surface disturbed areas (Figure 10). A possible lower grinding stone (BP SA4) was identified within the proposed area (Figure 11). The artefact was identified by the slightly smoothed surface area.

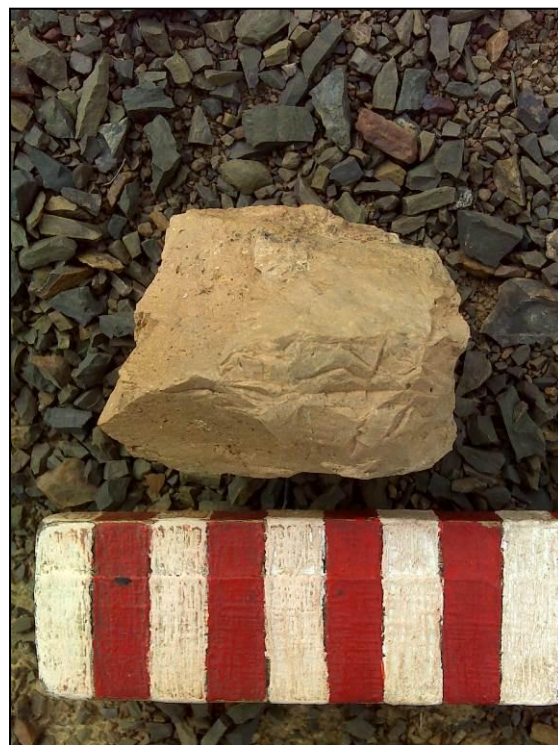
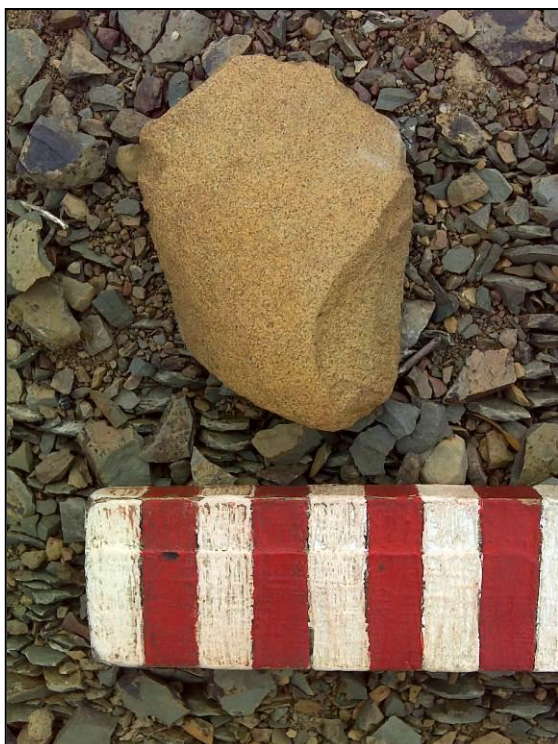
Figures 12 – 13. Examples of Middle Stone Age stone artefacts documented within the vicinity of the proposed Borrow Pit 6 (BP6) site.

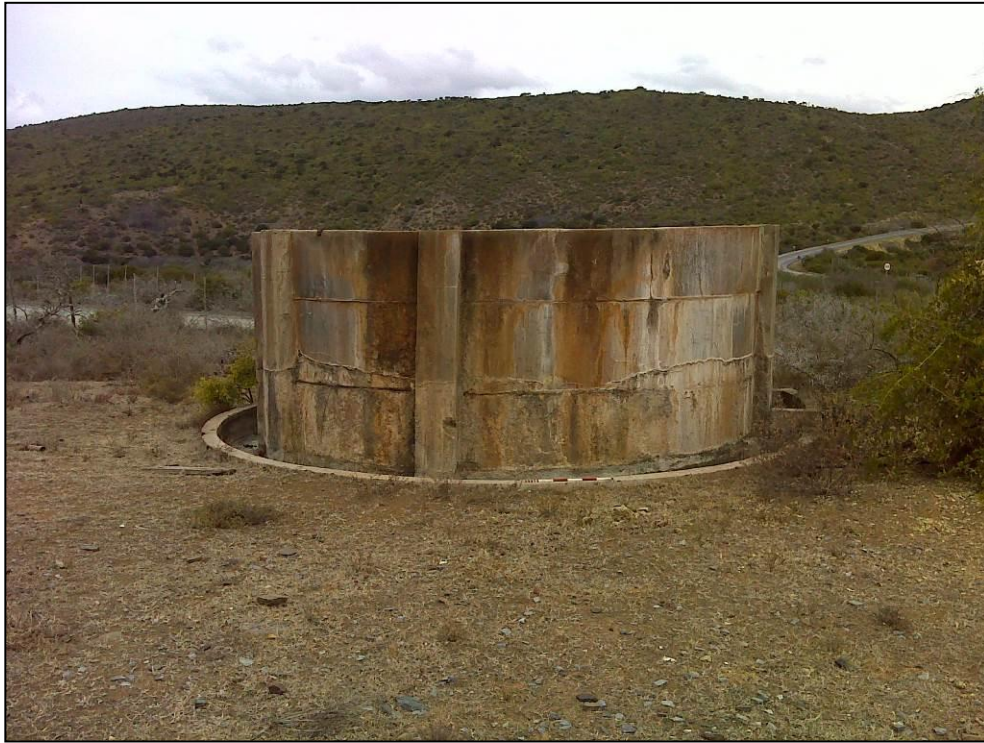
One disused reservoir and trough (Figure 16-17) were documented outside of the proposed borrow pit area (BP6-4 and BP6-5). It is unlikely that these structures will be affected during development activities

Figure 16. View of the disused water reservoir situated outside of the area proposed for the borrow pit.

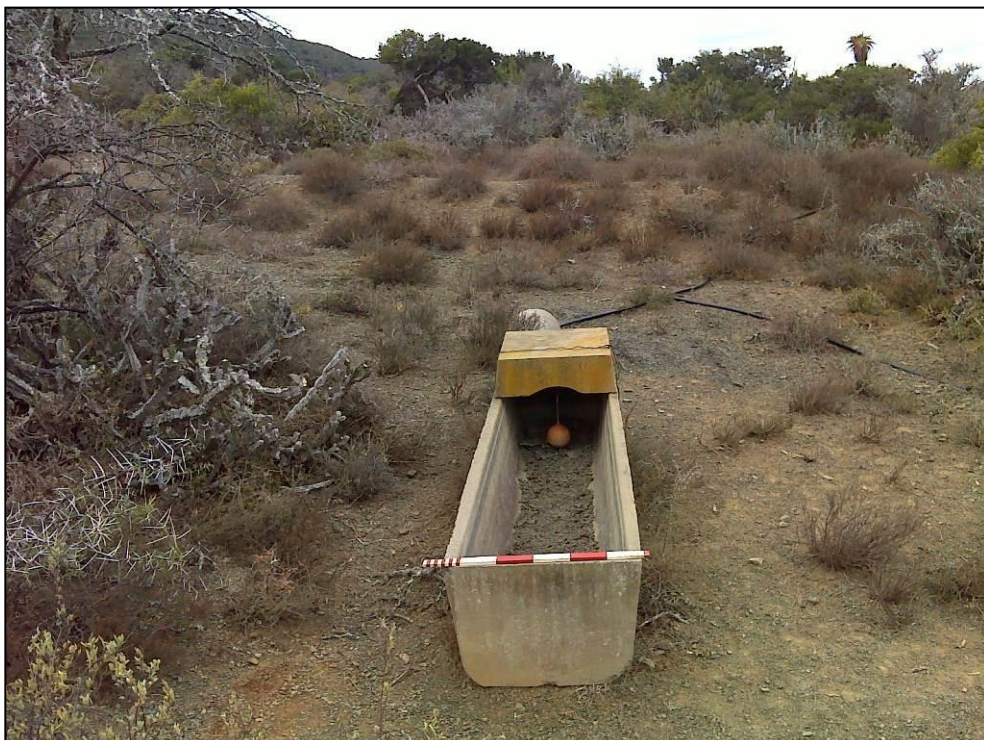
Figure 17. View of the disused water trough situated outside of the area proposed for the borrow pit.

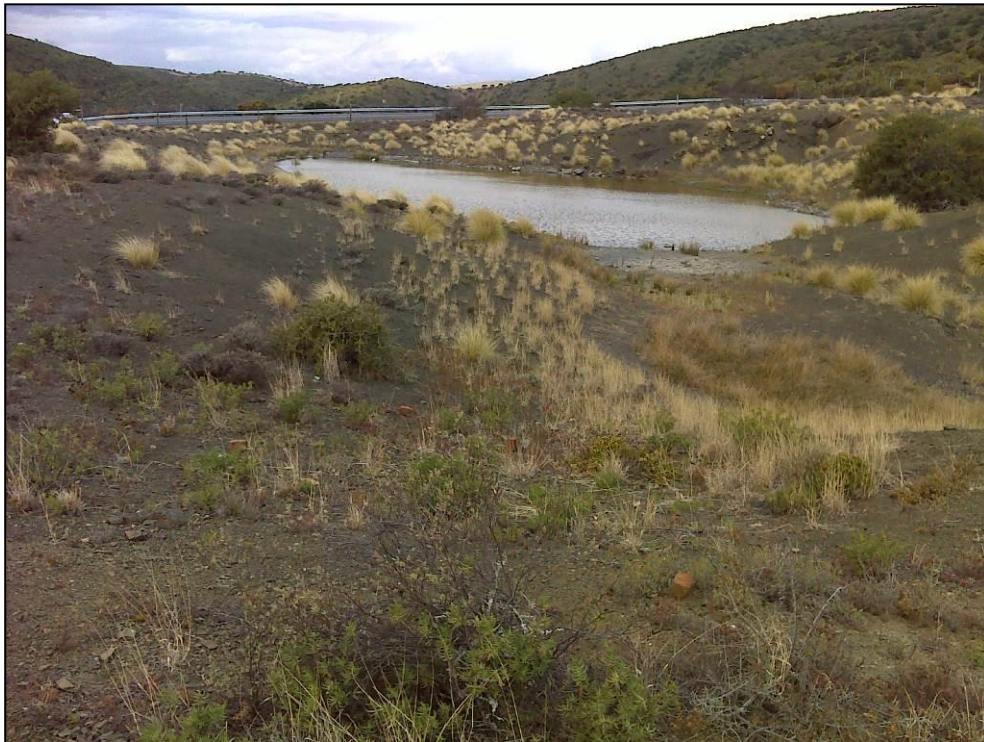
Figure 19. View of the existing borrow pit at the area proposed for Borrow Pit 7 (BP7).

The intention is to expand and deepen the existing borrow pit area across the entire hill summit area to a depth of 3 m. The existing borrow pit area is approximately 40 m x 25 m in extent (Figure 19). The proposed borrow pit area including the existing borrow pit is approximately 155 m x 105 m in extent. The geological make-up is a grey, moderate to highly weathered mudrock shale.

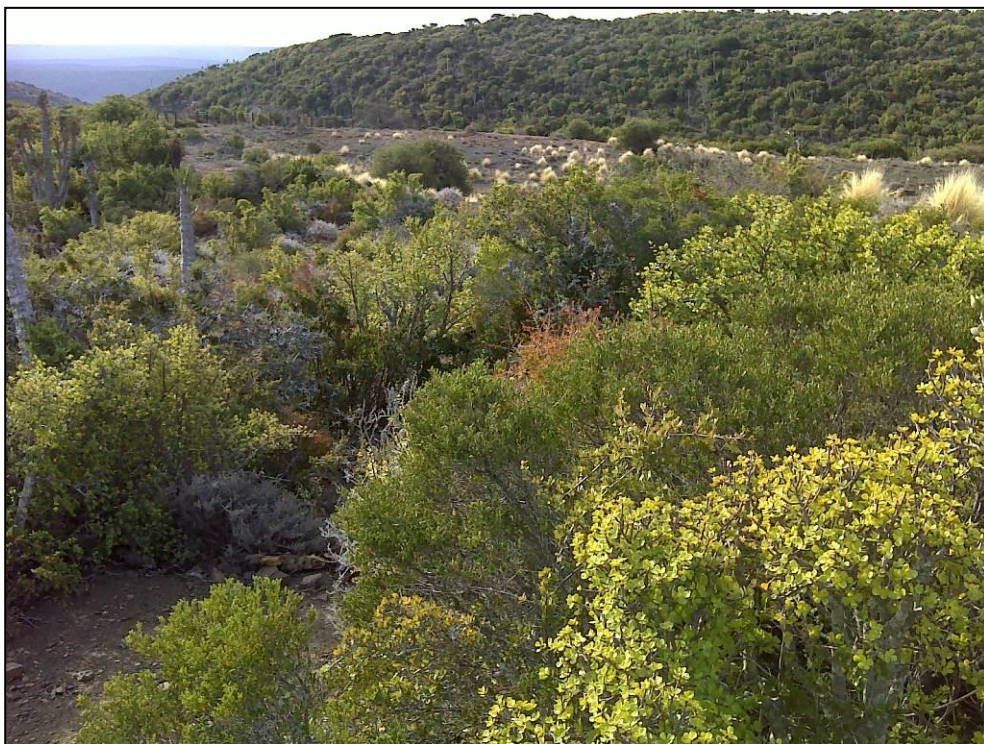
Figure 20. View of the general landscape, vegetation cover, and kraal complex in the distance.

The vegetation cover is dense Great Fish Thicket that obscured archaeological visibility (Figures 20-21). The exposed and disturbed surface and soil eroded areas were investigated for the possibility of encountering archaeological heritage remains (Figure 22).

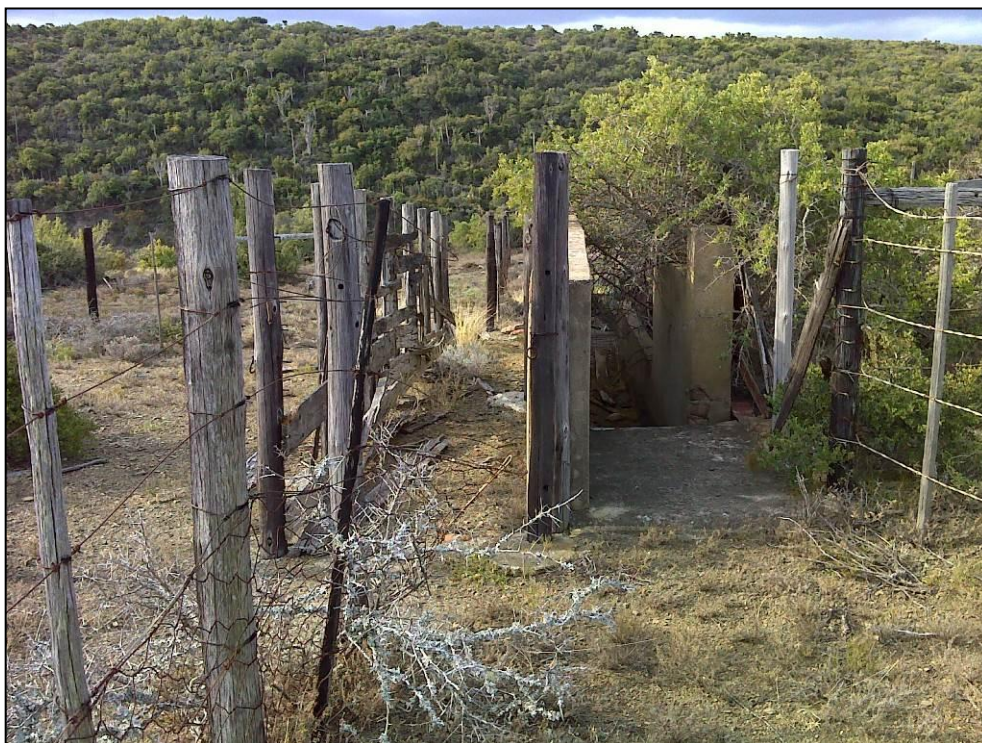
It is possible that the historical artefact scatter may have been disturbed by the construction and continuous utilisation of the area as a working kraal and dipping tank complex. The vegetation growth may also have hampered the context of the area artefacts and it possible that the historical artefact scatter may have occurred where the existing borrow is currently situated.

Figure 23. Close-up view of the disused trough within the kraal enclosure.

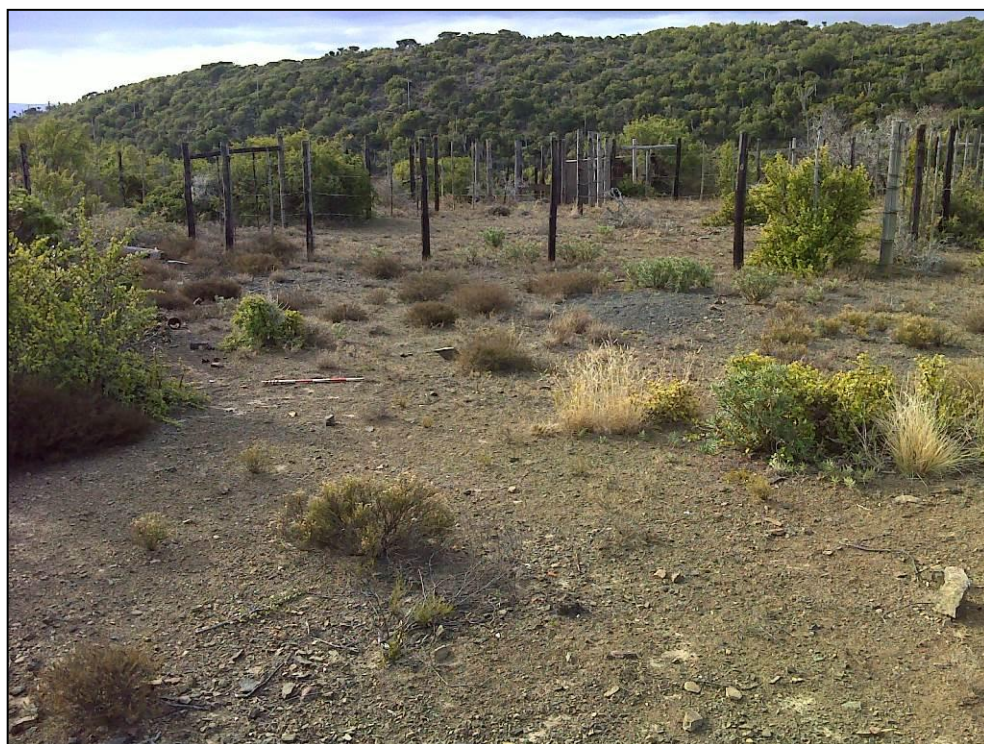
Historical artefacts, probably of the late 1800's and early-mid 1900's, were documented within and beyond the western boundary of the proposed borrow pit area. The relatively large scatter area, approximately 90 m x 50 m in extends into the kraal and dipping tank complex (Figure 24). It is possible that these artefacts were disturbed during the construction of the kraal complex. The historical scatter seemed to occur within the dense thicket vegetation as well.

Figure 24. View of the area housing historical material in relation to the kraal complex.

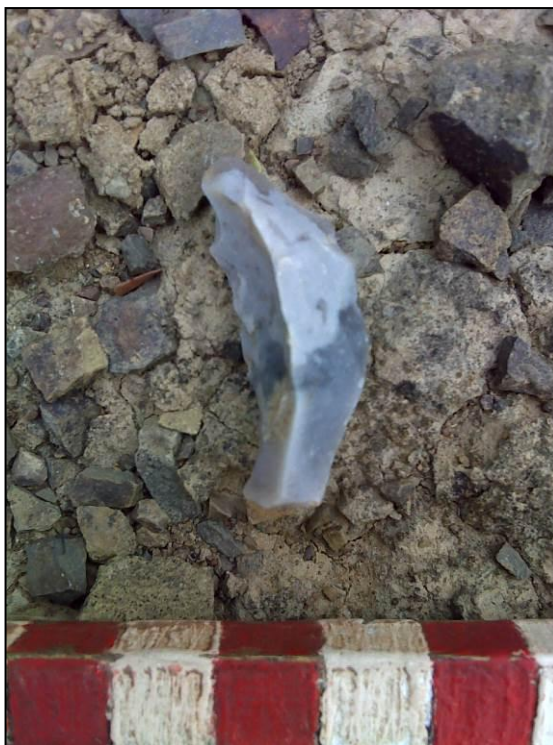
One Later Stone Age (LSA) stone artefact was encountered during the survey (Figure 25). The stone artefact was documented within the historical scatters area near to the kraal and dipping tank complex. The stone artefact has been retouched and was manufactured on a chalcedony raw material. However, it is possible that stone artefacts may occur in primary context (*in situ*) 50 cm – 80 cm underneath the dense vegetation.

Figure 25. Example of one isolated stone artefact scatter documented within the proposed borrow pit area.

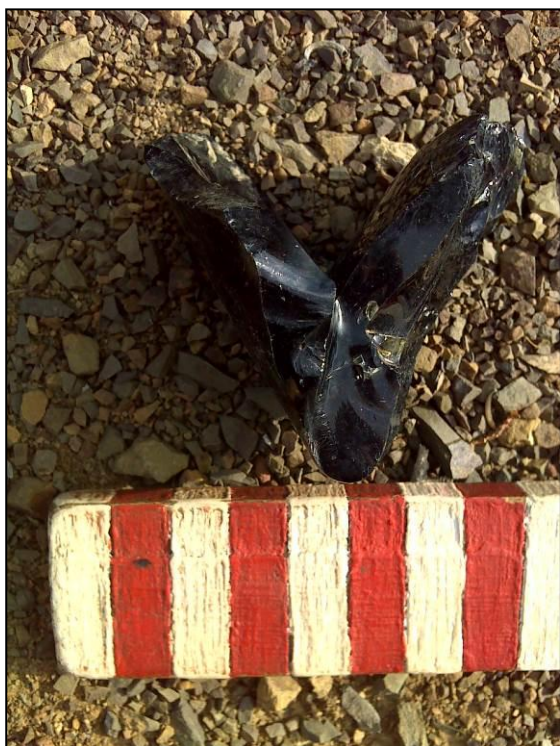
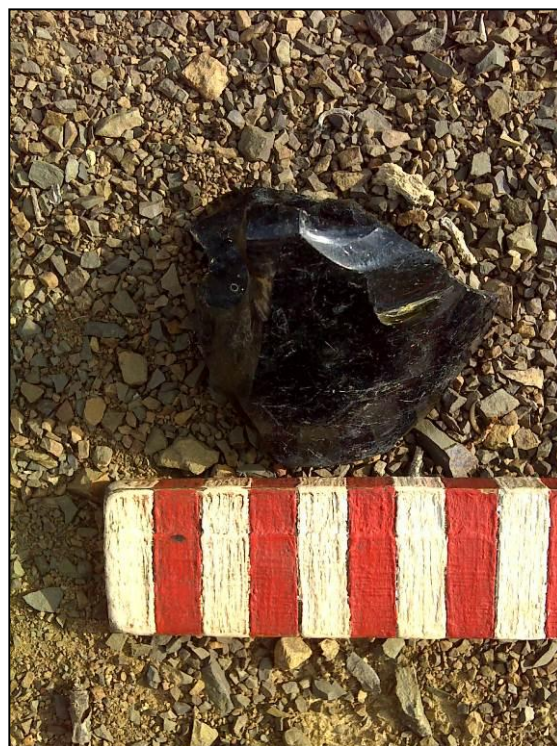
Two pieces of thick glass show working and modification of intentional flaking were documented within the historical scatter (Figures 26-27). Historically, glass pieces were modified into flakes and tools instead of stone as it was considered a good raw material. No chips associated with the working of the glass were observed in association with the glass pieces.

Figures 26 – 27. Examples of possible intentionally flaked glass documented within the proposed borrow pit area.

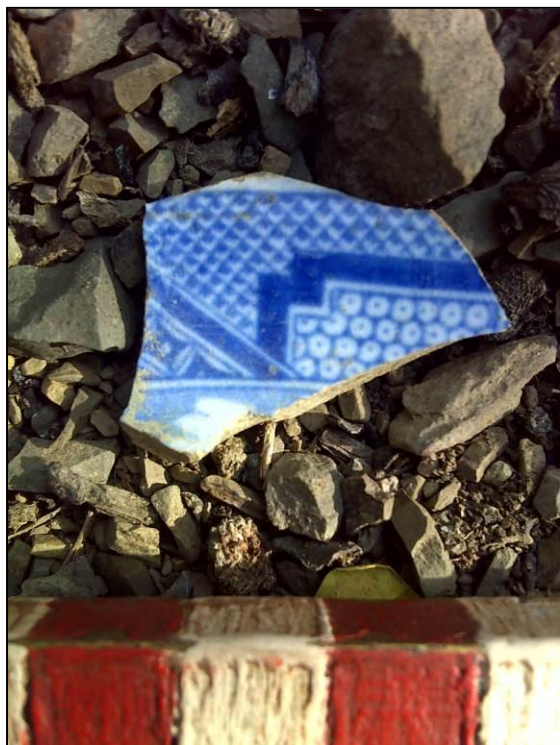
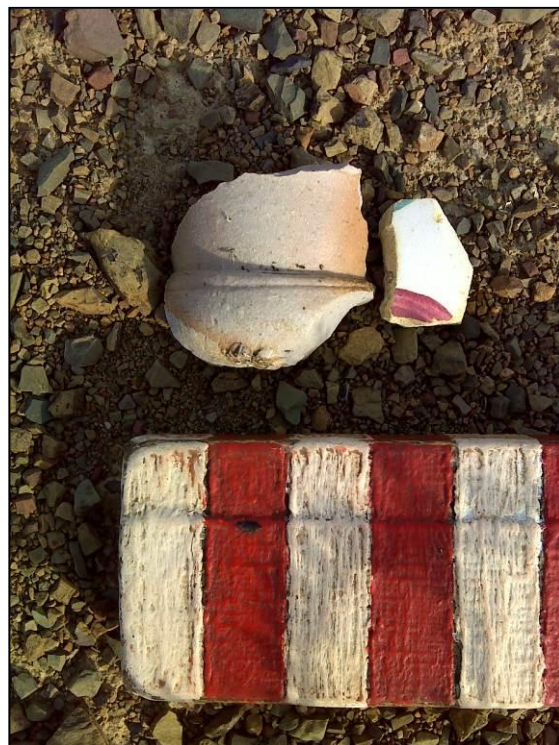
The historical scatter included fragments of salt glazed stoneware and ceramic sherds of bottles and plates (Figures 28 -29). The ceramic sherds comprised painted decoration and transfer printed designs. Broken glass fragments were also documented (Figure 30). One bottle with the inscription "Talana 1949" was still intact (Figure 31). A small fragment of the stem of clay pipe was documented on the hill slope (BP7 H3); however, no inscription was available to identify its origin.

Figures 28 – 29. Examples of stoneware and ceramic sherds documented within the historical scatter.

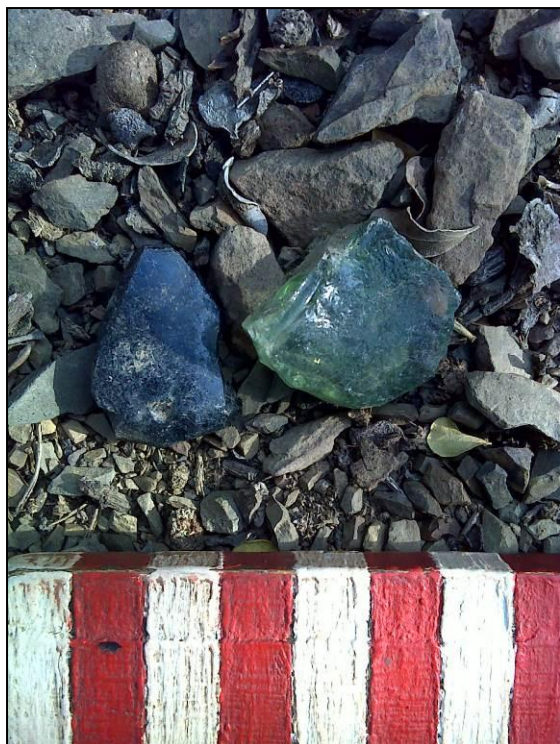
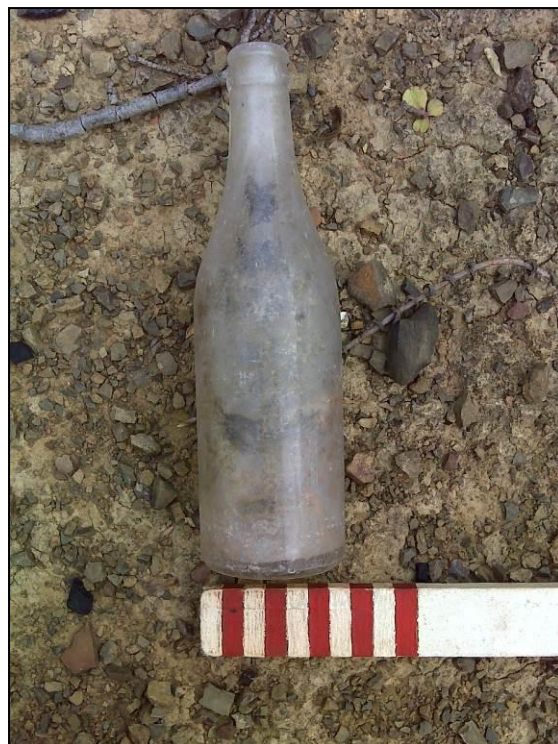
Figures 30 – 31. Examples of broken glass fragments and an intact glass bottle with the inscription "Talana 1949".

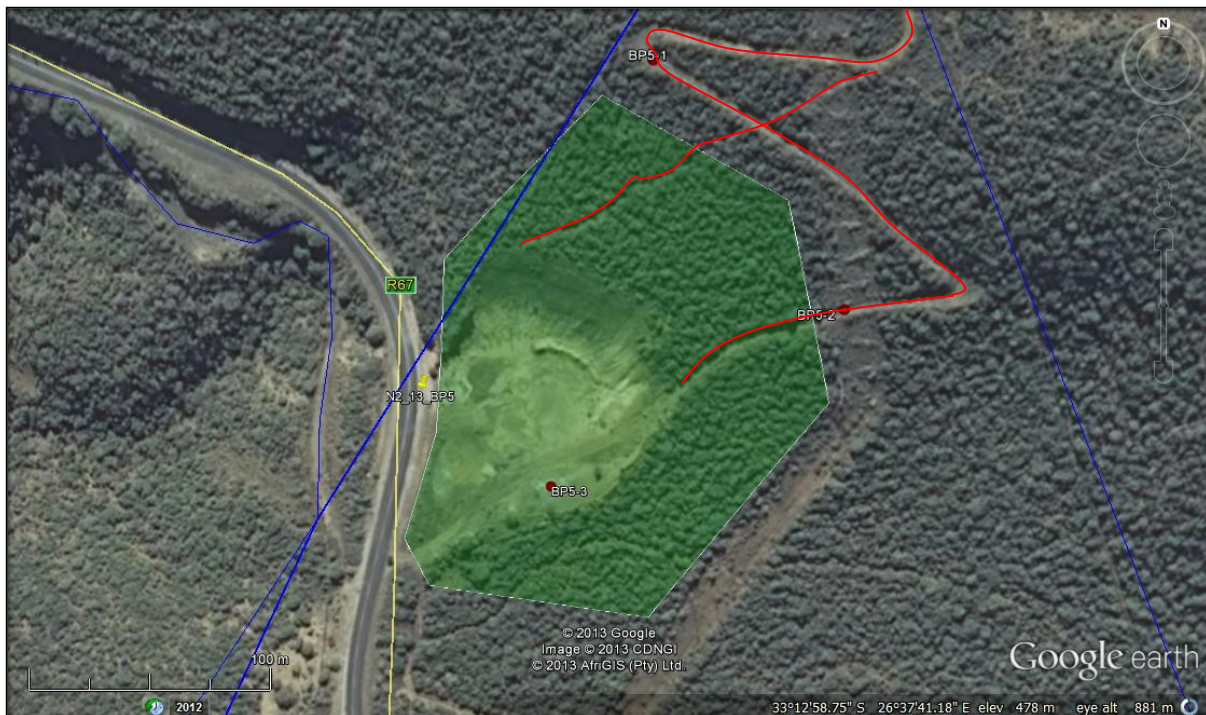
Figure 32. Close-up aerial view of the area proposed for Borrow Pit 5 (BP5) showing the plotted general GPS points and upgraded roads (red lines).

BP5 is located approximately 1.4 km south of BP7 on land owned by Makana Municipality (Figure 3). The intention is to expand the existing borrow pit area. However, it seems that the existing borrow pit area has recently been upgraded and is currently being utilised indicated by the upgraded roads (Figure 32, red lines).

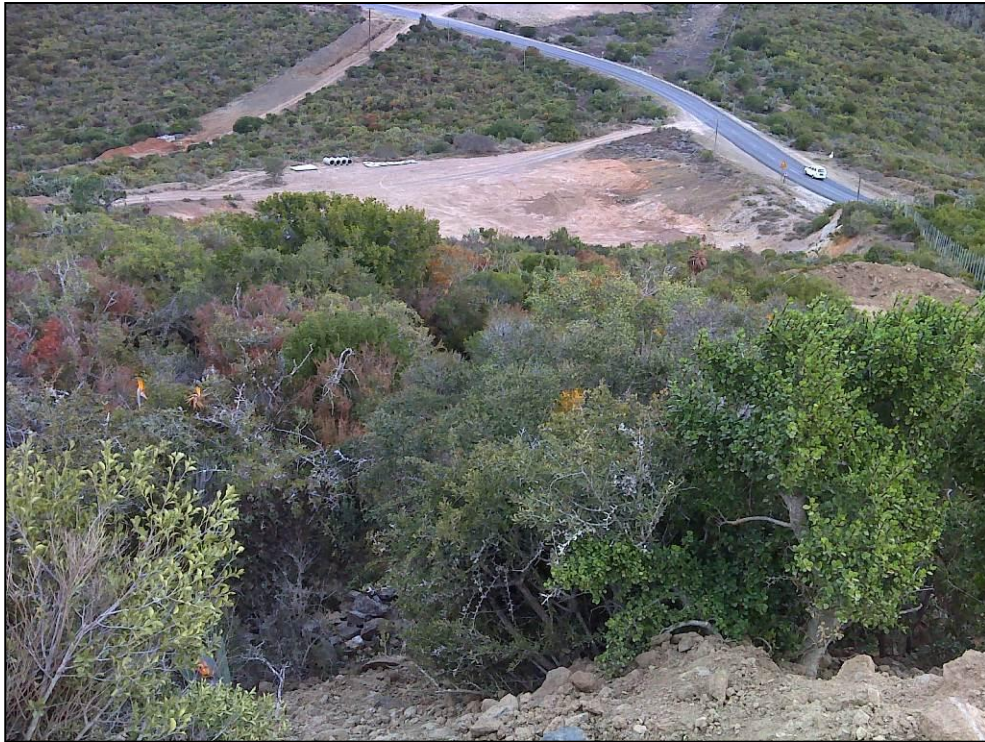
The existing borrow pit area is approximately 95 m x 80 m in extent (Figure 33). The proposed borrow pit area including the existing borrow pit is approximately 195 m x 150 m in extent. The geological make-up is a top half of dark grey, highly weathered mudrock shale overlying maroon and yellow/brown highly weathered foliated mudstone.

Figure 33. View to the south showing the general landscape, dense thicket vegetation, and existing borrow pit.

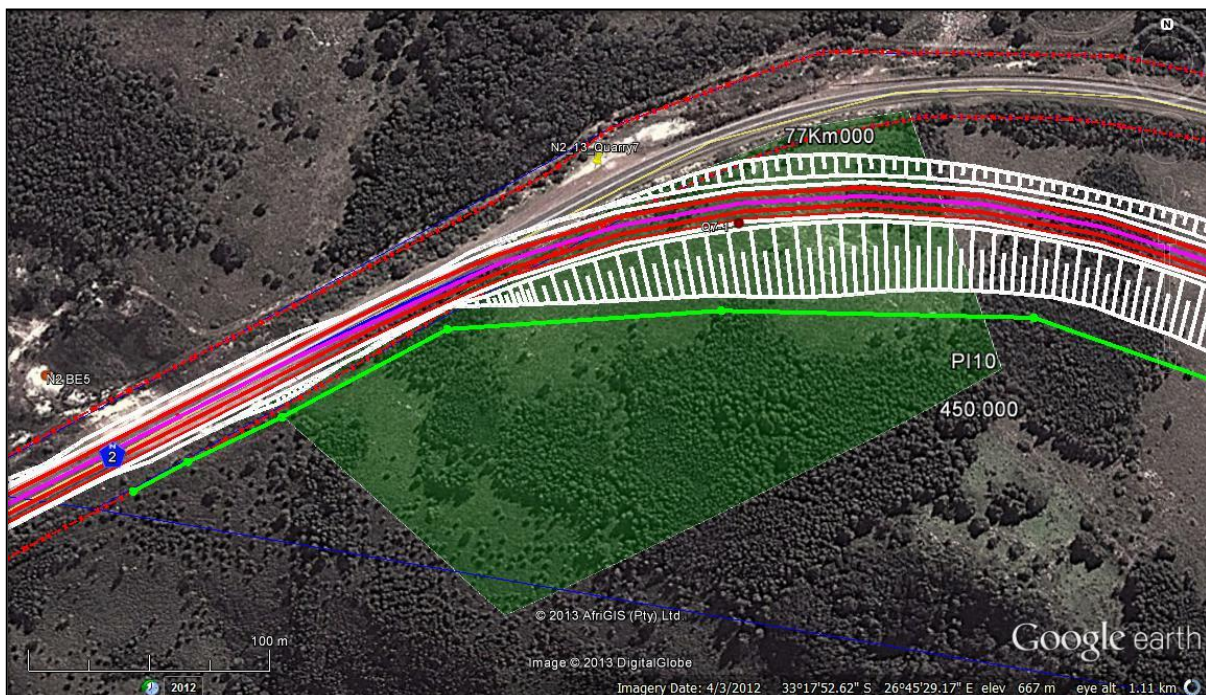
Figure 36. Close-up aerial view of the area proposed for Quarry 7 (Q7) showing the plotted general GPS points.

Q7 is located on the Farm Greenhills 358 and is situated on a bend of the N2 National Route. A section of the proposed quarry area is demarcated as being included into the new layout for the upgrade of the N2 National Route (Figure 36).

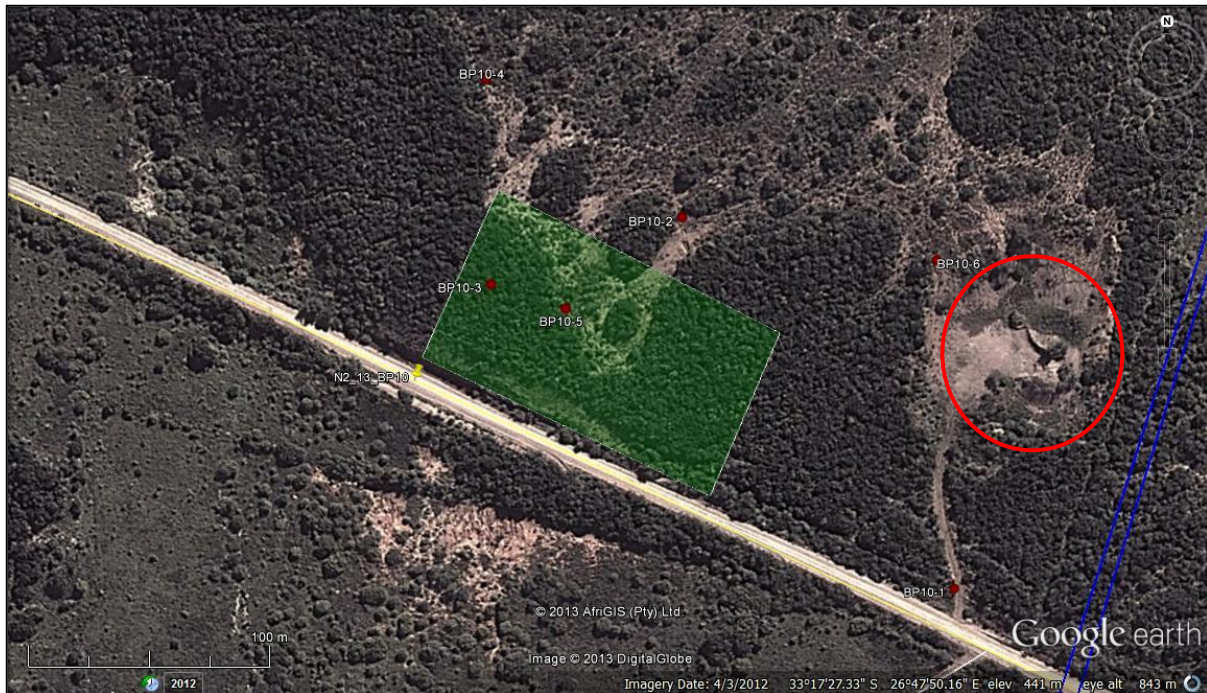
Figure 40. Close-up aerial view of the area proposed for Borrow Pit 10 (BP10) showing the plotted general GPS points and existing diggings (red circle).

An existing quarry area or digging is located outside of the proposed borrow pit area on an internal farm gravel road that extends from the entrance gate (BP10-6, red circle, Figure 40) (Figure 41). There is no existing quarry on the proposed area; therefore, the establishment of the quarry will create the first surface excavation. The proposed borrow pit area is approximately 125 m x 70 m in extent (at the widest points). The geological make-up is khaki, highly weathered, very closely jointed mudstone. Blasting may be required to loosen the material.

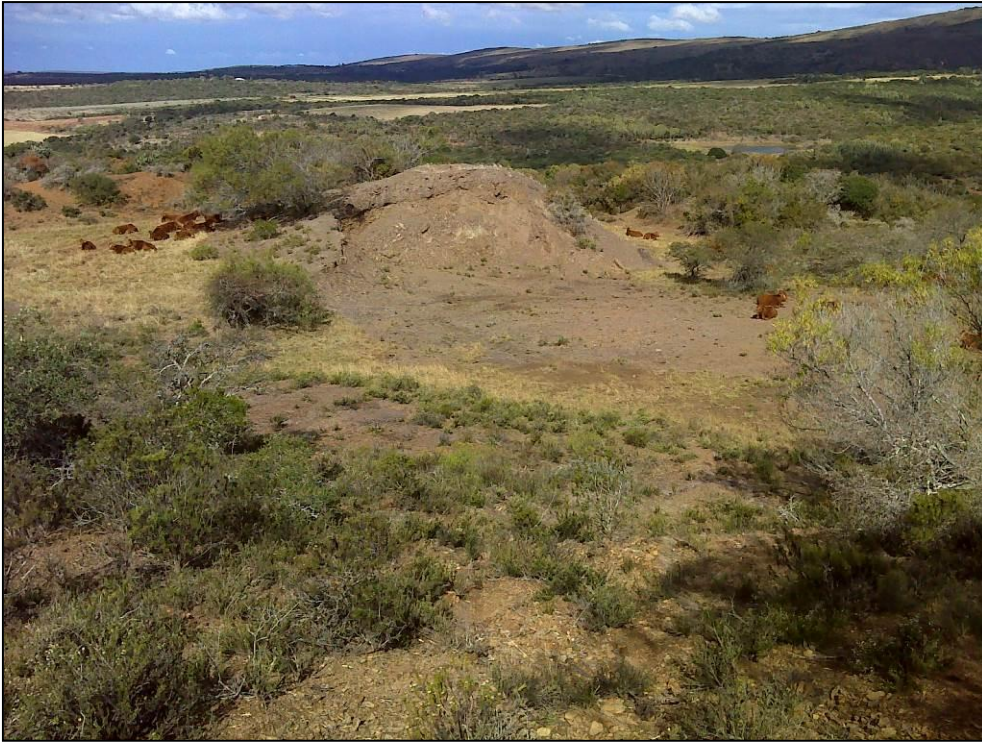
Figure 41. View of the existing borrow pit / digging.

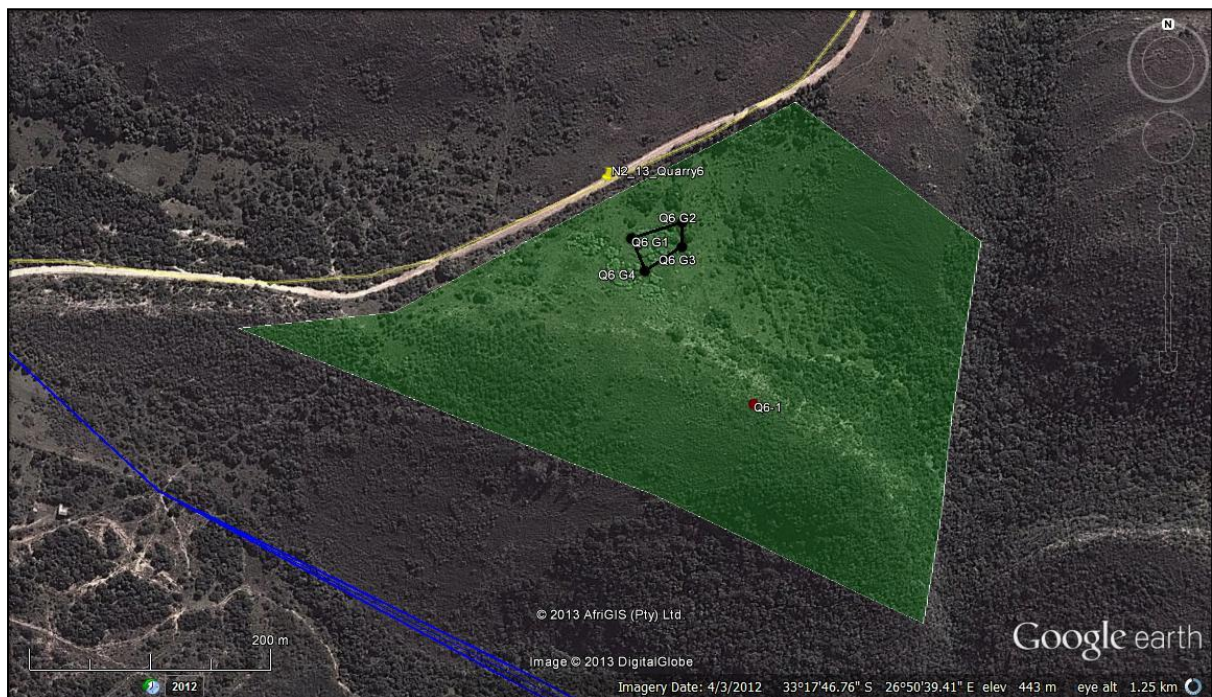
Figure 44. Close-up aerial view of the area proposed for Quarry 6 (Q6) showing the plotted general GPS points and the demarcated area housing the informal burial area (black block).

There is no existing quarry on the proposed area; therefore, the establishment of the quarry will create the first surface excavation. The proposed borrow pit area is approximately 620 m x 320 m in extent (at the widest points) (Figure 44). The geological make-up is light grey, slightly to unweathered, hard rock quartzite. The quartzite ridge is situated on a minor gravel side road with the hard rock outcropping at the surface. Reserves appear to be extensive with an area of 80 m x 40 m x 12 m visible reserve estimate. Borehole drilling will be required to remove samples. The quarrying activities are proposed to advance from the south.

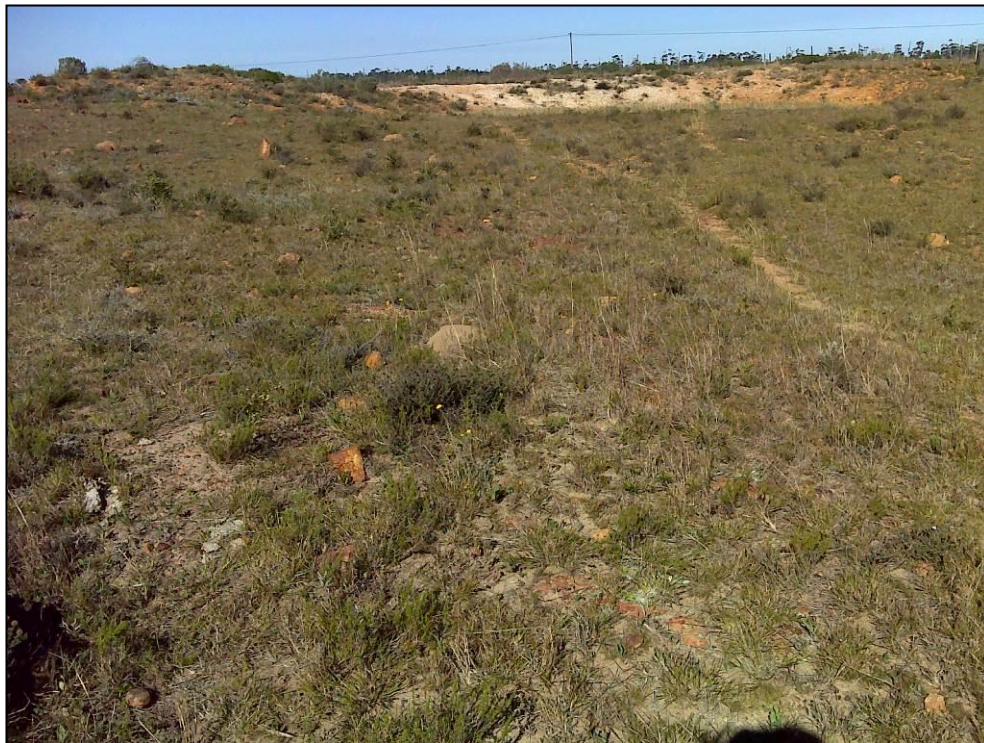
Figure 47. View of the general landscape showing the disturbance of the surface by the construction of a dam wall.
