A PHASE 1 ARCHAEOLOGICAL IMPACT ASSESSMENT (AIA) FOR THE PROPOSED N2 NATIONAL ROUTE (N2-13) BETWEEN GRAHAMSTOWN AND THE FISH RIVER BRIDGE AS WELL AS SIX BORROW PITS AND THREE QUARRIES, EASTERN CAPE PROVINCE.

Compiled by: Ms Celeste Booth
Department of Archaeology
Albany Museum
Somerset Street
Grahamstown
6139
Tel: 046 622 2312
Fax: 046 622 2398
Email: C.Booth@am.org.za

Date: September 2013

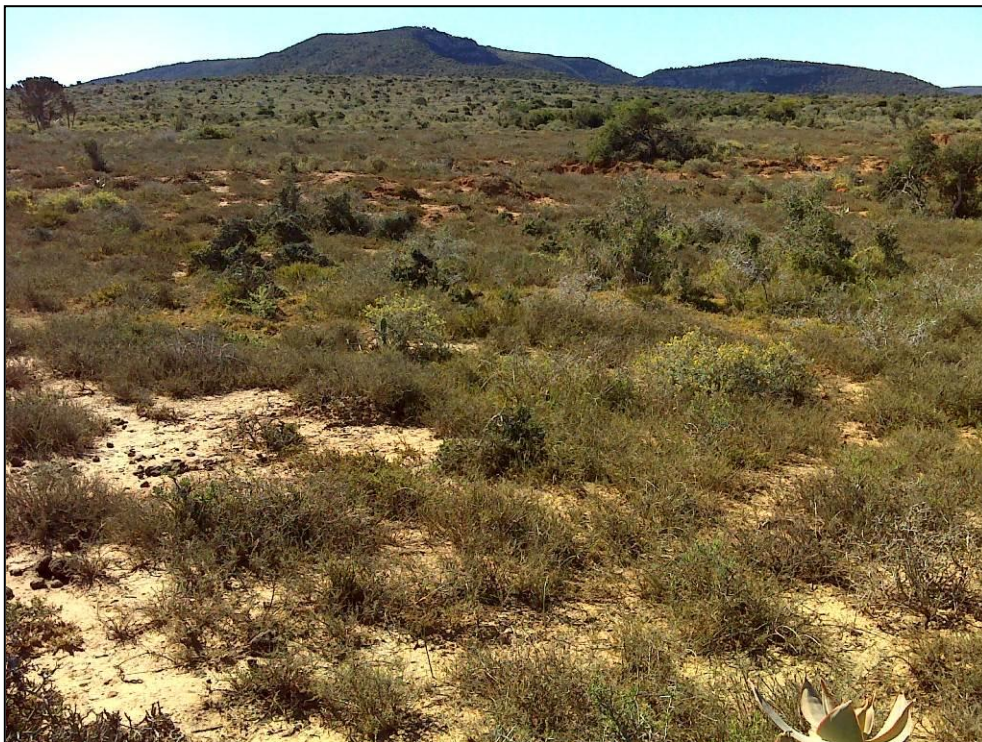
Figure 50. View of the general landscape showing soil erosion affected areas.

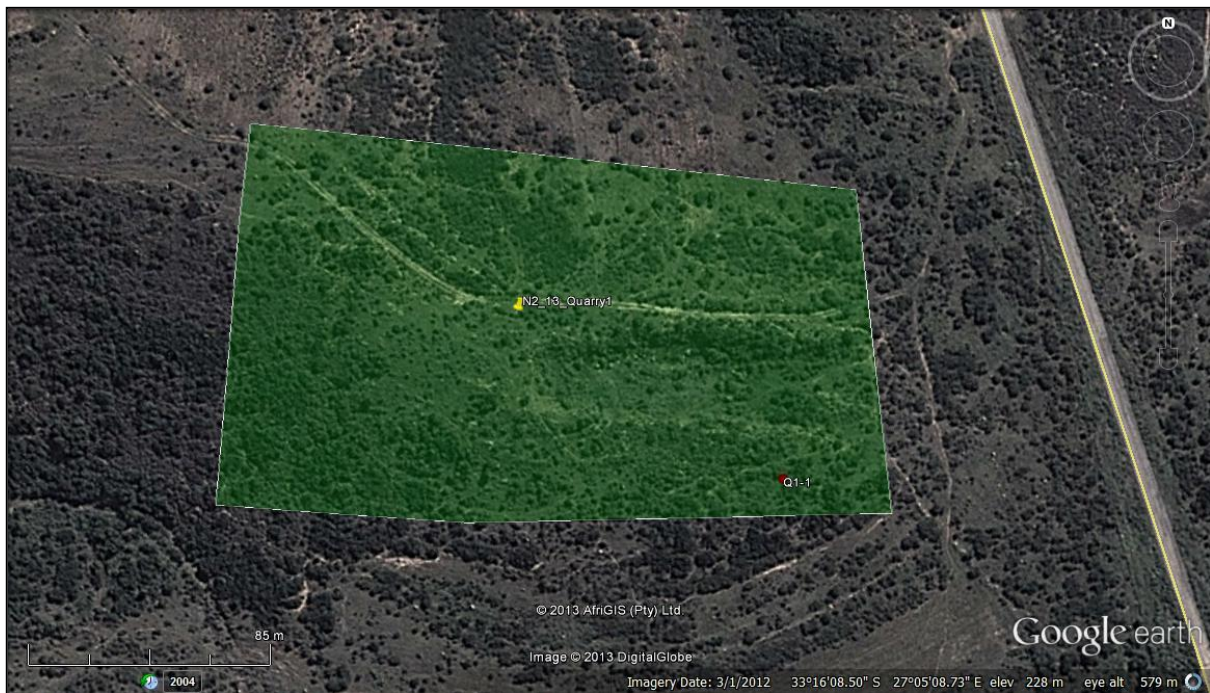
Figure 52. Close-up aerial view of the area proposed for Quarry 1 (Q1) showing the plotted general GPS points.

The proposed borrow pit area including the existing borrow pit is approximately 230 m x 120 m in extent (Figure 52). The geological make-up is a hard, grey sandstone on the contact between the Fort Beaufort and Ripon foundations. Drilling activities are required. The very old quarry area, approximately 75 m x 30 m in extent, is situated along the ridge that was mined for what appears to be Macadam Stone (Figure 53).

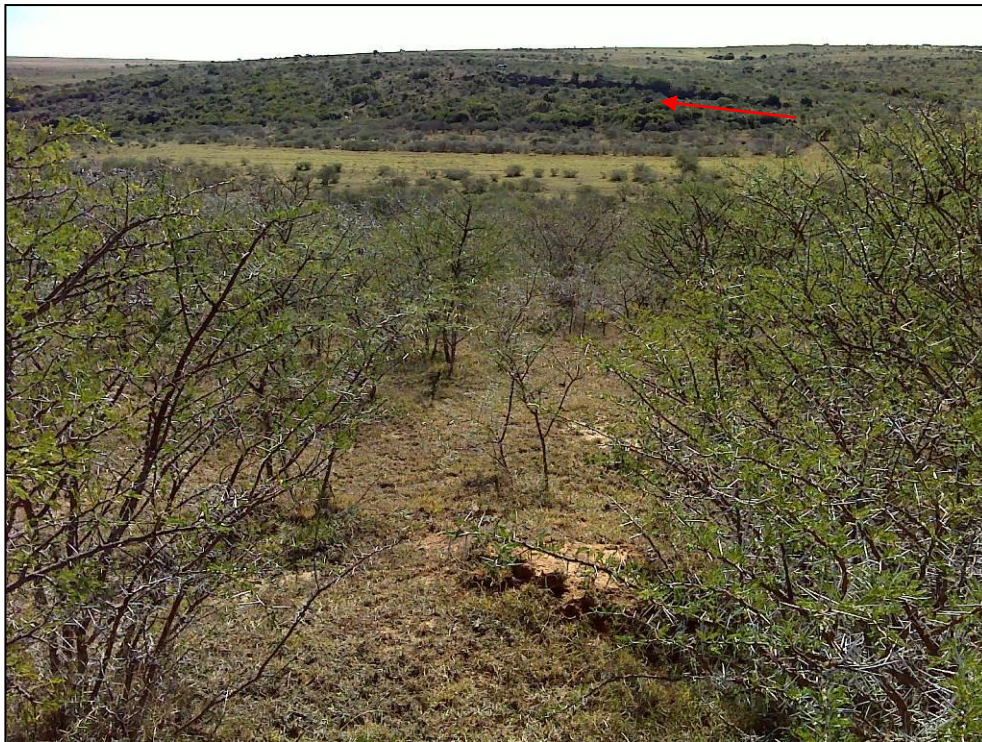
Figure 53. View of the general landscape, vegetation cover, and existing quarry in the distance (red arrow).

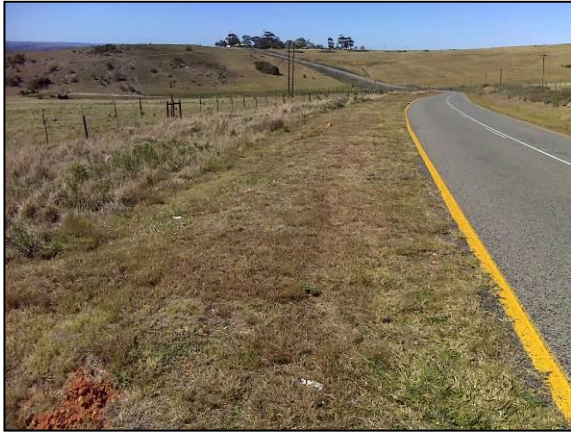
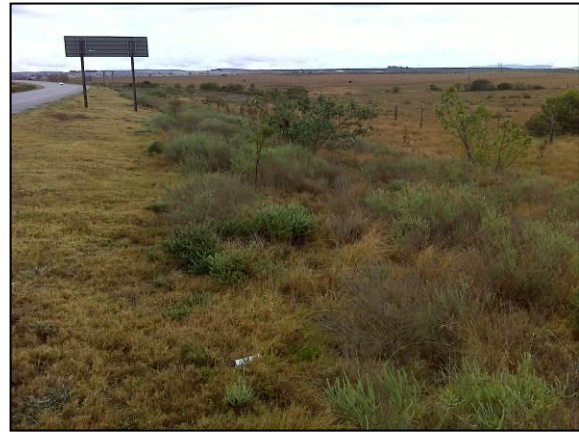
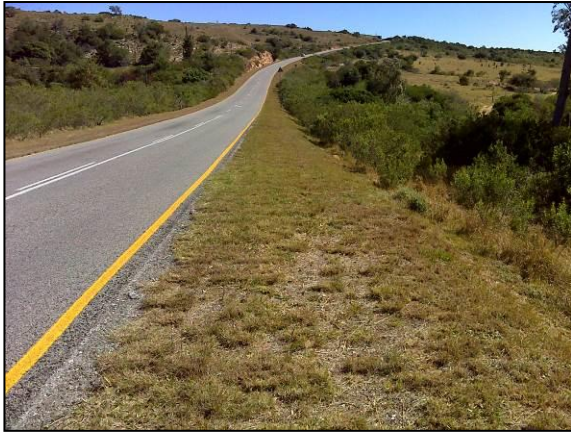
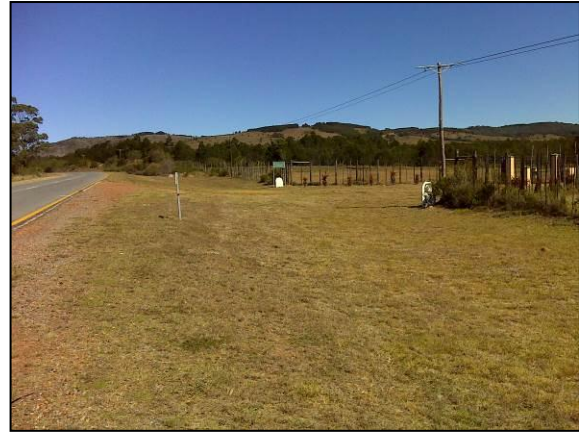
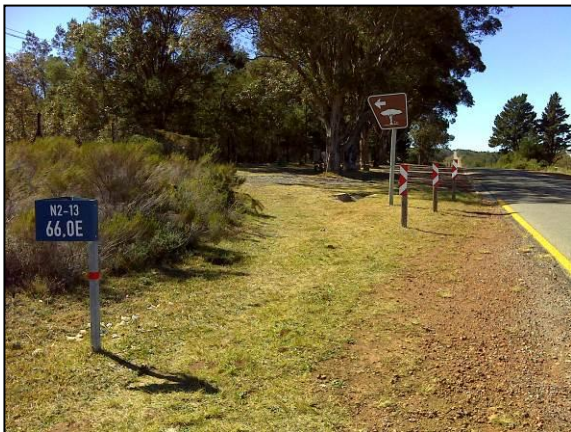
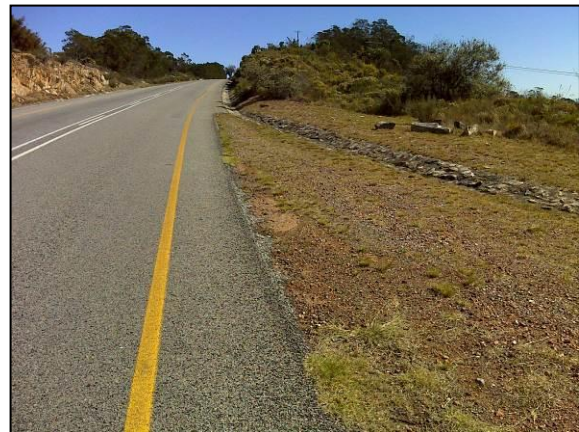
Figures 59 – 64. Examples of surface disturbance activities associated with the construction and maintenance of the road, the erection of farm boundary fences, power lines and telephone lines, as well farm entrances and several picnic spots occur within the road reserve area.

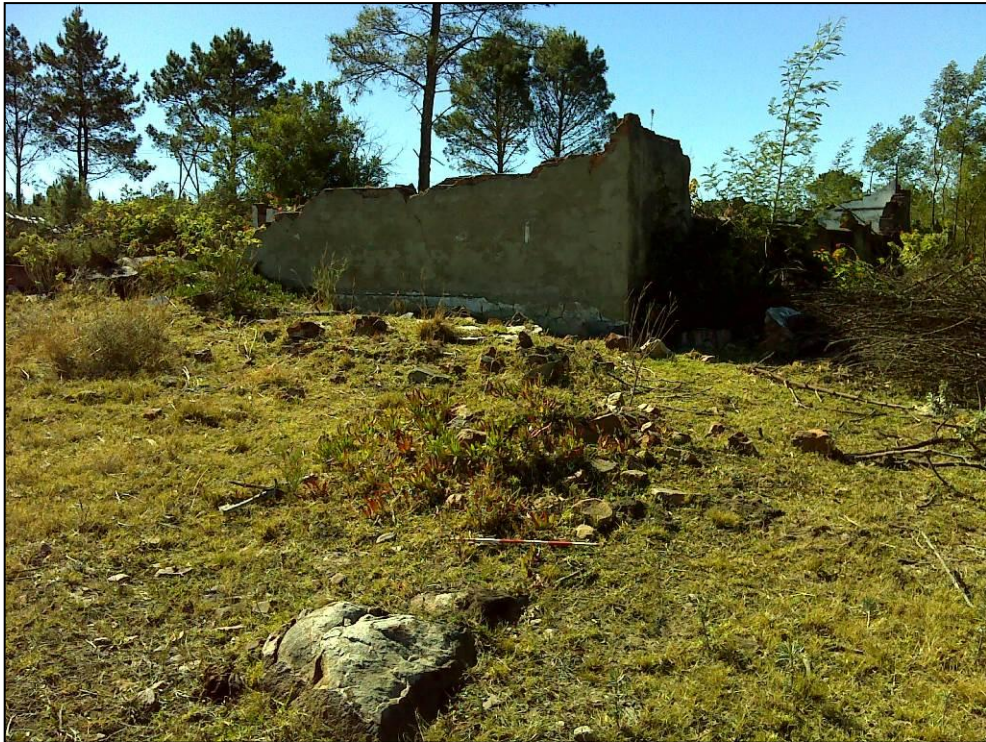
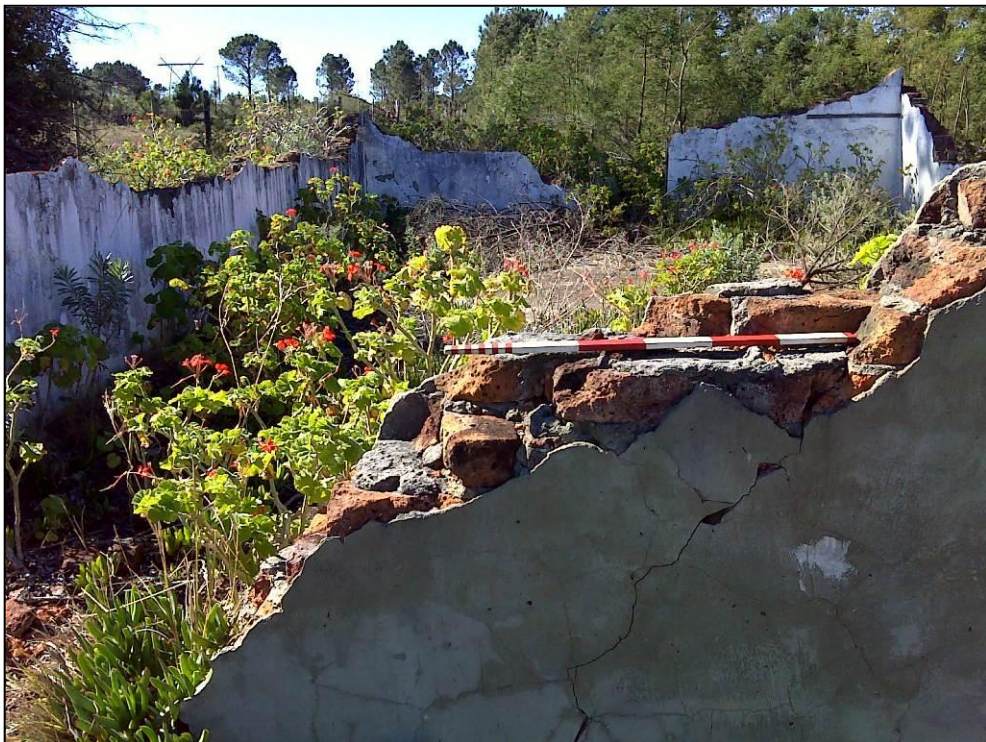
N2 BE2 is situated about 100 m north of the N2 national road and will not be affected by the construction of the upgrade activities along the entrance of the Farm The Orchards (Figure 65). The site includes the ruin of a farmhouse (Figures 66-67). The area was investigated for the possible remains of historical artefacts. However, no artefacts or a dump site / midden were observed within close vicinity to the ruin. The relatively dense and overgrown vegetation cover and Black Wattles obscured the surface visibility.

Figure 66. View of the ruin of the farmhouse.

Figure 67. Close-up view of the ruin of the farmhouse.

4. N2 BE2: The ruin of the farmhouse is situated approximately 100 m north of the current N2 National Route. According to the layout of the proposed N2 road upgrade the structure will not be negatively affected during the construction activities. However, if the layout changes and it is possible that the changes would require that the structure be affected or demolished a historical archaeologist, historical architect, or historical built environment specialist be appointed to assess the significance of the ruins and make further recommendations.

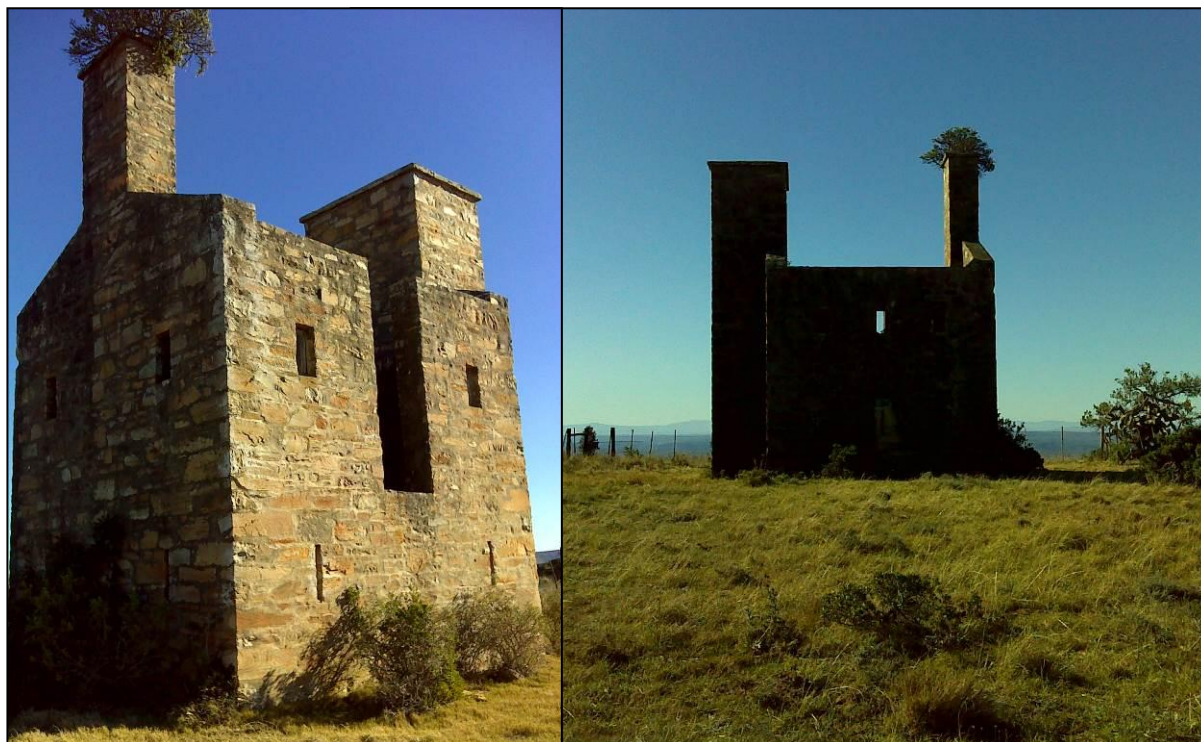
The proposed N2 alternative road layout was not available; therefore it is unknown to what extent the construction activities of the road upgrade may affect the site. The construction of the N2 alternative along this route may have both positive and negative influences on the fortified structure. The influences may boost tourism and visitors to the site however it may also instigate vandalism and deterioration if not included into the management plan of the proposed N2 upgrade project. The appropriate mitigation and conservation measures for the site must be implemented if the alternative route has been determined to be the preferred option for the N2 National Route upgrade (see section 11 for full recommendations).

Figure 74. Alternative views of the Fraser's Camp Signal Tower.

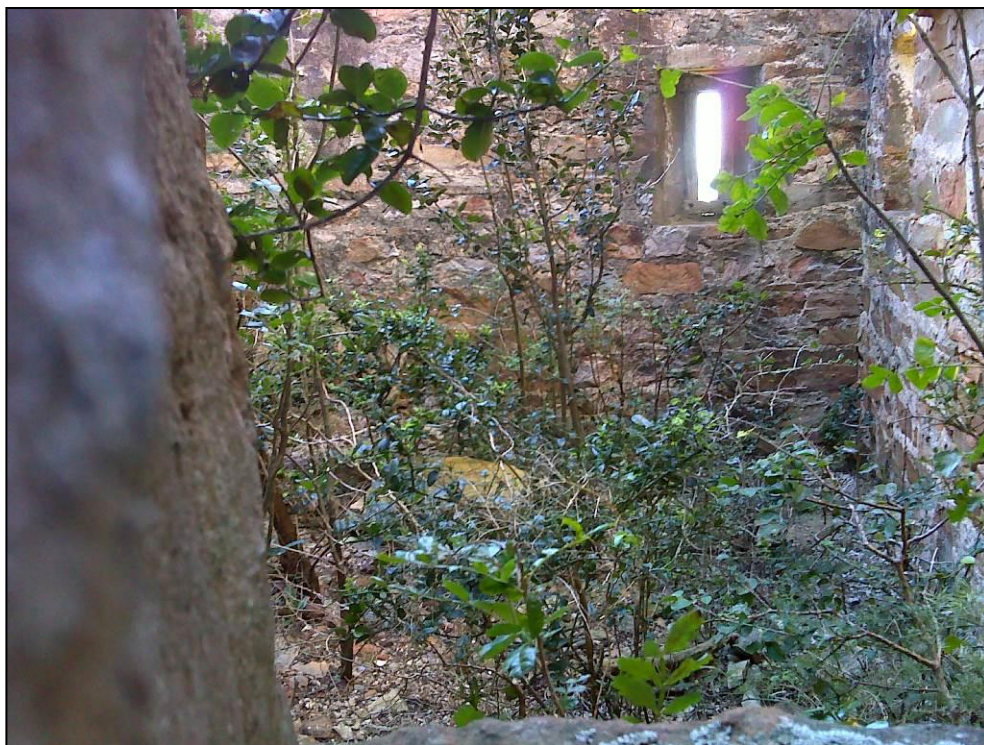
Figure 75. View of the overgrown vegetation cover inside the structure.

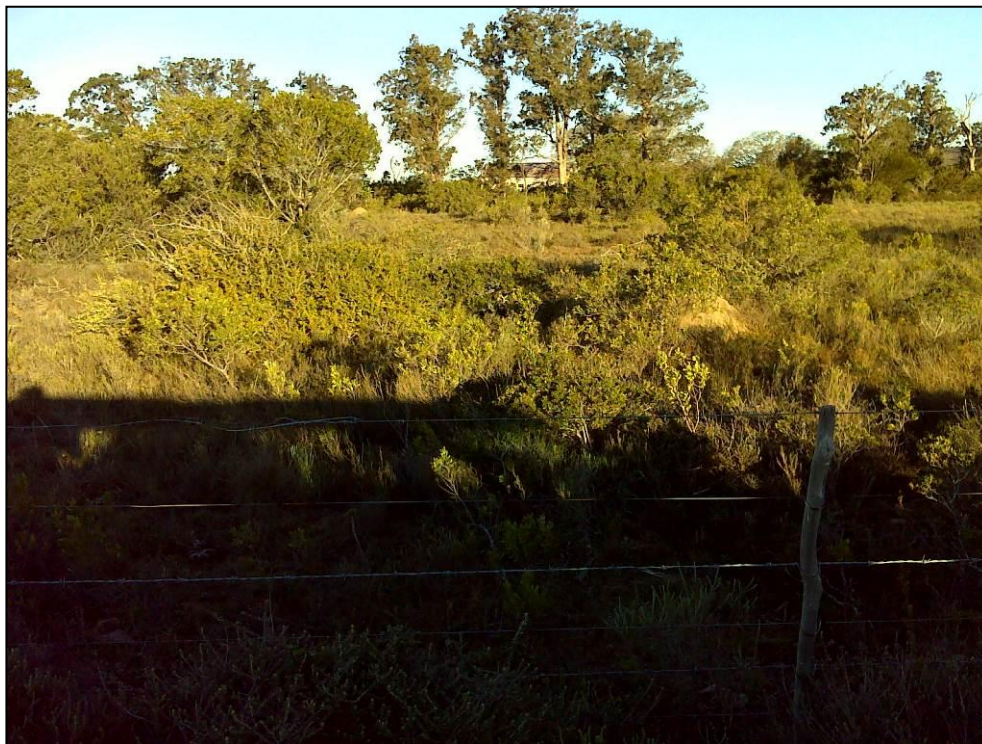
Figure 77. View of the farmhouse showing the distance from the existing road reserve boundary.

8. N2 BE20: The farmhouse is situated approximately 100 m from the current N2 National Route. According to the layout of the proposed N2 road upgrade the structure will not be negatively affected during the construction activities. However, if the layout changes and it is possible that the changes would require that the structure be affected or demolished a historical archaeologist, historical architect, or historical built environment specialist be appointed to assess the significance of the ruins and make further recommendations.

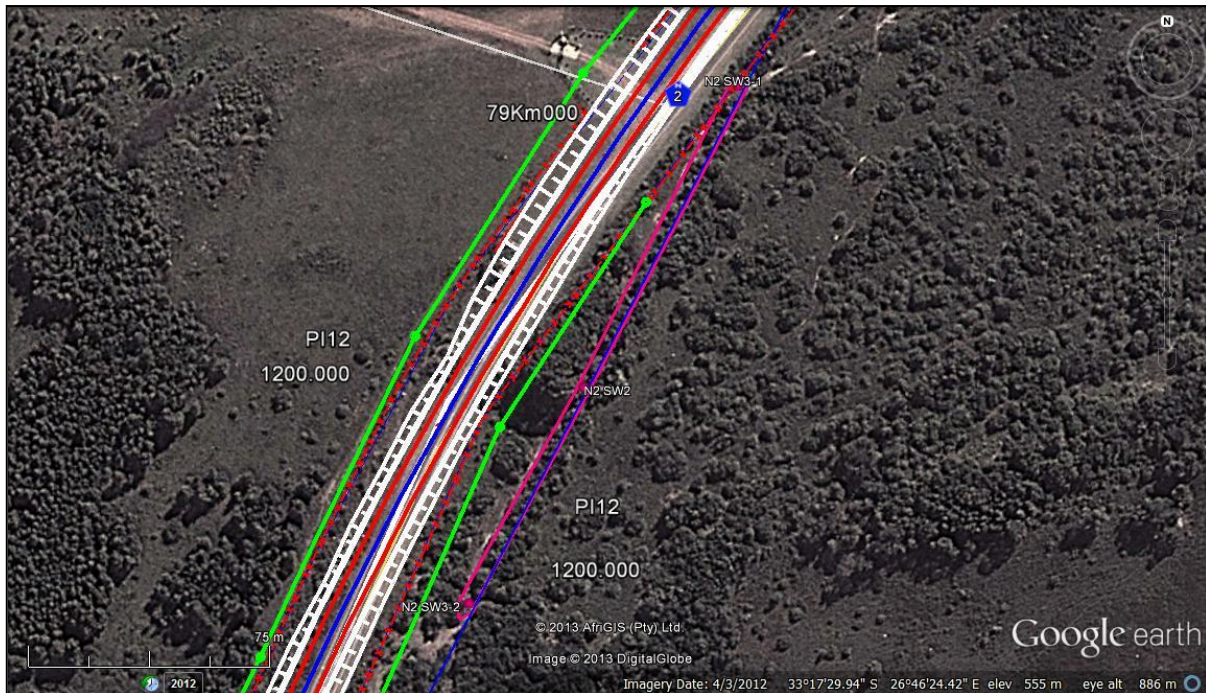
Figure 85. Close-up aerial view of the location of the dry packed stone wall and circular feature on the Farm Komsfontain 360.

These dry packed stone wall features (N2 SW2 and N2 SW3) are situated on the Farm Komsfontain 360 and are probably associated with the farmstead recorded as N2 BE20 in this report (Figure 85). These features are situated between 0 m at the area marked N2 SW3-1 and 10 m at the area marked N2 SW2-3 from the proposed boundary layout of the proposed N2 road upgrade.

The stone wall has been overgrown by vegetation and is difficult to observe at first glance. This was the case at the area marked N2 SW3-1 (Figure 87). The condition of the stone is relatively intact at the area marked N2 SW3-1 but seems to become indiscernible as a row of stones towards the area marked N2 SW3-3. N2 SW2 is still in a good condition.

It is highly likely that the stone wall and circular pen will be negatively affected during the construction activities. The appropriate mitigation and conservation measures must be implemented (see section 11 for full recommendations).

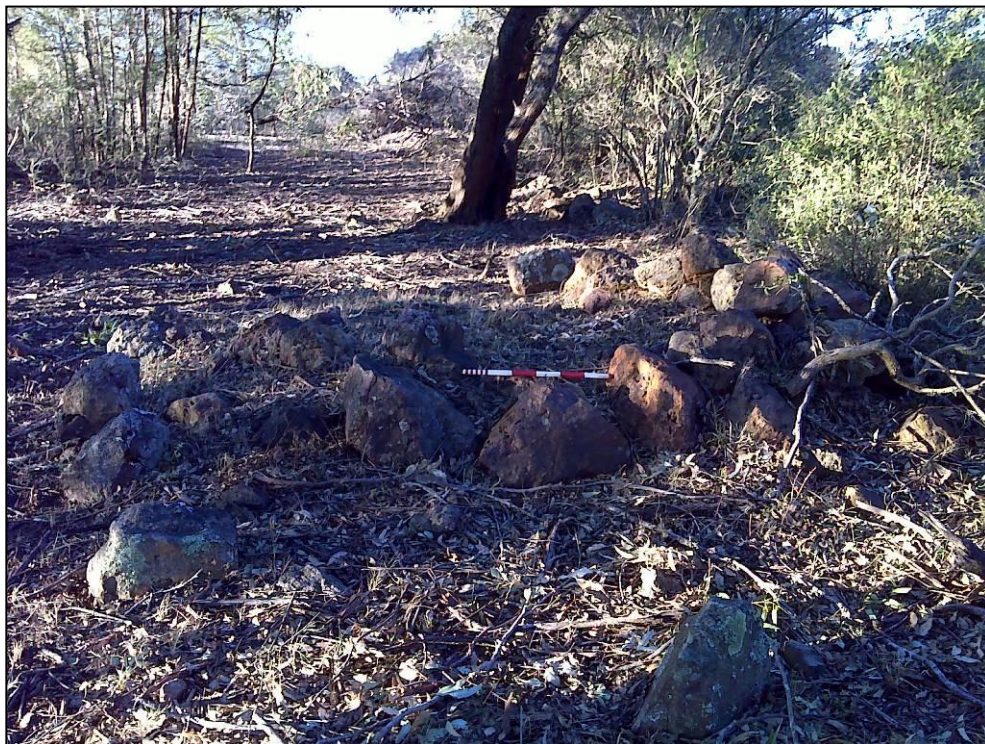
Figure 86. View of the circular stone feature (N2 SW2).

10. N2 SW2 and N2 SW3: The dry packed circular pen (N2 SW2) and dry packed stone wall are situated between 10 m and 20 m from the current boundary of the road reserve. According to the layout of the proposed N2 road upgrade the structures may be negatively affected by during the construction activities. This section of the road is proposed to be widened, therefore, decreasing the distance between the proposed N2 road and the features to between 0 m and 10 m. It is recommended that construction activities do not occur within the road reserve on this section of the proposed road upgrade.

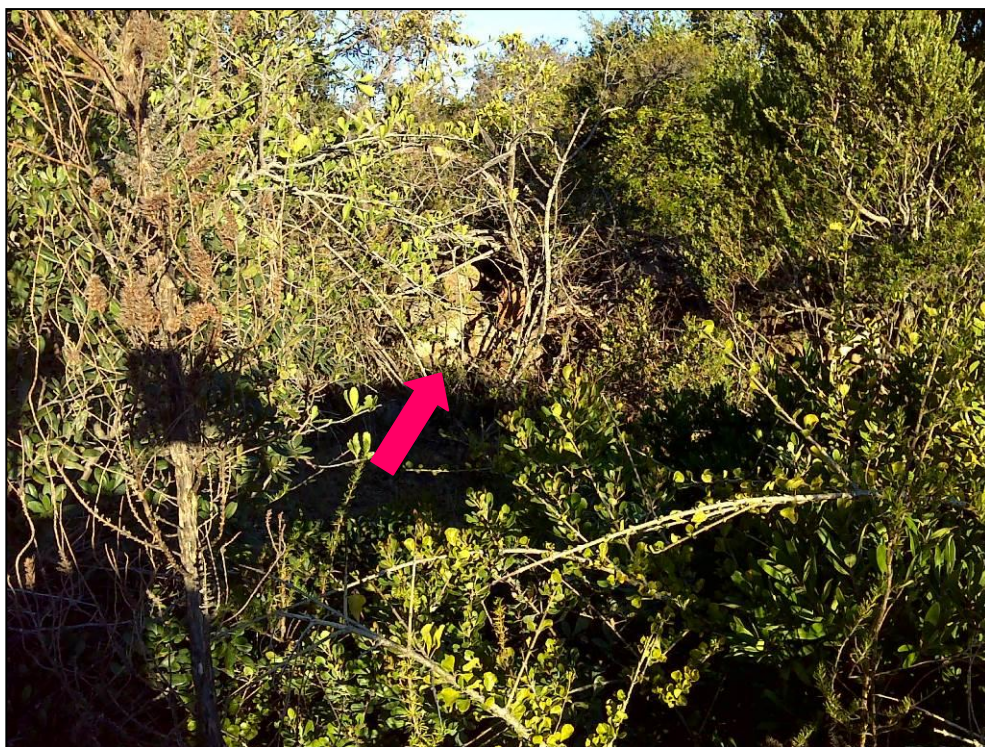
Figure 87. View of the stone wall situated in the dense vegetation.

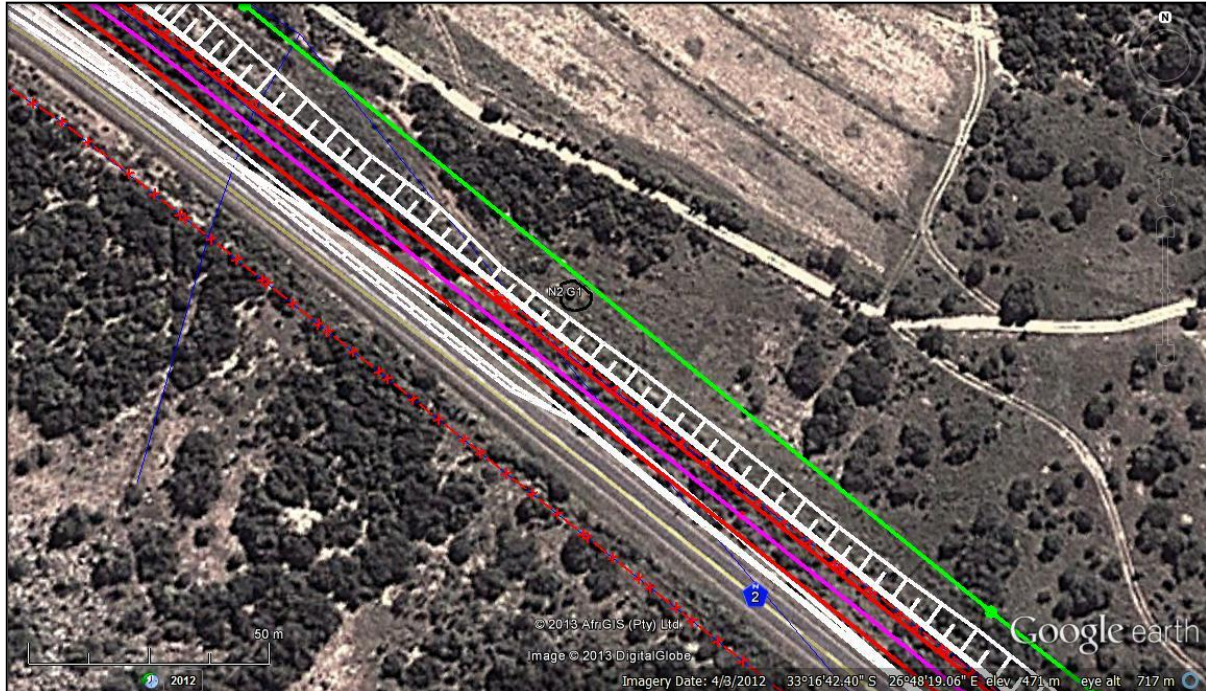
Figure 88. Close-up aerial view of the location of the informal burial area on the farm Honeykop.

One informal burial area, comprising seven graves was reported and identified. The site is situated within the proposed layout for the construction activities for the N2 road upgrade and approximately 20 m x 20 m in extent (Figure 88). Mr Crous who owns the farm provided information on the burial area. The graves are those of farm workers whose families no longer reside on the farm, however, they do still come and visit the graves. Visitation is apparently not regular; however, the site is a significant living heritage and memory site.

The appropriate mitigation and conservation measures must be considered. Informal burial areas are protected under the National Heritage Resources Act 25 of 1999. The first option is that the area be considered a no-go development zone is strongly recommended. Alternatively, consultative processes with the affected family members must be conducted to suggest the possibility of exhumation and reburial (see section 11 for full recommendations).
