**ARCHAEOLOGICAL IMPACT ASSESSMENT
OF 10 BORROW PITS AND FIVE NEW QUARRIES
FOR THE PROPOSED UPGRADING OF THE
GRAVEL ROAD BETWEEN
GARIES AND HONDEKLIPBAAI
NORTHERN CAPE**

**NORTHERN CAPE PROVINCIAL ADMINISTRATION:
DEPARTMENT OF ROADS AND PUBLIC WORKS**

**NOVEMBER
2011**

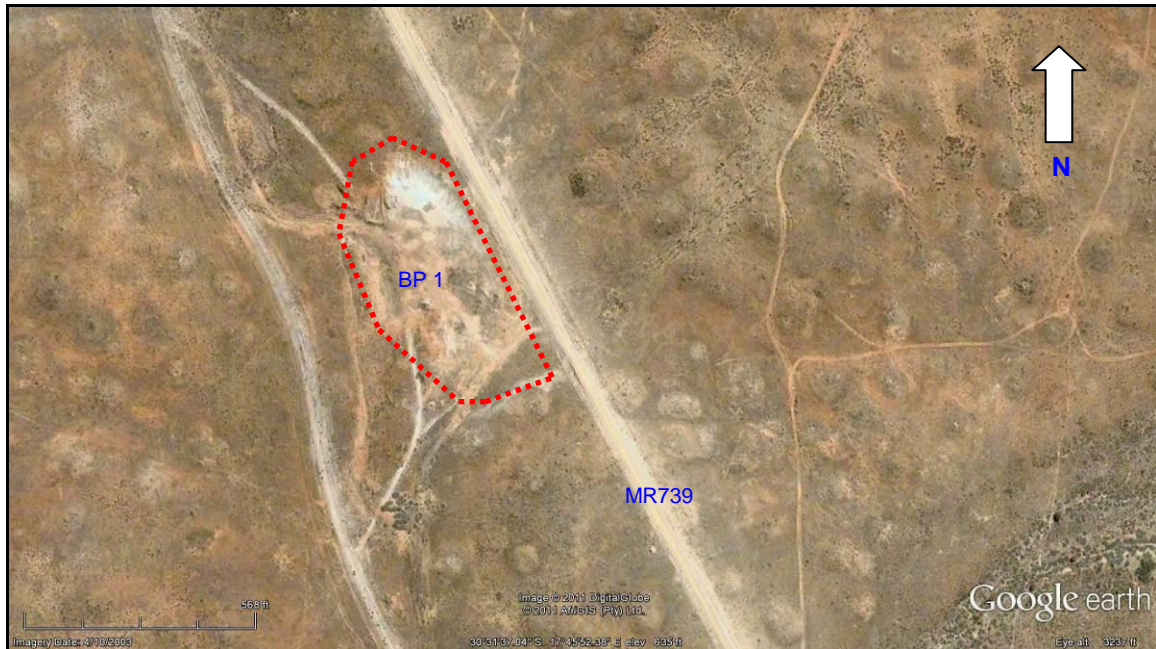
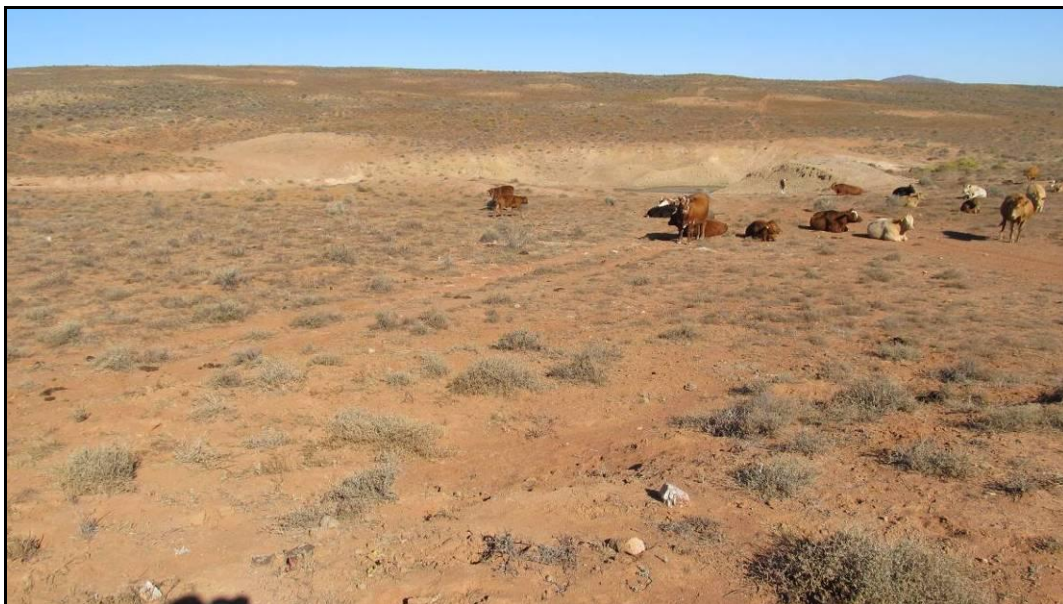
Figure 3. Google aerial photograph of BP 1

BP 1 is located directly alongside (i.e. north of) MR739 - Garies-Hondeklipbaai Road (Figures 3 & 4). Material will be re-used from the borrow pit, while additional fill will be exploited from the western and northern edges. There are no significant landscape features on the proposed site. The receiving environment is very, degraded. There are numerous small tracks and 2 x 2 tracks that intersect the site and trampling and overgrazing by cattle and goats is heavy. Surrounding land use is vacant land/grazing.

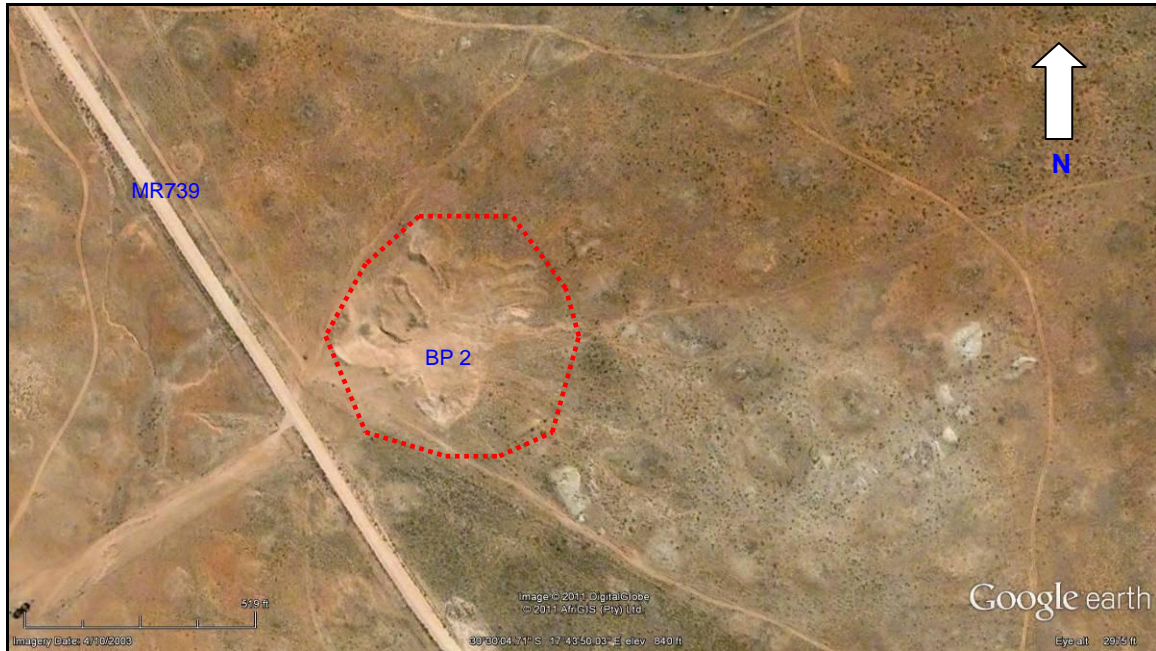
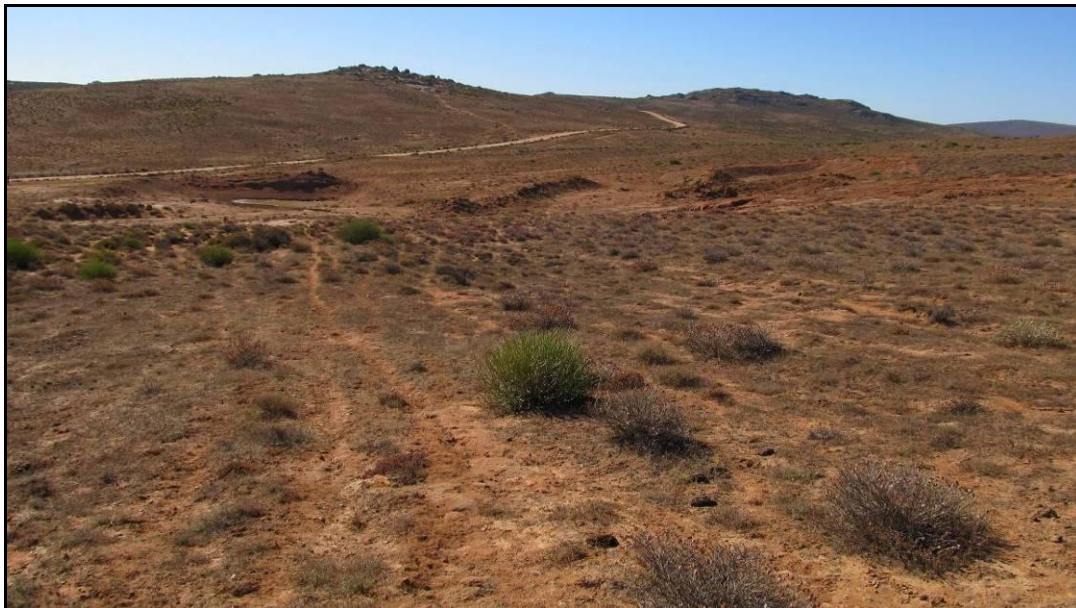
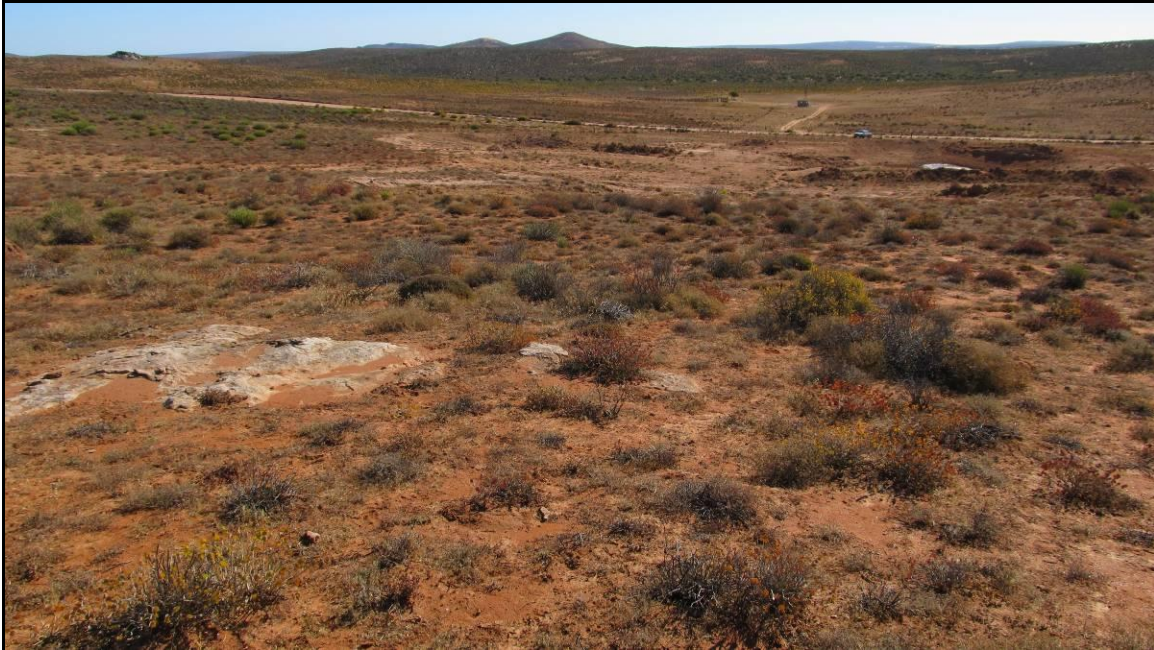
Figure 5. Google aerial photograph of BP 2

BP 2 is located directly alongside (i. e. north of) MR739. Existing material and spoil dumps from the borrow pit will be used for fill, and a small section to the north will be cut back for new gravel (Figures 5-7). There are no significant landscape features on the proposed site, although an outcropping of granite does occur about 150 m to the northwest. The surrounding area is heavily trampled and degraded, and the south western slopes are eroded and sheet washed. There are several old tracks and roads that intersect the borrow pit and the surrounding area. Surrounding land use is vacant land/grazing.

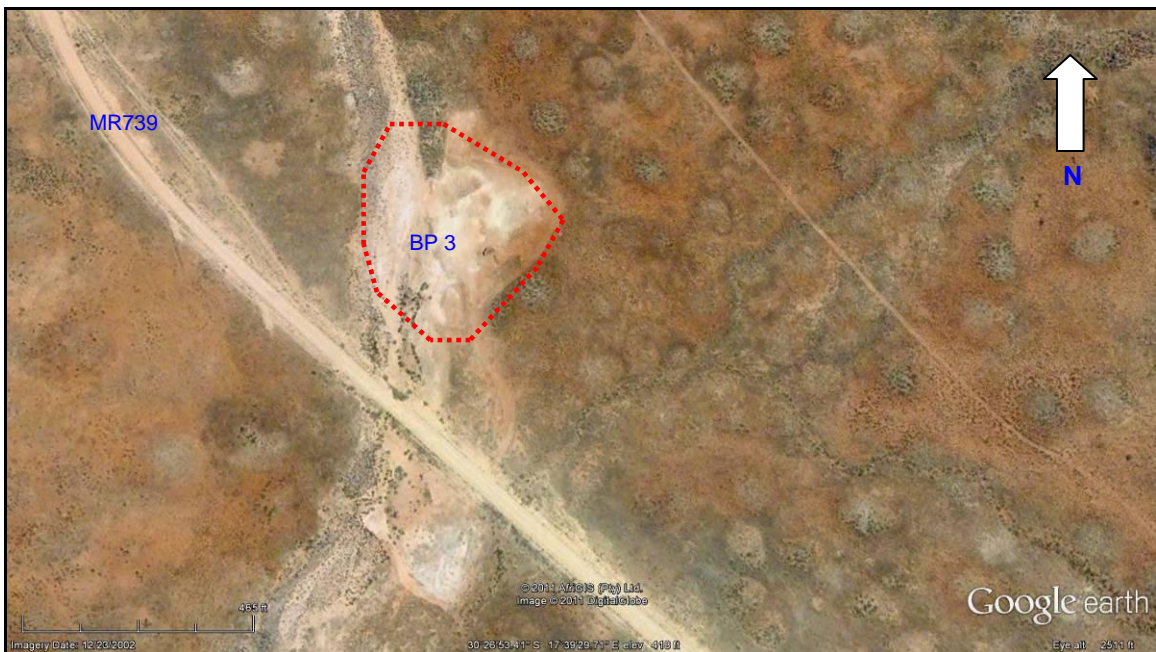
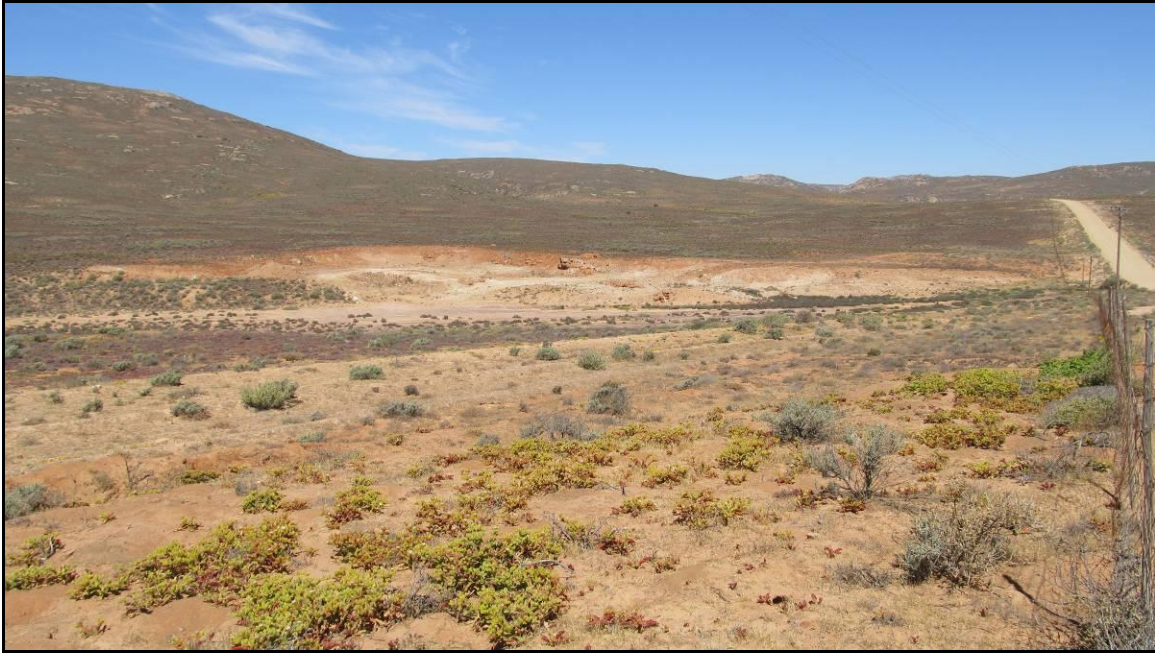
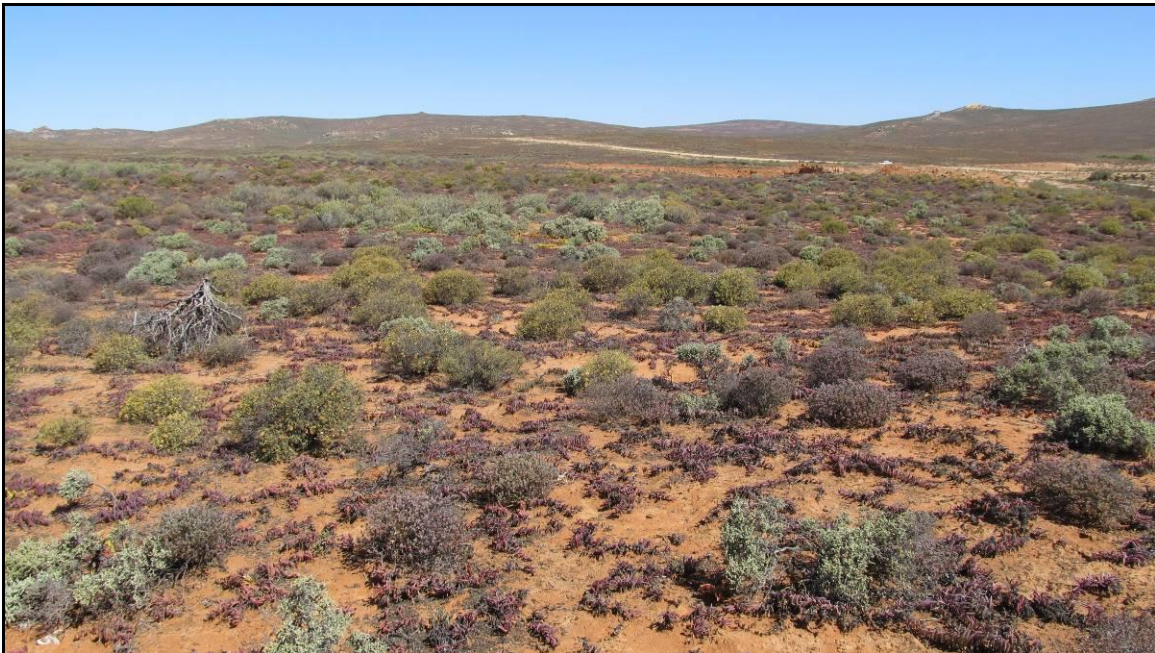
Figure 8. Google aerial photograph of BP 3

BP 3 is located alongside (i. e. north) of MR739 and partly within a dry river bed. Fill material will be sourced from the borrow pit, and new material will be exploited from the northern and north eastern edges, which are covered in fairly thick veld and ground cover (Figures 8-10). The surrounding area has been quite heavily trampled and grazed and there are several 2 x 2 tracks that intersect the area.

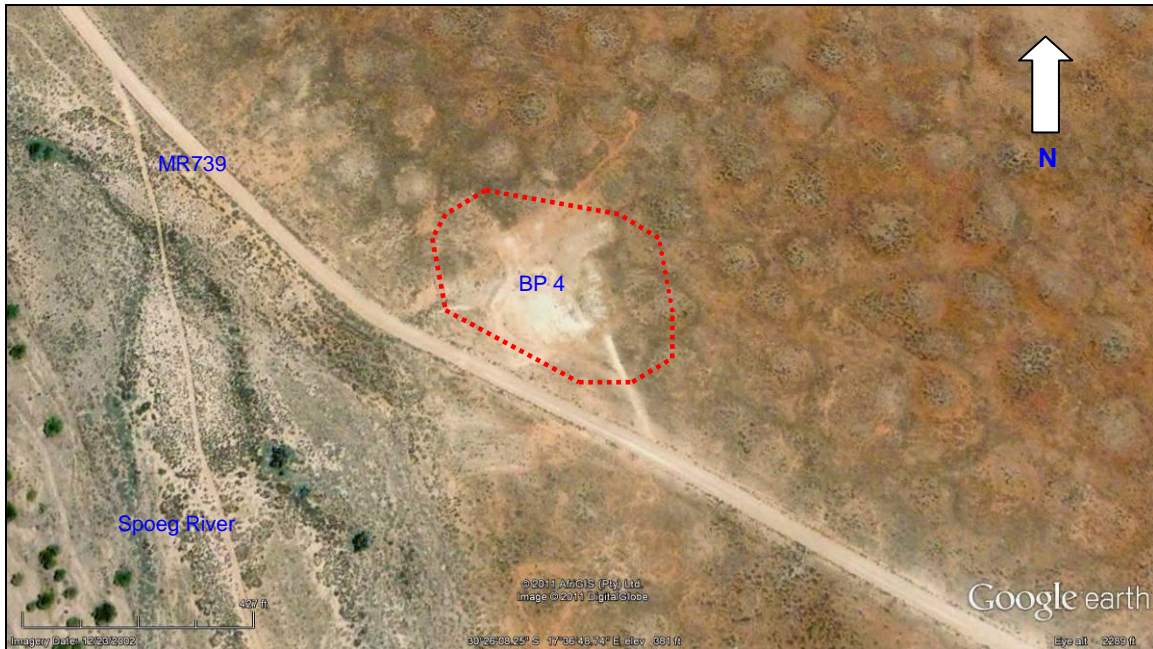
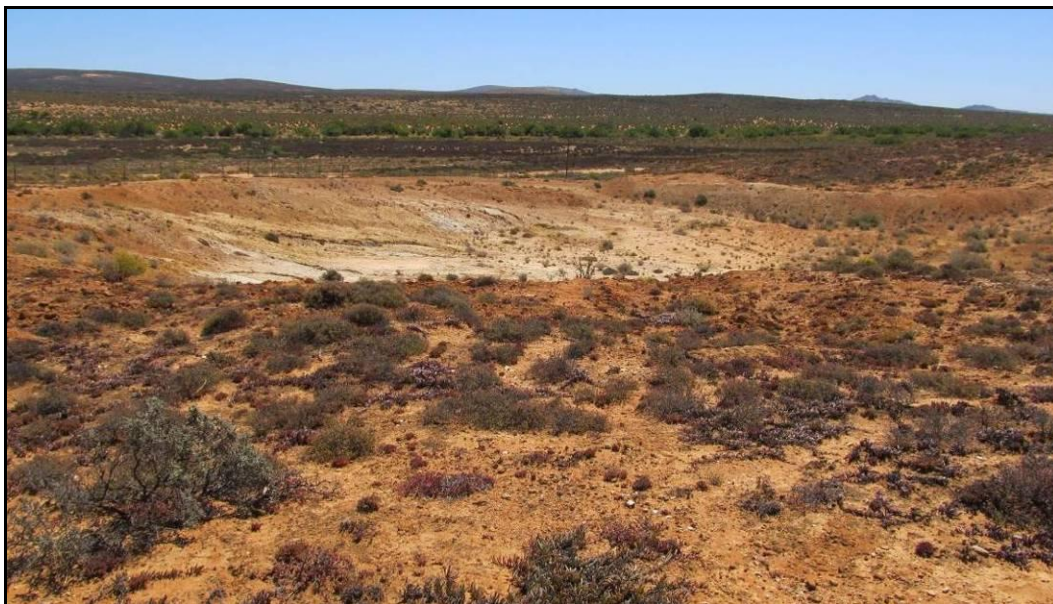
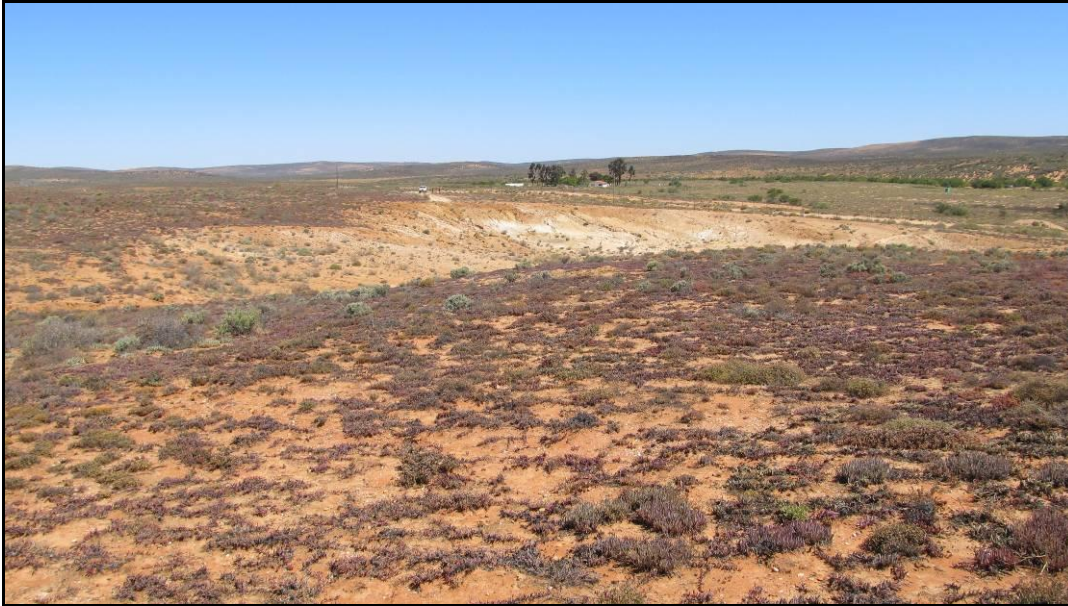
Figure 11. Google aerial photograph of BP 4

BP 4 is located directly alongside (i. e. north of) MR739. Existing gravel will be sourced from the borrow pit and new fill material will be exploited from the western, northern and north eastern edges (Figures 11-13). The receiving environment is covered in natural veld and some ground cover, but there are patches of open ground in places. There are no significant landscape features on the proposed site. There are several small tracks that intersect the site and a small dry stream cuts through the western portion of the borrow pit, that discharges into the Spoeg River south of the road. Surrounding land use is vacant land/grazing.

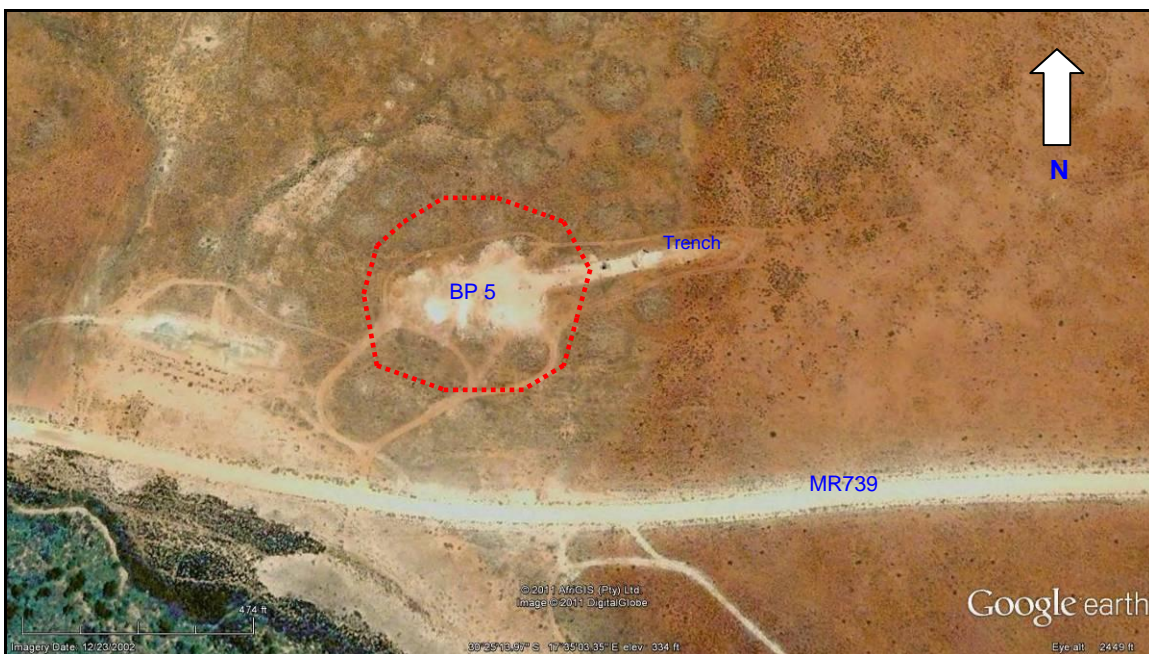
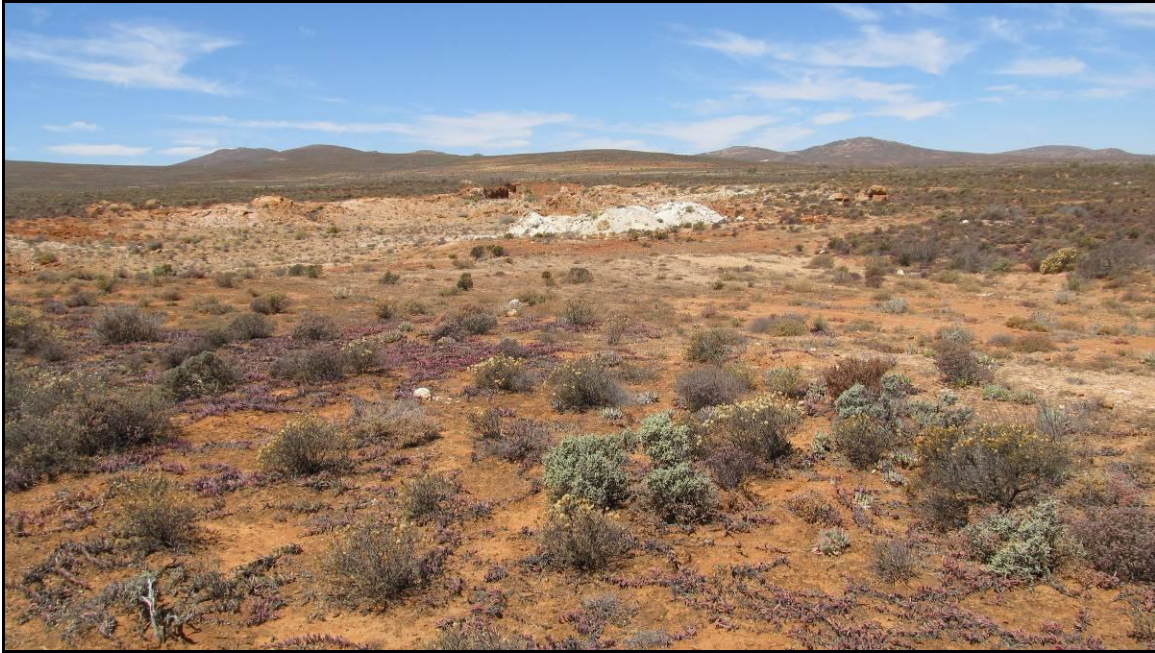
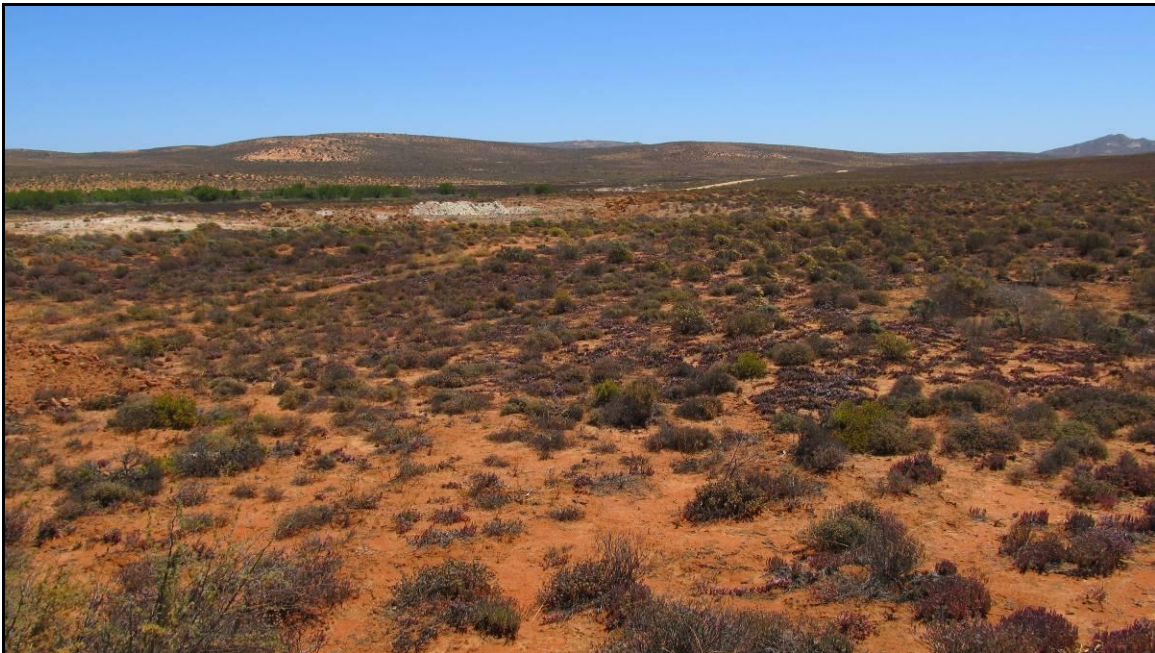
Figure 14. Google aerial photograph of BP 5

BP 5 is located directly alongside (i. e. north of) MR739. Existing fill will be sourced from the borrow pit and new material will be exploited from around the edges of the pit (Figures 14-16). The receiving environment in the north and north east is covered in natural veld. In the south, the receiving environment is degraded and is quite heavily overgrazed. There are several small tracks that intersect this portion of the site, as well as around the perimeter of the borrow pit in the north. A, long deep trench (possibly a diamond prospecting trench) has been excavated to the south east of the borrow pit. Surrounding land use is vacant land/grazing.

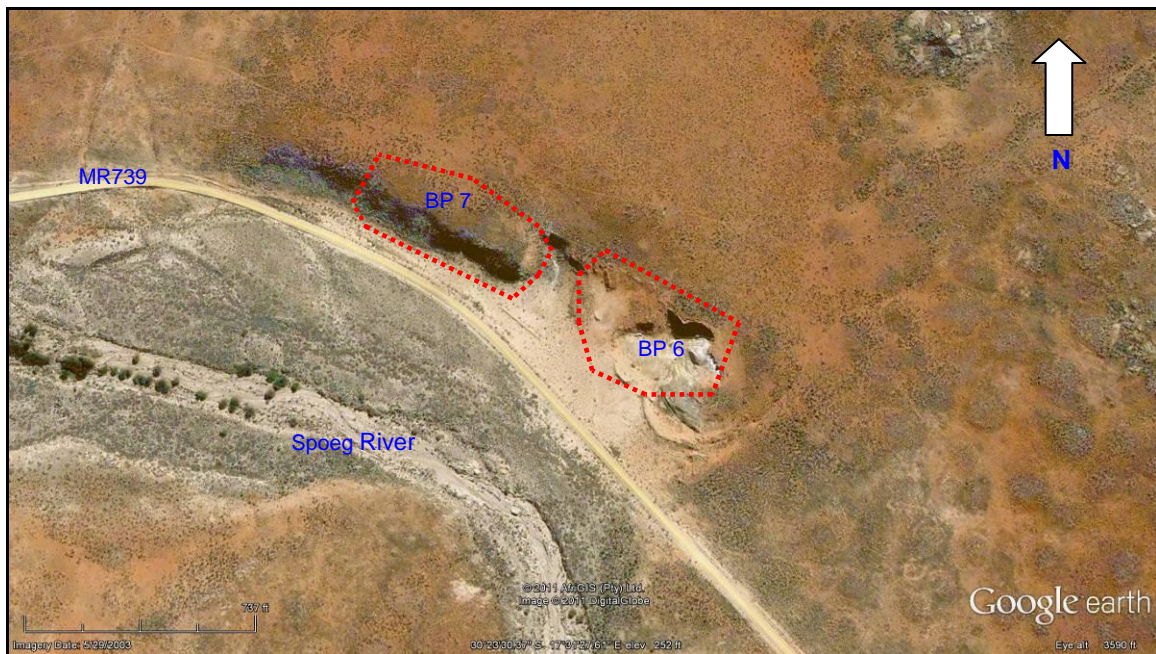
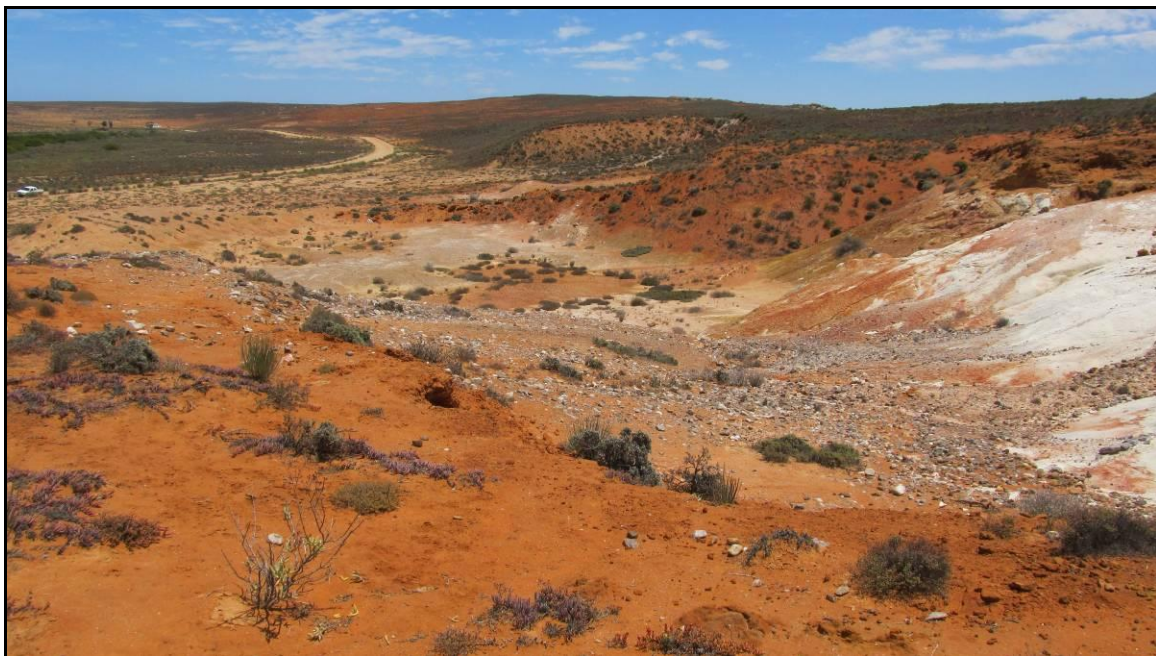
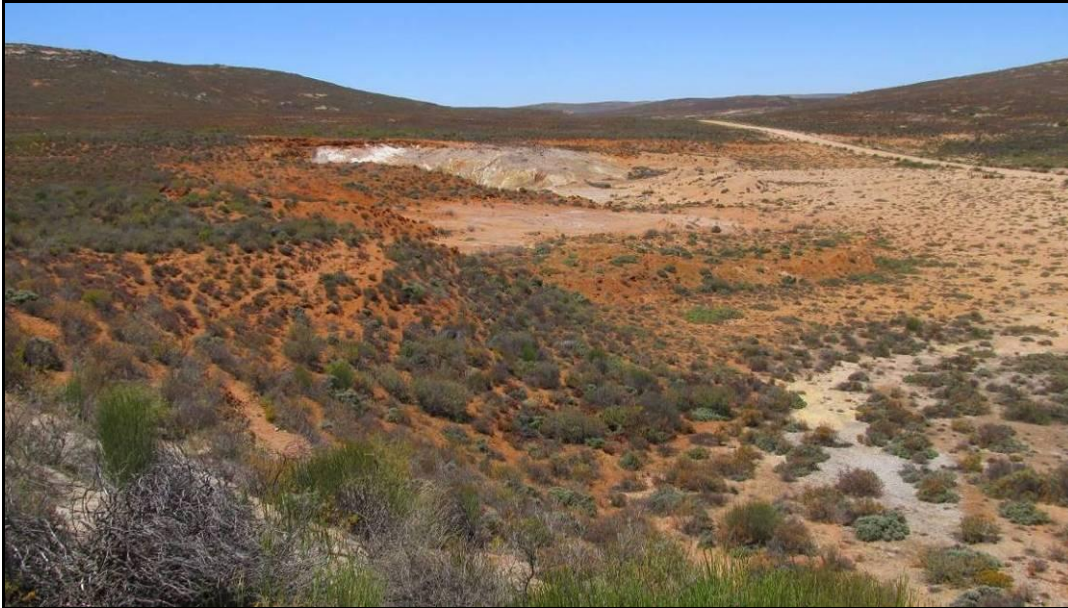
Figure 17. Google aerial photograph of Borrow Pit 6 and 7

BP 6 and BP 7 are situated directly adjacent each other, alongside (i. e. north of) MR739. The large borrow pits have been extensively exploited and new fill material will be cut back along the very steep ridge line across the northern portion of the site, which is covered in *Restio* grasses, succulent veld and ground cover, with open compact patches of red brown soils occurring in places. The very steep eastern slopes are covered in round river quartzite cobbles (Figures 17-19).

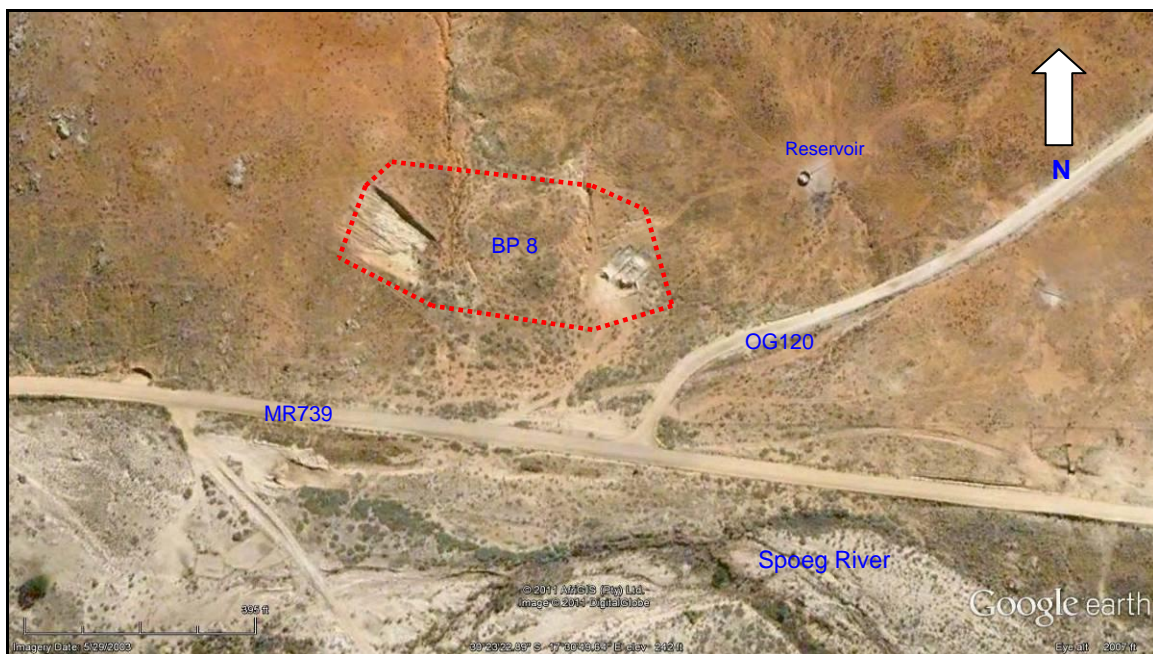
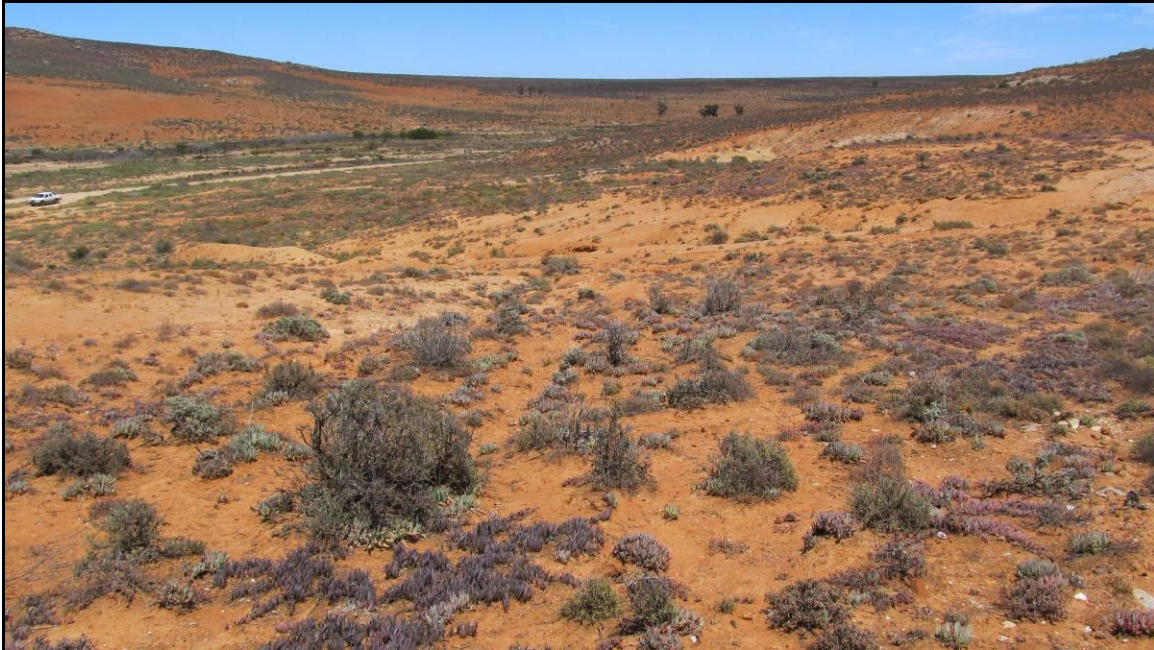
Figure 20. Google aerial photograph of BP 8

BP 8 is located alongside (i. e. north of) MR739, just before the intersection with OG120. The borrow pit has been extensively exploited and new material will be cut back from the north and north eastern edge of the quarry. Substantial volumes of existing fill will also be used from the borrow pit (Figures 20 & 21). The south eastern slopes are heavily eroded and sheet washed. There is a small concrete reservoir about 100 m to the north east of the pit. A small dry stream intersects the site in the west, and discharges into the Spoeg River which is located south of the road. Surrounding land use is vacant/grazing.

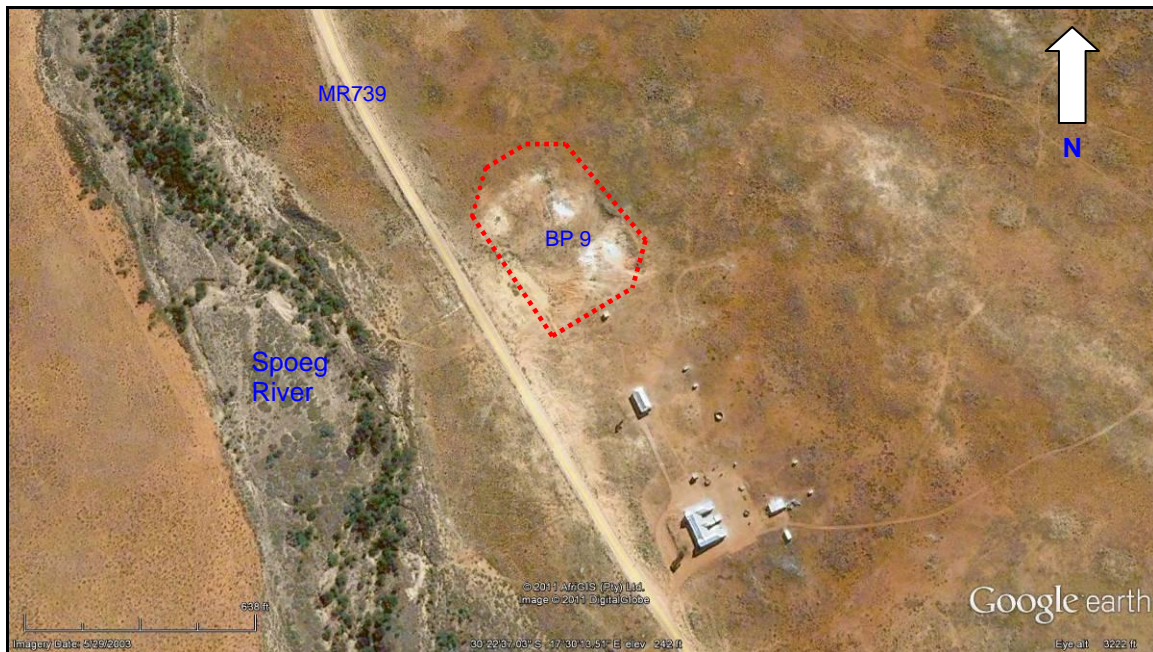
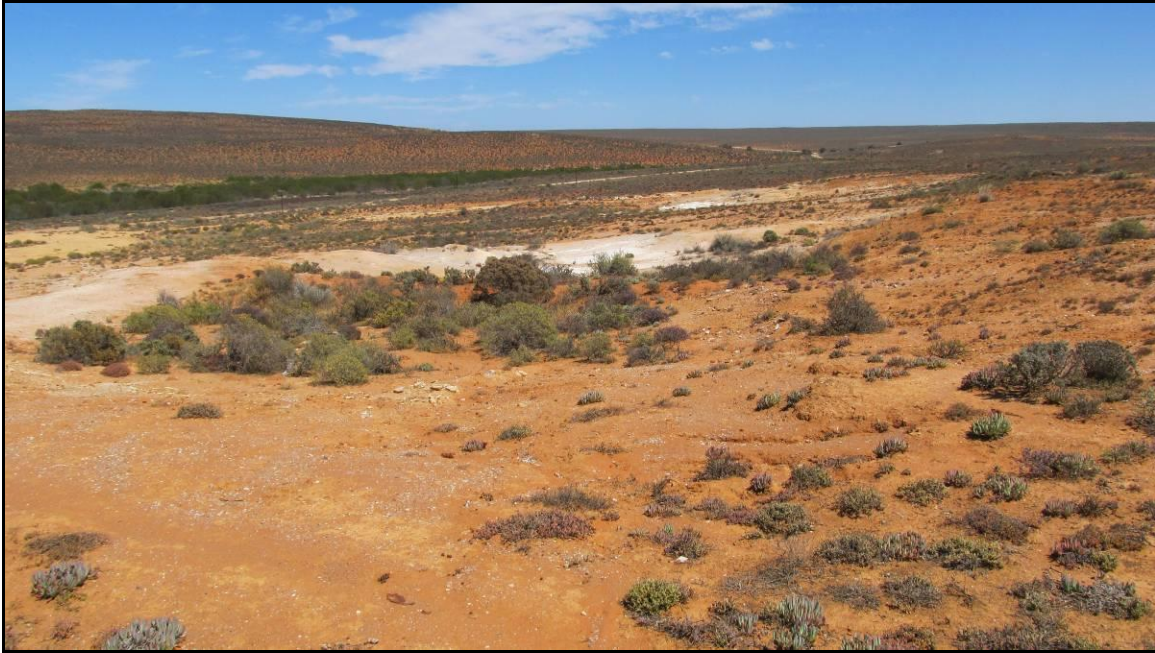
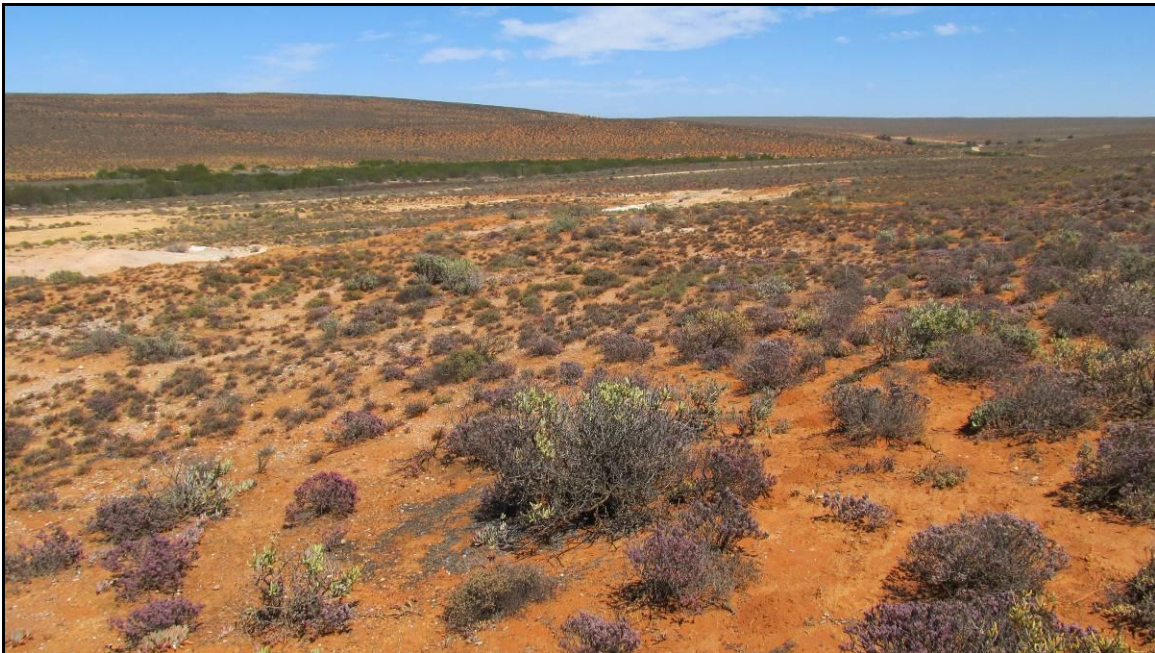
Figure 22. Google aerial photograph of BP 9

BP 9 is located directly alongside (i. e. north) of MR739. The borrow pit has been extensively exploited and new fill material will be excavated from the north and north eastern edges (Figures 22-24). There are several modern farm buildings that occur to the south east of the quarry. The Spoeg River is located south of the road. Surrounding land use is vacant land/grazing.
