## **Heritage Impact Assessment**

### **Leslie Coal Mine Project**

**Proposed Leslie Coal Mine near Leandra, Mpumalanga Province**

**Issue Date:** 11 July 2018  
**Revision No.:** 1.2  
**Client:** Kongiwe Environmental Services  
**PGS Project No:** 303 HIA

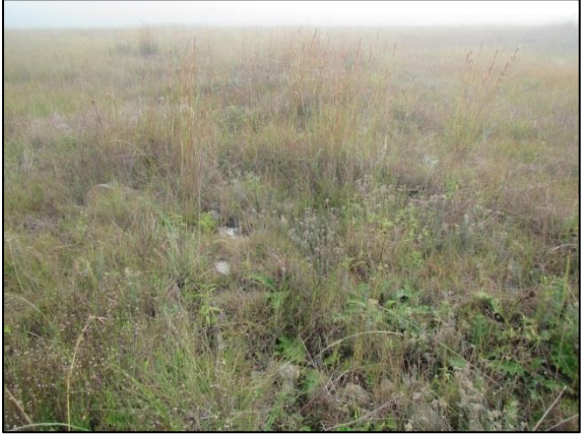
Site number	Lat	Lon	Infrastructure	Description	Heritage Significance	Heritage Rating
LES002	S26.28972°	E28.90321°	1A	<p>Burial ground consisting of 60-70 graves. It is still being visited by at least one family according to the property owner, Mr Saaiman. The burial ground is overgrown with vegetation and many of the headstones and dressings are deteriorated to varying degrees. There is also no demarcation or fencing present. The oldest grave with a known burial date is from 1958.</p> <p><b>Site extent: 30x10m</b></p>	High	GP.A

<p data-bbox="241 762 1070 791"><i>Figure 17 - Burial site at LES002, showing overgrown nature of burial ground</i></p>				  <p data-bbox="1435 772 1800 801"><i>Figure 18 – Example of headstone</i></p>		
  <p data-bbox="427 1276 887 1305"><i>Figure 19 – Inscribed headstone at LES002</i></p>				  <p data-bbox="1382 1276 1856 1305"><i>Figure 20 - Inscribed head marker at LES002</i></p>

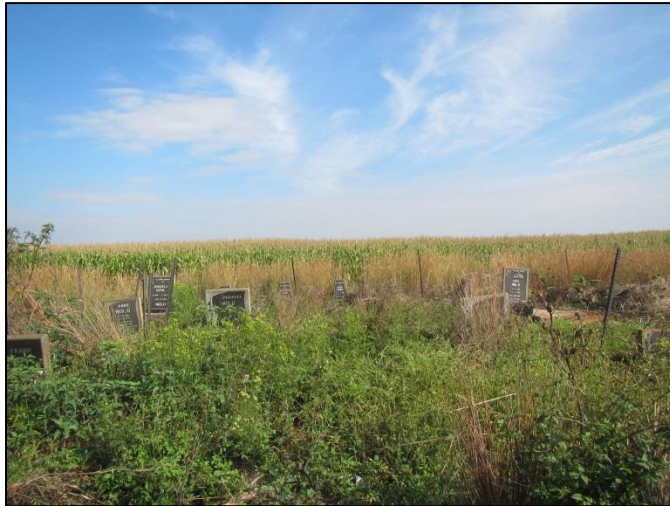
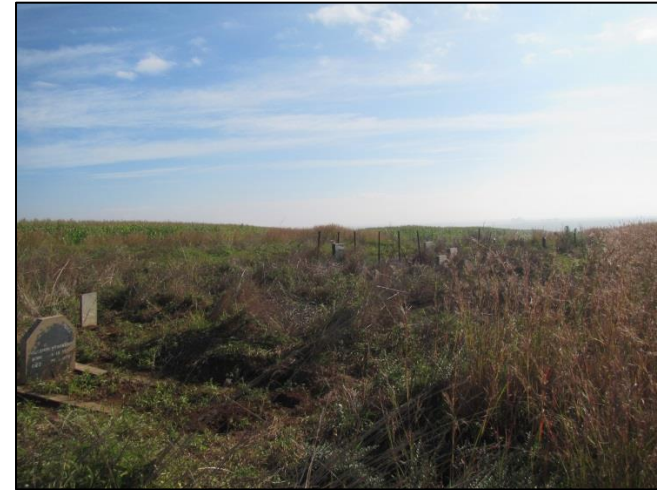
Site <sup>2</sup> number	Lat	Lon	Infrastructure	Description	Heritage Significance	Heritage Rating
LES003	S26.27931°	E28.91056°	1A	Burial ground consisting of 50-60 graves located between two maize fields. The burial ground is overgrown with vegetation and many of the headstones and dressings are deteriorated to varying degrees. There is also no demarcation or fencing present. The oldest grave with a known burial date is from the 1960s, while some of the graves are of more recent origin. <b>Site extent: 50x10m</b>	High	GP.A

Figure 21 – Burial site at LES003

Figure 22 - Burial site at LES003

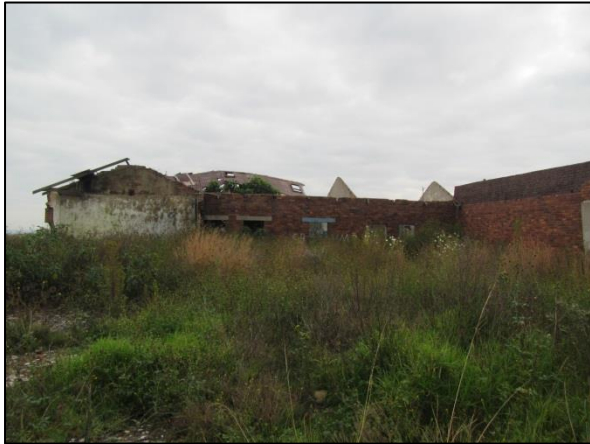
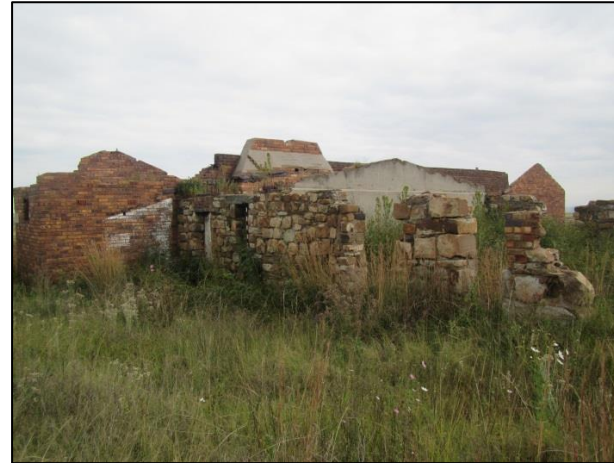
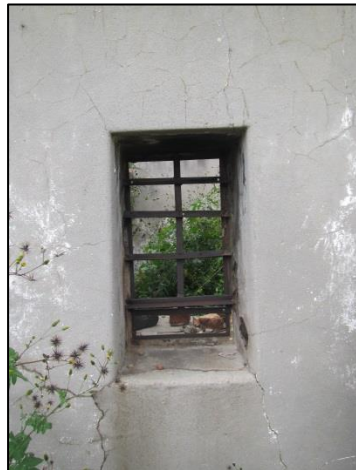
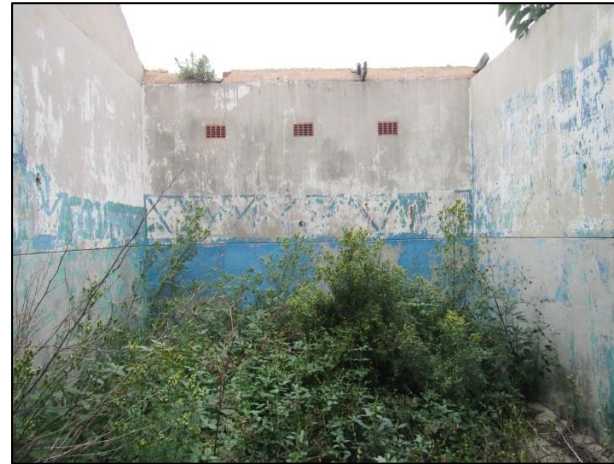
Site number	Lat	Lon	Infrastructure	Description	Heritage Significance	Heritage Rating
LES004	S26.29019°	E28.90572°	1A	The remains of an old brick structure with a concrete foundation, with a stone-and-brick structural addition behind it. Concrete and brick lintels are visible on both sections of the structure with iron bars on some of the windows. According to the farmer, the structure was allegedly utilised as some kind of jail. The structure has an unusual layout with most rooms leading straight out into the courtyard and no indoor passages. Some of the rooms are painted. It is possible that the structure was used for storage or perhaps even as a school. This site is visible on the 1 <sup>st</sup> Edition 1965 topographic map therefore confirming that it is at least almost 60 years old. <b>Site extent: 30x30m</b>	Low	GP.B

*Figure 23 – Front view of brick structure at LES004*

*Figure 24 –Rear view of structure with stone-built addition at LES004*

*Figure 25 – Iron bars in window LES004*

*Figure 26 – Painted room LES004*

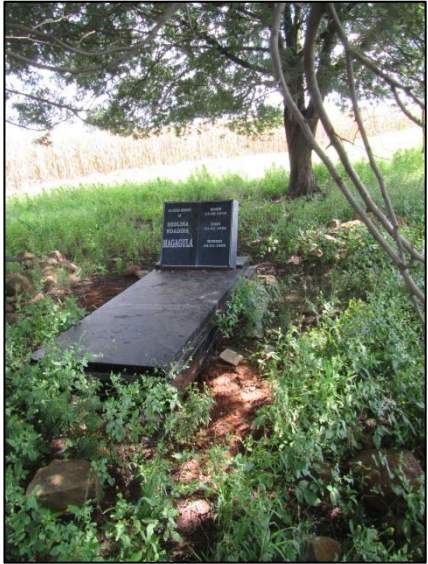
Site number	Lat	Lon	Infrastructure	Description	Heritage Significance	Heritage Rating	
LES005	S26.29264°	E28.94217°	1A	Burial site consisting of a single grave. The grave has a granite headstone and dressing. The date of the grave is 1955. <b>Site extent: 5x5m.</b> <i>Outside of study area so mitigation impact is low, however caution is still advised if the development layout plan changes.</i>	High	GP.A

<p><i>Figure 27 – Single grave at LES005</i></p>

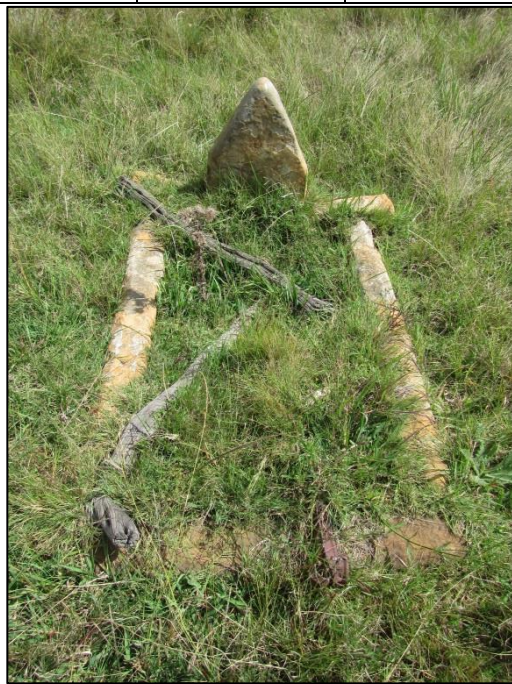
Site number	Lat	Lon	Infrastructure	Description	Heritage Significance	Heritage Rating
LES006	S26.28640°	E28.94129°	1A	Burial site consisting of a single grave. Stone headstone (with no inscription) and dressing. Deterioration indicates that it is likely to be quite old. Size of the grave indicates it belongs to a child. <b>Site extent: 5x5m</b> <i>Outside of study area so mitigation impact is low, however caution is still advised if the development layout plan changes.</i>	High	GP.A

Figure 28 - Burial site at LES006, single grave

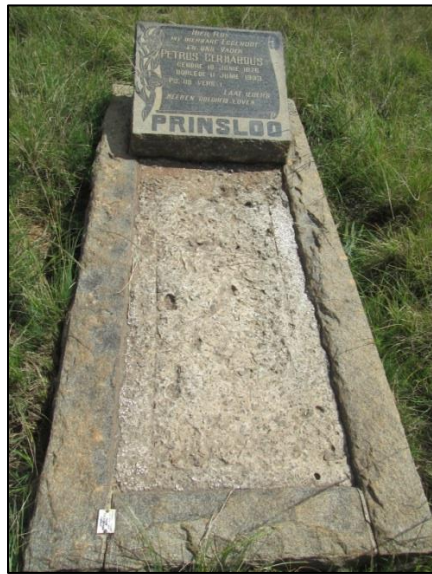
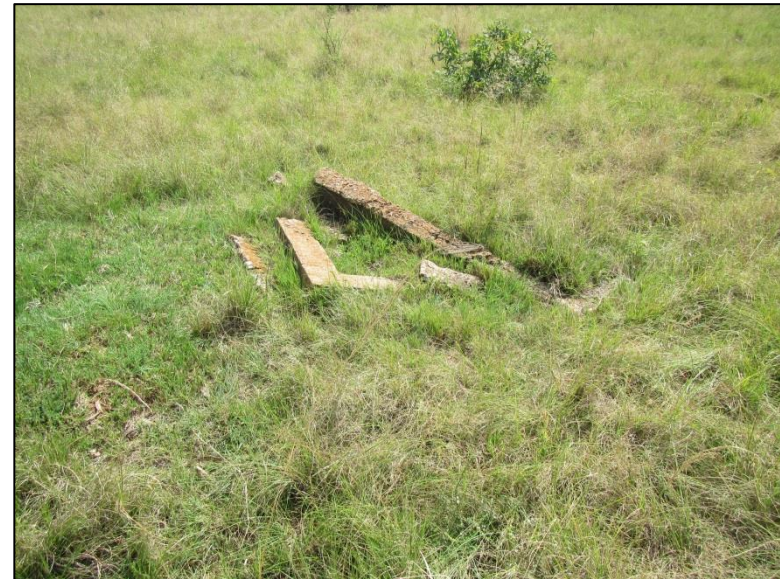
Site number	Lat	Lon	Infrastructure	Description	Heritage Significance	Heritage Rating
LES007	S26.28727°	E28.93728°	1A	Burial site with single grave having a granite headstone and dressing. The date of the grave is 1933. There is a possible second grave located immediately adjacent to this grave, but it is more likely to be the remains of an old dressing for this grave. <b>Site extent: 5x5m.</b>	High	GP.A

Figure 29 – Single grave at LES007

Figure 30 – Remains of old dressing at LES007

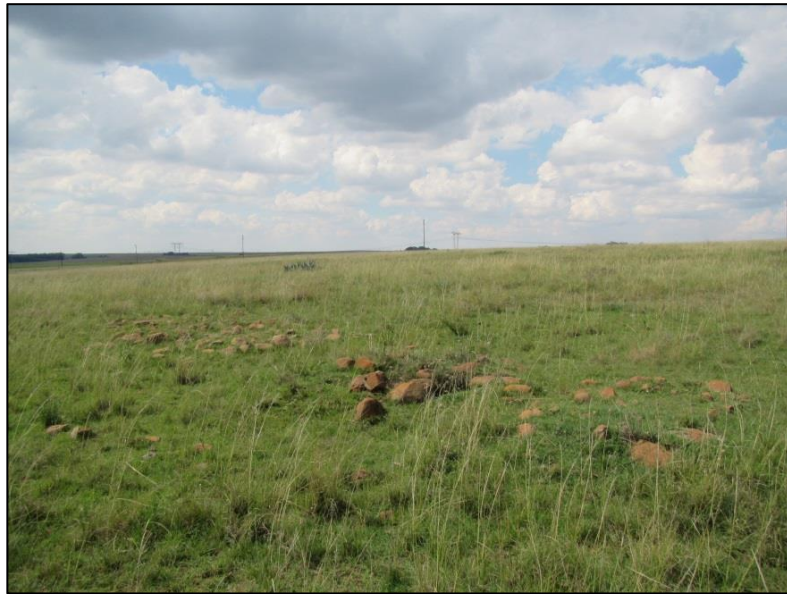
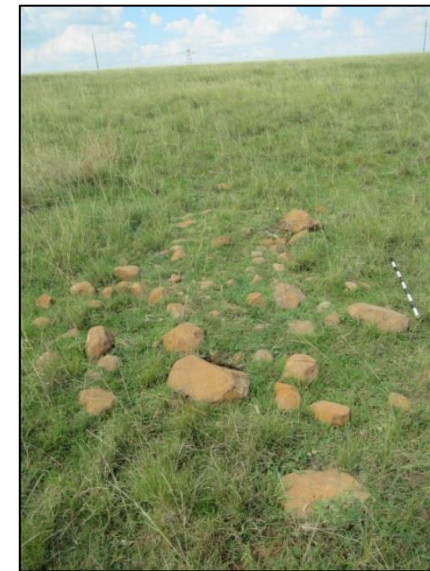
Site number	Lat	Lon	Infrastructure	Description	Heritage Significance	Heritage Rating
LES008	S26.29019°	E28.93983°	1A	Burial ground consisting of five very old stone packed graves facing East to West. One of them has been disturbed by an animal burrow . <b>Site extent: 15x5m.</b> <i>Outside of study area so mitigation impact is low, however caution is still advised if the development layout plan changes.</i>	High	GP.A

Figure 31 – Burial site at LES008

Figure 32 – Example of one of the stone packed graves at LES008

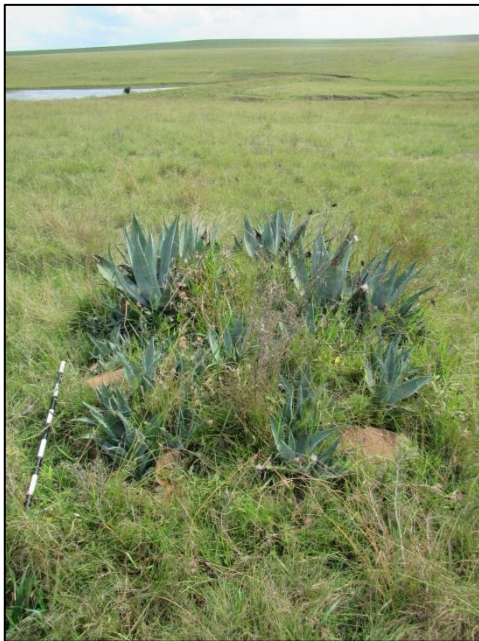
Site number	Lat	Lon	Infrastructure	Description	Heritage Significance	Heritage Rating
LES009	S26.29001°	E28.94002°	1A	Burial site consisting of a single grave. This is a stone packed grave like those at LES008, heavily overgrown with aloes. It could be of a similar age as it is situated only 30m to the NE of LES008. <b>Site extent: 5x5m.</b> <i>Outside of study area so mitigation impact is low, however, caution is still advised.</i>	High	GP.A

Figure 33 - Single grave at LES009

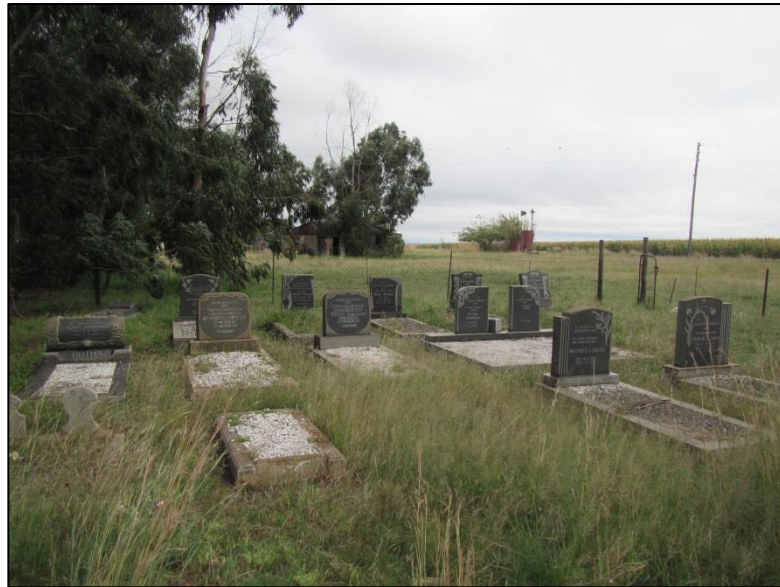
Site number	Lat	Lon	Infrastructure	Description	Heritage Significance	Heritage Rating
LES010	S26.28404°	E28.96680°	1A	Burial ground consisting of 19 graves situated at the side of the Ogies Road, 250m South of the proposed access road on the Eastern side of study area 1A. Most of the graves have granite headstones and dressings. The oldest grave is dated 1942. <b>Site extent: 15x15m</b> <i>Outside of study area so mitigation impact is low, however caution is still advised if the development layout plan changes.</i>	High	GP.A

Figure 34 – Burial ground at LES010

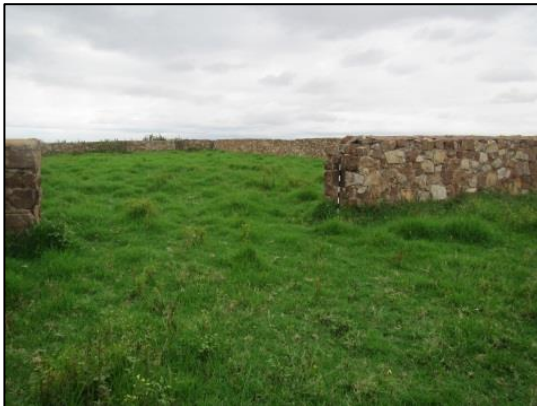
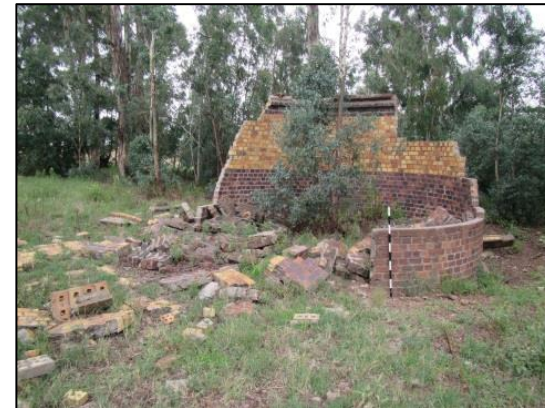
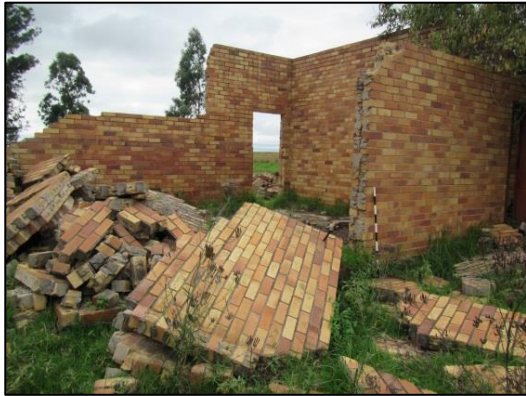
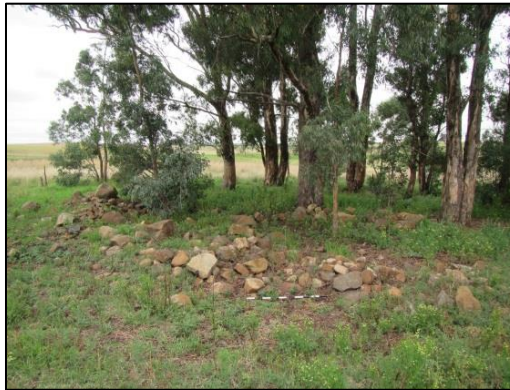
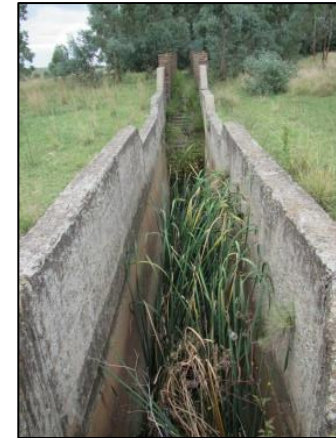
Site number	Lat	Lon	Infrastructure	Description	Heritage Significance	Heritage Rating
LES011	S26.28100°	E28.91961°	1A	The remains of an old farmstead consisting of: a) a stone cattle kraal; b) a brick silo; c) a stone structure with multiple rooms; d) a derelict brick house with iron lintels; and e) a well-preserved sheep dipping station. This site is visible on the 1 <sup>st</sup> Edition 1965 topographic map, therefore confirming that it is likely to be 60 years old. <b>Site extent: 100x100m.</b>	None	None

Figure 35 – a) Cattle kraal at LES011

Figure 36 – b) Brick silo at LES011

*Figure 37 – c) Derelict brick structure at LES011*

*Figure 38 – d) Remains of stone structure at LES011*

*Figure 39 – e) Sheep dipping station at LES011*

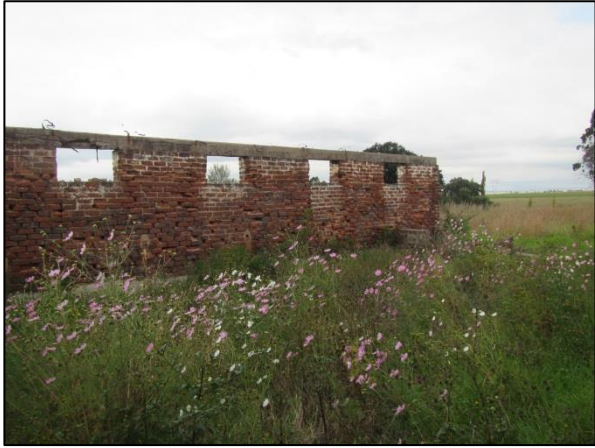
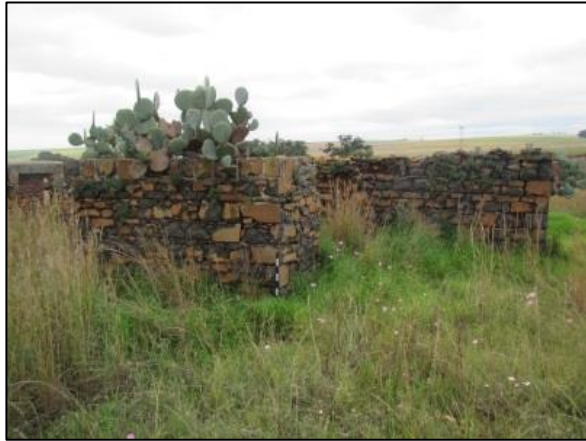
Site number	Lat	Lon	Infrastructure	Description	Heritage Significance	Heritage Rating
LES012	S26.28024°	E28.93978°	1A	The site comprises an a) old brick structure with stone foundation which may have been a stable, with concrete troughs along the inner edges of the building; b) a stone-and-brick outbuilding; and c) a small 3-roomed brick house with concrete lintels. The site most likely dates to the 1930s due to the Imperial brick style and a stone foundation. This site is visible on the 1 <sup>st</sup> Edition 1965 topographic map therefore confirming that it is likely to be 60 years old. <b>Site extent: 70x20m.</b>	Low	GP.B

*Figure 40 – a) Brick stable at LES012*

*Figure 42 – b) Stone-and-brick structure at LES012*

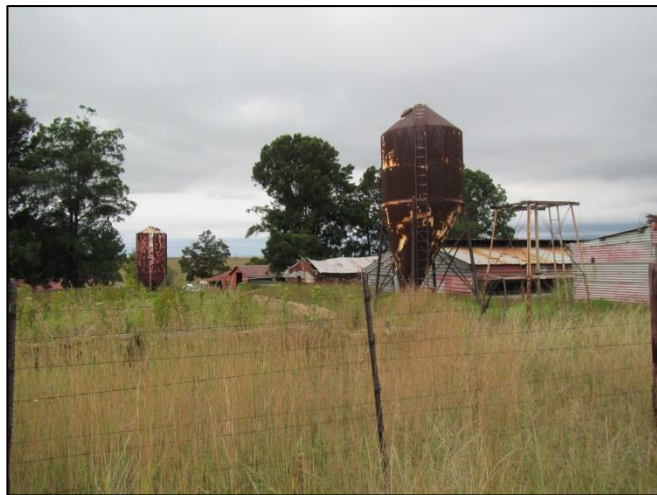
Site number	Lat	Lon	Infrastructure	Description	Heritage Significance	Heritage Rating
LES013	S26.41222°	E28.94926°	1C	The site comprises relatively old agricultural infrastructure which is currently being utilised. The structures are of little heritage significance. <b>Site extent: 50x20m</b>	None	None

*Figure 44 – Agricultural infrastructure at LES013*

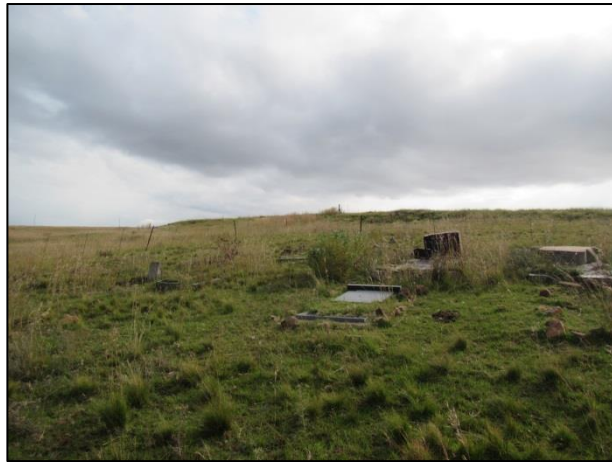
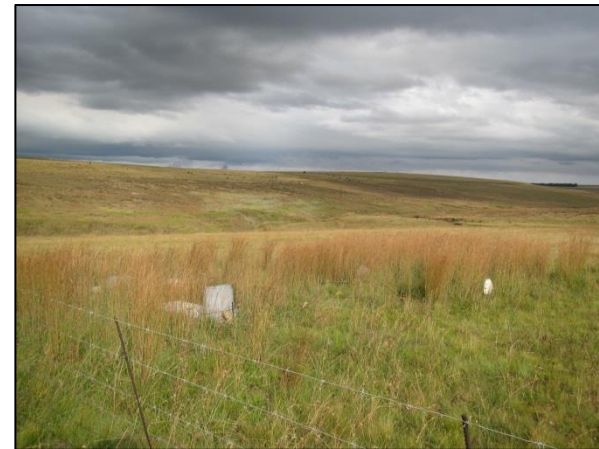
Site number	Lat	Lon	Infrastructure	Description	Heritage Significance	Heritage Rating
LES014	S26.41823°	E28.95012°	1C	Burial ground consisting of 30-40 graves, that is still being visited as the surrounding grass has been cut. However the portion of the burial ground on the other side of the fence is partially overgrown. The graves are mostly stone-packed, with a few having granite headstones and dressings. The oldest known grave is dated 1961. The burial ground is situated approx. 100m East of (outside) the southern portion of study area 1C. <b>Site extent: 15x10m</b> <i>Outside of study area so mitigation impact is low, however caution is still advised if the development layout plan changes.</i>	High	GP.A

Figure 45 – Burial site at LES014

Figure 46 – Overgrown nature of a portion of the burial ground at LES014

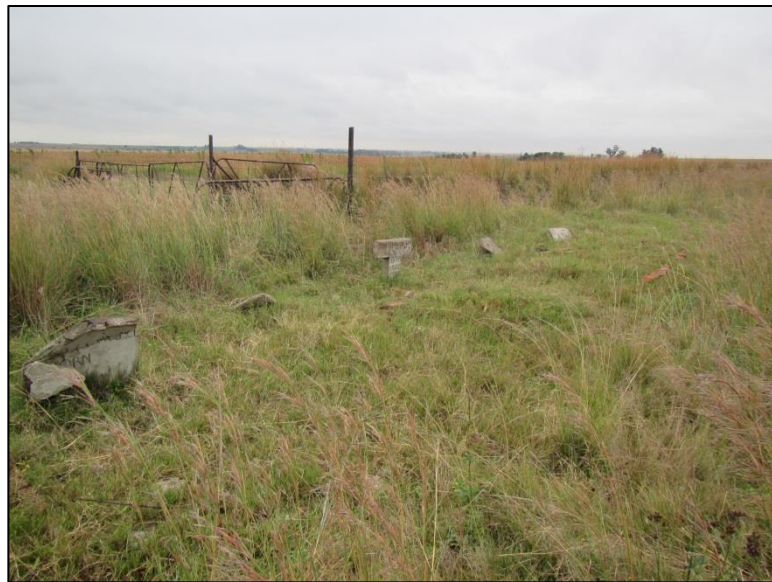
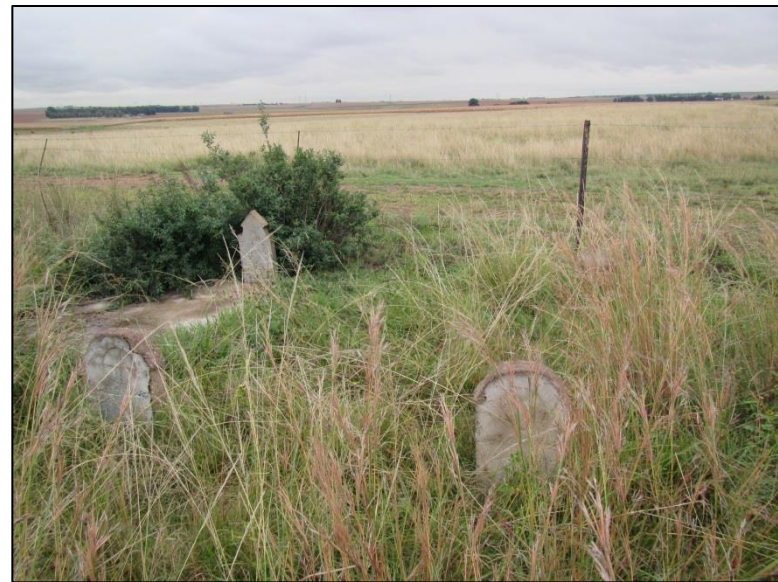
Site number	Lat	Lon	Infrastructure	Description	Heritage Significance	Heritage Rating
LES015	S26.32320°	E29.05077°	1B	Burial ground consisting of 20-30 graves, however, the number is not clear due to the heavily overgrown vegetation. At least one of the graves is still being visited. The graves are mostly stone-packed, with some graves having concrete headstones and dressings, and one having a granite headstone. The burial ground is situated close to the proposed shaft entrance of Area 1B. <b>Site extent: 30x5m.</b>	High	GP.A

*Figure 47 - Burial ground at LES015*

*Figure 48 – Concrete headstones at LES015*

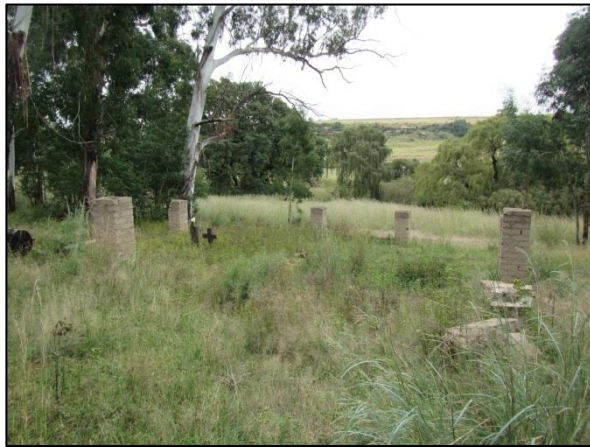
Site number	Lat	Lon	Infrastructure	Description	Heritage Significance	Heritage Rating
LES016	S26.41745°	E28.93229°	1C	Burial site consisting of two graves situated within derelict brick walling. The graves are marked with wooden crosses and one has a marble dressing. The state of the burial ground indicates that it is quite old. According to Cobus Rolf, owner of the neighbouring properties, the graves belong to Johan Wasserman, a previous owner, who subsequently sold it to Aron Bogatsu. <b>Site extent: 10x10m.</b> <i>Outside of study area so mitigation impact is low, however caution is still advised if the development layout plan changes.</i>	High	GP.A

Figure 49 - Burial site at LES016

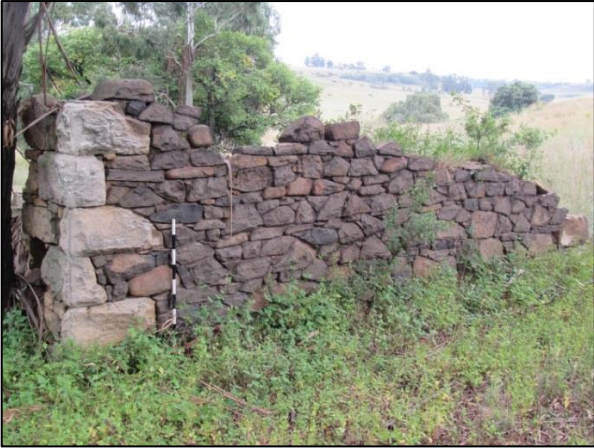
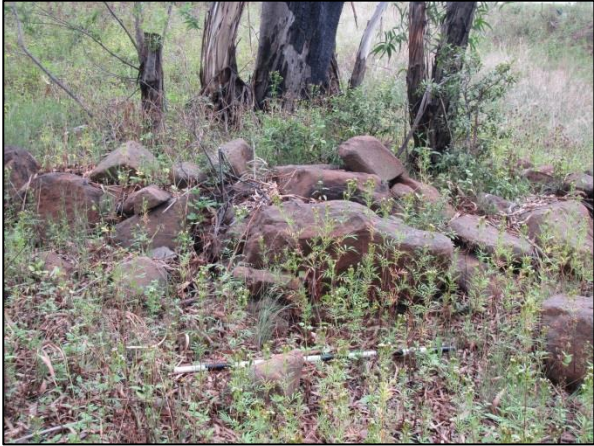
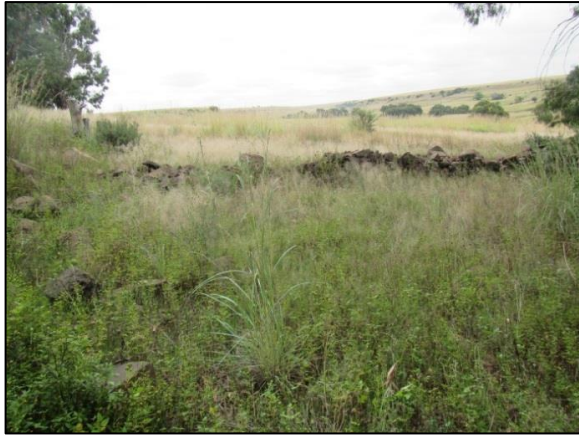
Site number	Lat	Lon	Infrastructure	Description	Heritage Significance	Heritage Rating
LES017	S26.41756°	E28.93251°	1C	The remains of several stone structures comprising an old colonial farmstead. The site consists of the remains of: a) two stone-built houses, one with sandstone cornerstones indicating historical age; b) a small circular stone pen; and c) a large rectangular stone cattle kraal (with two conjoined pens). <b>Site extent: 50x50m</b>	Low	GP.B

<p>Figure 51 – a) Remains of stone structure with sandstone cornerstones at LES017</p>

<p>Figure 52 – b) Remains of circular pen at LES017</p>

<p>Figure 53 – c) Remains of stone cattle kraal at LES017</p>

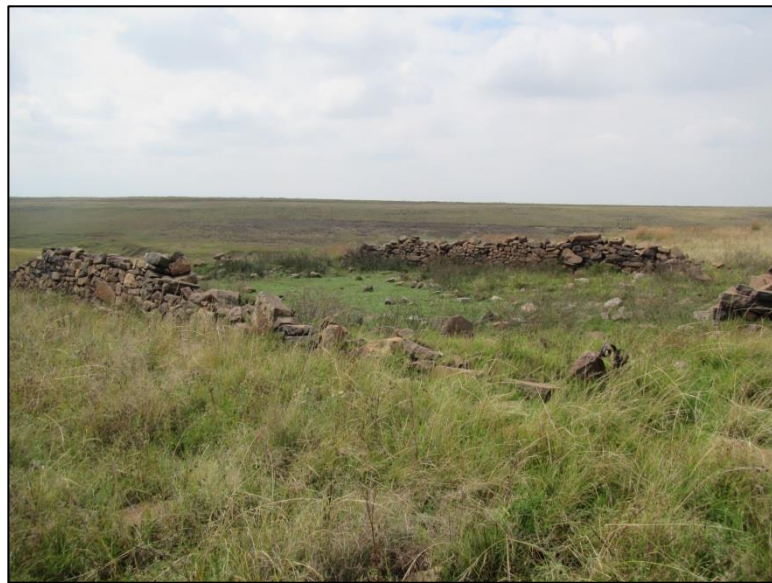
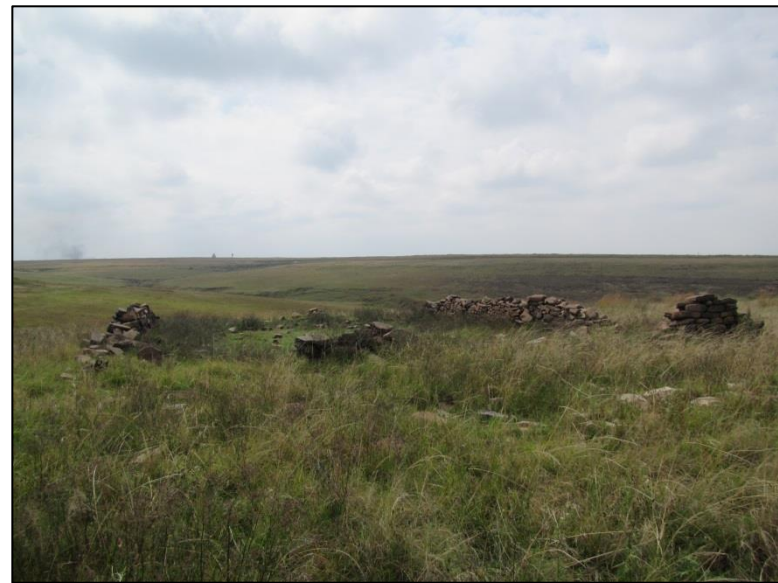
Site number	Lat	Lon	Infrastructure	Description	Heritage Significance	Heritage Rating
LES018	S26.42055°	E28.94891°	1C	The remains of a stone structure, probably of colonial origin. Sitting 40m South East outside of the boundary of 1C. <b>Site extent: 20x10m.</b> <i>Outside of study area so mitigation impact is low, however caution is still advised if the development layout plan changes.</i>	Low	GP.C

Figure 54 – Stone structure at LES018

Figure 55 – Stone structure at LES018

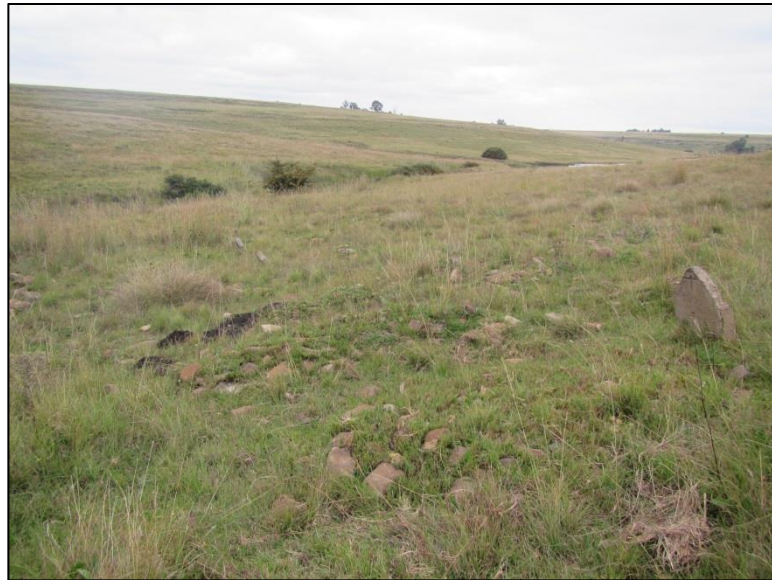
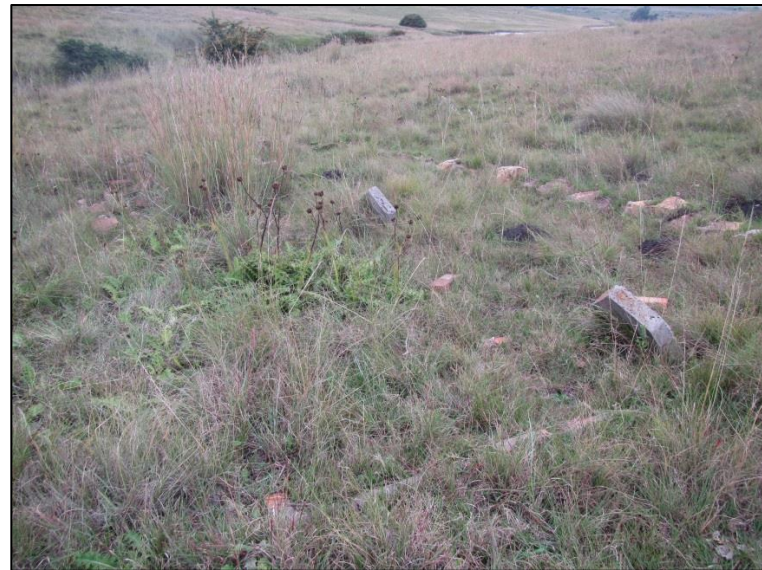
Site number	Lat	Lon	Infrastructure	Description	Heritage Significance	Heritage Rating
LES019	S26.40471°	E28.93918°	1C	Burial ground consisting of 24 visible graves, that are mostly stone packed with a few graves having concrete headstones and dressings. The graves are not being visited. However, according to the farm owner, one belongs to an old woman who used to live in the farmstead nearby. The ages of the graves are unknown. <b>Site extent: 20x20m.</b>	High	GP.A

Figure 56 - Burial site at LES019

Figure 57 – Burial site at LES019

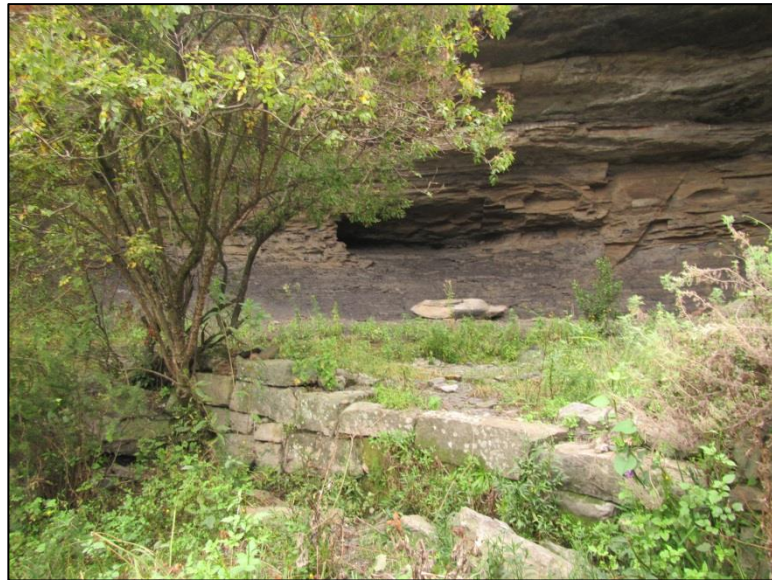
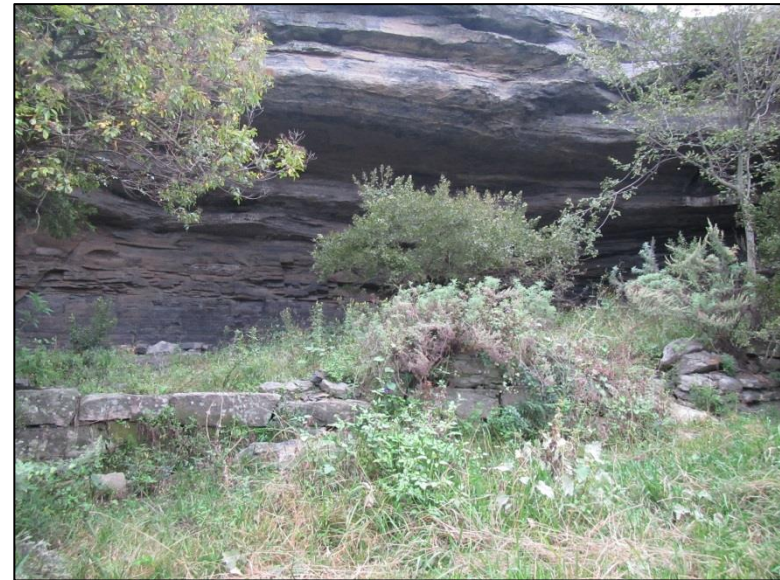
Site number	Lat	Lon	Infrastructure	Description	Heritage Significance	Heritage Rating
LES020	S26.40253°	E28.92926°	1C	A low stone wall built in front of a rock shelter. No visible signs of occupation within the shelter. According to the property owner Douglas Kelly, the wall was built by the previous farm owner. <b>Site extent: 10x5m.</b>	None	None

*Figure 58 – Low stone wall in front of rock shelter LES020*

*Figure 59 – Different view of low stone wall at LES020*

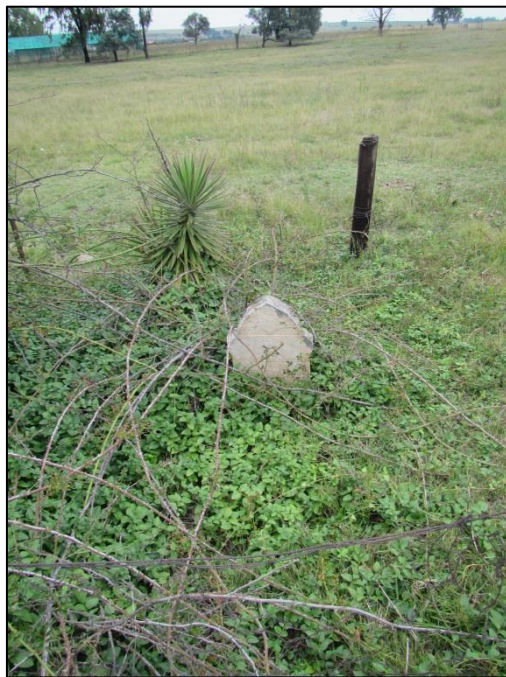
Site number	Lat	Lon	Infrastructure	Description	Heritage Significance	Heritage Rating
LES021	S26.40392°	E28.94488°	1C	Burial site consisting of a single grave of a child with a concrete headstone. The grave is dated 1922. <b>Site extent: 5x5m.</b> <i>Outside of study area so mitigation impact is low however caution is still advised.</i>	High	GP.A

Figure 60 - Single grave at LES021

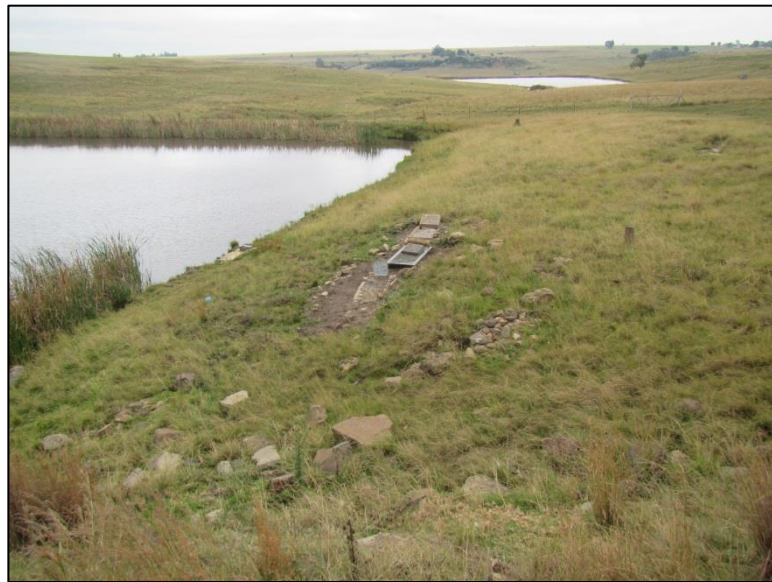
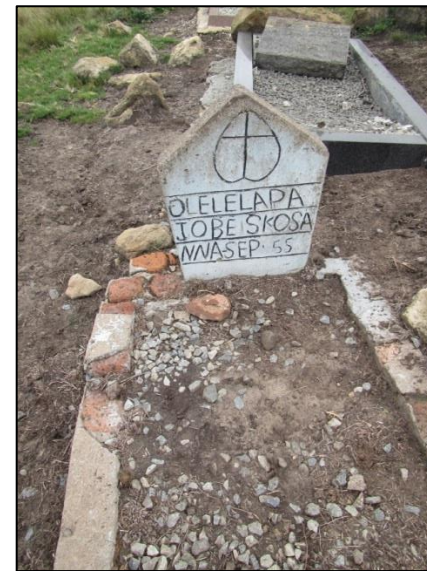
Site number	Lat	Lon	Infrastructure	Description	Heritage Significance	Heritage Rating
LES022	S26.40651°	E28.94081°	1C	Burial ground consisting of 8 graves. Some have granite dressings and headstones, others have concrete dressings and headstones, and some are stone packed with stone head markers. The oldest known grave is dated 1955. Some of the graves are still being visited. <b>Site extent: 15x10m.</b>	High	GP.A

Figure 61 - Burial ground at LES022

Figure 62 – Oldest known grave at LES022

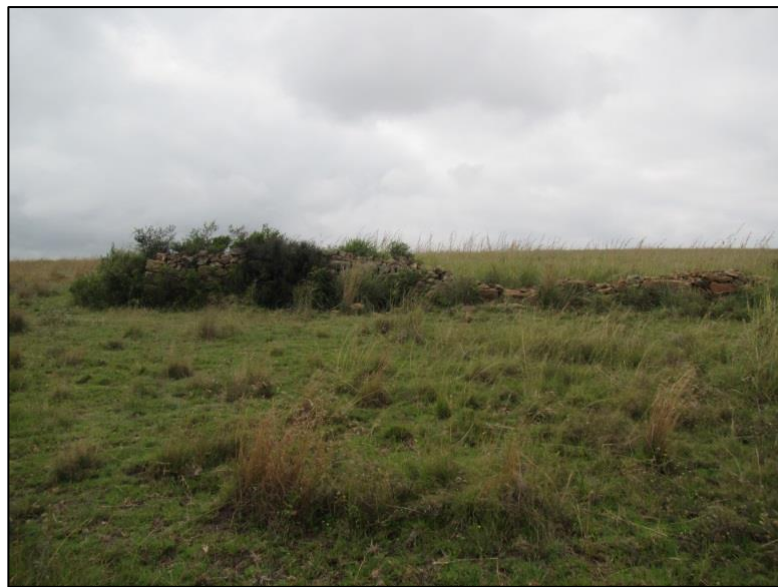
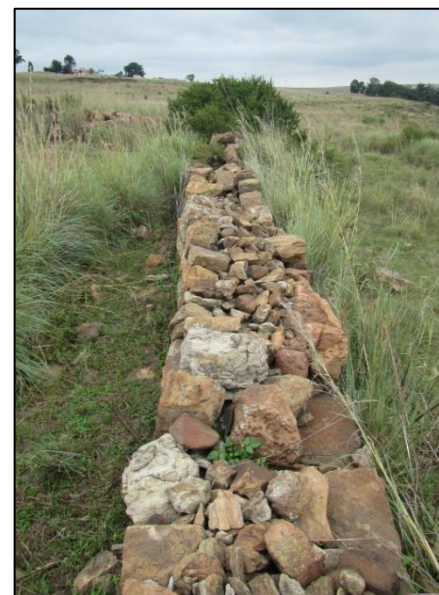
Site number	Lat	Lon	Infrastructure	Description	Heritage Significance	Heritage Rating
LES023	S26.41190°	E28.93368°	1C	The remains of a stone cattle kraal. <b>Site extent: 35x15m.</b>	None	None

*Figure 63 – Remains of old stone cattle kraal at LES023*

*Figure 64 – Detailed view of stone wall at LES023*

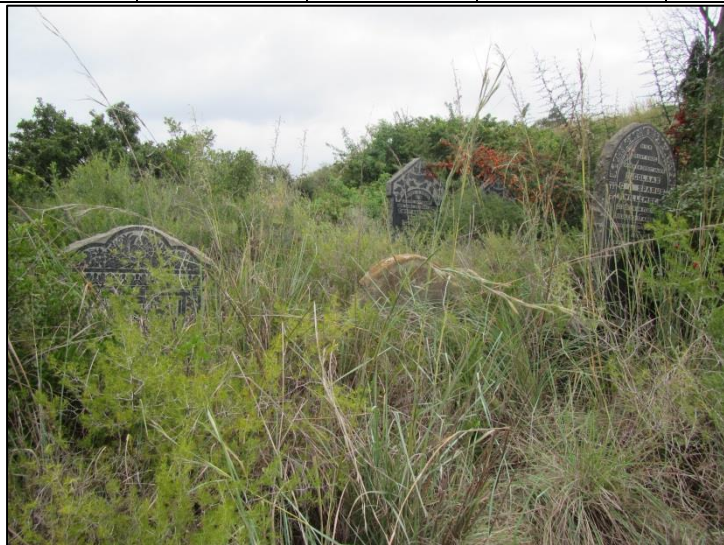
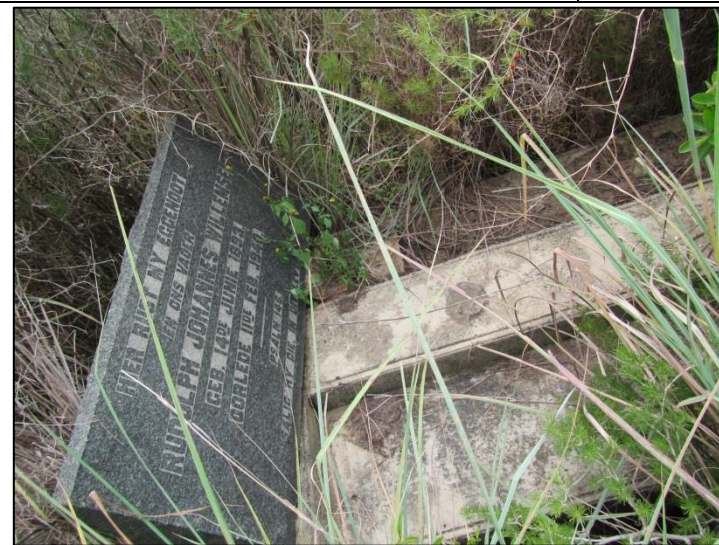
Figure 65 – Burial site at LES024

Figure 66 – One of the more visible graves at LES024

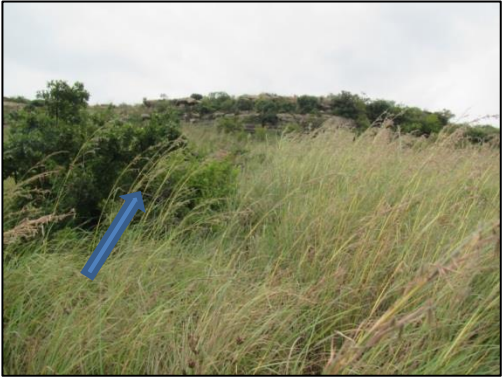
Site number	Lat	Lon	Infrastructure	Description	Heritage Significance	Heritage Rating
LES025	S26.40547°	E28.93092°	1C	Four possible stone packed graves are situated about halfway along the line of the remains of a low, old stone wall running up the hill, according to Douglas Kelly, the farm owner. However, it was not possible to confirm the location due to the heavily overgrown nature of the grass. The graves should become visible if the grass is burned. <b>Site extent: 50x5m.</b> <i>The entire portion of the wall should be considered highly sensitive until the exact location of the graves is confirmed.</i>	High	GP.A

<p><i>Figure 67 – General environment within which LES025 lies, view looking up-hill along the remains of the stone wall following the direction of the blue arrow (on the left hidden by vegetation)</i></p>

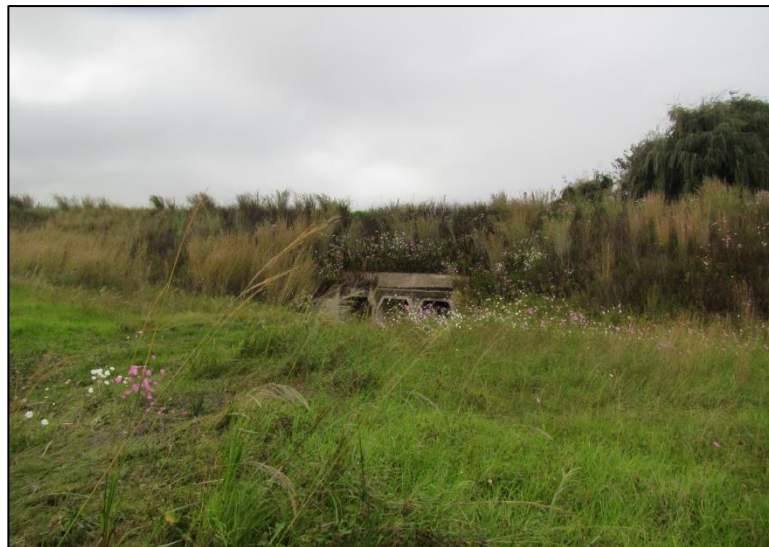
Site number	Lat	Lon	Infrastructure	Description	Heritage Significance	Heritage Rating
LES026	S26.28697°	E28.96350°	1A	An old culvert found outside the study area. <b>Site extent: 5x5m.</b> <i>Outside of study area so mitigation impact is low, however caution is still advised if the development layout plan changes.</i>	Low	None

Figure 68 – Old culvert at LES026

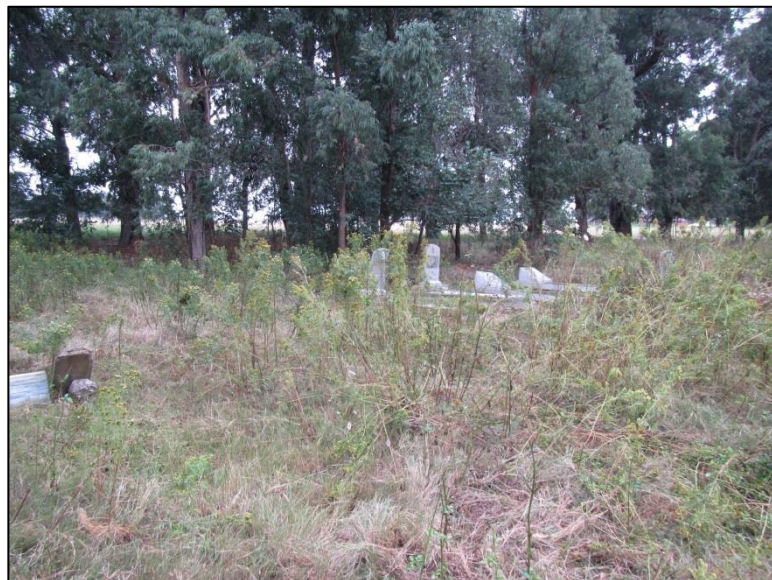
*Figure 69 - Burial ground at LES027*
