A PHASE 1 ARCHAEOLOGICAL IMPACT ASSESSMENTS OF THE PROPOSED WESLEY – PEDDIE 132 KV POWER LINE FOR THE AUTHORISED UNCEDO LWETHU WIND ENERGY FACILITY, NGQUSHWA LOCAL MUNICIPALITY, AMATHOLE DISTRICT, EASTERN CAPE PROVINCE.

Date: April 2014

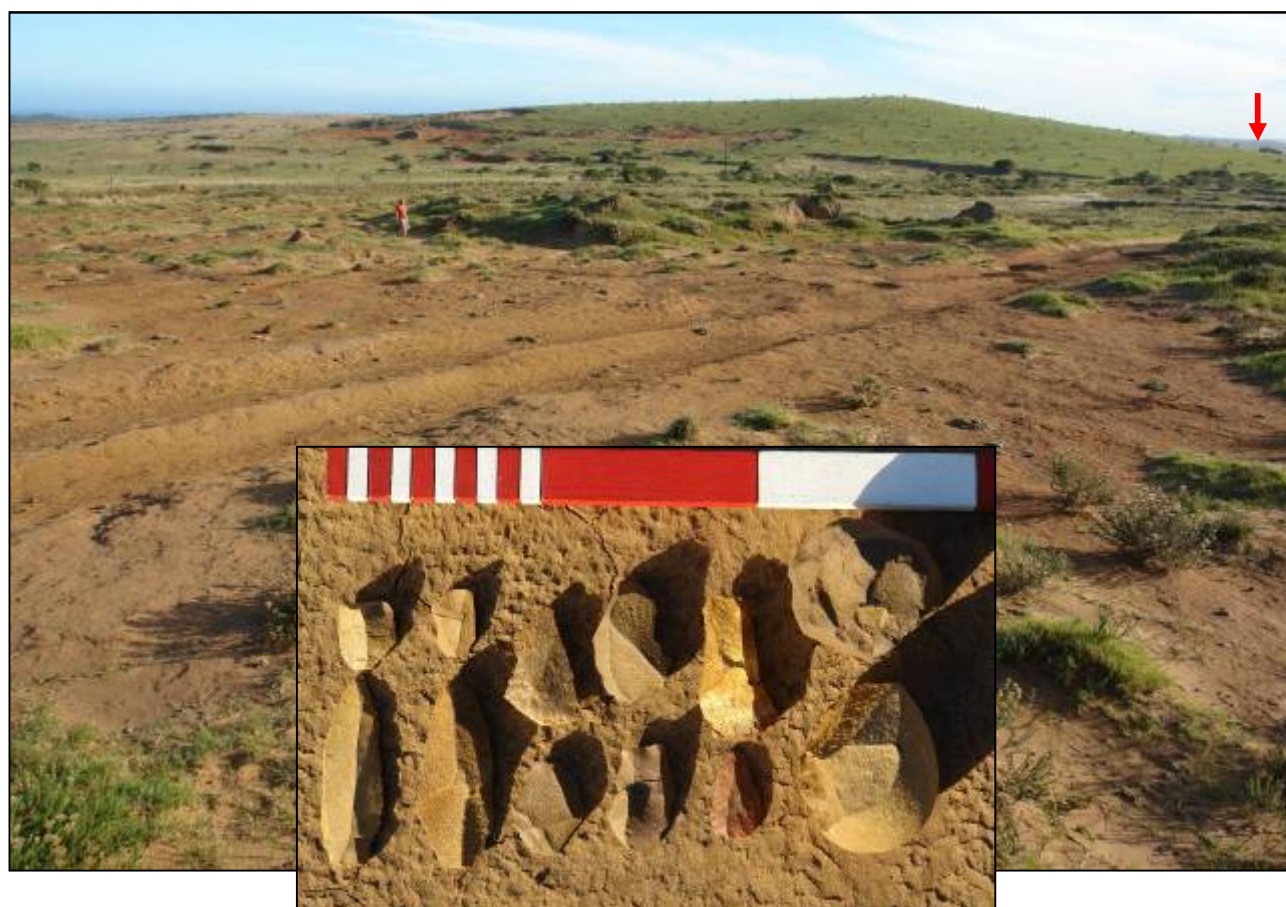
Figure 1. A general view of the sand mines in the vicinity of the power line and a sample of Middle Stone Age stone tools observed at these disturbances. The power line starts to the right of the hill in the back ground, marked by the red arrow.

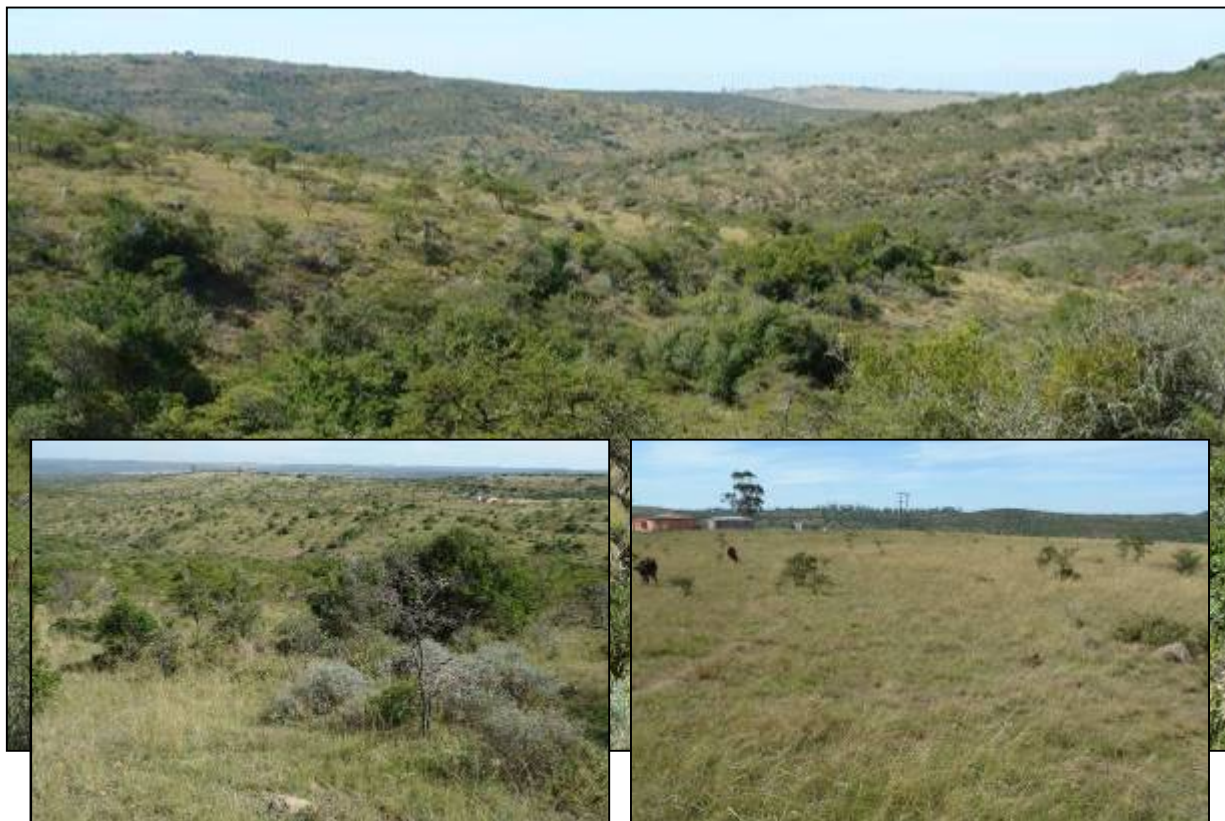
Figure 4. General views of the power line route from KwaNdaba (main image and right insert) to Wooldridge (left insert).

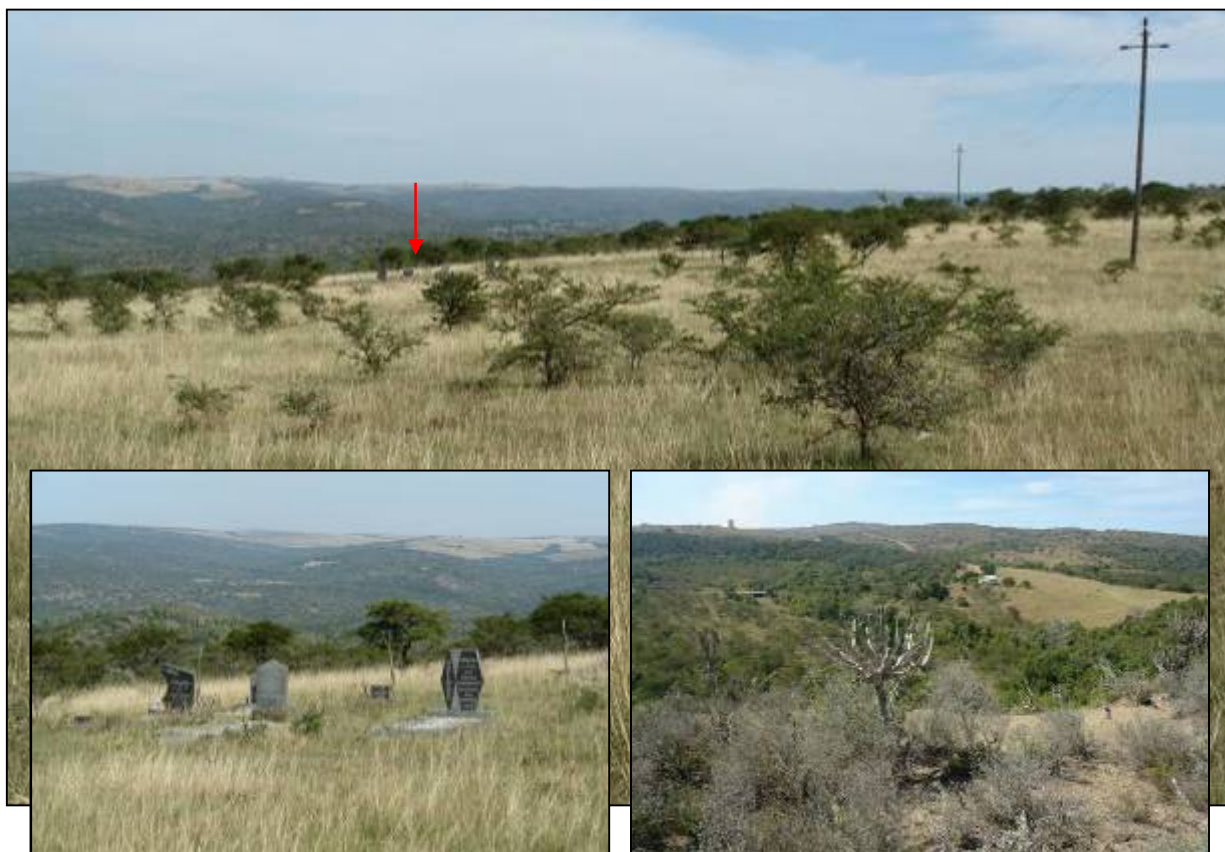
En route to Wooldridge the route passes small settlements next to the gravel road and descends down a long, steep gradient into the Bira River valley (Map 6a) (Figure 5, right insert). The line crosses through the settlement and close to at least two graves sites (there may be more) (Map 6b) (Figure 6). It is inappropriate for the power line to traverse straight through the settlement and will impact on the 'sense of place' of the graves. It is recommended that the route follows the alternative blue route along the gravel road.

Figure 5. General views of the route to Wooldridge (main image), the graveyard marked by the red arrow (left insert) and a view from Wooldridge towards the graveyard in the far distance.

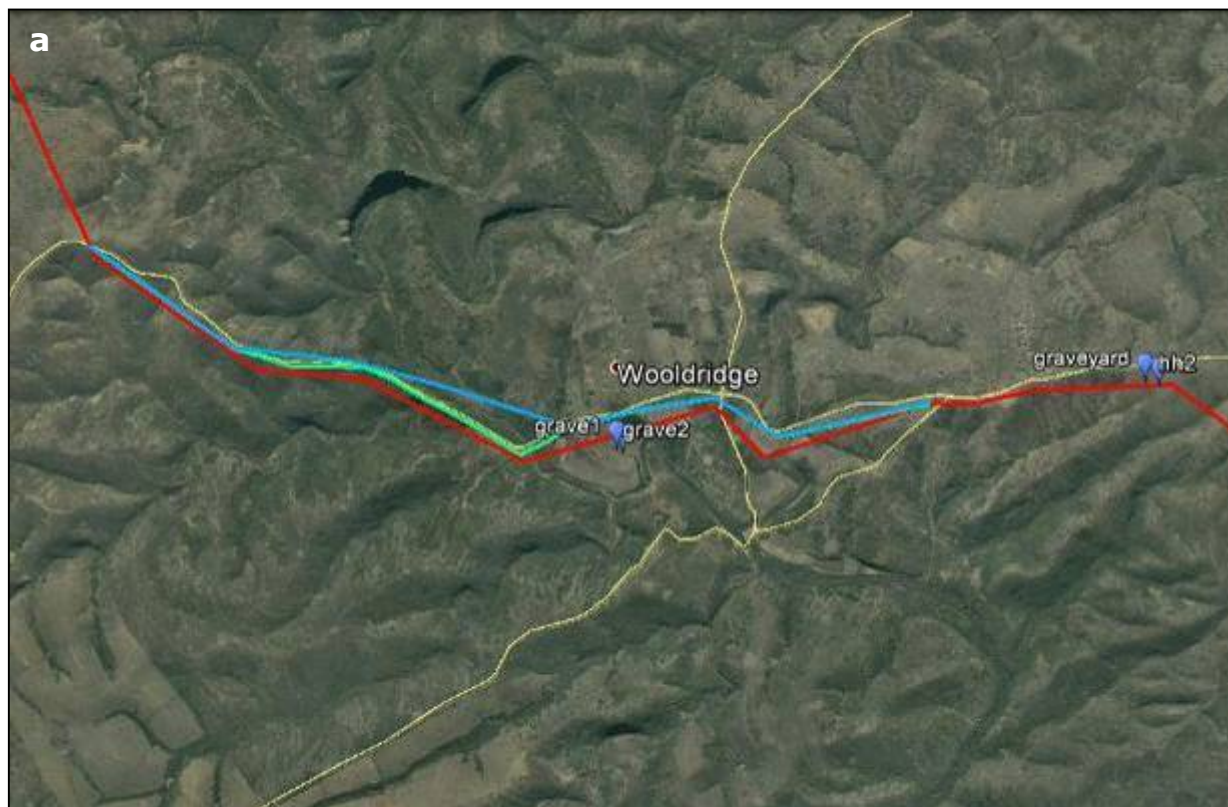
Map 6. Aerial images of the power line (red line) from Woodridge to Feni (a). The green square marks a settlement with graves and the broken white line agrees with the blue route as an alternative route.

- It is recommended that the route follows the alternative blue route along the gravel road.
4. It is possible that there are more graves or even graveyards 'hiding' in the dense vegetation along the servitude of the power line, or may be included once/if the layout changes. It is of great importance that these features, if they exist, are identified during the public participation meetings.

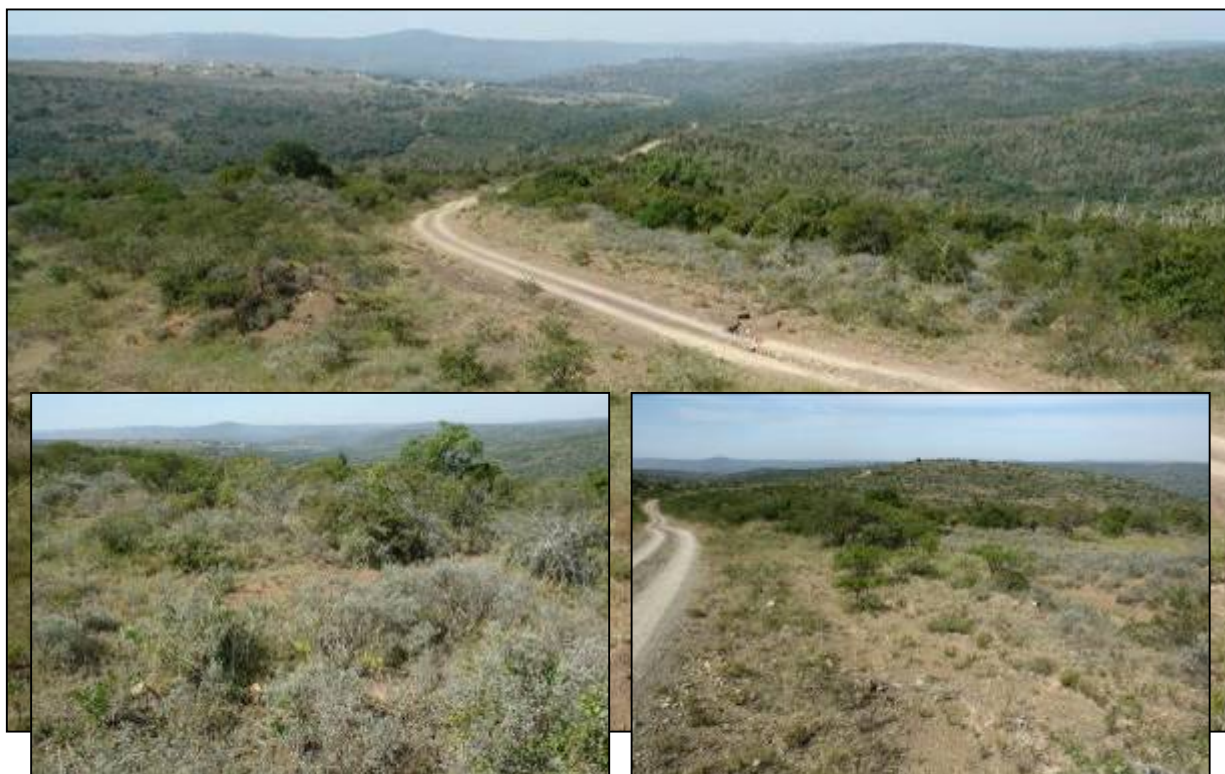
Figure 7. General views of the route from Wooldridge and the Bira River valley (main image) towards Feni.

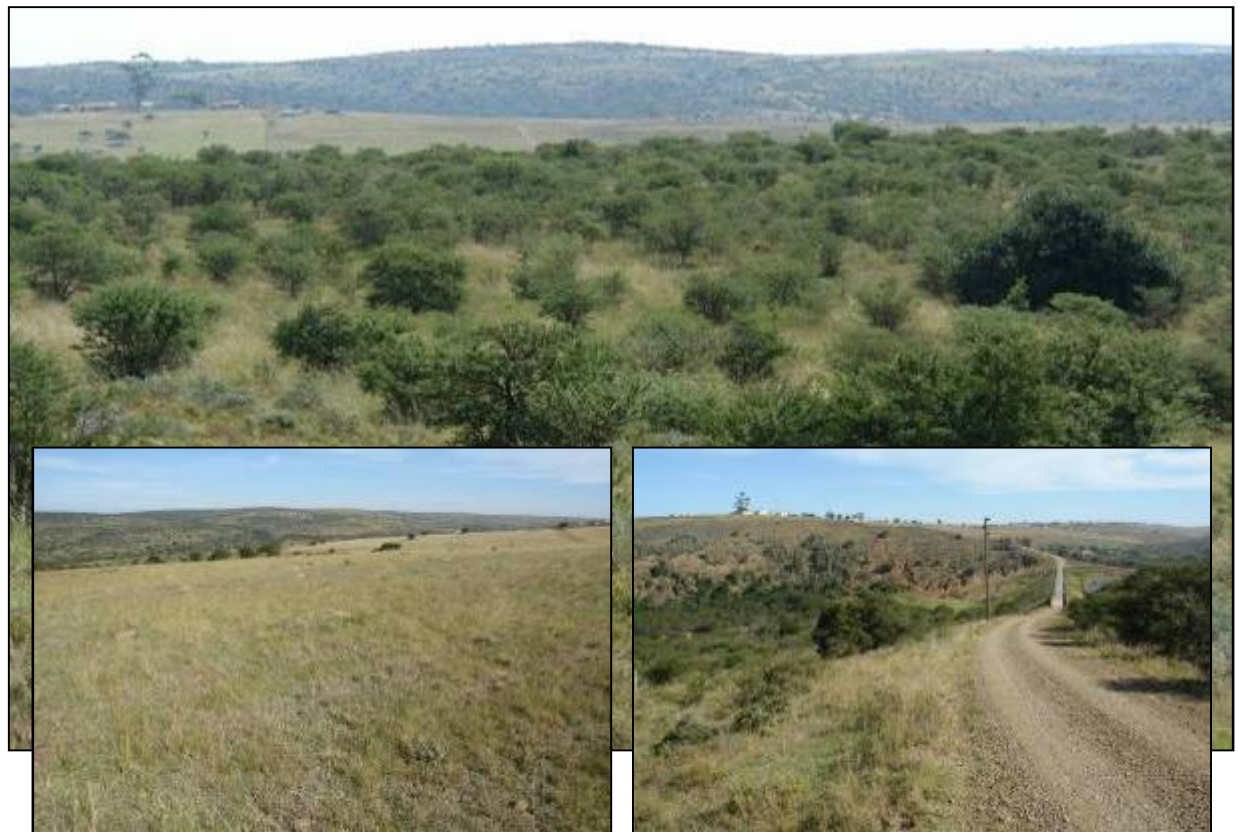
Figure 8. General views of the route to Feni visible in the far distance (main image), towards Woodridge (left insert) and the route around Feni along hill slope south towards the Peddie Substation (right insert).

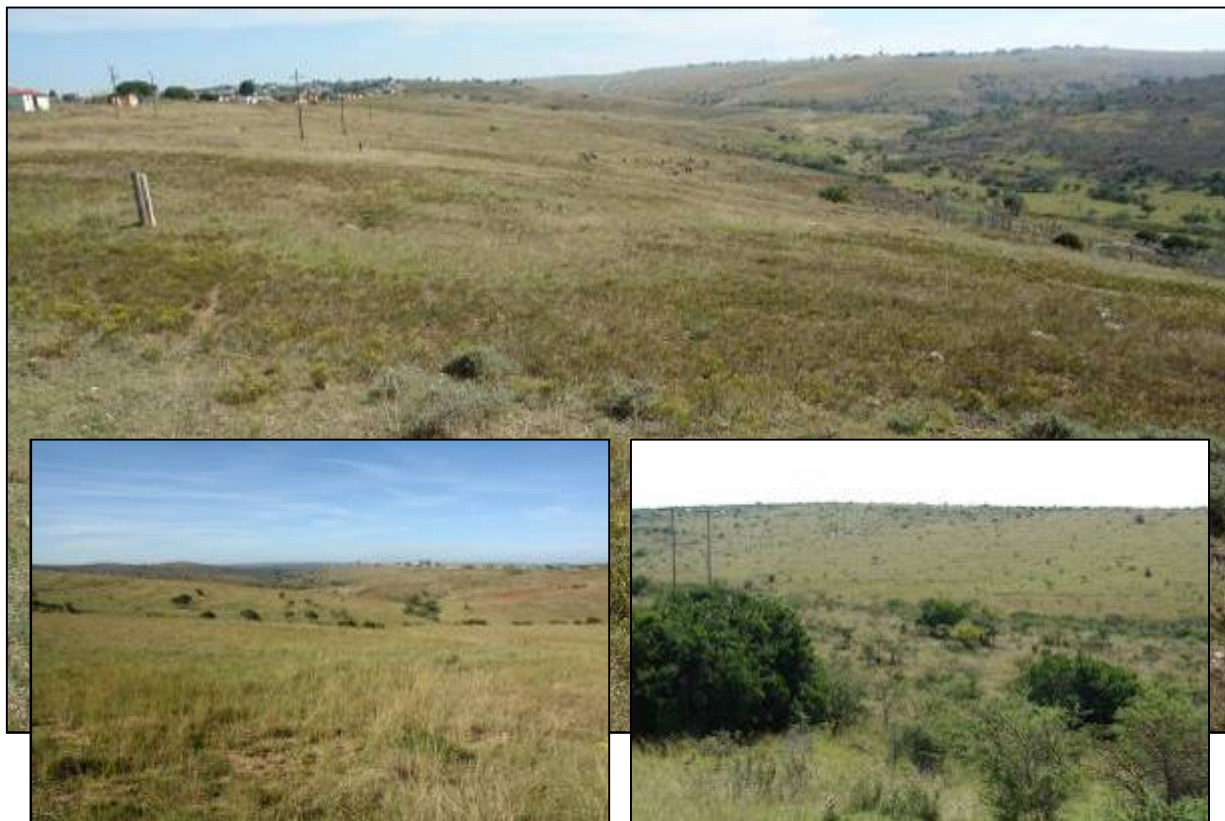
Figure 9. General views of the route from Feni along the valley towards the R345 and the Peddie Substation (main image), from the R345 towards Feni in the far distance (left insert) and a view from the R345 towards the Peddie Substation (right insert).

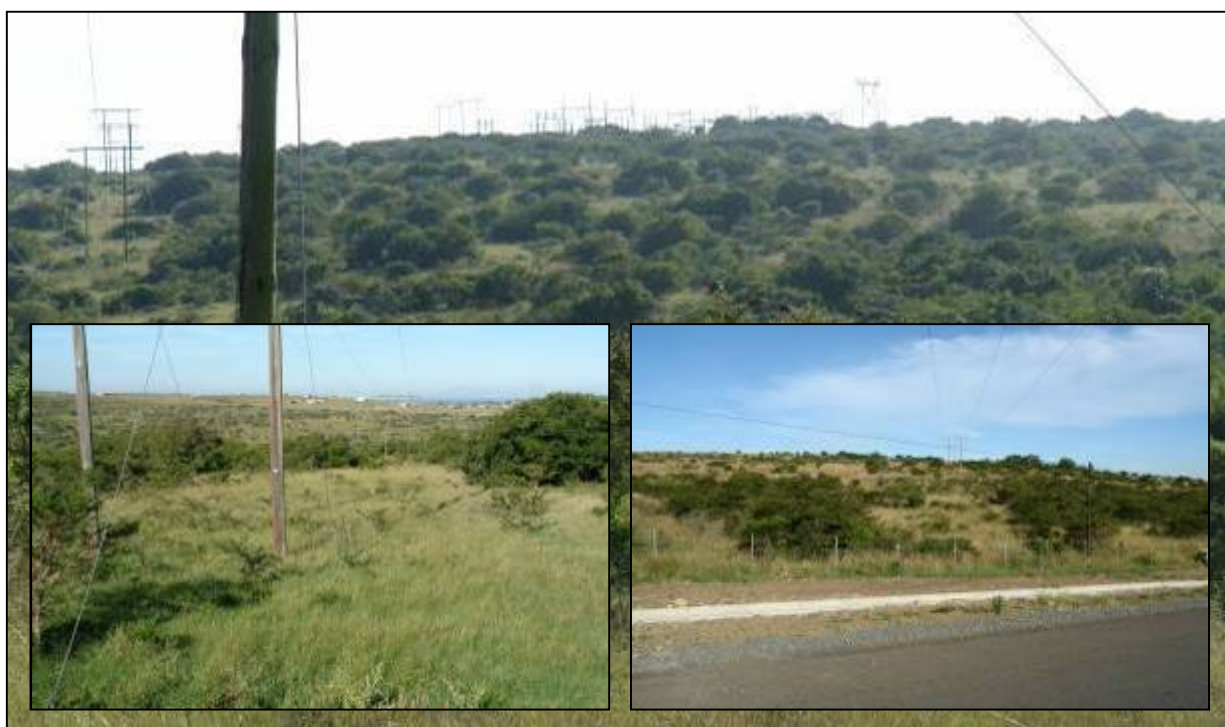
Figure 10. General views towards the Peddie Substation from the N2 (main image), towards the N2 from the substation (left image) and a view from the N2 towards Feni.
