**PHASE 1 ARCHAEOLOGICAL IMPACT ASSESSMENT  
OF THE PROPOSED CONSTRUCTION OF TOURISM UNITS  
AT ELANDSBERG REST CAMP AND  
STAFF VILLAGE NEAR THE ROODEWERF PARK OFFICE,  
TANKWA KAROO NATIONAL PARK,  
HANTAM LOCAL MUNICIPALITY, NORTHERN CAPE**

(Assessment conducted under Section 38 (8) of the National Heritage Resources Act (Act 25 of 1999) as part of an Environmental Impact Assessment)

**FEBRUARY 2014**

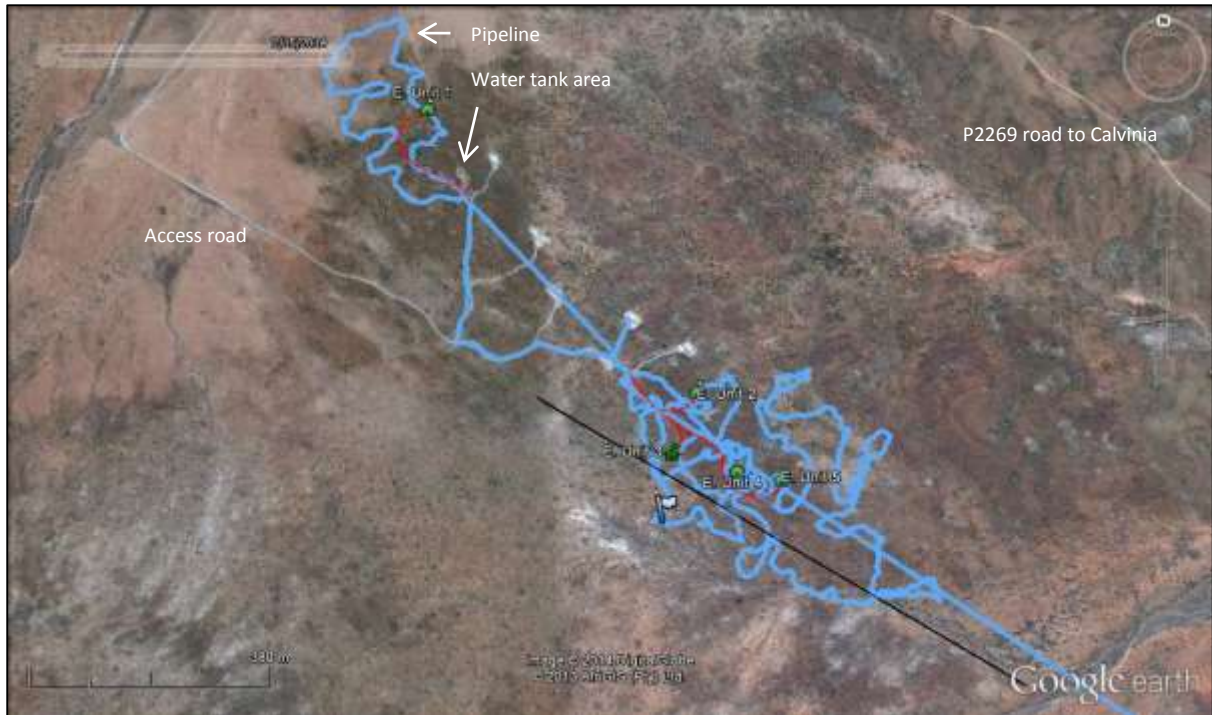
Figure 4: Google earth image showing the location of the Elandsberg Rest Camp in the eastern part of the Elandsberg range. The five existing cottages with linking roads are evident in the centre of the image. The proposed additional units are indicated by the green house icons labelled E Units 1 to 5 and the proposed new roads are indicated by red lines. The black line indicates the position of the low dry stone wall and the flag the possible burial cairn. The relevant 1:50 000 topographical map is 3219BB Ymanskraal.

**Results of the survey:** As the exact positions of each proposed unit and internal linking road were not available when the fieldwork was done, a wider survey was made of the general area surrounding the development (Figure 4). Visibility of archaeological material on the ground surface was good throughout the affected area. A low density of Stone Age artefacts, distributed on the surface in a patchy manner, a possible burial cairn and low dry stone wall were recorded (Appendix Table 1). Although dolerite boulders are abundant, no rock engravings were observed. A well-developed patina of desert varnish is not present.

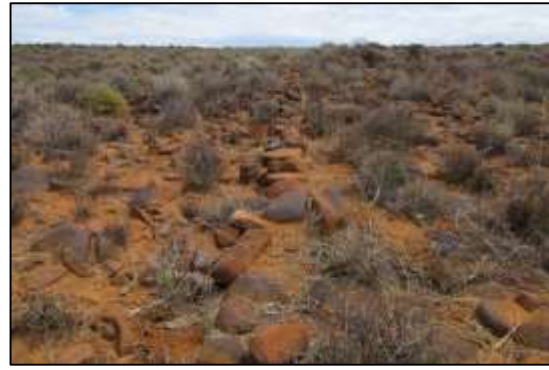
Figure 16: View to the northwest close to the area of Unit 5. Figure 17: View towards the northwest along a portion of the dry stone wall to the southwest of Units 4 and 5.

The low dry stone wall recorded (Figure 17, Appendix Table 1) lies to the southwest of Units 2 to 5 and is indicated by a black line on Figure 4. From the Google earth image it is evident that the wall is at least 1.5km in length. It is not clear what age this structure is but it is probable that it is older than 60 years. A couple of metal posts were seen in close proximity to the wall, but it is possible that these were added to the original boundary wall. There appear to be no buildings or ruins in the immediate vicinity of the affected area and this was confirmed by Mr C. Strauss (Oom Conrad) who used to farm locally and is the father of the present Park Manager, Mr Conrad Strauss (pers.comm.).

In the case of the wall, however, it is possible that building activities and heavy vehicle traffic may have a direct impact on it as it may be damaged or destroyed. At the point closest to the proposed development, it is situated only some 20m to the southwest of proposed Unit 3. It is possible, indeed likely, that boulders from the wall may be robbed for the construction of the proposed units.

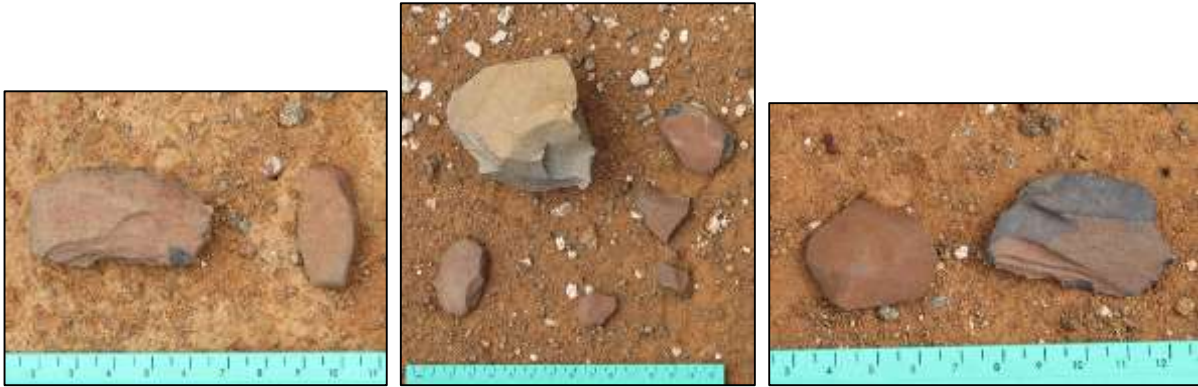
Figures 18, 19 and 20: Hornfels flakes and core (top left in middle photo) with varying degrees of weathering and patination recorded in the area around proposed Unit 1. The scale is in cm.

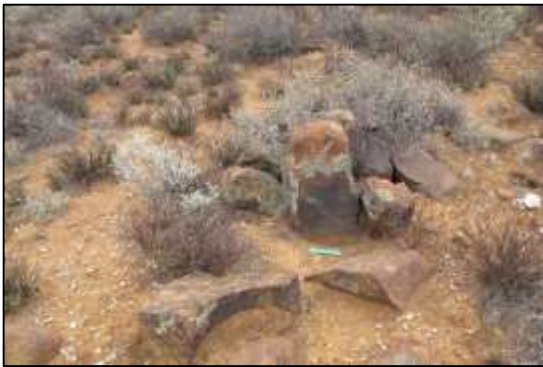
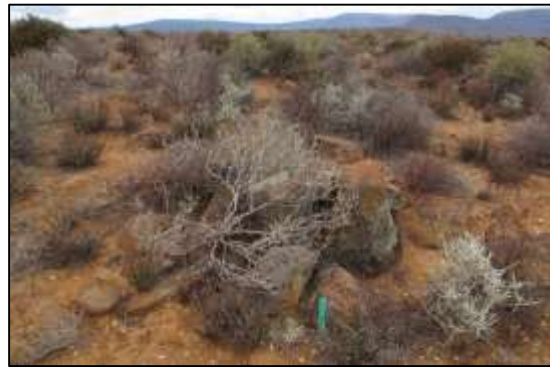
Figures 21a and b: Views towards the north and northeast respectively of the possible burial cairn at Elandsberg Rest Camp. The ruler is about 15cm in length.

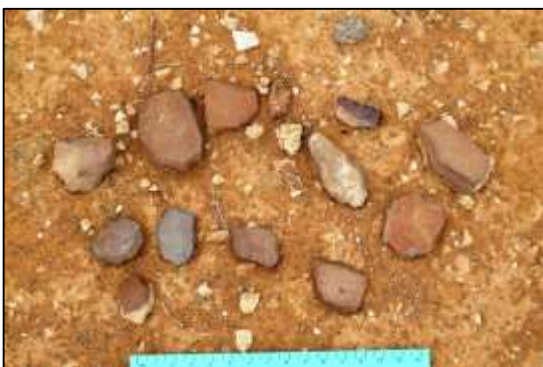
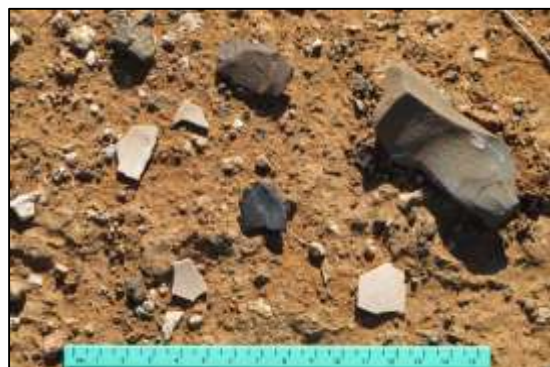
Figure 22: A scatter of hornfels artefacts, mostly weathered, noted in the vicinity of the possible burial cairn. Figure 23: Ostrich eggshell fragments with hornfels flakes and chunk. The scale is in cm.

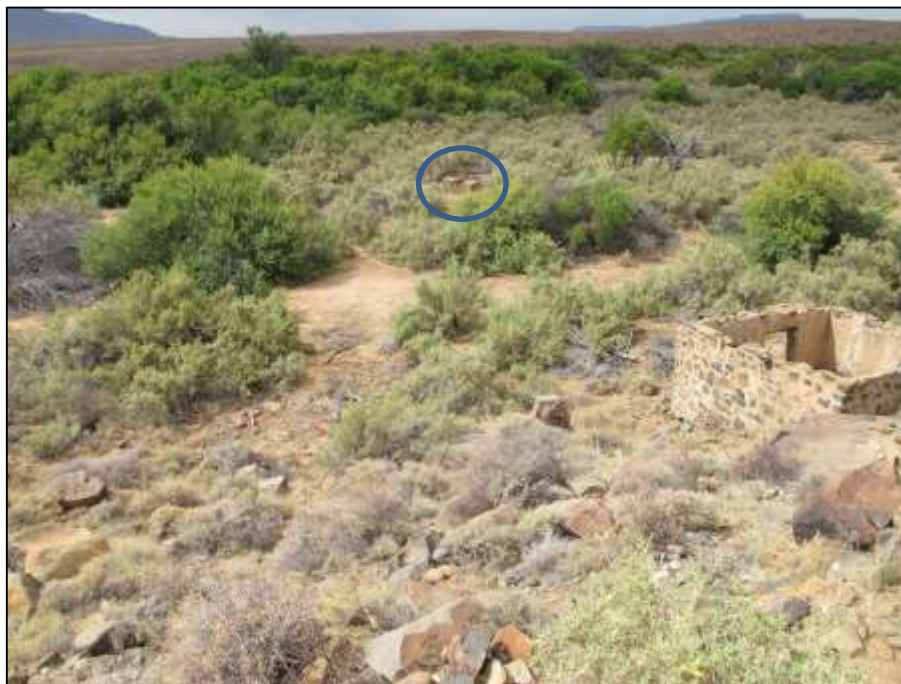
Two low stone and mortar pillars were observed some 28 m to the southeast of the ruin (Figures 50, 53 and 54, Appendix Table 2). Grooves on the inner facing sides of the pillars suggest that they could be part of a sluice gate to control the flow of water for irrigation (Figure 53). It is possible that embankments of soil, with some associated dressed blocks of stone, to the northeast of the gate indicate the remains of a channel (Figures 53 and 54) which must have been associated with the nearby 'lane'. Signs of digging and disturbance are evident throughout this area but the dense vegetation and heaps of dead branches prevent good visibility of these features.

Figure 50: C Band area – view towards the south with the possible sluice gate indicated by the blue oval. Detail of the rubbish heap to the left (northeast) of the ruin is shown in Figure 55.

It is therefore recommended that the structures and associated features (such as the sluice gate, boulder borders and historical rubbish dumps) be mitigated. Mitigation would be undertaken by a professional historical archaeologist with a permit issued by SAHRA and should involve:

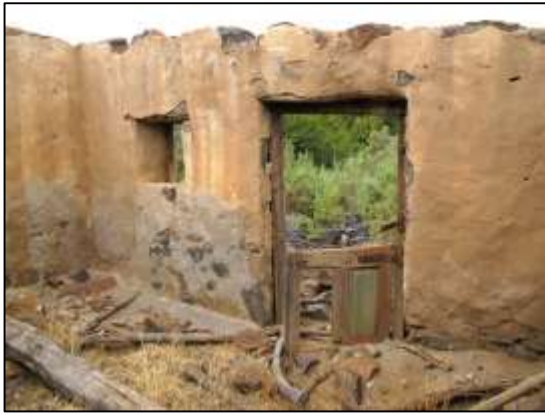
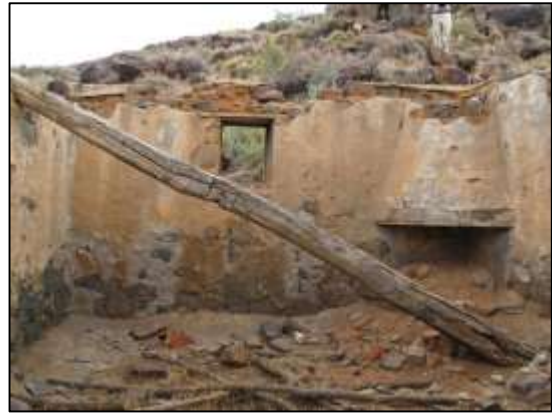
Figure 51: View towards the southeast from the interior of the ruin. Figure 52: Interior showing the corner hearth.

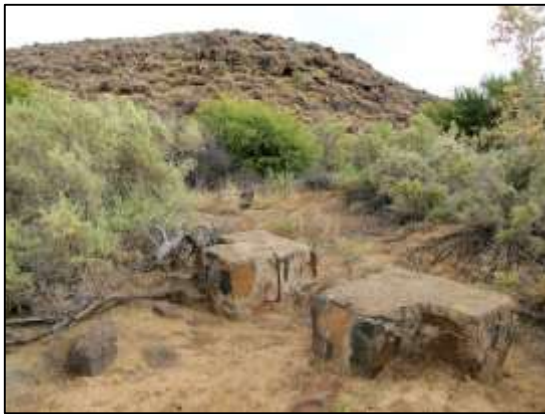
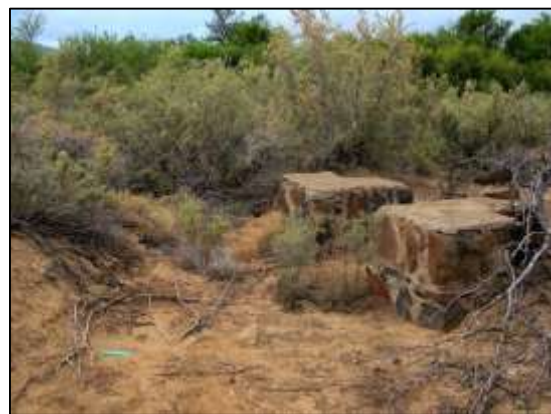
Figures 53 and 54: Views towards the north and southeast of the possible sluice gate and possible remains of a channel. The green ruler is about 15cm in length.

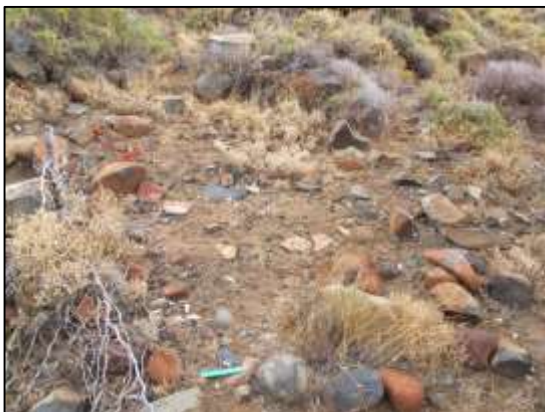
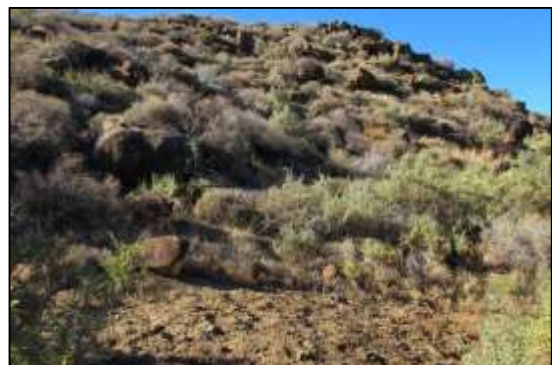
Besides the sluice gate and the house itself, other features include partly-damaged low walls or borders made of dolerite boulders, a small soil-covered rubbish midden of domestic debris on either side of the house (Figures 55 and 56) and dispersed materials such as fragments of glass, metal (including a square nail and an old chair; Figures 57 and 58), ceramics, bone, dressed stone blocks and more modern cement breeze blocks. These items are scattered amongst the bushes surrounding the house and along the access route. Artefacts, mostly

Figure 55: Part of the rubbish dump to the northeast of the ruin. Figure 56: View towards the north of the rubbish dump area to the southwest of the ruin. Quarrying of stone occurred in the past on the lower slopes of the hill (see Figure 63 below).

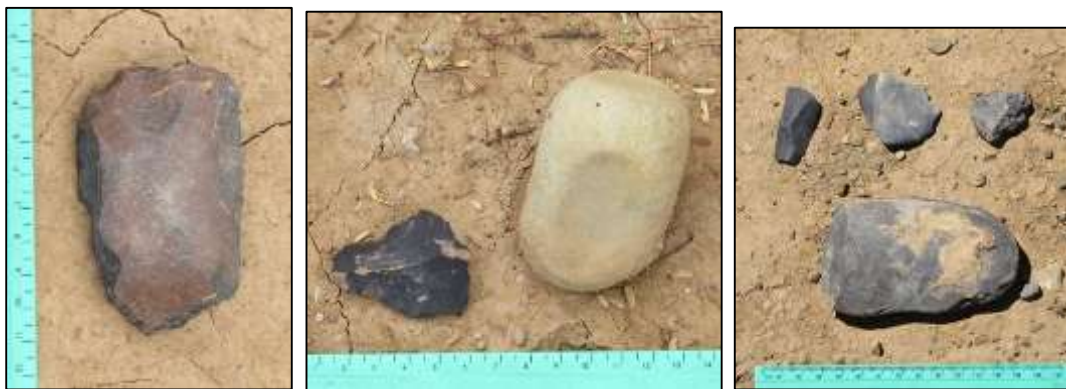
Figures 60 to 62: Stone artefacts seen near the ruin and C Band. Weathered tool with one retouched and one damaged edge; hornfels flake and quartzite cobble with polished surfaces; hornfels flakes and flaked pebble. The scale is in cm.

sandstone was also used (Figures 60 and 67). Most of the stone artefacts recorded were made of fairly fresh-looking hornfels but some weathered and patinated pieces were noted. Hornfels would be locally available where Ecca Group mudrocks have been baked by dolerite intrusions. There is in fact a quarry close to the cemetery to the southeast of the Roodewerf Park Office where slabs of baked mudrock has been exploited for building stone (Figure 31). Some of the Ecca sandstones are fine-grained, homogeneous and dense, so they could have been a reasonably good source of raw material for the manufacture of artefacts (J. Almond, pers. comm.). A single flaked piece of quartzite was seen (Figure 68). Most of the pieces seem to be of LSA or possibly MSA/LSA origin, but a definite ESA handaxe was also recorded (Figure 69). A quartzite cobble with a polished facet was probably used as a grindstone (Figure 61).

made of hornfels as well as occasional ones made of sandstone, were also recorded amongst these historical and modern fragments (Figures 60 to 62). Signs of quarrying of dolerite are evident on the slopes of the hill behind the house (Figure 63). There is a small rock niche where a boulder has been wedged between two rock faces (Figure 64) to the northeast of the quarrying area. Several OES fragments were noted at the small overhang.

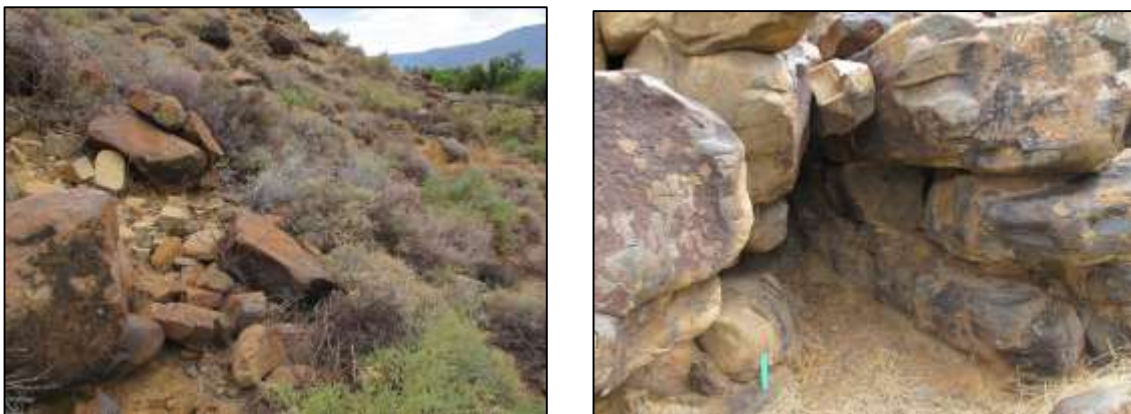
Figures 63 and 64: On the dolerite hill behind the ruin - view to the northeast of some quarried blocks of dolerite; the small rock niche. The green ruler is about 15cm in length.

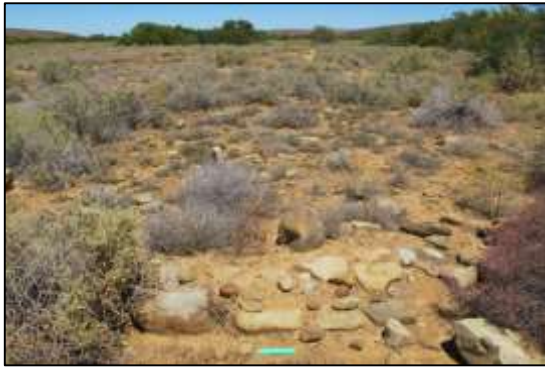
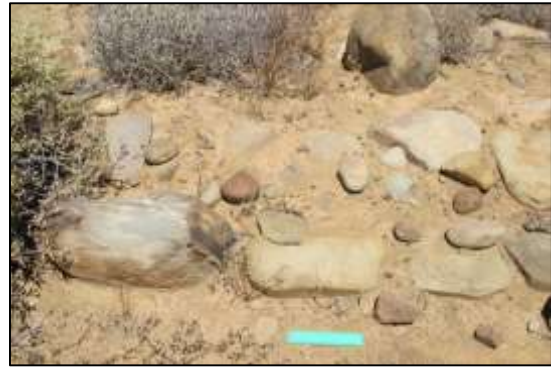
Other historical structures recorded in the rest of the affected area, away from C Band, are a small fragment of a possible foundation wall (Figures 65 and 66), a low dry stone wall of dolerite boulders marking a boundary (Figures 72 to 74) and the remains of a possible kraal (Figures 75 and 76). The section of foundation wall is only about 4 to 5m in length and approximately 50cm wide. Stone Age remains, as well as a bullet casing, were found in close proximity to historical and/or modern ceramic and glass fragments, (Figures 67 and 68). Weathered and patinated ESA artefacts, probably made of fine-grained sandstone, were seen amongst river cobbles close to the foundation. These consist of a handaxe, a flaked cobble and a large flake (Figures 69 to 71). The dry stone wall is similar to that at the Elandsberg Rest Camp and consists of dolerite and sandstone boulders and blocks (Figures 72 to 74). It is at least 550m in length and is indicated by a black line in Figure 31.

Figures 65 and 66: B Band area - view towards the west of the possible foundation wall; detail of the wall. The green ruler is about 15cm in length.

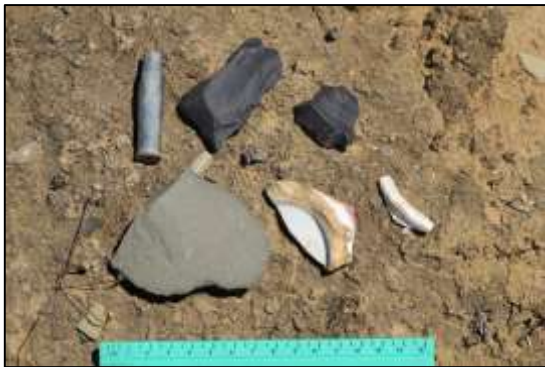
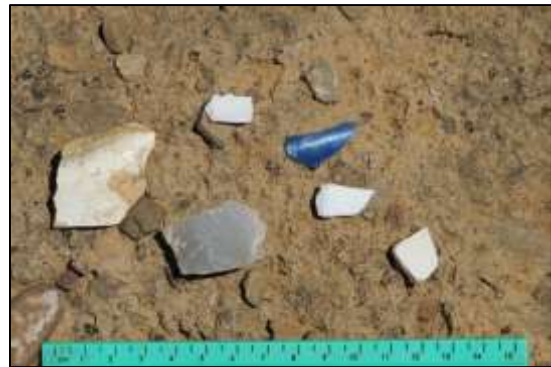
Figures 67 and 68: B Band and the vicinity of the possible foundation wall - hornfels and fine-grained sandstone found in association with a bullet and ceramic fragments; the only quartzite flake noted in association with ceramic and glass fragments. The scale is in cm.

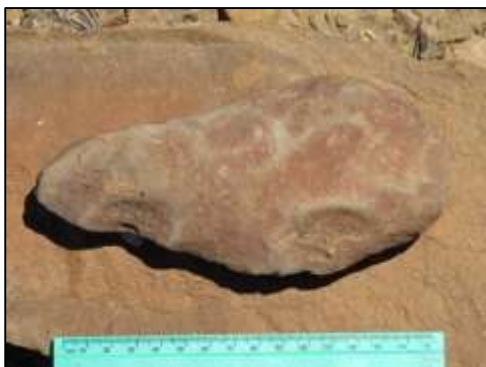
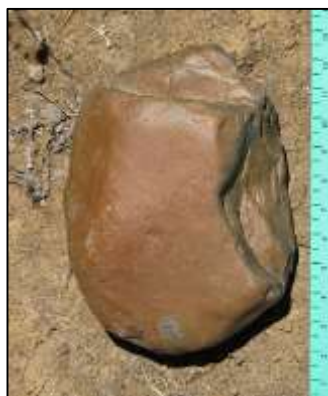
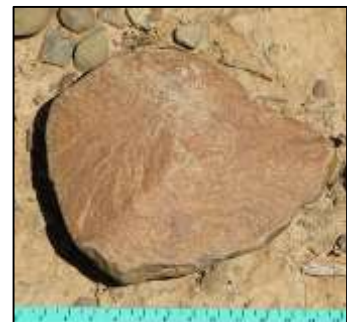
Figures 69 to 71: B Band and the vicinity of the possible foundation wall - ESA handaxe; flaked cobble and large flake. The scale is in cm.

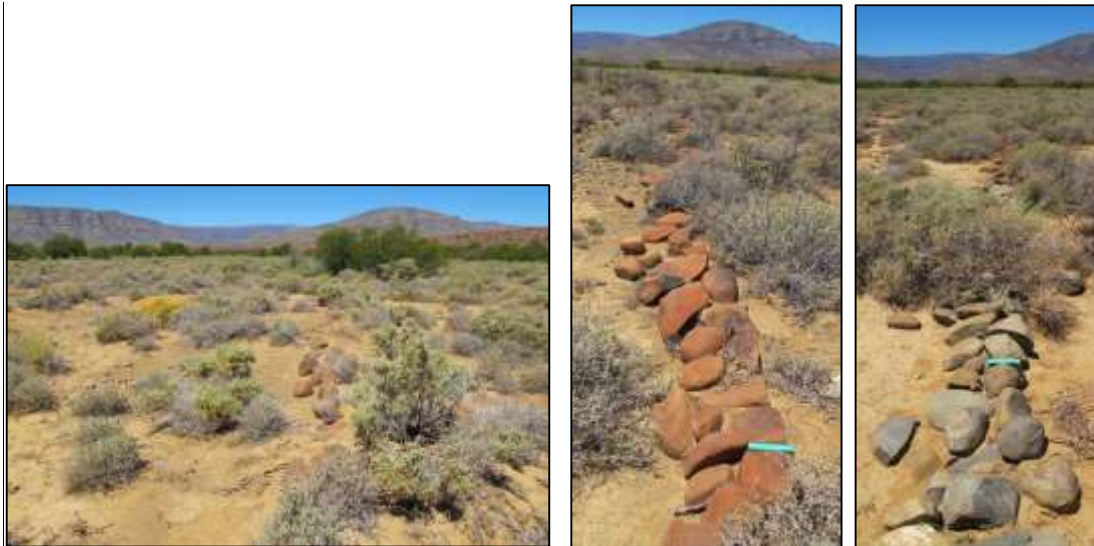
Figures 72 to 74: The stone wall near A Band and recreation area – view towards the southeast; detail of section with dolerite boulders; detail of section with sandstone blocks.

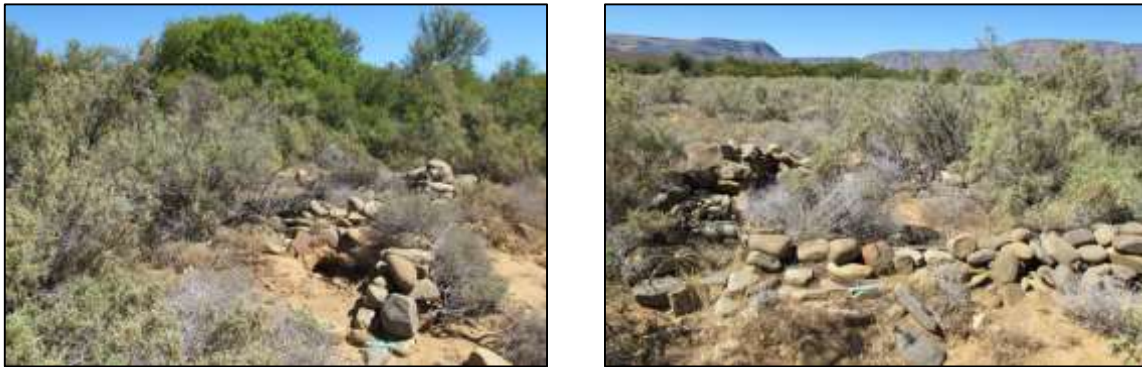
The possible kraal, located close to the Renoster River and to the southeast of the recreation area, is orientated in a northeast/southwest direction. It consists of a rectangular dry stone walled structure, approximately 5.5m x 3m, with a dividing wall (Figures 75 and 76). The walls have collapsed in places and bushes growing amongst them impeded visibility to some extent. Low density scatters of glass and ceramic fragments, a few metal items and pieces of bone were noted in the vicinity of the kraal (Figures 77 to 79). The bone included a piece of rib, part of a long bone and a fragment with cut marks (Figures 77 and 78). Hornfels and fine-grained sandstone artefacts were also observed (Figures 79 and 80).

Figures 75 and 76: A Band and recreation area - views to the southwest and northeast of the possible kraal to the southeast of A Band. The green ruler is about 15cm in length.

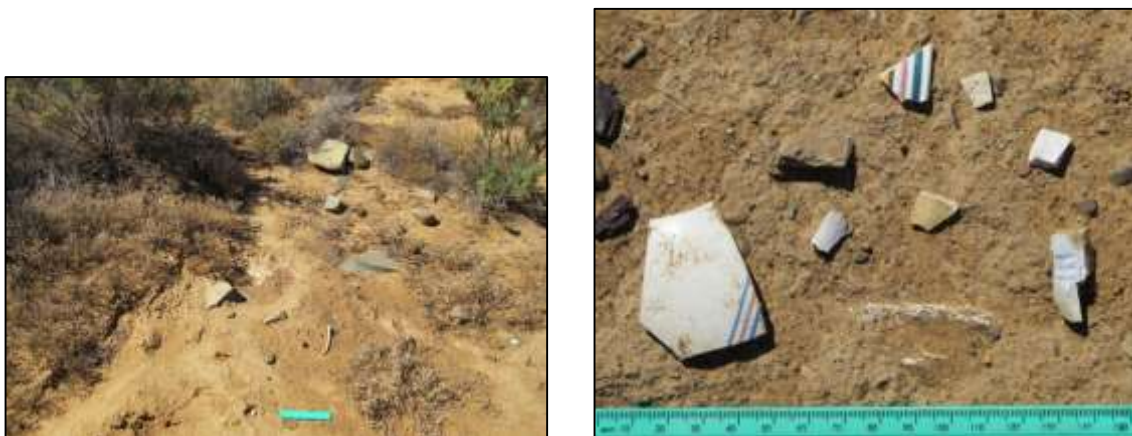
Figures 77 and 78: Area of possible kraal near A Band and recreation area – area with pieces of bone, metal, glass and ceramic fragments; fragments of ceramics and bone, including one showing cut marks (bottom right). The scale is in cm.

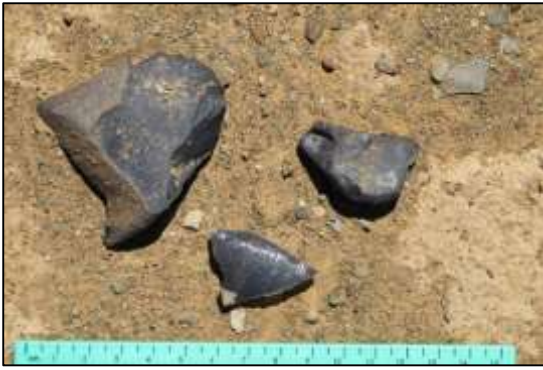
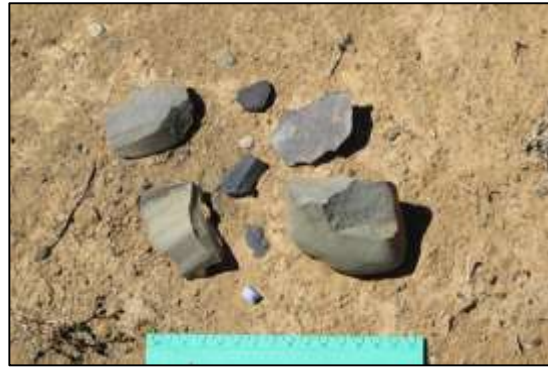
Figures 79 and 80: Area of possible kraal near A Band and recreation area – hornfels flakes and glass fragment; fine-grained sandstone and hornfels flakes and chunks. The scale is in cm.

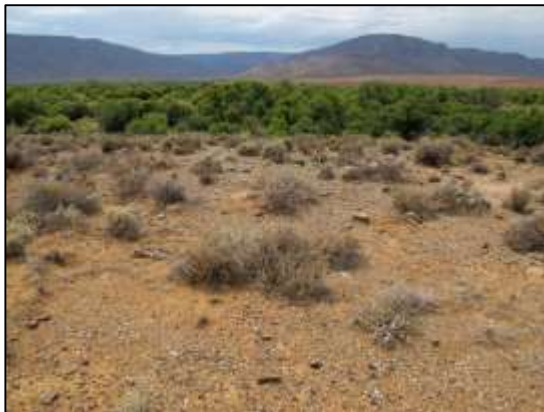
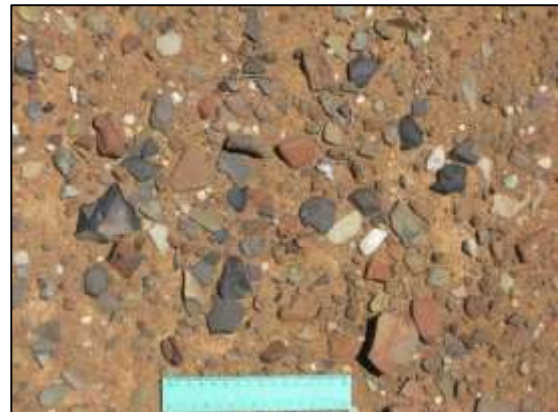
Figure 83: View towards the east of the finer surface gravels overlying the bouldery high-level gravels. Figure 84: Detail of the finer surface gravels including numerous flaked clasts (Photo courtesy of J.E. Almond). The green ruler is about 15cm in length.

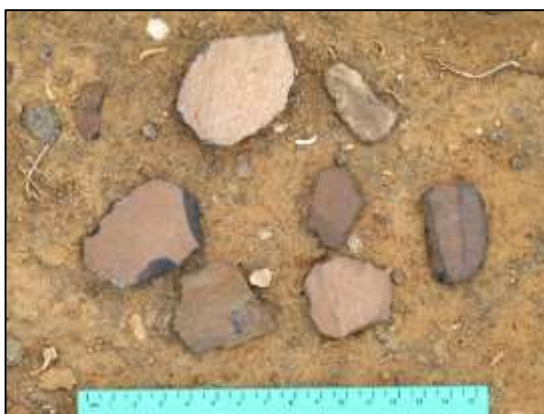
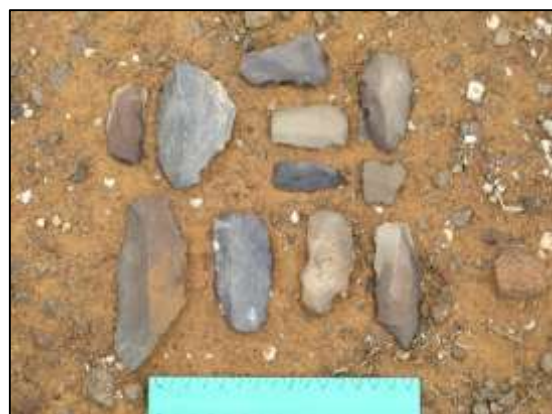
Figure 85: Examples of some of the weathered hornfels MSA and LSA artefacts observed on the lower slopes of the hill. Figure 86: Re-exhumed MSA blades close to an aardvark burrow. The green ruler is about 15cm in length.

It is therefore recommended that mitigation be undertaken by a professional archaeologist with a permit issued by SAHRA. This should involve:

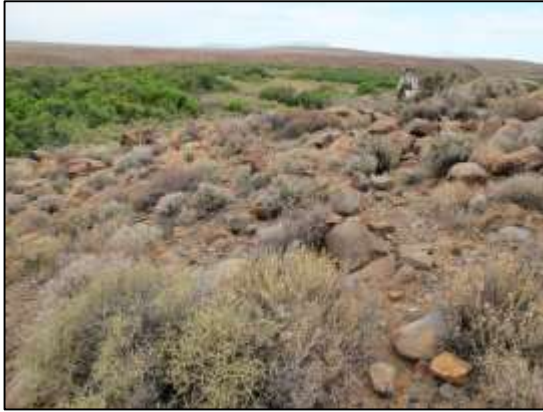
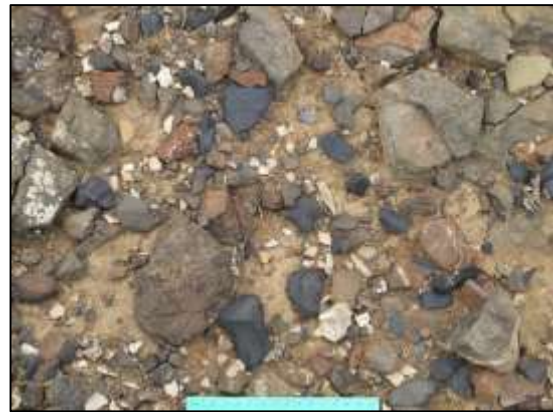
Although no significant Stone Age material was located in the formerly cultivated area of the proposed Staff Village and the sparse material seen is in a highly disturbed context, the slopes of the dolerite hill to the north of the affected area are extremely rich in terms of stone artefacts. Hundreds of MSA and LSA artefacts are scattered on the hill (Figure 81). Many of these are very weathered and patinated (e.g. Figure 85) and form a background scatter amongst the dolerite boulders covering the hill slopes. High concentrations of flaked hornfels, including numerous fresh-looking artefacts, occur among finer surface gravels and silts overlying bouldery high-level gravels situated on a pediment surface some 6 to 10m above the present valley floor (Figures 82 to 84). The finer surface gravels occur in a fairly well-defined area, the approximate extent of which was marked by the author's tracks (Figure 31, Appendix Table 2). Besides hornfels, other raw materials include fine-grained sandstone and quartzite, with rare chert, including pale grey Matjiesfontein chert probably sourced from the Collingham Formation outcrop in the western Tanqua Karoo (J. Almond, pers. comm.). Several MSA blades observed in association with an armadillo burrow have probably been displaced from lower-lying levels within the silty alluvium (Figure 86). Of the numerous weathered hornfels artefacts seen amongst the bouldery dolerite colluvium on the slopes, the densest concentration of artefacts was located towards the top of the hill, immediately northwest of the ruin (Figure 87). Here LSA artefacts of hornfels and chert occur in association with abundant OES fragments and occasional small pieces of bone (Figure 88).

Figure 87: View towards the south of the top of the dolerite hill. Figure 88: Detail of LSA hornfels artefacts in association with OES and bone fragments at the top of the hill. The green ruler is about 15cm in length.
