**ARCHAEOLOGICAL IMPACT ASSESSMENT
THE PROPOSED UPGRADING OF THE
LOUISEVALE ROAD WASTE WATER TREATMENT
WORKS IN LOUISEVALE, UPINGTON
NORTHERN CAPE PROVINCE**

Archaeological study proposed upgrading of the Louisevale Road Waste Water Treatment Works

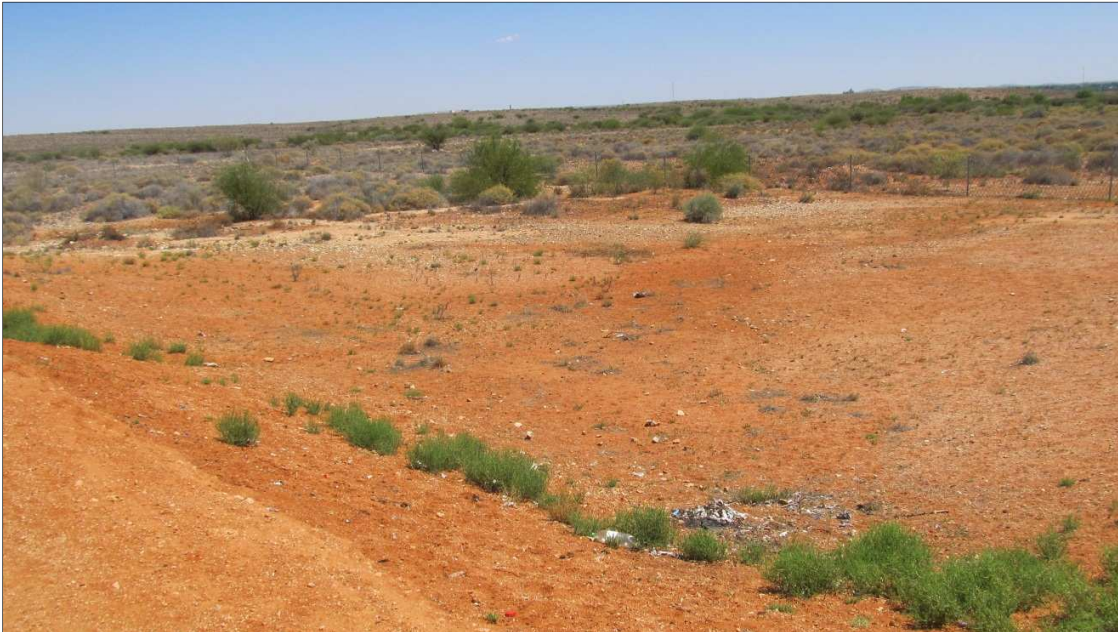
Figure 4. View of the existing footprint area facing north east. Notice the already severely disturbed terrain in the foreground where some of the proposed expansion will take place.

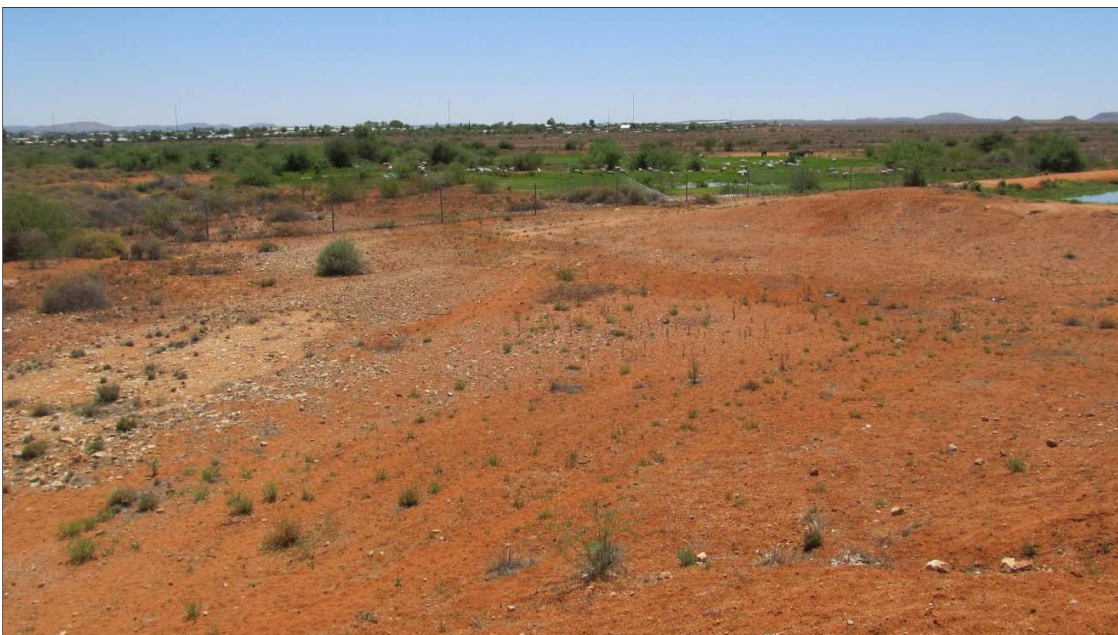
Figure 5. View of the existing footprint area facing south east. The artificially created wetland area is in the background of the plate, immediately behind the boundary fence.

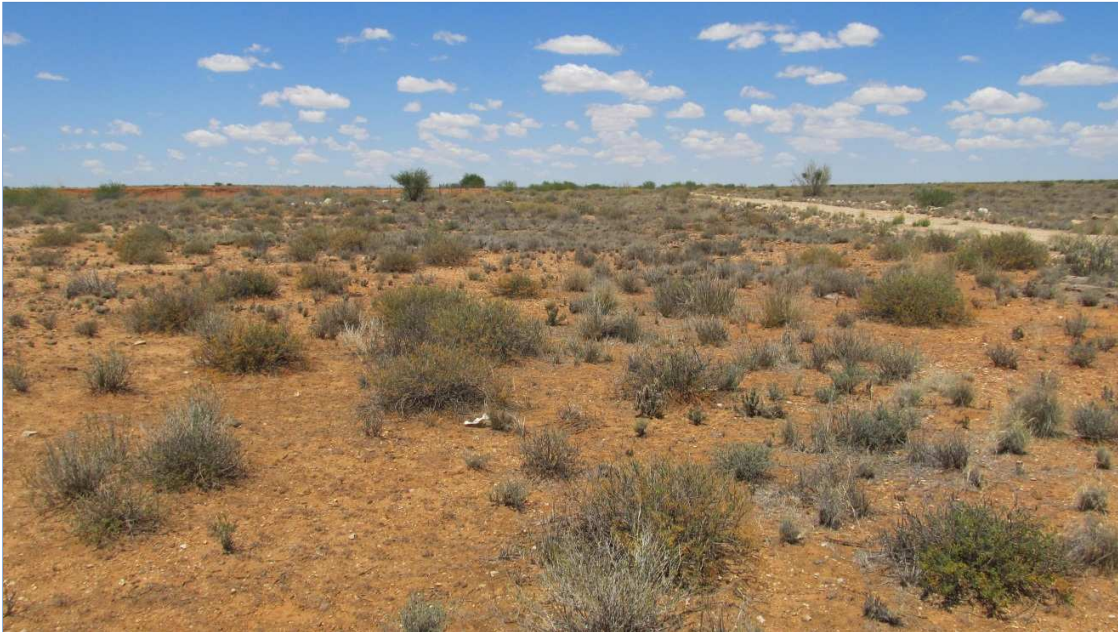
Figure 6. View of the proposed site facing west. The gravel road is the northern limit of the proposed expansion programme.

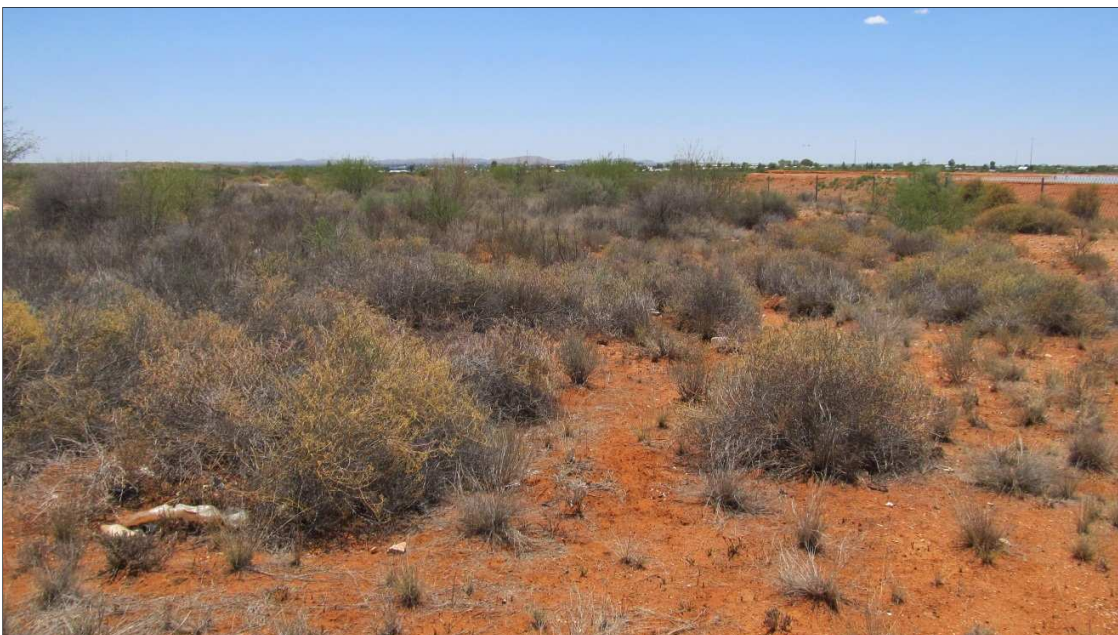
Figure 7. View of the proposed site facing north east. The existing WWTW is to the right of the plate

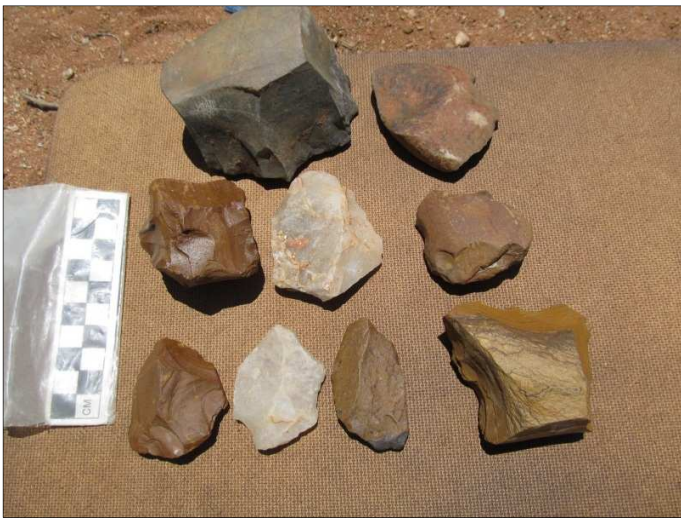
Seven cores (comprising 20% of the lithics) were also counted, perhaps indicating the desirability of the raw material, while only one core in indurated shale was found. Frequencies of formally retouched tools was very low; two double sided retouched pointed flakes (812 & 819) and one retouched end and side scraper (805) was found. No organic remains such as bone, pottery, or ostrich eggshell were found.

Figure 8. Collection of tools encountered during the study. Scale is in cm

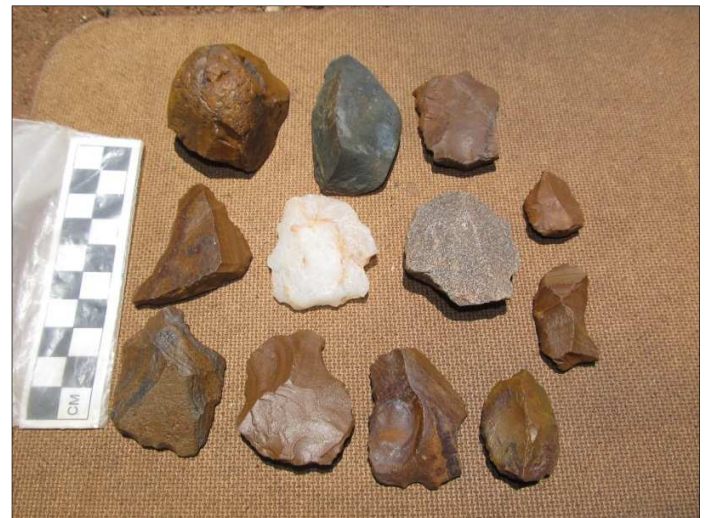
Figure 9. Collection of tools encountered during the study. Scale is in cm
