HERITAGE IMPACT ASSESSMENT

THE PROPOSED KALAHARI-EAST BULK WATER SUPPLY SCHEME PHASE 1A ASKHAM TO PHILANDERSBRON, NORTHERN CAPE

Heritage Impact Assessment proposed Kalahari East Bulk Water Supply Scheme Phase 1A
Askham to Philandersbron

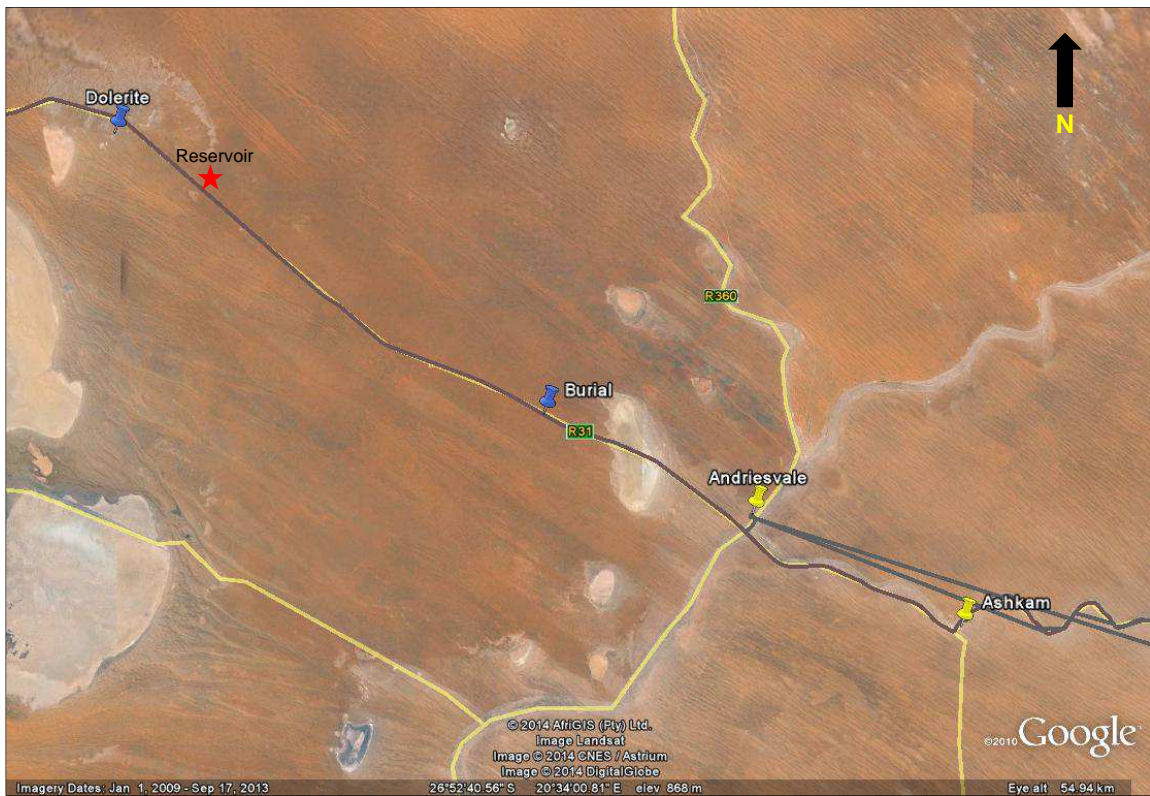
Figure 12. Location site of burial recorded along the proposed pipeline route.

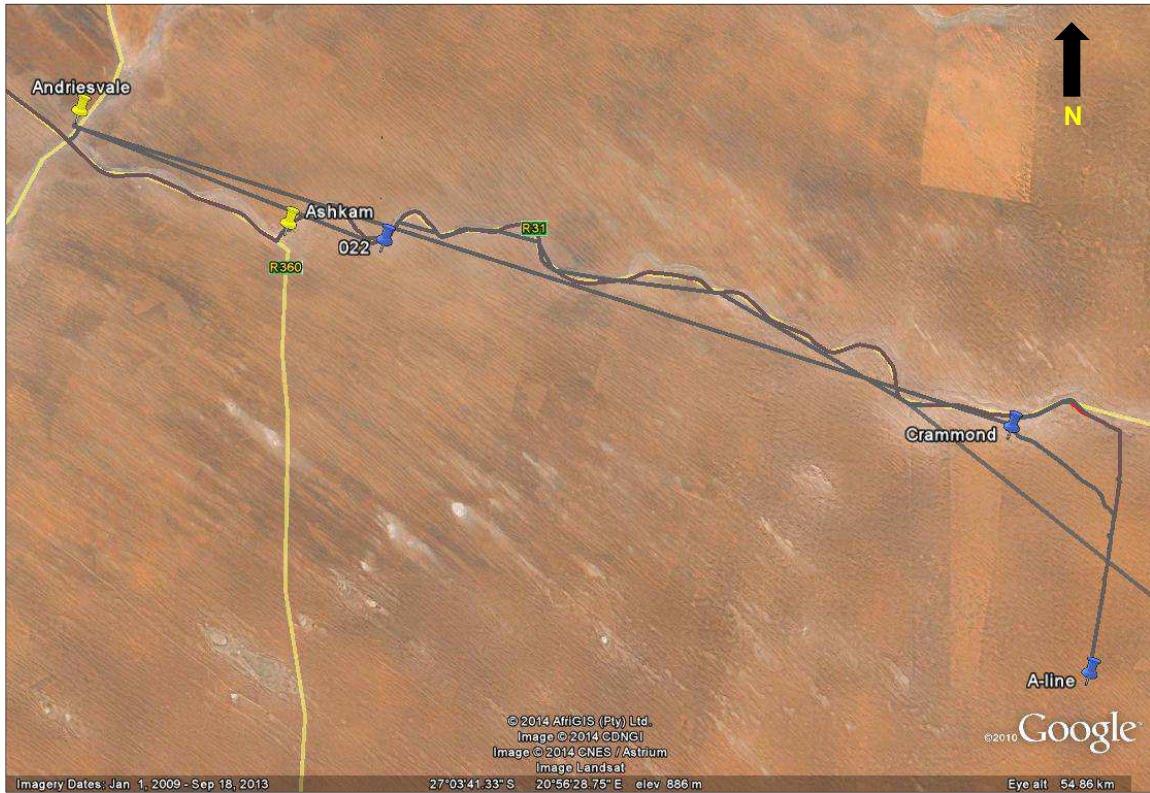
Figure 13. Location of archaeological occurrences recorded along the proposed pipeline route

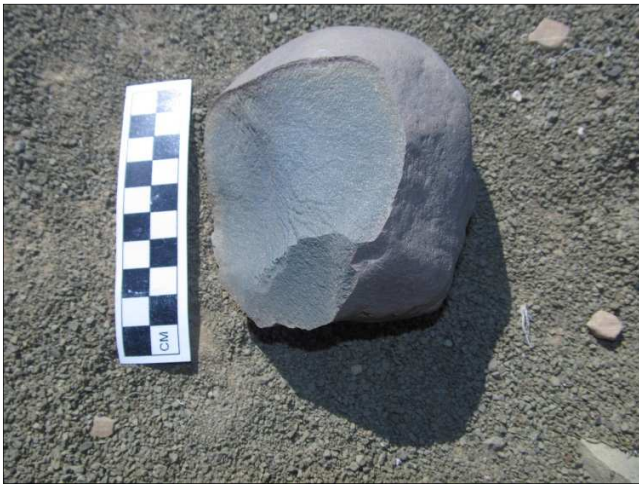
Figure 14. Site 001. Scale in cm.

A handful of stone implements (Sites 001-003), including several MSA quartzite and indurated shale flakes, chunks, and a quartzite disc/prepared core were found in a severely degraded area between the existing reservoir at Philandersbron and the Namibia Road (Figures 14 & 15).

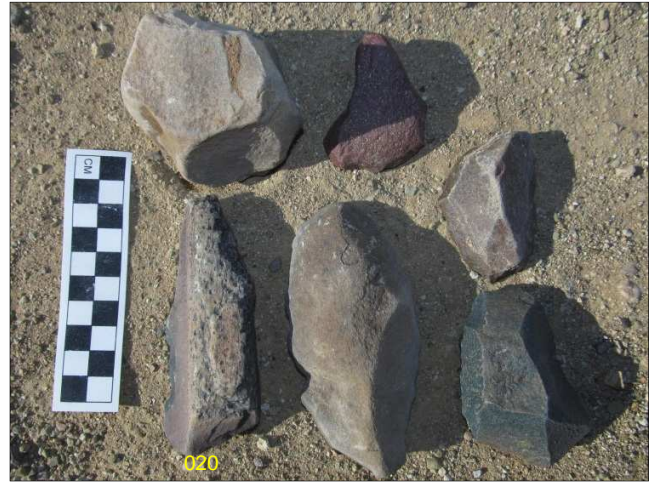
Figure 19. Site 017-020. Scale in cm.

Two MSA quartzite flakes (Sites 017 & 019), several highly weathered and partially retouched indurated shale MSA flakes (Site 018), and a chunky weathered, retouched indurated shale 'knife' was recorded in the road reserve (R360) between Rietfontein and Askham (Figures 19 & 20). The tools were all found on a raised terrace covered in loose weathered indurated shale gravels.

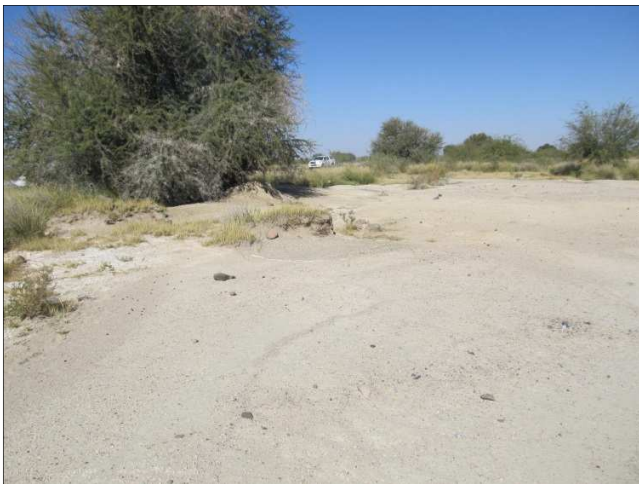
Several MSA quartzite flakes were recorded on eroded and sheet washed gravels (Site 013) outside the road reserve near the entrance to the town of Rietfontein (Figures 17 & 18). A chunk/minimal core (Site 014), a flaked cobble (015) and a broken indurated shale MSA flake (Site 016) were also found near the intersection with the R360.

Figure 17. Site 013. Sheet-washed gravels near entrance to Rietfontein. Note the bakkie alongside the road.

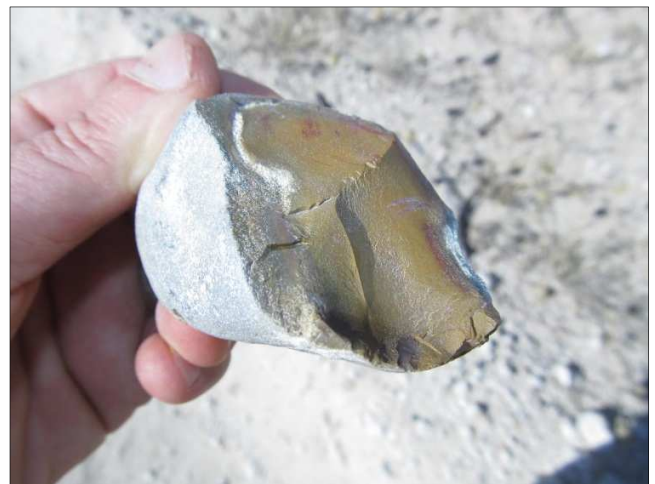
Figure 21. Site 022. Scale in cm.

One (possible) minimal chunk/core (Site 022) was found in the road reserve (R31) between Askham and Crammond (Figure 21).

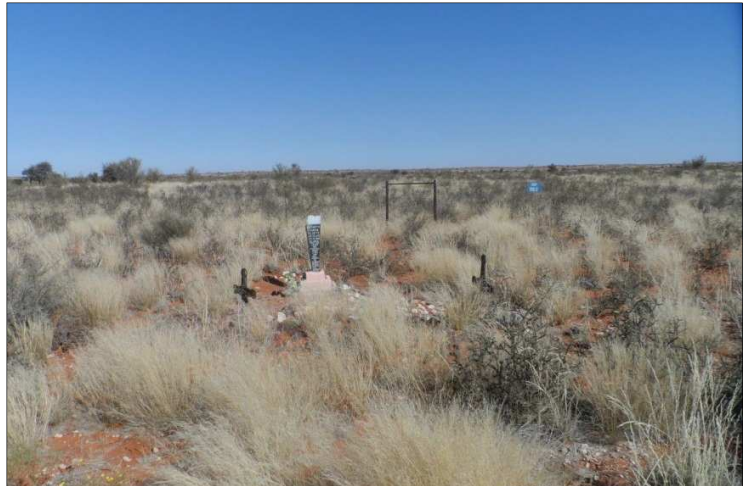
Three Christian graves (S 26 53 03.3 E 20 32 48.2) were encountered in the road reserve (R360) between Rietfontein and Andriesvale/Askham (Figure 22). The photograph and GPS co-ordinates for the graves were supplied by the biophysical consultant.

Graves (including unmarked graves and burials) have a high local significance and are protected under Section 36 of the NHRA.

Figure 22. Graves in the road reserve alongside the 360

3. The graves in the R360 road reserve between Rietfontein and Andriesvale/Askham must be avoided during construction of the pipeline. The graves must be taped off and clearly demarcated prior to construction work commencing, and should not be disturbed in any way. The Environmental Control Officer must be responsible for ensuring the graves are protected during the entire construction phase of the project.

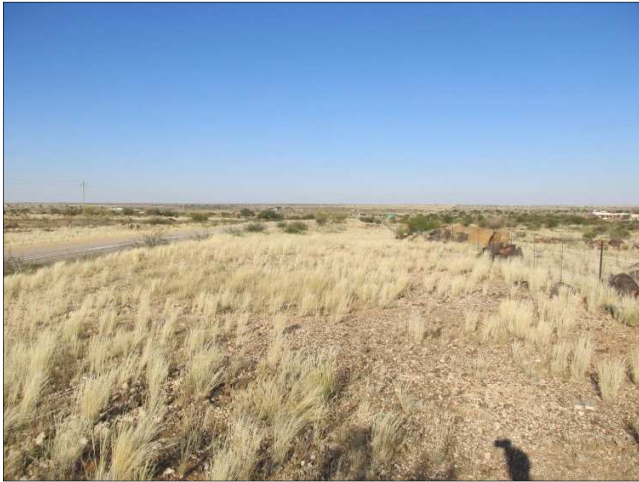
No rock engravings were found alongside the road (R360) where several outcroppings of dolerite occur in the road reserve near Klein Mier (refer to Figures 41 & 42).

Figure 41. 360 North approaching Klein Meir. Note dolerite boulders alongside the fence line

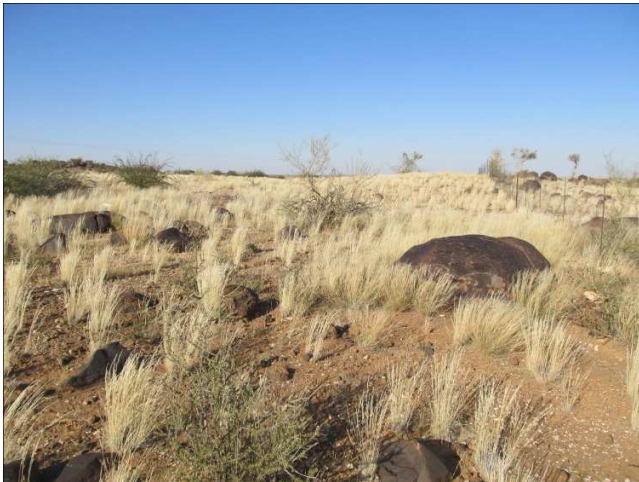
Figure 42. 360 North. Dolerite boulders in road reserve
