HERITAGE IMPACT ASSESSMENT

THE PROPOSED KALAHARI-EAST BULK WATER SUPPLY SCHEME PHASE 1A ASKHAM TO PHILANDERSBRON, NORTHERN CAPE

Assessment conducted under Section 38 (8) of the
National Heritage Resources Act 25 of 1999

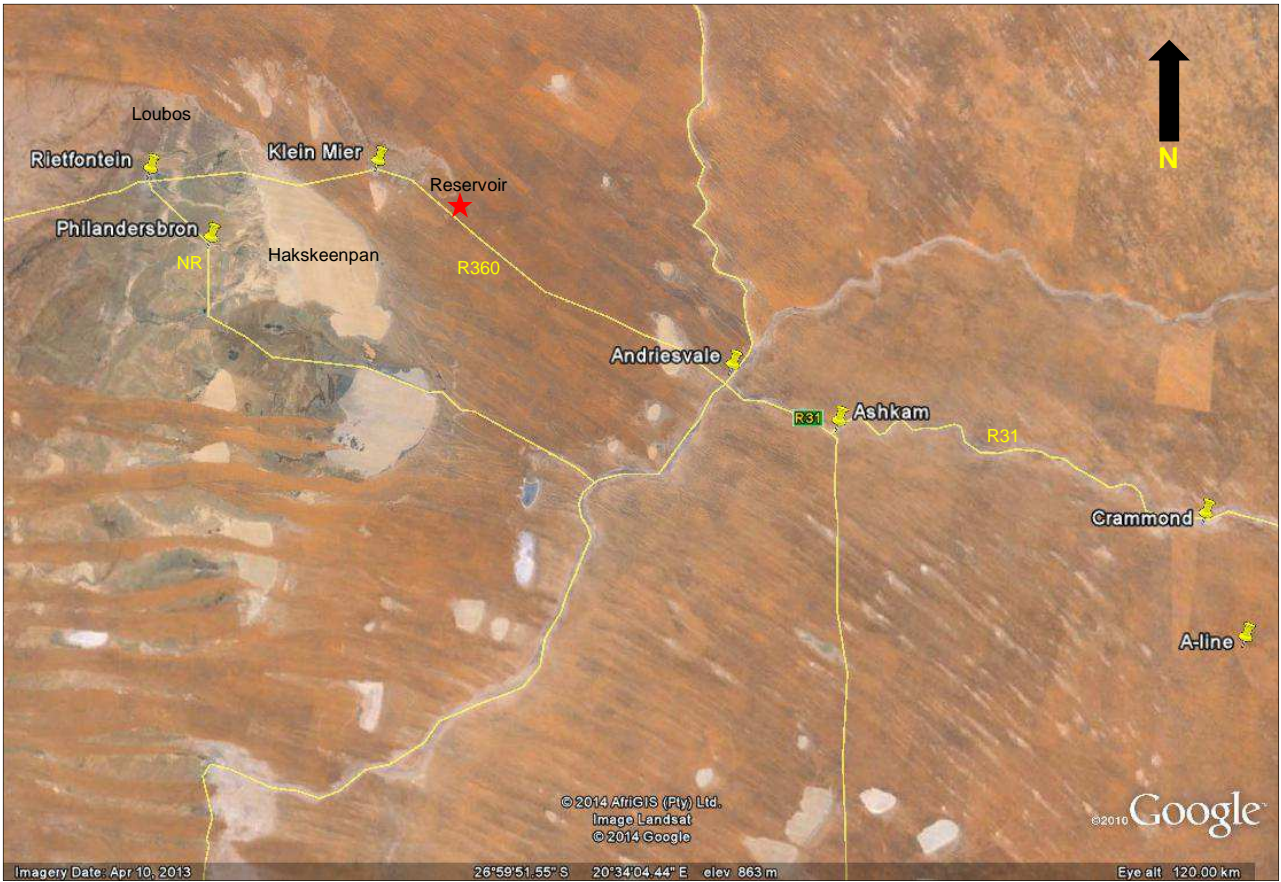
Figure 2. Google Aerial photograph indicating the towns along the proposed pipeline route. The location site for the proposed reservoir (red star) is also indicated. Note the settlement of Loubos north of Rietfontein.

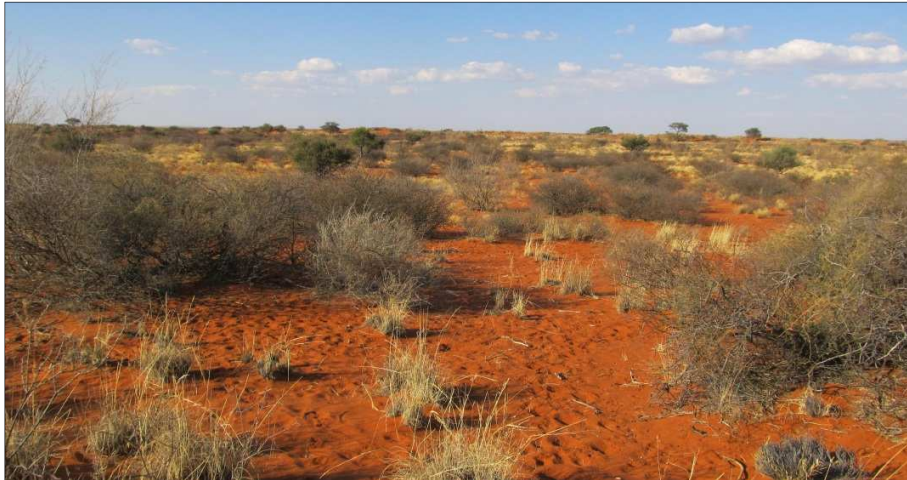
Figure 4. Footprint area of the proposed earth reservoir, view facing north east

The receiving environment comprises mainly grasses and sporadic trees on a substrate of red windblown (aeolian) Kalahari sands (Figures 4-9). There is almost no surface stone in the proposed footprint area, although some loose calcrete and some shallow outcropping of calcrete occurs in places (refer to Figure 7). There are no natural sources of water such as streams, springs or drainage channels in the 3.3 ha footprint area.

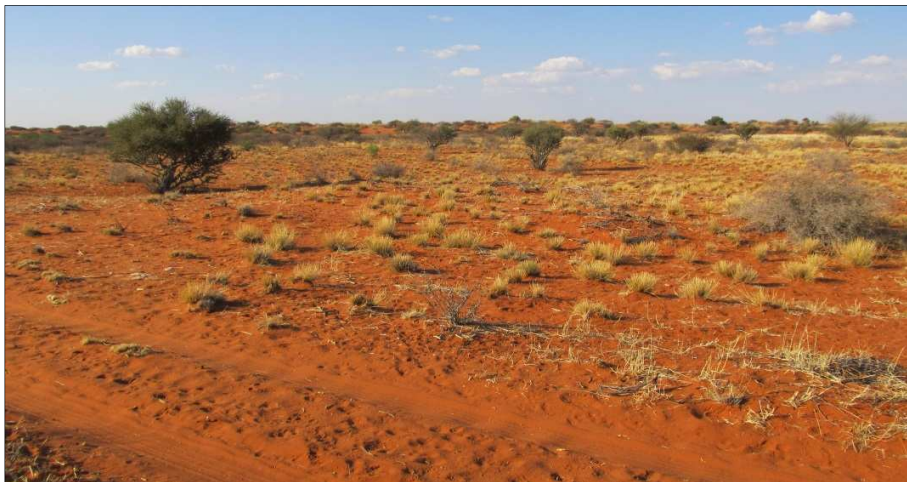
Figure 5. Footprint area of the proposed earth reservoir, view facing north

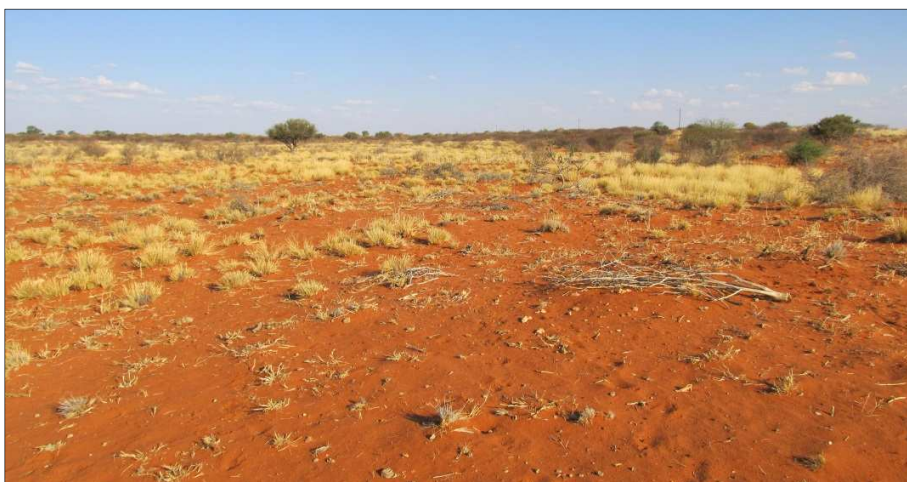
Figure 6. Footprint area of the proposed earth reservoir, view facing south east.
Arrow indicates powerlines alongside R360

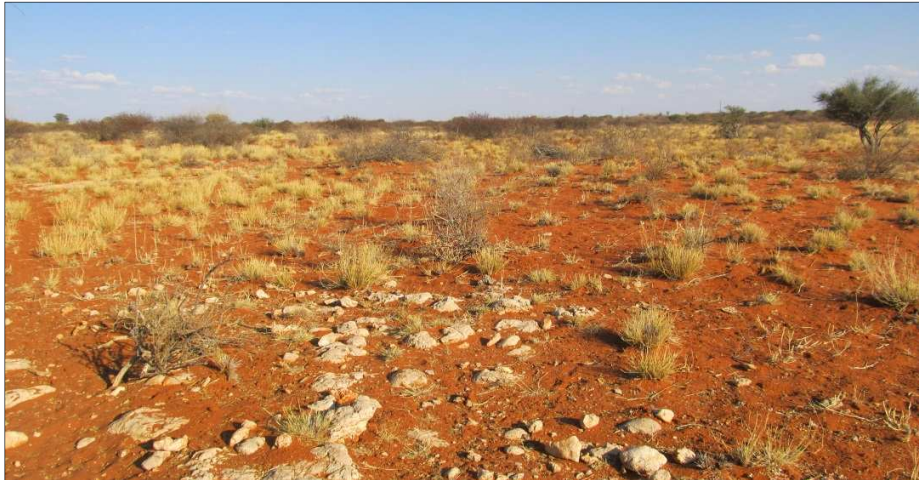
Figure 7. Footprint area of the proposed earth reservoir, view facing east. Note the calcrete outcropping in the foreground.

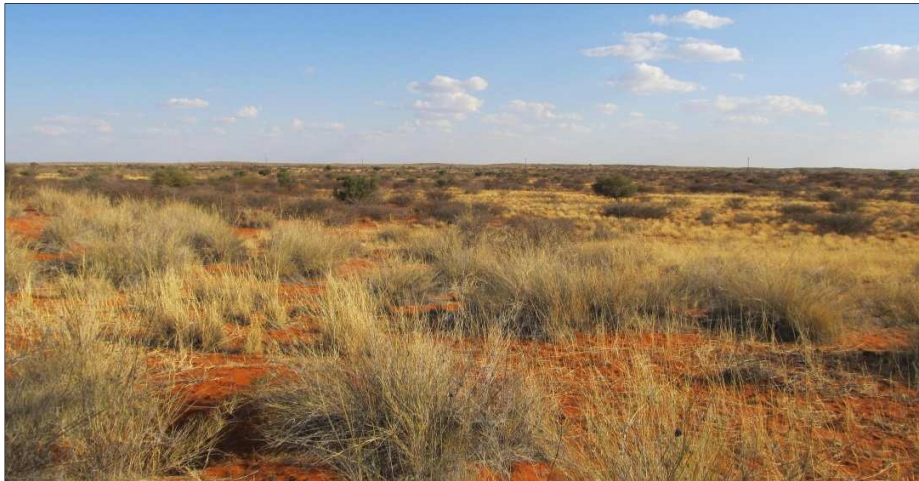
Figure 8. Footprint area of the proposed earth reservoir, view facing south

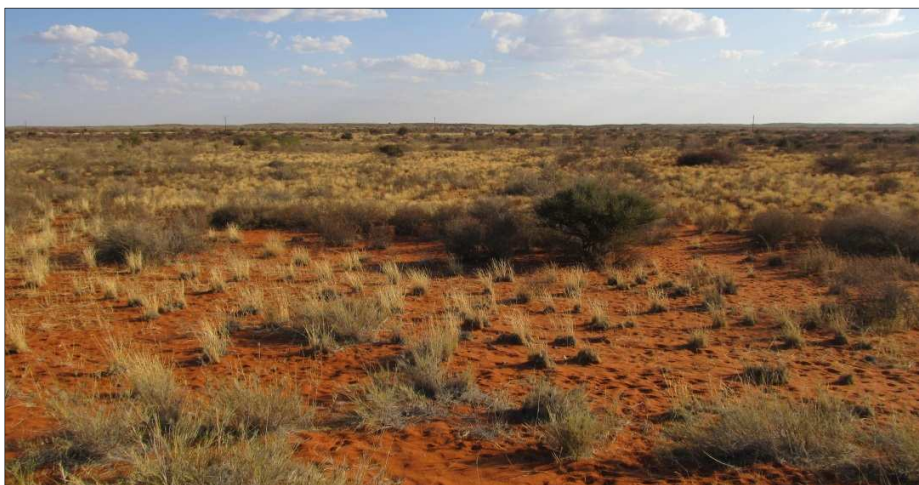
Figure 9. Footprint area of the proposed earth reservoir, view facing south east

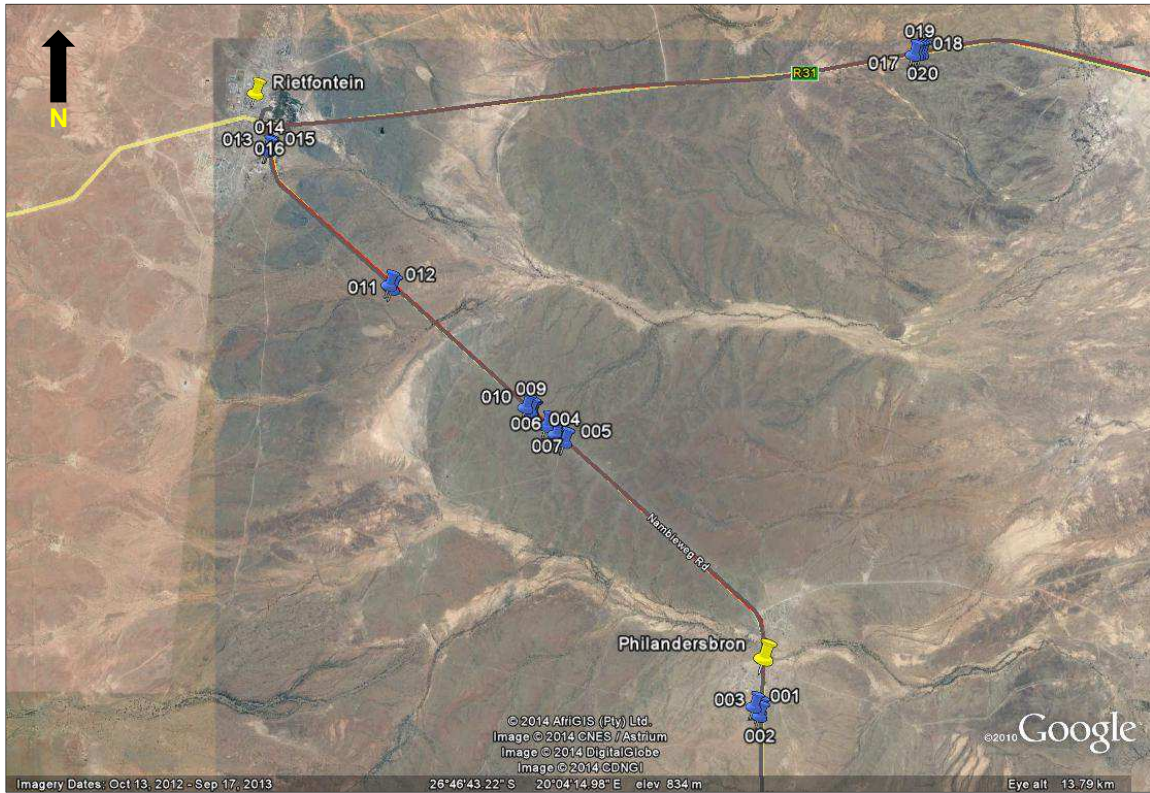
Figure 10. Location of archaeological occurrences recorded along the proposed pipeline route

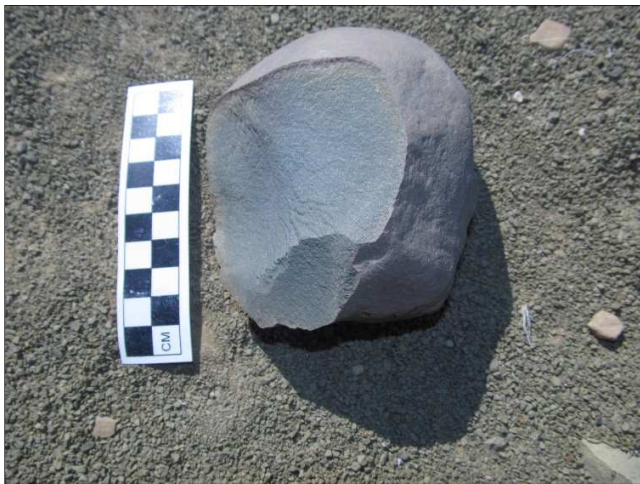
A handful of stone implements (Sites 001-003), including several MSA quartzite and indurated shale flakes, chunks, and a quartzite disc/prepared core were found in a severely degraded area between the existing reservoir at Philandersbron and the NR (Figures 13 & 14).

Figure 13. Site 001. Scale in cm.

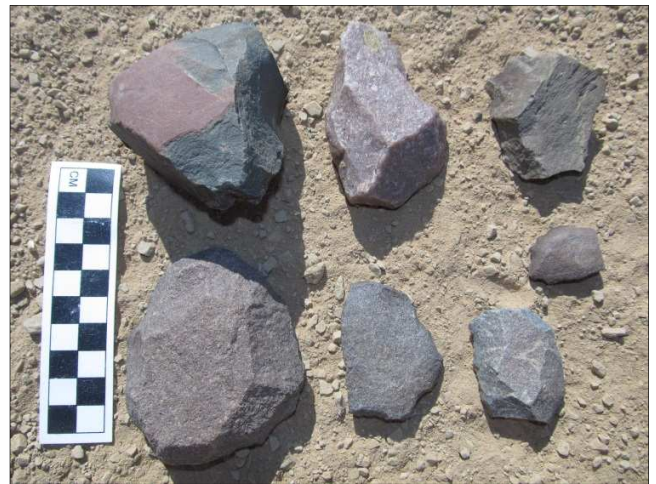
Figure 14. Sites 002 & 003. Scale in cm.

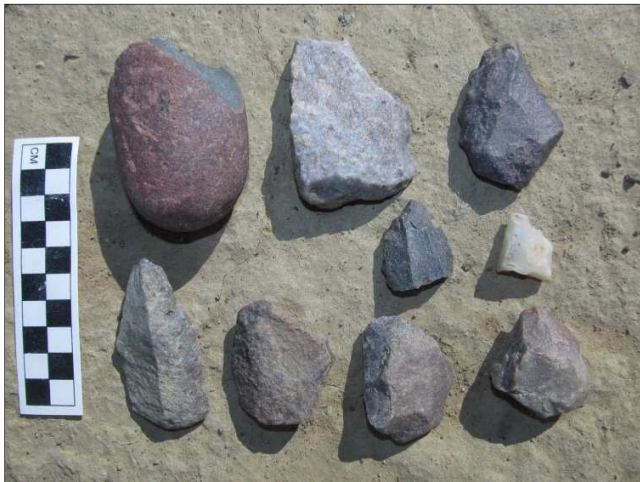
Isolated tools (Sites 004-012) were encountered in the road reserve between Philandersbron and Rietfontein. These included a jasperlite flake, MSA quartzite flakes, chunks, flaked cobbles and a single round core (Figure 15). Wide open gravels characterize the surrounding environment beyond the road reserve/fence.

Figure 15. Sites 004-012. Scale in cm.

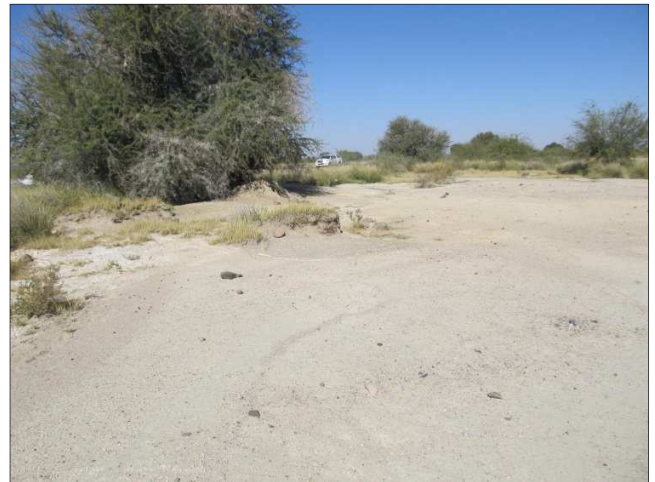
Figure 16. Site 013. Sheet-washed gravels near the entrance to Rietfontein. Note the bakkie alongside the road.

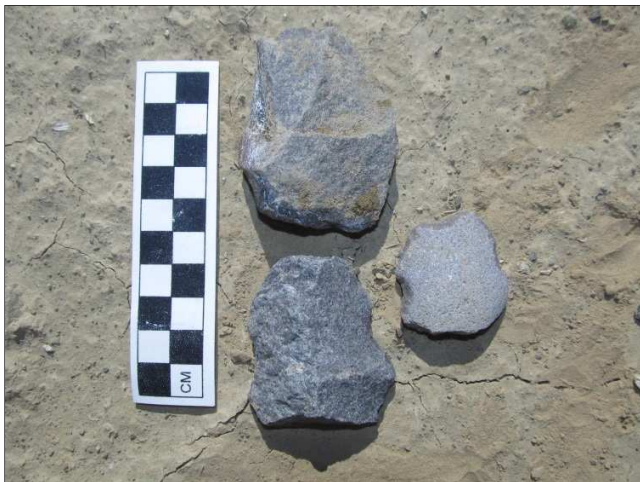
Several MSA quartzite flakes were recorded on eroded and sheet washed gravels (Site 013) outside the road reserve near the entrance to the town of Rietfontein (Figures 16 & 17).

Figure 17. Site 013. Scale in cm.

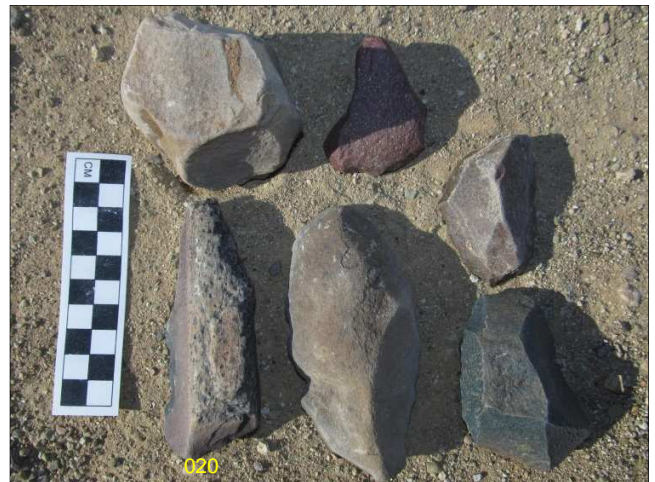
Two MSA quartzite flakes (Sites 017 & 019), several highly weathered and partially retouched indurated shale MSA flakes (Site 018), and a chunky weathered, retouched indurated shale 'knife' was recorded in the road reserve between Rietfontein and Askham (Figures 18 & 19). The tools were all found on an artificially raised terrace covered in loose weathered indurated shale gravels.

Figure 18. Site 017-020. Scale in cm.

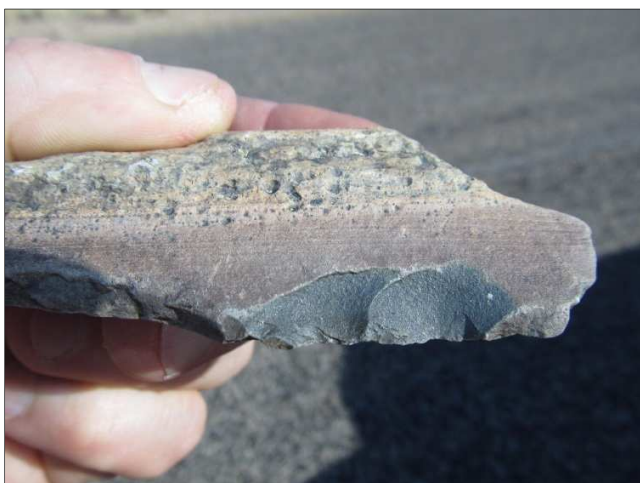
Figure 19. Site 020.

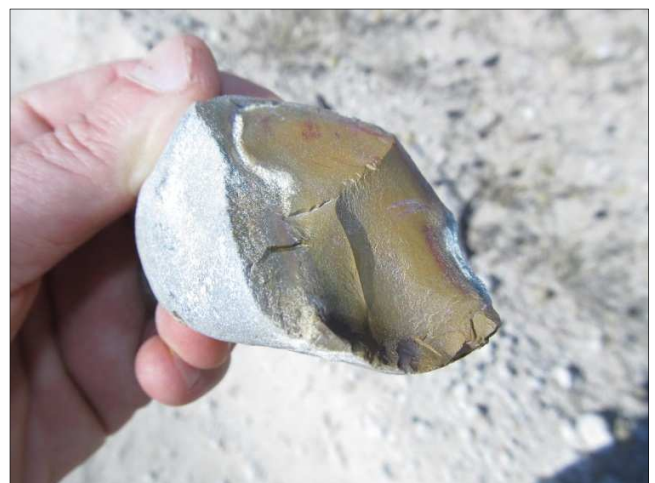
One (possible) minimal chunk/core (Site 022) was found in the road reserve between Askham and Crammond (Figure 20).

Figure 20. Site 022. Scale in cm.

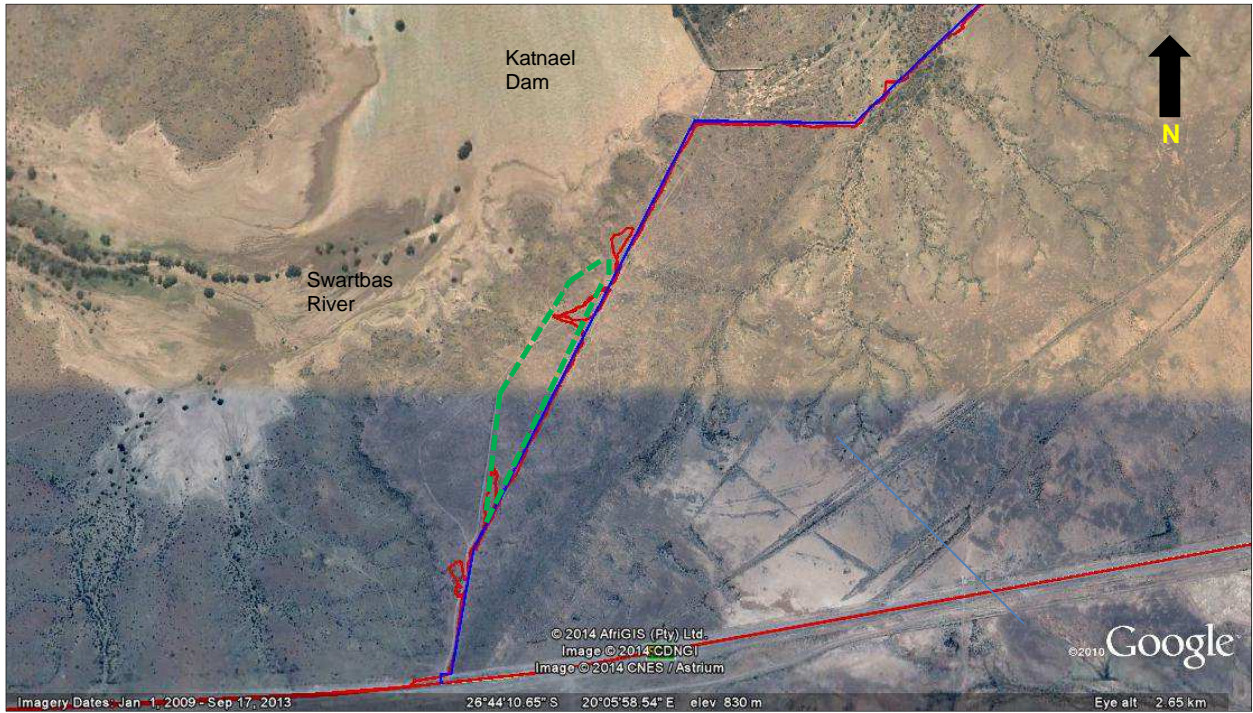
Figure 22. The proposed Loubos pipeline. Sensitive archaeological landscape (green polygon). It is assumed that the gravels extend beyond the farm road/green line, but this area was not assessed by the archaeologist.

In-situ scatters of ESA and MSA tools on gravels alongside the proposed Loubos pipeline are threatened by construction activities. Measures must be implemented to avoid, and not damage or disturb these potentially significant (Grade 3B) archaeological remains.

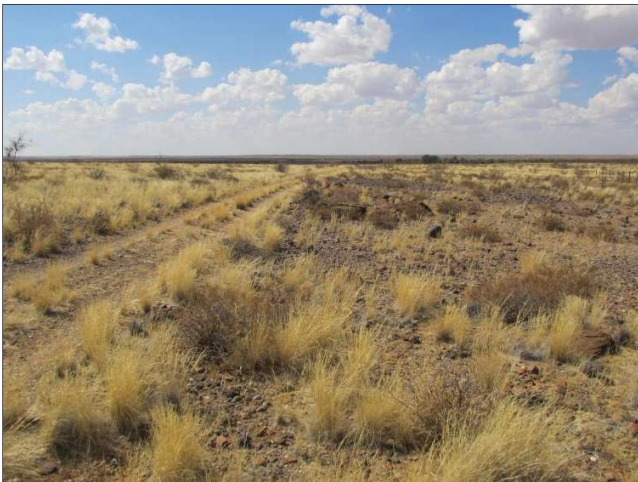
Figure 23. Gravels between road and the fence. It is assumed that the gravels extend west of the road

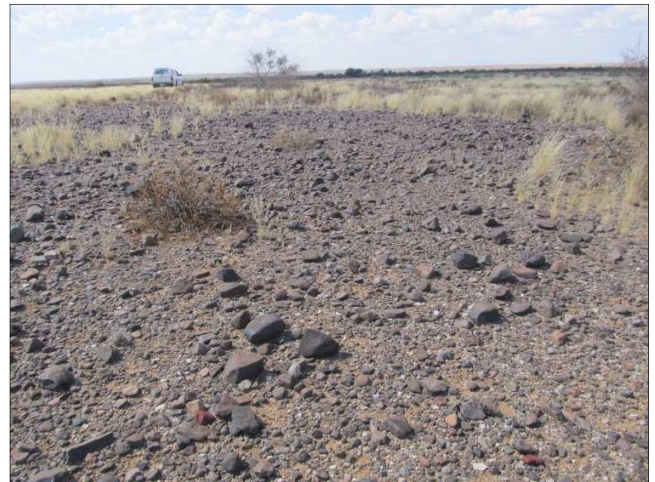
Relatively large numbers of *in-situ*, Early and Middle Stone Age implements were recorded on a series of gravel deposits that occur directly alongside the fence line/the proposed pipeline route (Figures 23-26). These gravels extend for several hundred metres on either side of the take-off road from the R360, overlooking the Katnael Dam. The gravels west of the road overlooking the dam were not assessed by the heritage practitioner, but it is assumed that similar heritage remains extend into this area. A few outcroppings of weathered dolerite occur in places but no rock engravings were found.

Figure 24. Gravels between road and the fence

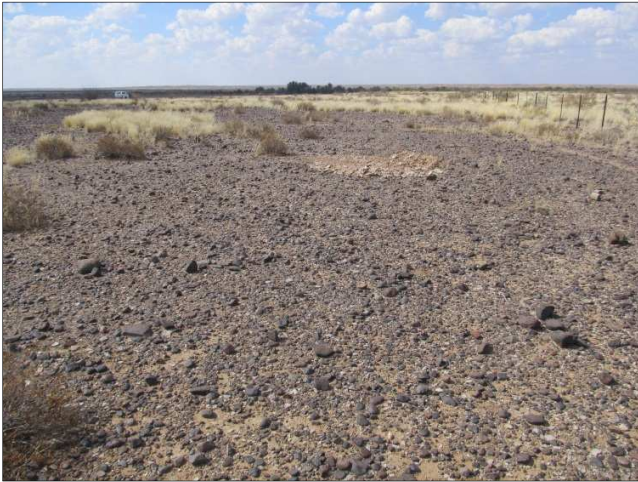
Figure 25. Gravels between road and fence. Note the two spoor track alongside the fence

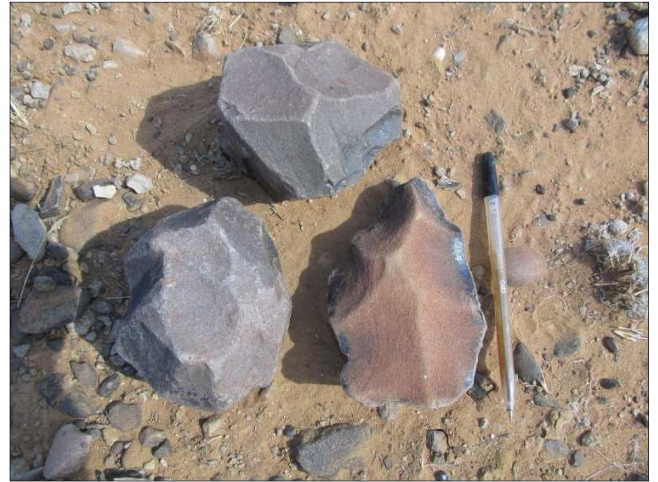
Figure 26. Gravels between the road and the fence

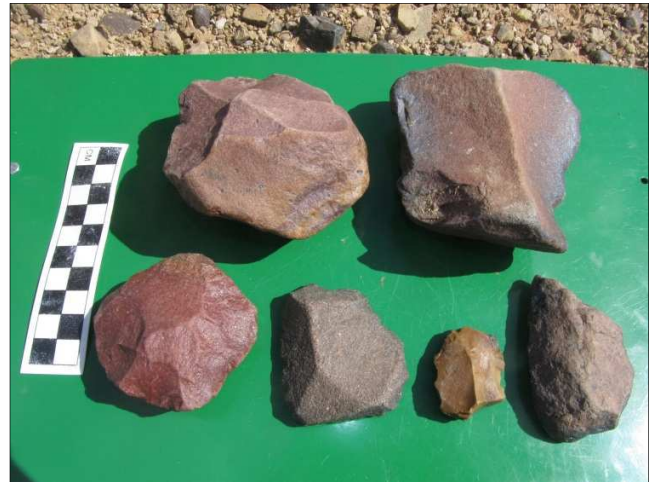
MSA tools recorded include (smaller) triangular-shaped, blunted, retouched and unmodified flakes, chunks, cobbles and several prepared cores, mostly in quartzite but also in weathered indurated shale. No blade tools or formal tools such as scrapers or points were found.

A collection of tools located during the study is illustrated in Figures 27-30. Most of the photographs are of lithics that were found alongside/close to the fence (in an isolated and disturbed context), while *in-situ* tools were mostly left in their primary context.

Figure 28. Collection of ESA, MSA and LSA implements. Scale is in cm

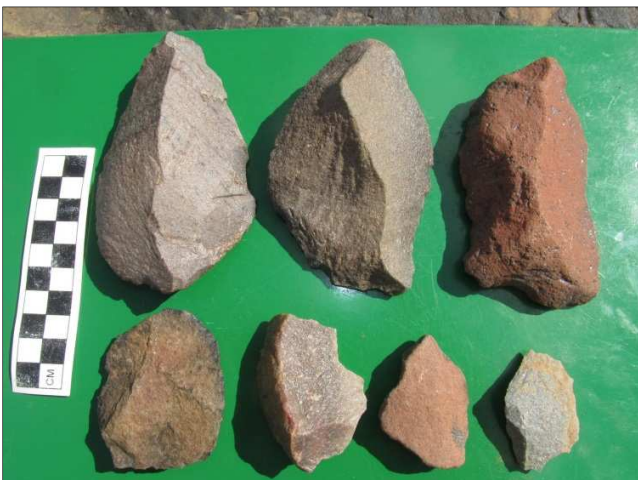
Figure 29. ESA and MSA tools. Scale is in cm

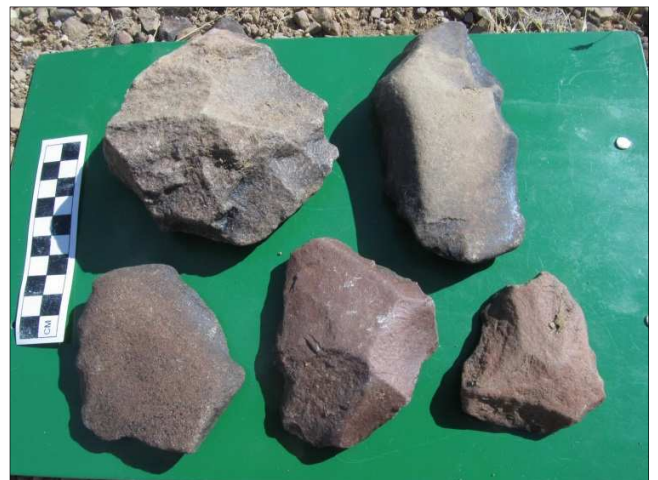
Figure 30. ESA & MSA tools. Scale is in cm

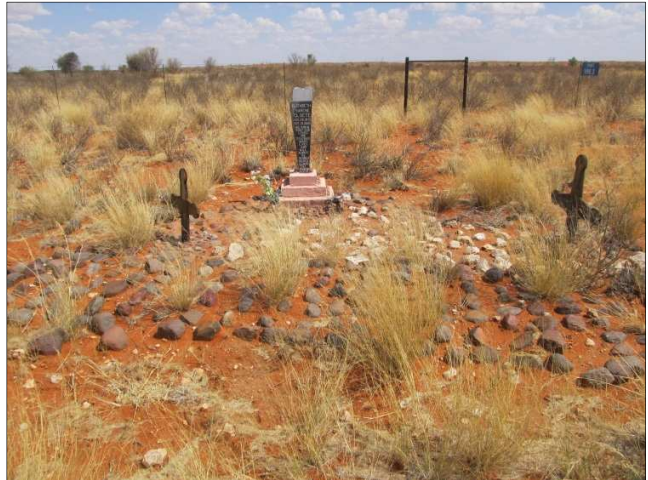
A Christian grave (S 26 56.291 E 20 39.345) was encountered in the road reserve (R360) near Andriesvale (Figure 32). The grave 'belongs' to Elizabeth Sarene Cloete, born 27-06-1972, died 07-10-2005. A single polished granite cross on a small painted plinth defines the area, but two separate wooden crosses (bearing the same name) are placed in the ground opposite each other, within a wider area of cemented and carefully placed stone cobbles. It does not look like the grave is a memorial to a road accident victim as these usually comprise a single cross alongside the road. It is therefore assumed that this is an informal burial/grave site

All graves (including unmarked graves and burials) have a high local significance and are protected under Section 36 of the NHRA.

Figure 32. Grave in the road reserve alongside the R360 near Andriesvale

7. The grave in the R360 road reserve near Andriesvale/Askham must be avoided during construction of the pipeline. The grave must be taped off and clearly demarcated prior to construction work commencing, and should not be disturbed in any way. The Environmental Control Officer must be responsible for ensuring the grave is protected during the entire construction phase of the project.
8. The above recommendations must be included in the Environmental Management Plan (EMP) for the proposed project.

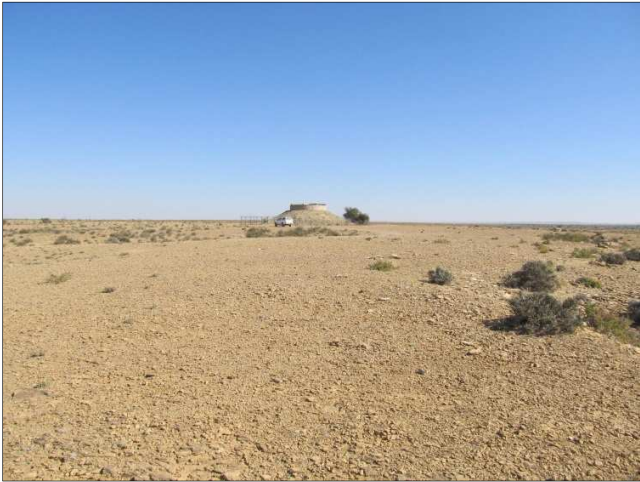
Figure 33. Reservoir at Philandersbron

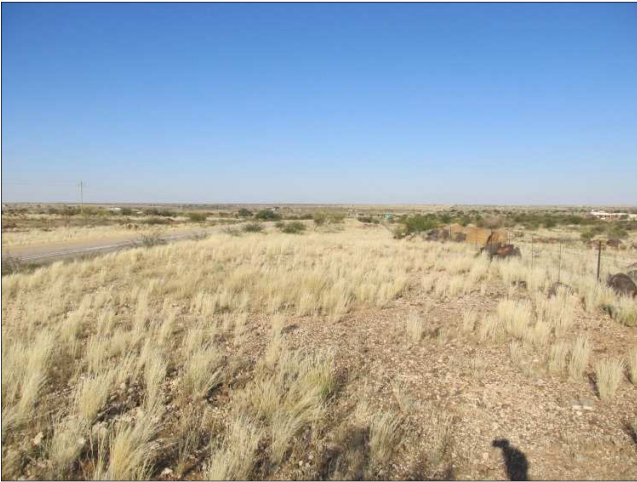
Figure 51. 360 North approaching Klein Meir. Note dolerite boulders alongside the fence line

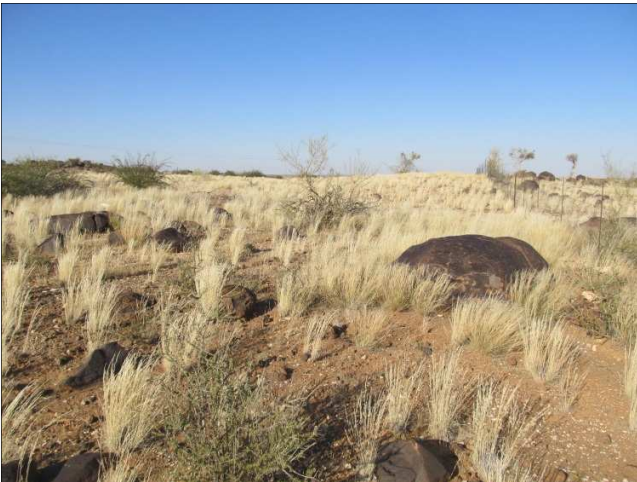
No rock engravings were found alongside the road (R360) where several outcroppings of dolerite occur in the road reserve near Klein Mier (refer to Figure 52).

Figure 52. 360 North. Dolerite boulders in road reserve

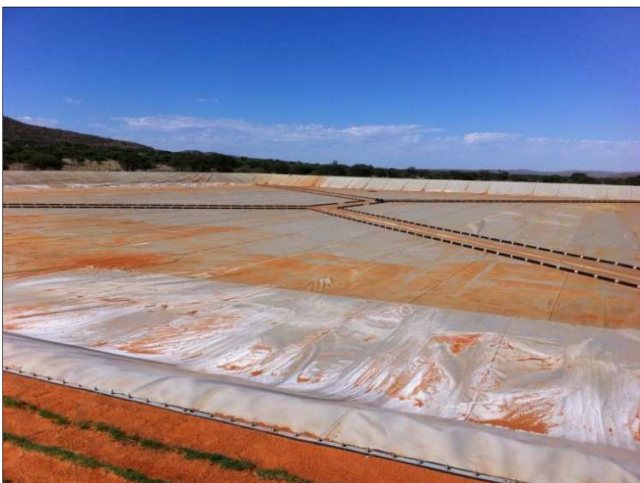
Figure 91. Example of an earth dam in the Northern Cape

According to the Environmental Assessment Practitioner (Clinton Geyser pers. comm.), the footprint area required for the proposed reservoir is 1.7 ha, while a further 1.6 ha will be used as source material (mainly sand) for construction of the earth dam wall. Figures 91 and 92 (in Appendix I) illustrate examples of an earth dam in the region.

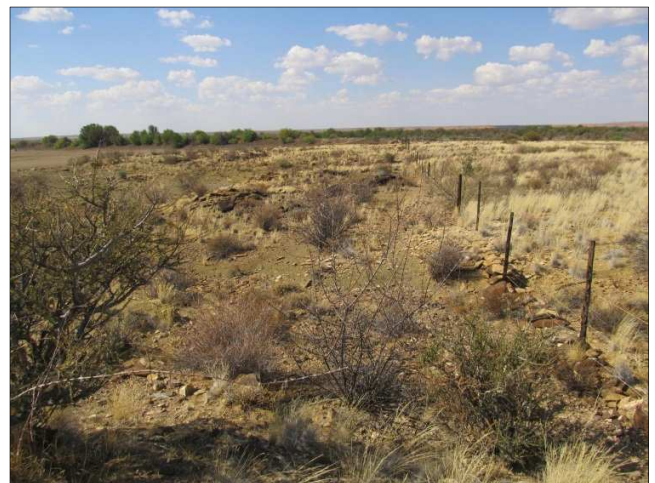
Implements were also found alongside the fence line, in the proposed pipeline route, but the route is fairly severely degraded. Erection of the fence has disturbed the surrounding veld, while a goat track, and a small 'twee spoor' pad/track has shifted and moved much of the gravel deposits around, so that sections of the route are almost clear of surface stone. The route alongside the Swartbas River is very severely degraded.

Figure 98. Proposed Loubos pipeline. View north with the Swartbas river in the background

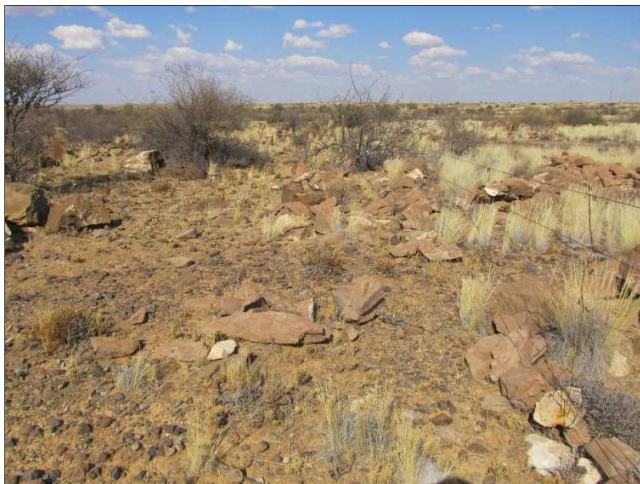
Figure 100. Proposed Loubos pipeline. View east

Archaeological visibility was very good along the proposed Loubos pipeline, from the R360/take off road, till the Katnael Dam wall. The floodplain of the Swartbas River and the Eskom servitude is very densely vegetated with acacias and kweek grass, resulting in low archaeological visibility (refer to Figures 105 & 106 in Appendix II). Large pieces of rocks from construction of the dam wall are also lying alongside the fence (refer to Figure 100).
