HERITAGE IMPACT ASSESSMENT PROPOSED REHABILITATION OF THE N7 BETWEEN OKIEP (KM 7.0) AND STEINKOPF (KM 47.2), NORTHERN CAPE

(In terms of Section 38(8) of the NHRA of 1999)

April 2014

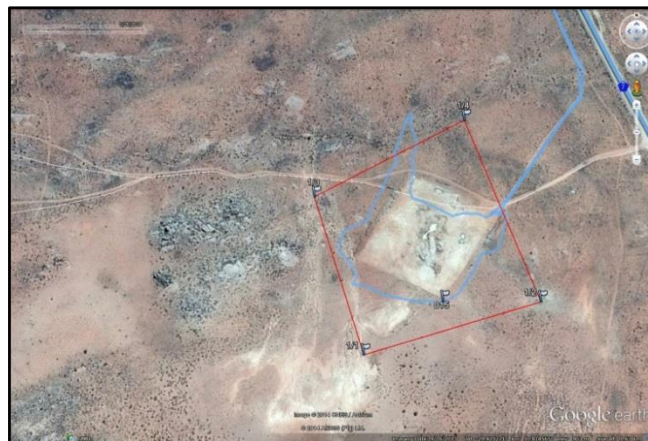
Figure 4: Position of the proposed borrow pit in red with the field survey tracks in blue.

The area to the north of the borrow pit was examined as there are a number of prominent granite boulders (Plate 3) which could have attracted prehistoric settlement. However, there is no evidence for any archaeological material in the proposed extensions to the existing borrow pit.

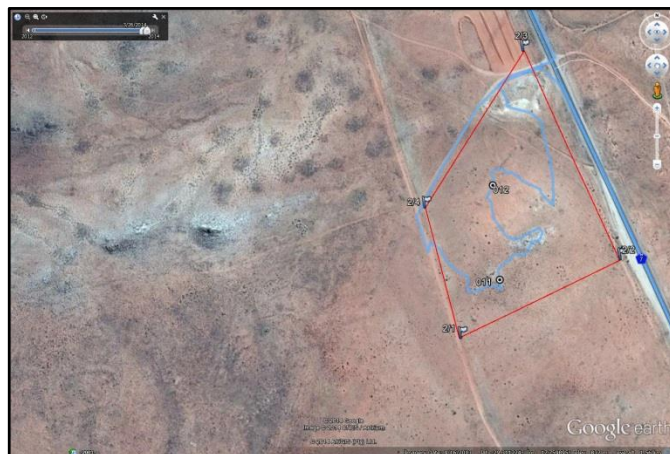
Figure 5: Position of the borrow pit with outline in red and field survey tracks in blue. Note the two koppies in the south.

This is an extension of an existing borrow pit which is located 20 m to the west of the N7. There are two small rocky koppies in the southern area of the proposed extension. They were closely examined for any signs of archaeological material, as koppies often formed a focus for prehistoric settlement.

The first koppie (Plate 4) contains a small scatter of broken ostrich eggshell pieces. None of the fragments have any sign of a flask mouth and the fragments do not appear to be archaeological.

There are no associated stone artefacts. The second koppie is in close proximity to the N7 and a small layby on the side of the road (Plate 5). It is clear that motorists have climbed over the fence and visited the koppie as it is covered in modern refuse, including empty bottles and pieces of clothing. There is no evidence of any archaeology around it.

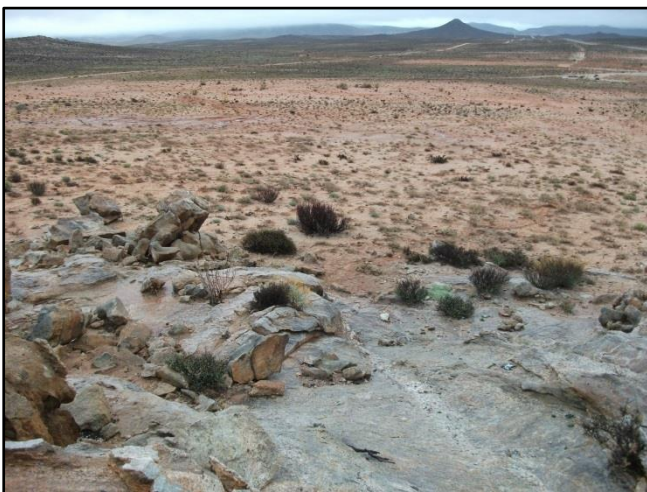
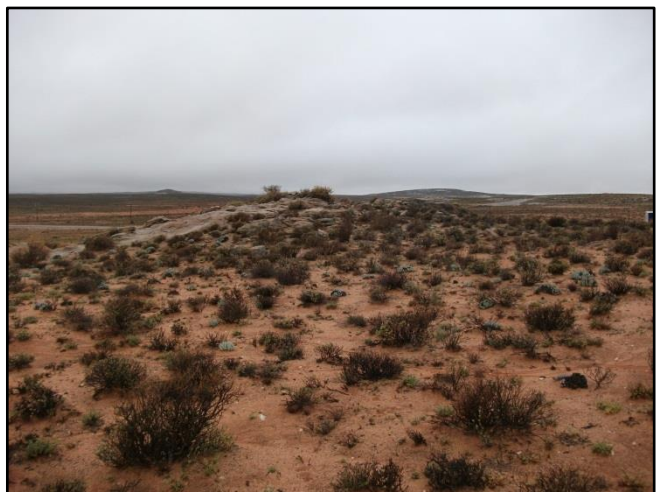
Plate 4: View from the first koppie looking north across the existing borrow pit. **Plate 5:** View of second koppie.

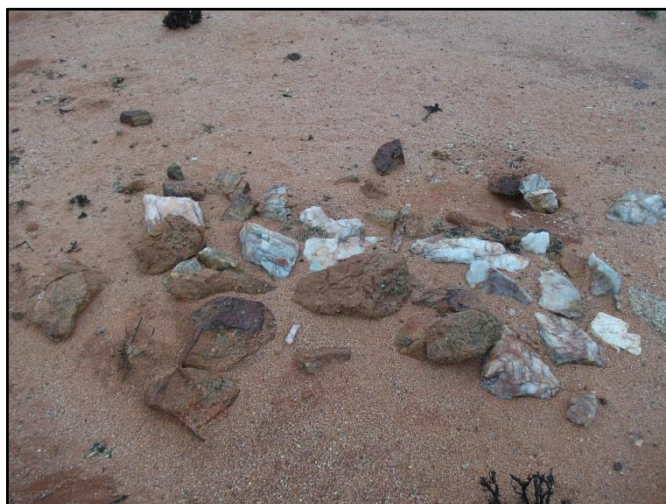
On the plains, away from koppies, is a small cairn (see Glossary) approximately 1.5 m long and 0.8 m wide (Plate 6). It is possible that it could represent a grave although this seems unlikely in view of the absence of any other evidence for human settlement. The cairn could also represent a prospecting hole which has been covered with rock. This is quite common in Namaqualand.

Plate 6: View of a small cairn in the proposed borrow pit area.

The expansion of six borrow pits has the potential to impact negatively on pre-colonial and historical archaeological material as well as graves. A single stone cairn and a scatter of fragmented ostrich eggshell were found in Borrow Pit 2. While the cairn could represent a grave, this seems unlikely in view of the absence of any other associated archaeological material in the vicinity. The ostrich eggshell is also not associated with any archaeological material.

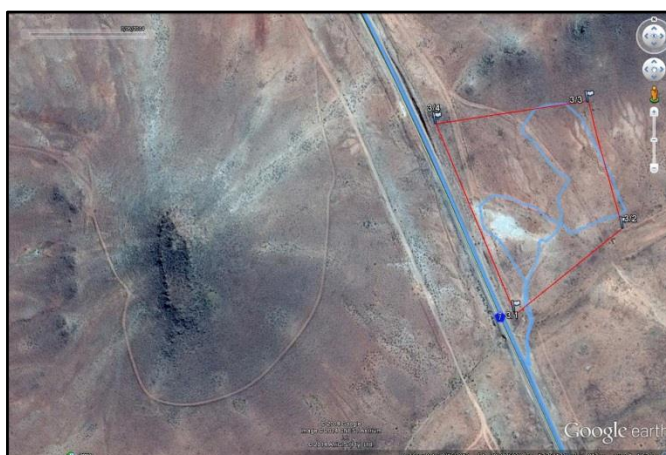
Figure 6: The position of the borrow pit on the lower slopes of a small koppie to the east of the N7.

A single small quartzite flake was recovered from the soil surface. There is no indication of any concentrations of stone artefacts. There is no archaeological reason why this site cannot be used.

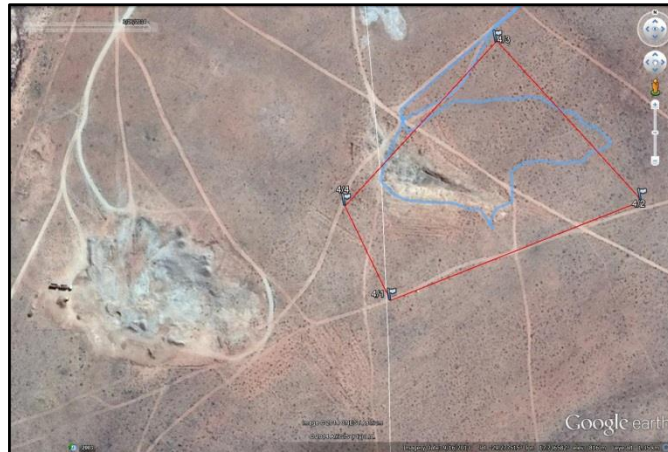
Figure 7: Borrow Pit 4 with outline of proposed extension in red and field tracks in blue.

This will be an extension of an existing borrow pit located to the south of Steinkopf and to the west of the N7. The borrow pit is at least 600 m from the road and will not be visible to passing traffic. It is situated on the communal lands outside of the town, in an area which has been traditionally used for

grazing by small stock farmers. The area was therefore carefully examined for any evidence of traditional land use, including stockposts and graves. The existing borrow pit is partially filled with rubble (Plate 7), probably deposited by residents from Steinkopf.

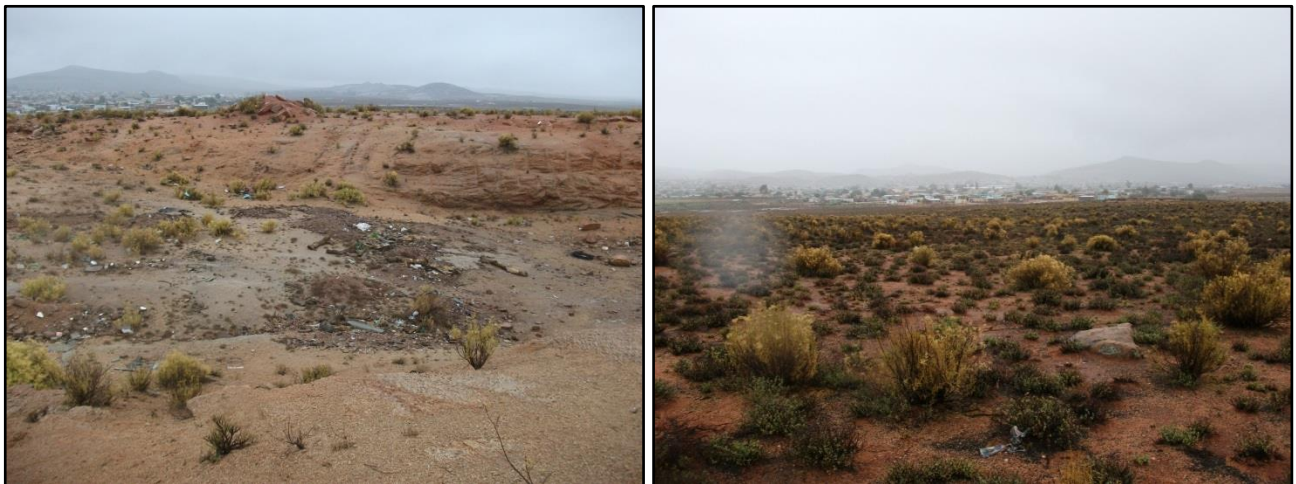
Plate 7: View of existing borrow pit 4. **Plate 8:** View of landscape around borrow pit 4.

No archaeological material was identified and there is no evidence that the area around the existing borrow pit is being used by livestock herders.

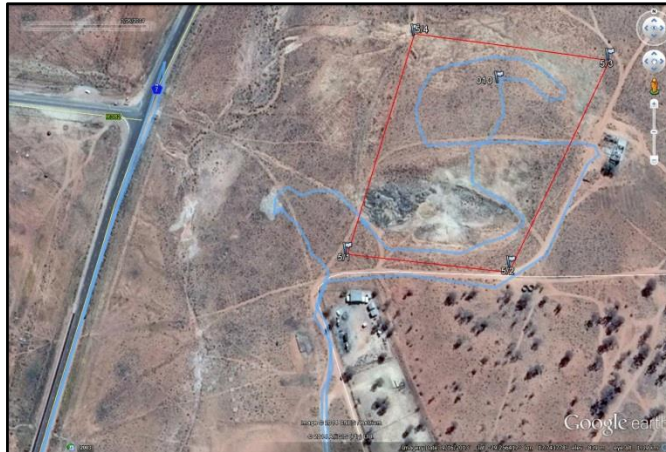
Figure 8: The borders of the extended borrow pit are shown in red and the tracks of the field survey in blue.

This will be an extension to an existing borrow pit located to the east of the town of Steinkopf and also immediately east of the intersection of the N7 with the road to Port Nolloth. The borrow pit is situated 200 m from the road and will be visible, although the general area around Steinkopf is already degraded with a number of commercial developments.

The borrow pit is already partially filled with residential refuse. There is some evidence of recent scraping of the ground surface, possibly to assess the soils for a gravel mine. The landscape is covered in ankle high scrub and is largely degraded. There is a flat large granite boulder (Plate 10) in the proposed extension which was examined for any evidence of grinding grooves which are common in Namaqualand. There is an abandoned modern house immediately outside the borders of the borrow pit. Its roof, windows and doors have been removed and it is not threatened by the mining.

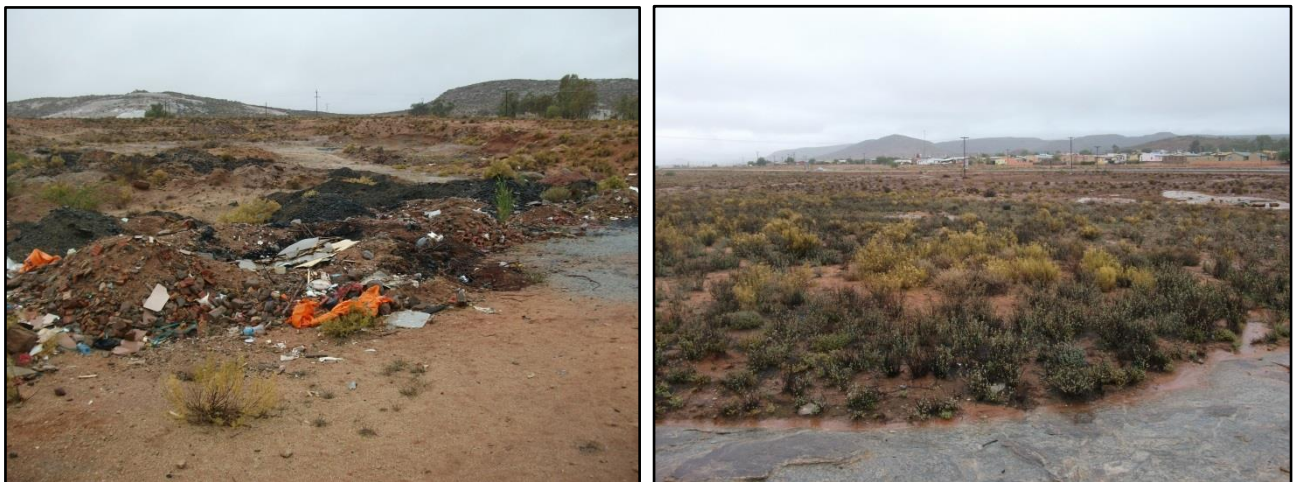
Plate 9: View of the existing borrow pit looking Eastward. **Plate 10:** View of the extension looking west to Steinkopf.

No archaeological remains were identified and there is no evidence of any grinding grooves in the granite bedrock.

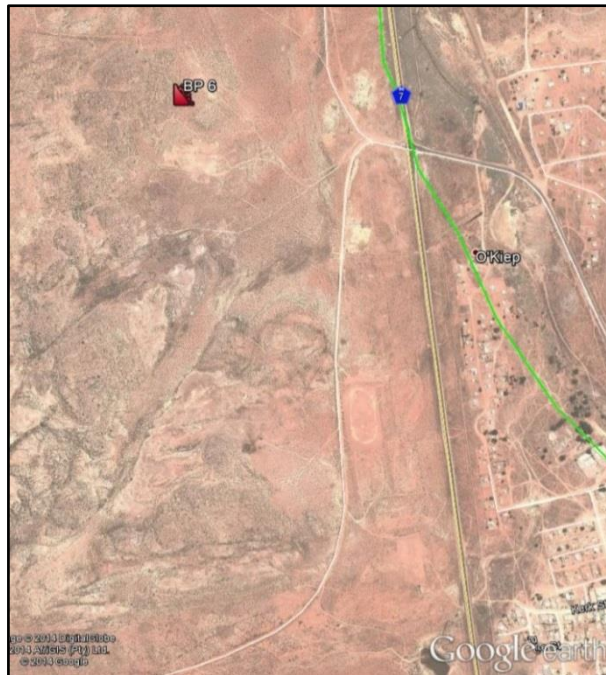
Figure 9: The location of Borrow Pit 6 to the west of Okiep.

Borrow Pit 6 was proposed as an alternative to Borrow Pit 3, some two weeks after completion of the field survey and our assessment is therefore at a desktop level. The proposed borrow pit is located some 500 m to the west of Okiep. Burke's (1995) map of the blockhouses around Okiep (Figure 3) is unfortunately not to scale and cannot be used to ascertain if any Boer War remains will be impacted by the proposed borrow pit. It is likely that the blockhouses will be located on high lying koppies with a good view of the town, and therefore it seems unlikely that any may be damaged by the new borrow pit.

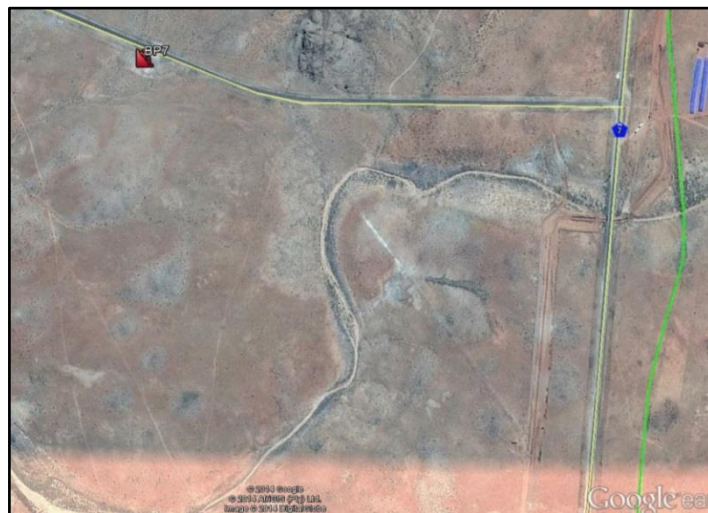
Figure 10: The location of proposed Borrow Pit 7 on the road to Bulletrap.

The proposed borrow pit is located some 800 m to the west of the N7 on the road to Bulletrap. It is in close proximity to three (3) borrow pits assessed by Kaplan (2008). He reported on MSA flakes, quartzite flakes and a lower grindstone – all of which he rated as having low significance. He also noted a well-constructed stone kraal which he concluded to be of low significance. The kraal is probably related to stockpost settlement in the vicinity of Bulletrap and is therefore of Living Heritage significance. It is unlikely that the proposed location of Borrow Pit 7 will impact on any heritage resources although Living Heritage resources are often of an intangible nature and difficult to identify.

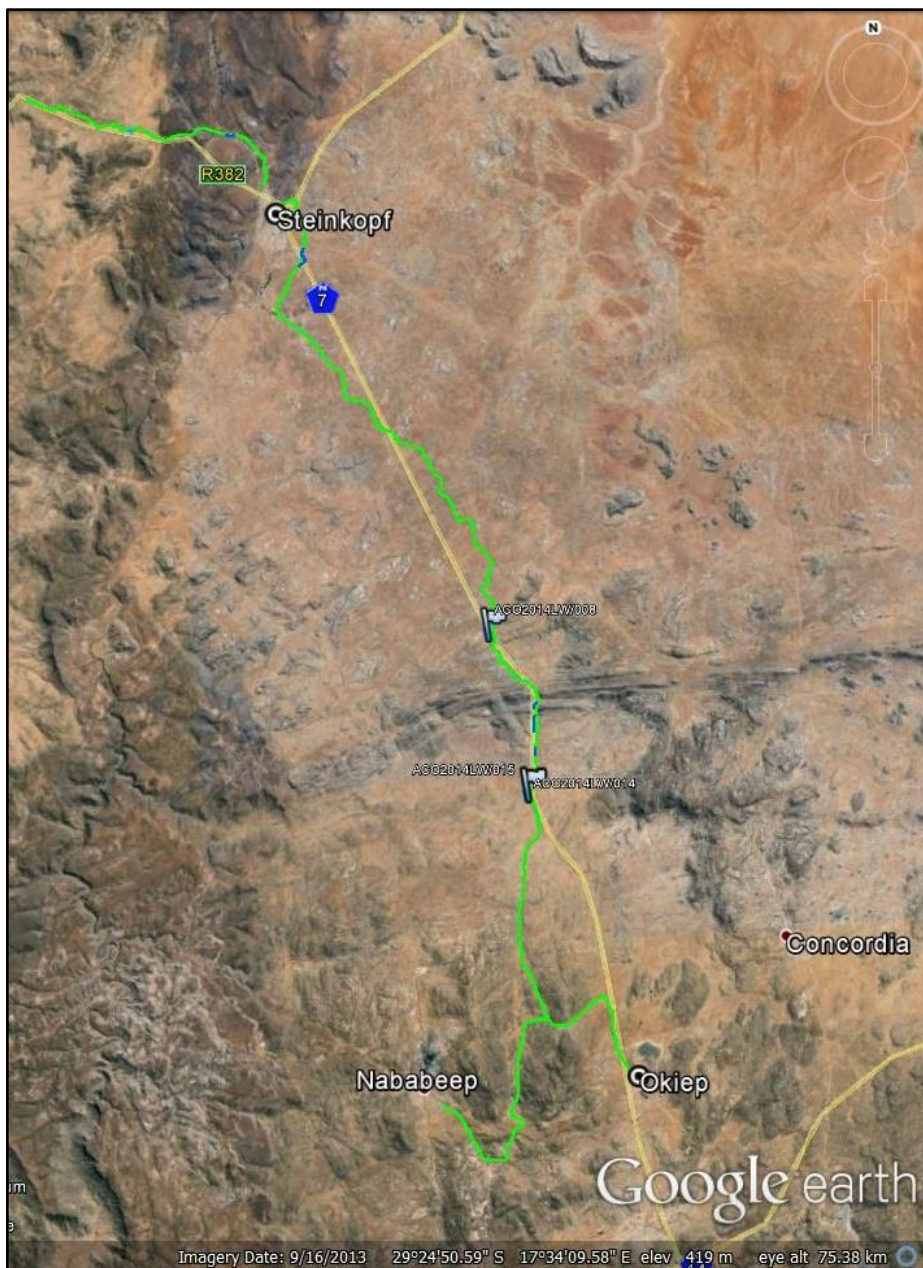
The historic narrow gauge railway line can still be traced on aerial photographs (Figure 11) and is clearly indicated on the 1:250 000 and 1:50 000 maps of the area. According to aerial photographs there are at least seven (7) points where the N7 crosses the railway line between Steinkopf and Okiep (Figure 11). The actual railway tracks and sleepers were removed more than 70 years ago, but the route is still indicated by raised earthen ridges. Large sections of the line were obliterated by the construction of the N7 and more recently, large sections have been destroyed by the excavations of trenches to bury the water pipeline between Okiep and Steinkopf. Remnant sections of the line still remain.

However, very few intact sections have been preserved within the road reserve. There are at least two sections of the railway track which are clearly visible within the road reserve. These are at ACO2014LW/008 and at ACO2014LW/014-15 (Figure 11).

Figure 11: The N7 closely follows the route of the narrow gauge railway line, crossing it on a number of occasions.

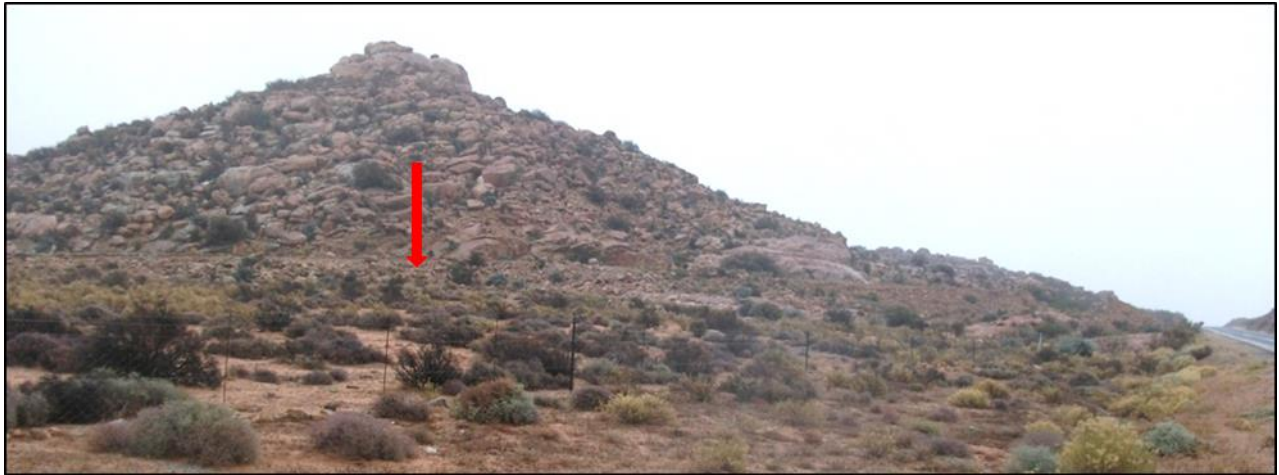
Plate 11: View of the remains of the railway line, running below the koppie (red arrow), and then crossing the N7 at Vrieskloofhoogte.

The route of the railway line (Plate 11) can clearly be seen as it winds around the hill. It then crosses the N7 at GPS16 or ACO2014LW/008. This section on the track is at risk as it is located in a narrow valley between two hills and on a slight rise. This section of the road through the kloof falls in Climbing Lane 4 (CL4). This may require the raised rail embankment (Plate 12) to be removed inside the road reserve. However, Plate 11 shows that a considerable section of the tracks remains outside the road reserve (see red arrow).

- It may be necessary for short sections of the raised rail embankment inside the road reserve at ACO2014LW/008 to be demolished during the construction of Climbing Lane 4 (CL4). It is concluded that this can be justified because a significant loop of the line has been retained to the west of the N7 at this point. Technically, a permit from SAHRA will not be required as the demolition will be in terms of Section 38(10) of NHRA. However, SAHRA may request that a permit for demolition is applied for;

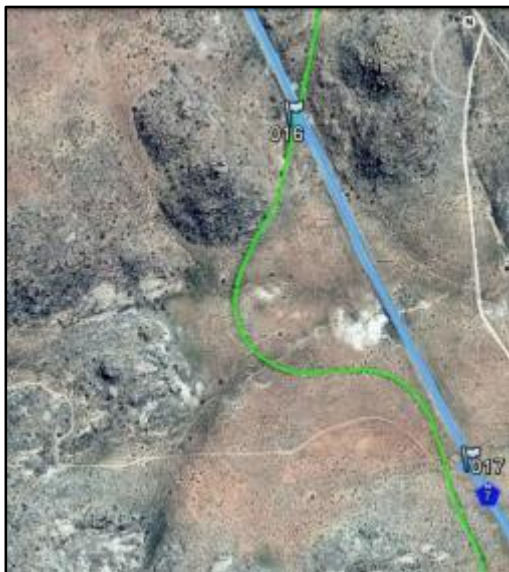
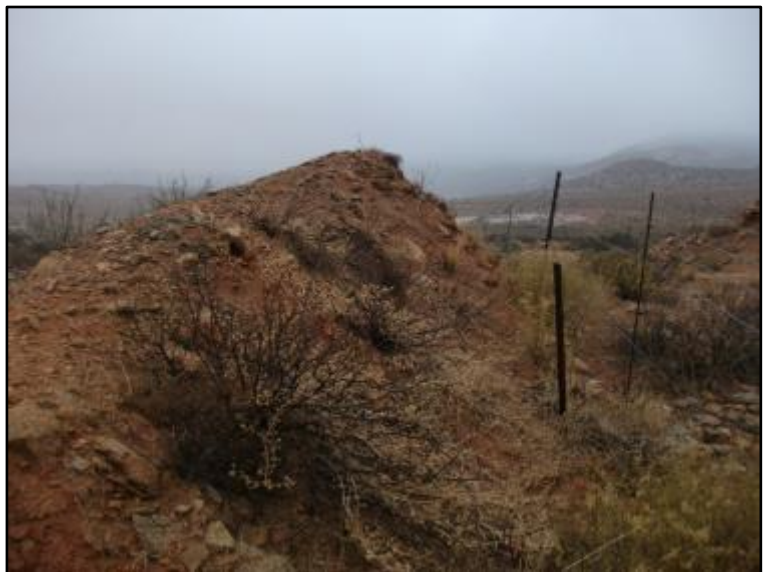
Figure 12: The railway line indicated in green and the N7 in blue. **Plate 12:** The raised earthen embankment of the rail line.

Both the N7 and the railway line pass through the narrow neck of Ratelpoort and here both the road and the excavations for the underground water pipeline have impacted significantly on the remnants of the track, but these are all outside the road reserve.

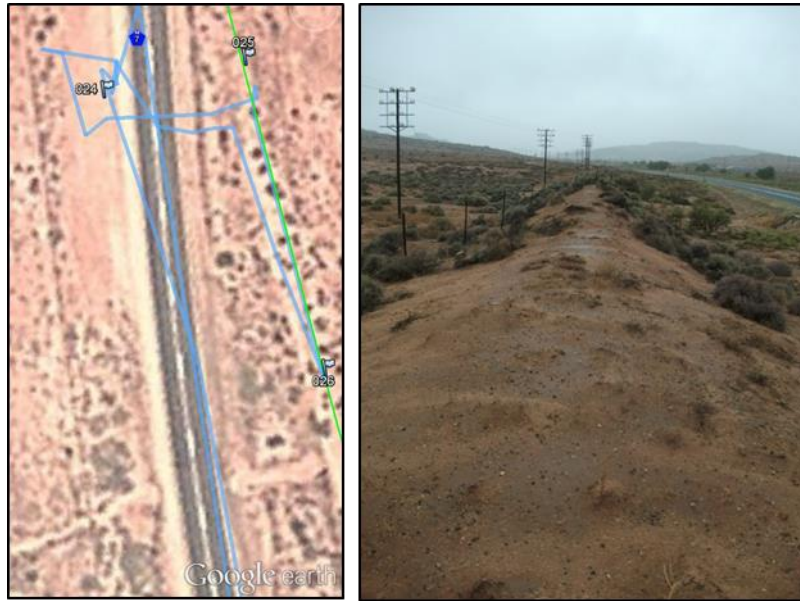
The only other sensitive location is at GPS25-26 or ACO2014LW/014-15 in Figure 13. Here the raised railway line runs inside the road reserve for a distance of about 40 m and is clearly visible (Plate 13) from the N7. This particular location is interesting as it is directly opposite a stone base for a water tank at GPS 27 or (ACO2014LW/016) further described below. The combination of the railway track and the water tank in this locality makes it significant in terms of the concentration of heritage resources.

Figure 13: The position of a short section of the railway track between 25 and 26. **Plate 13:** shows the section of track inside the road reserve, running parallel to the N7. Note the fence on the left.

- It is recommended that the section of the raised embankment of the rail line inside the road reserve (ACO2014LW/014-15) should be conserved. Its significance is enhanced by its close proximity to the stone base of a water tank of historic significance. While no climbing lanes are proposed for this section of the N7, due care should be taken during the construction of the road shoulder and this area should not be used for a construction/laydown camp;

The second section at GPS25 and 26 or ACO2014LW/014-15 is situated on a level section of road, opposite a circular stone base of a water tank used by steam locomotives. There are no plans to widen the road at this section. The proximity of the stone base of the water tank to the raised railway line inside the road reserve makes this a particularly sensitive heritage location. It is recommended that no construction yards are placed here to avoid impacts to heritage.

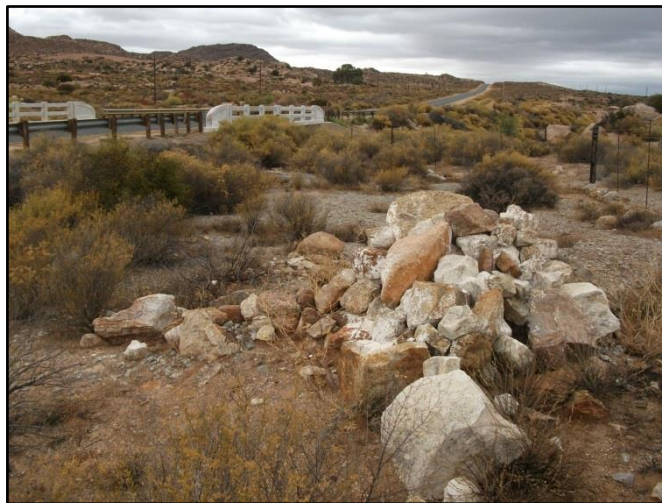
Plate 14: A whitewashed stone cairn in the road reserve at GPS 5.

There is a single white-washed stone cairn in the road reserve next to a bridge. It is unclear whether this has any heritage significance. It does not appear to resemble a cairn over a grave and it seems more likely that it is a marker related to the road construction.

- If the white-washed cairn must be demolished to make way for the rehabilitation of the road, then care should be taken as there is a very small possibility that it may be a grave marker;

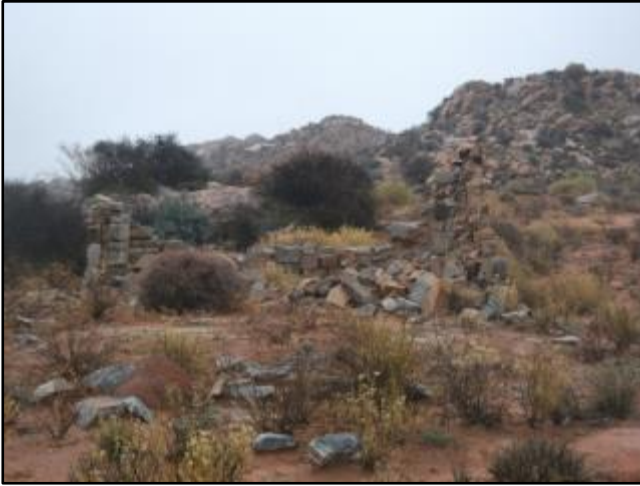
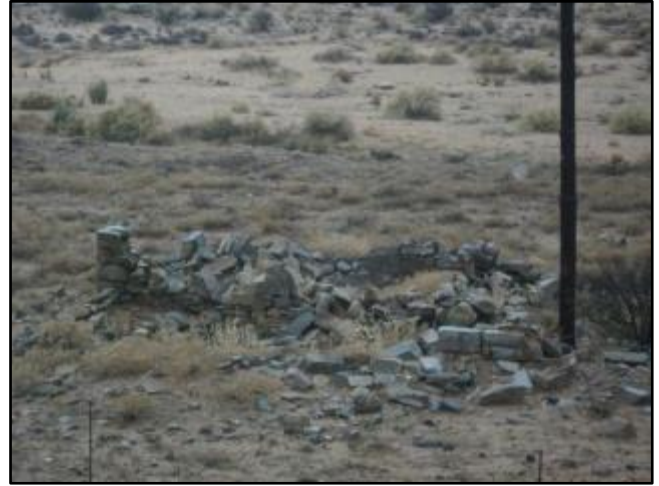
A number of stone structures were recorded outside the road reserve. They were recorded (Table 2) and photographed. Both rectangular buildings are approximately 10 m outside of the road reserve and will not be impacted (Plates 15 and 16). They are probably associated with the railway line but since they were outside the road reserve, they were not investigated further.

Plate 15: View of stone structure ACO2014LW/01. **Plate 16:** Stone structure ACO2014LW/012.

A number of stone structures were identified immediately outside the N7 road reserve. Some of these structures are probably associated with the historic railway line and/or the defence of the line during the Boer War. It is recommended that no construction camps/laydown areas are established in close proximity to these structures.

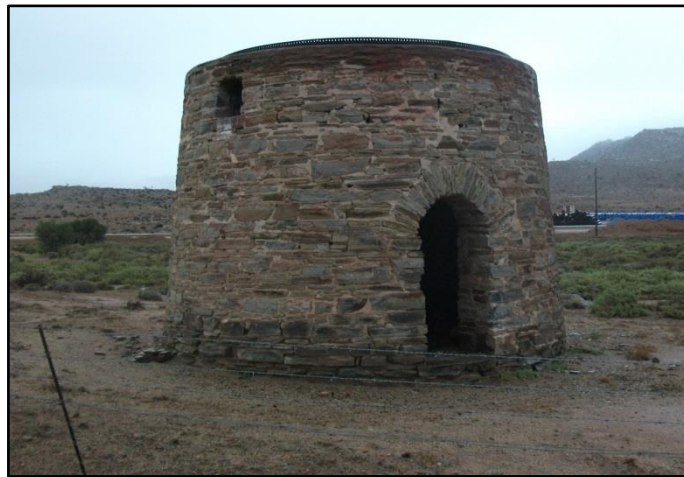
Of significance, is the circular stone base of a water tank (for filling steam locomotives) (Plate 17) which is located only about 3 m outside the road reserve (Table 2) and opposite ACO2014LW/014-15.

Plate 17: The base of the water tank immediately outside the road reserve.

The water tank, which is of high significance in terms of the railway line, is very close to the boundary of the road reserve (Plate 17). There is the potential for the structure to be damaged during the widening of the road. It is particularly vulnerable to the activities of construction workers.

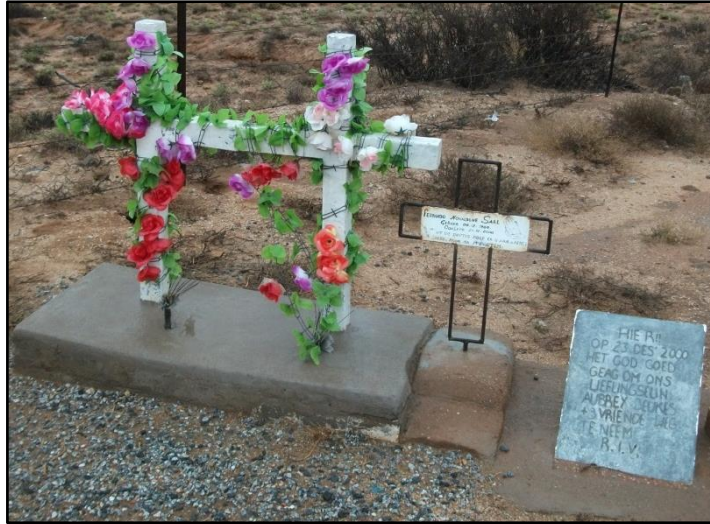
A few recent memorials to individuals killed in road accidents were recorded (Table 2). These memorials have no specific heritage protection.

Plate 18: Roadside accident memorial in the road reserve.

- Since road accident memorials are not protected by the NHRA, they may be removed if necessary during road rehabilitation. However, it is suggested that an empathetic solution to development in the road reserve would be to attach the crosses and flowers to the fence of the road reserve.
