HERITAGE IMPACT ASSESSMENT

**THE PROPOSED LOERIESFONTEIN BULK WATER
SUPPLY PIPELINE AND RESERVOIR,
LOERIESFONTEIN, NORTHERN CAPE**

Assessment conducted under Section 38 (8) of the
National Heritage Resources Act 25 of 1999

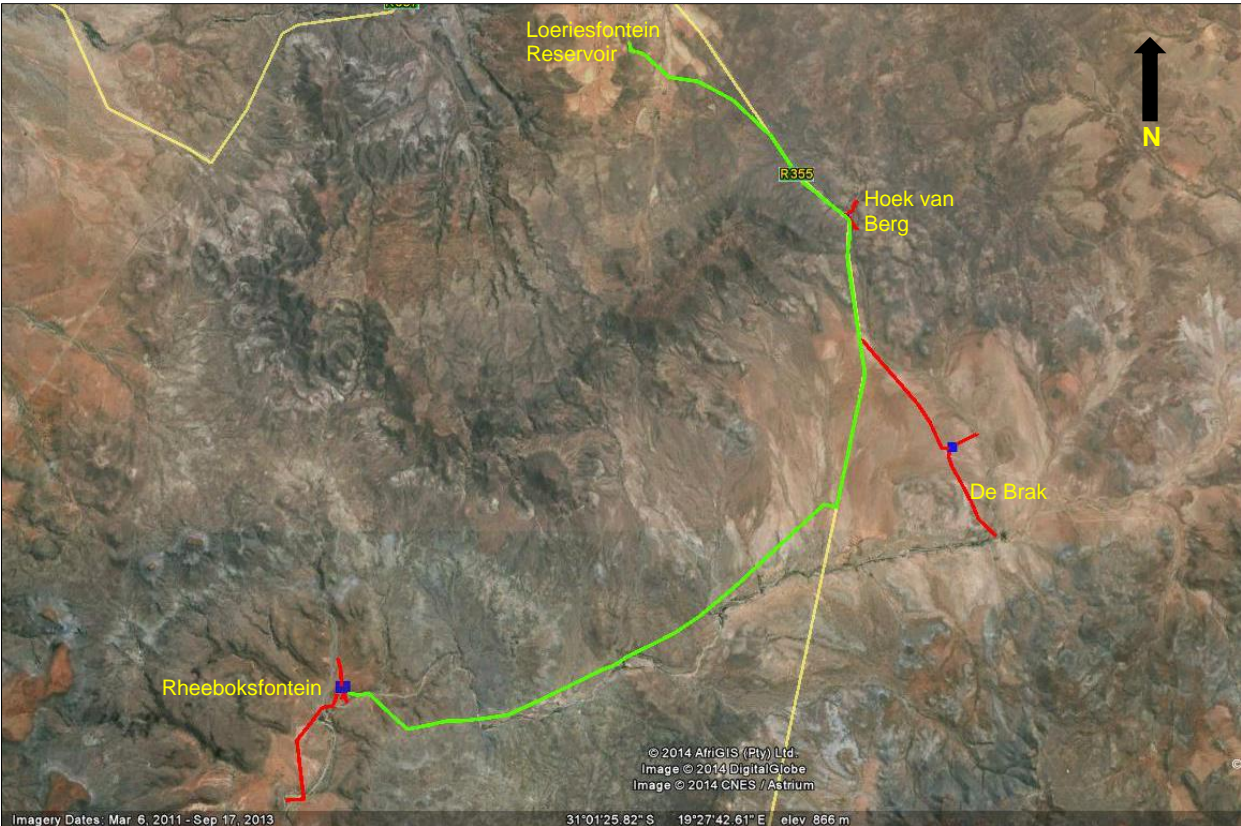
Figure 2. Google Aerial photograph indicating the proposed infrastructure for the Loeriesfontein Bulk Water Supply Pipeline and Reservoir. The main pipeline (rising main) is in green, while the feeder pipelines are in red. The blue polygons are the proposed new holding reservoirs, one of which is also planned at Hoek van Berg.

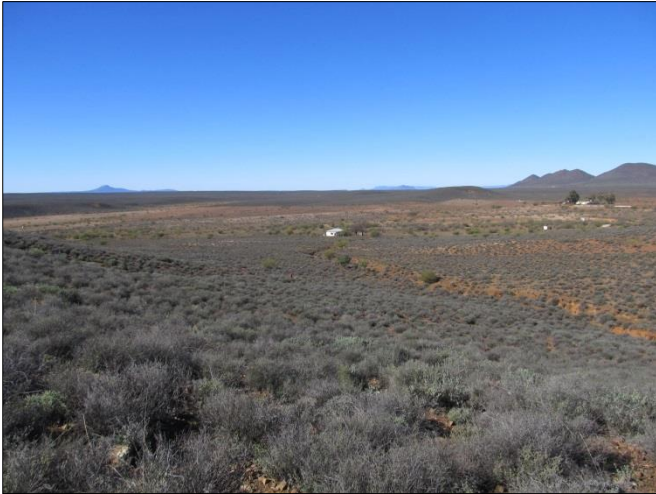
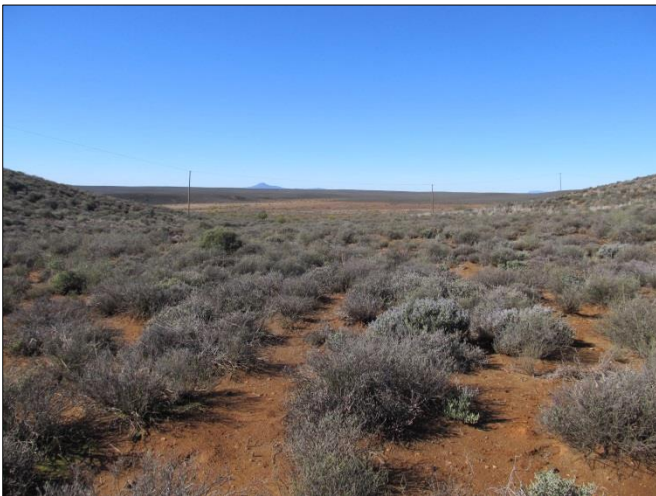
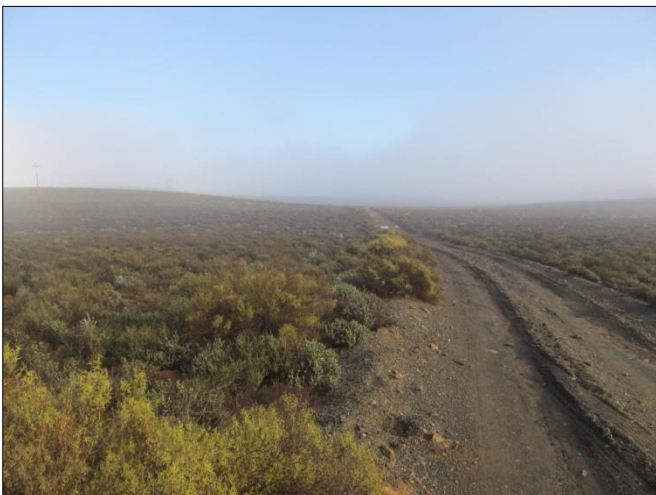
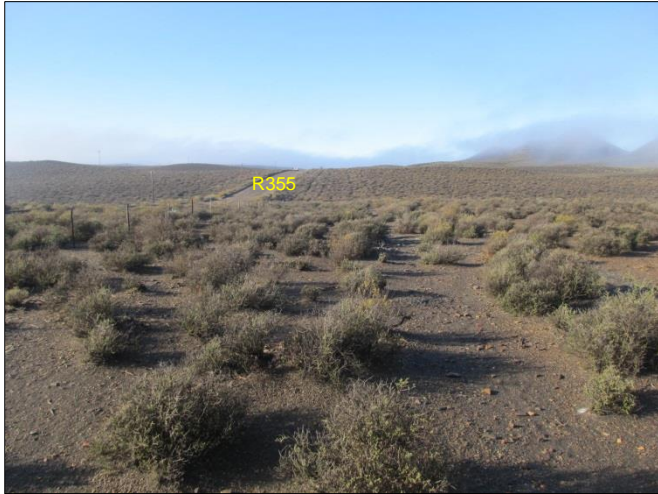
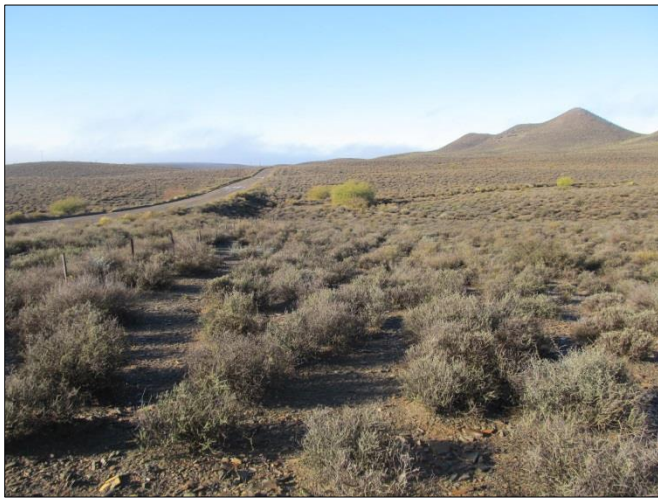
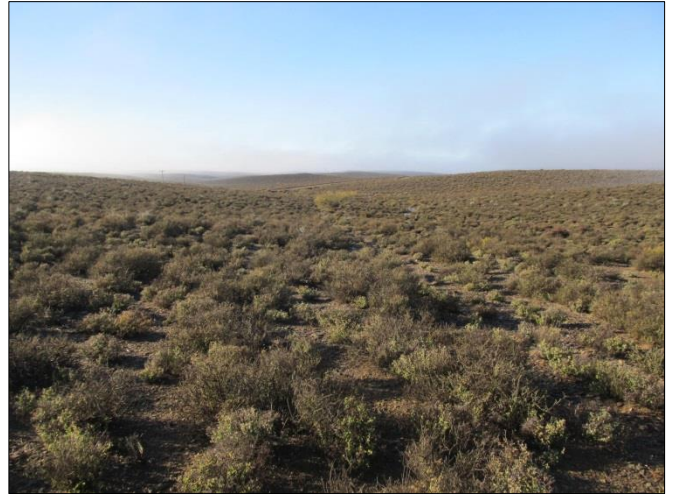
The receiving environment between the Loeriesfontein reservoir and the R355 is fairly severely degraded. The proposed route (nearly 3.5kms) follows an old erosion donga, sheet washed slopes, gravel farms roads, and a small twee spoor track before connecting with the R355. The surrounding hills and flatlands are covered in gravels of shale and low scrub. A short section of the proposed route crosses a red sandy patch of dry land agriculture with relatively large numbers of Acacias, which has been heavily overgrazed (Figures 21-28).

Figure 21. Route from Loeriesfontein Reservoir to R355

Figure 22. Route from Loeriesfontein Reservoir to R355

Figure 23. Route from Loeriesfontein Reservoir to R355

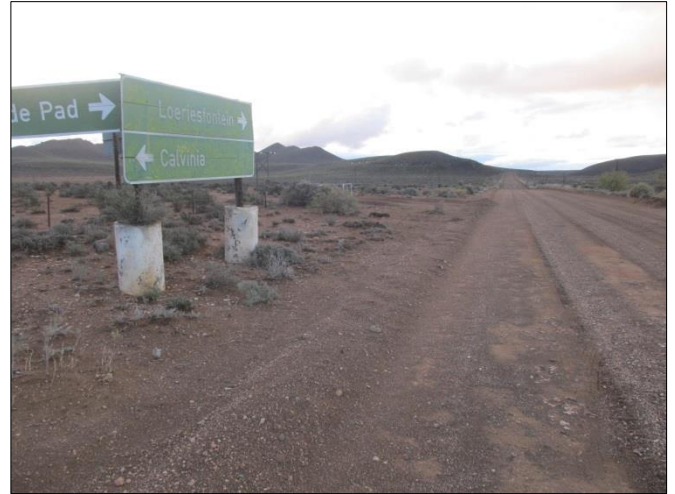
Figure 30. Route alongside R355 to Loeriesfontein

About 8kms of the proposed rising main will be located in the R355 road reserve (Figure 29 & 30), while most of the feeder or connecting pipelines on Rheebofsfontein, Hoek van Berg and De Brak follow existing gravel roads (refer to Figure 2). A short section (0.65km) of the pipeline on the farm De Brak crosses grazing land between a new borehole alongside a dry river and the access road to the farm werf (Figure 31).

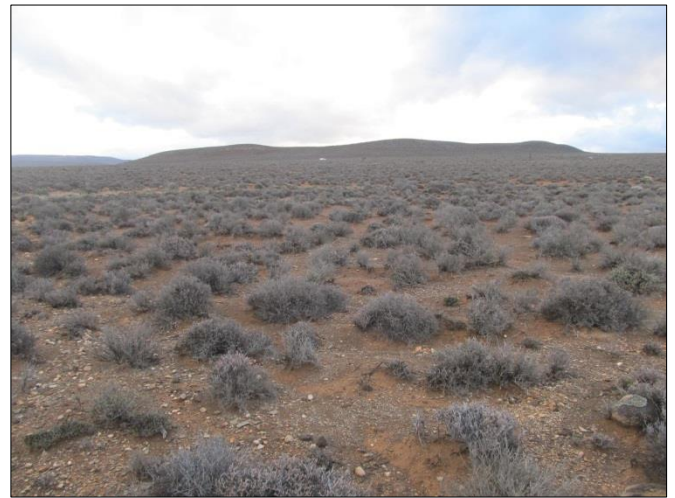
Figure 31. Proposed route on the Farm De Brak

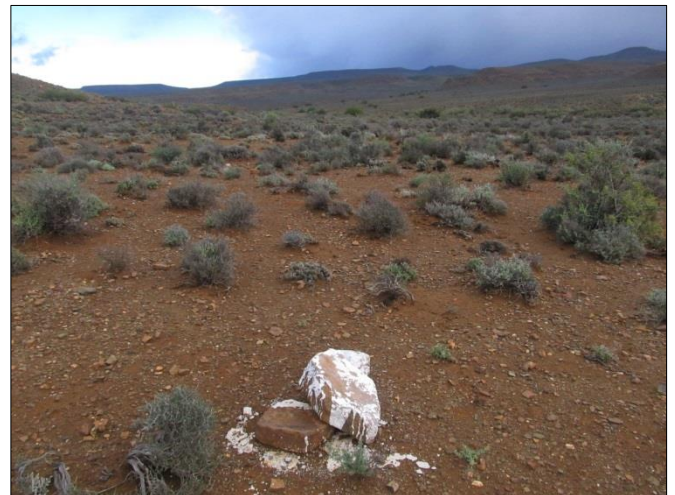
The footprint area for the proposed holding reservoirs on Rheebofsfontein, Hoek van Berg and De Brak is illustrated in Figures 32-34. The footprint area for the reservoir at Hoek van Berg is an old borrow pit alongside the R355.

Figure 32. Footprint area for the proposed Rheebofsfontein holding reservoir

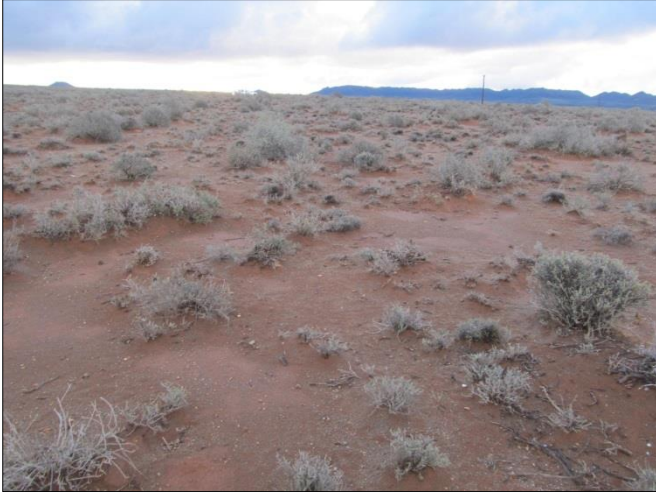
Figure 33. Footprint area for the proposed De Brak holding reservoir

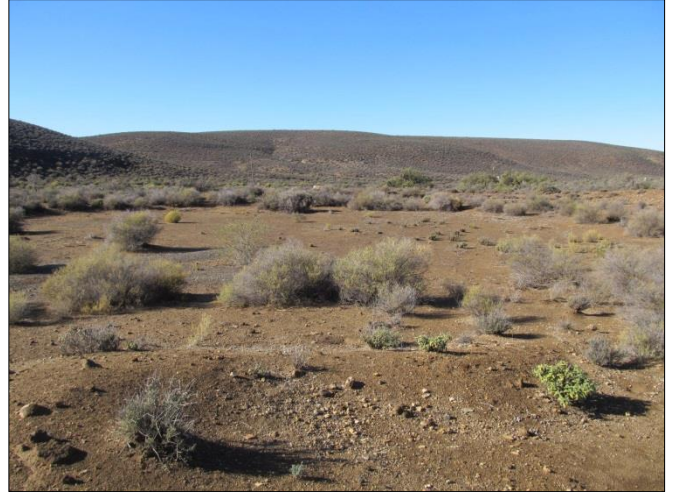
Figure 34. Footprint area for the proposed Hoek van Berg holding reservoir (old quarry)

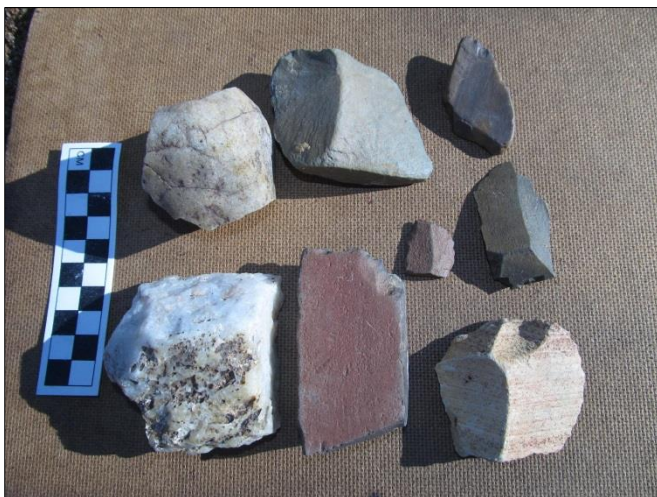
A few isolated implements were found along the proposed pipeline route on the Farm Rheebofsfontein (refer to Table 2 in Appendix I). These include three MSA flakes in weathered indurated shale (027, 030 & 070), one weathered ironstone (037) MSA flake, and one snapped LSA indurated shale flake (029). A quartzite minimal core/chunk (034) was also found in the pipeline route. No archaeological remains were found in the footprint area of the proposed Rheebofsfontein holding reservoir, which comprises mostly red sands and some shale gravel on the edges.

Figure 35. Collection of tools from the Farm Rheebofsfontein. Scale is in cm

The very small numbers and isolated context in which they were found means that the pre-colonial archaeological remains recorded during the study are rated as having low (3C) local significance.

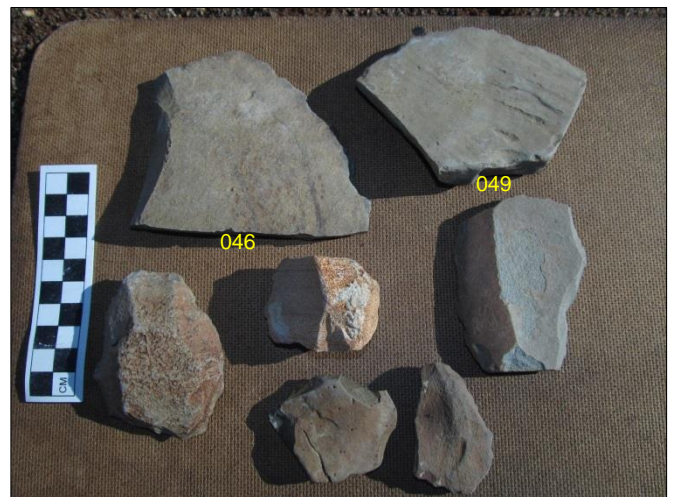
A large weathered, indurated shale core (063) and several weathered indurated shale MSA flakes (065 & 065) were found on the Farm Hoek van Berg alongside the R355. The two existing boreholes occur on this farm. All the tools were found among rubble alongside the proposed holding reservoir/old borrow pit.

Figure 36. Collection of tools from the Farm Hoek van Berg. Scale is in cm

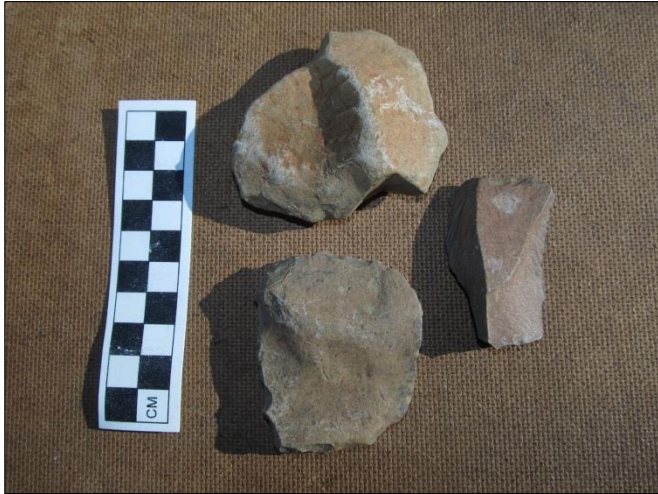
Several weathered indurated shale MSA flakes, including two broken/snapped LSA flakes/blades (069) were encountered in the open veld alongside the R355.

Figure 37. Tools (069) found in the open veld alongside the R357. Scale is in cm

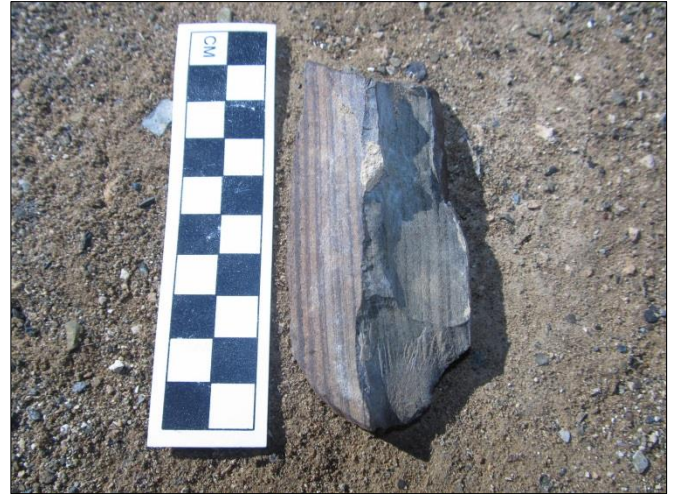
Figure 38. Broken indurated shale LSA blade (069) alongside the R355. Scale is in cm

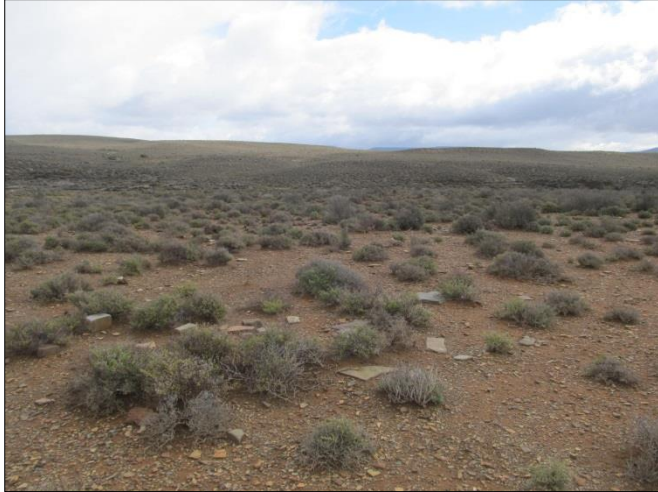
The ruins of a small stone structure were found alongside the proposed pipeline route overlooking the gravel road on the Farm Rheeboksfontein (Figures 39 & 40). The ruins might be the remnants of a late 19th/early 20th Century shepherd's hut (veewagterhuis), or a small stock post. A few blocks of shale were found scattered, about including several pieces of English transfer ware.

Figure 39. Site 038. Remains of a small stock post. Note the blocks of shale lying about, likely sourced from a nearby river

The ruins of the stock post/shepherd's hut have also been rated as having low (3C) local significance. Very little of the structure remains apart from a few scattered blocks of shale and some ceramics lying around.

1. No archaeological mitigation is required.
2. Should any unmarked human burials/remains or ostrich eggshell water flask caches for example be uncovered, or exposed during construction activities, these must immediately be reported to the archaeologist (Jonathan Kaplan 082 321 0172), or Ms Jenna Lavin at the South African Heritage Resources Agency (021 462 4502). Burials or caches of ostrich eggshell must not be removed or disturbed until inspected by the archaeologist.

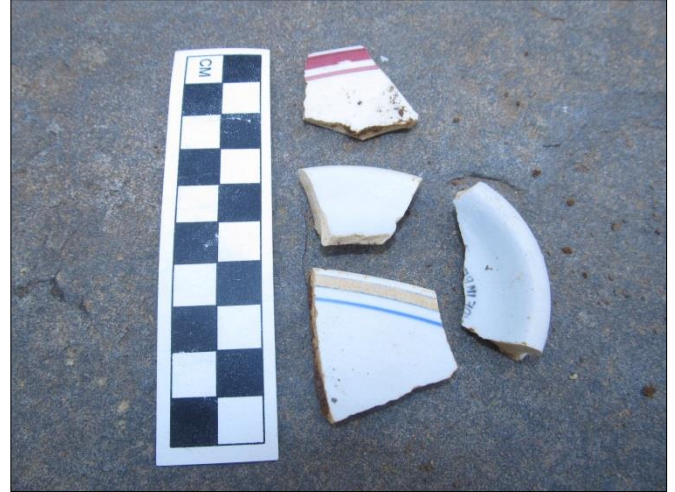
Figure 40. Site 038. A few pieces of ceramic found lying scattered about. Scale is in cm
