HERITAGE IMPACT ASSESSMENT
Assessment of Structures and proposed development
at

220 Murray/ Gladys Manzi road, New England, Pietermaritzburg

August 2019

Revised : June 2022

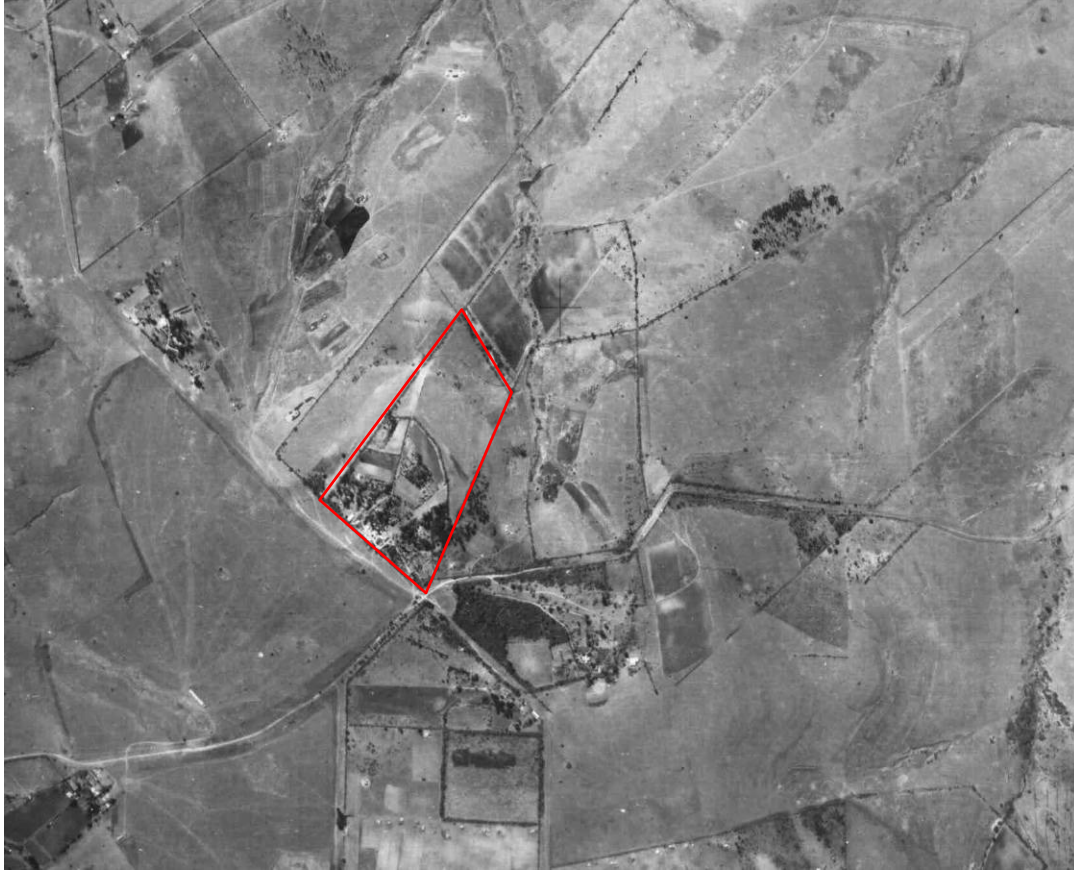
Aerial photo 1930-1940

A 1930's aerial photograph shows a farm with lush vegetation and clear divisions of land by planting. It also shows a lot of activity around the farmstead ie. clear of vegetation. This could indicate building or quarrying. The size of the house or other structures is unclear.

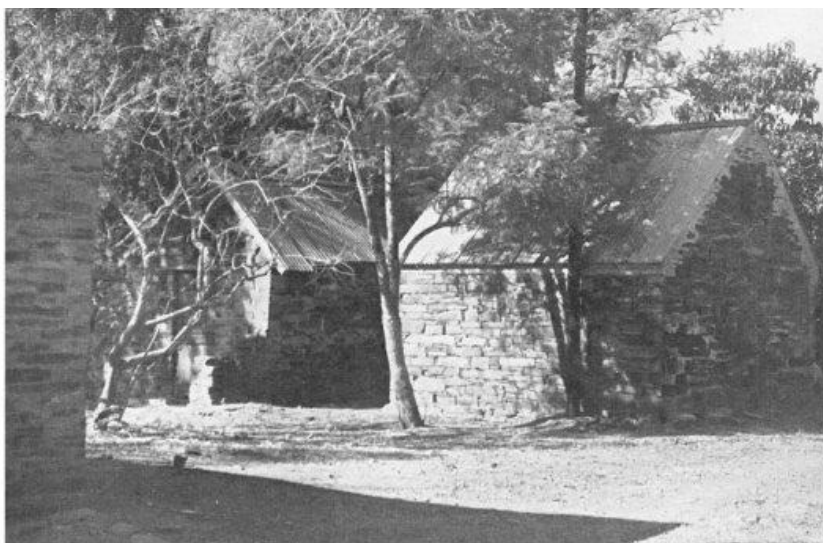
"the armoury and dog house" 1960 "Hattersley"

All of the structures contain shale, quarried on the farm. The two small storerooms appear to be the oldest structures (c.1900) in their original form, and are rumoured to have been used by the British regimental officers as an armoury and dog-house for hunting. (*ref. Hattersley*) They may have originally been shepherds huts, although the one building is clearly scaled for keeping animals.

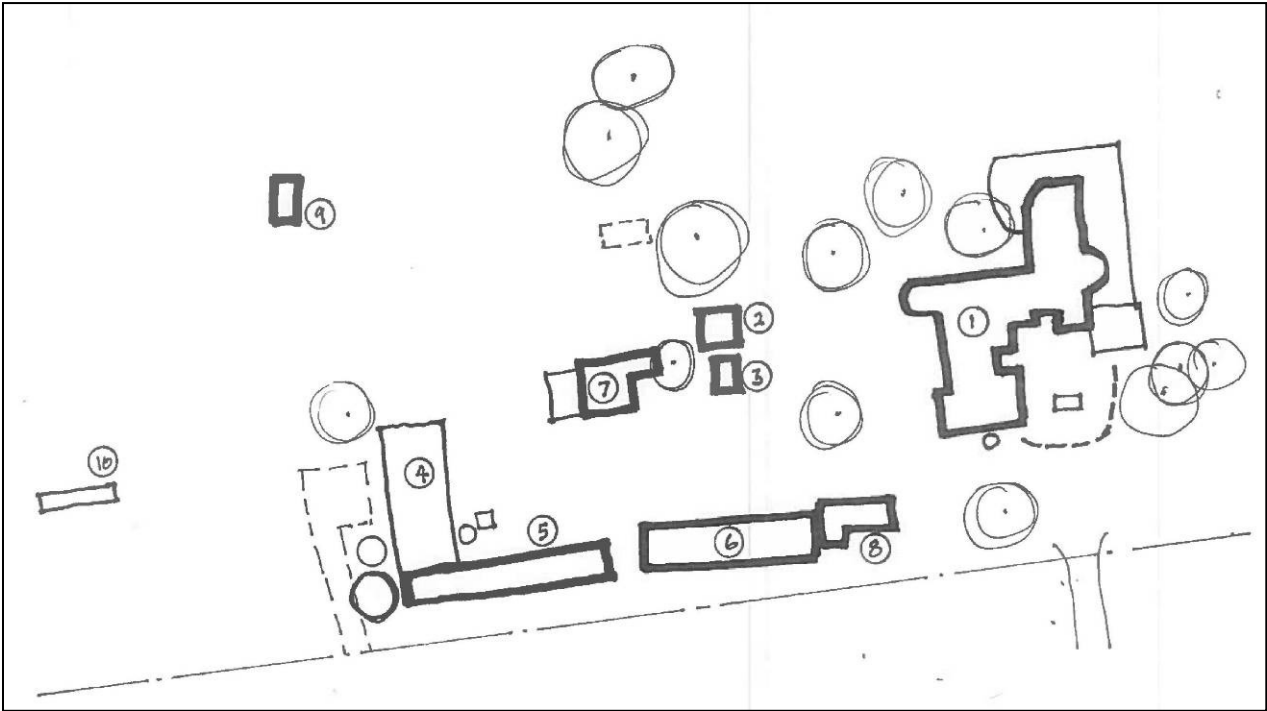
Site Plan of existing structures (no. 11-12 off the page – refer to survey drawing)

The existing structures are as follows (refer to site plan) :

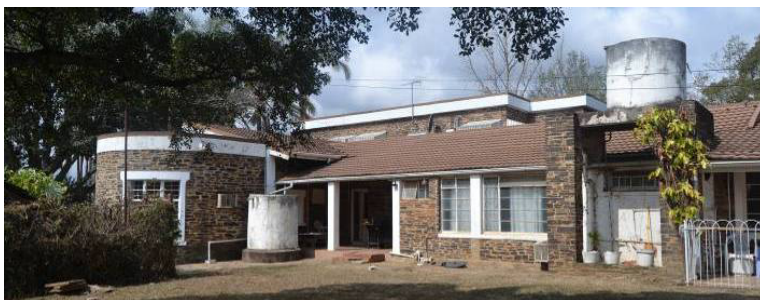
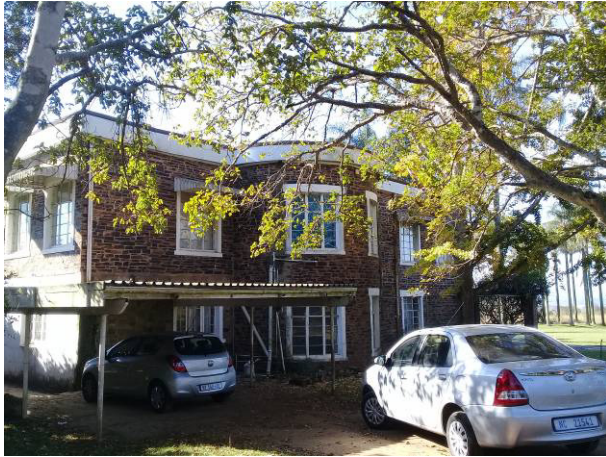
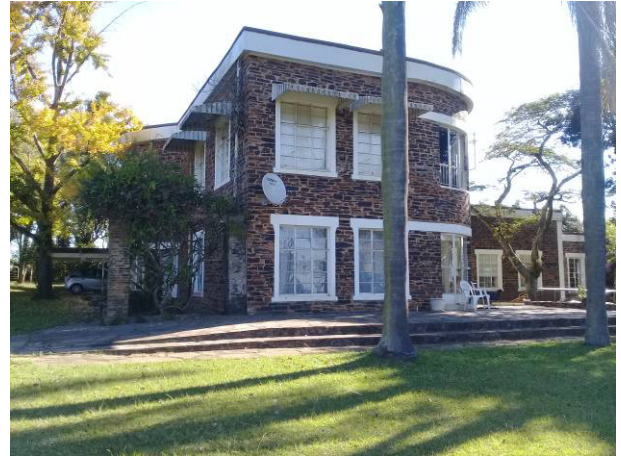
1. Main house :

The main house is constructed of stone, shale, clay brick and mortar.

The evident style of the main house is of the era of “Bauhaus” or “the international style” with characteristic horizontal lines, flat roofs, rectangular openings, geometric facades and the use of circular form in plan. The style was started in 1919 in Germany, but only influenced South African buildings in the 1930’s.

On closer investigation, the house has at least 3 layers of construction. There appears to be a core of a small stone cottage and possibly an outbuilding, which have been swallowed up by additions. The original walls, doors and a window of the cottage exist internally. The later addition, being the most dominant, is double storey and built of local shale. The external walls of shale appear to have been built either by different stone masons or at different times, due to the differences in the sizing of the shale and the quality of workmanship.

Internally, a circular hallway and stairway are a feature. The roof construction has suffered and caused damage to the walls and ceilings.

The house is in-coherent and currently used as multiple living spaces.

The main house (building 1) is an unusual example of the style using local shale, whereas other examples were plastered. It is best appreciated from the East and North and sits well within an open space.

However, the integrity of the historical structure has been eroded by layering of construction in different periods, making it difficult to single out one significant period.

The large rooms and hall of the house would adapt well to a non-residential use.

The main house is recommended as a Grade 3C for its age, its architectural features from the 1930 period and for its unique use of natural stone from the farm.

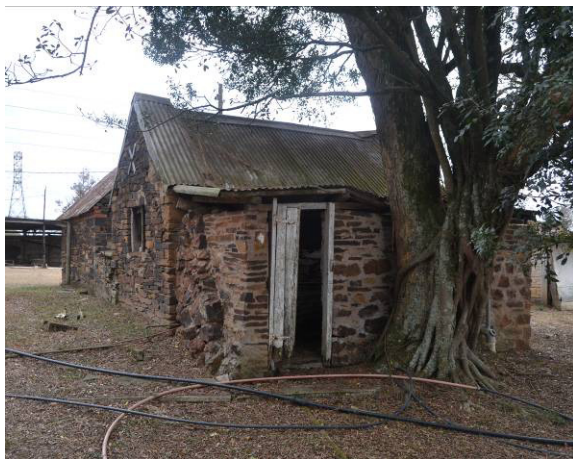
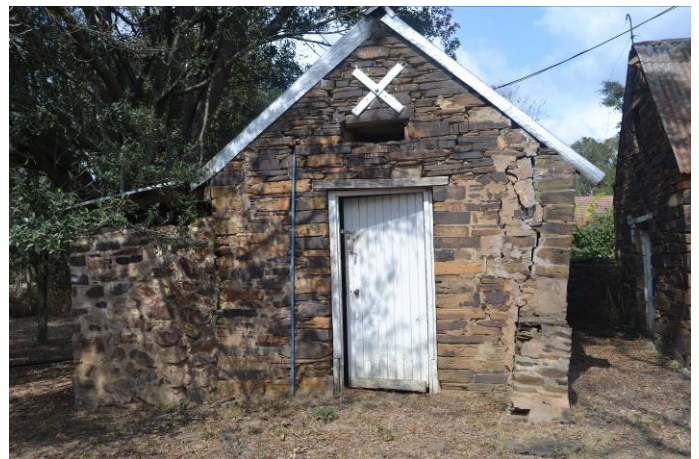
2. Stone store room “the armoury” :

Dry stacked shale single room building with a later addition to the East side.

The storerooms built of shale (building 2 and 3), although historic by their association with British settlers, the Boer War and sport, are delicate and would suffer if construction was in close proximity to the structures. Their historic significance is linked to the land as hunting ground and farmland.

The two storerooms are recommended as Grade 3C for their age, their association with an historic event and function and for its use of natural stone from the farm.

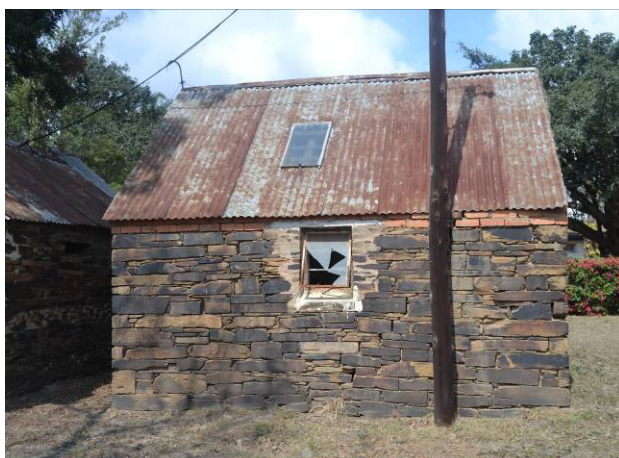
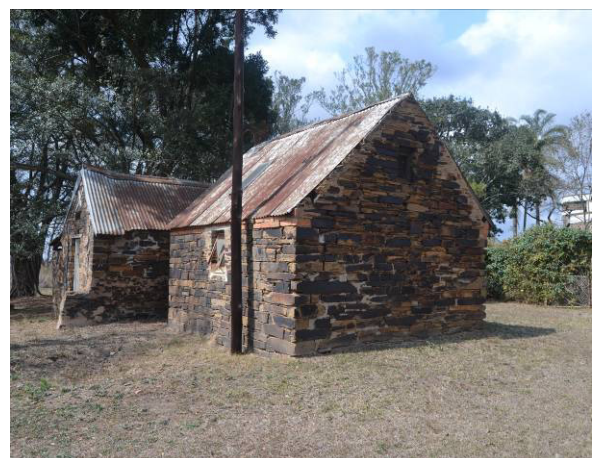
3. Stone store room “the dog house”:

Dry stacked shale single room building with low eaves and lintels.

The buildings are in close proximity to each other and trees have attached themselves to the structure. The buildings were featured in “Camera in Natal” by Hattersley in 1960.

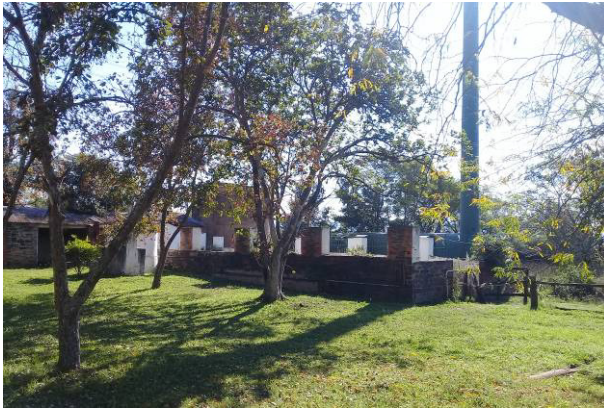
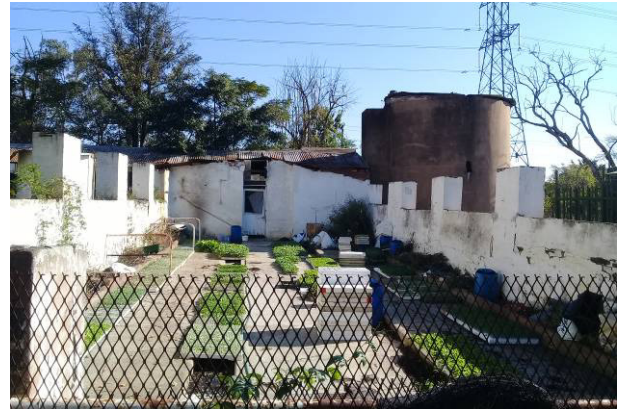
4. The dairy :

Walled structure without a roof that housed the dairy. Materials are shale, clay brick and mortar. Inside face of the walls and piers are plastered and floor is concrete with drainage channels. Other structures are scattered around, eg. Silos.

The other farm buildings, including the diary and stables are utilitarian and not noteworthy structures and not significant.

The other farm structures are recommended as not conservation worthy (NCW).

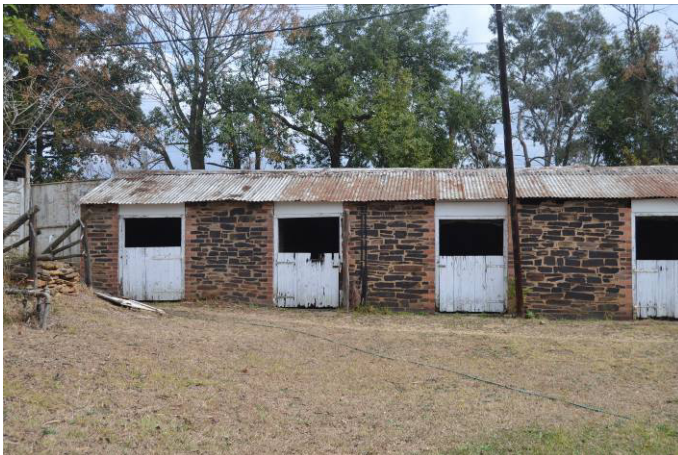
5. The stables/ cattle sheds :

Inter-leading stables with stone floor, shale and clay brick walls. Corrugated iron roof and large timber stable doors.

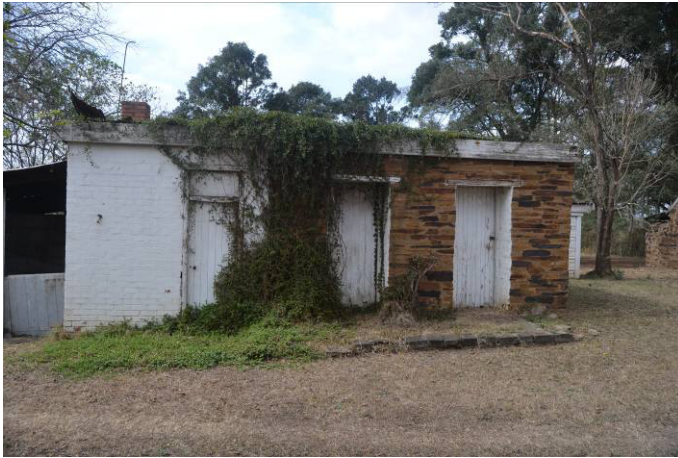
7. Outbuilding 1:
Rooms constructed of shale, clay brick and precast concrete fence.
Note engravings in the shale visible on the outside (South and West sides) various "Hlatshana" and "Herbert...Foxon".

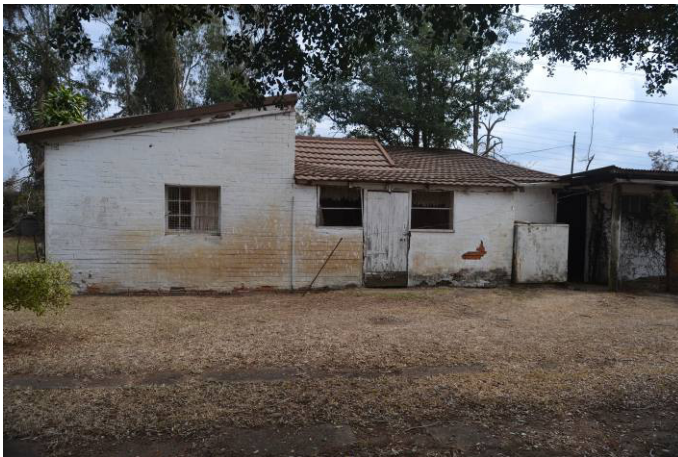
8. Outbuilding 2 :
Servants living quarters, constructed of brick and mortar.

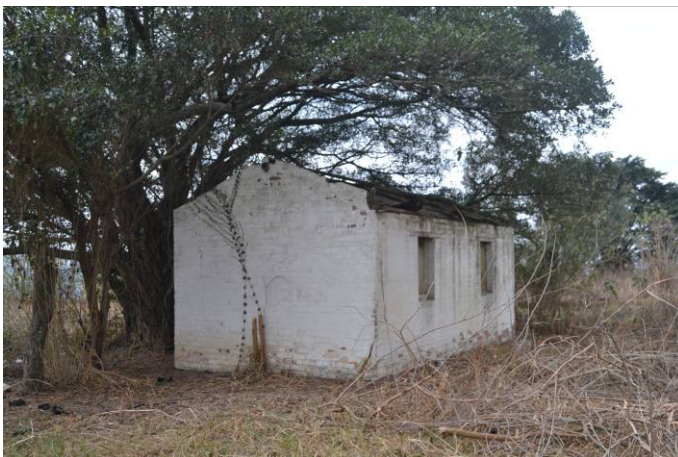
9. Outbuilding 3 :
Two-roomed single dwelling, separated from the farmstead. Clay brick and mortar with timber frame windows. In a state of disrepair.

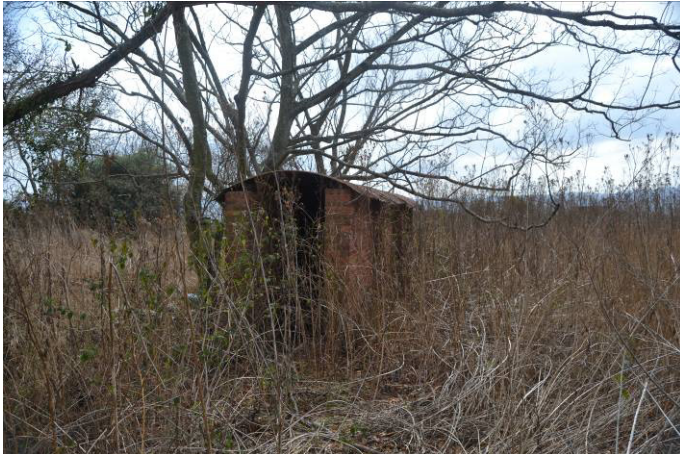
10. Dip tank :

Facebrick structure, two walls and concrete channel, roofed with corrugated iron.

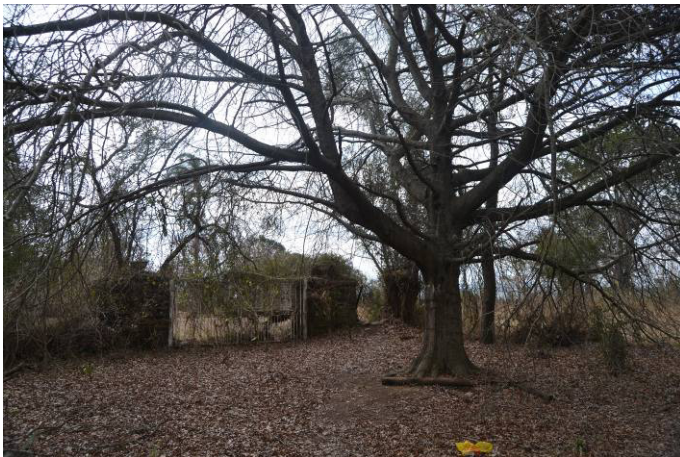
11. Gate and gate posts :

Located at the South-West corner of the site, the original entrance-way onto the farm. Shale posts and walls with decorative urns frame the gate. Decorative wrought-iron gate and cattle-grid. Decorative wrought iron archway is no longer there, but recorded in 2009.

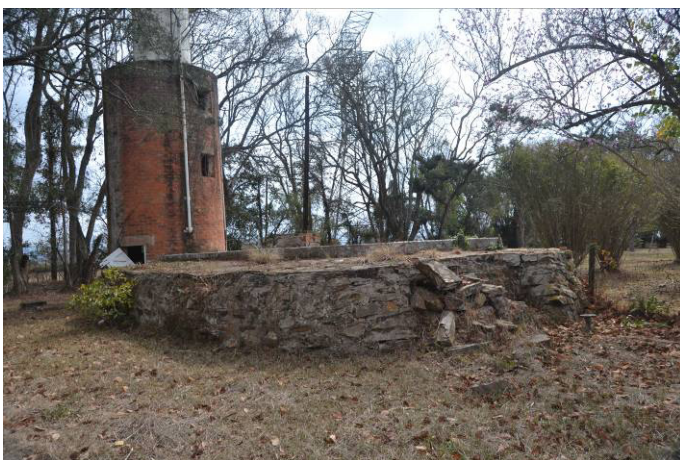
12. Water reservoir (located in the SW corner of the site close to the road boundary) :

Shale and stone outer walls and clay brick circular water tower.
