MARITIME HERITAGE FIELD SURVEY FOR DURBAN OIL IMPORT PIPELINE

MARITIME HERITAGE DESKTOP SURVEY FOR SAPREF'S DURBAN OIL IMPORT PIPELINE:**DURBAN, KWAZULU-NATAL****SOUTH AFRICA**

Report #: 2019/DBN/001
Status: First
Revision #: 1
Date: 12 May 2019

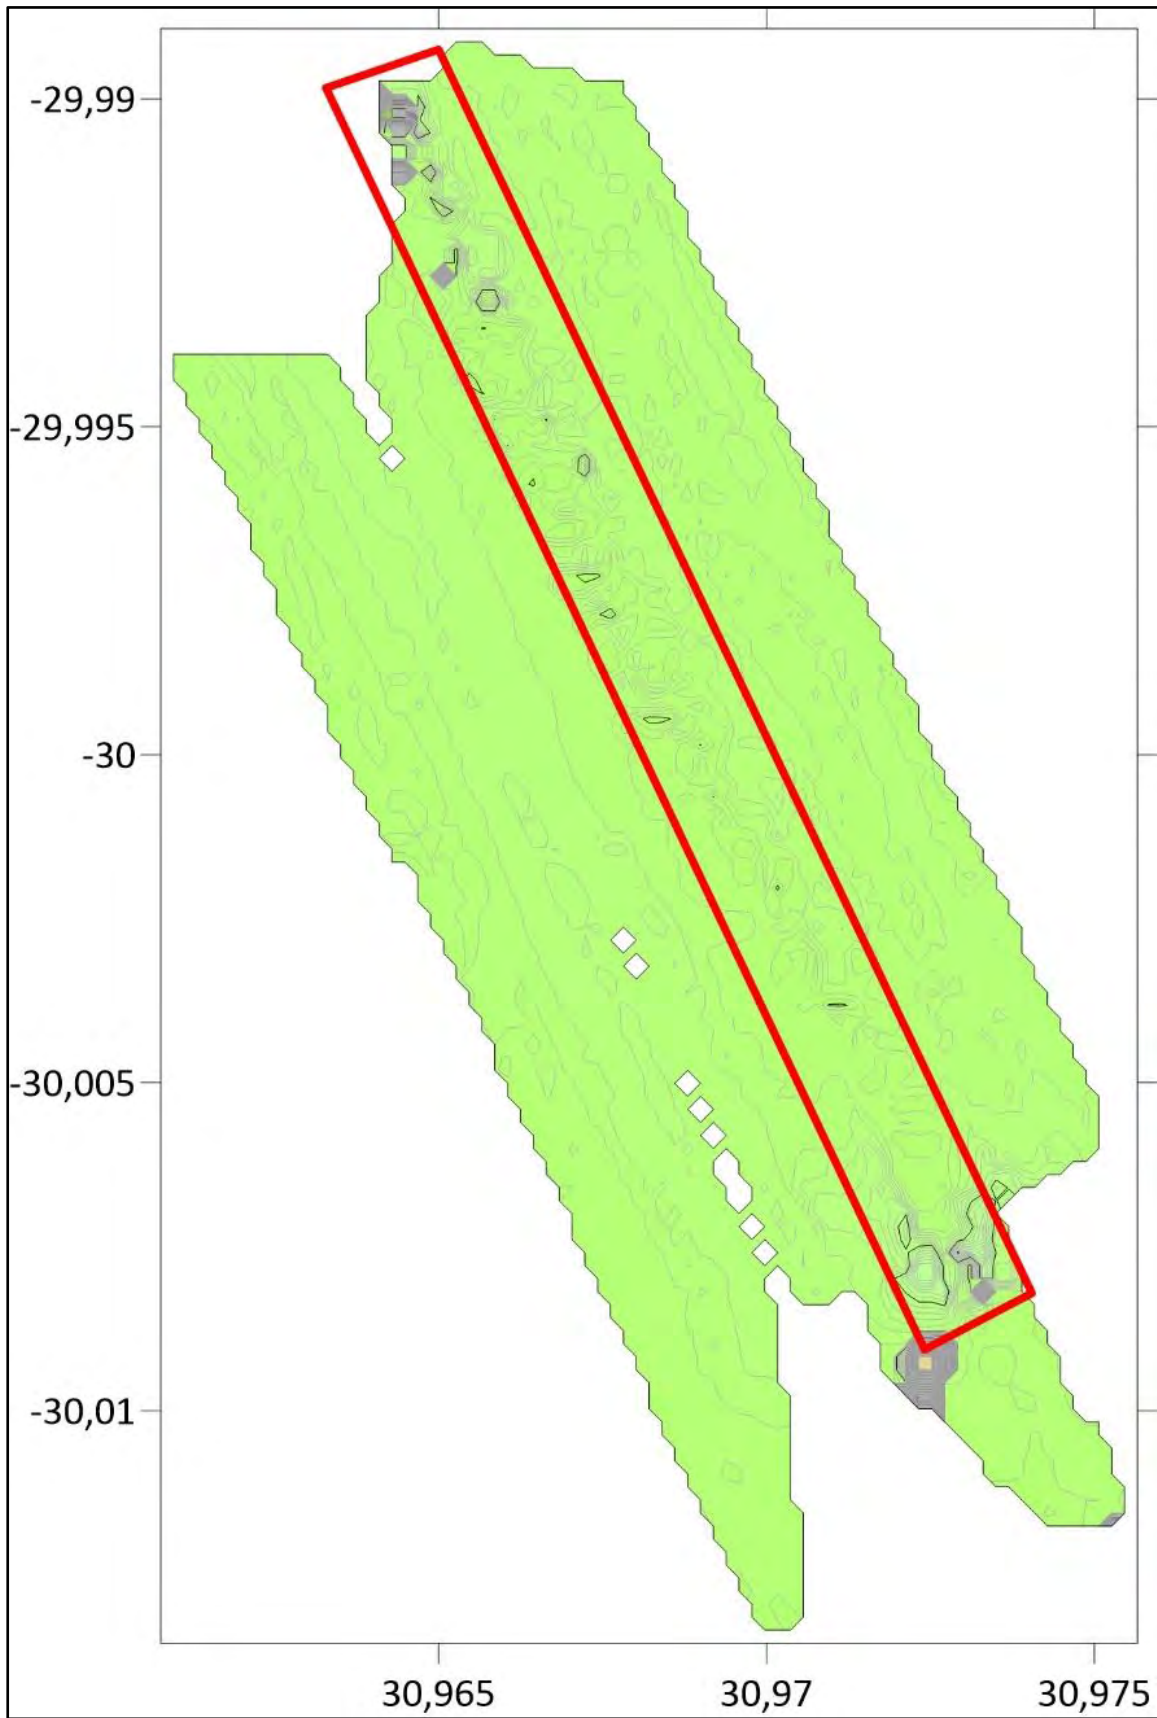
Figure 8: Magnetometer Survey Mosaic with Pipeline marked

The red polygon demarcates the magnetic signature of the pipeline and the PLEM (Figure 8).

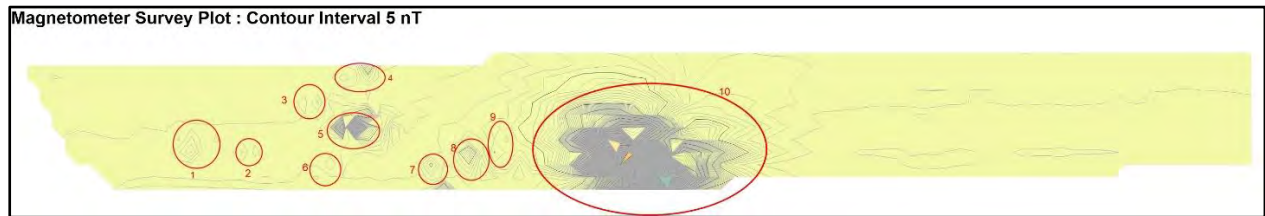
Shipwrecks and the associated debris field generally has much larger, more complex magnetic signatures (Figure 11). Even wooden ships had a fair amount of ferrous material on them, such as cannon, anchors and metal fasteners.

Figure 11: Magnetometer survey from a different site with a large iron wreck and scattered wreckage from a wooden vessel – For comparison purposes.

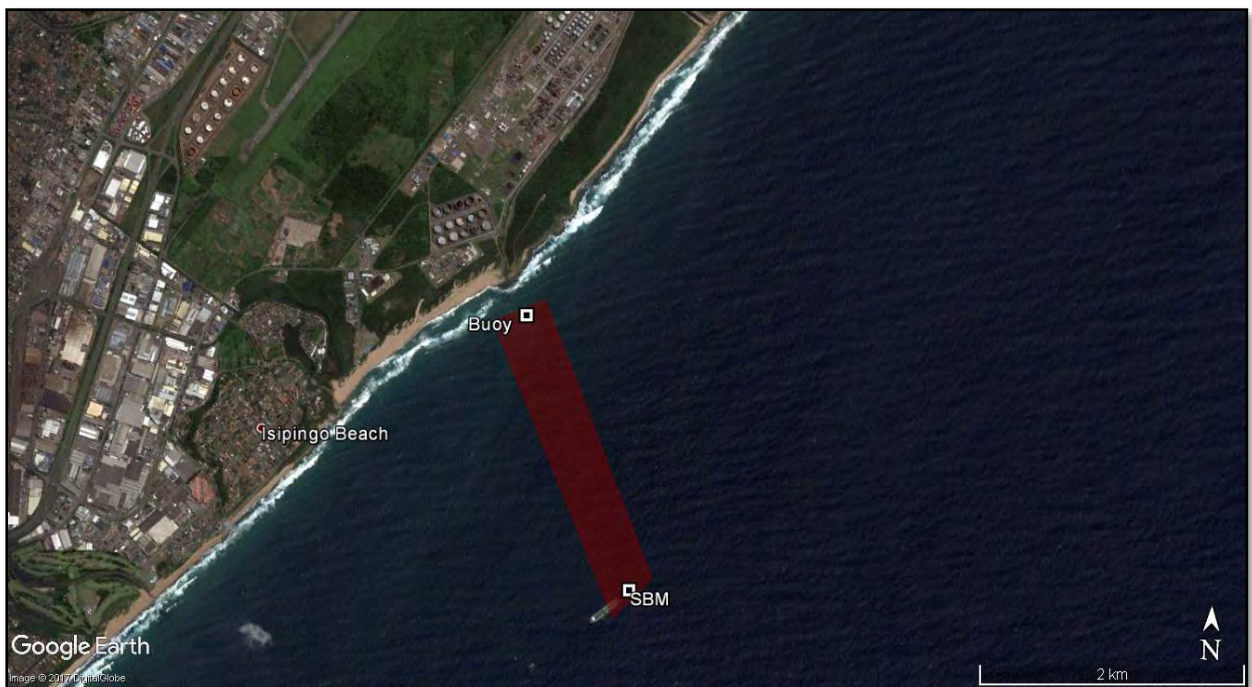
SAPREF's Oil Import Pipeline off Isipingo, is 2.6 km long from the inshore buoy to the offshore SBM. The area under investigation is the exposed pipeline which begins at about 11 m and shelves to about 38m depth.

Figure 1: SAPREF's Oil Import Pipeline Area (Google Earth 2017)

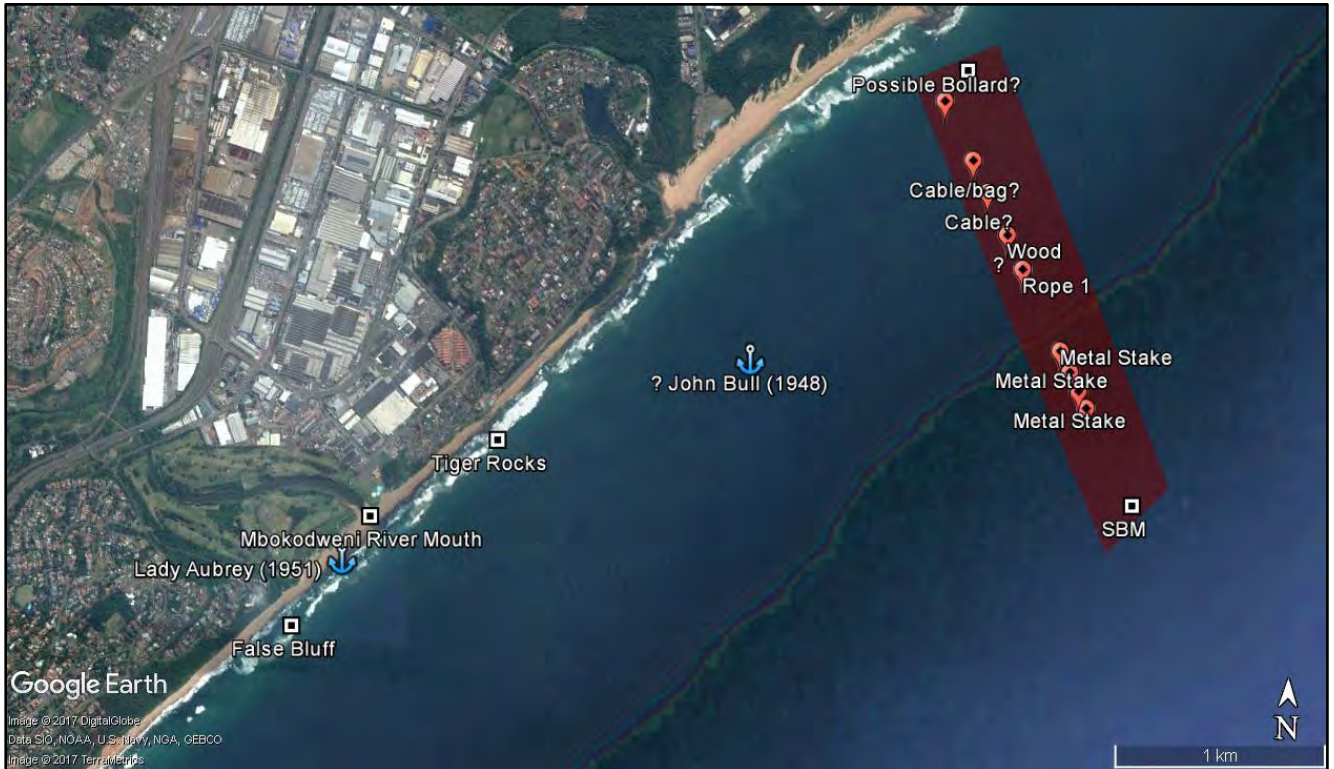
Figure 2: Site Map with approximate wreck locations and relevant landmarks (Google Earth 2017)

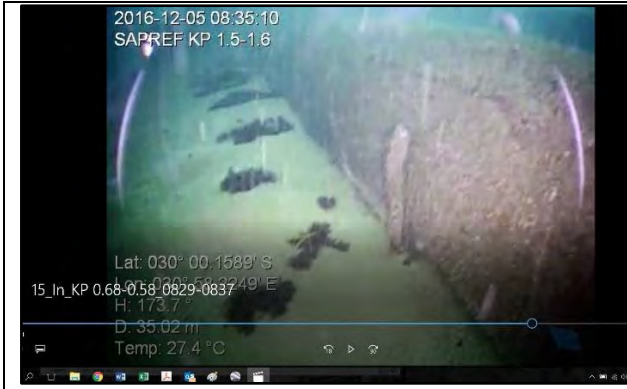
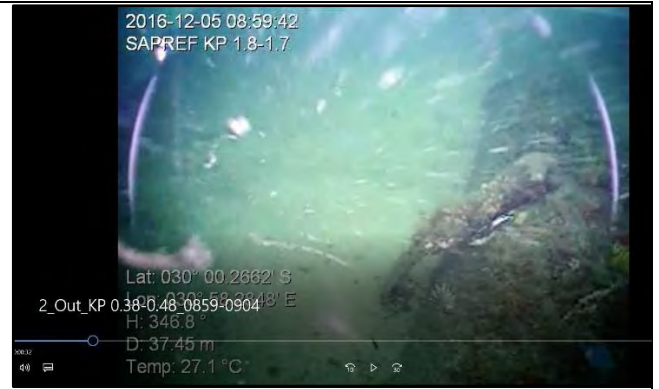
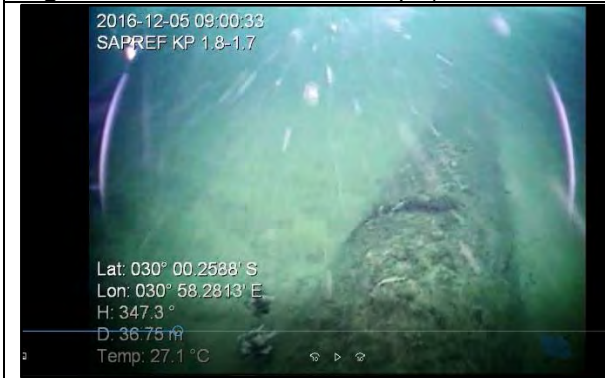
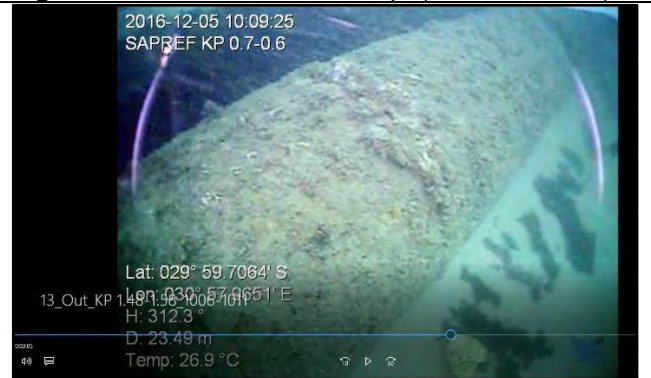
There are a number of rounded metal stakes/straps along the pipeline. According to SAPREF engineers (Pers Comm: 2017) these straps are residues of the construction process and are at regular intervals along the pipe.

Figure 4: Remains of metal strap (SAPREF 2016)

Figure 5: Remains of metal strap (SAPREF 2016)

Figure 6: Remains of metal strap (SAPREF 2016)

Figure 7: Remains of metal strap (SAPREF 2016)

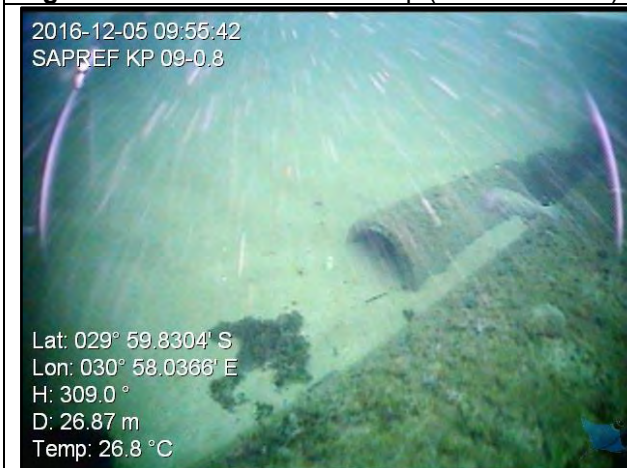
This pipeline is outside a major metropolitan area and a major port, a certain amount of detritus washes up around the pipe, such as cabling and pipes.

Figure 8: Concrete pipe (SAPREF 2016)

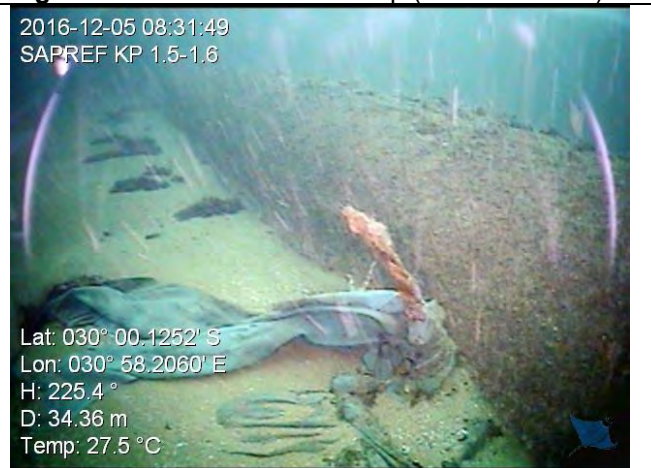
Figure 9: Steel cable with plastic attached (SAPREF 2016)

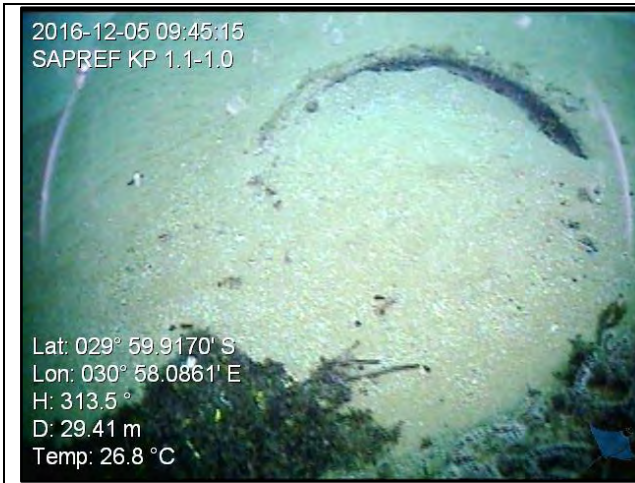
The ROV footage is an excellent tool for locating cultural artefacts, however I cannot make a definitive statement regarding the age or significance of the following possible cultural heritage objects without eyes-on.

Figure 14: Possible porthole (SAPREF 2016)

- SAPREF divers could take detailed photographs of the possible porthole and bollard (with a scale), fanning away the sand in order to get detail;
- Additionally, the divers should perform a 30m circular search from the possible MUCH resources, taking video. This footage can be assessed in order to make a recommendation that will fulfil the requirements of the NHRA.

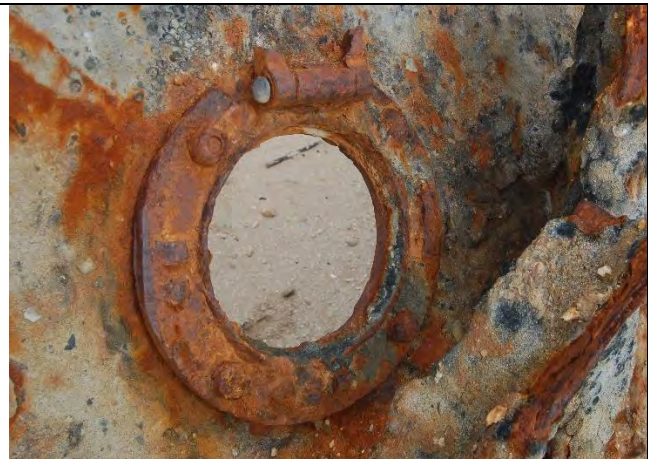
Figure 15: Porthole from the *County of Pembroke* (1903) wreck for comparative purposes (Maitland 2005)

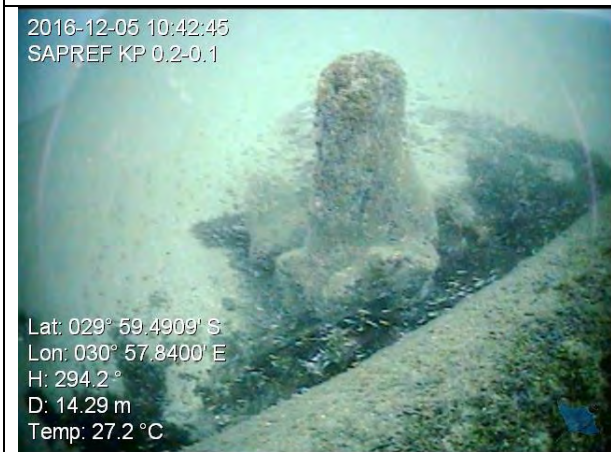
Figure 16: Possible bollard (SAPREF 2016)

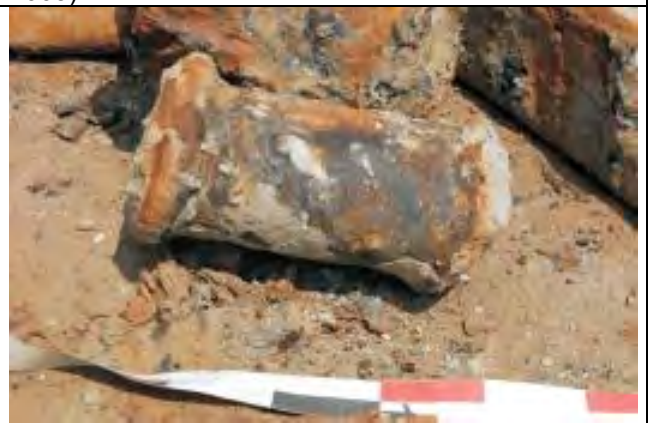
Figure 17: Bollard from the *Karin* (1927) wreck for comparative purposes (Maitland 2010)

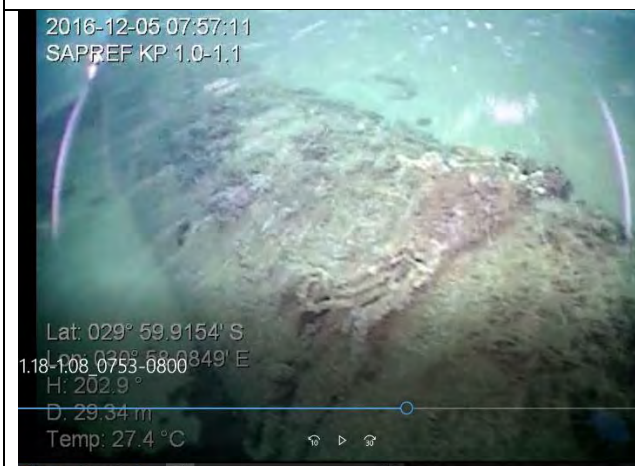
Figure 18: Rope 1 (SAPREF 2016)

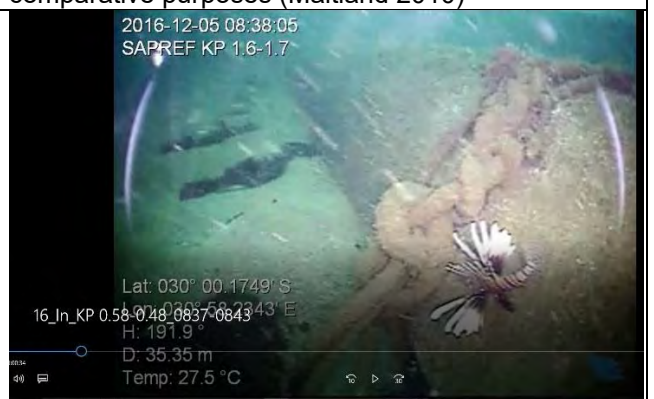
Figure 19: Rope 2 (SAPREF 2016)

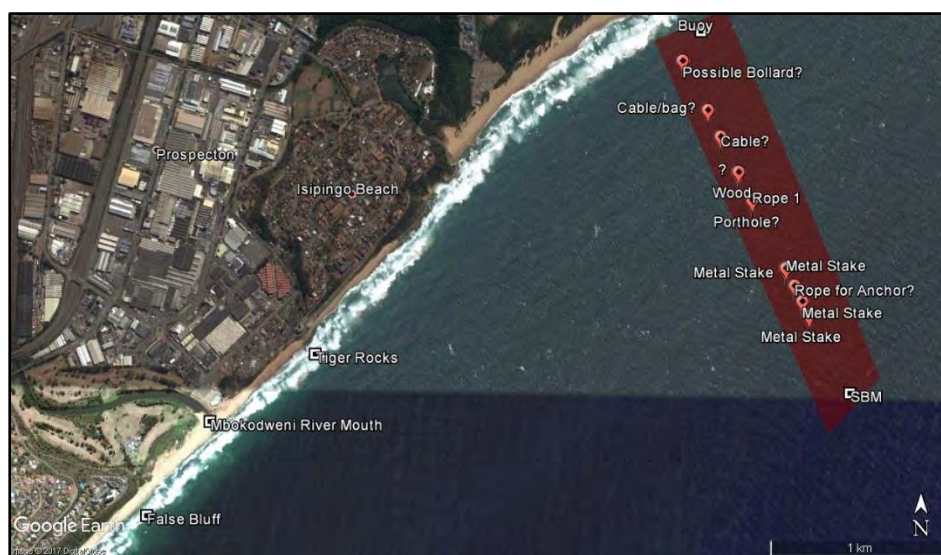
It is my understanding that the current stabilisation of the “pipelined will be the 600m length of pipeline with a 100m run-in on each side. Ergo, this is 1 300 and 2 100m from the PLEM respectively, and therefore in the area where some of the possible MUCH objects are. However, the observed objects are just outside of the stabilisation area.

Figure 20: Stabilisation zone in relation to possible MUCH objects

Investigation into the possible MUCH sites should be undertaken during the annual maintenance dives, in the following manner:
