PHASE 1 ARCHAEOLOGICAL IMPACT ASSESSMENT

**for the Proposed Casteel Dam Safety Rehabilitation Project on a Portion
of the Remaining Extent of the Farm Kasteel 231 KU, Acornhoek,
Mpumalanga**

Casteel Dam Safety Rehabilitation Project

Project Ref: Casteel Dam Safety Rehabilitation Project
Report No: NEC-2402231
Report Version: 2

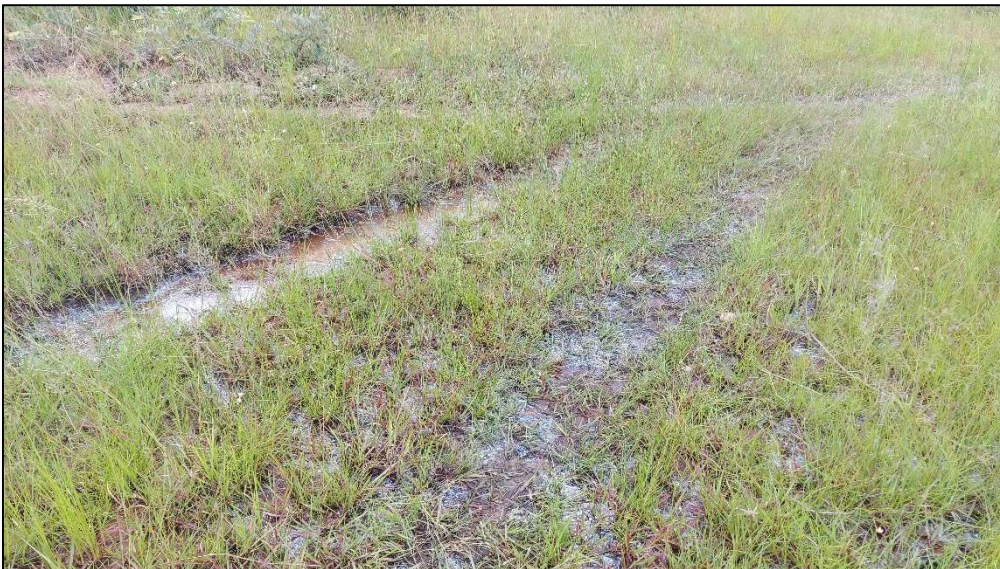
Figure 19: Sections of wet and marshy conditions to the south of the dam.

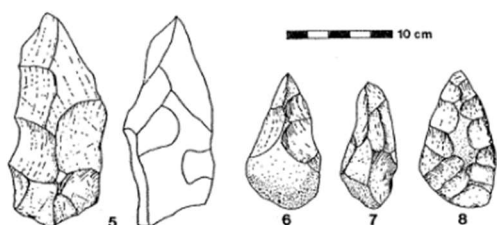
Figure 21: ESA artefacts from Sterkfontein (Volman 1984).

These artefacts are often associated with rocky outcrops or water sources. **Figures 21 – 23** below are examples of stone tools often associated with the Early, Middle and Later Stone Age of southern Africa.

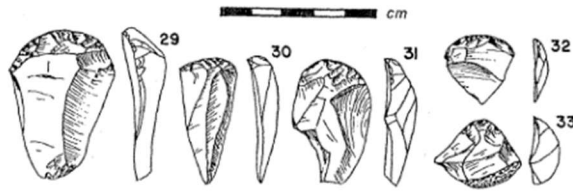
Figure 23: LSA scrapers (Klein 1984).

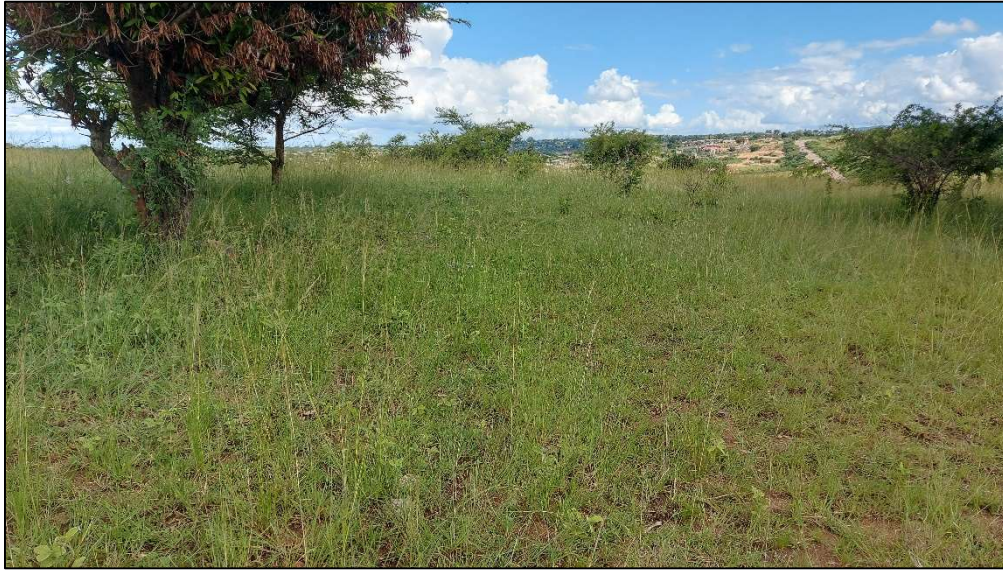
Figure 24: Environment associated with Site B01.

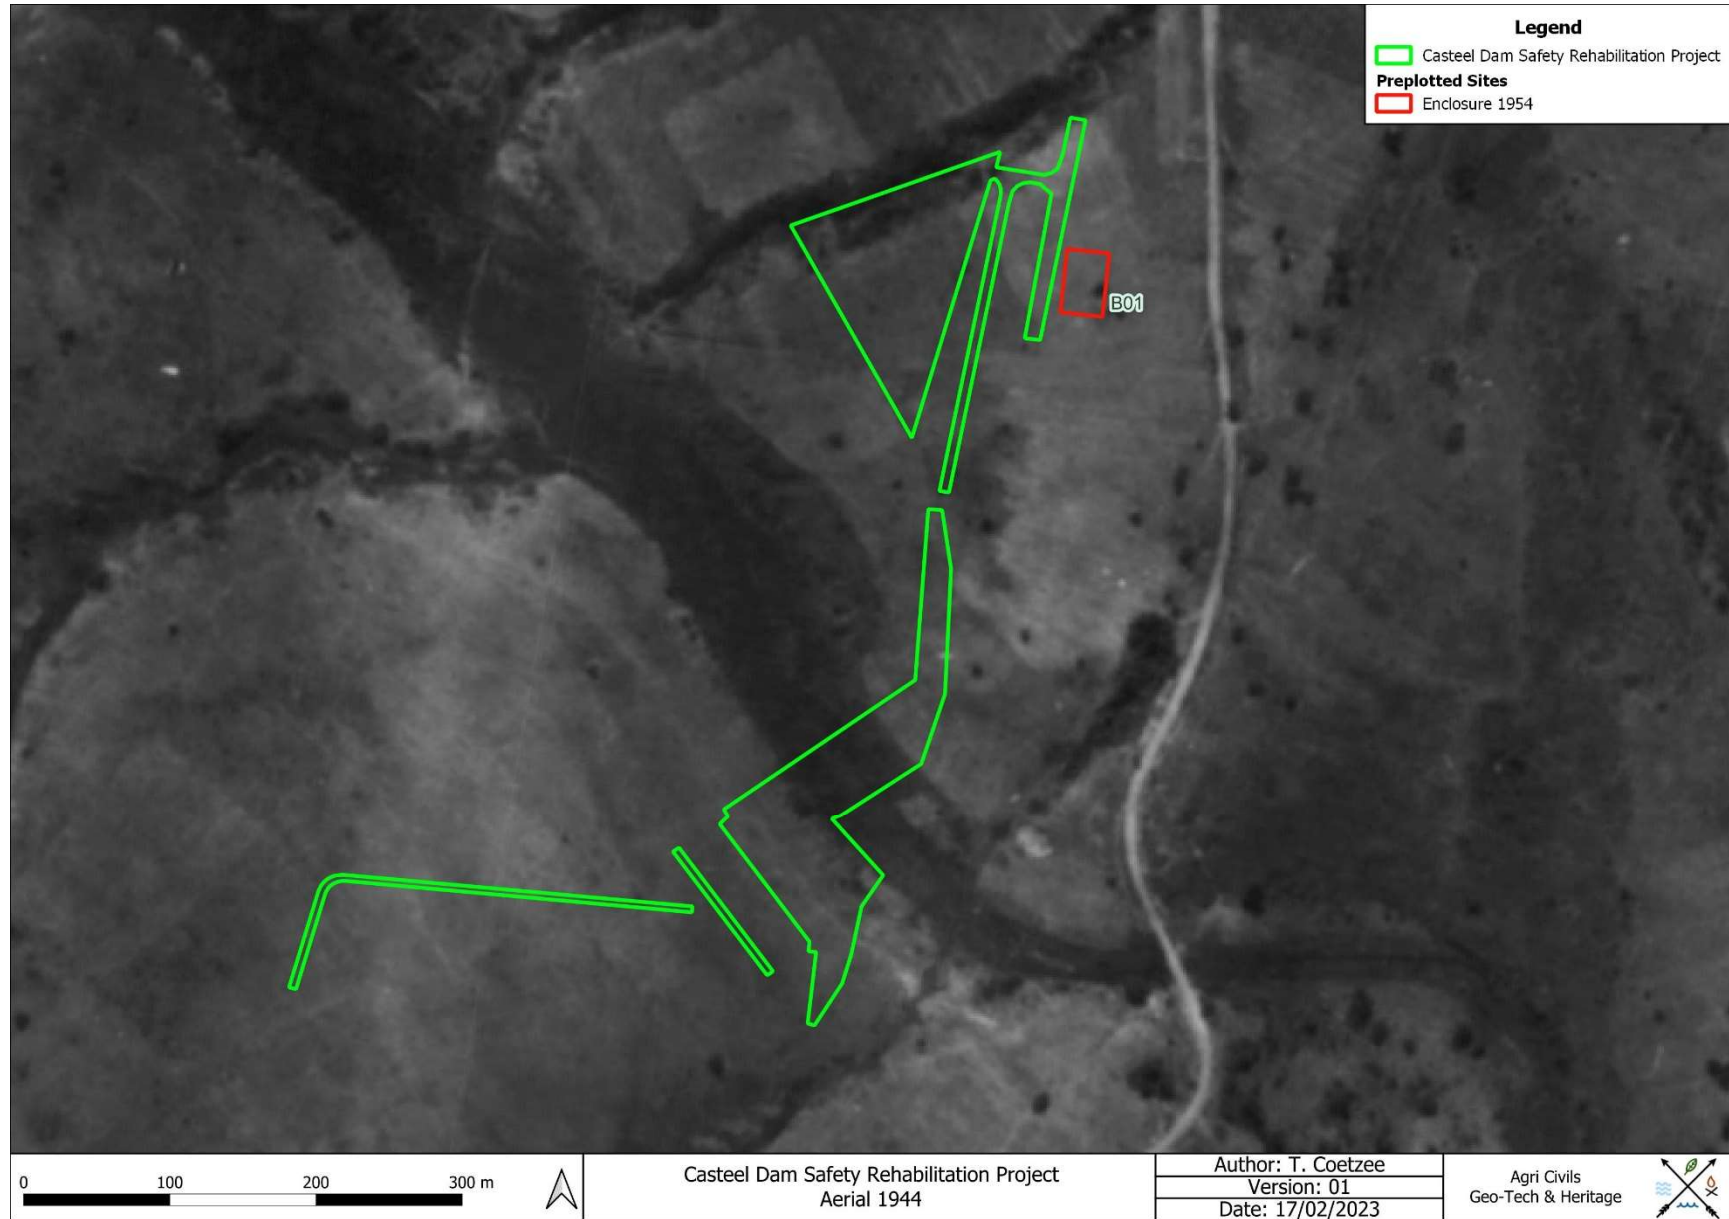
The aerial image dating to 1944 (**Appendix A: Figure 26**) shows the demarcated study area prior to the construction of the Casteel Dam. No structures are visible within the demarcated boundaries and the entire area appears to be cultivated. A road is also noted to the east of the study area while a few buildings are visible in the general area.

Figure 26: Study area superimposed on a 1944 aerial image.

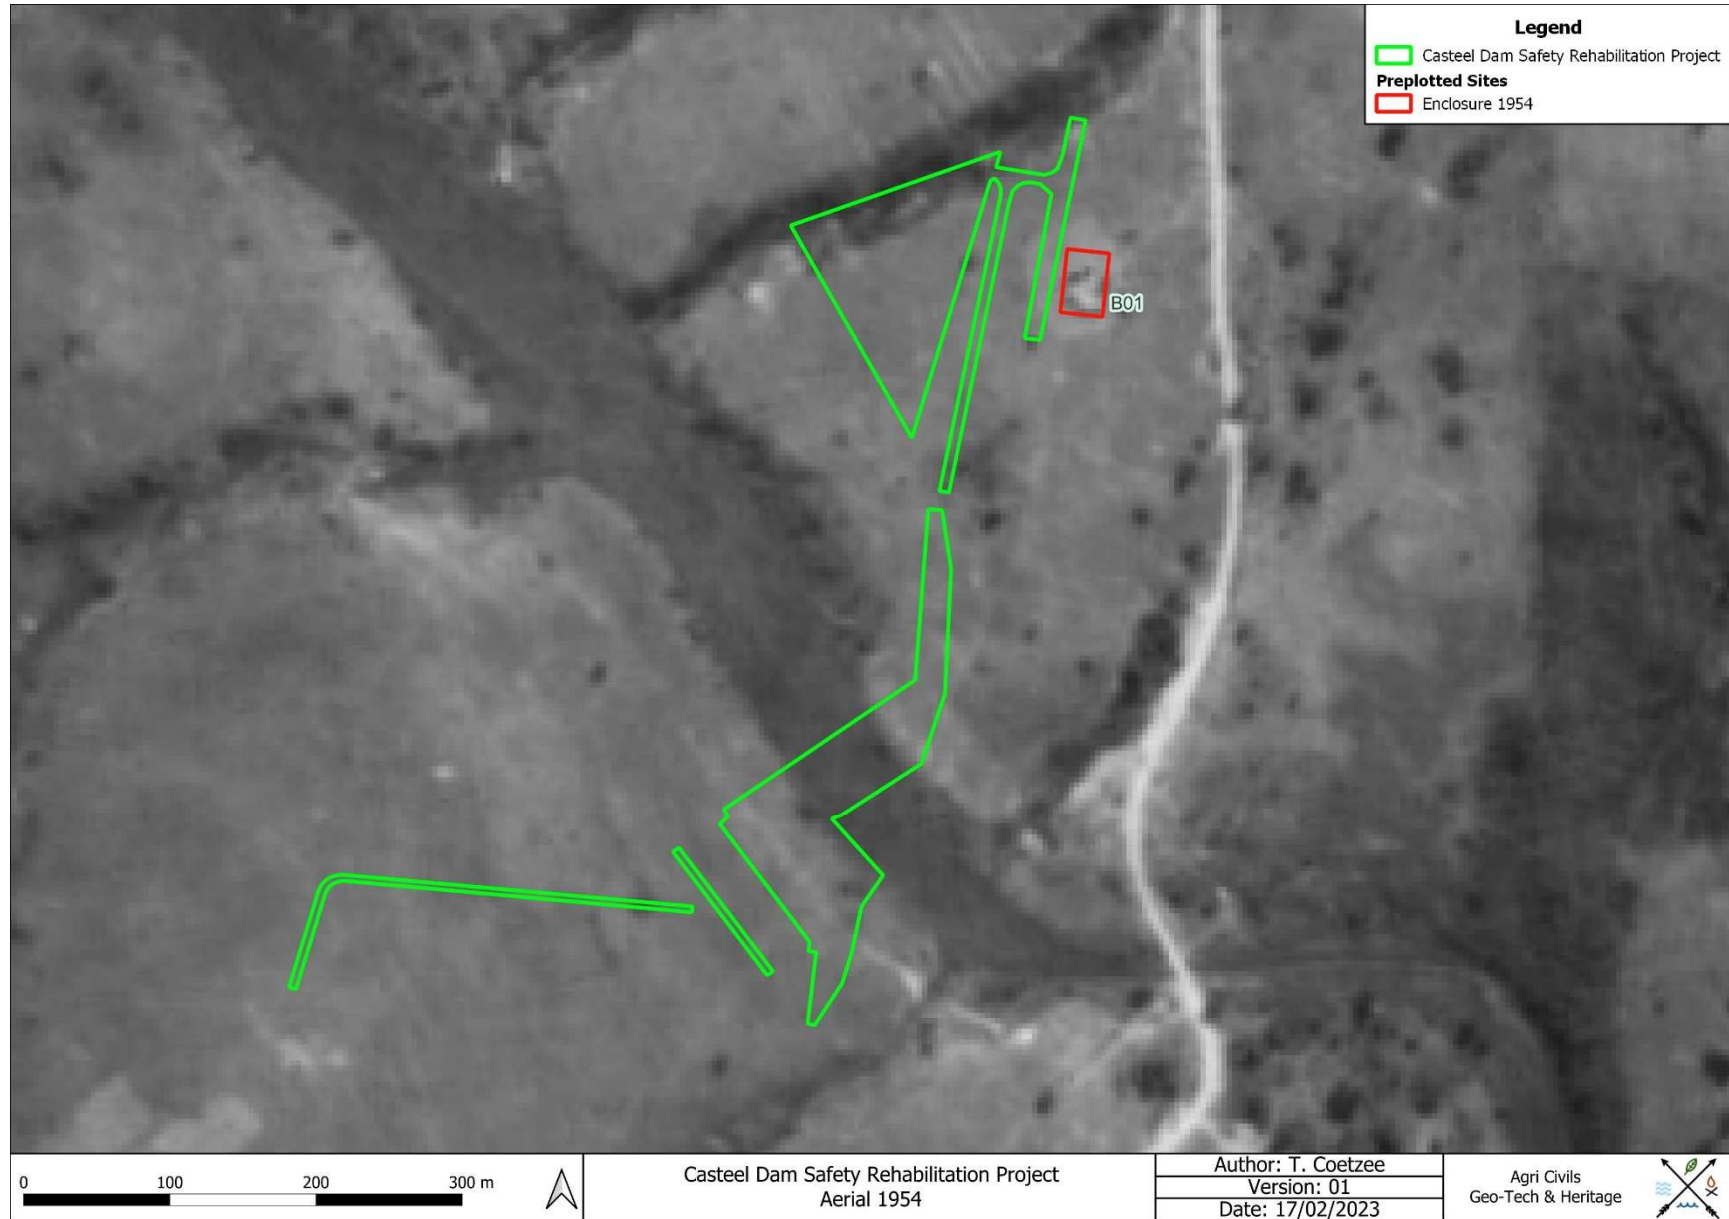
One potential site dating to the Historic Period were noted on the historical aerial imagery dating to 1954 (**Appendix A: Figure 27 & Table 3**). The site (B01) is visible on the 1954 aerial image as an enclosure within what appears to be a clearing. The area measures approximately 0.1 ha. The enclosure is no longer visible on the 1965 aerial image (**Appendix A: Figure 28**), while the clearing remains visible until 1974. This suggests that the enclosure was constructed between 1944 and 1954 (**Appendix A: Figures 26 & 27**), but were demolished by 1965 (**Appendix A: Figure 28**).

Figure 27: Study area superimposed on a 1954 aerial image.

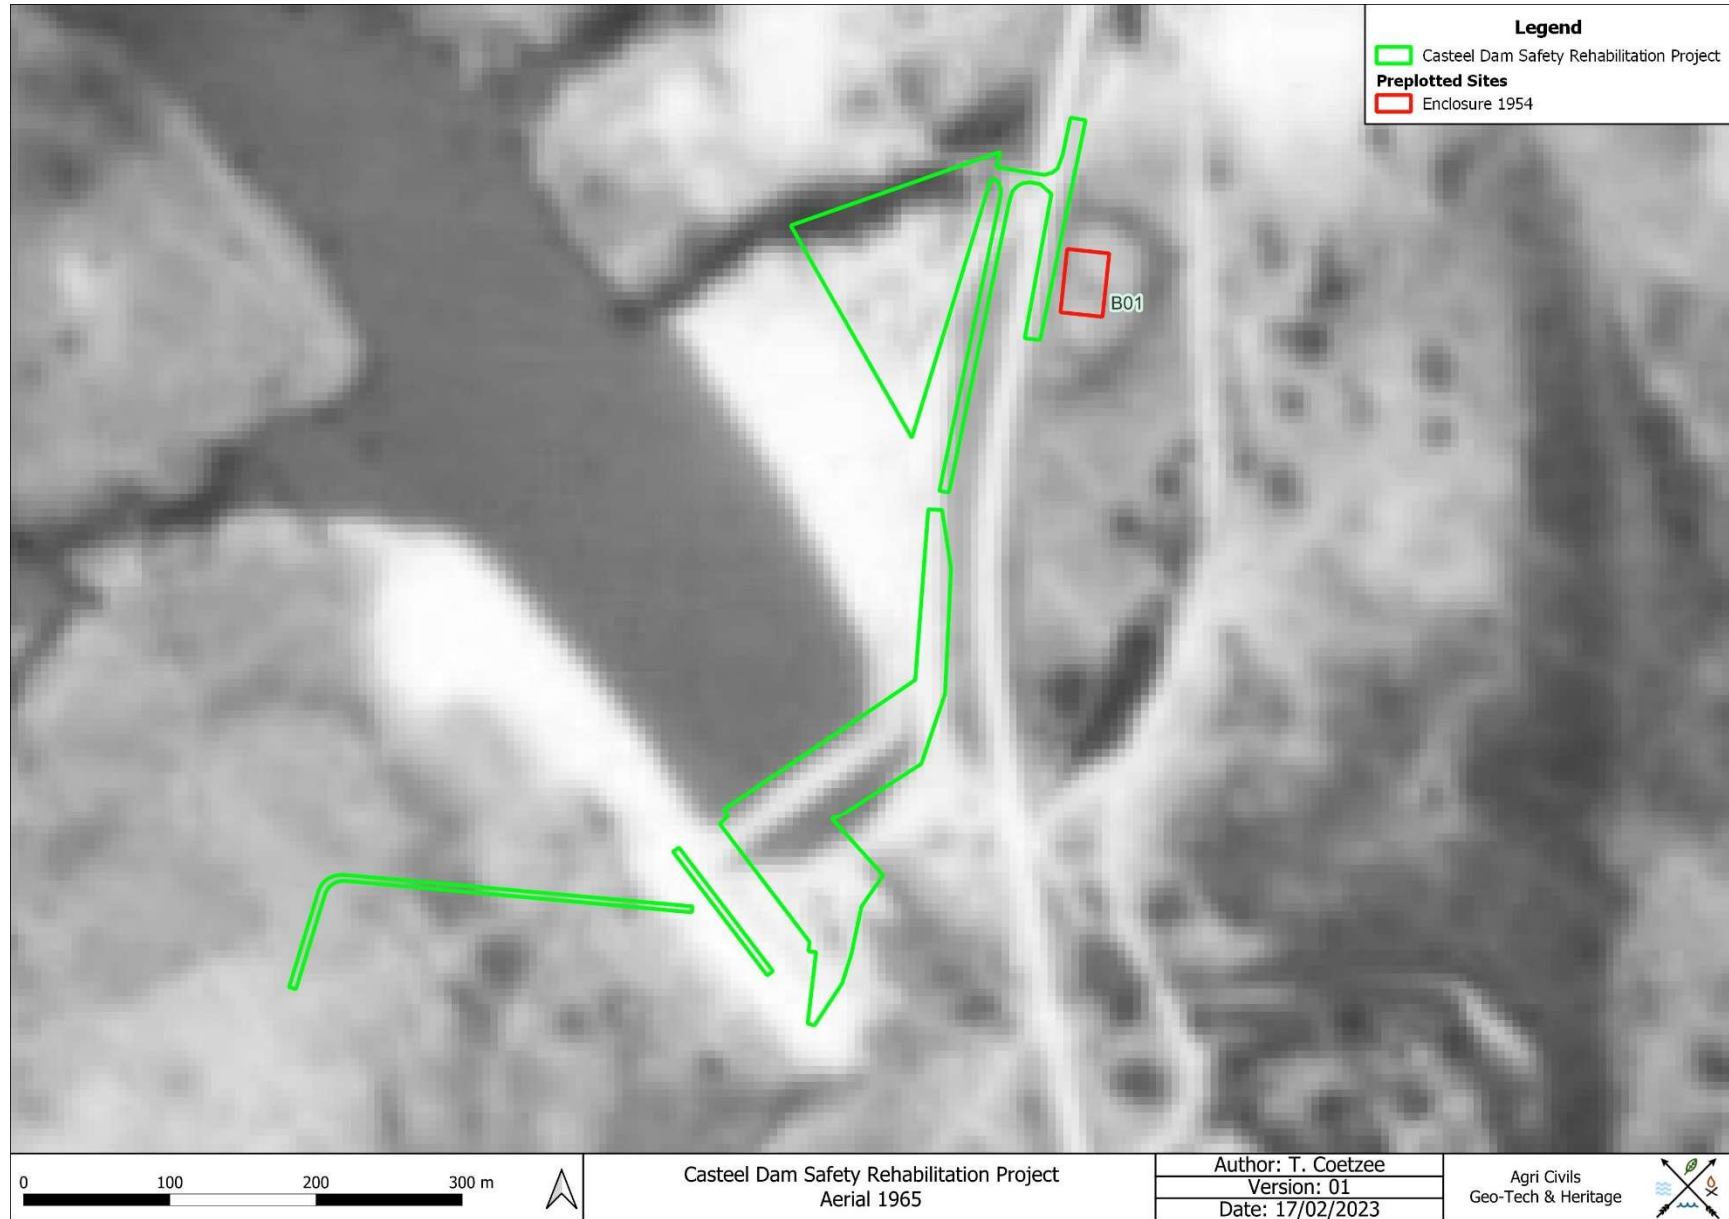
When the 1965 aerial image is inspected (**Appendix A: Figure 28**), the Casteel Dam is noted, as well as the road now known as the R40 running directly to the east of the dam. The entire demarcated study area also appears to be disturbed by a combination of cultivated fields and what appears to be activities relating to the construction of the dam. The enclosure at Site B01 is no longer visible, but the clearing appears to be present.

Figure 28: Study area superimposed on a 1965 aerial image.

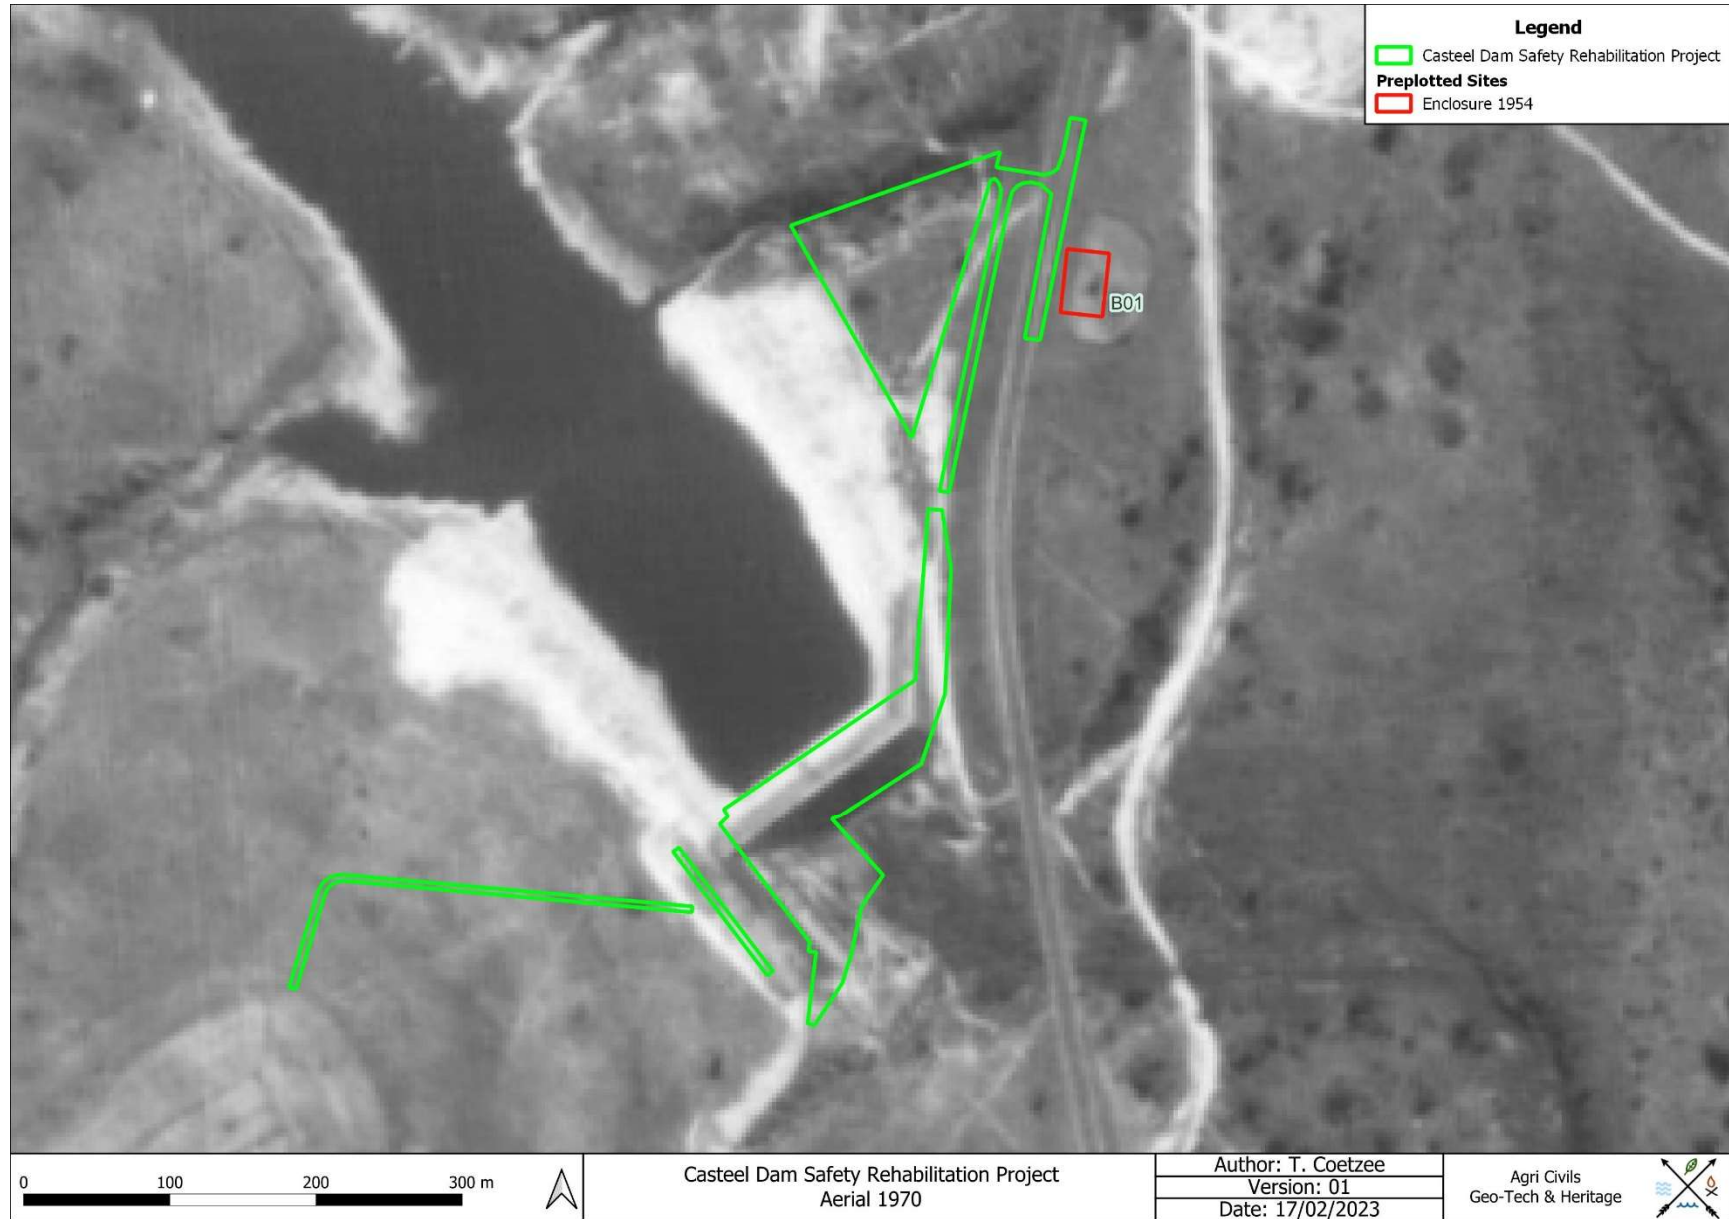
The 1970 aerial image (**Appendix A: Figure 29**) shows the same detail noted on the 1965 aerial image. Additional buildings in the general area are noted as well.

Figure 29: Study area superimposed on a 1970 aerial image.

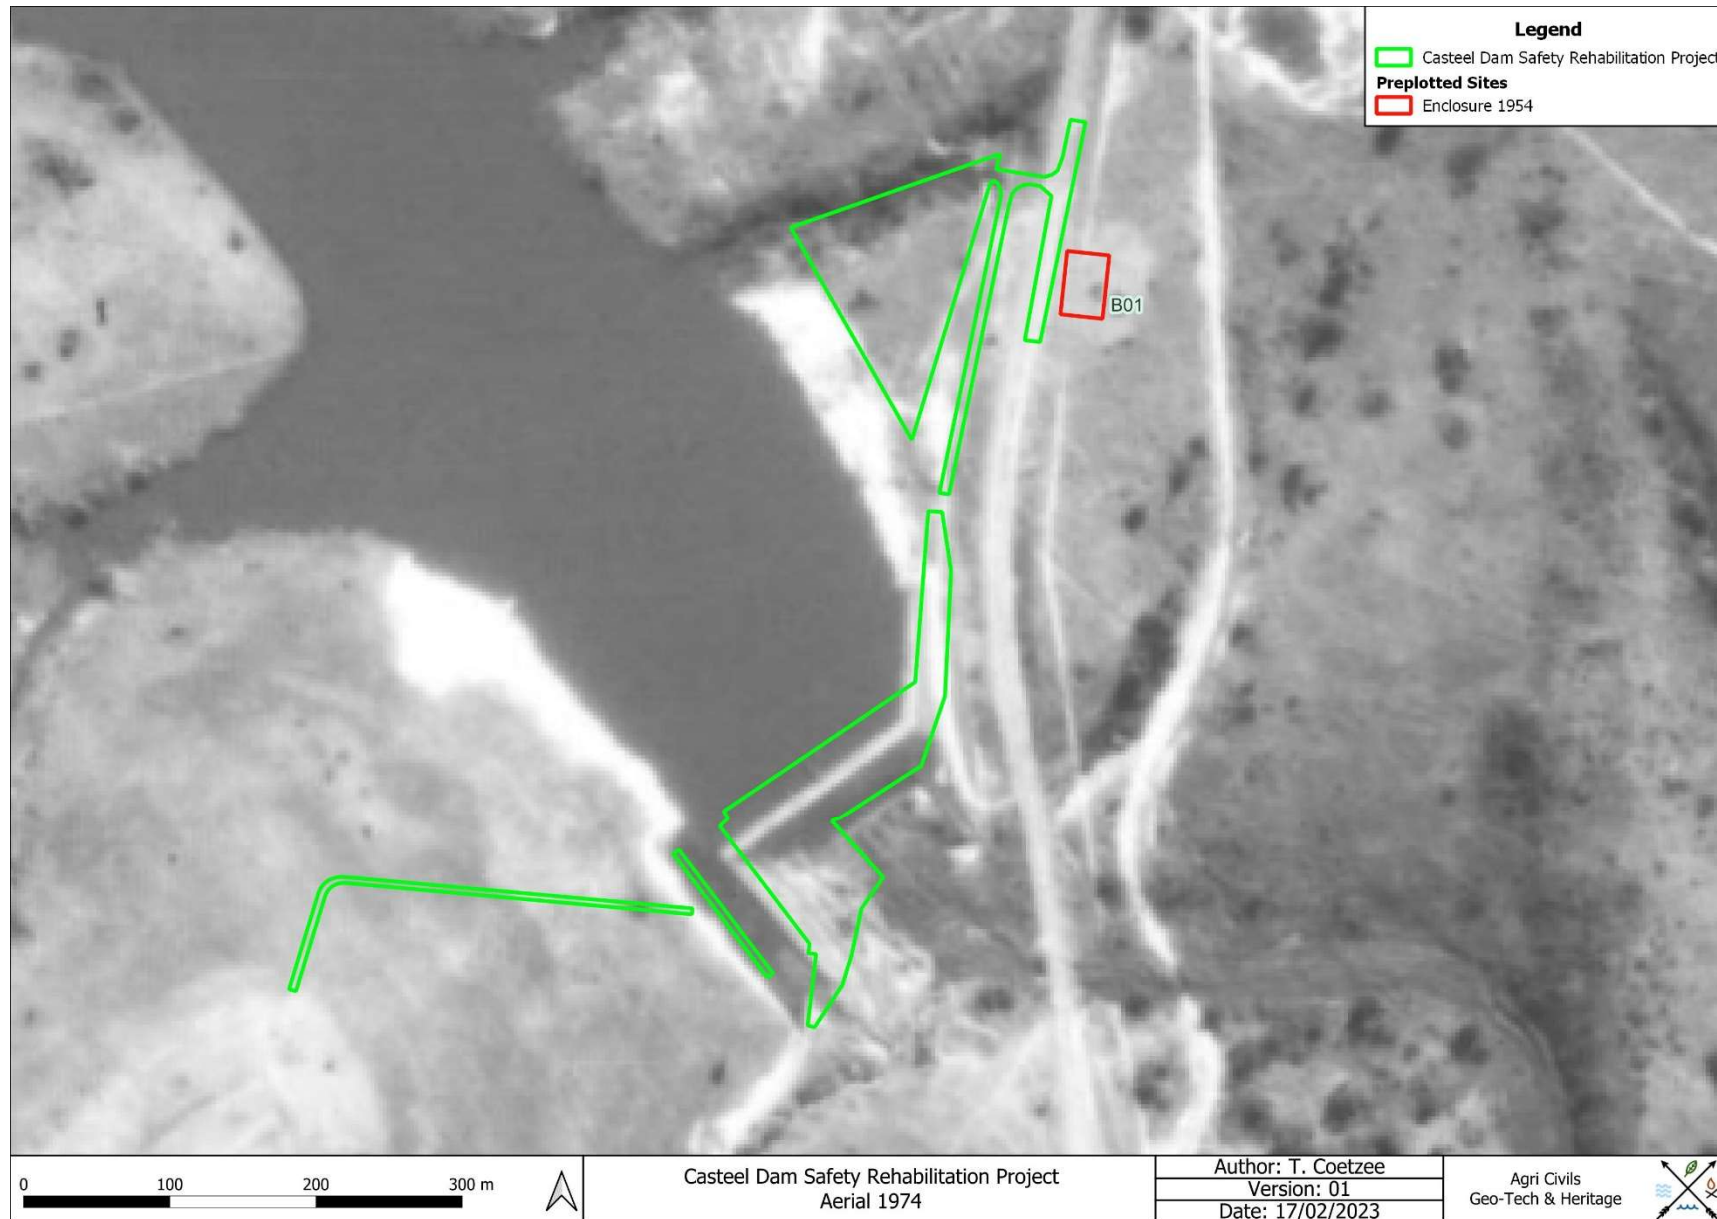
The 1974 aerial image (**Appendix A: Figure 31**) reflects the same detail observed on the 1970 aerial image, while the clearing at Site B01 is still visible.

Figure 31: Study area superimposed on a 1974 aerial image.

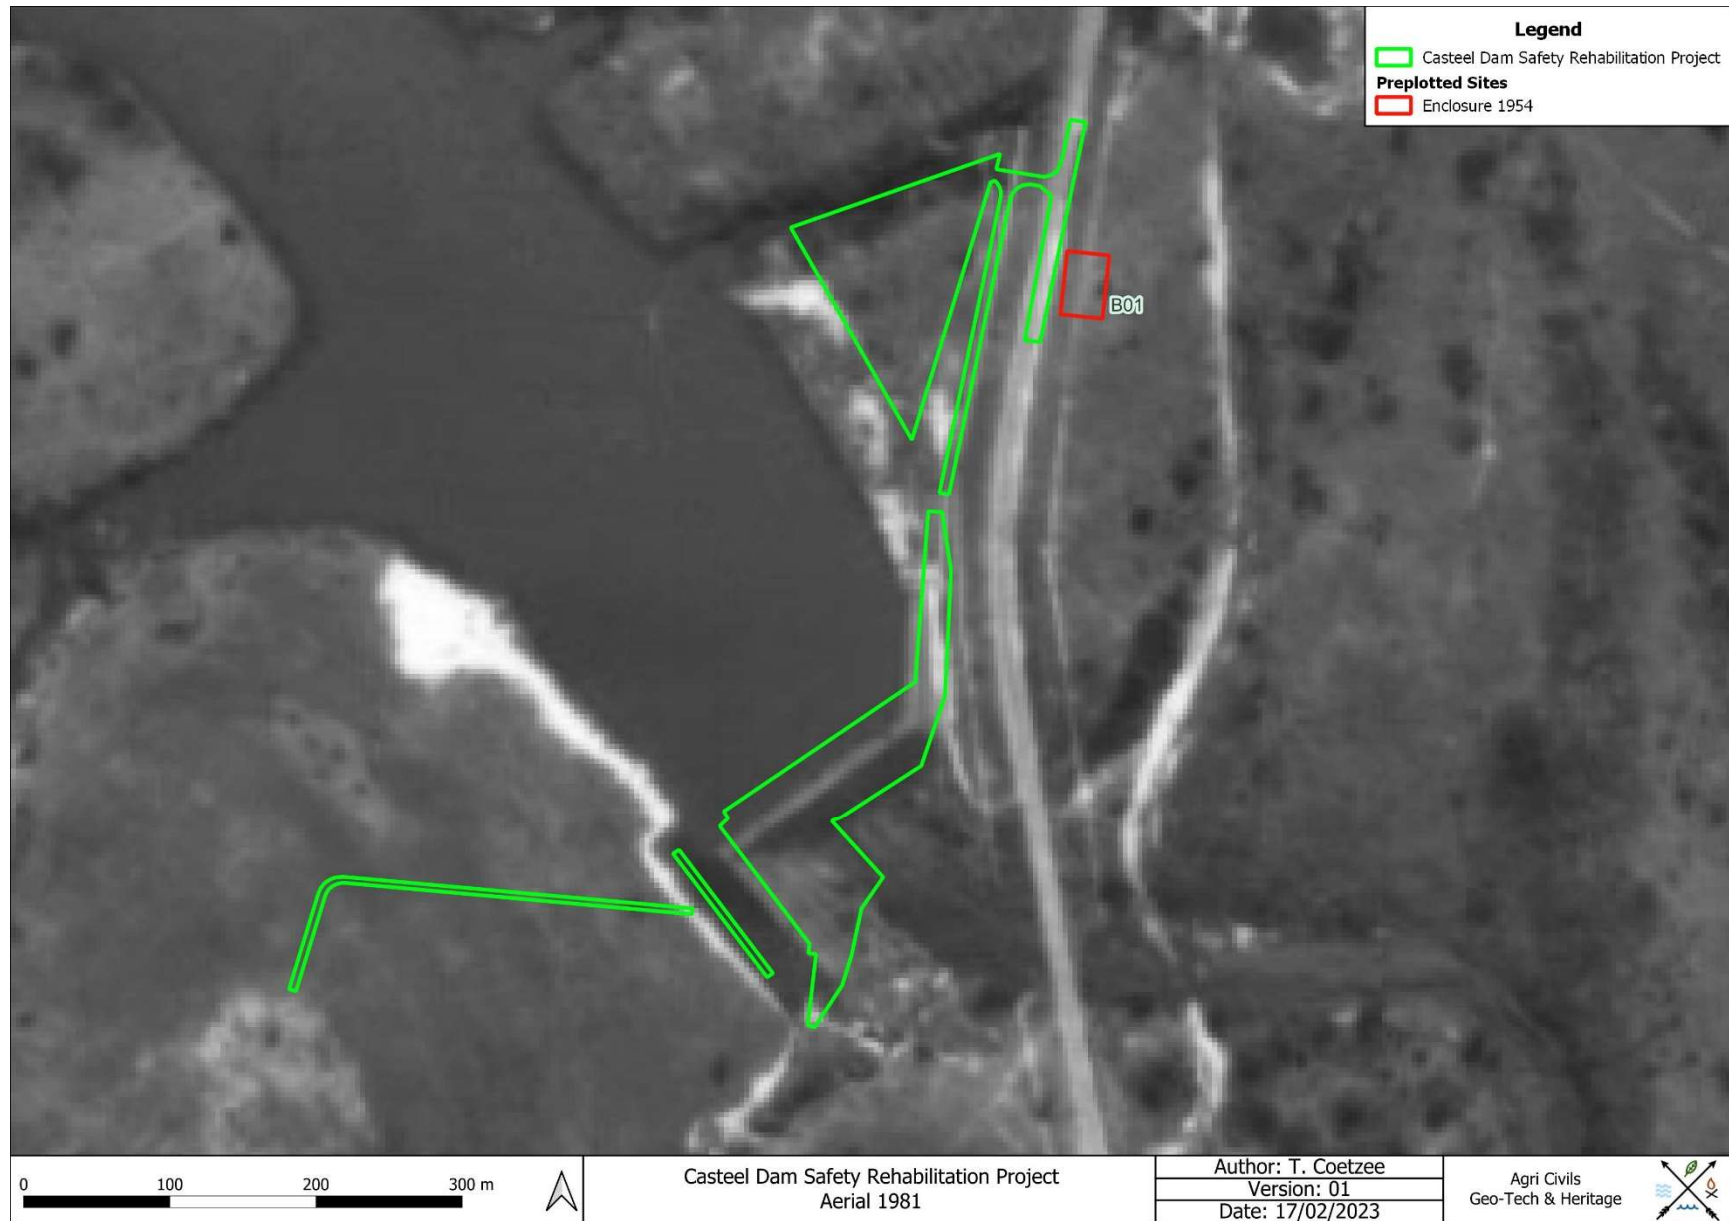
The clearing previously noted at Site B01 is no longer visible on the 1981 aerial image (**Appendix A: Figure 32**), and the majority of the area appears to be no longer cultivated.

Figure 32: Study area superimposed on a 1981 aerial image.

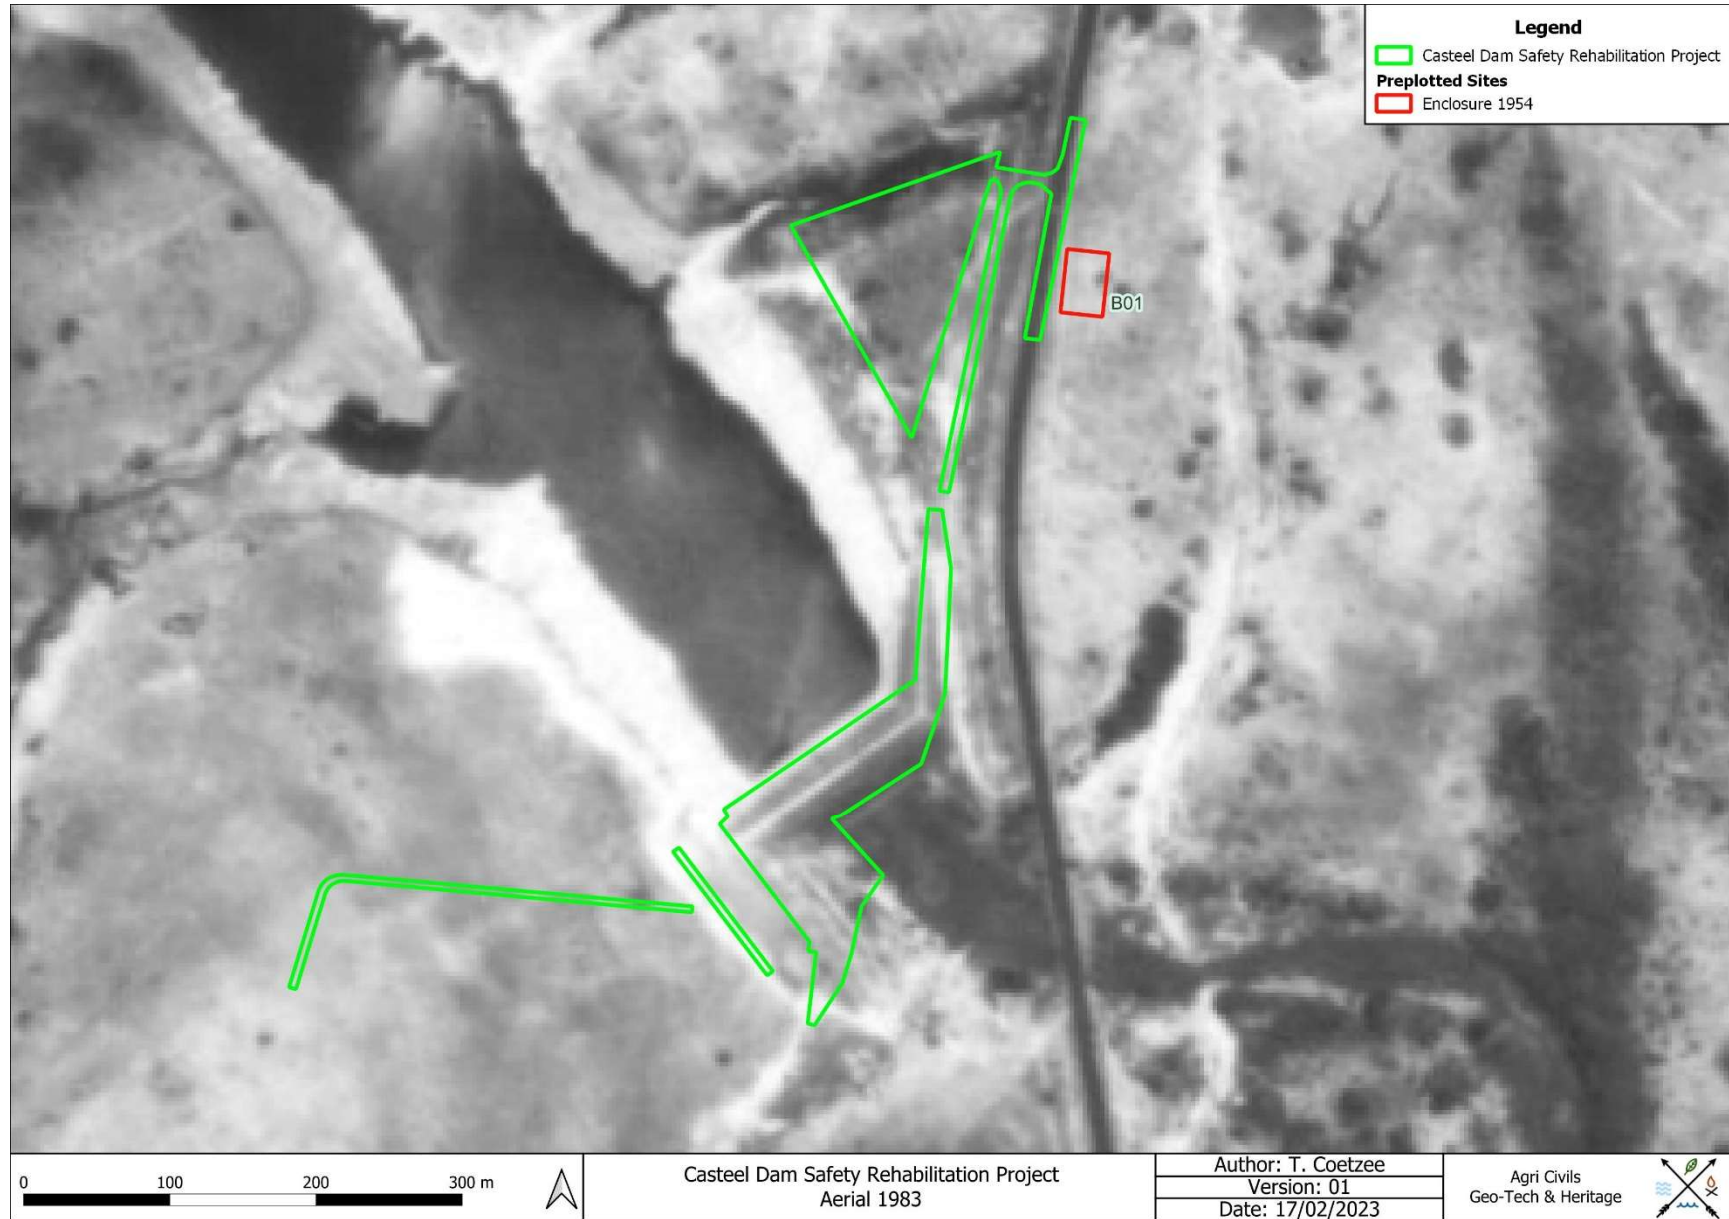
The only difference noted on the 1983 aerial image (**Appendix A: Figure 33**) is that the road directly to the east of the proposed study area (R40) appears to have been tarred.

Figure 33: Study area superimposed on a 1983 aerial image.

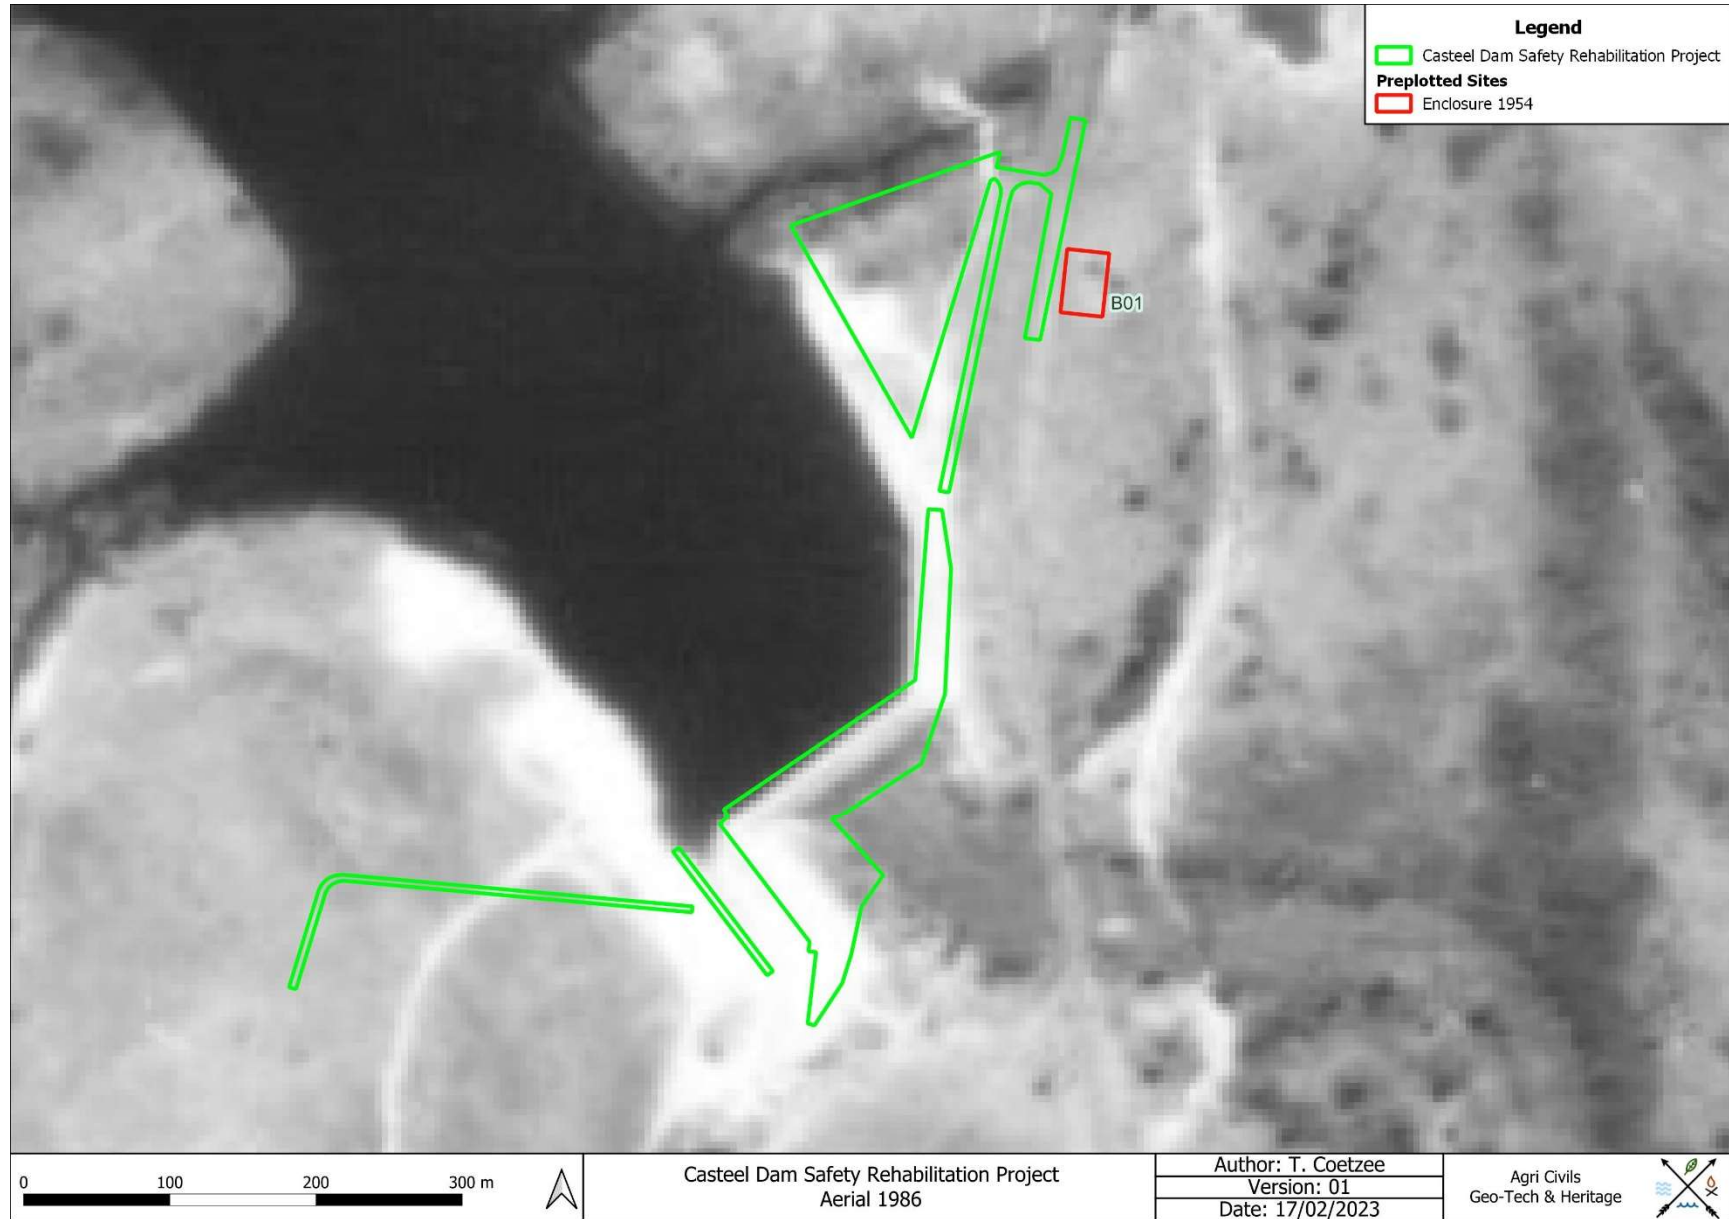
The only additional detail noted on the 1986 aerial image (**Appendix A: Figure 35**) is what appears to be vegetation clearing and construction activities directly to the south of the dam. An access road to the southeast is also noted. These activities might relate to earlier rehabilitation work conducted at the dam.

Figure 35: Study area superimposed on a 1986 aerial image.

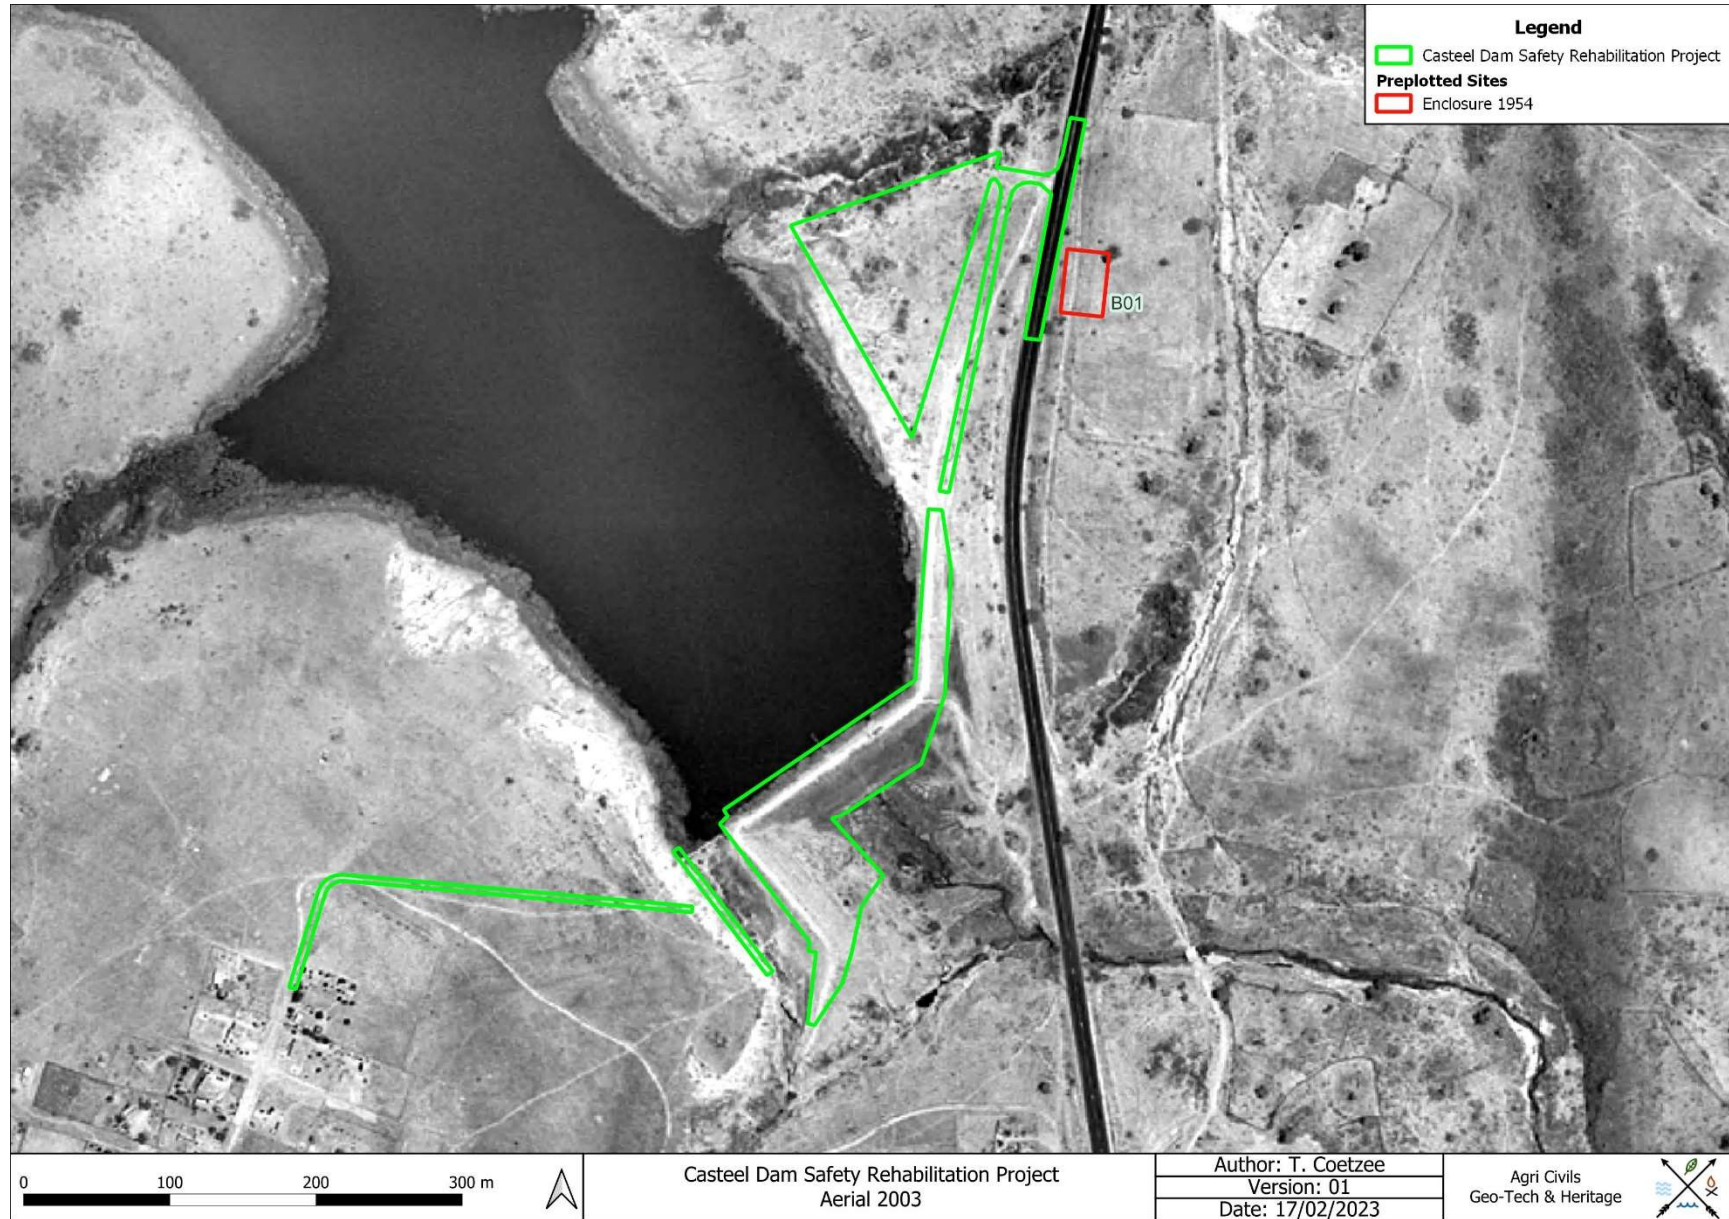
The 2003 aerial image (**Appendix A: Figure 37**) shows a significant increase in residential development to the south of the study area, while no buildings or structures are noted within the demarcated project boundary.

Figure 37: Study area superimposed on a 2003 aerial image.
