**HERITAGE IMPACT ASSESSMENT:  
PROPOSED ROAD UPGRADE TO ACCESS THE  
RIETRUG WIND ENER G FACILITY, SUTHERLAND  
MAGISTERIAL DISTRICT, NORTHERN CAPE**

Required under Section 38(8) of the National Heritage Resources Act (No. 25 of 1999)  
as part of a Heritage Impact Assessment.

**Dr Jayson Orton**  
**ASHA Consulting (Pty) Ltd**  
23 Dover Road, Muizenberg, 7945  
Tel: (021) 788 1025 | 083 272 3225  
Email: jayson@asha-consulting.co.za

1<sup>st</sup> draft: 30 June 2021  
Final report: 25 July 2021

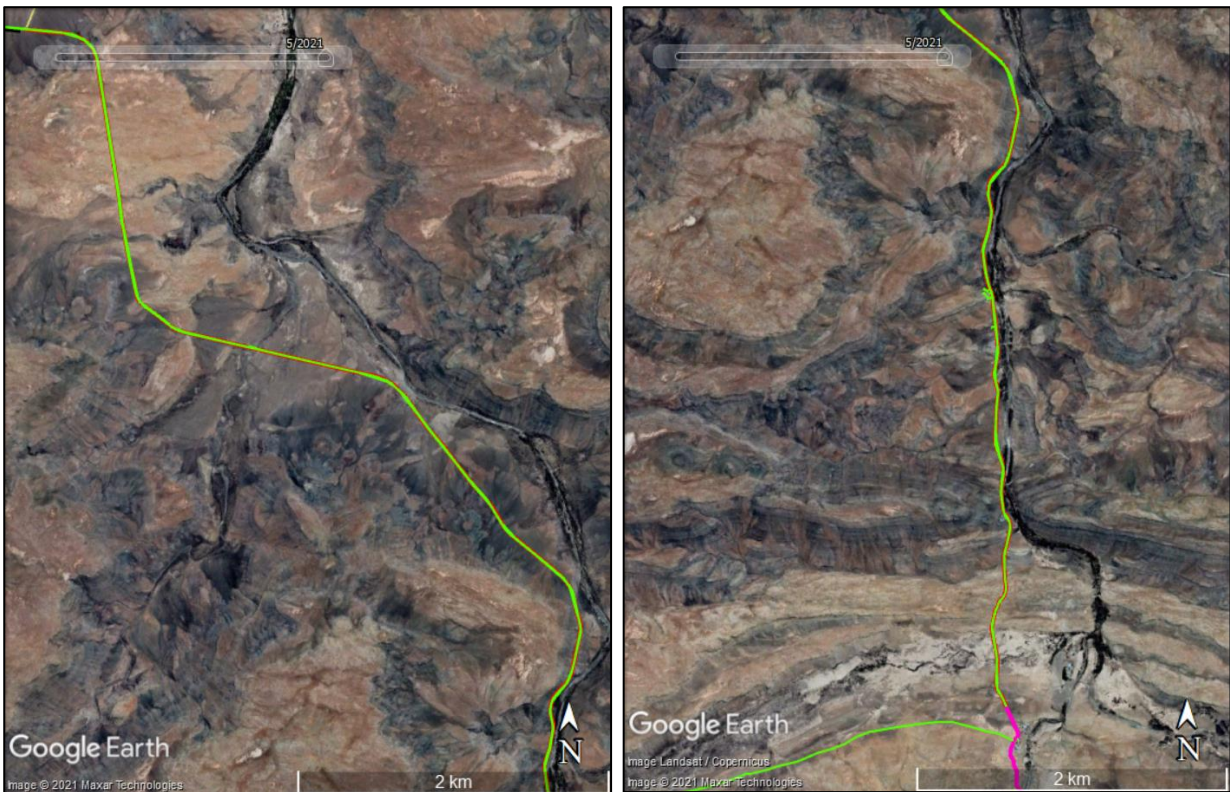
**Figures 3 & 4:** Northern and southern parts of the study area with survey tracks in green.

The site was examined on 15 and 18 November 2016 (Figures 3 & 4). This was during early summer but, in this dry area, the season makes no meaningful difference to vegetation covering and hence the ground visibility for the archaeological survey. Other heritage resources are not affected by seasonality. Most of the road was examined from the vehicle but in places where heritage was seen along the road these resources were checked on foot. During the survey the positions of finds and survey tracks were recorded on a hand-held Global Positioning System (GPS) receiver set to the WGS84 datum. Photographs were taken at times in order to capture representative samples of both the affected heritage and the landscape setting of the proposed development.

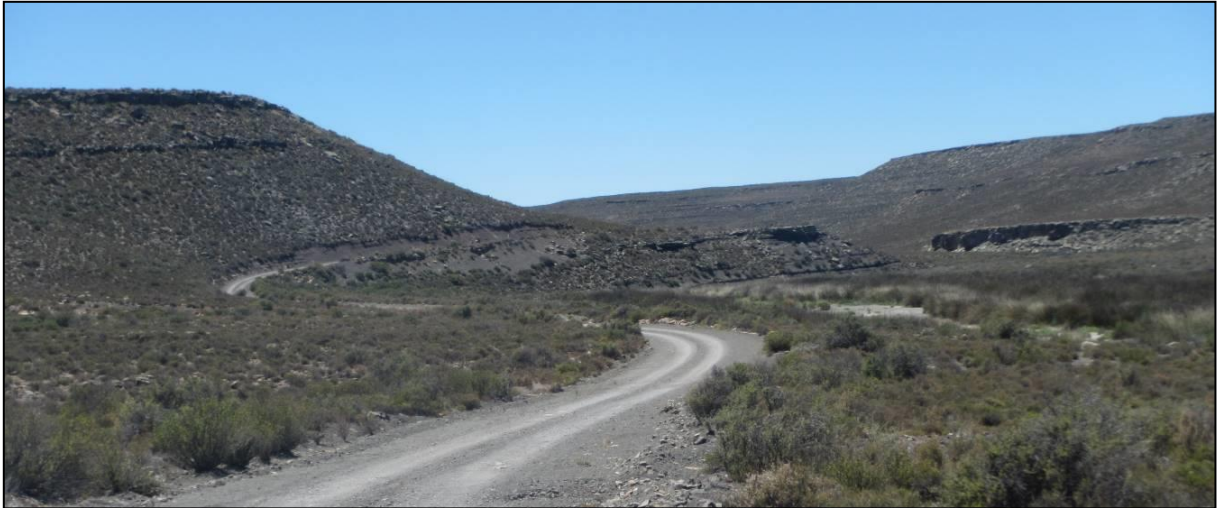
**Figure 5:** View towards the north in the north-eastern part of the study area where the road comes off the high ground and follows the Riet River (visible to the right).

The road itself is a gravel road that winds through undulating terrain. The section to be upgraded runs through a flat area before dropping slightly towards the Riet River (Figure 5). Here it is largely situated on a cutting above the river (Figure 6). Once out of the river valley it again crosses open, flat country.

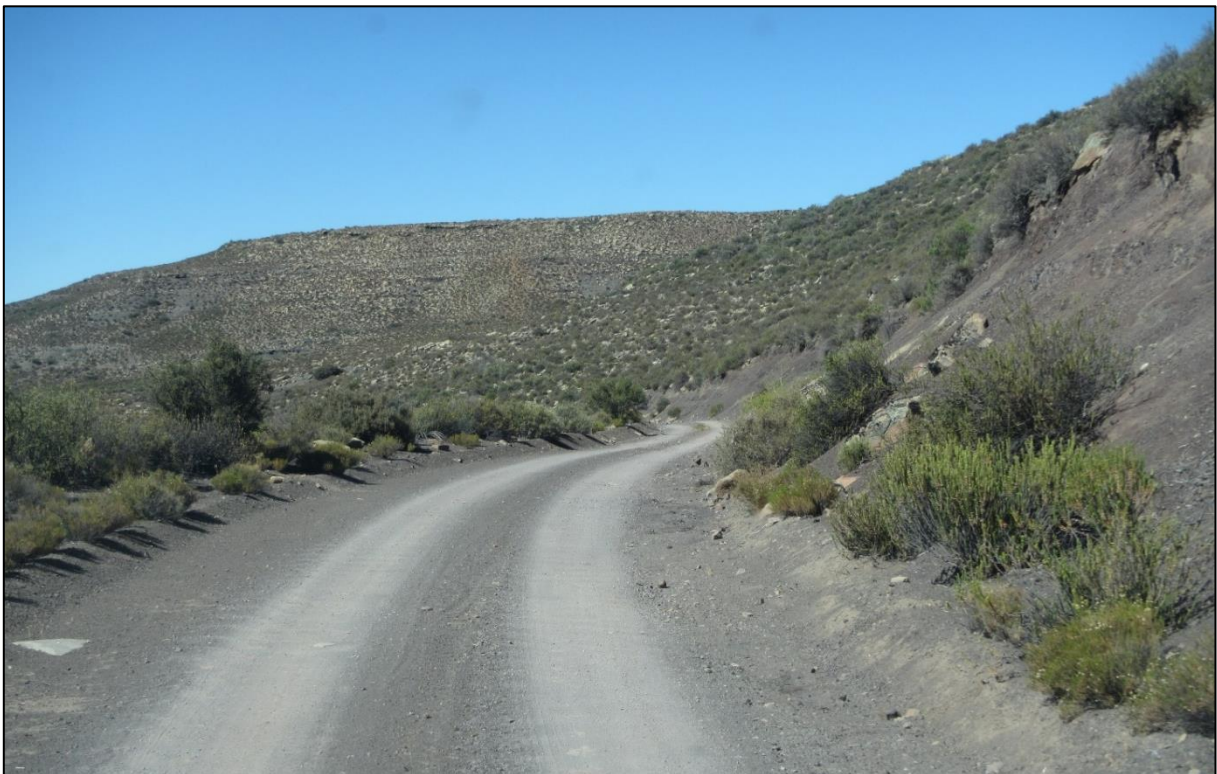
**Figure 6:** View towards the south in the northern part of the area where the road is cut into the embankment alongside the Riet River.

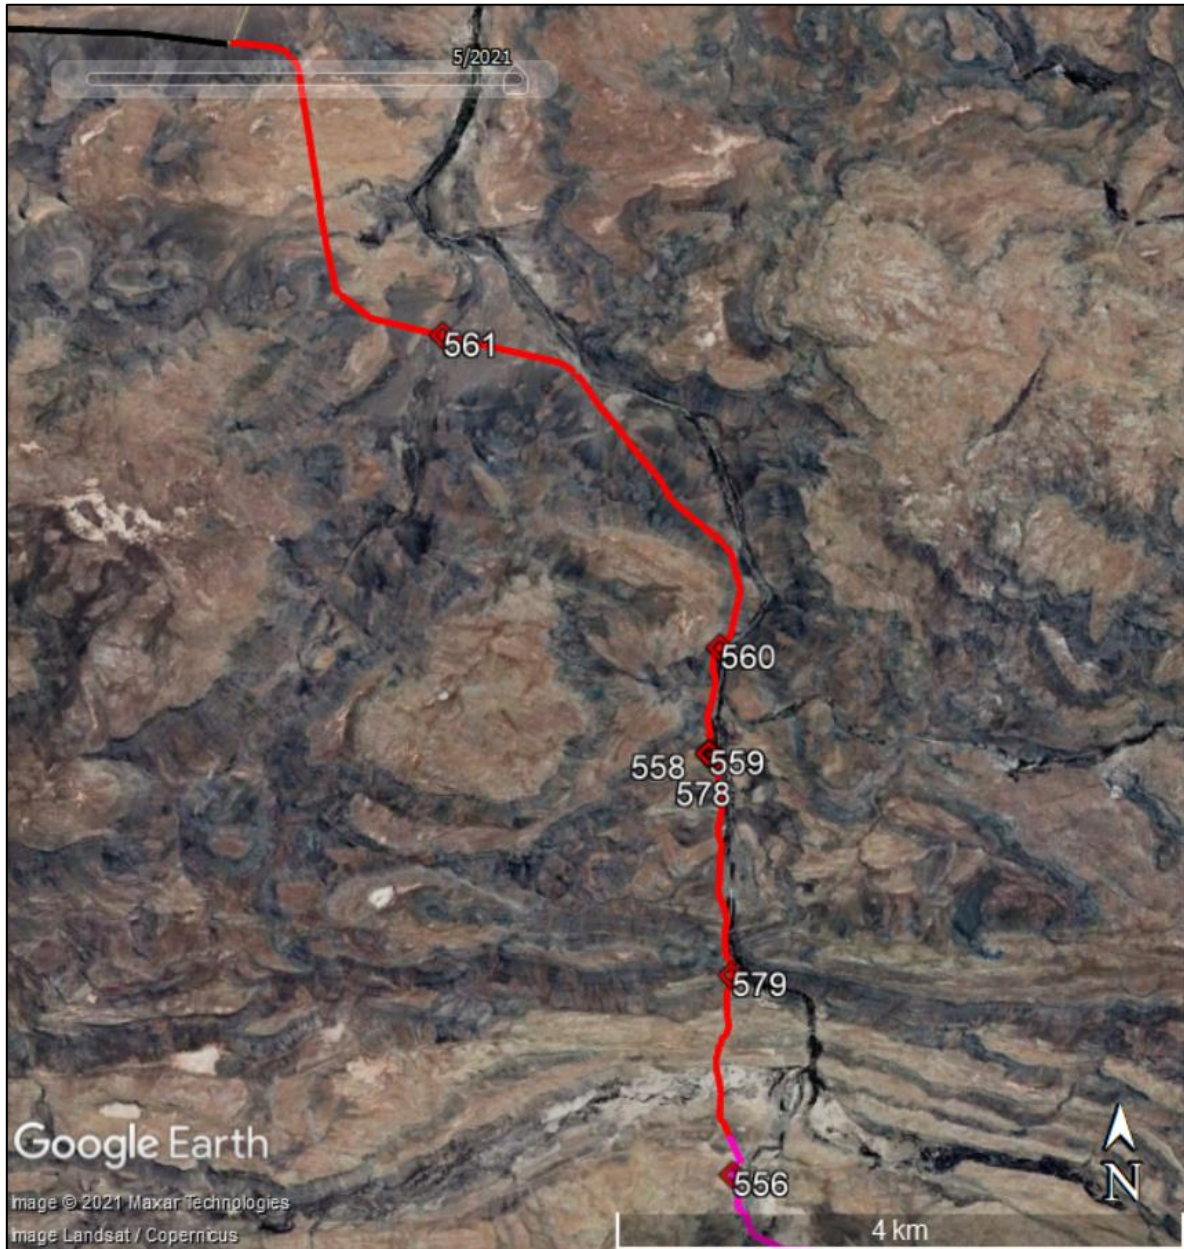
**Figure 7:** Aerial view of the study area showing the heritage resources recorded along the route.

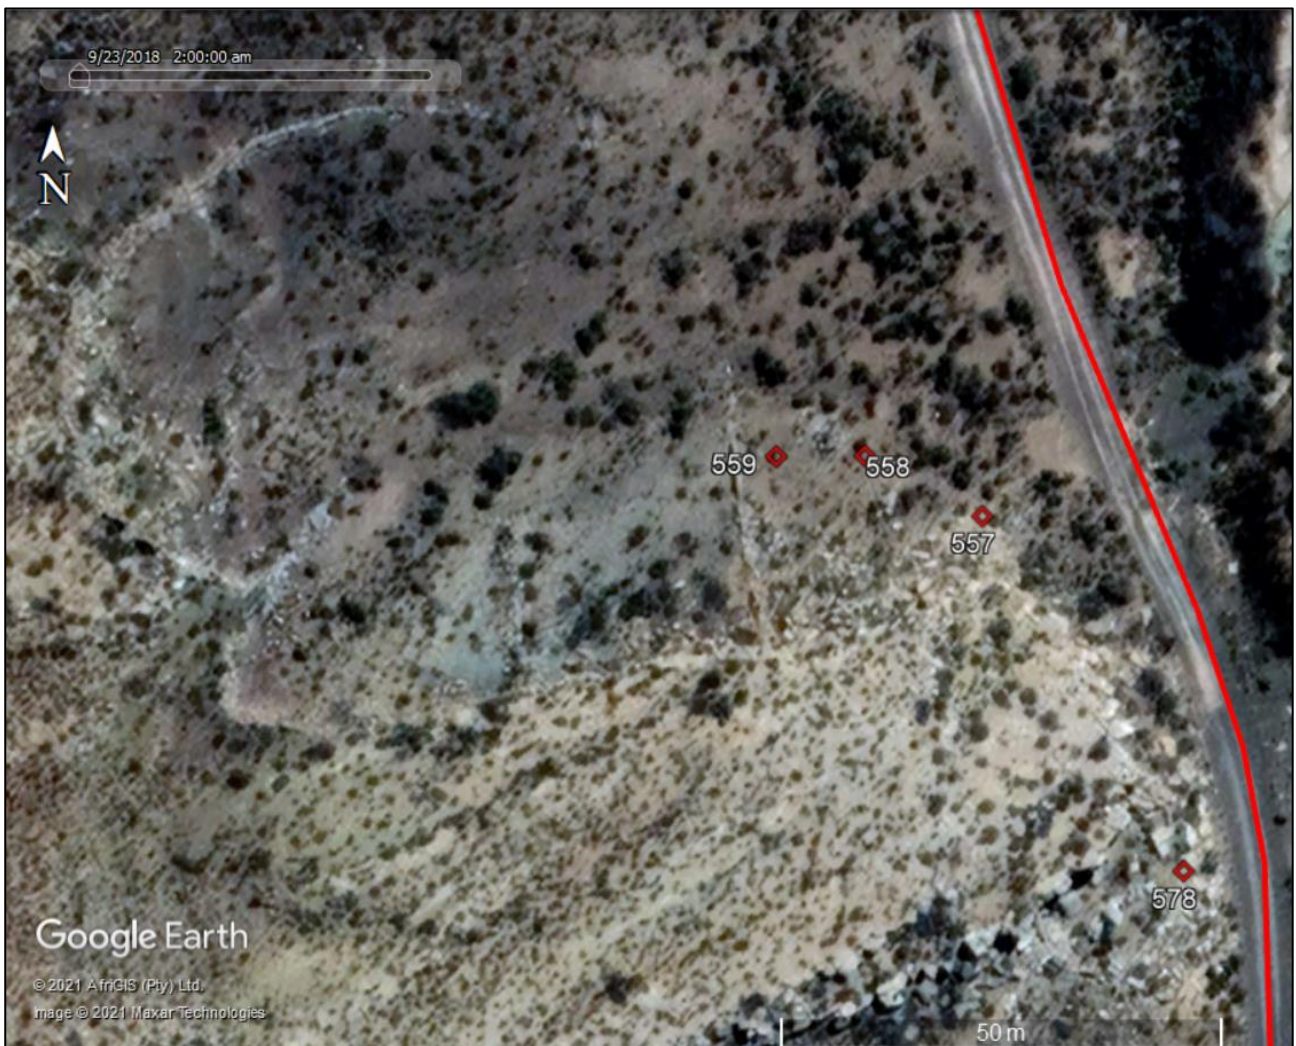
**Figure 8:** Aerial view of the area in which waypoints 557, 558, 559 and 578 were recorded. The stone walling stretching west of waypoint 559 is evident.

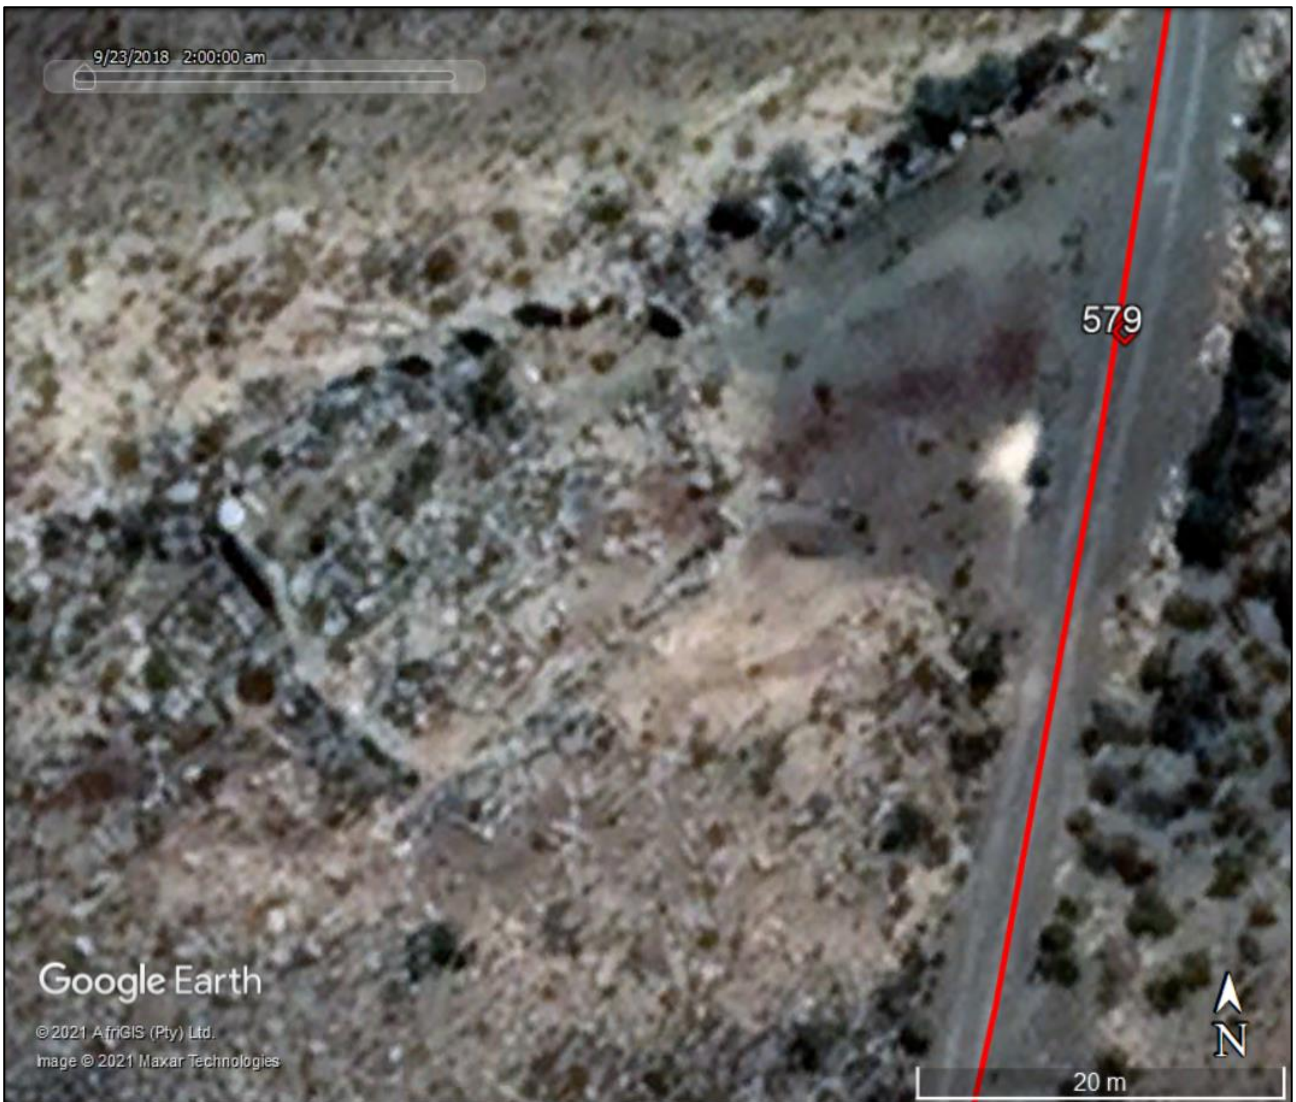
**Figure 9:** Aerial view of the area in which waypoint 579 was recorded. The stone kraal can be seen against the scarp to the west of the waypoint.

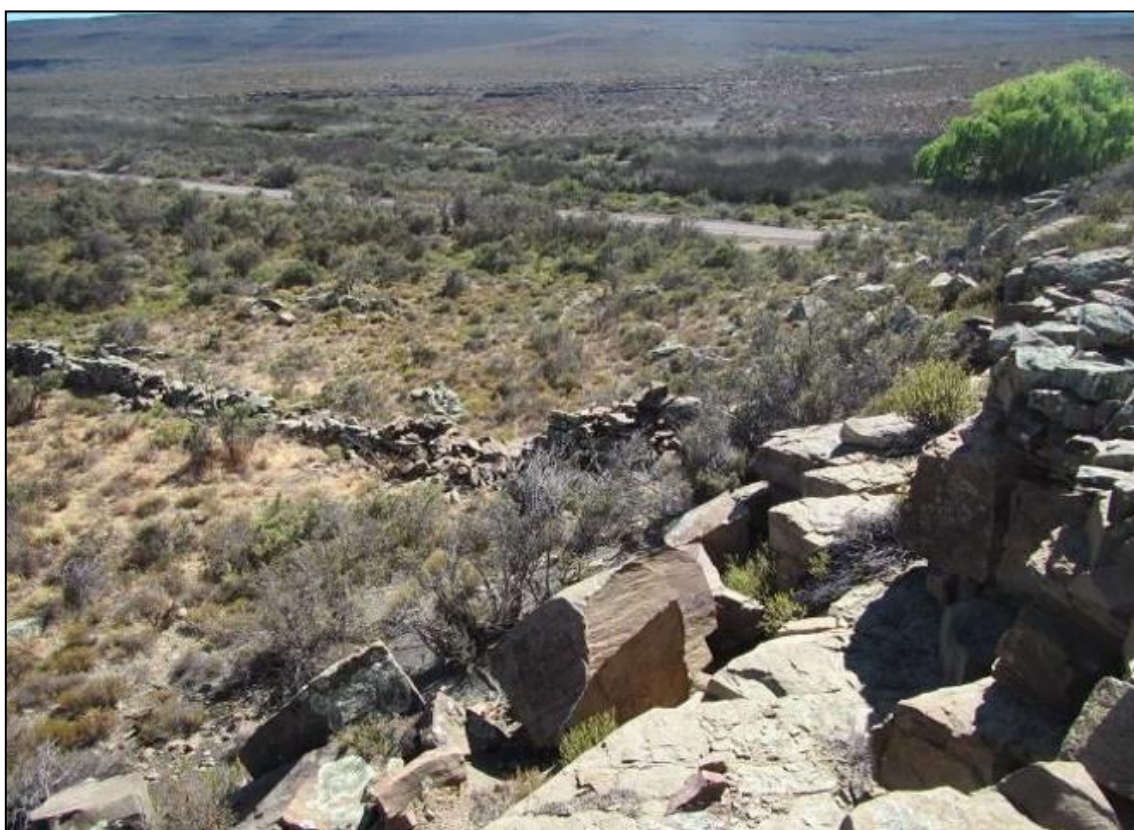
**Figure 10:** View towards the northeast from the rocky headland showing the eastern end of the large kraal (waypoint 559). The domestic area and smaller features lie in the background between the kraal and the gravel road.

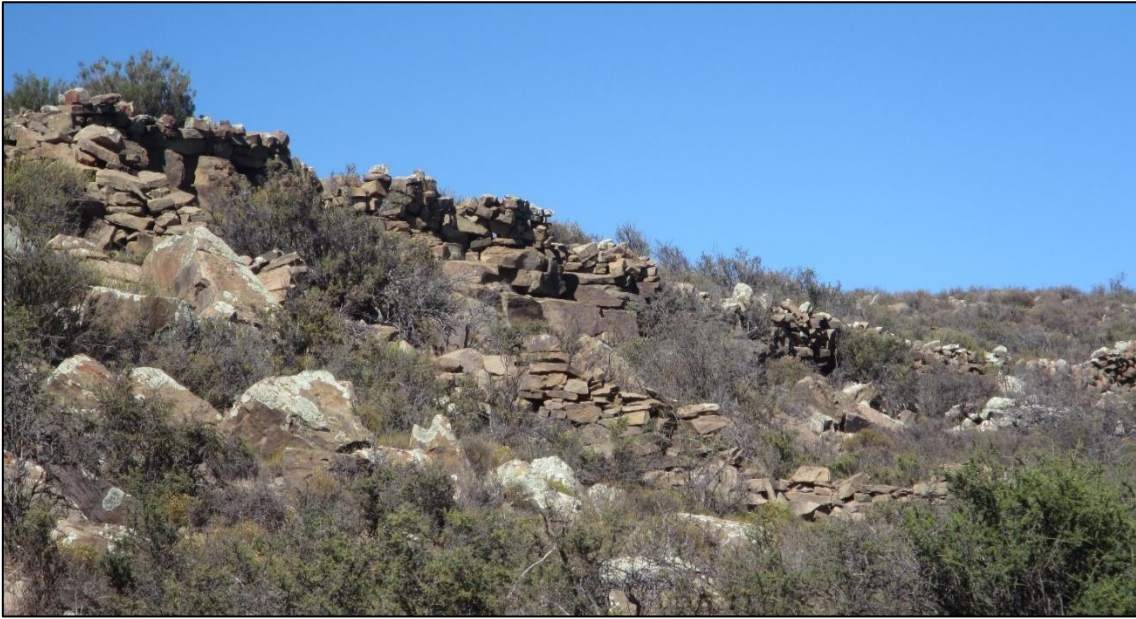
**Figure 11:** View towards the southwest showing the stone walling stretching up the side of the shallow valley onto the edge of the headland (waypoint 559).

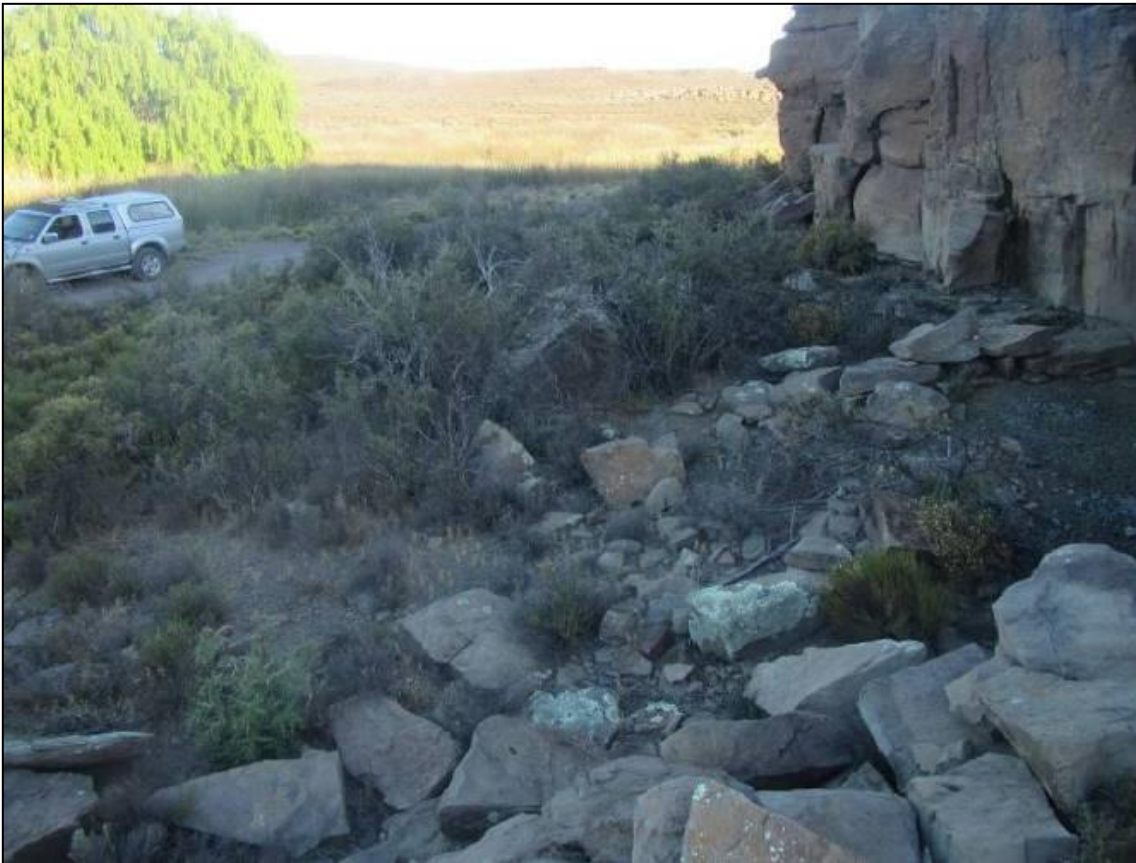
**Figure 12:** View towards the southeast showing some of the smaller enclosures with associated historical domestic refuse at the foot of the low cliff (waypoint 557).

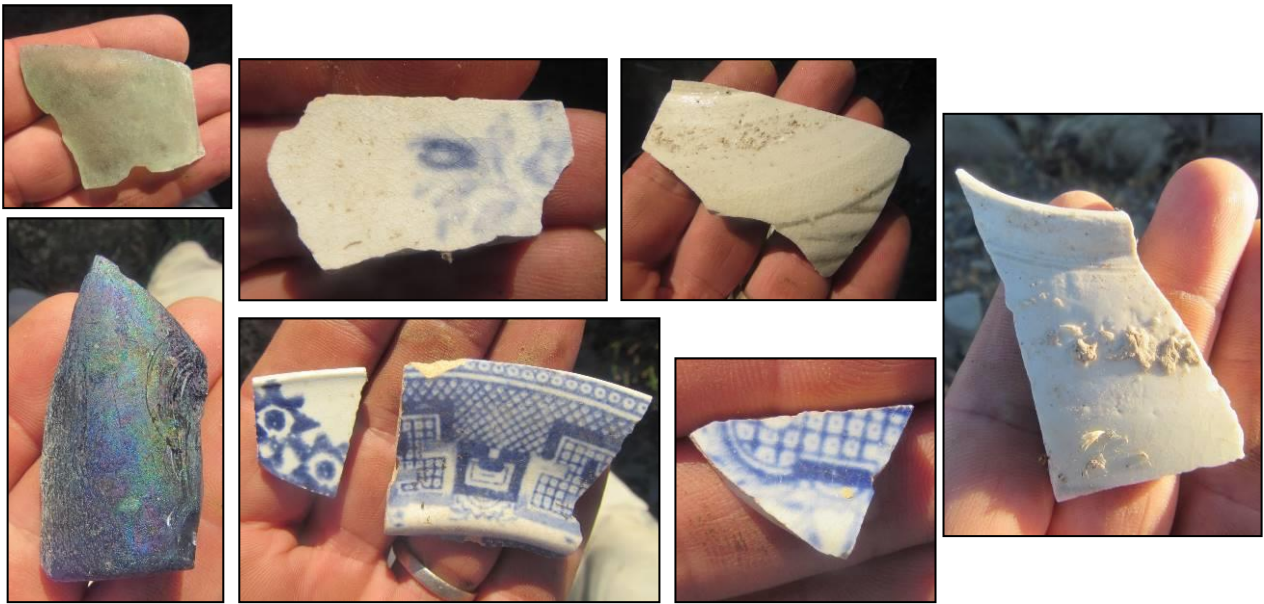
**Figure 13:** Compilation of some of the historical artefacts seen in the vicinity of waypoints 557 and 558.

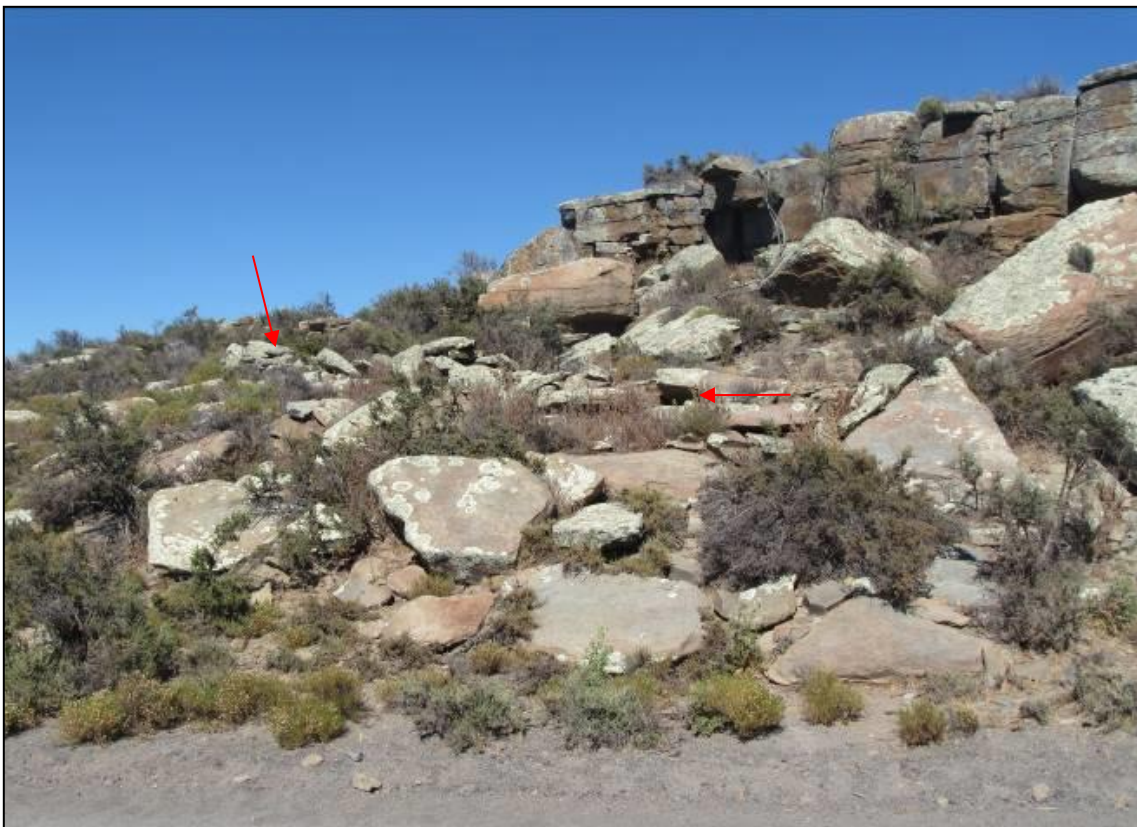
**Figure 14:** View towards the west showing the enclosure on the southern side of the headland (578; walling arrowed). The road is visible in the foreground.

- These areas must be monitored by the ECO;
- If avoidance is not possible in any areas (as may be the case at waypoint 578), then an archaeologist will need to be contracted to record the structure in detail as well as any artefacts associated with it;

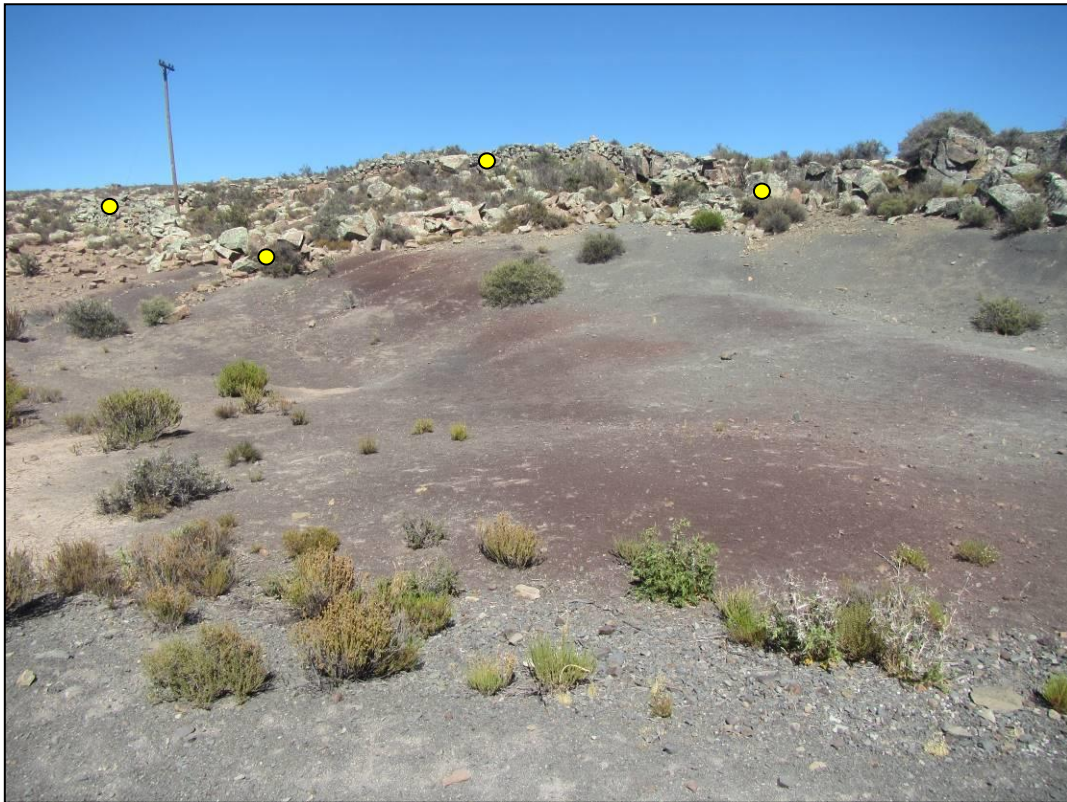
Some 1.5 km to the south there is a single, approximately rectangular piled stone *kraal*. It has been slightly impacted by the excavation of a shallow borrow pit between it and the road and the installation of a telephone pole within the *kraal* (Figure 15).

**Figure 15:** View towards the west showing the square piled stone kraal located at waypoint 579. Its corners are approximately indicated by the yellow dots. The edge of the subject road is in the immediate foreground at lower left.

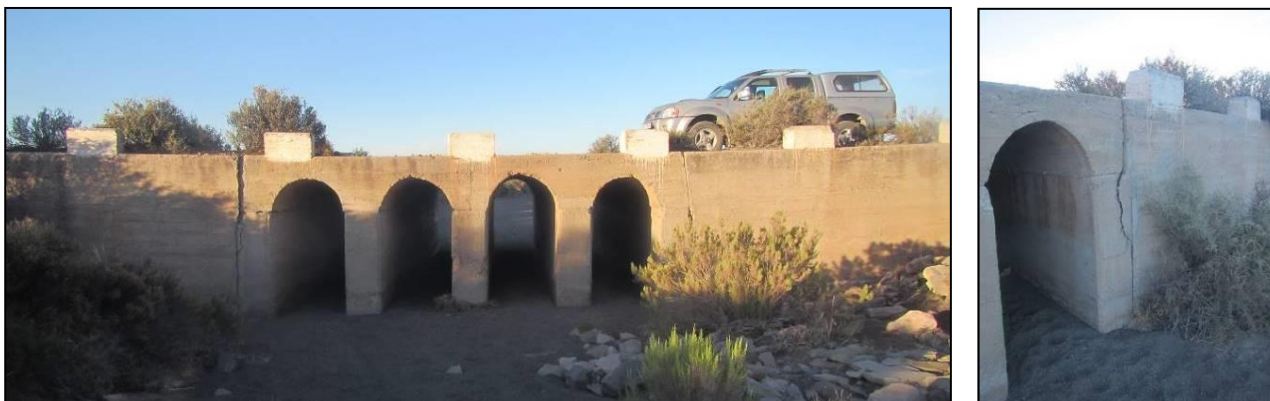
The main historical built environment resources relevant to this project relate to the road itself. The first is a concrete culvert with 4 arched openings and which is showing signs of deterioration (Figures 16 & 17). Its age is unknown but it could well be older than 60 years.

**Figures 16 & 17:** View of the largest built structure along the road (waypoint 561). It has been built of modern concrete and is showing signs of deterioration.

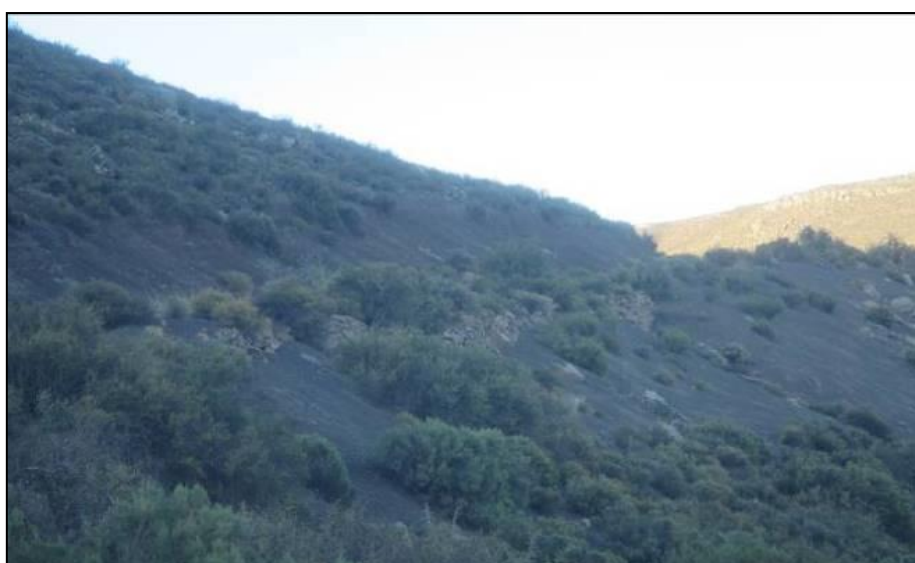
The second aspect is along the section of road built on a cutting above the Riet River. This section has a low and somewhat informal drystone retaining wall running along below the carriageway for much of its length (Figures 18 & 19). It would appear as though later roadworks have resulted in much gravel spilling over the edge of the road and creating a scree slope over and below the walling. Figure 20 shows that the road pre-dates 1960 and this implies that the drystone walling is greater than 60 years of age. The concrete culvert could have been a later addition but there is no way to confirm this.

**Figure 18:** View towards the north showing the road cutting in the slope above the Riet River (waypoint 560).

- Landscape scarring, especially in the area along the Riet River, must be minimised;
- To protect the drystone walling, no work may take place east of the current road surface along the Riet River;

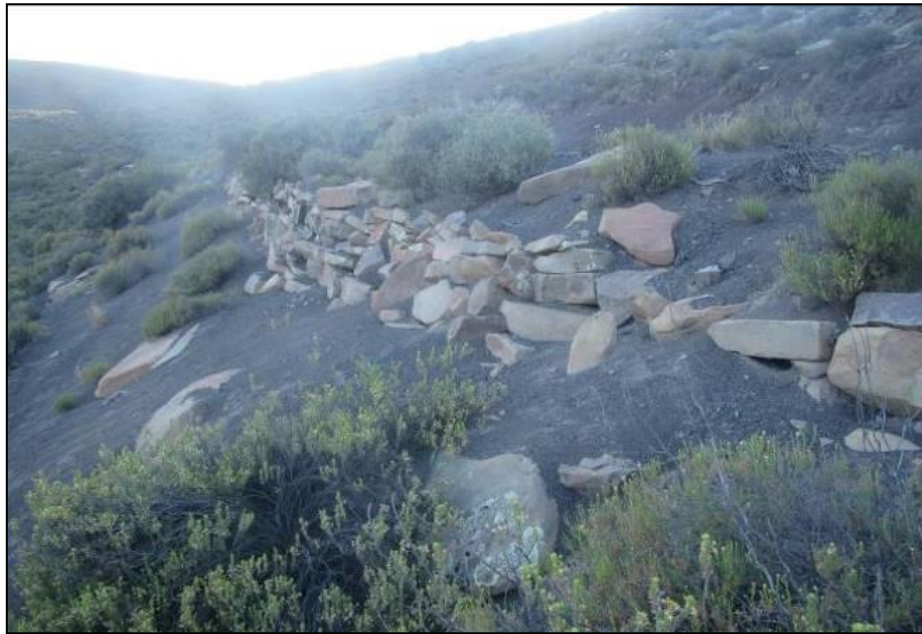
**Figure 19:** View towards the south of a section of the drystone walling supporting the road above the Riet River (waypoint 560).

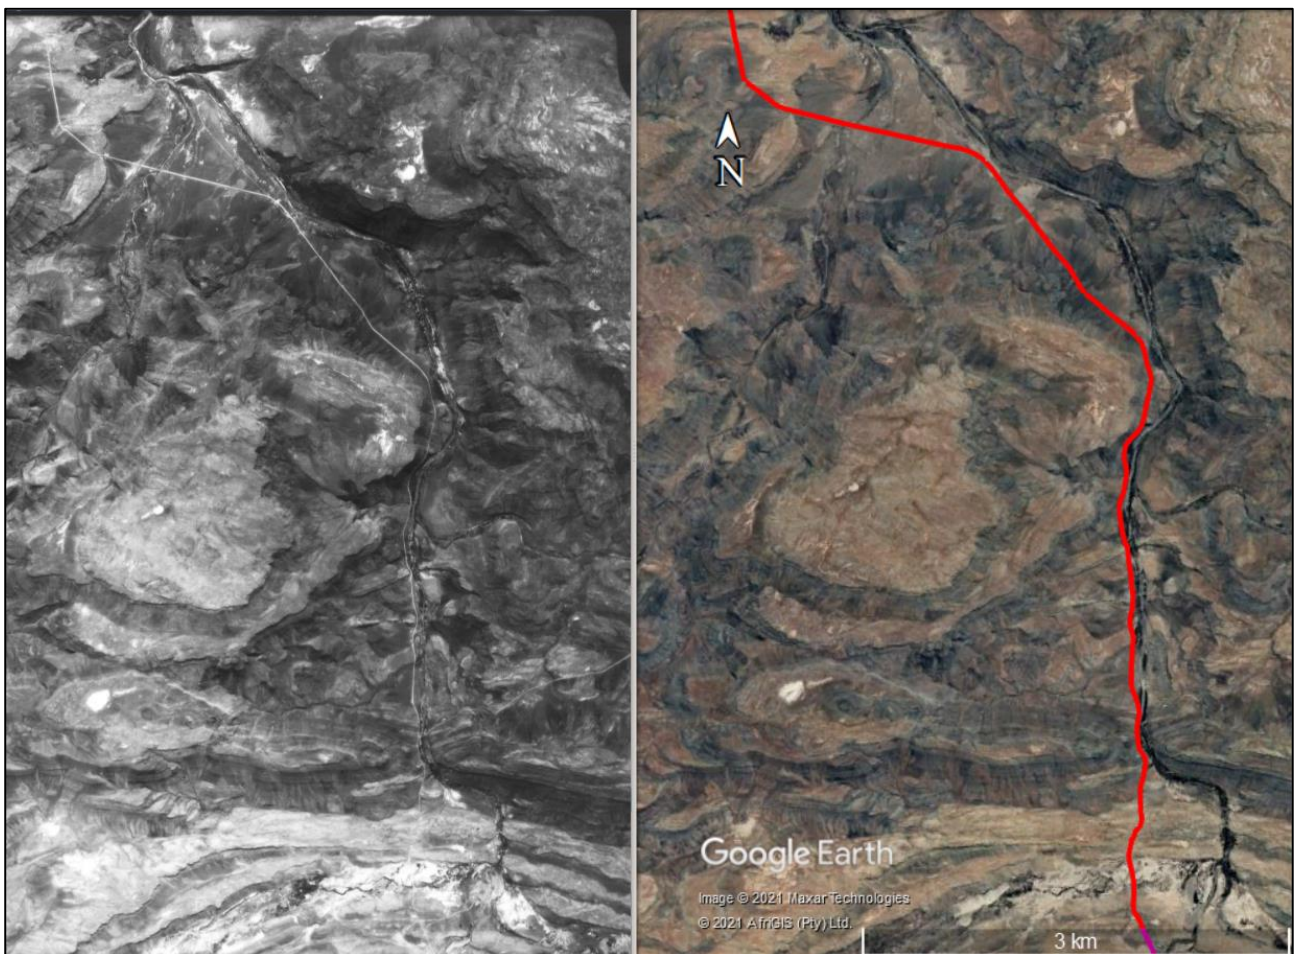
**Figure 20:** Aerial view (Job 450, Strip 11, photograph 4622) of almost the entire length of the upgrade section in 1960 (left) and 2020 (right). Importantly, the road cutting and dry-stone walling must have already been in place before 1960.

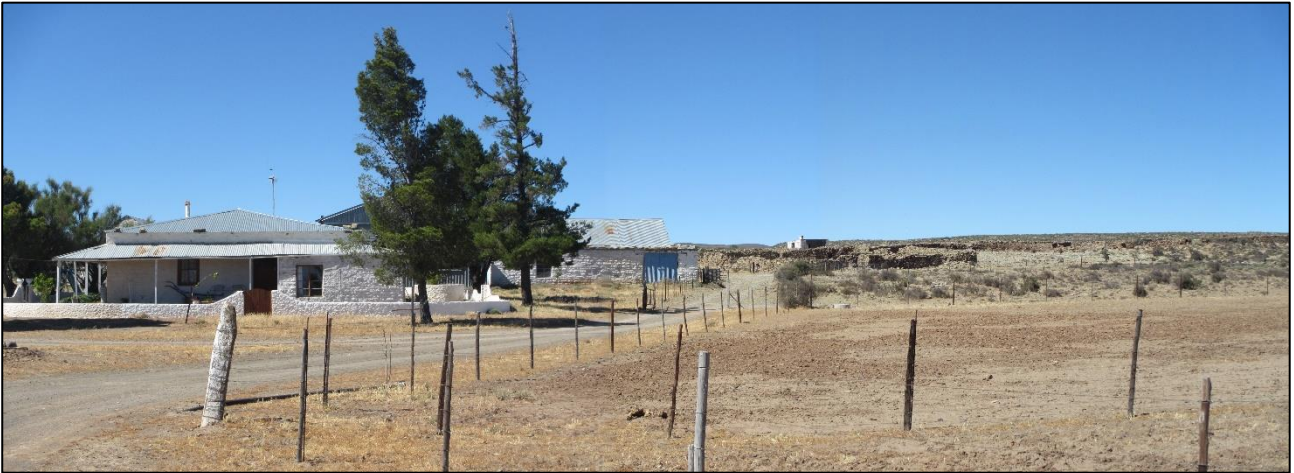
*Figure 21: View into the farmstead (waypoint 556).*

The farm complex at the southern end of the upgrade section is an important heritage resource (Figures 21 & 22). It will not be affected in any way by the presently proposed project which ends about 130 m north of the complex. The complex includes historical houses as well as many drystone-walled features.

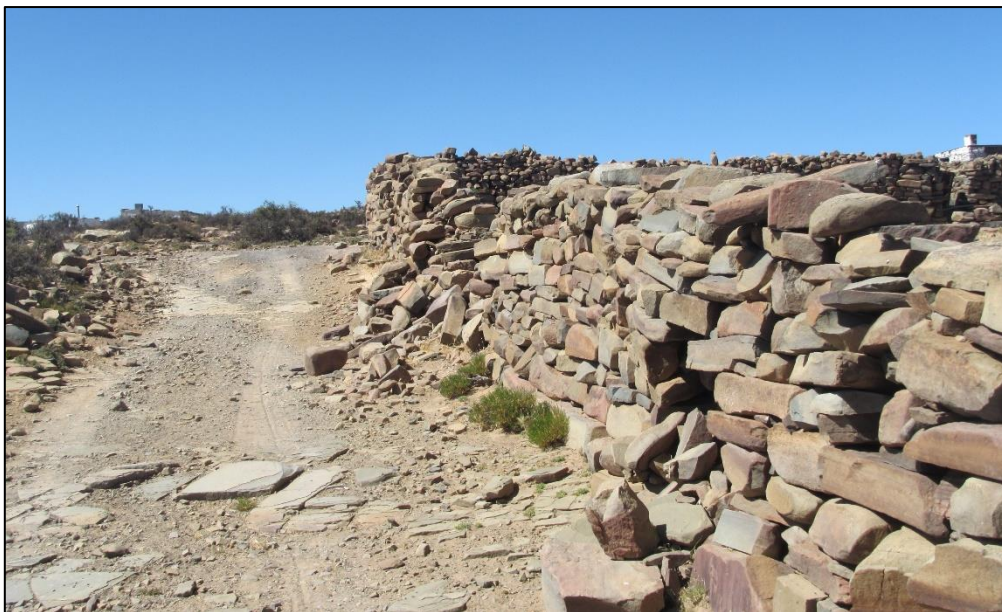
*Figure 22: Stone-walled kraal in the complex at waypoint 556.*

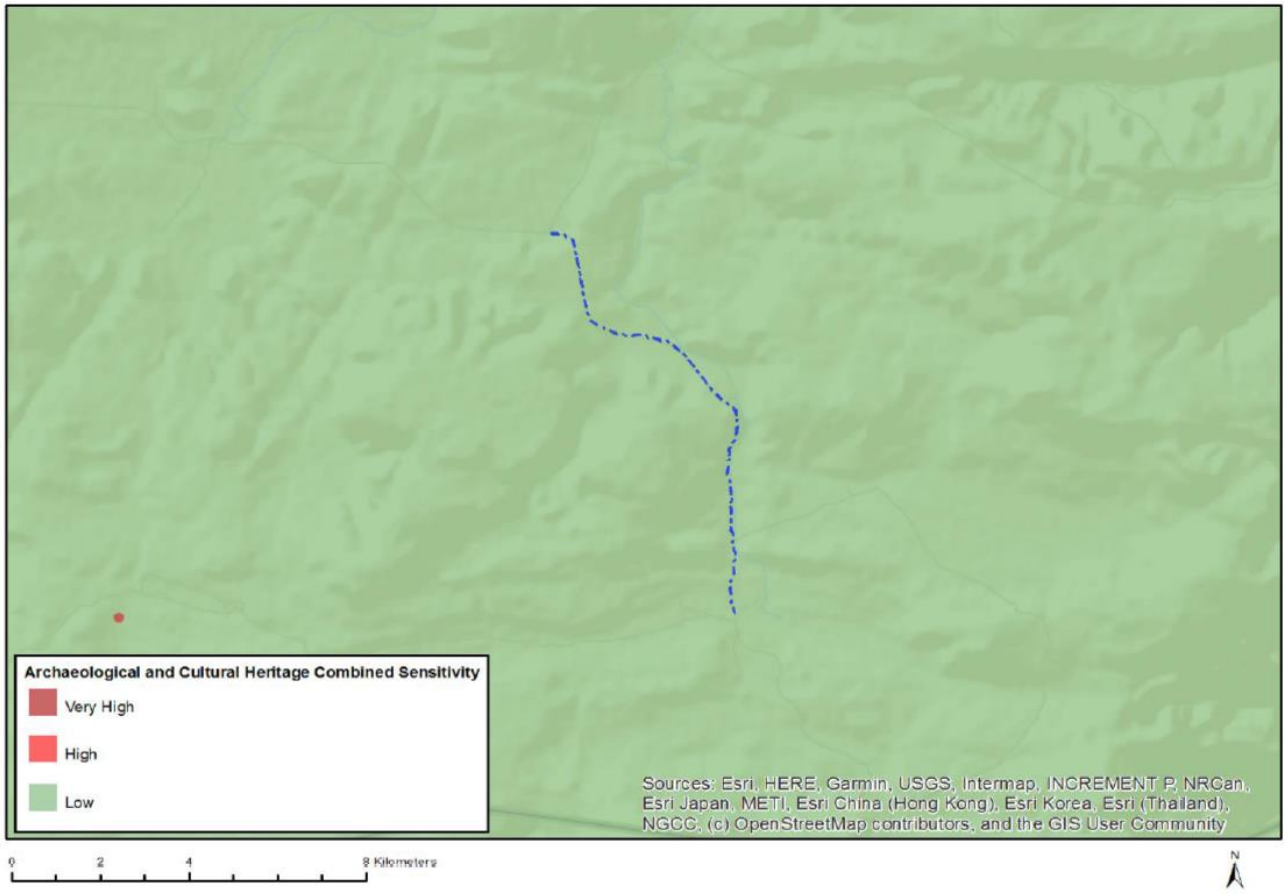
The map below is extracted from the screening tool report and shows the archaeological and heritage sensitivity to be low throughout the study area. The site visit showed that the majority of the site is indeed of low sensitivity with only a few specific locations (where archaeological resources were found) considered to be of higher sensitivity. Figures 7 to 9 in the report show the areas considered to be archaeologically sensitive. Since the sites are not of high cultural significance, these can be considered as medium sensitivity areas. A photographic record and description of the relevant heritage resource is contained within the impact assessment report. The specialist thus generally agrees with the screening tool sensitivity rating but noting that the low sensitivity is not uniform.
