WESTRAND STRENGTHENING PROJECT, SPANNING RANDFONTEIN, KRUGERSDORP & WESTONARIA, WESTRAND DISTRICT MUNICIPALITY, GAUTENG PROVINCE.

Phase 1 – Heritage Impact Assessment

Issue Date: 31 January 2019
Revision No.: 0.1
Project No.: 334HIA

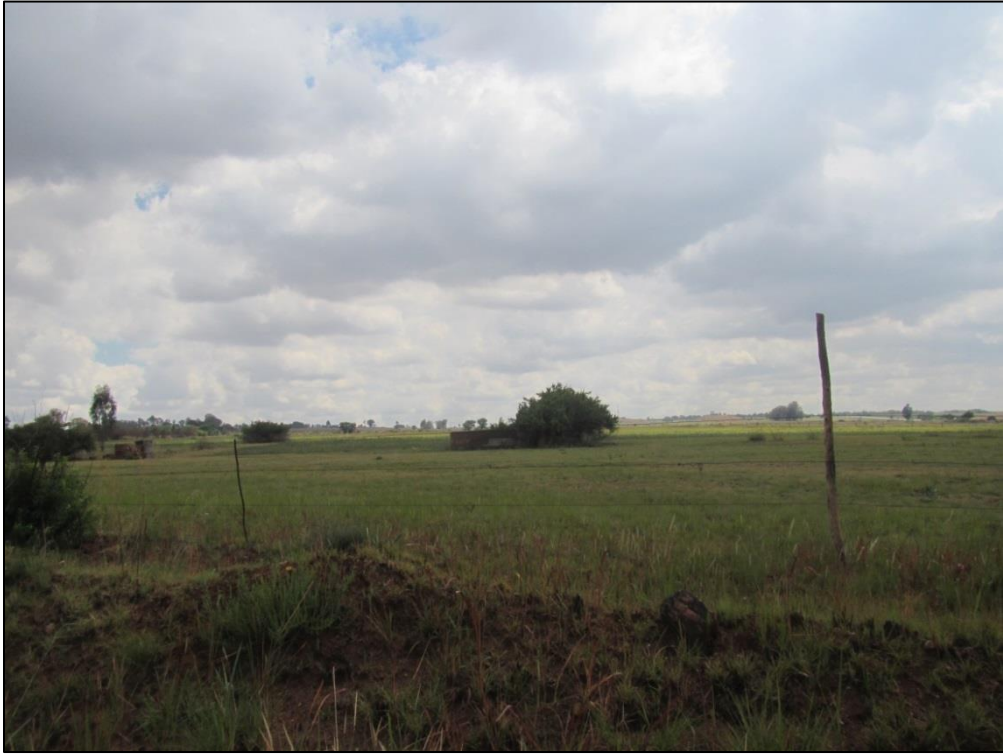
Site ¹ number	Lat	Lon	Description	Heritage Significance	Heritage Rating
WTR001	S26.29377°	E27.54612°	The site comprises of the remains of a brick built dam. This structure appears to date from the historic to recent past due to its design and the construction materials employed as well as its representation on the Historical Topographic maps. The structure measures 10m x 10m.	Low	GP.C

<p>Figure 32 – Remains of old brick dam</p>

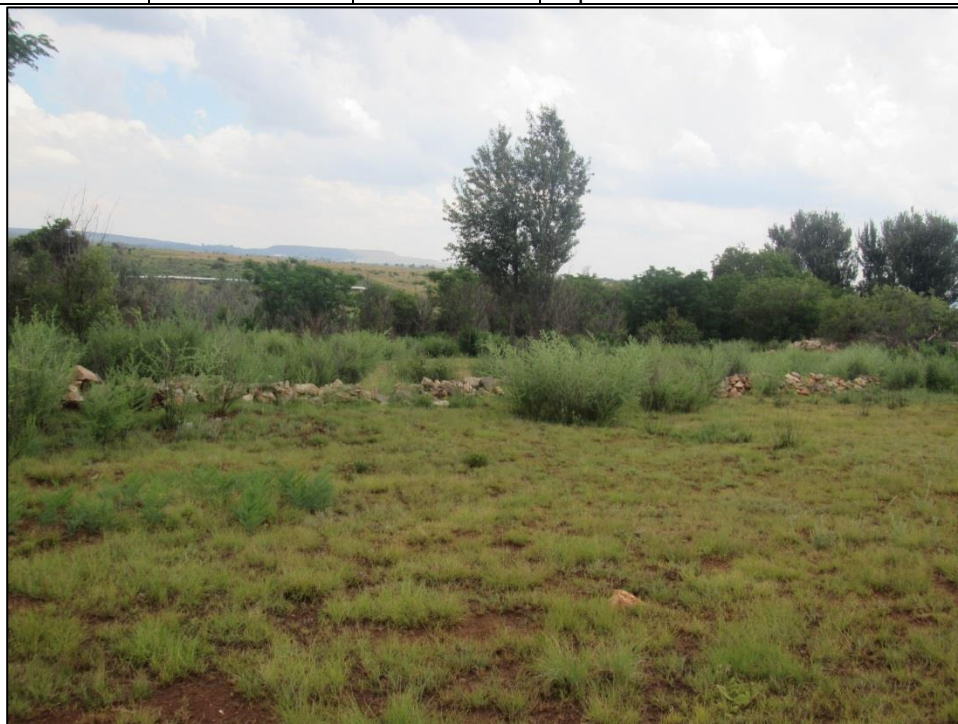
Site ⁵ number	Lat	Lon	Description	Heritage Significance	Heritage Rating
WTR005	S26.30261°	E27.59350°	The site comprises the remains of old stone walling. Presumably forming part of the farming compound at WTR006, the wall varies in height between 0.5m and 1.5m high, and is approximately 100m long with a small stone-built pen at its westernmost end, it was most likely used contain cattle. The wall is dry packed and in a relatively good state of repair. The site measures 150m in length.	Low	GP.C

Figure 48 – View of the stone walling at WTR005

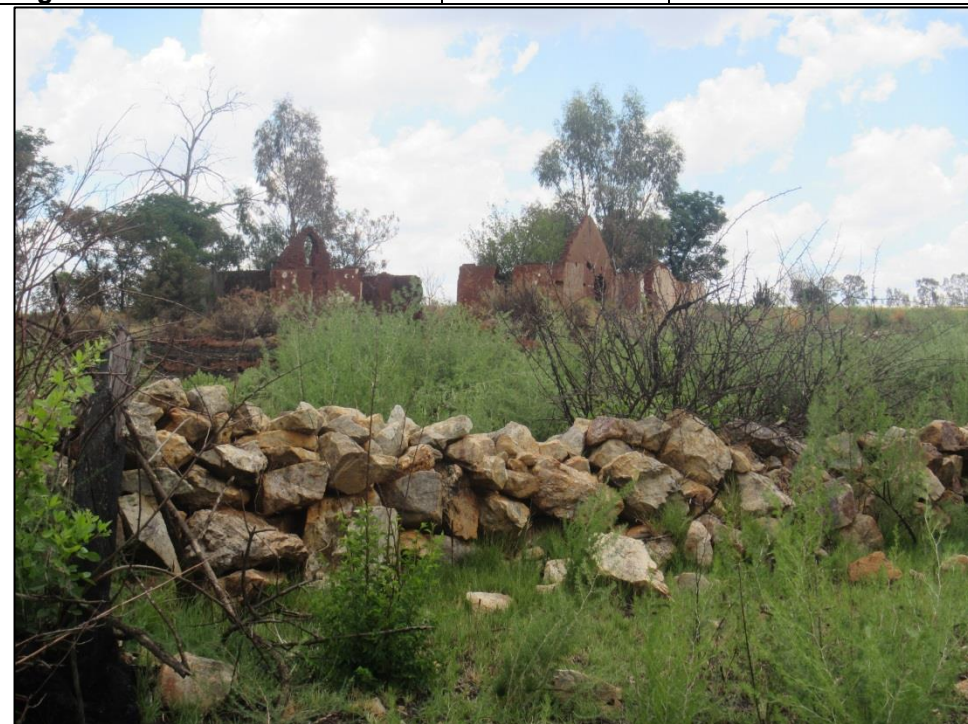
Figure 49 – Higher portion of the stone walling in the foreground, with site WTR006 in the background

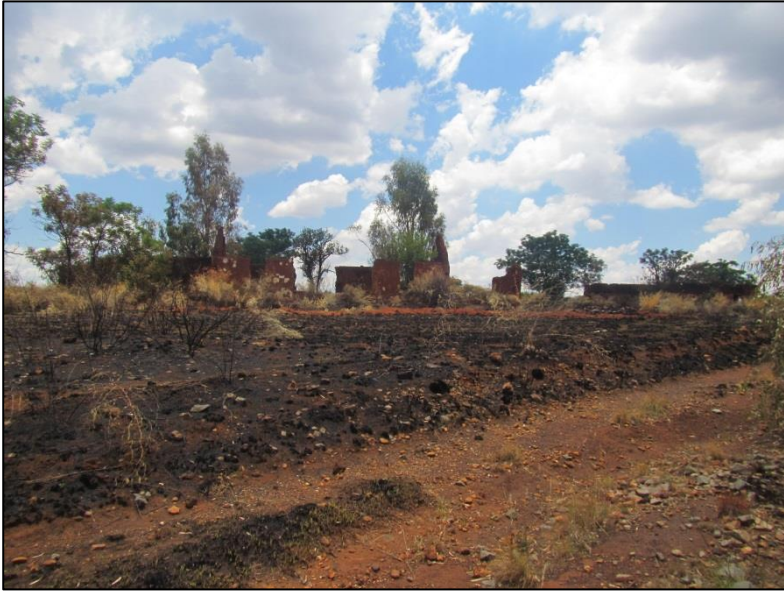
Site ⁶ number	Lat	Lon	Description	Heritage Significance	Heritage Rating
WTR006	S26.30238°	E27.59296°	<p>The site comprises two structures, the remains of an old farmhouse and its associated utility building (wagon shed). The farmhouse is a large multi-room house constructed of different types of bricks on a stone foundation. The bricks vary from mudbricks, through red bricks to relatively modern blue bricks. The 'header and stretcher' brick laying technique observed in its construction indicates an age older than 60 years. The remains of a verandah are visible along one side.</p> <p>Interestingly, there is also an outside oven built with bricks and standing on a concrete (and brick) plinth. This type of outdoor oven is known historically to be associated with the Voertrekkers, thus the likelihood of this farmstead being older than 100 years is quite high.</p> <p>The utility building is made of wattle, daub and stone, with two rooms. The lower part of the shed wall is constructed of stone, with mud bricks at the top. There is a door in the one side and the one end is completely open but this is probably due to weather damage. The structure was most likely used as a wagon shed.</p> <p>The overall site measures 80m x 40m. The main farmhouse measures 35mx15m and the utility building measures 18mx10m.</p>	Low	GP.B

Figure 50 – View of the whole of WTR006

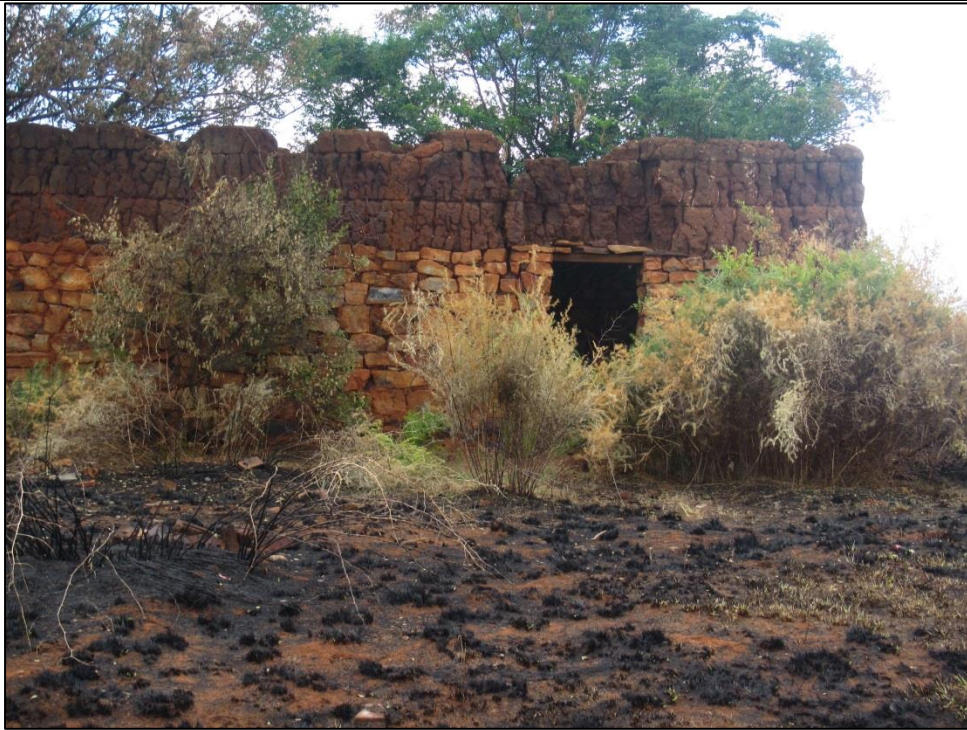
Figure 56 – View of utility building at WTR006

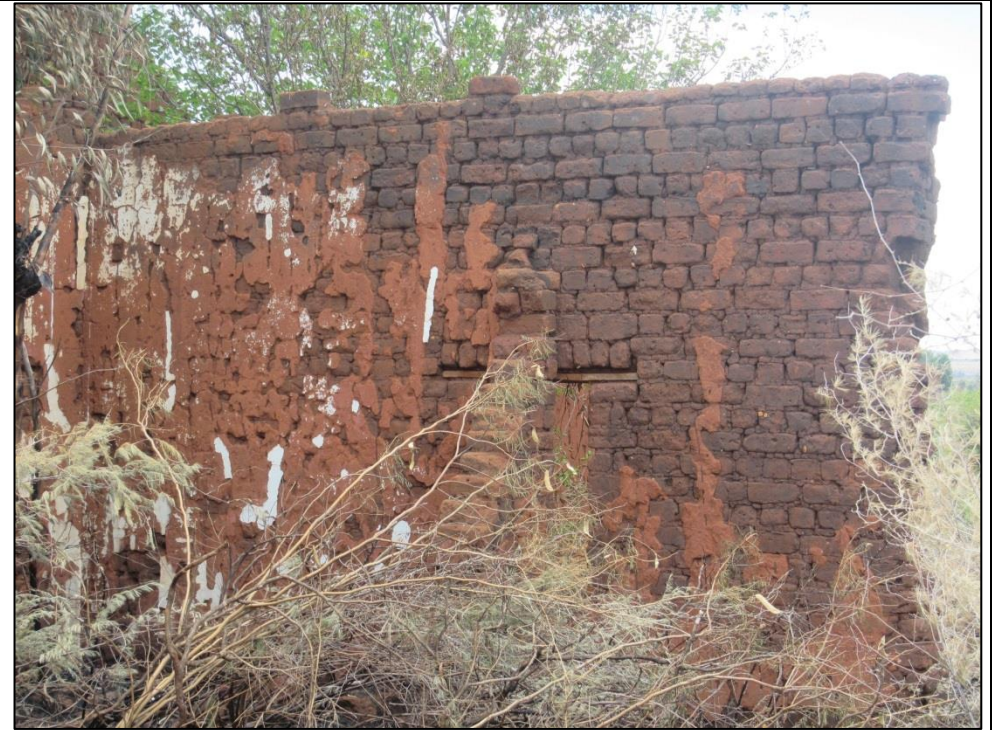
Figure 57 – One can see the 'header-stretcher' bricklaying technique

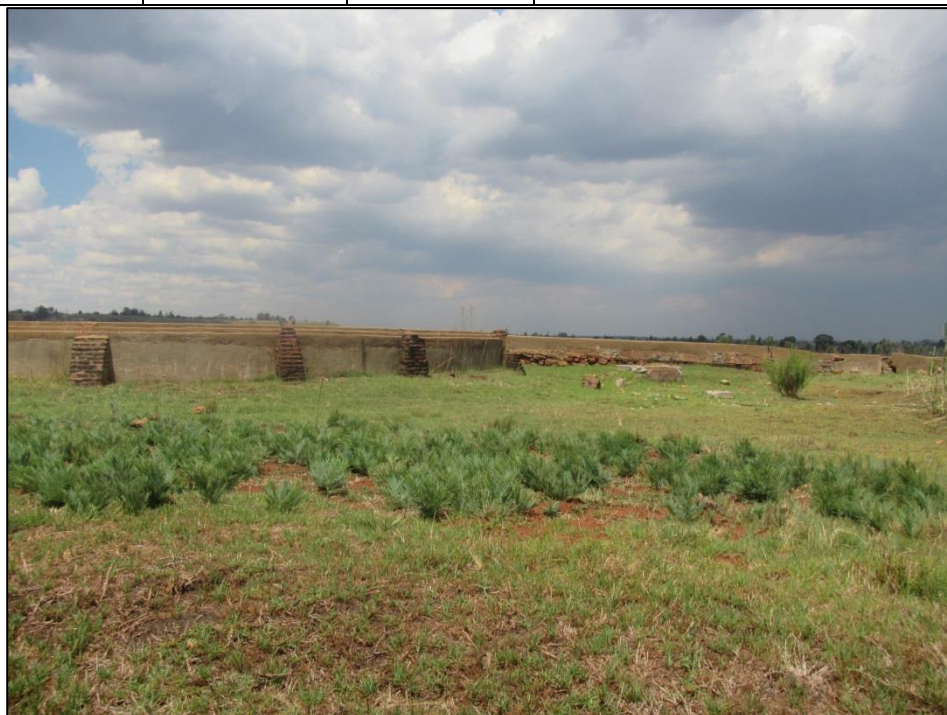
Site ⁷ number	Lat	Lon	Description	Heritage Significance	Heritage Rating
WTR007	S26.28798°	E27.62622°	The site comprises old farming infrastructure, consisting of several reservoirs and the foundations of 3-4 unknown structures. The reservoirs are constructed out of brick, stone and concrete and are connected with a spillway. These structures are shown on the historical topographic maps. In addition, this structure appears to date from the historic to recent past due to its design and the construction materials employed. The structure measures 65m x 25m.	Low	GP.C

Figure 58 – Overall view of reservoirs and spillway at WTR007

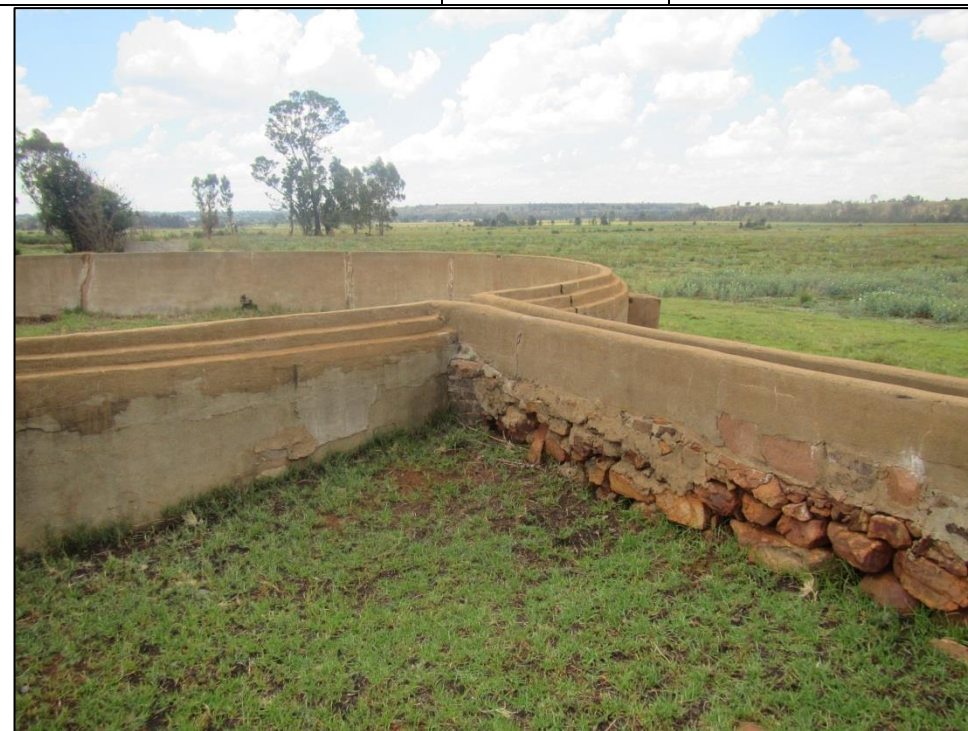
Figure 59 – Circular reservoir and upper portion of spillway

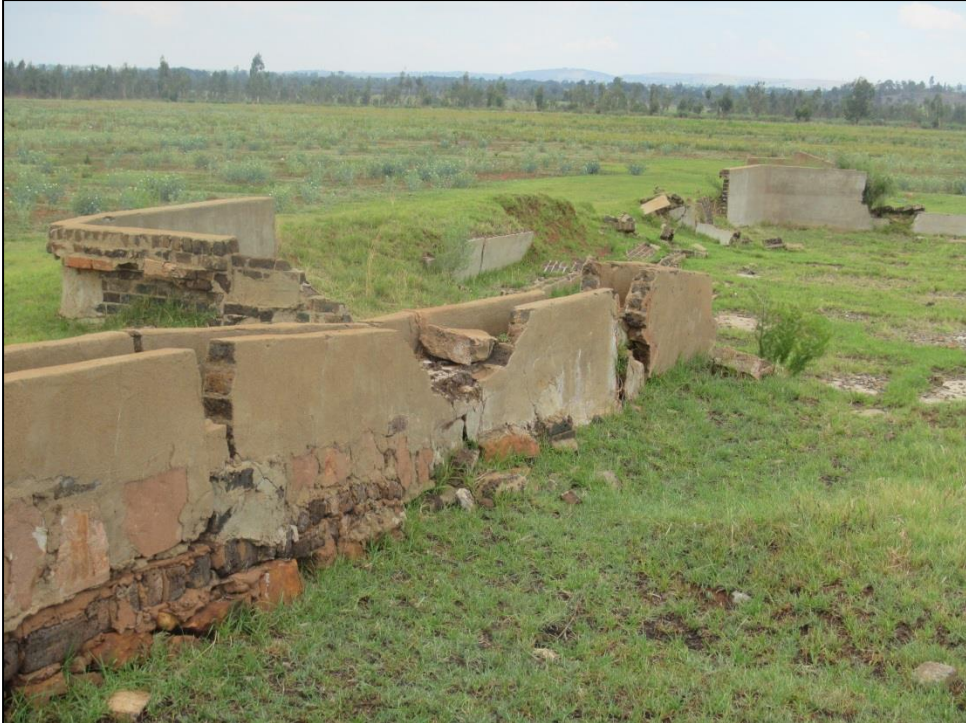
Figure 60 – Lower portion of spillway and remains of lower rectangular reservoir

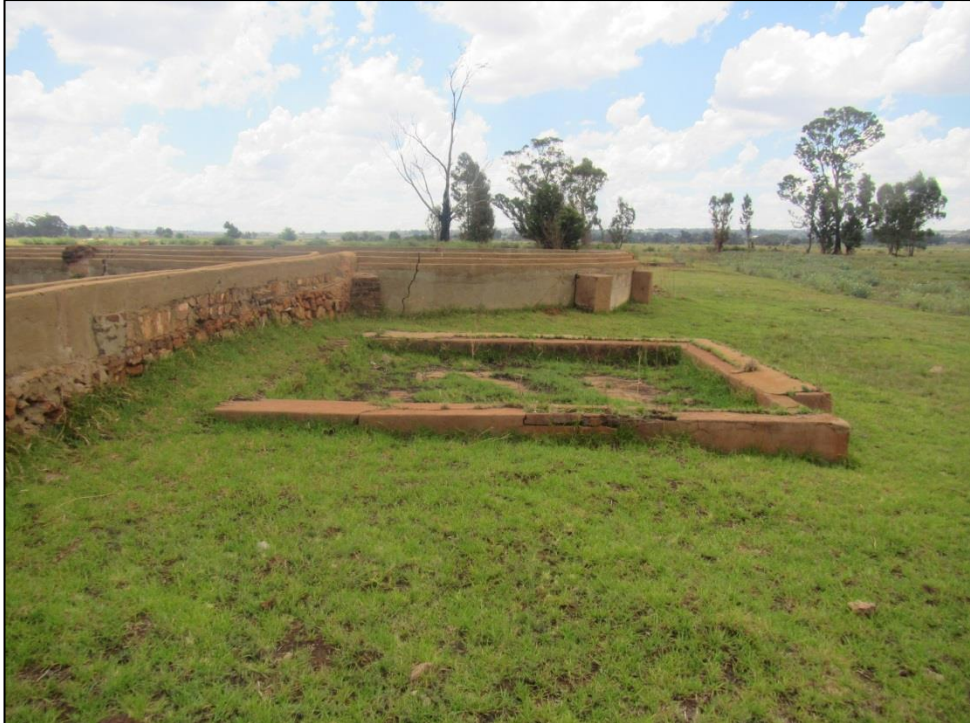
Figure 61 – Foundational remains of unknown structure next to spillway

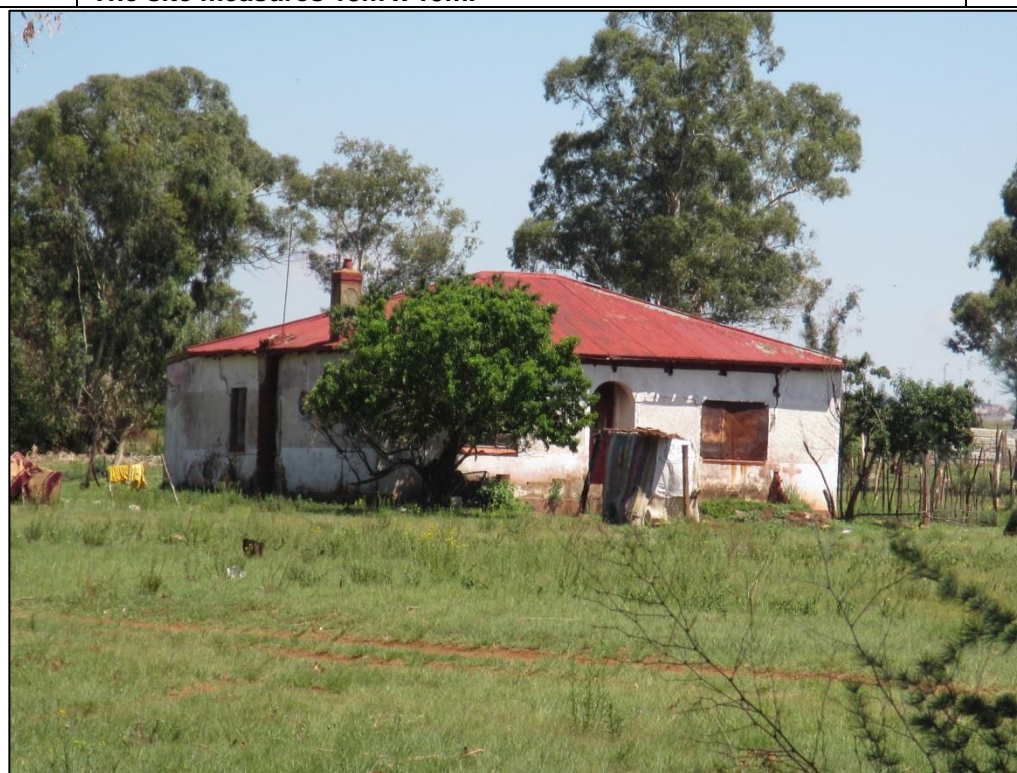
Site ¹¹ number	Lat	Lon	Description	Heritage Significance	Heritage Rating
WTR011	S26.24599°	E27.72098°	<p>The site comprises an old house that is currently occupied and associated outbuildings. It is at least 60 years old as indicated by the historical topographic maps. In addition, this structure appears to date from the historic to recent past due to its design and the construction materials employed.</p> <p>The site measures 15m x 15m.</p>	Low	GP.C

Figure 70 – View of structure at WTR011

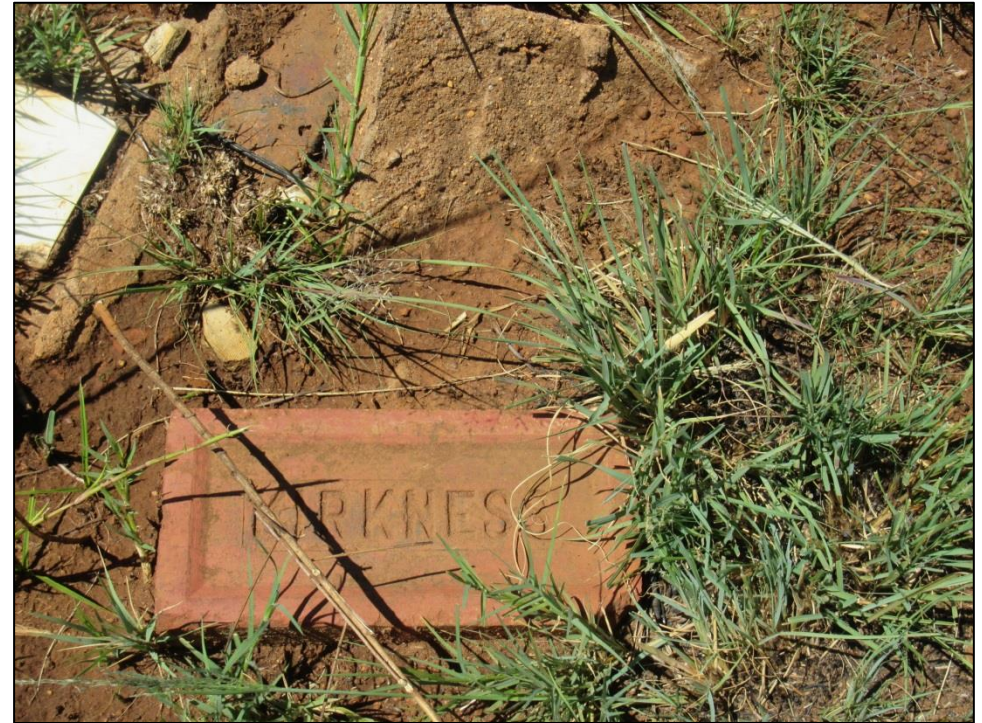
Figure 81 – Example of a Kirkness brick identified on site

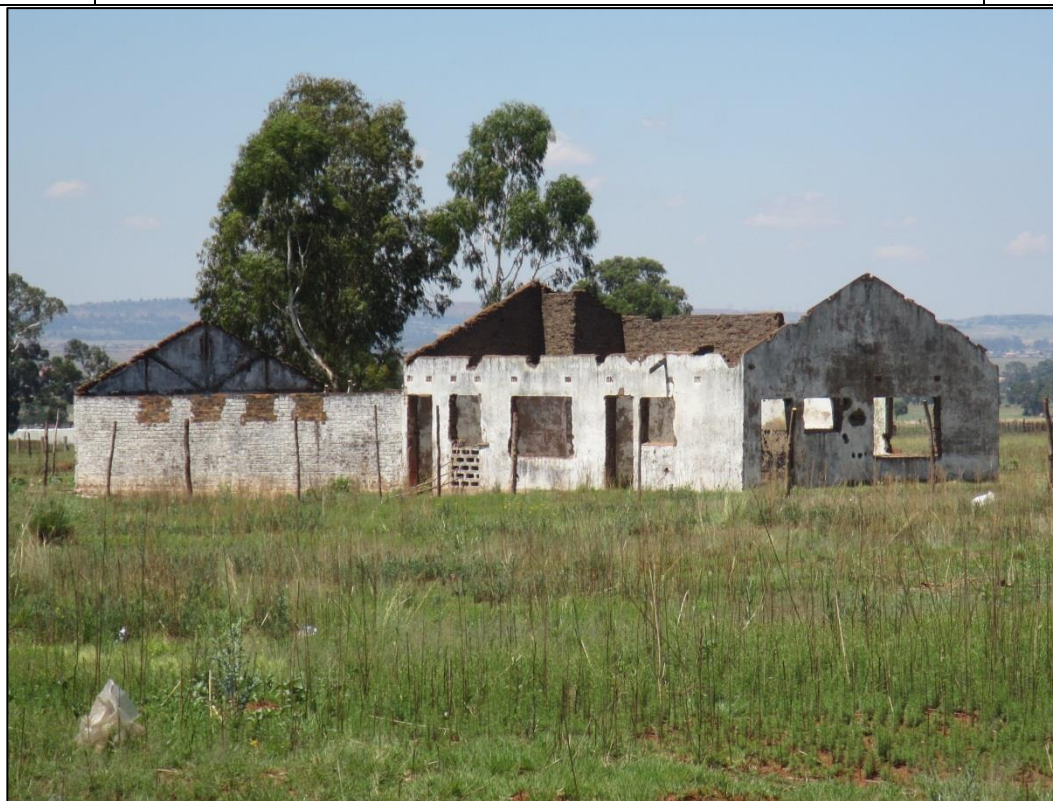
Site ¹⁵ number	Lat	Lon	Description	Heritage Significance	Heritage Rating
WTR015	S26.24230°	E27.71787°	The site comprises the remains of an old house. It is at least 60 years old as indicated by the historical topographic maps. In addition, this structure appears to date from the historic to recent past due to its design and the construction materials employed. The site measures 25m x 10m.	Low	GP.C

Figure 83 – View of structure and one of the outbuildings

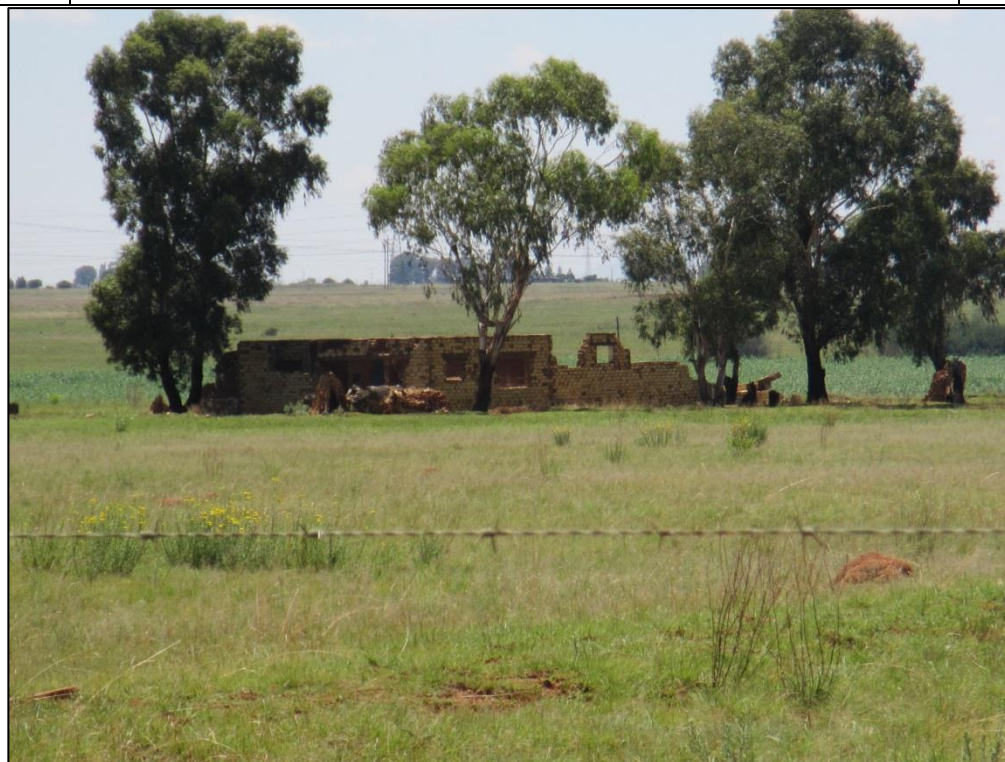
Site ¹⁷ number	Lat	Lon	Description	Heritage Significance	Heritage Rating
WTR017	S26.25129°	E27.71817°	<p>The site comprises the remains of an old house. It is at least 60 years old as indicated by the historical topographic maps. In addition, this structure appears to date from the historic to recent past due to its design and the construction materials employed.</p> <p>The site measures 25m x 10m.</p>	Low	GP.C

Figure 86 – View of the structural remains at WTR017

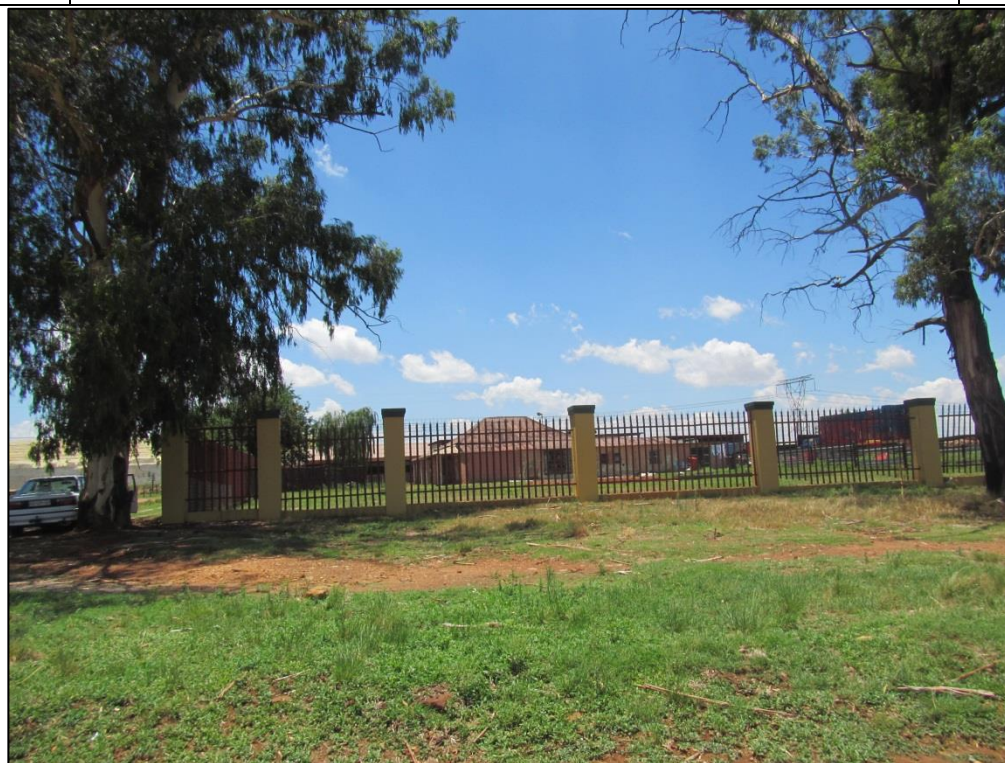
Site ¹⁸ number	Lat	Lon	Description	Heritage Significance	Heritage Rating
WTR018	S26.24155°	E27.73526°	<p>The site comprises an old house that is currently occupied and associated outbuildings. It is at least 60 years old as indicated by the historical topographic maps. In addition, this structure appears to date from the historic to recent past due to its design and the construction materials employed.</p> <p>The site measures 100m x 100m.</p>	Low	GP.C

Figure 87 – View of structure and one of the outbuildings

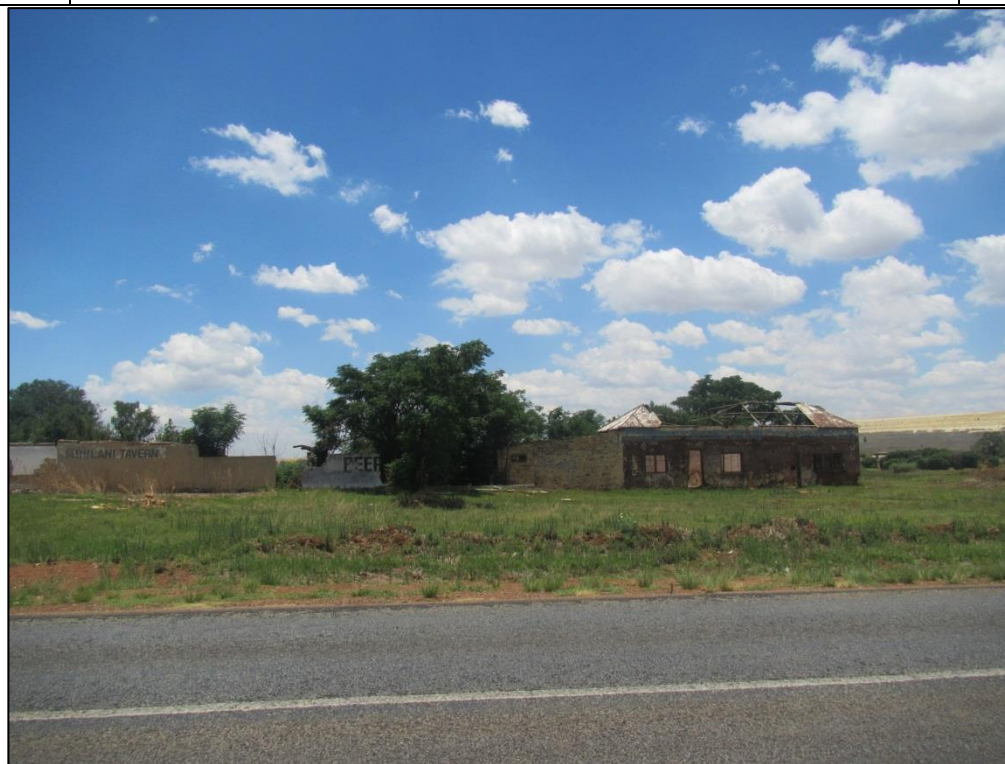
Site ¹⁹ number	Lat	Lon	Description	Heritage Significance	Heritage Rating
WTR019	S26.24161°	E27.72844°	<p>The site comprises the remains of an old set of shops. It is at least 60 years old as indicated by the historical topographic maps. In addition, this structure appears to date from the historic to recent past due to its design and the construction materials employed.</p> <p>The site measures 100m x 60m.</p>	Low	GP.C

Figure 88 – View of structure and one of the outbuildings
